M E M O R A N D U M

SUBJECT: Mitigations Supporting Final Return to Service Plan

DATE: October 13, 2022

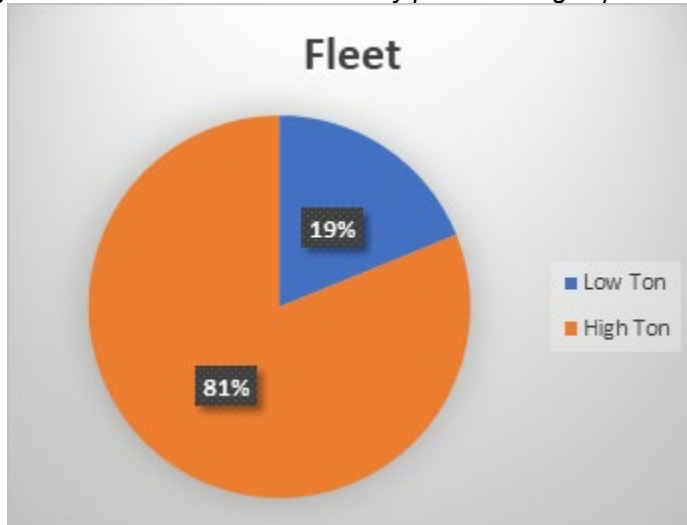
Figure 1. Fleet distribution of axle by press tonnage specification

The total population of axles on the 7K fleet is 2,992. Of this population, 564 axles were originally assembled with at least one wheel satisfying the lower press tonnage specification; 2,428 were assembled with the higher press tonnage specification, representing 19% and 81% of the fleet respectively as shown in Figure 1 below.

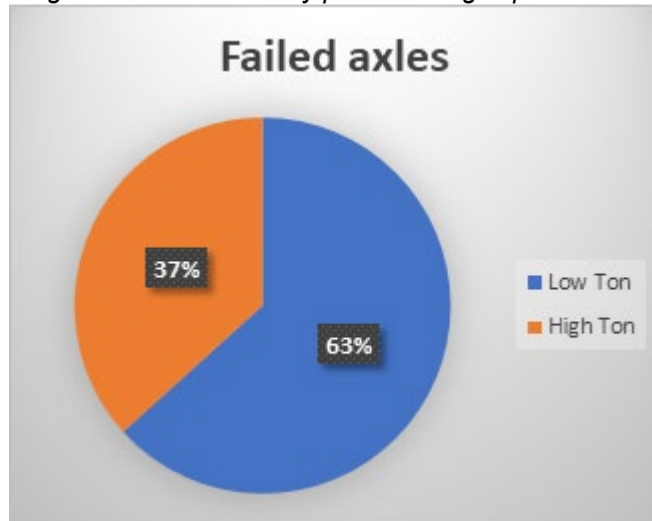
Figure 2. Failed axles by press tonnage specification

Of the 79 axle failures, 50 were assembled utilizing the lower tonnage specification and 29 utilizing the higher tonnage specification, representing 37% and 63% of the failures respectively as shown in Figure 2 below. There is no clear trend of the failure rate between the two press tonnage populations.

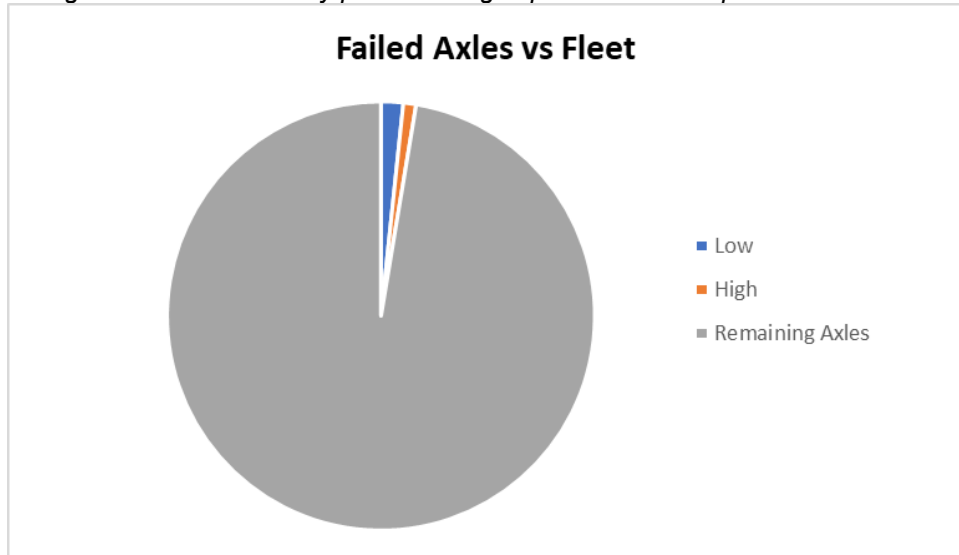
Figure 3. Failed axles by press tonnage specification compared to the Fleet

Of the 2992 axles, 50 axles assembled with the lower tonnage specification failed, representing 1.7% of the entire fleet and 29 axles assembled with the higher tonnage specification failed, representing 1.0% of the entire fleet as summarized in Table 3 and Figure 3 below.
