Washington Metropolitan Area Transit Authority
Board Action/Information Summary

Briefing on Jumper Cable Inspection and Repair

Briefing on Jumper Cable Inspection & Repair

Safety Committee
March 24, 2016

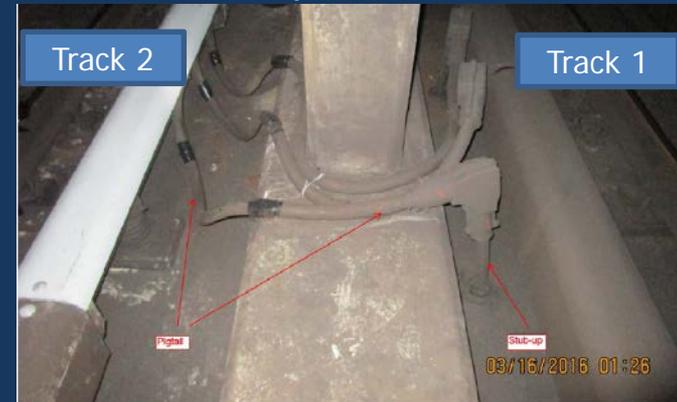
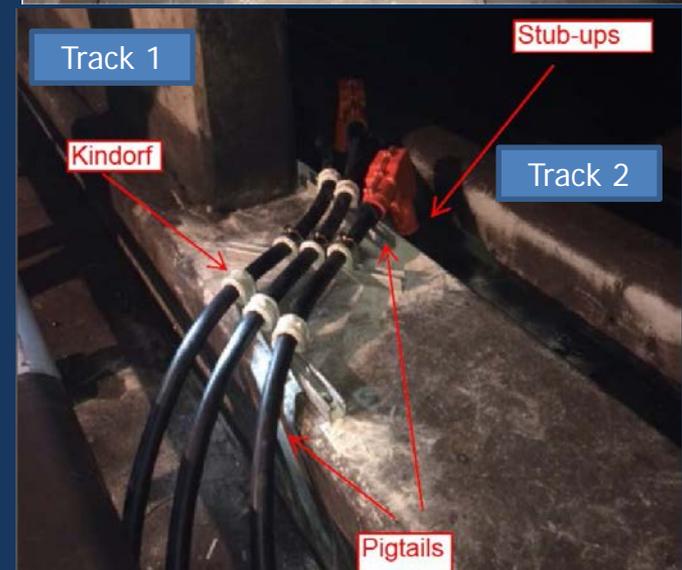
McPherson Sq (Before and After)

- Three of the 27 considered “highest priority”
 - McPherson Square (Recent Incident)
 - Potomac Avenue
 - Foggy Bottom
- All 27 defects have been corrected
- Inspection revealed 338 locations requiring non-emergency repair
- Inspection and repair process communicated to NTSB and FTA WMATA Safety Oversight
