Washington Metropolitan Area Transit Authority  
**Board Action/Information Summary**

Update on Derailment Investigation

SUBJECT: Board Member Questions  
August 6, 2015 Derailment

# Update on Derailment Investigation

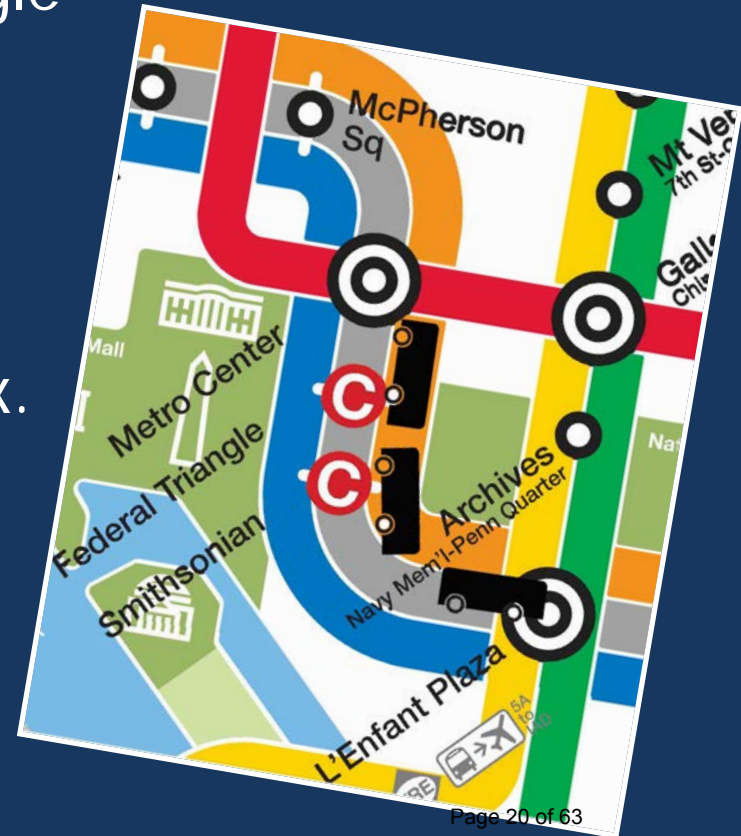
- August 6, 2015 at 5:20 a.m.
- Derailment between Federal Triangle and Smithsonian
- Five cars came off the rails; no passengers
- Manual operation; traveling approx. 15 mph
- Significant disruption August 6-7; total shutdown followed by single tracking
