October 7, 2019 Incident at Farragut West

Preliminary Briefing

Safety and Operations Committee
October 10, 2019

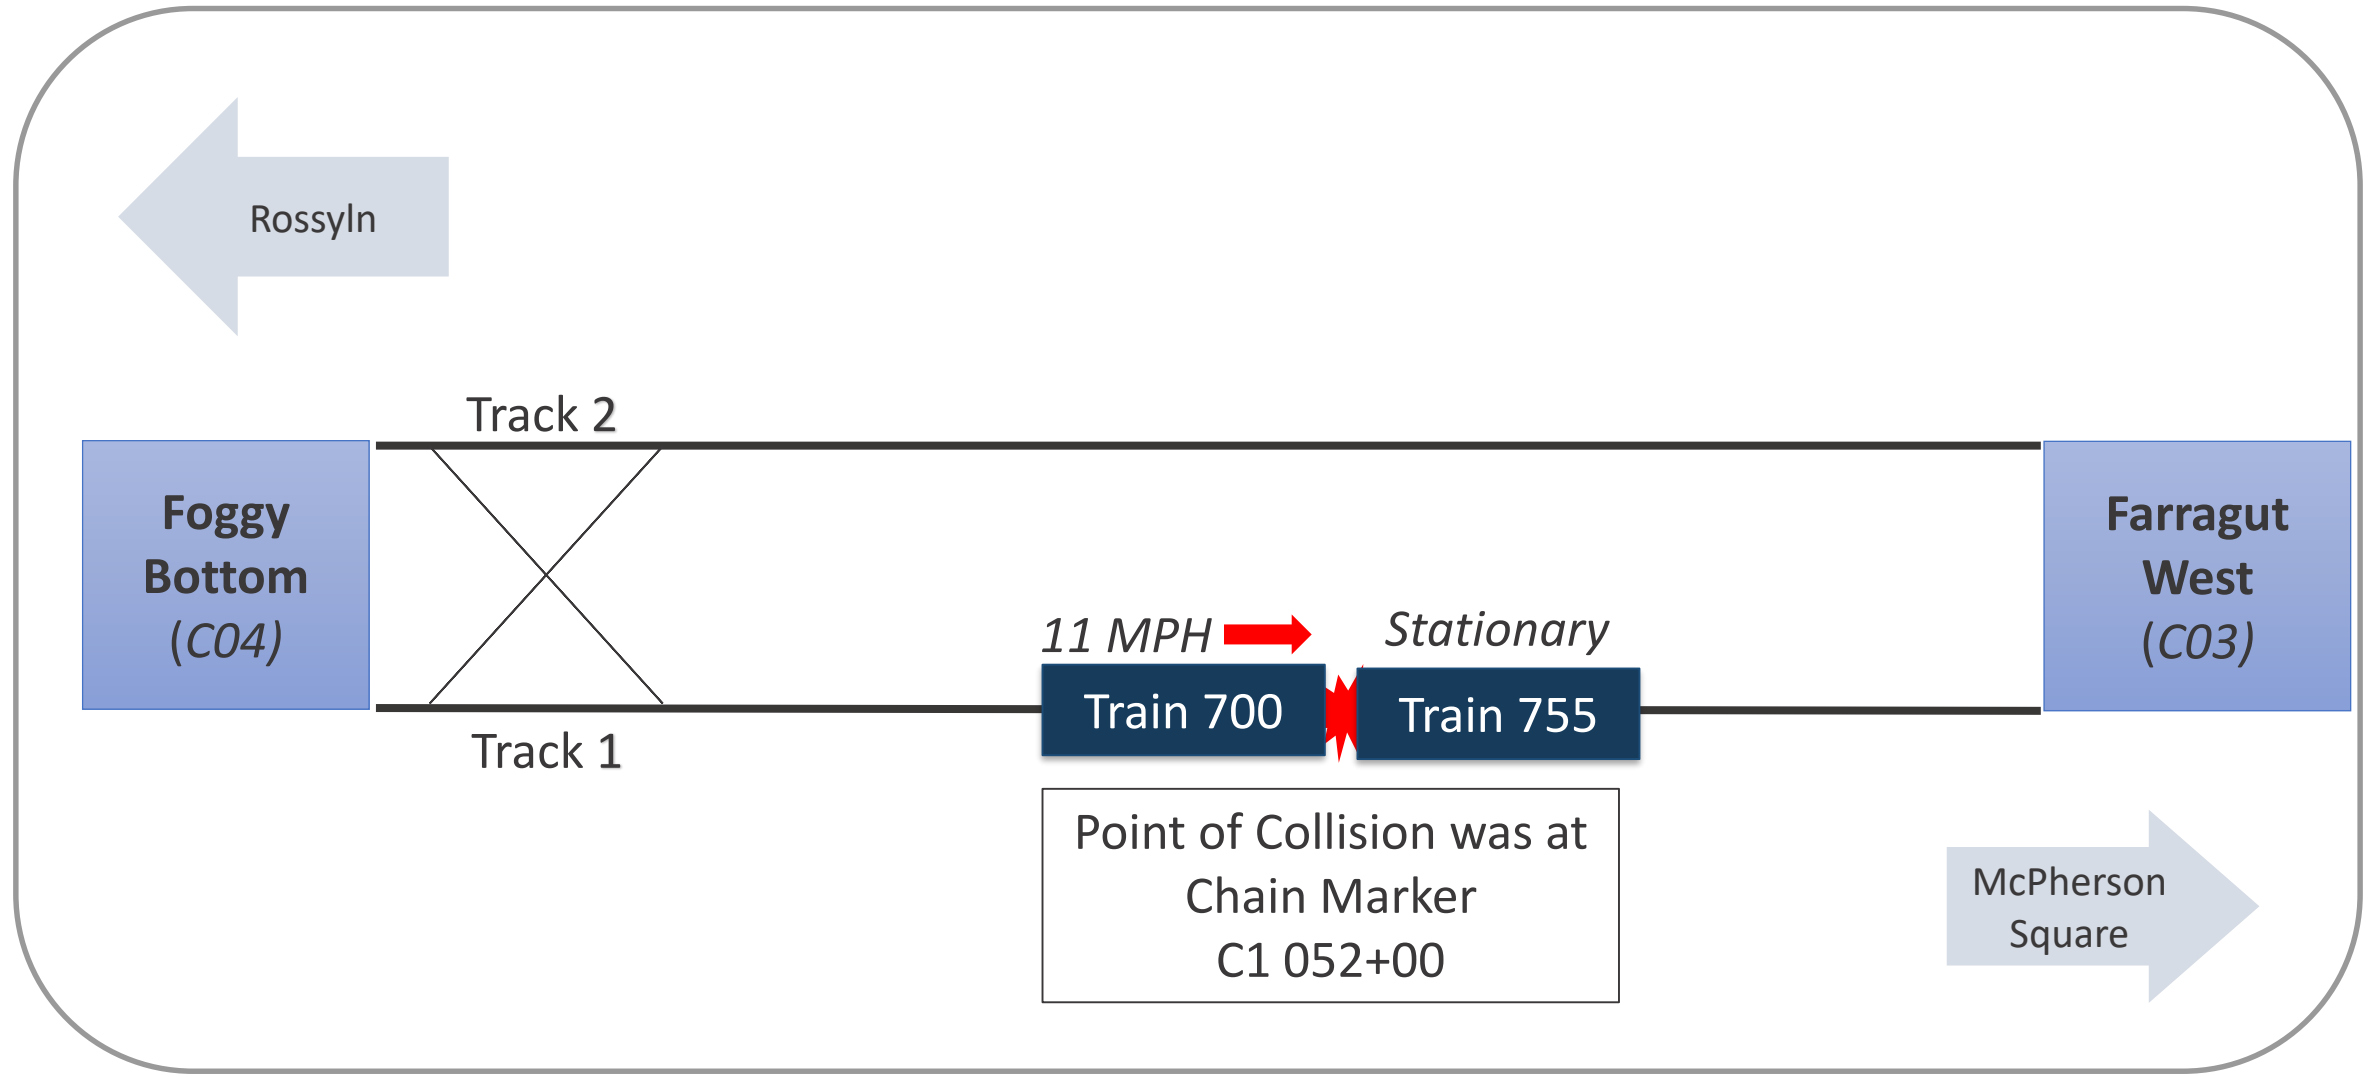
Track Diagram

Outside
Farragut
West: Train
#700 made
contact with
Train #755
on track #1

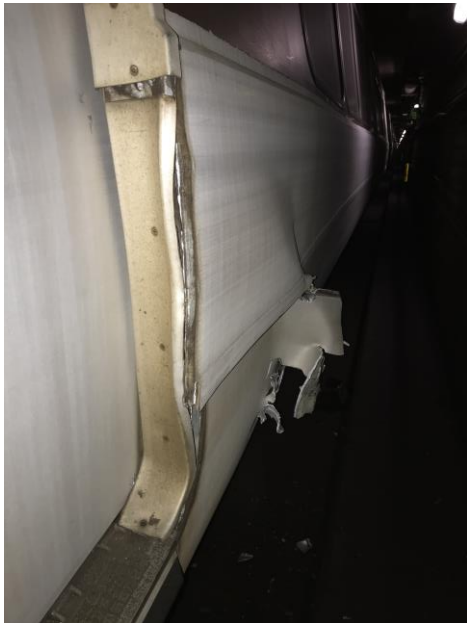
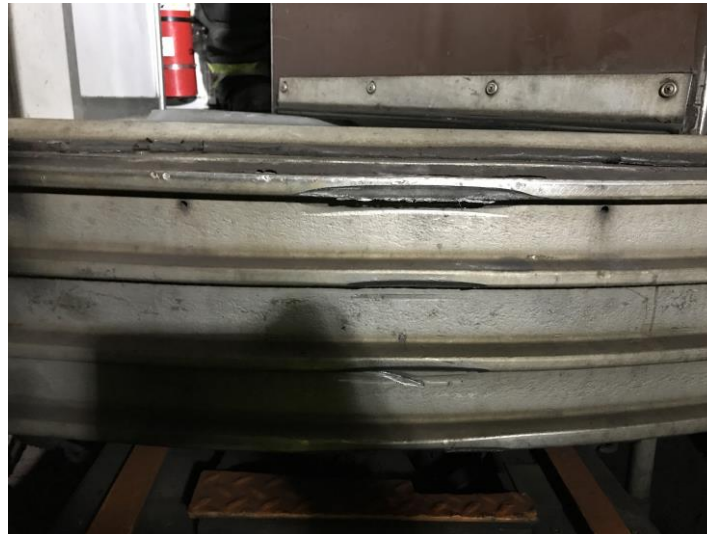
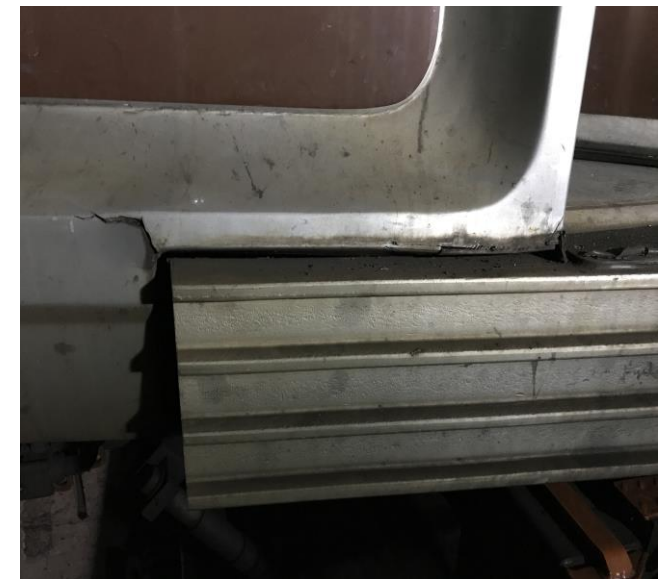
- Examination of the trainsets in the positions at which they came to rest, indicated that all wheels of both trains were resting on the running rails.
- The second car of Train 755 (stationary train) had separated (18") from the third car of the consist.
- There was visual damage to both train consists involved, with the lead car of Train 700 sustaining the most damage.
