Update on January 15, 2018 Derailment

Washington Metropolitan Area Transit Authority

Derailment: January 15, 2018

Farragut North Station

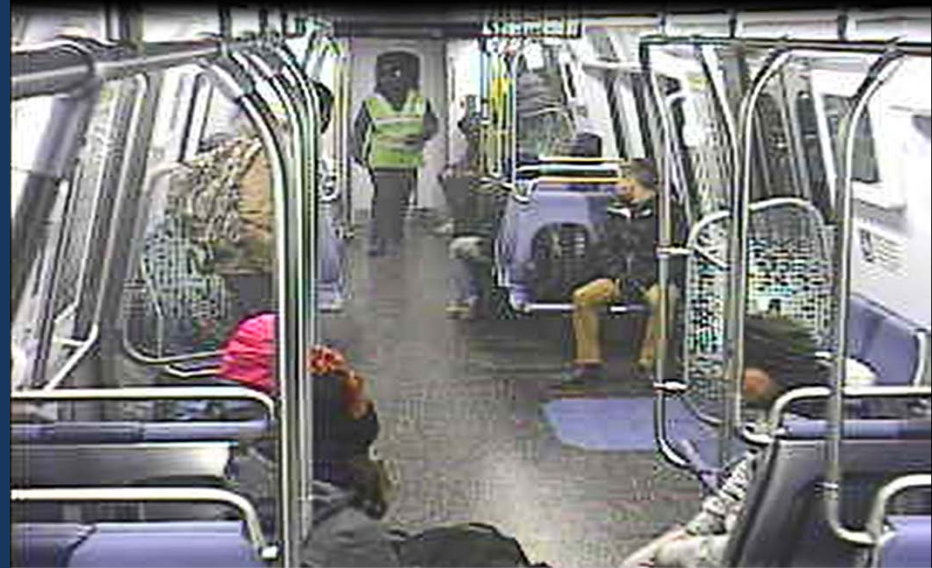
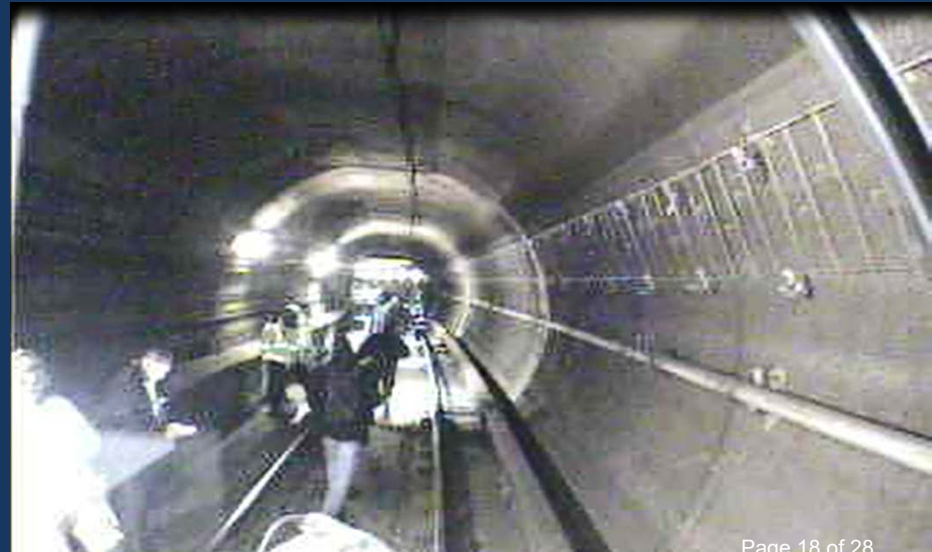
Evacuation/Life Safety

- Smoke reported likely concrete dust
- Tunnel lighting illuminated
- Evacuation path was free of obstructions
- No injuries were reported
- Tunnel fans working
- PLNT engineering analysis requested of fan operations
- Incident Hot-wash conducted

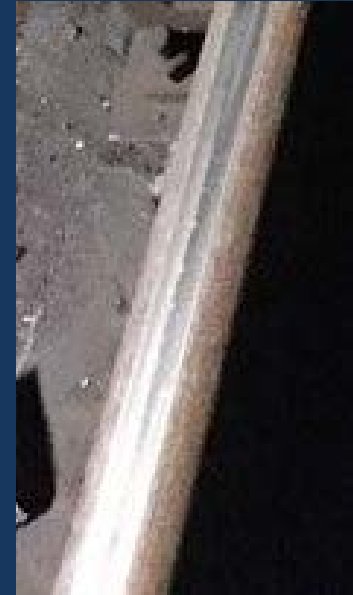
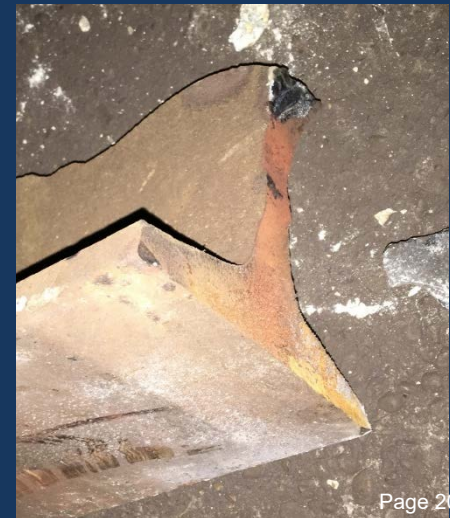
Track and Structures

WMATA Safety personnel responded to the scene and commenced with investigative activities. An eight foot section of rail was found to be fractured and was determined to be the Point of Derailment (POD). A crack at the base of the broken rail appeared to show signs of oxidation, which suggests that the integrity of the rail was compromised prior to the rail fully fracturing during the incident. This section of rail was removed, quarantined and sent for metallurgical testing to aid in identifying the root cause of the derailment. A final determination on the root cause or contributing factors in this incident has not been made; however, the fractured rail obviously played a significant role in this event. At 10:30 AM on January 16, 2018, normal service resumed.

- 7K video reflects rail was intact
- No ATC issues (bobbing track circuits)
- Rail manufactured in 1993
- Rail located on low side of unguarded curve at CM A1 28+20
- Crack present at base-appeared to exhibit signs of oxidation
- Environmental conditions-Dry
- Weather-under evaluation
- Rail sent for independent analysis
