Collector Shoe Assemblies Update

Washington Metropolitan Area Transit Authority

Safety & Operations Committee
March 7, 2024

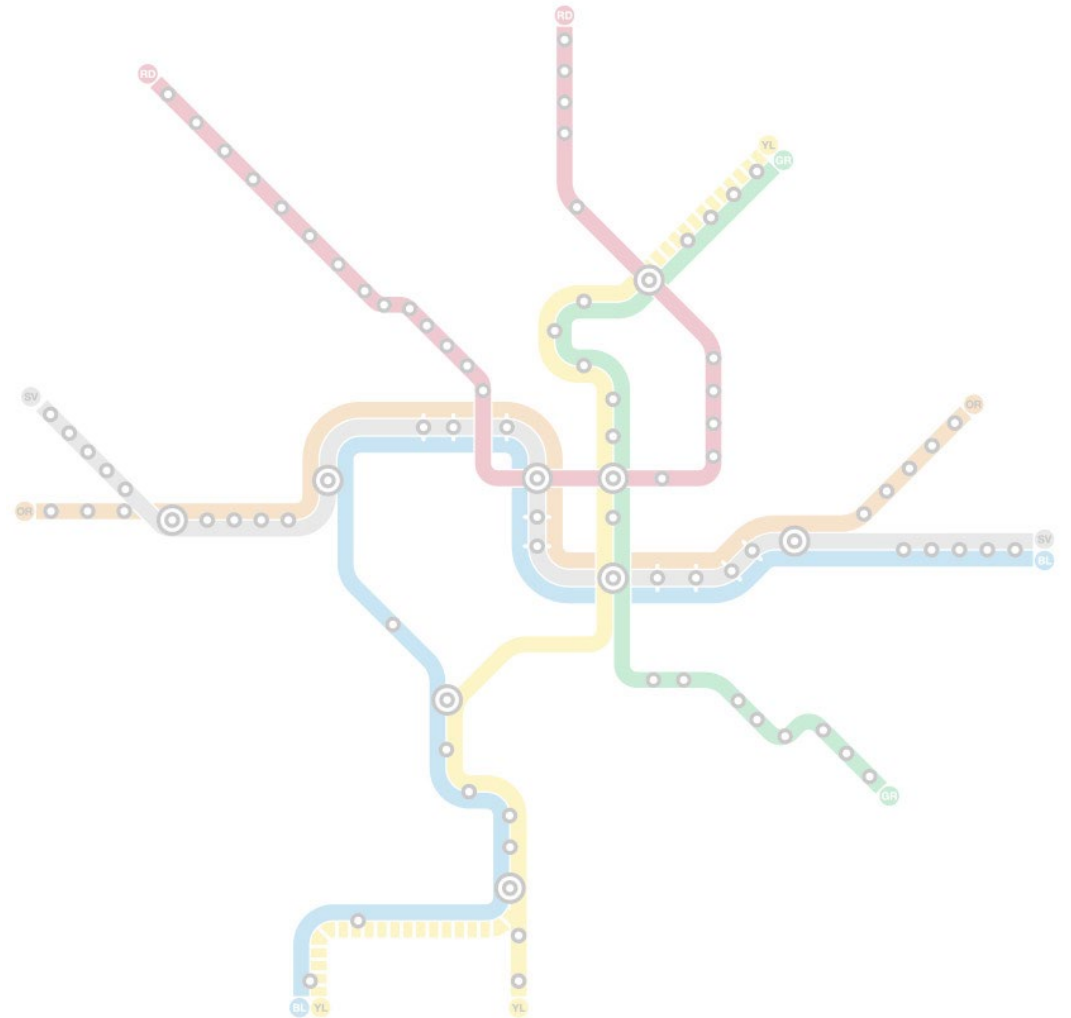
Eastern Market Incident on Feb.15, 2024

- Collector shoe assembly (draws electric power to the train by contacting third rail) dislodged
- Dragged and grounded causing second collector shoe on same railcar to fail in station limits
- Resulted in smoke and fire
- Rail Operations and Metro Transit Police personnel immediately evacuated the train and station

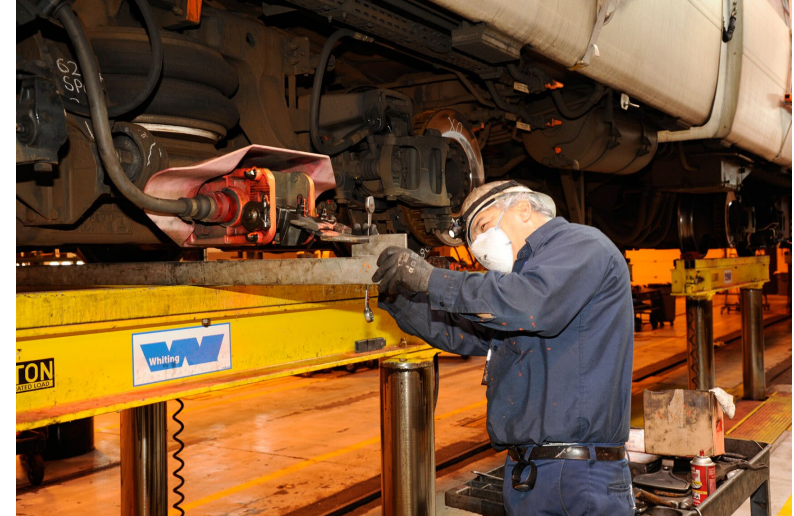
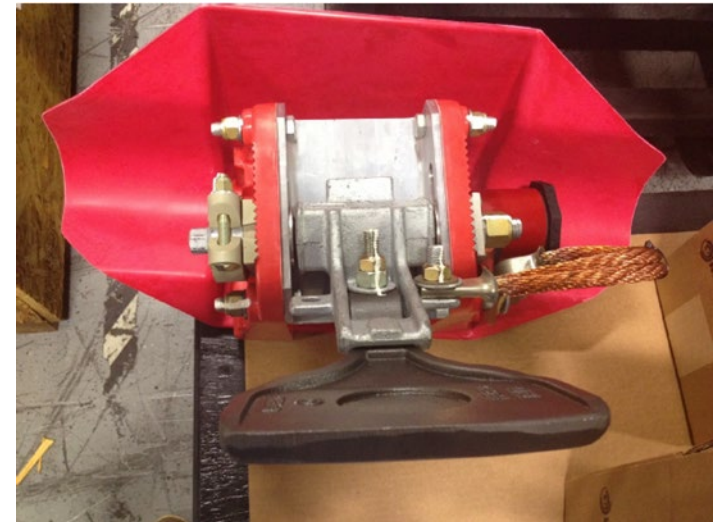
Railcar Maintenance & Engineering Actions

- Completed fleet inspection of all railcars
- Improved procedures for inspections, including quality review, completed
- Engaged the Original Equipment Manufacturer and outside consultants
- Ongoing review vehicle and maintenance data
- **Coming:** A test program will start week of March 10 to measure third rail height, third rail current, and thermal imagery of the entire system

Track & Structures and Power Actions

- Completed Track Geometry Vehicle inspections on all lines
- Completed walking inspections on all lines
- Engaged an outside consultant
- **Ongoing:** Measuring the height of every end of the third rail
