Board Information Item III-C

Update on Derailment and 2000/3000 Series Railcars

Safety & Operations Committee October 12, 2023

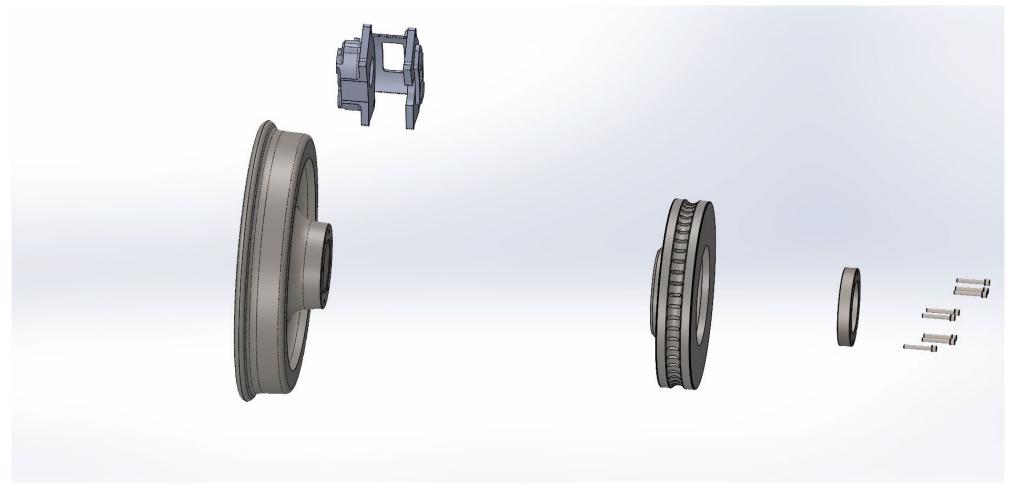
Animation of Friction Disc Assembly

The 2K/3K railcars are equipped with a friction brake system which uses brake discs to provide service and emergency braking effort. The brake discs are secured to the outer surface of the wheel hub with eight (8) one-half inch (1/2") diameter bolts.
