Union Station – Train Separation Event October 9, 2020

Preliminary Investigation
Briefing
October 22, 2020

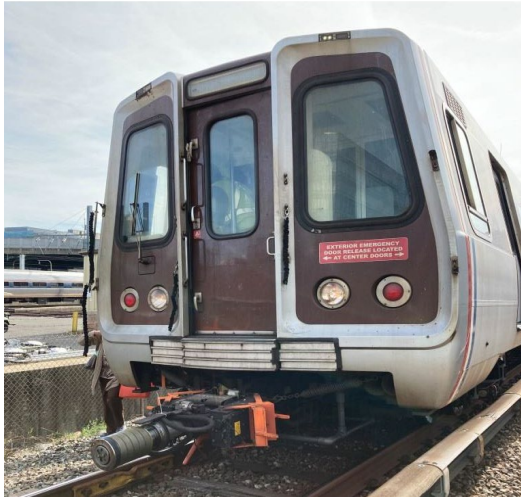
Car 6079 Front Coupler assembly coupled to half of car 6075 Front Coupler

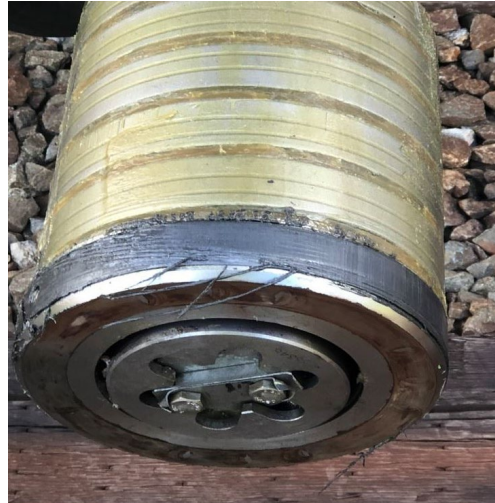
Car 6075 Front Mechanical Coupler Draft Bar

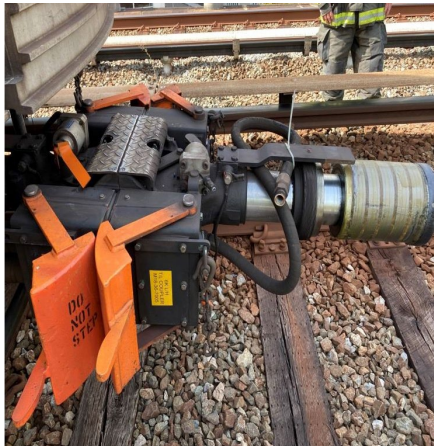
Close up of Car 6079 Front Coupler assembly coupled to half of car 6075 Front Coupler

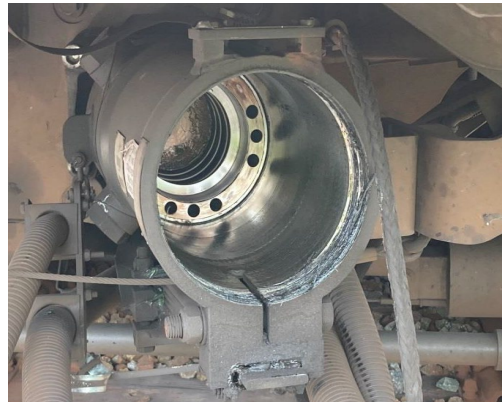
Car 6075 Front Mechanical Coupler Buffer Tube

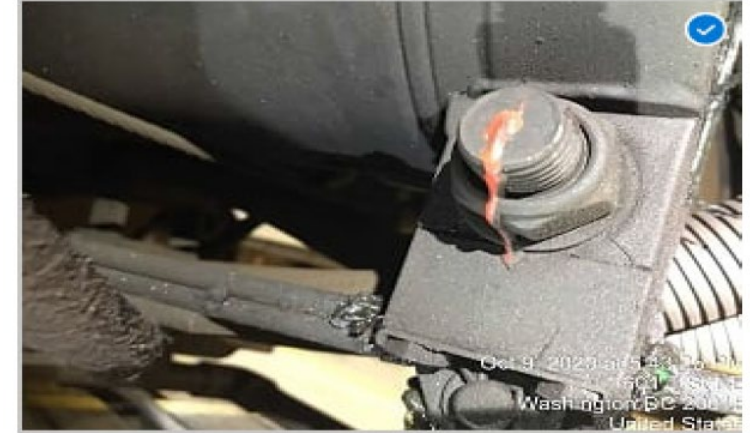
Torque stripe when the buffer tube was installed in car 6075

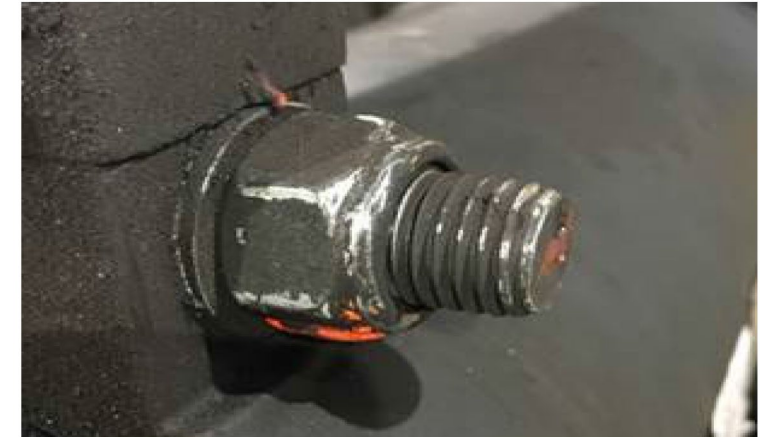
Torque stripe when the buffer tube was delivered to the MRO Shop
