# Results in Brief

OIG 18-07  
April 6, 2018

## Evaluation of the Rhode Island Avenue - Brentwood Station (RIABS) Incidents

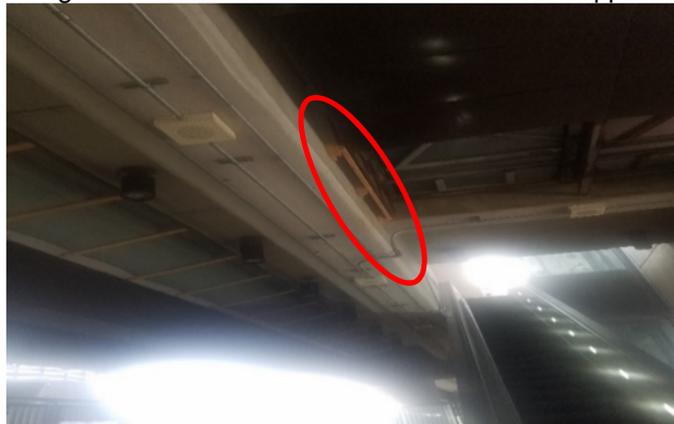
Figure 2: Previous Location of Steel Bracket Support

The inspection process did not identify the conditions leading to the steel bracket support falling on August 31, 2016. The steel bracket support between the escalator and the structure could not be easily examined as it was 16.9 feet above the mezzanine level in a hard-to-reach area (Refer to Figure 2).

The supporting elements of tilework were in a secluded position, and the failed anchor bolts, which caused the RIABS steel bracket to fall, were hidden from view.

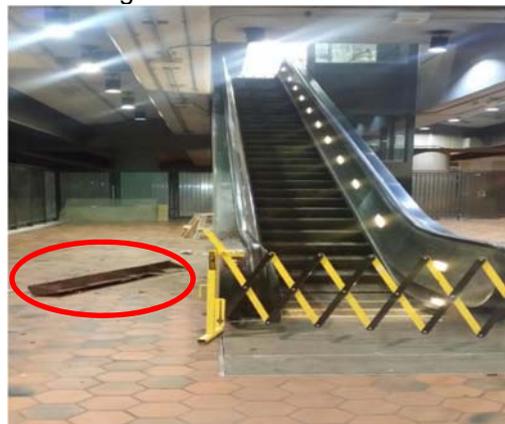
Figure 3: Fallen Steel Beam

Having a more robust inspection process may have prevented the steel bracket support located between the escalator and platform structure from falling to the mezzanine area (Refer to Figure 3). This incident created a potential safety risk had an individual been standing in that area.

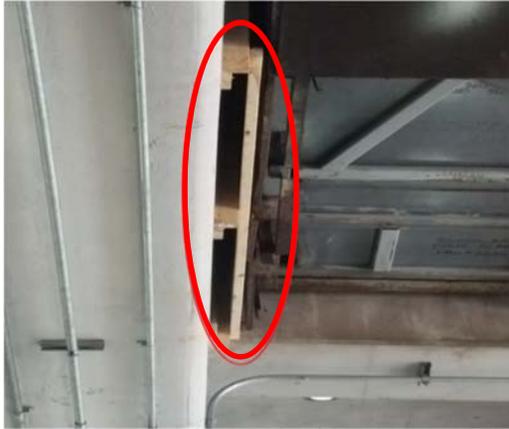
Figure 6: Incident 1 Temporary Repair

- Subsequent to the August 31, 2016 incident, TRST reinforced the area where the steel bracket support fell with a temporary structural falsework, or a wooden stabilizer (Refer to Figure 6). In addition, similar reinforcement was performed on the other side of the escalator. On September 1, 2016, the Office of Plant Maintenance met with ENGA and developed a repair plan for the permanent repair.
- Subsequent to the September 1, 2016 incident, to mitigate future risk, TRST reinforced the area where the concrete fell with safety/debris netting at the site of the incident. In addition, the same netting was installed on the remaining underside of the deck areas on both sides to prevent additional concrete from falling to the ground (Refer to Figure 7).

In April 2017, approximately eight months after the two incidents occurred, the OIG visited the RIABS and found the temporary structural falsework and safety netting were still in place. The OIG conducted site visits at RIABS in September 2017 and January 2018, and found that they were still in place.

5. Periodically inspect the condition of the temporary structural falsework and safety netting at RIABS for continued safety. (Action: Chief Operating Officer) (*Risk – High*)

6. Complete permanent repairs related to the two incidents. (Action: Chief Operating Officer) (*Risk – High*)
