**Dulles Metro Silver Line Concrete Panel Assessment  
Innovation Center Station Precast Inspections**  
Herndon, Virginia

**DeSimone Consulting Engineers**

Report Issued: August 24, 2020

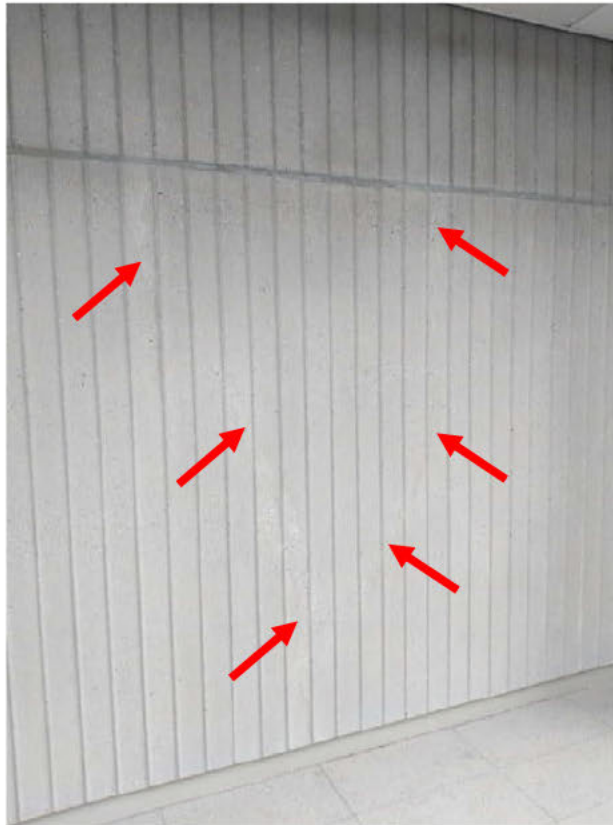
Figure 5: Repaired cracks at Panel 101. Source: DeSimone.

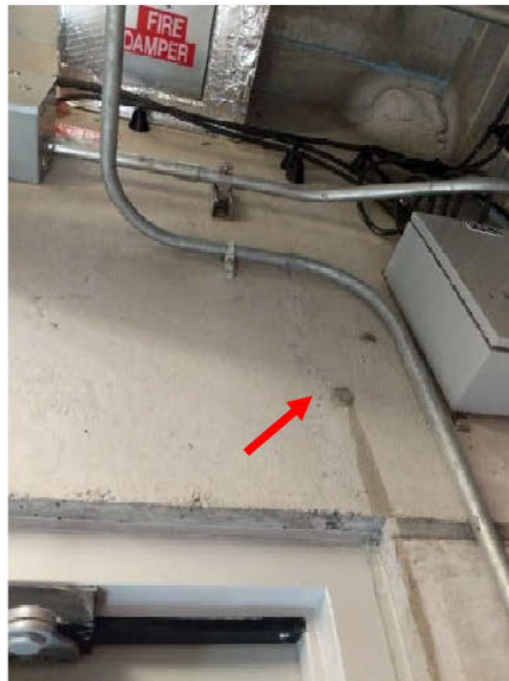
- 4.5 Brick spalling was observed at the exterior face of Panels 205 and 219 at the exterior face of the West Service Room elevation; See Figure 9.
- 4.6 DeSimone noticed efflorescence at Panel 100 at an interior face of the West Service Room elevation; See Figure 6.

- 5.6 Superficial discoloration was observed by DeSimone at cracked Panel 100 (See Page 9), which was noted to exhibit signs of efflorescence.
- 5.7 Two (2) cracks that appear to previously have been repaired at Panel 206 and Panel WP-1313 appear to have a new crack that has formed in the repair material (See Pages 14 and 27, respectively).

Figure 6: Efflorescence observed at Panel 100. Source: DeSimone.

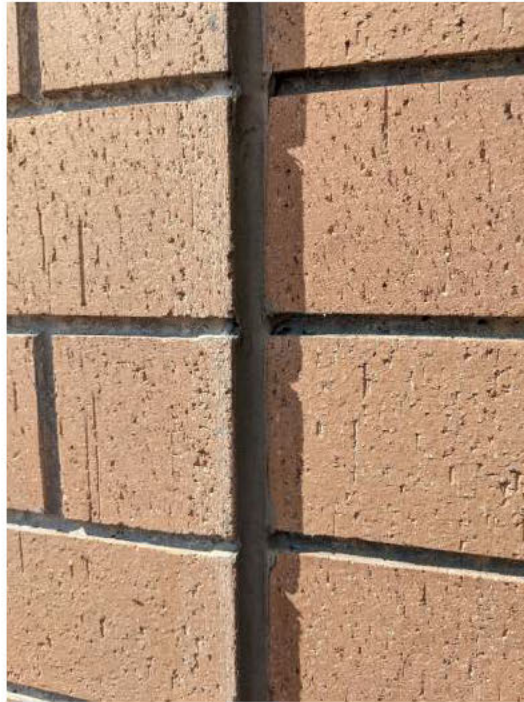
- 4.7 DeSimone noted the edge of Panel 200 being outboard of joint and not being flush with the adjacent Panel 201 at the exterior face of the West Service Room elevation; See Figure 7.

Figure 7: Edge of panel outboard and not flush with adjacent panel at Panels 200, 201.  
Source: DeSimone.

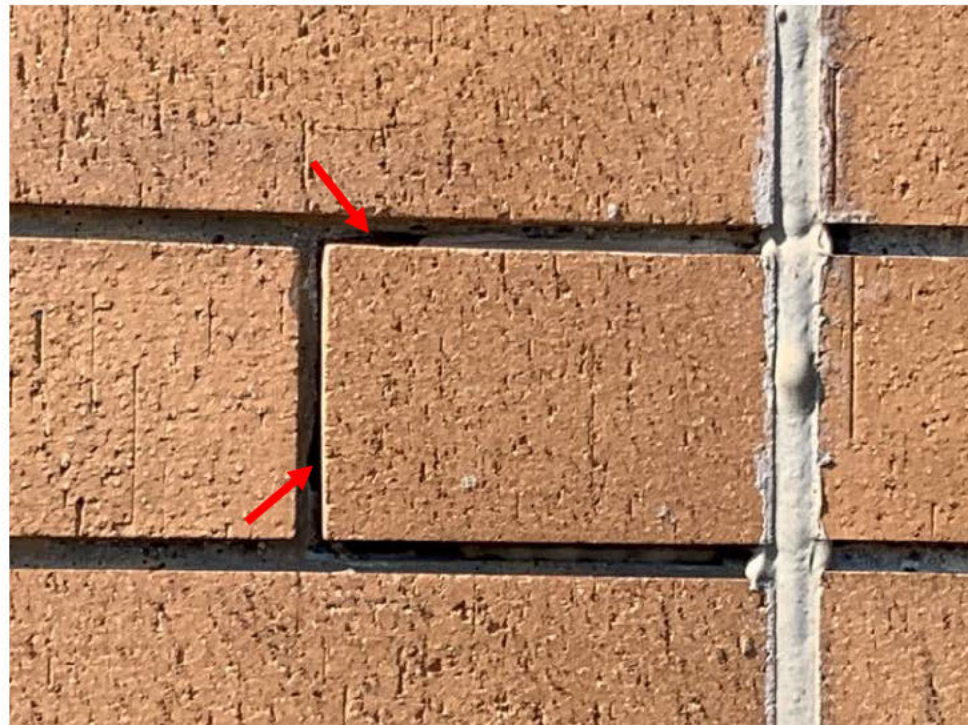
- 4.8 DeSimone observed voids in the mortar joints/pointing of the exterior face of the West Service Room elevation; See Figure 8.
- 4.9 DeSimone noticed spider cracks and regions of propagating cracks at Panels 412 at an interior elevation of the West Service Room, Panels WP-1328-RI, WP-1321-RI, WP-1324, WP-1329 at the East Service Building parapets, and WP-1239 at the Stair 4 elevation.

Figure 8: Voids in mortar joints at Panel 201. Source: DeSimone.

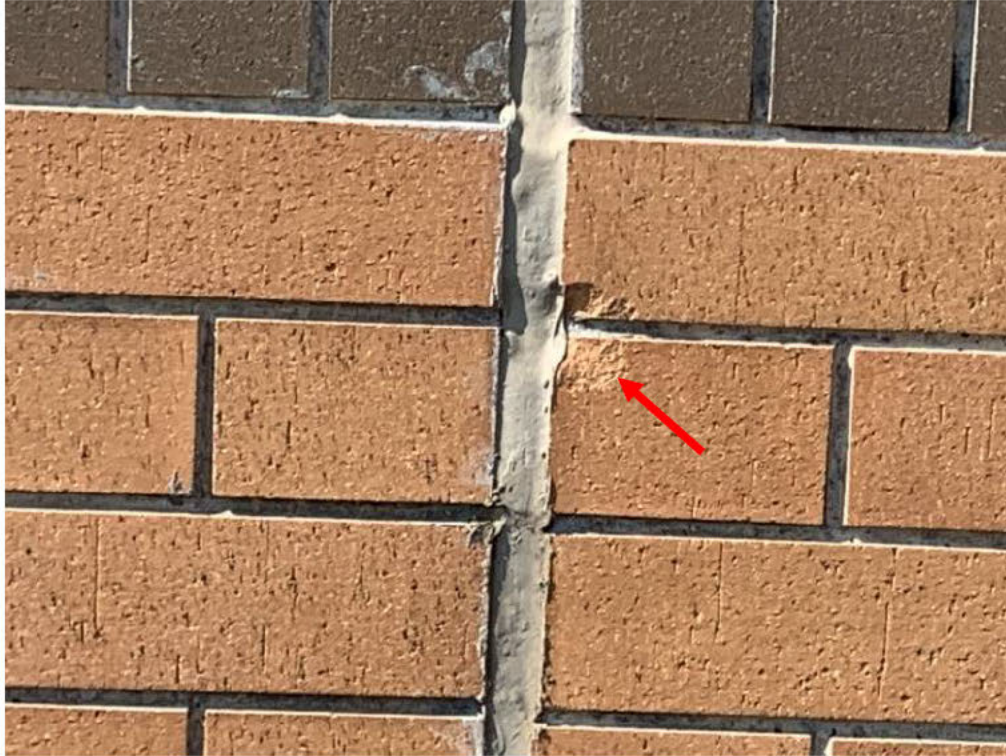
Figure 9: Spalling of brick masonry noted at Panel 205. Source: DeSimone.

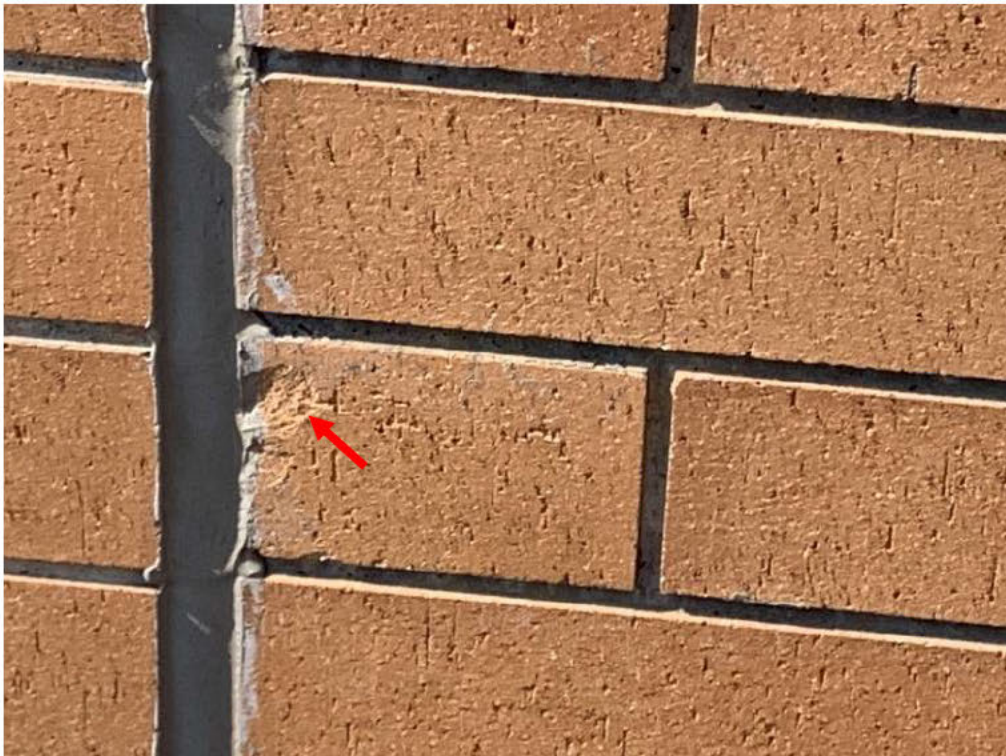
Figure 10: Spalling of brick masonry noted at Panel 219. Source: DeSimone.

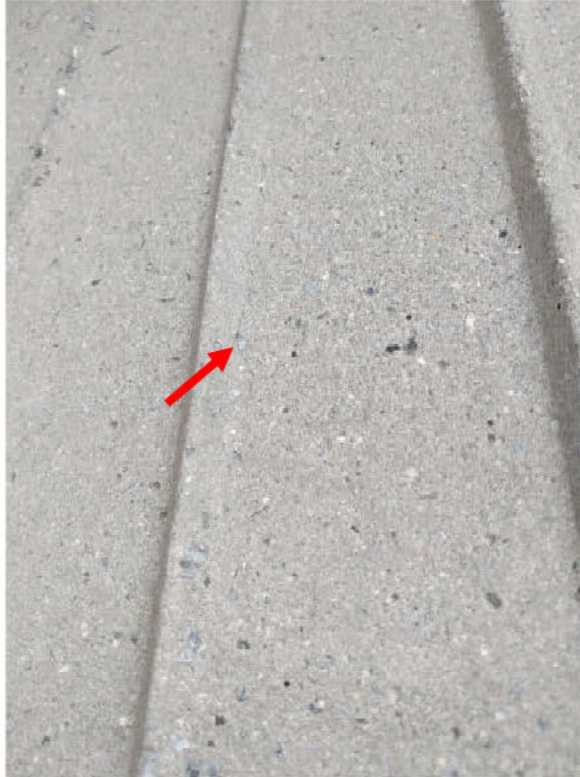
Figure 11: Crack at ticketing booth side of Panel 100. Source: DeSimone

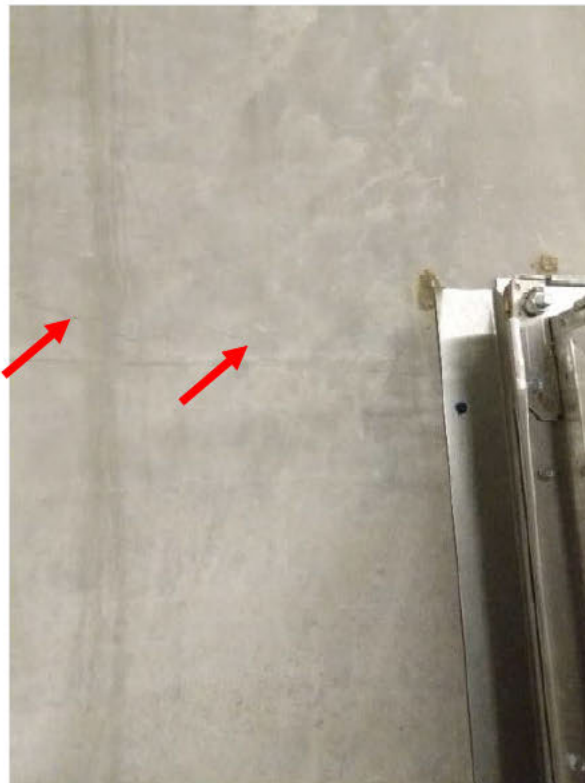
Figure 12: Crack at interior of Panel 219. Source: DeSimone

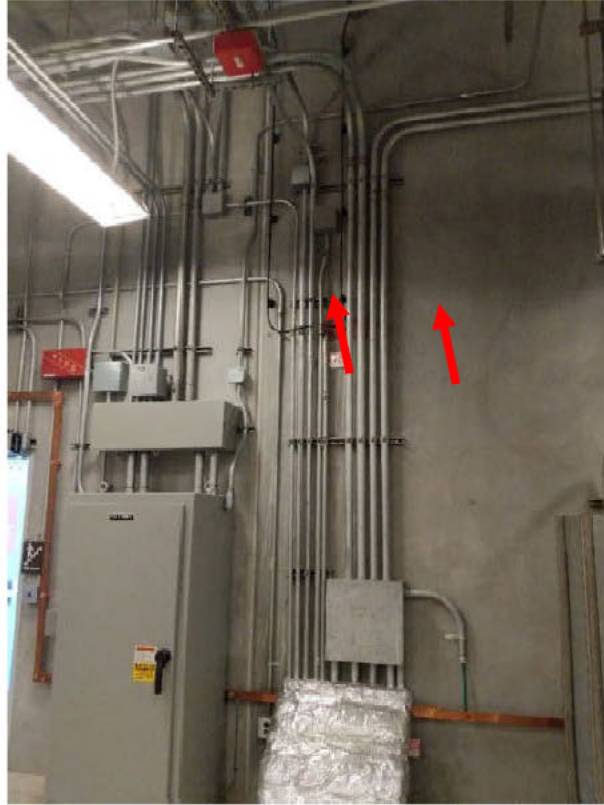
Figure 13: Interior face of Panel 231. Source: DeSimone.

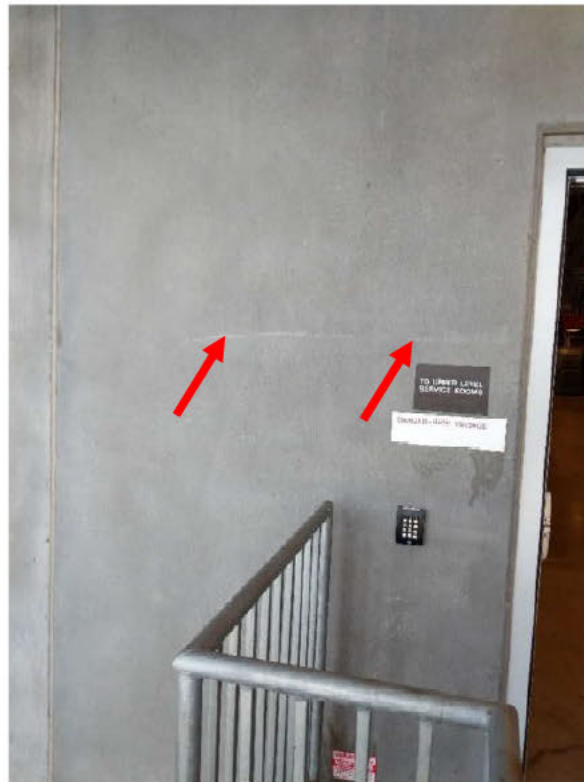
Figure 14: Repaired crack at exterior face of Panel 232. Source: DeSimone.

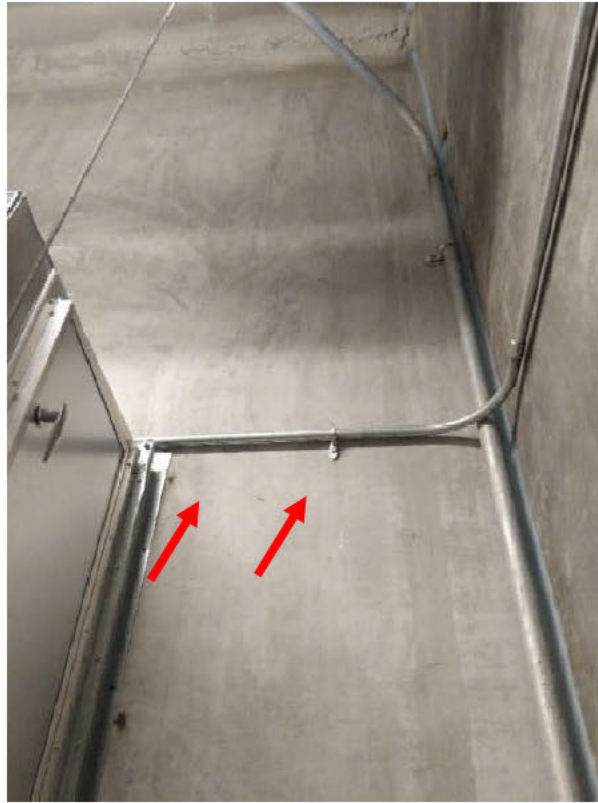
Figure 15: Interior face of Panel 220. Source: DeSimone.

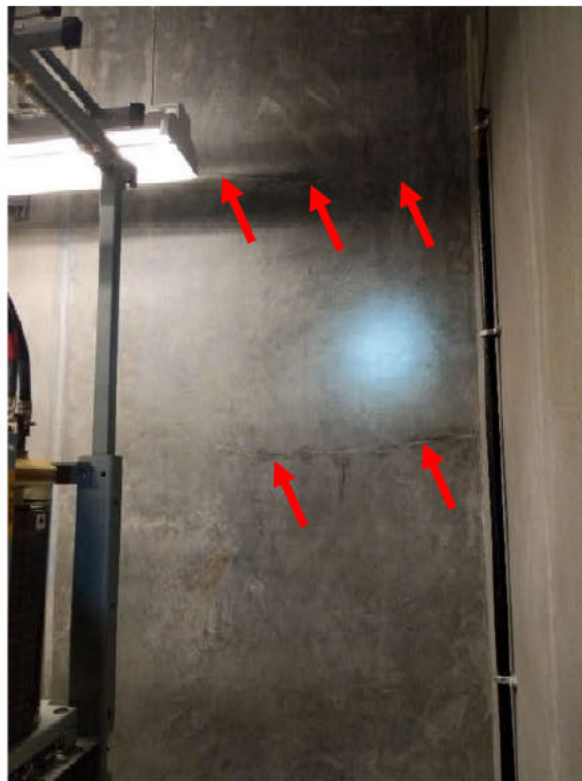
Figure 16: Interior face of Panel 206. Refer to Appendix C for photo showing location of cracking at previous repair. Source: DeSimone.

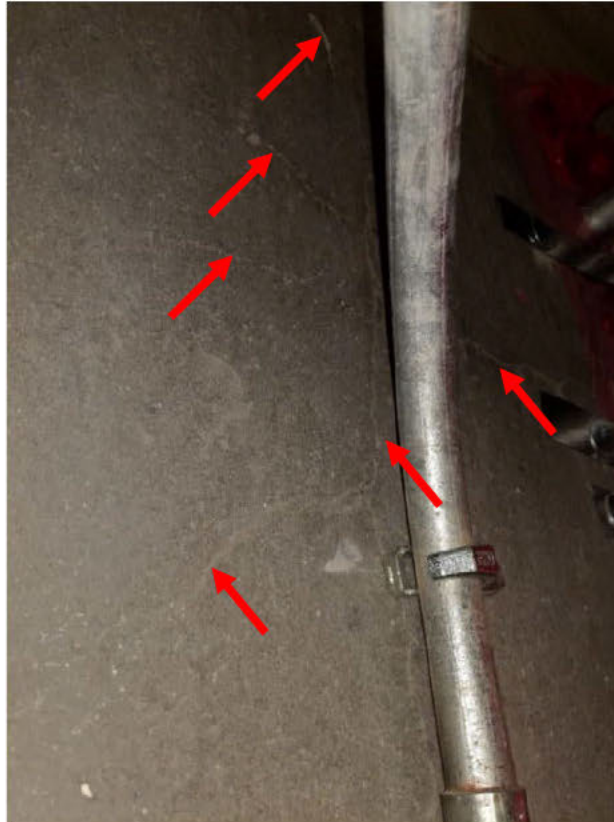
Figure 17: Interior face of Panel 412. Source: DeSimone.

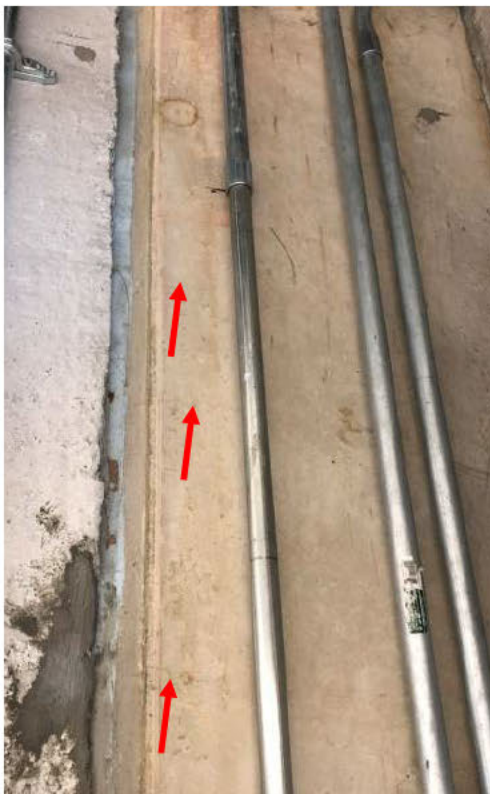
Figure 26: Interior face of Panel 1421 (Four cracks at this panel). Source: DeSimone.

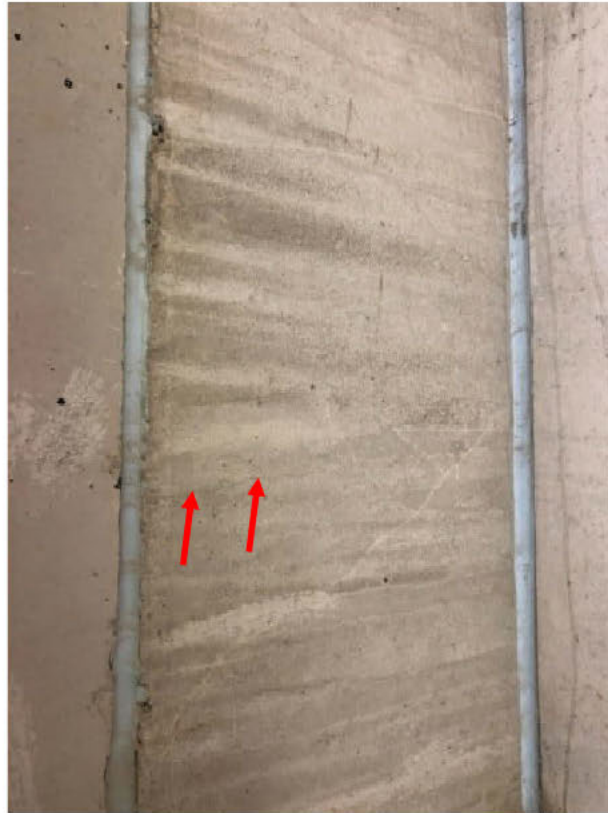
Figure 27: Interior face of Panel 1421. Source: DeSimone.

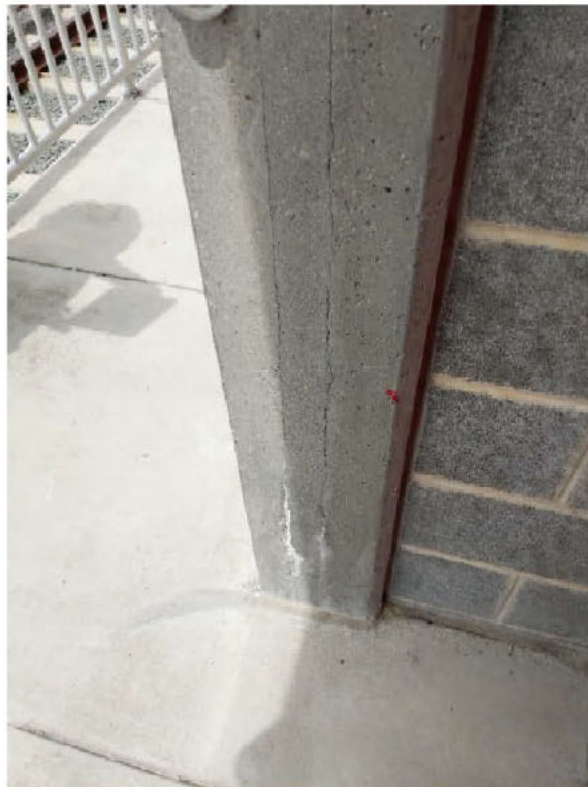
Figure 42: Exterior face of Panel WP-1313. Refer to Appendix C for photo showing location of cracking at previous repair. Source: DeSimone.

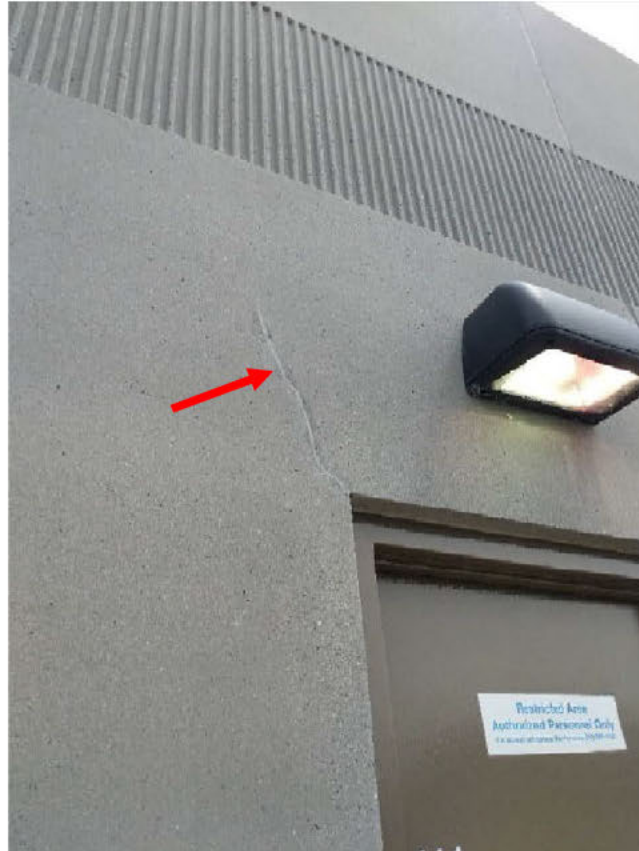
Figure 43: Exterior face of Panel WP-1315. Source: DeSimone.

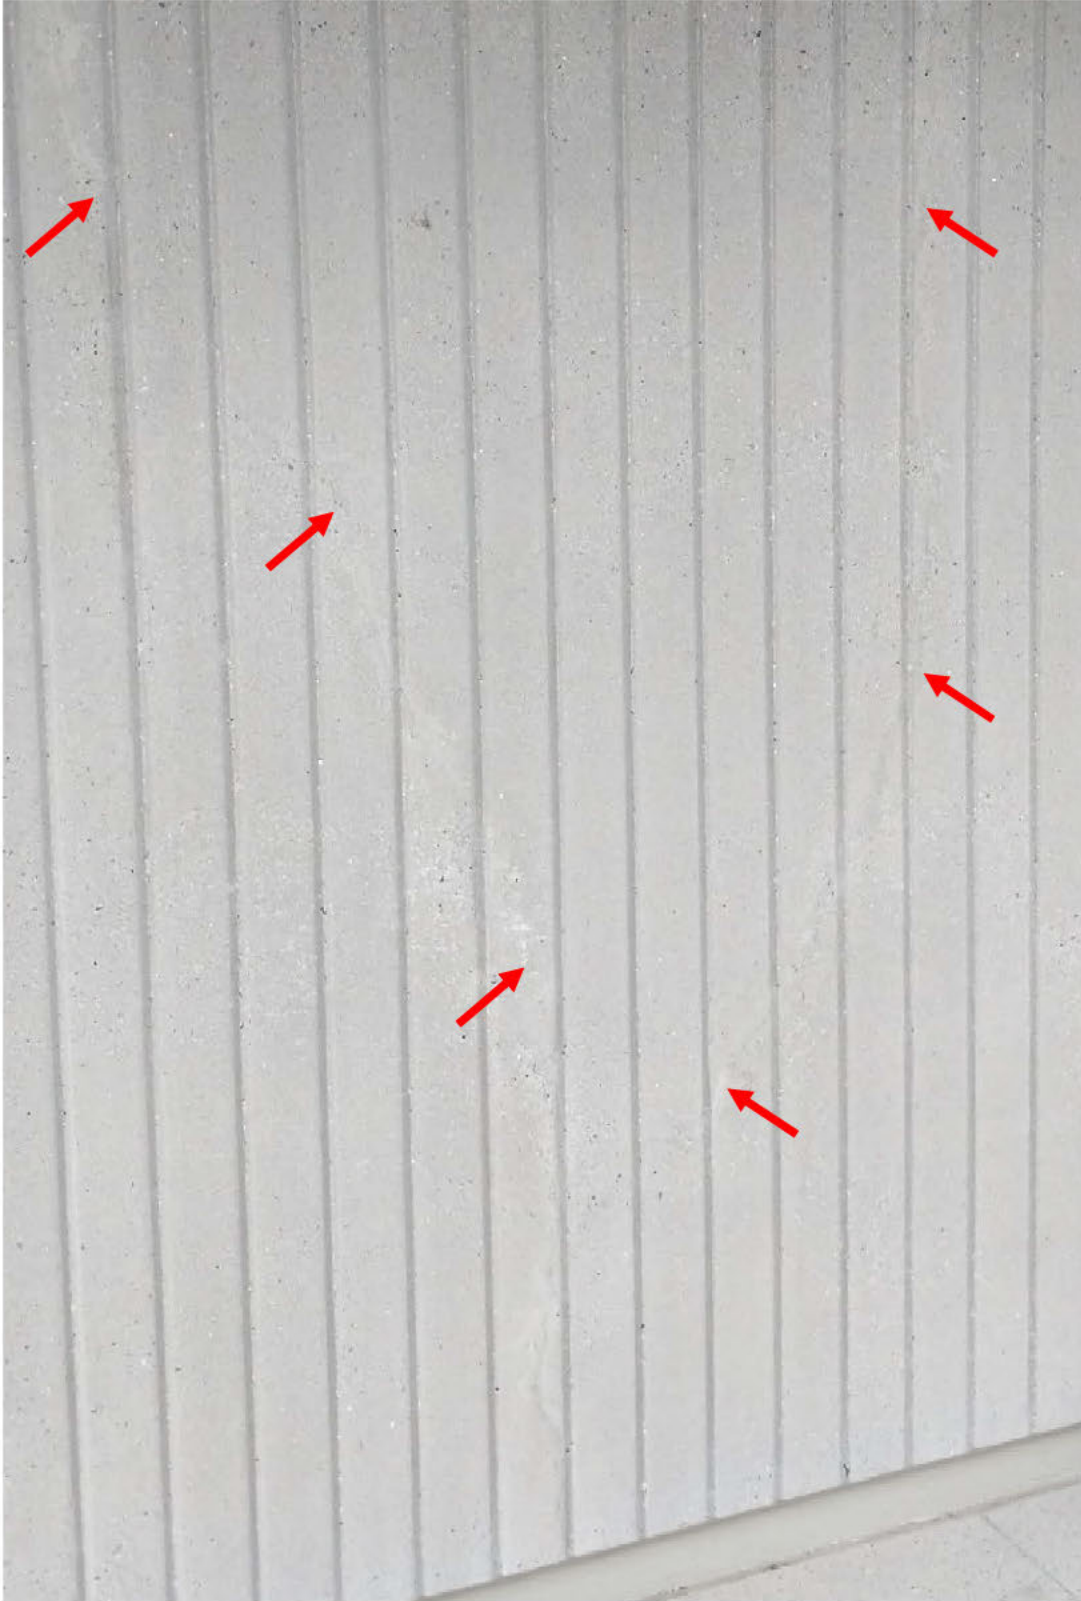
Figure 1: Repaired cracks at Panel 101. Source: DeSimone.

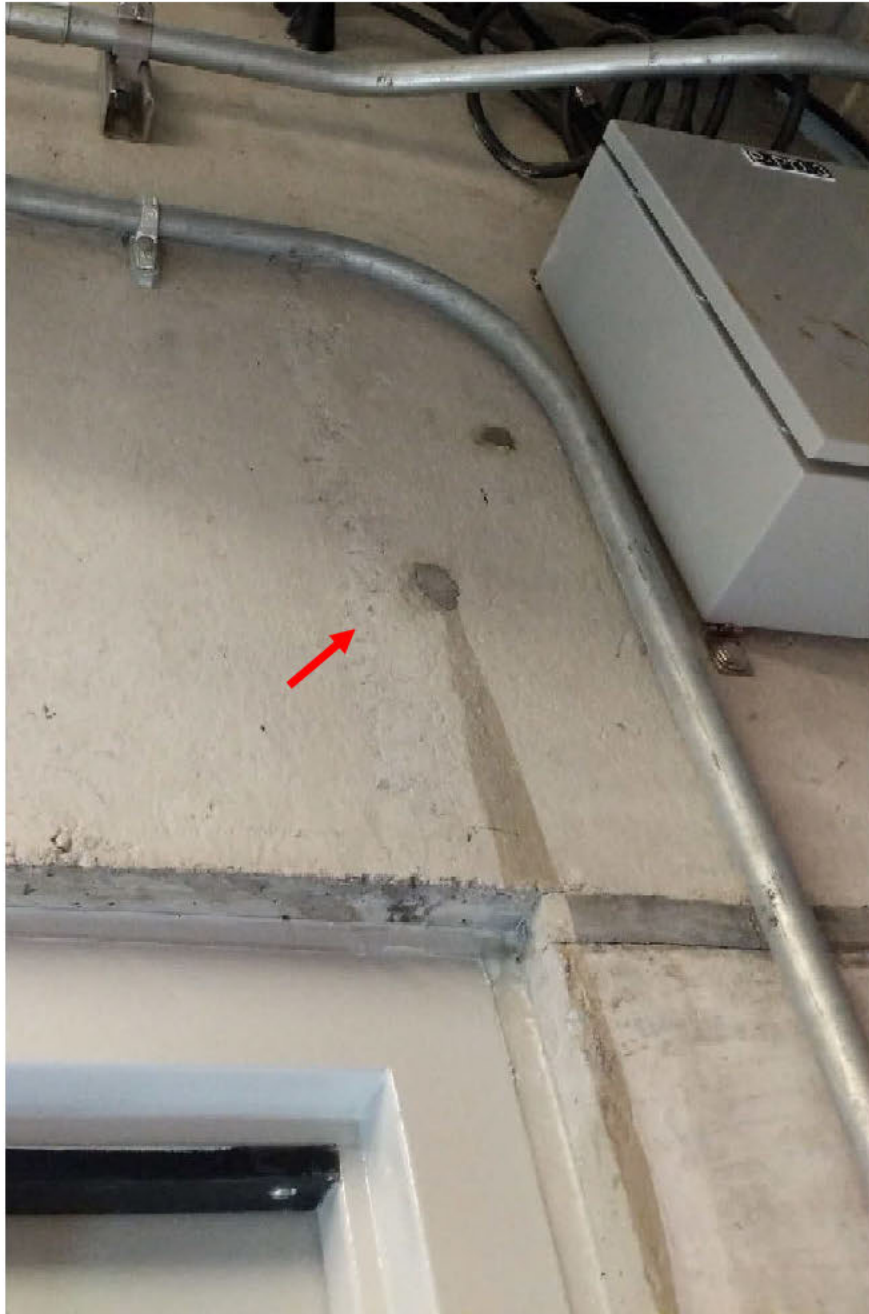
Figure 2: Efflorescence observed at Panel 100. Source: DeSimone.

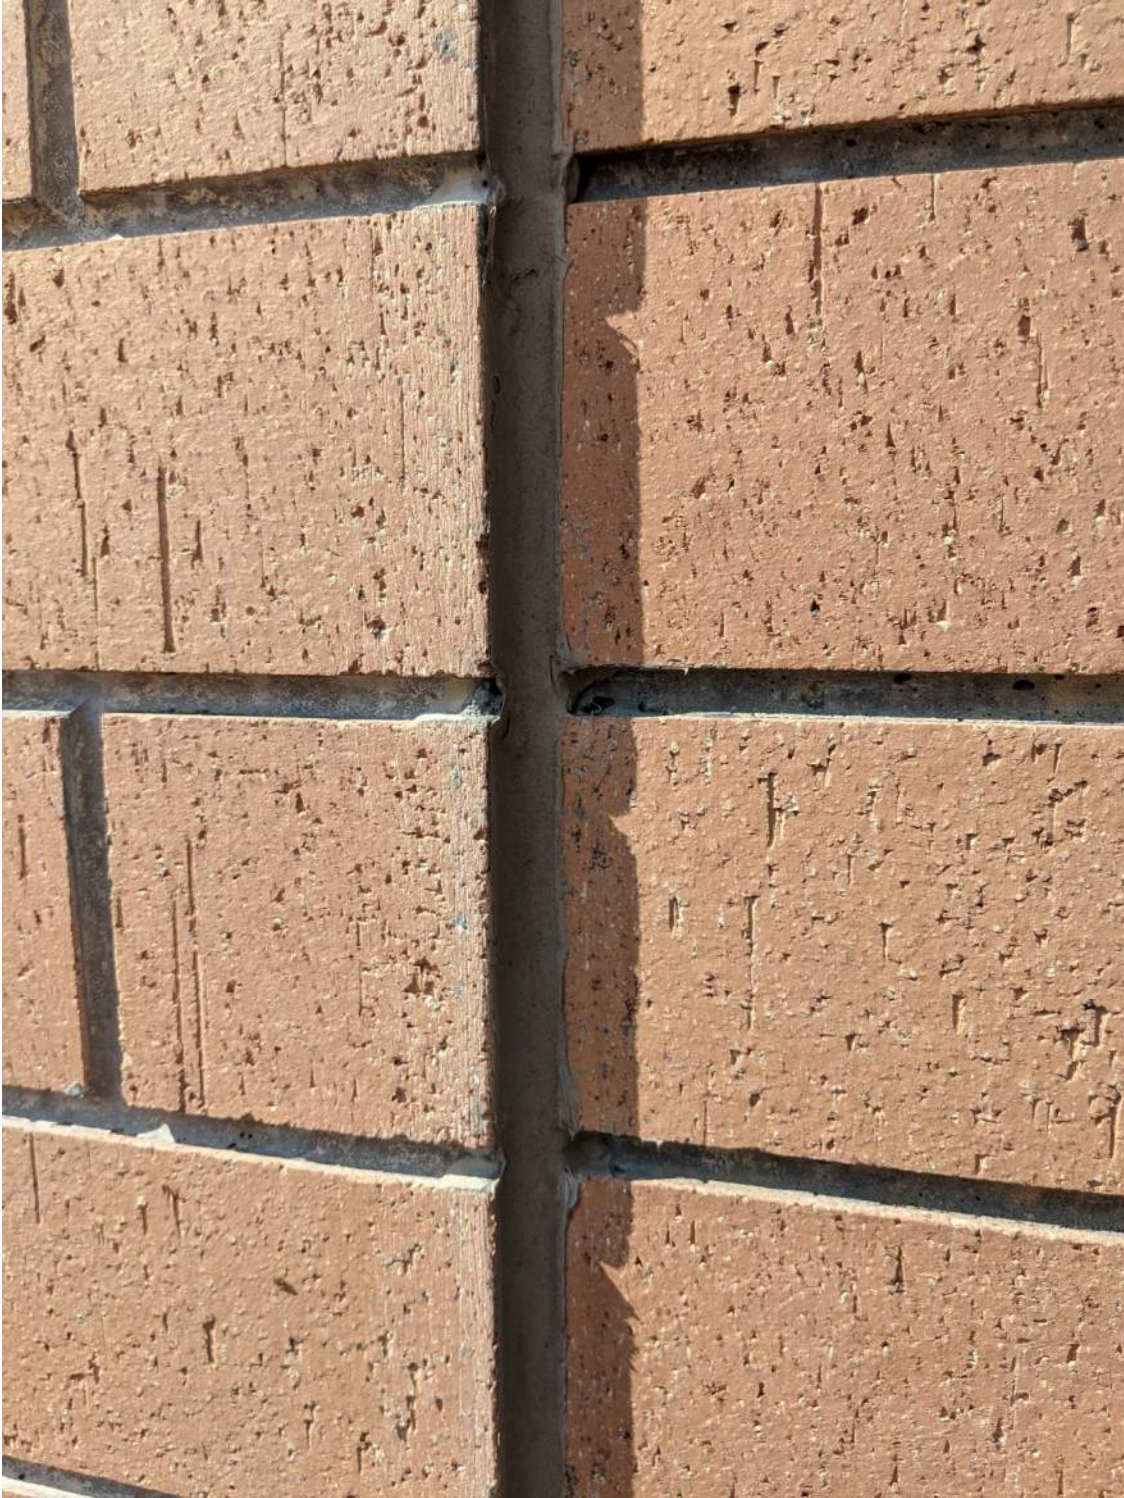
Figure 3: Edge of panel outboard and not flush with adjacent panel at Panels 200, 201.  
Source: DeSimone.

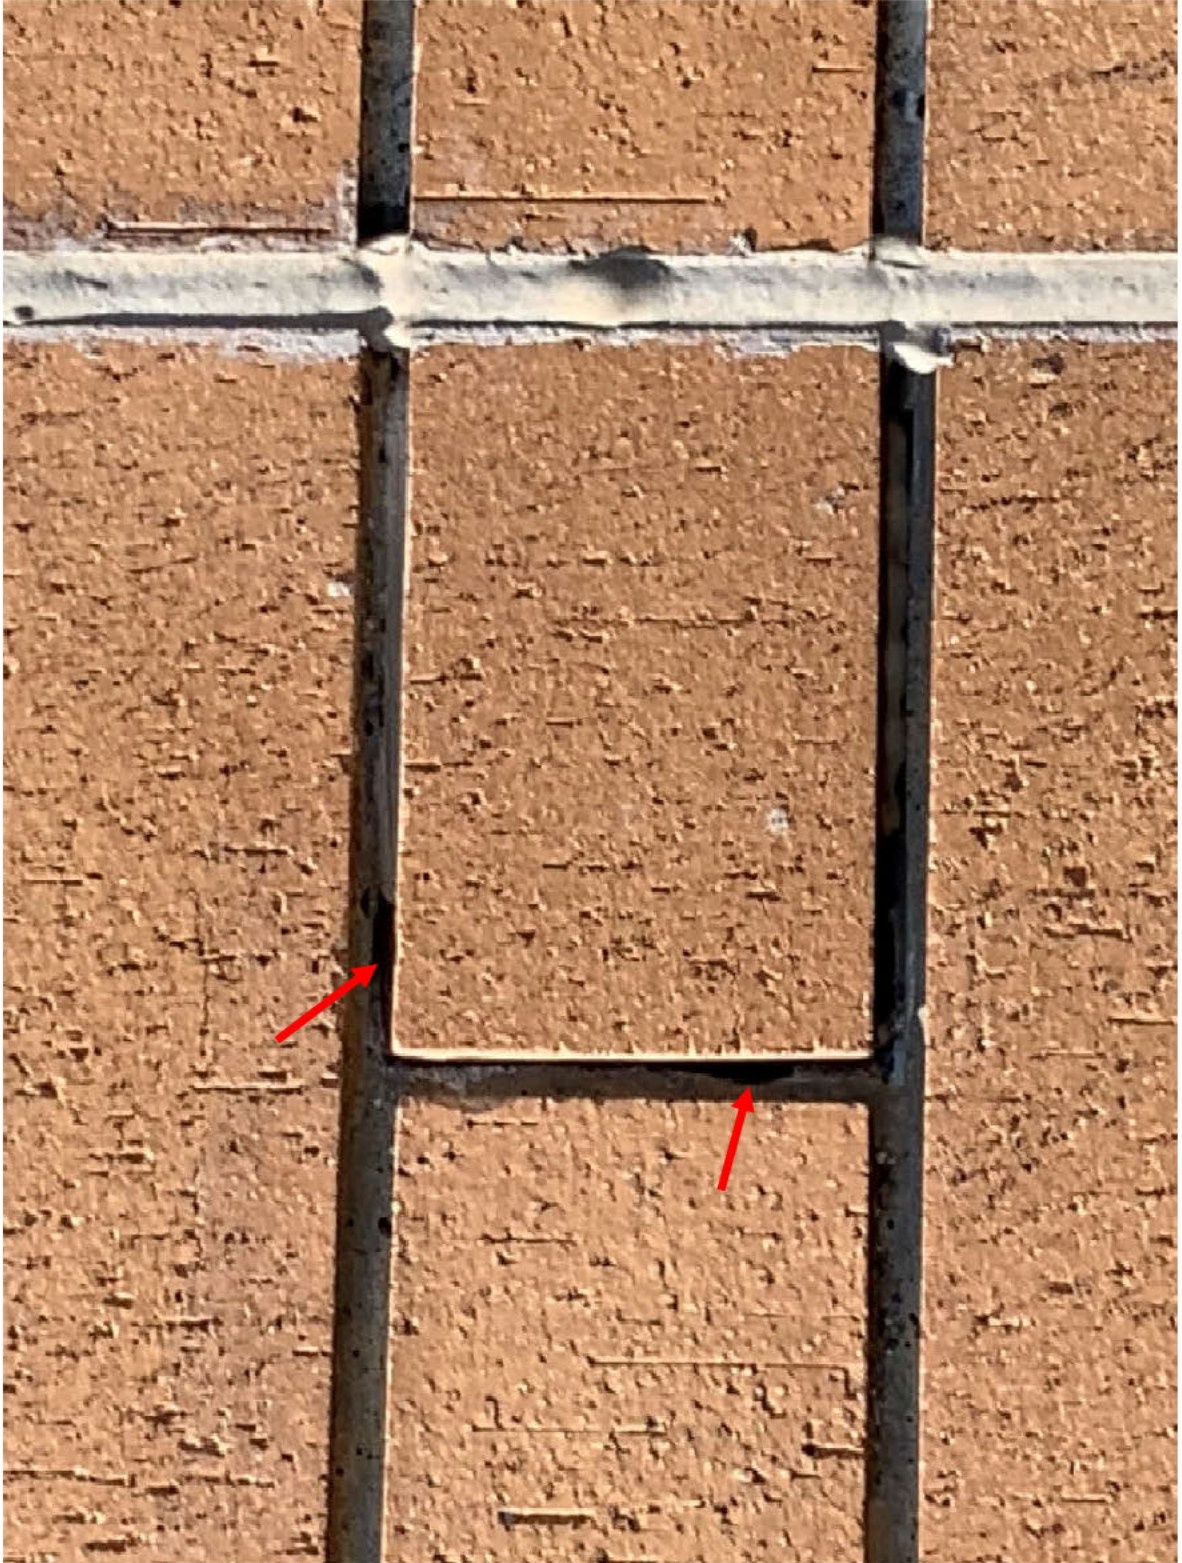
Figure 4: Voids in mortar joints at Panel 201. Note Photo is rotated 90° for clarity. Source: DeSimone.

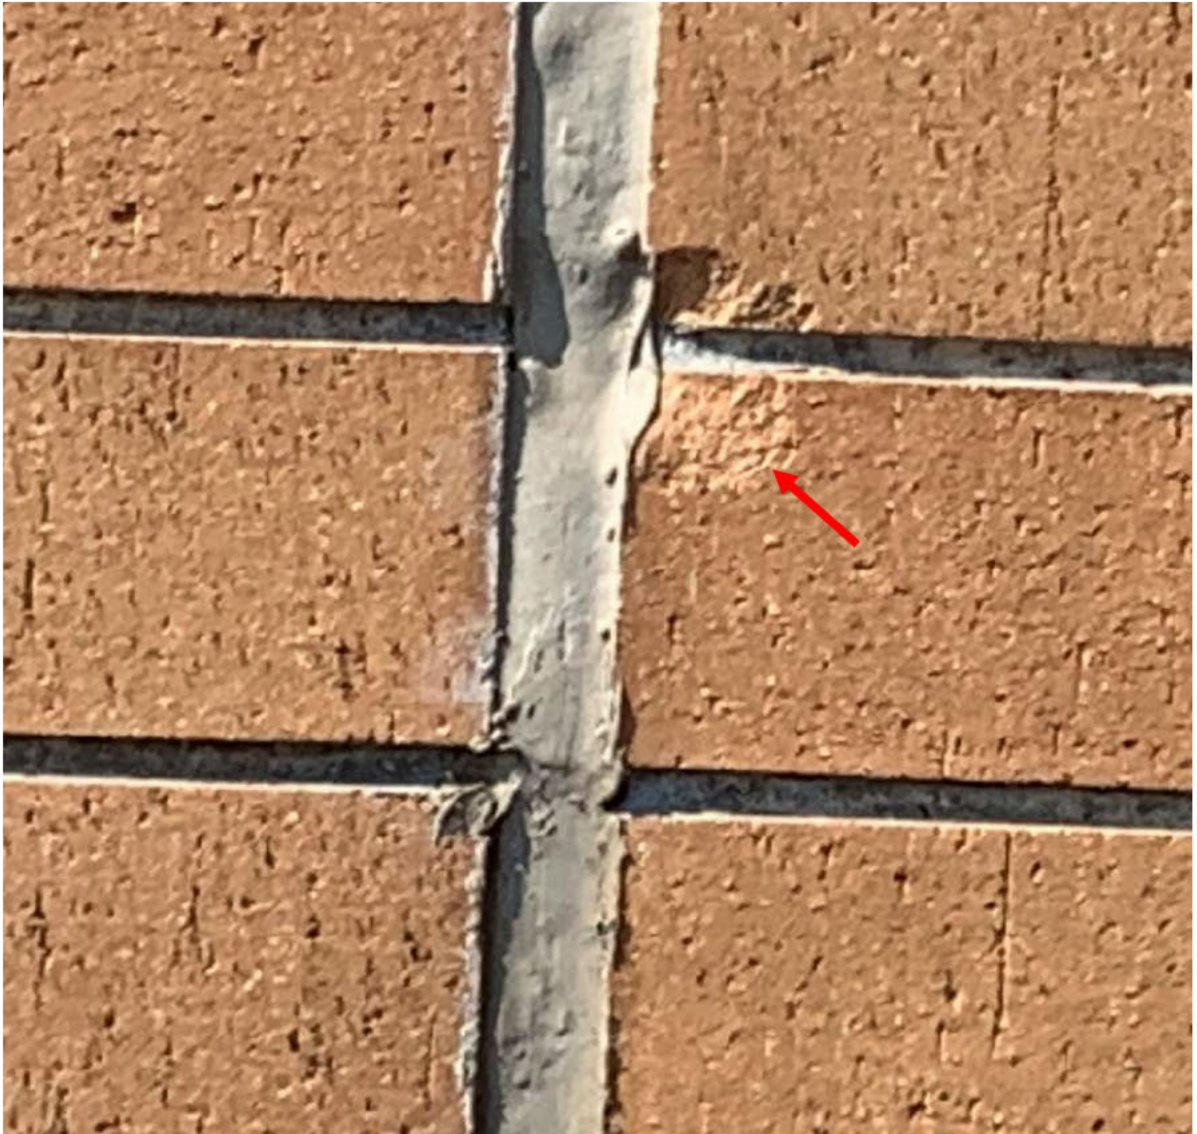
Figure 5: Spalling of brick masonry noted at Panel 205. Source: DeSimone.

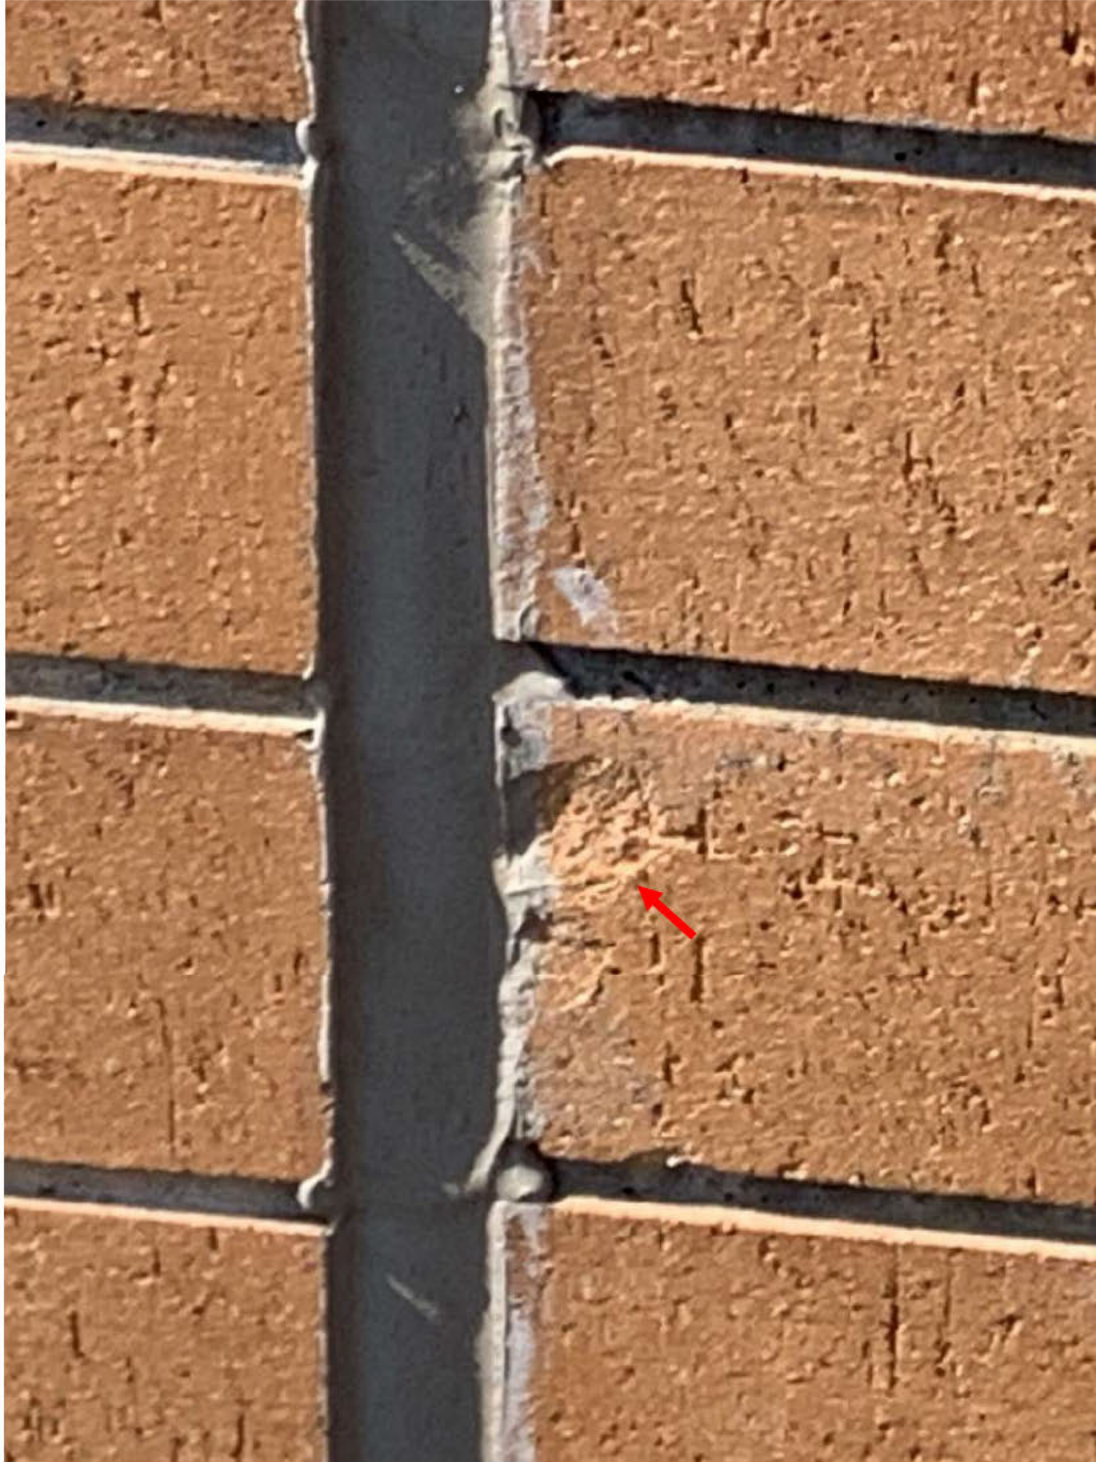
Figure 6: Spalling of brick masonry noted at Panel 219. Source: DeSimone.

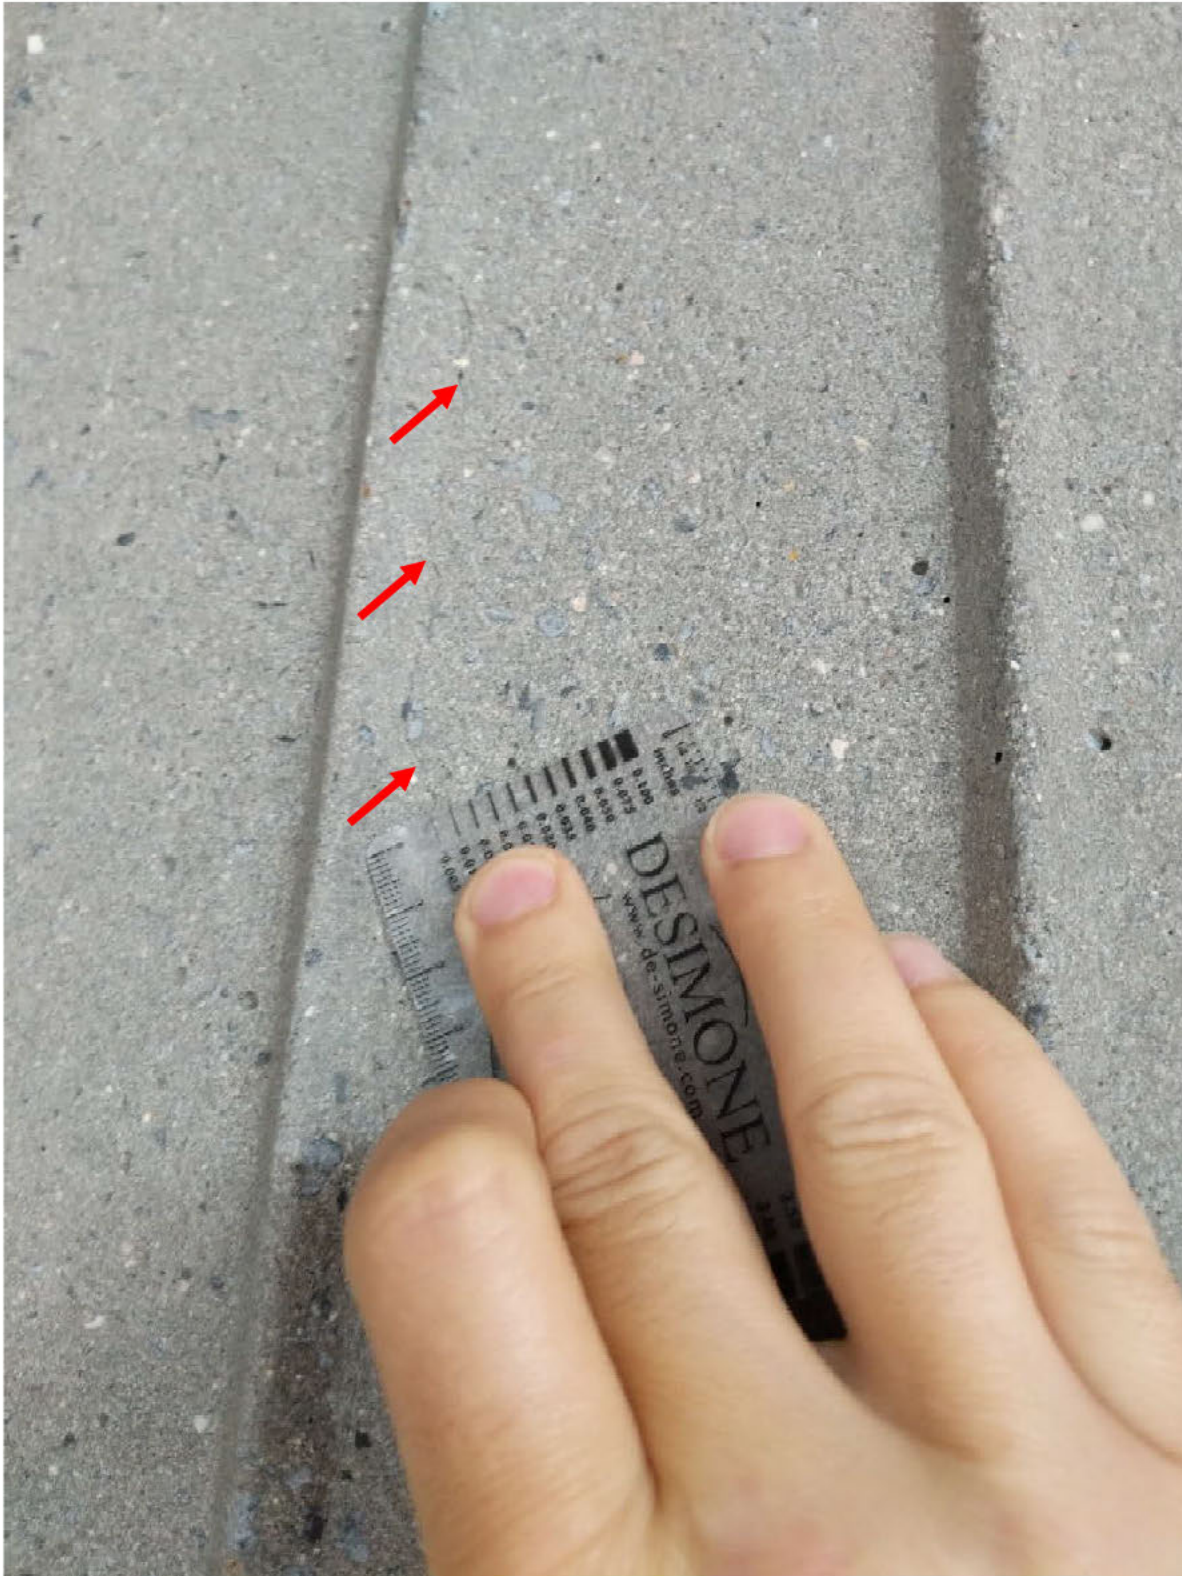
Figure 7: Crack at ticketing booth side of Panel 100. Source: DeSimone.

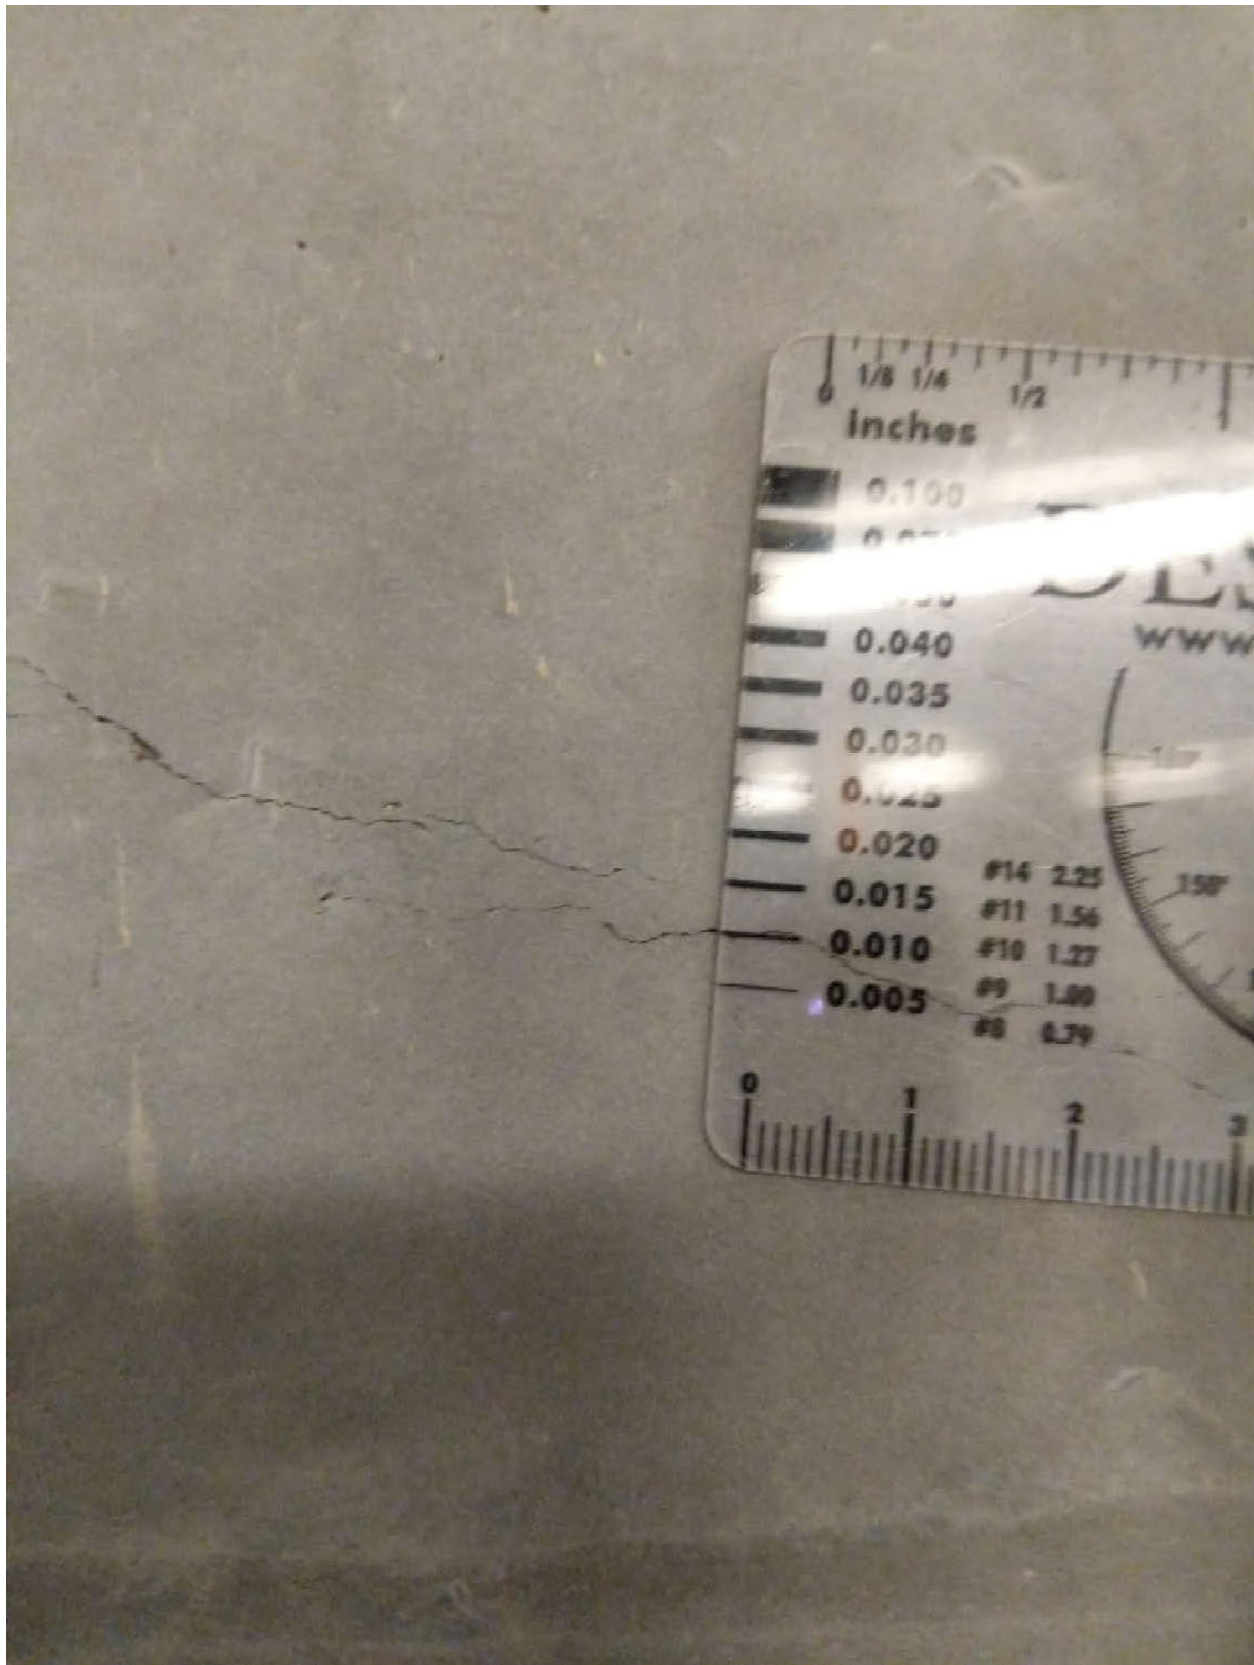
Figure 8: Crack at interior of Panel 219. Source: DeSimone.
