**Dulles Metro Silver Line Concrete Panel Assessment  
Innovation Center Station Precast Inspections**  
Herndon, Virginia

**DeSimone Consulting Engineers**

Report Issued: August 24, 2020

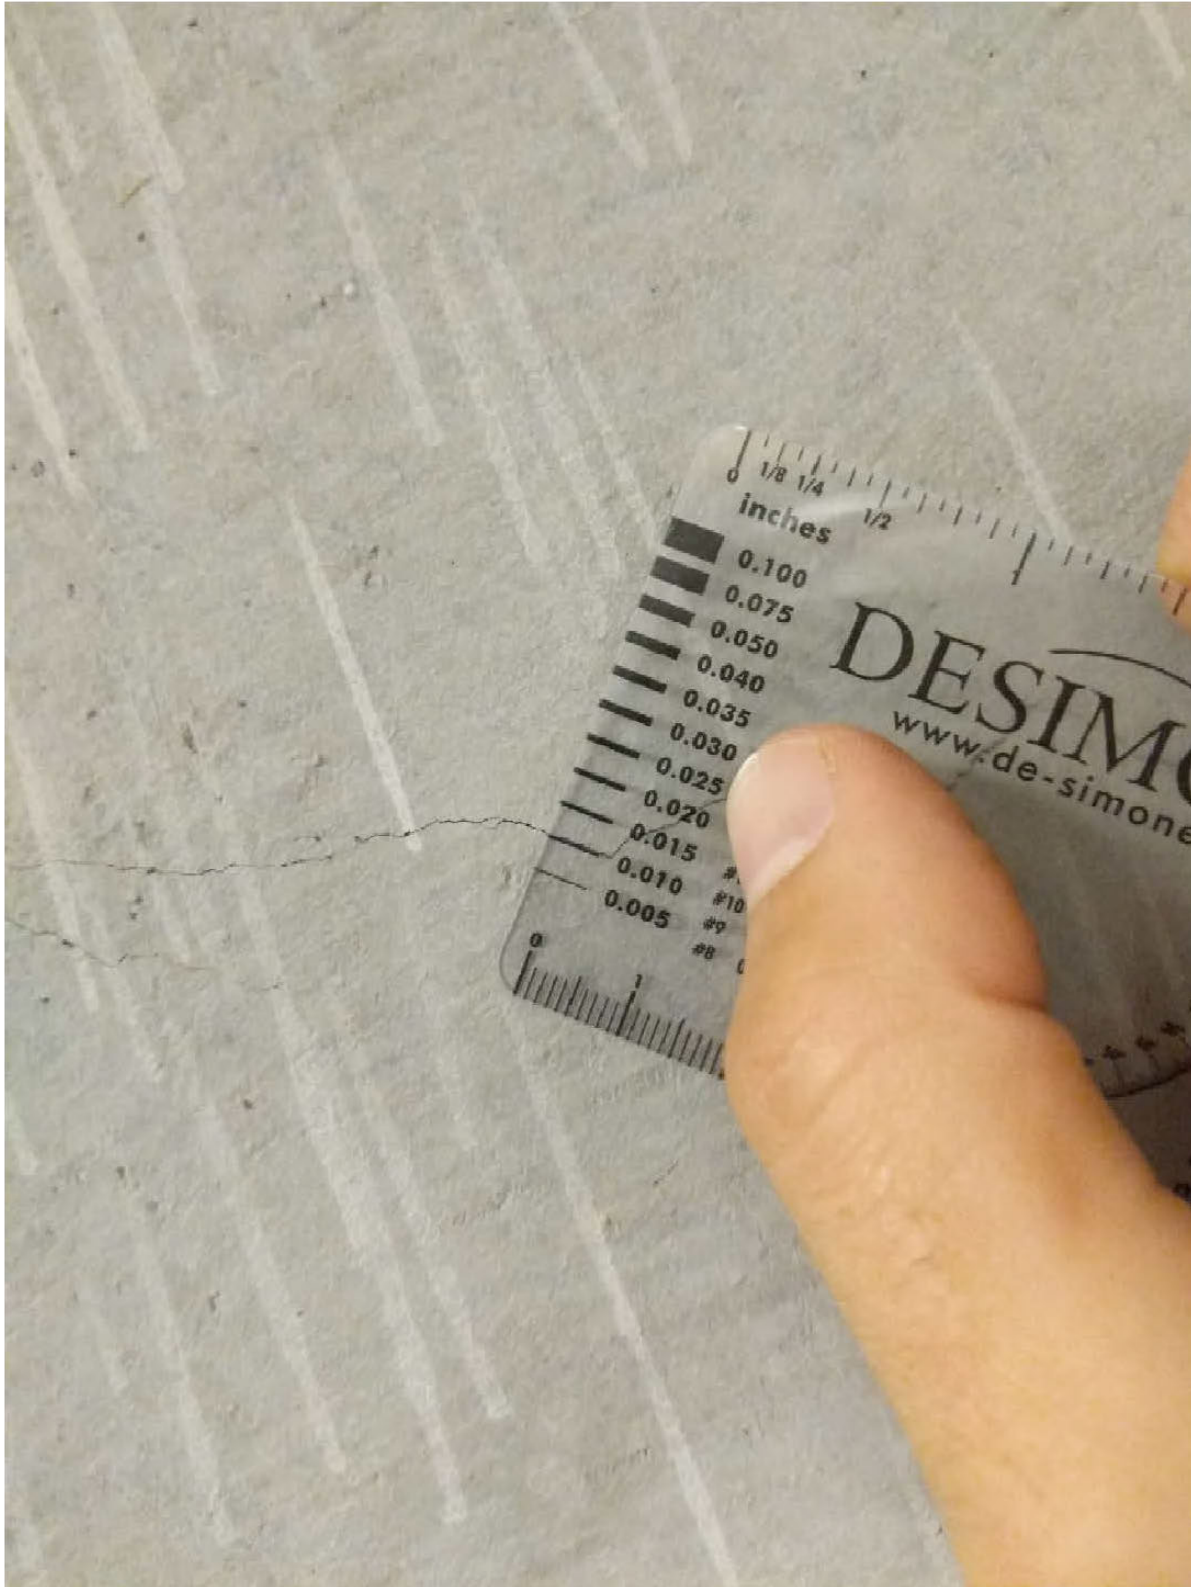
Figure 9: Crack at interior face of Panel 231. Source: DeSimone

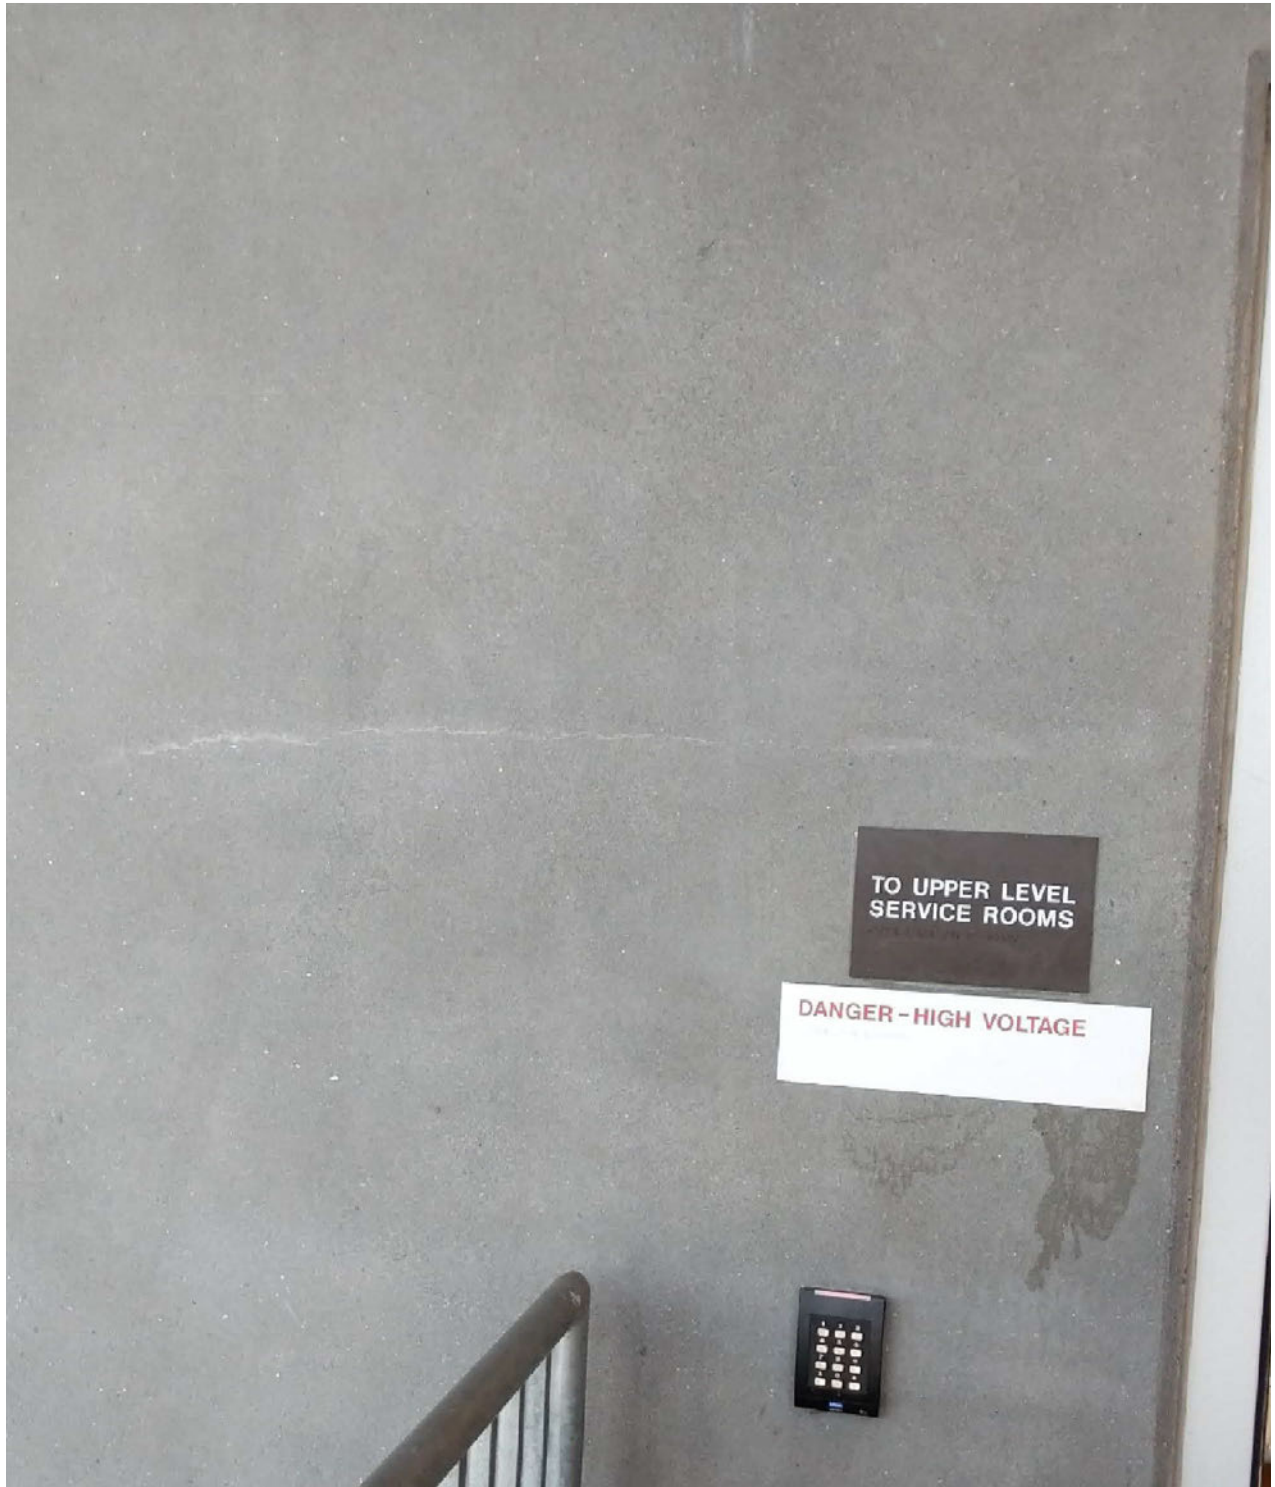
Figure 10: Repaired crack at exterior of Panel 232. Source: DeSimone

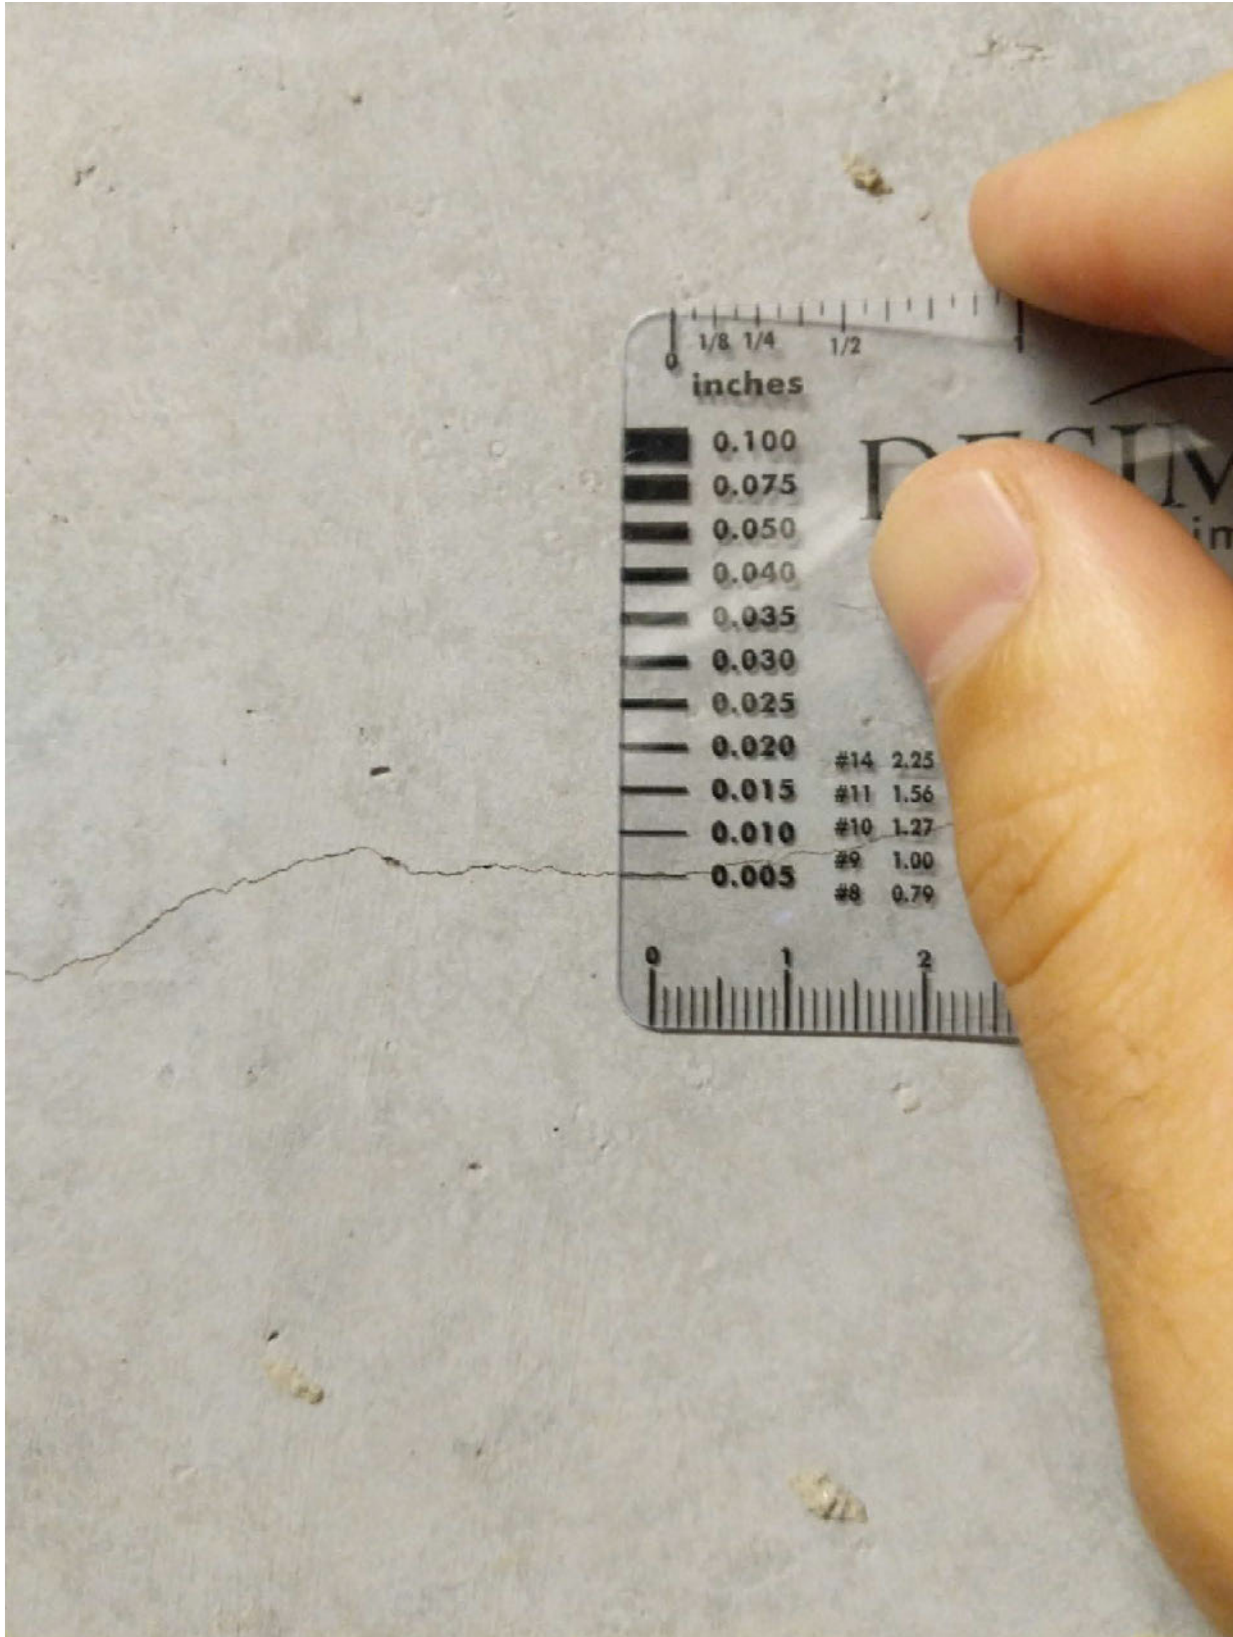
Figure 11: Crack at interior face of Panel 220. Source: DeSimone.

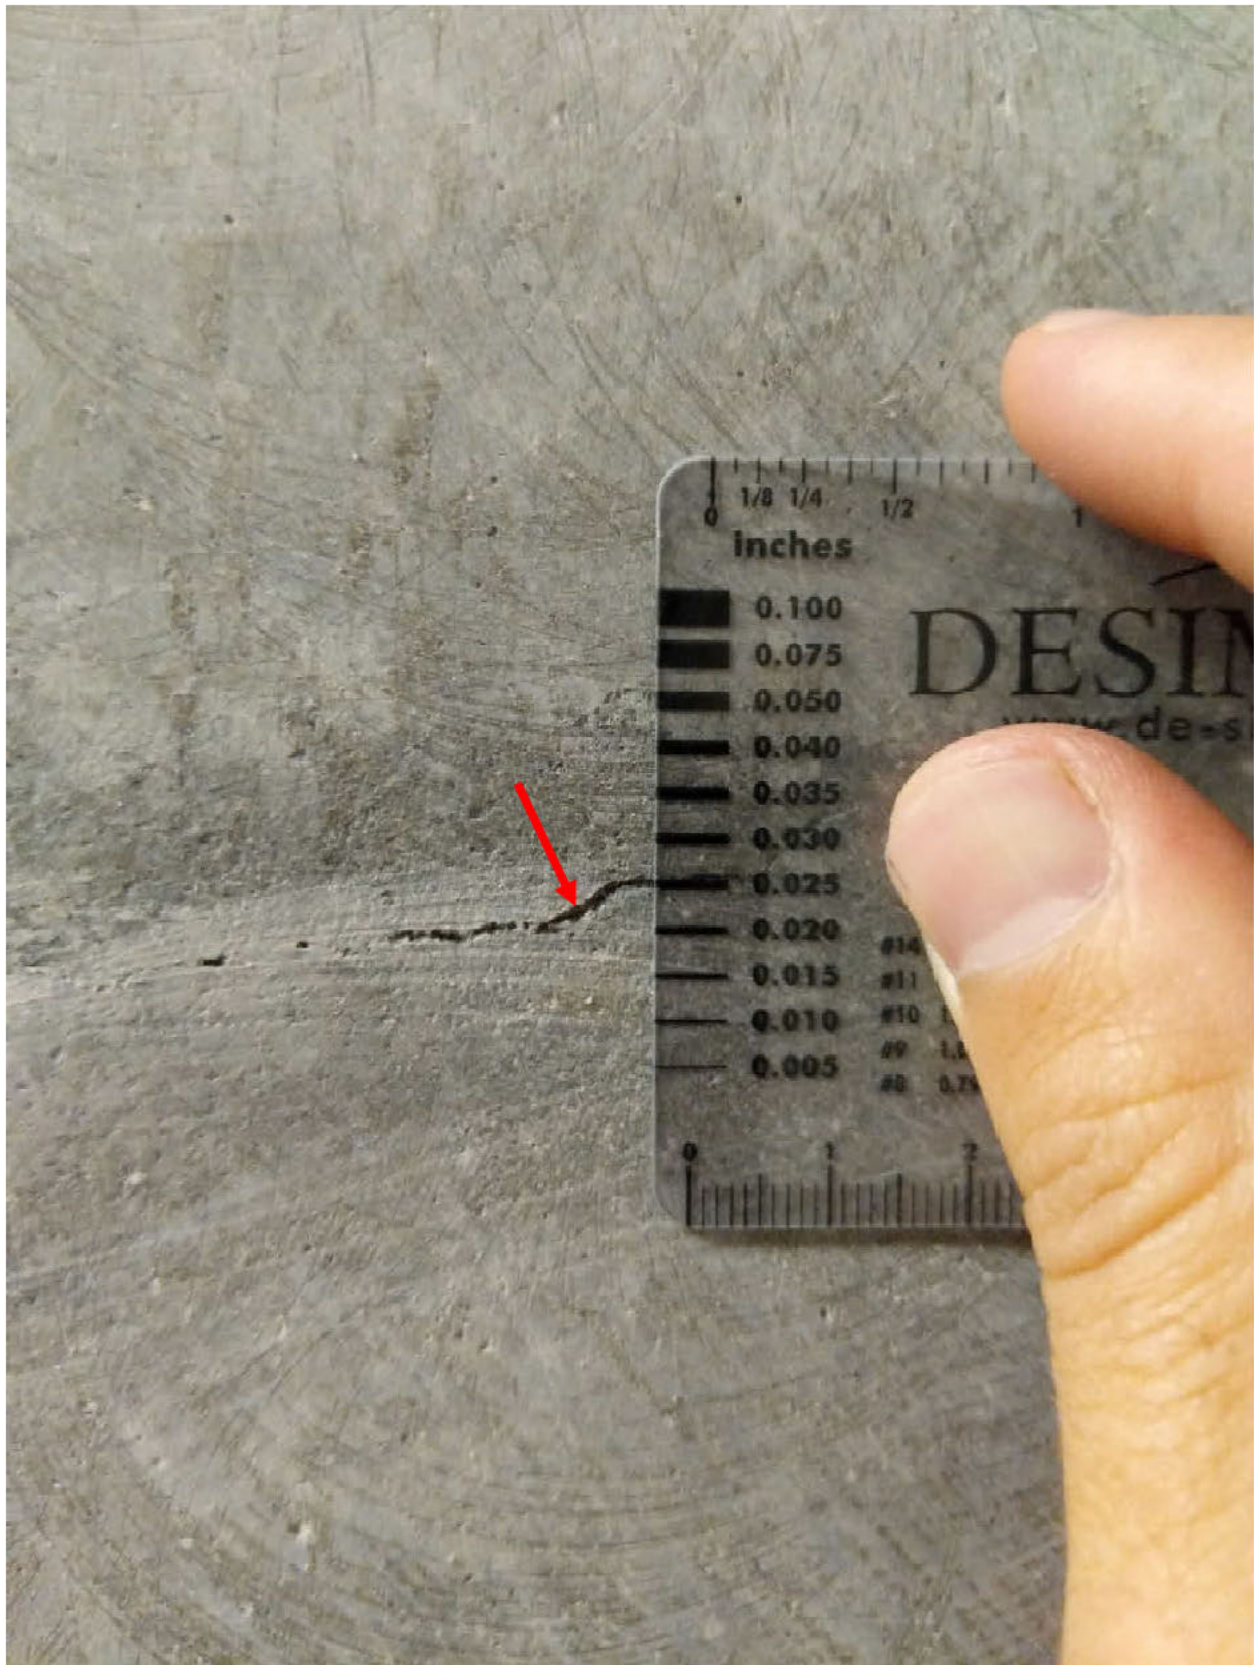
- 5.6 Superficial discoloration was observed by DeSimone at cracked Panel 100 (See Page 9), which was noted to exhibit signs of efflorescence.
- 5.7 Two (2) cracks that appear to previously have been repaired at Panel 206 and Panel WP-1313 appear to have a new crack that has formed in the repair material (See Pages 14 and 27, respectively).

Figure 12: Crack at previous repair location at interior face of Panel 206. Source: DeSimone.

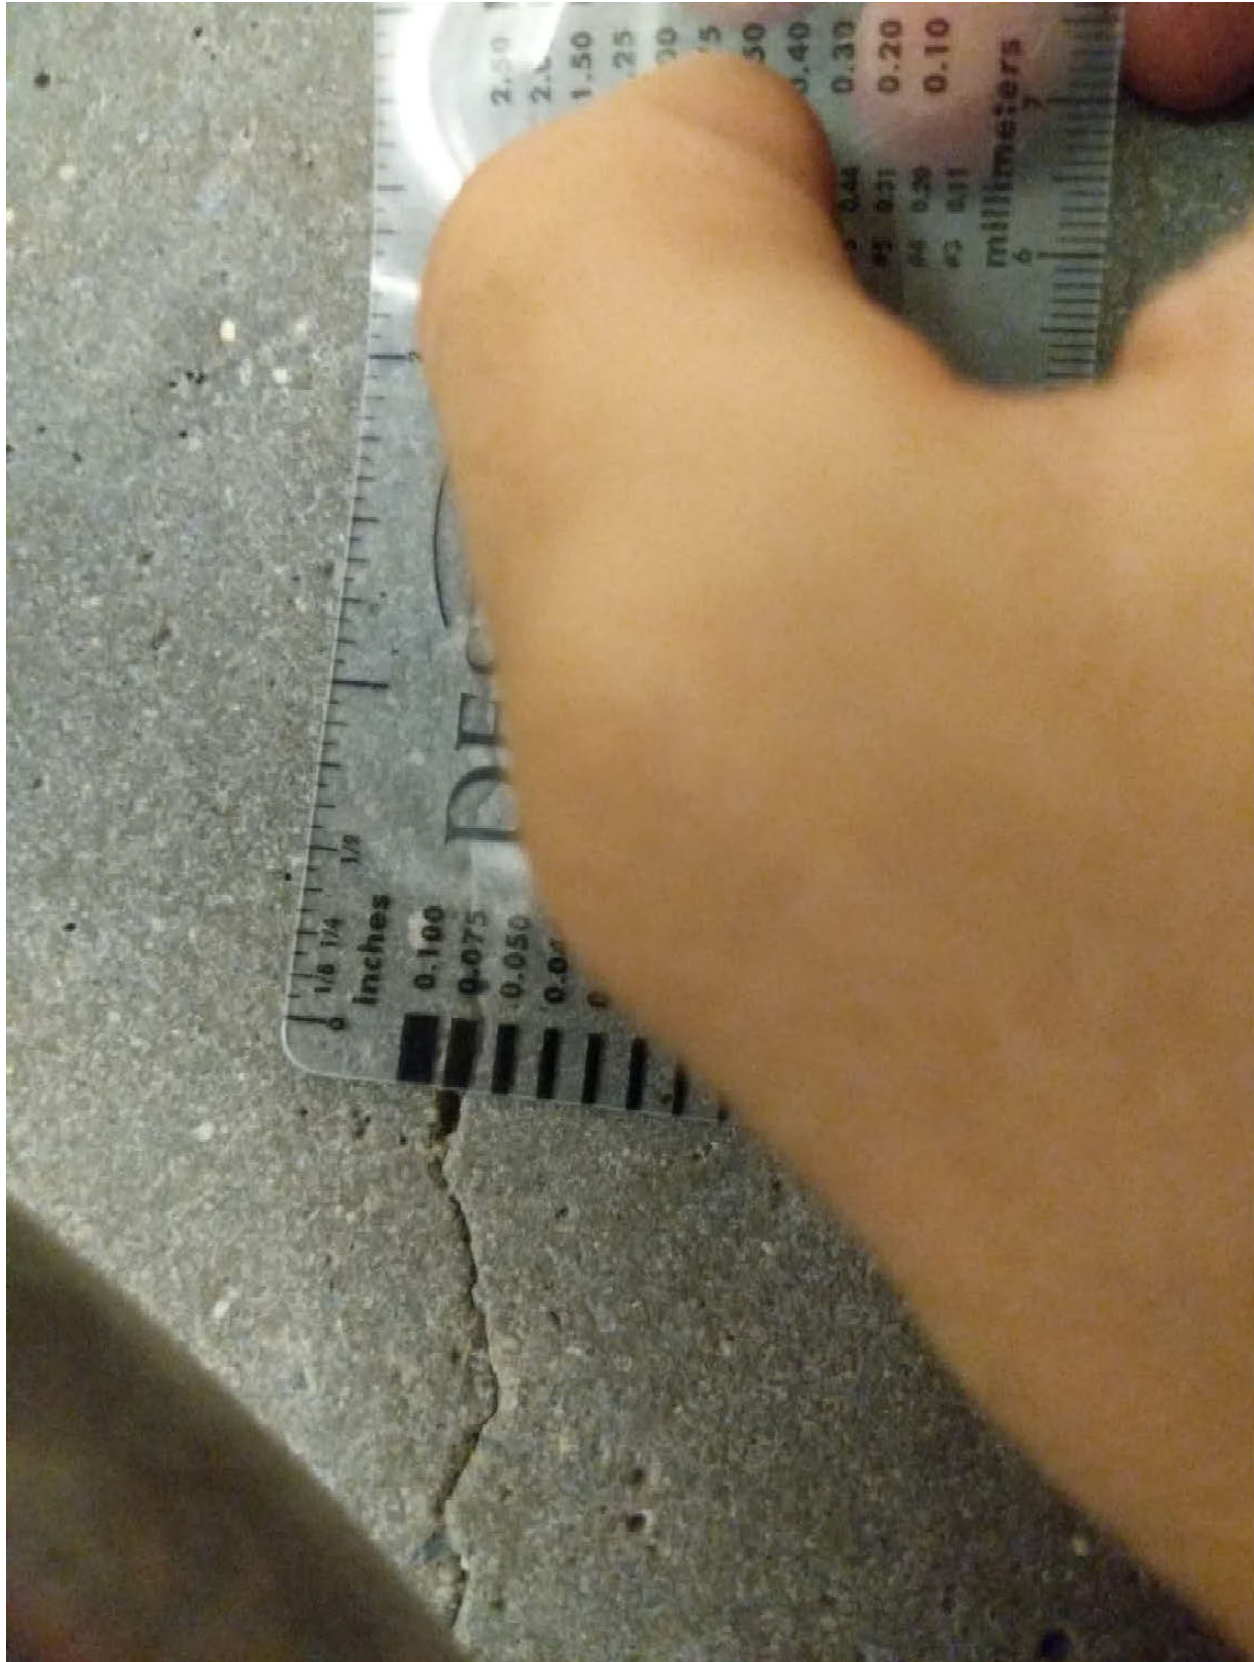
Figure 13: Spider cracks at interior of Panel 412. Source: DeSimone.

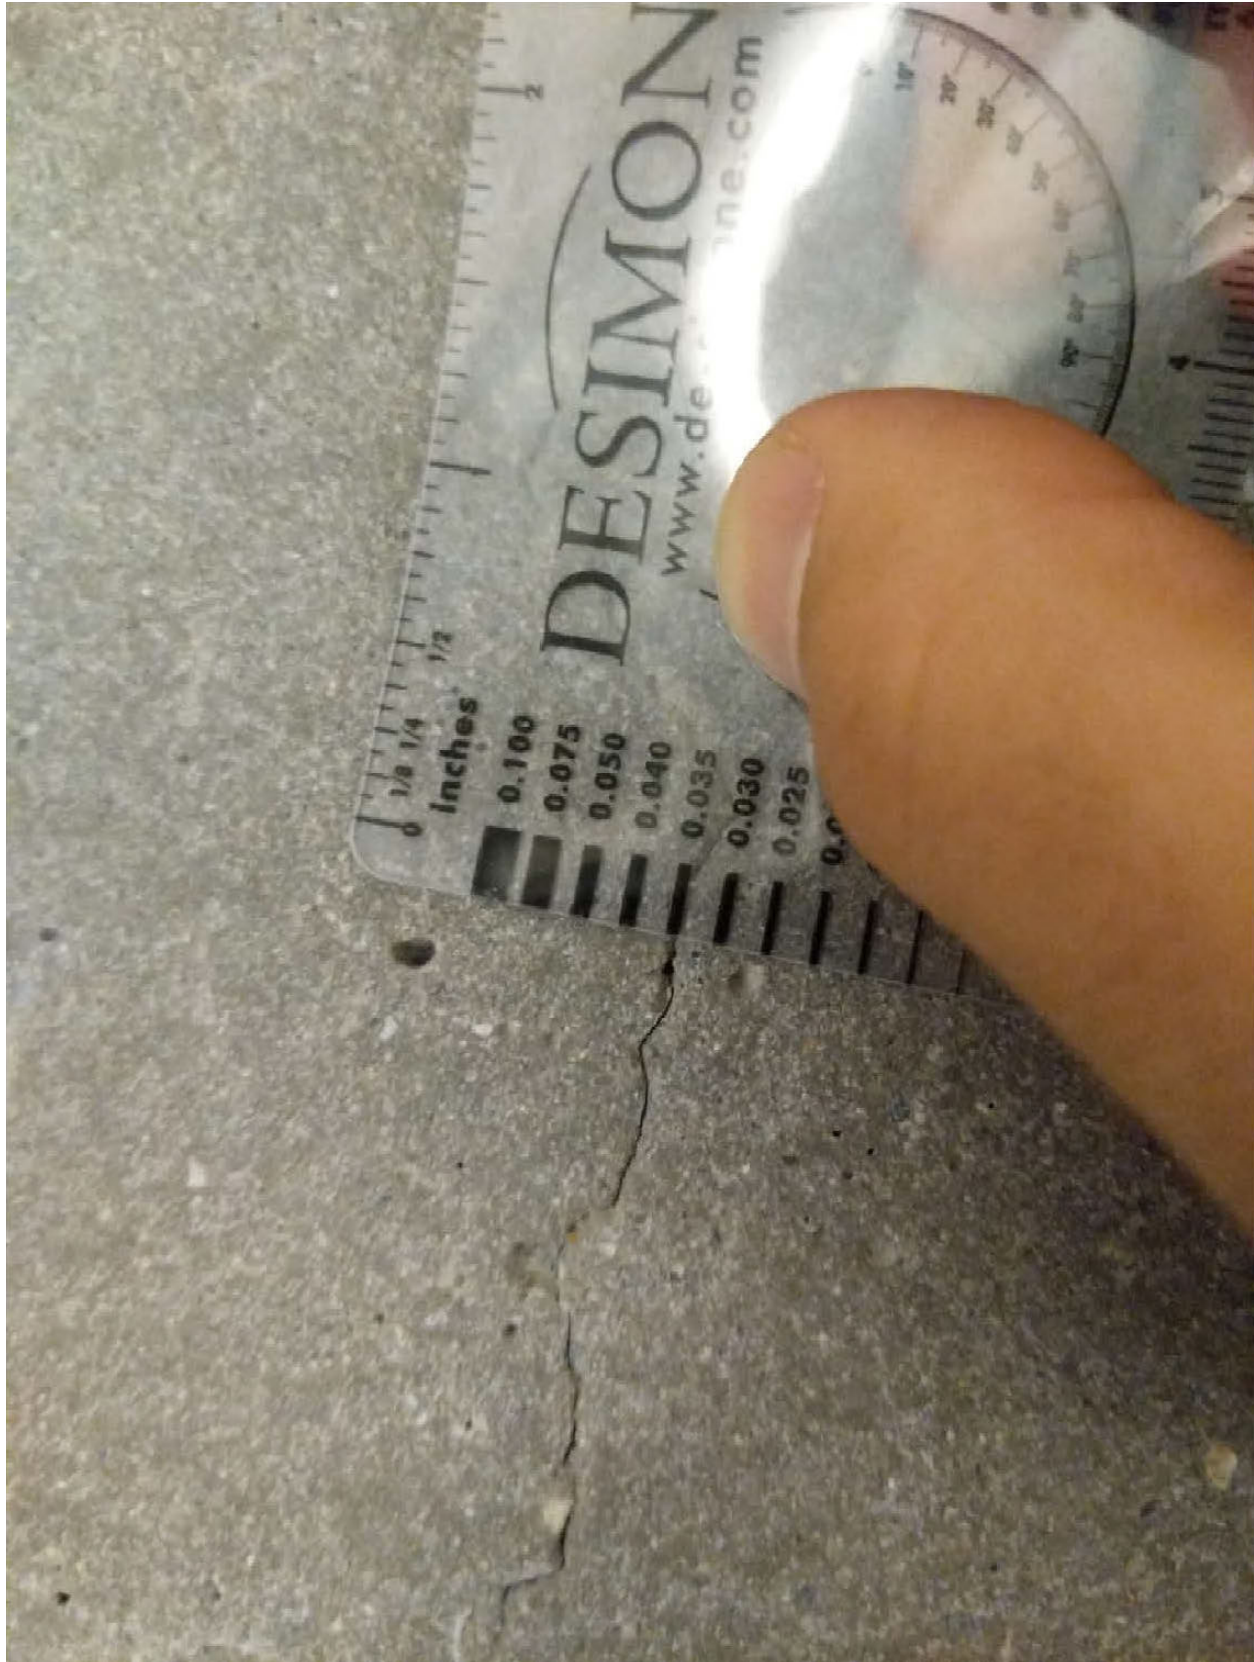
Figure 14: Separate region of spider cracks at interior of Panel 412. Source: DeSimone.

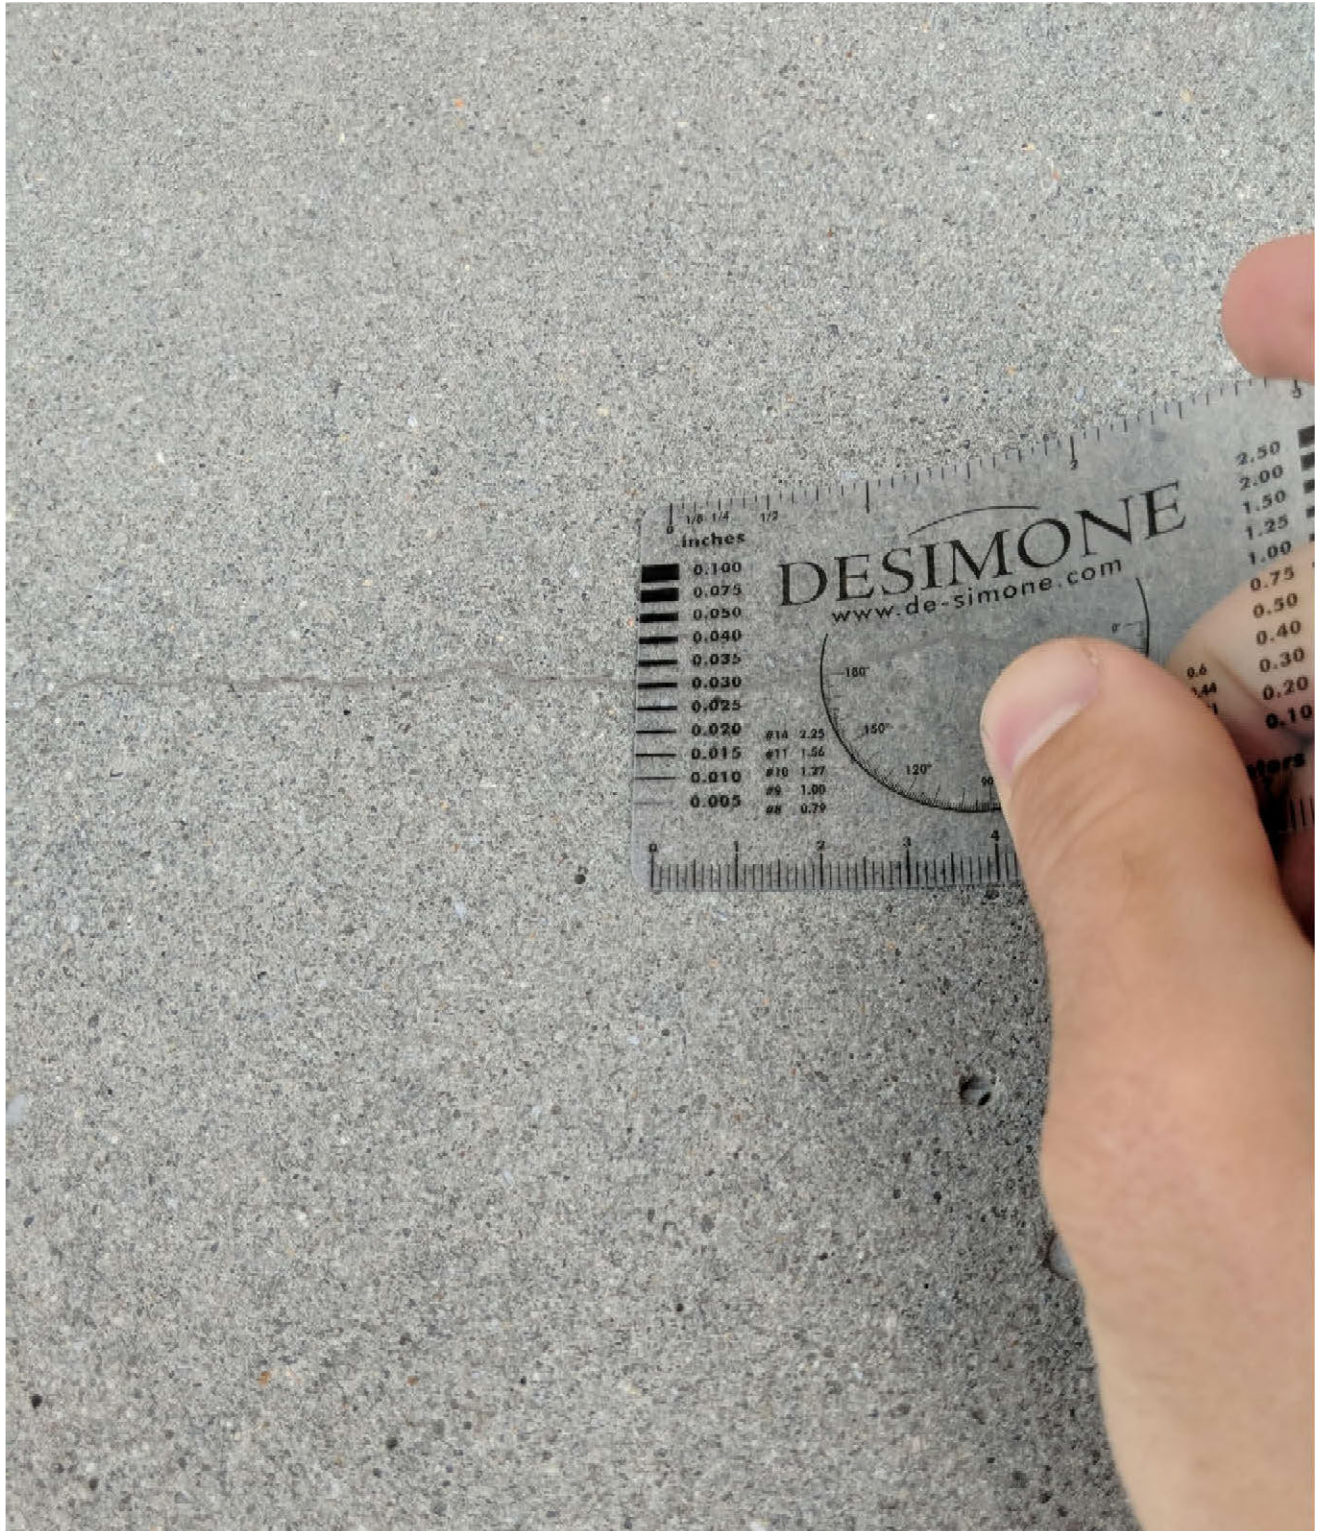
Figure 15: Repaired crack at exterior face of Panel 402. Source: DeSimone.

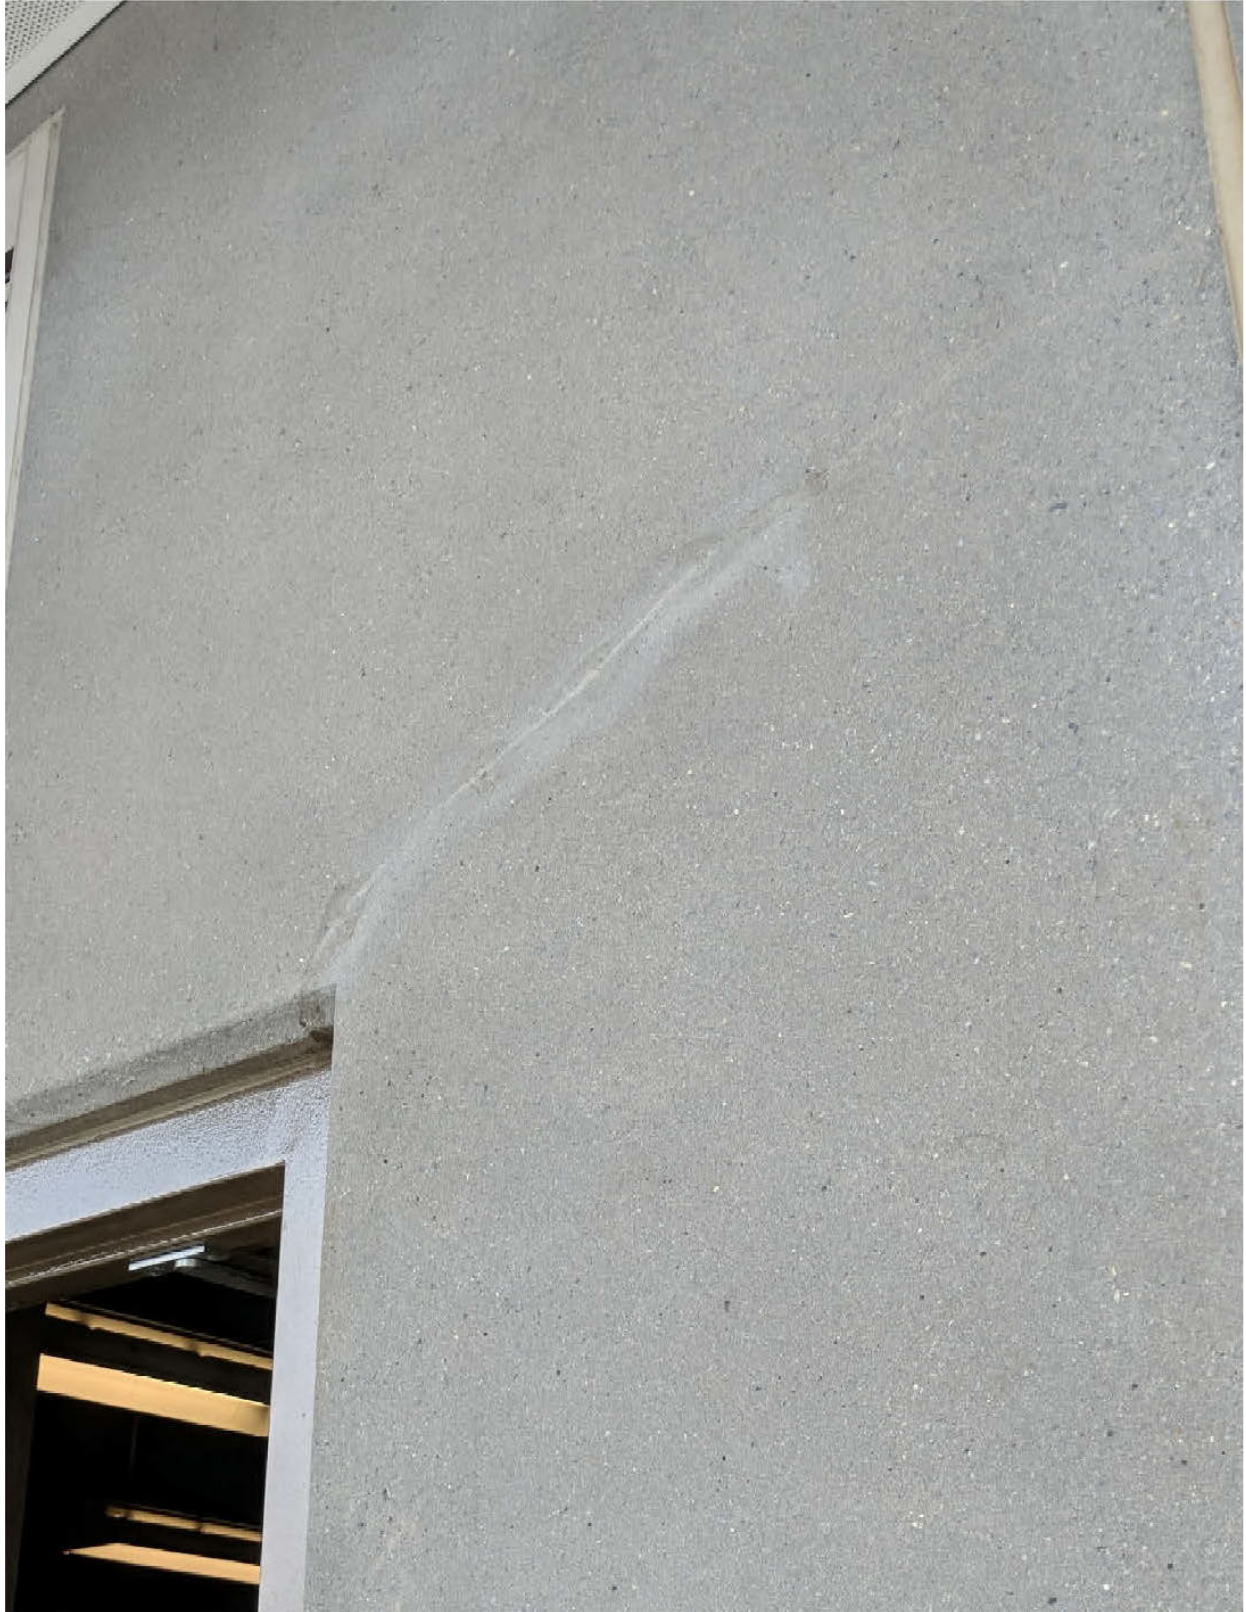
Figure 16: Repaired crack at exterior face of Panel 404. Source: DeSimone.

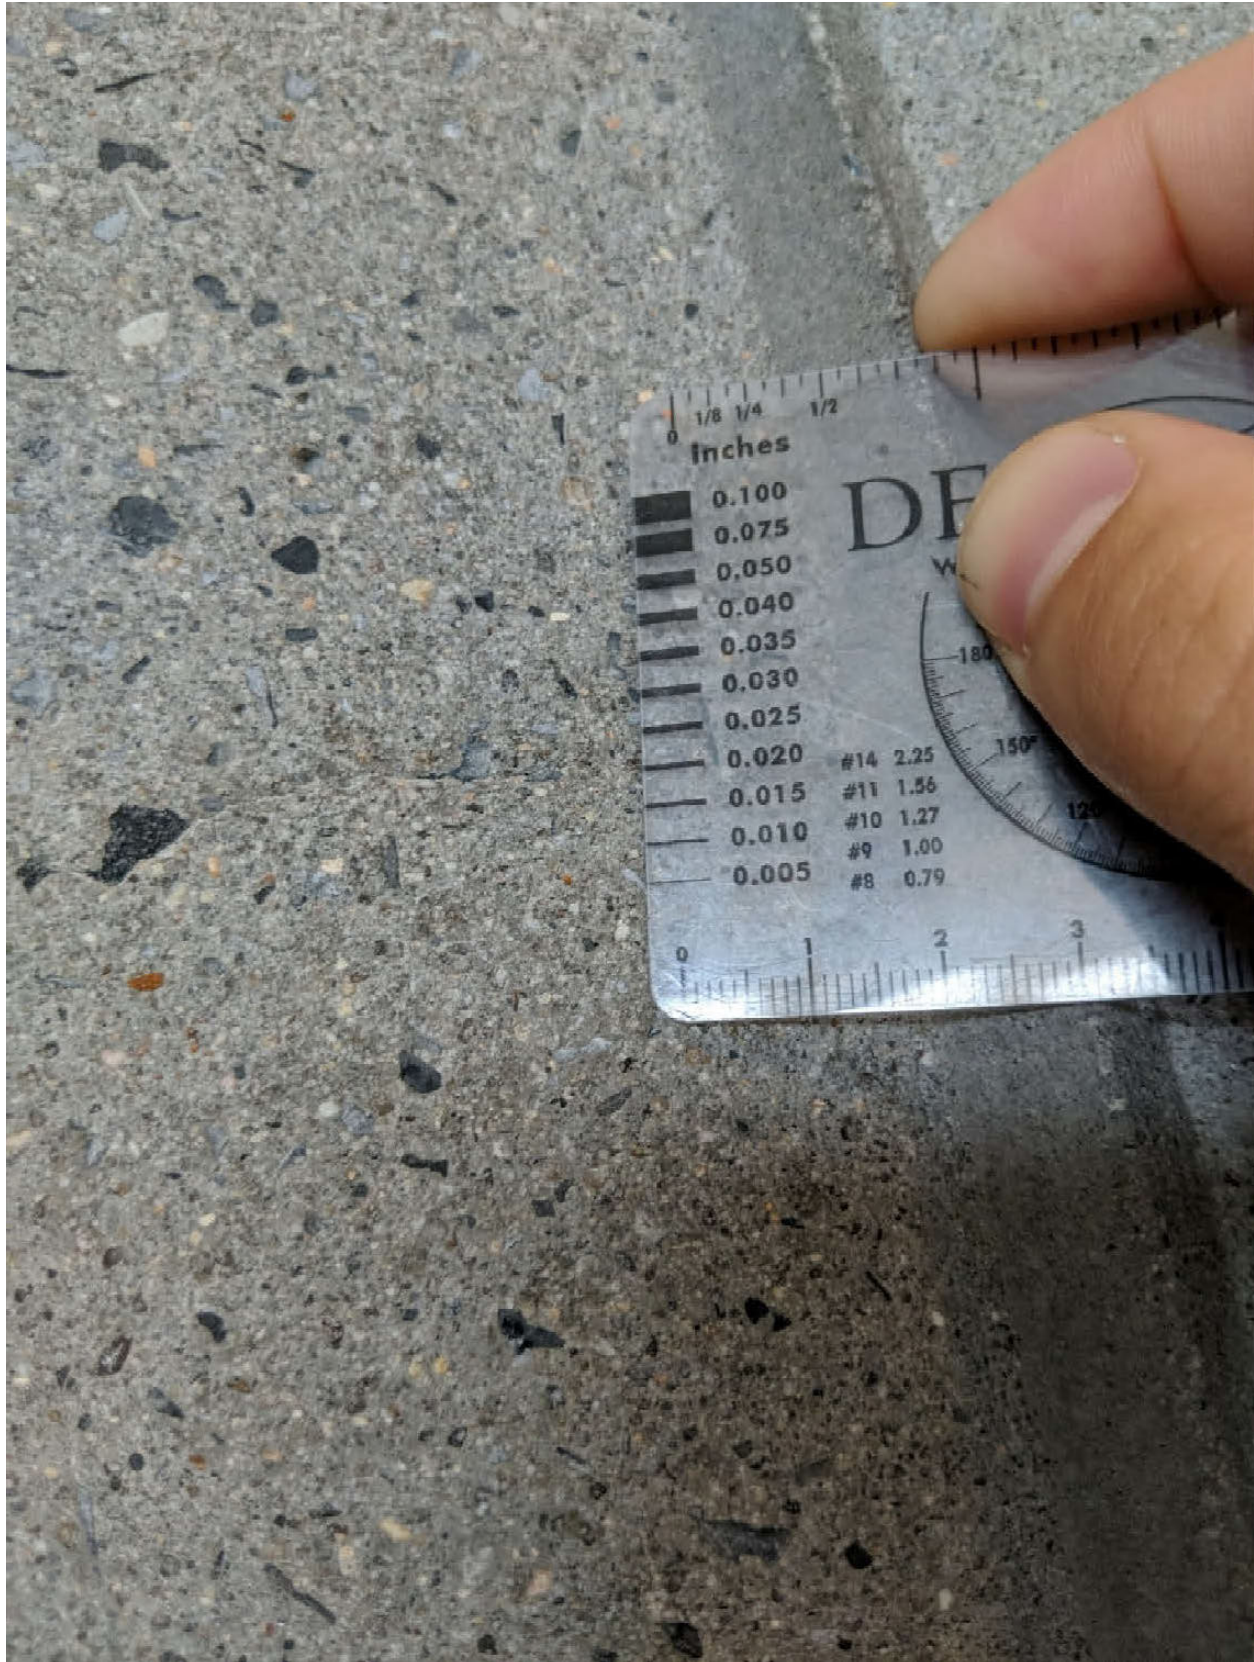
Figure 17: Crack at exterior face of Panel 107. Source: DeSimone.

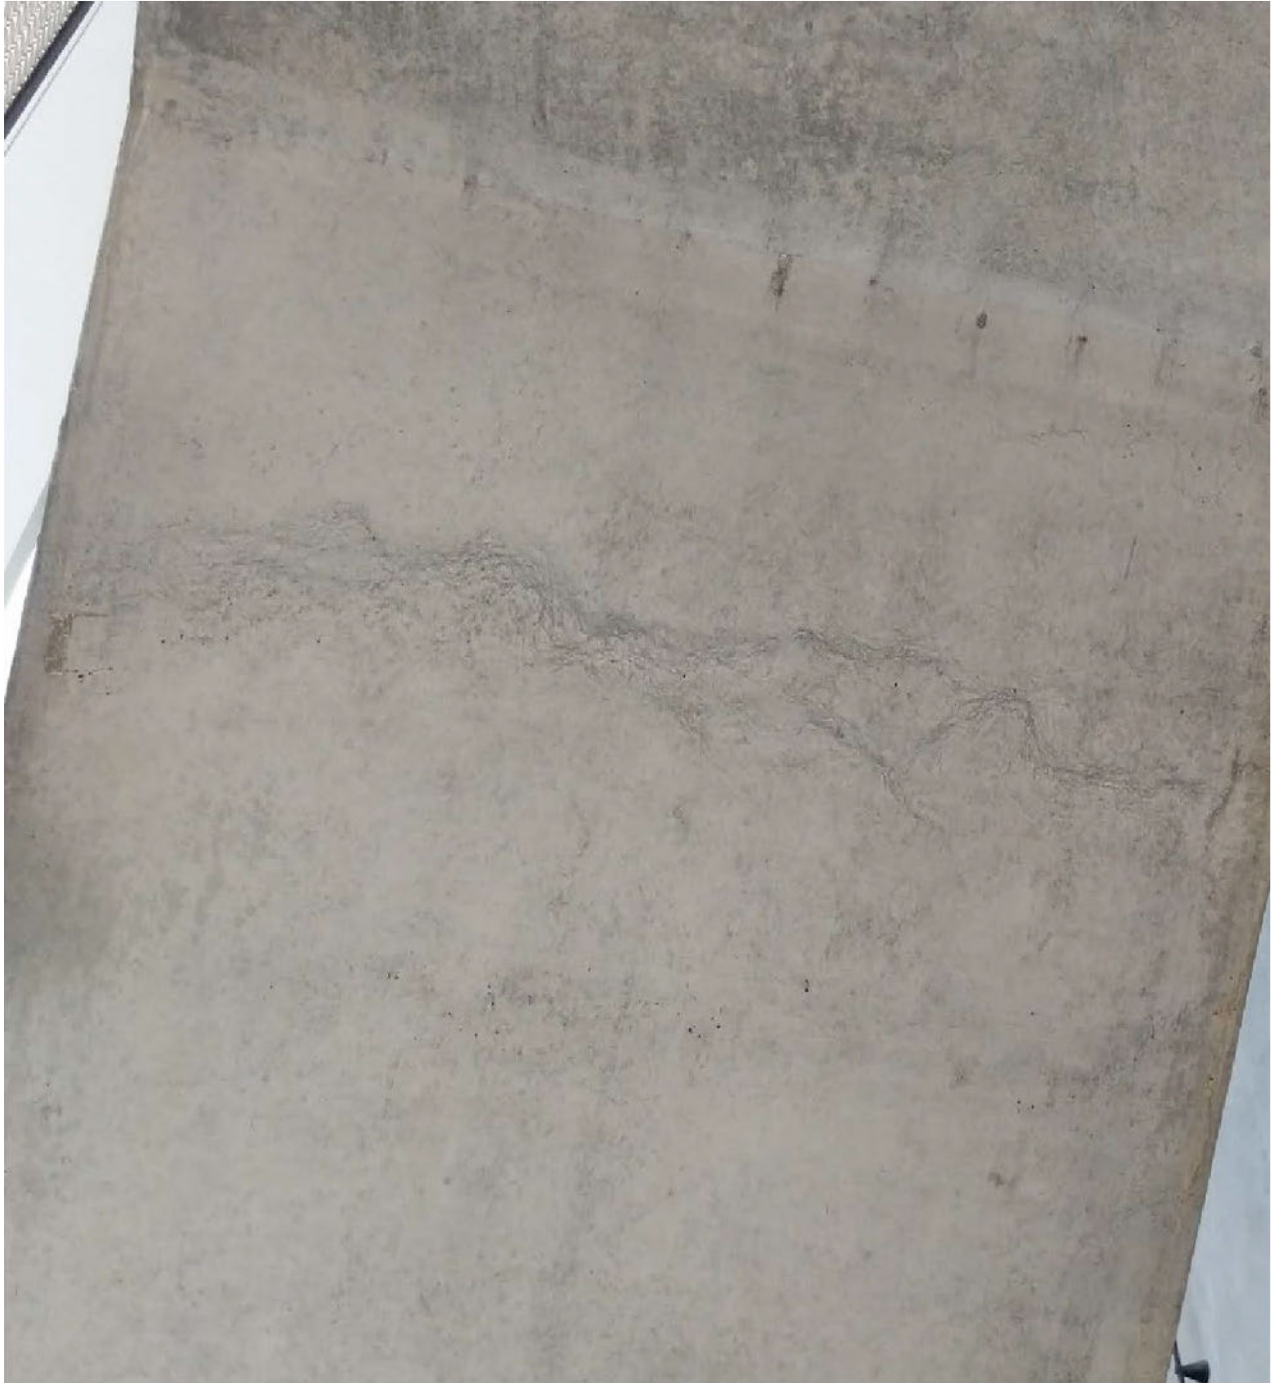
Figure 18: Crack at underside of Panel ST-4. Source: DeSimone.

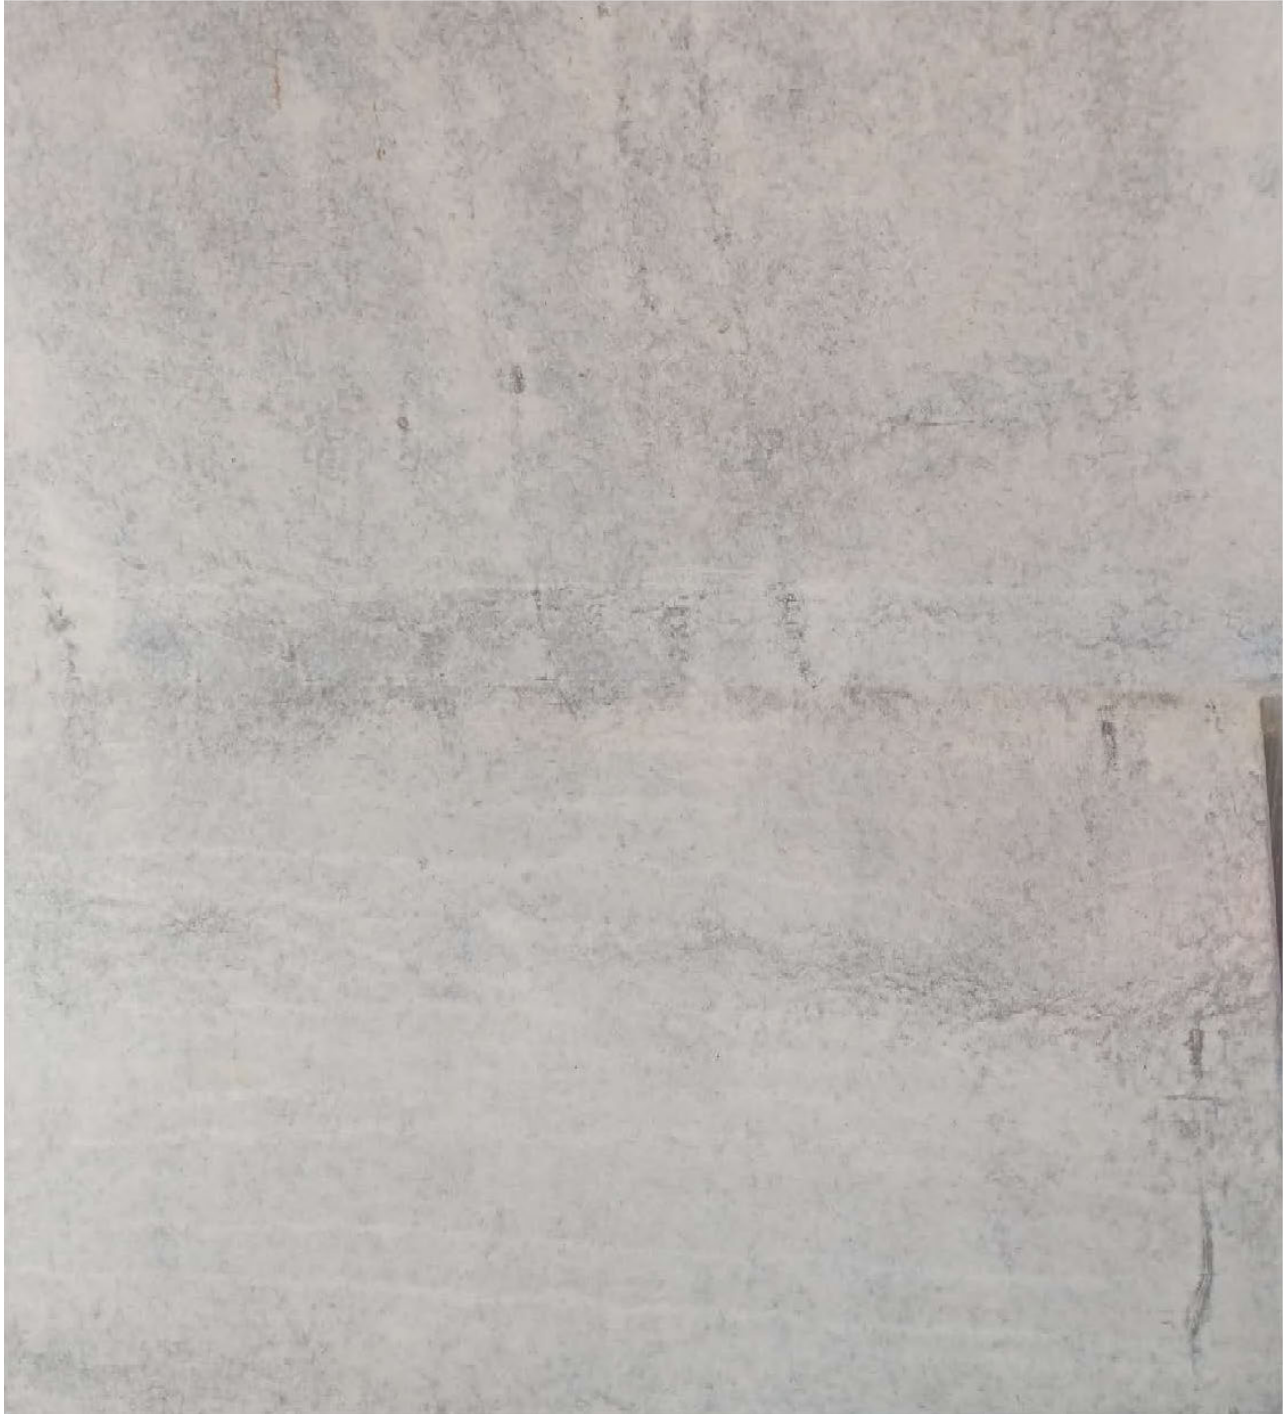
Figure 19: Crack at underside of Panel ST-2. Source: DeSimone.
