**Dulles Metro Silver Line Concrete Panel Assessment  
Innovation Center Station Precast Inspections**  
Herndon, Virginia

**DeSimone Consulting Engineers**

Report Issued: August 24, 2020

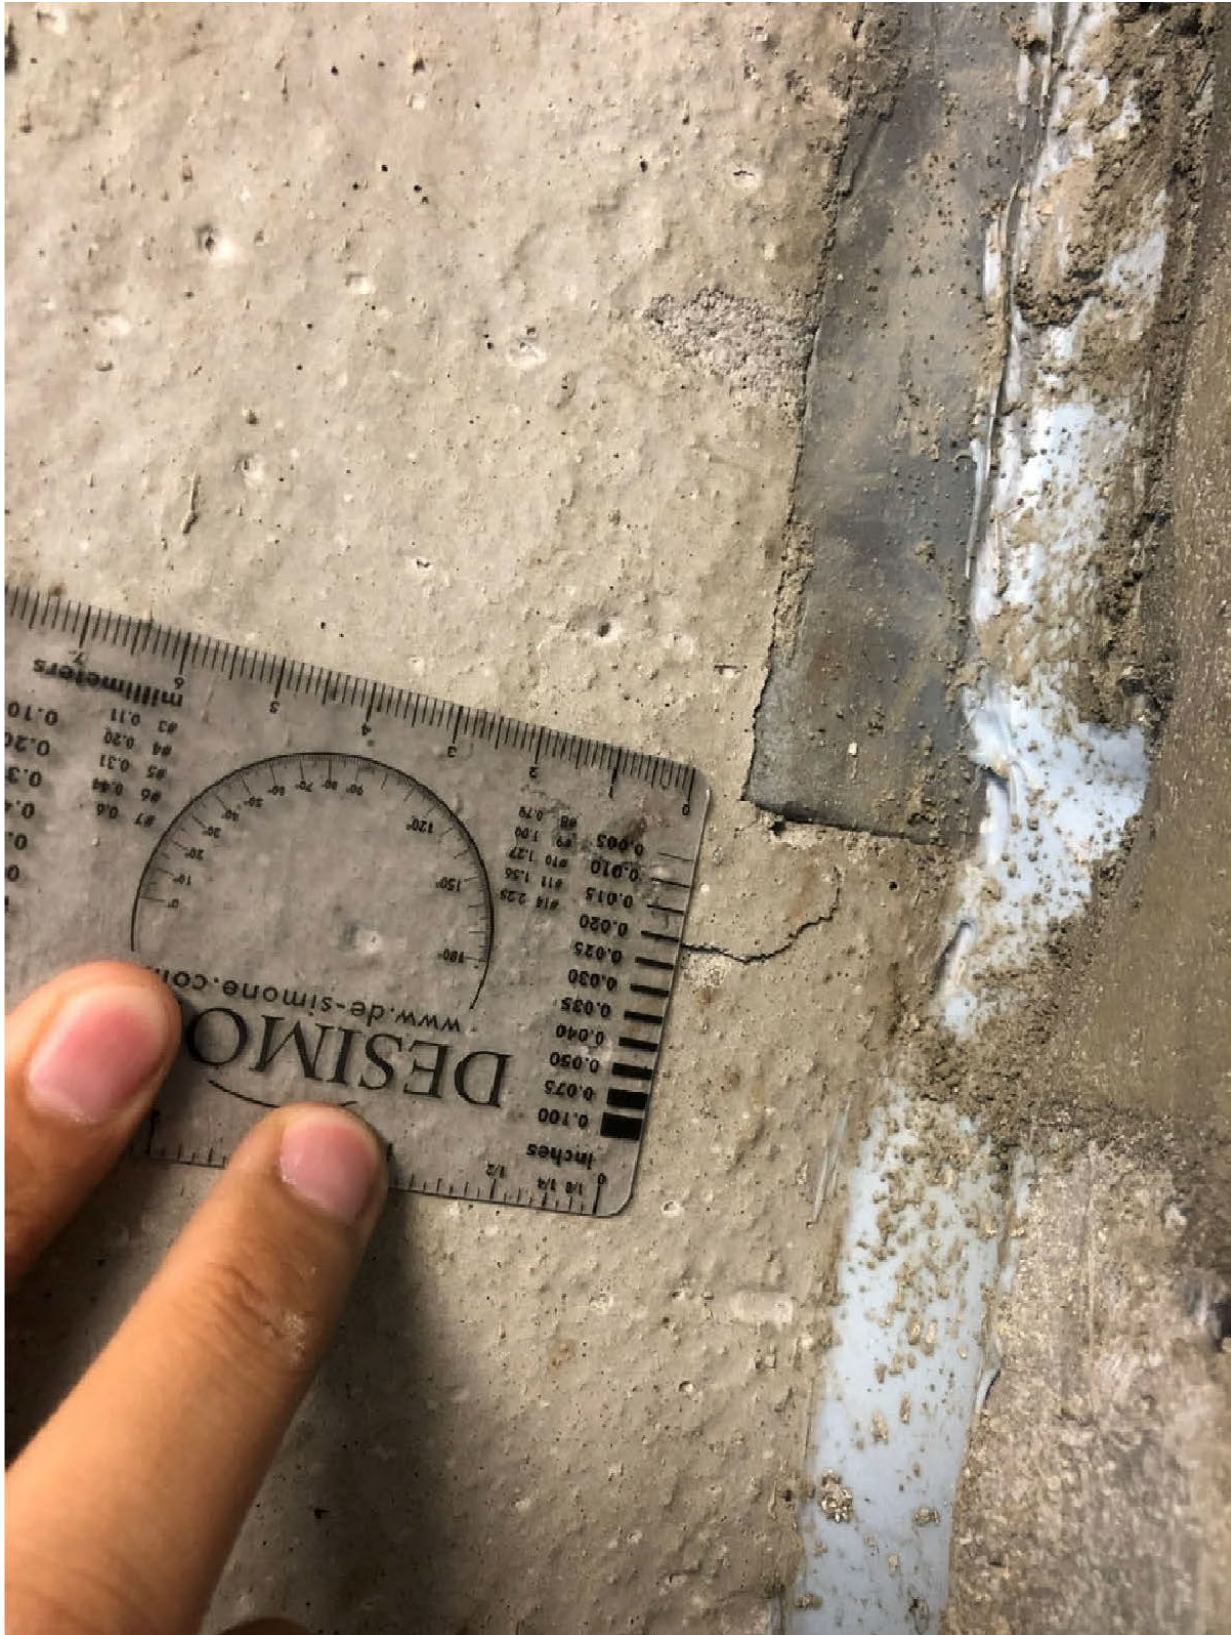
Figure 20: Crack at Interior face of Panel 1404. Source: DeSimone.

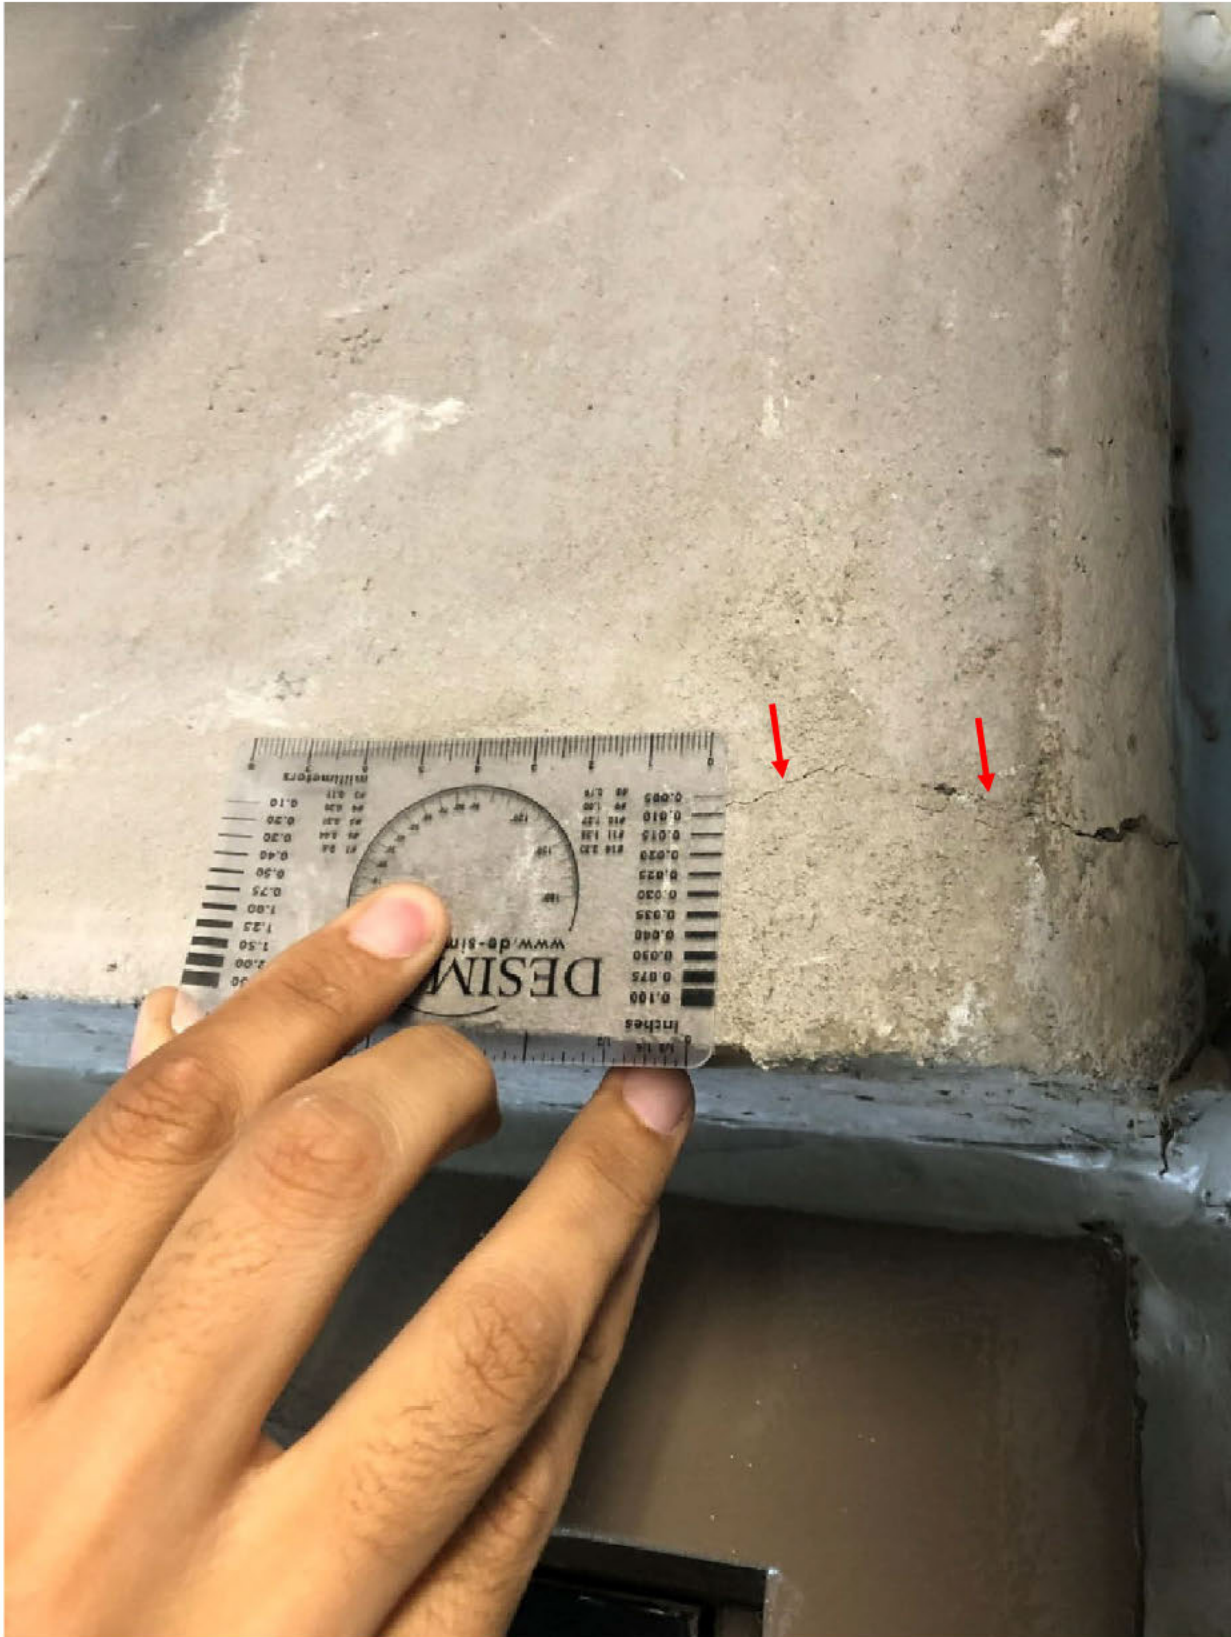
Figure 21: Crack at separate region of interior face of Panel 1404. Source: DeSimone.

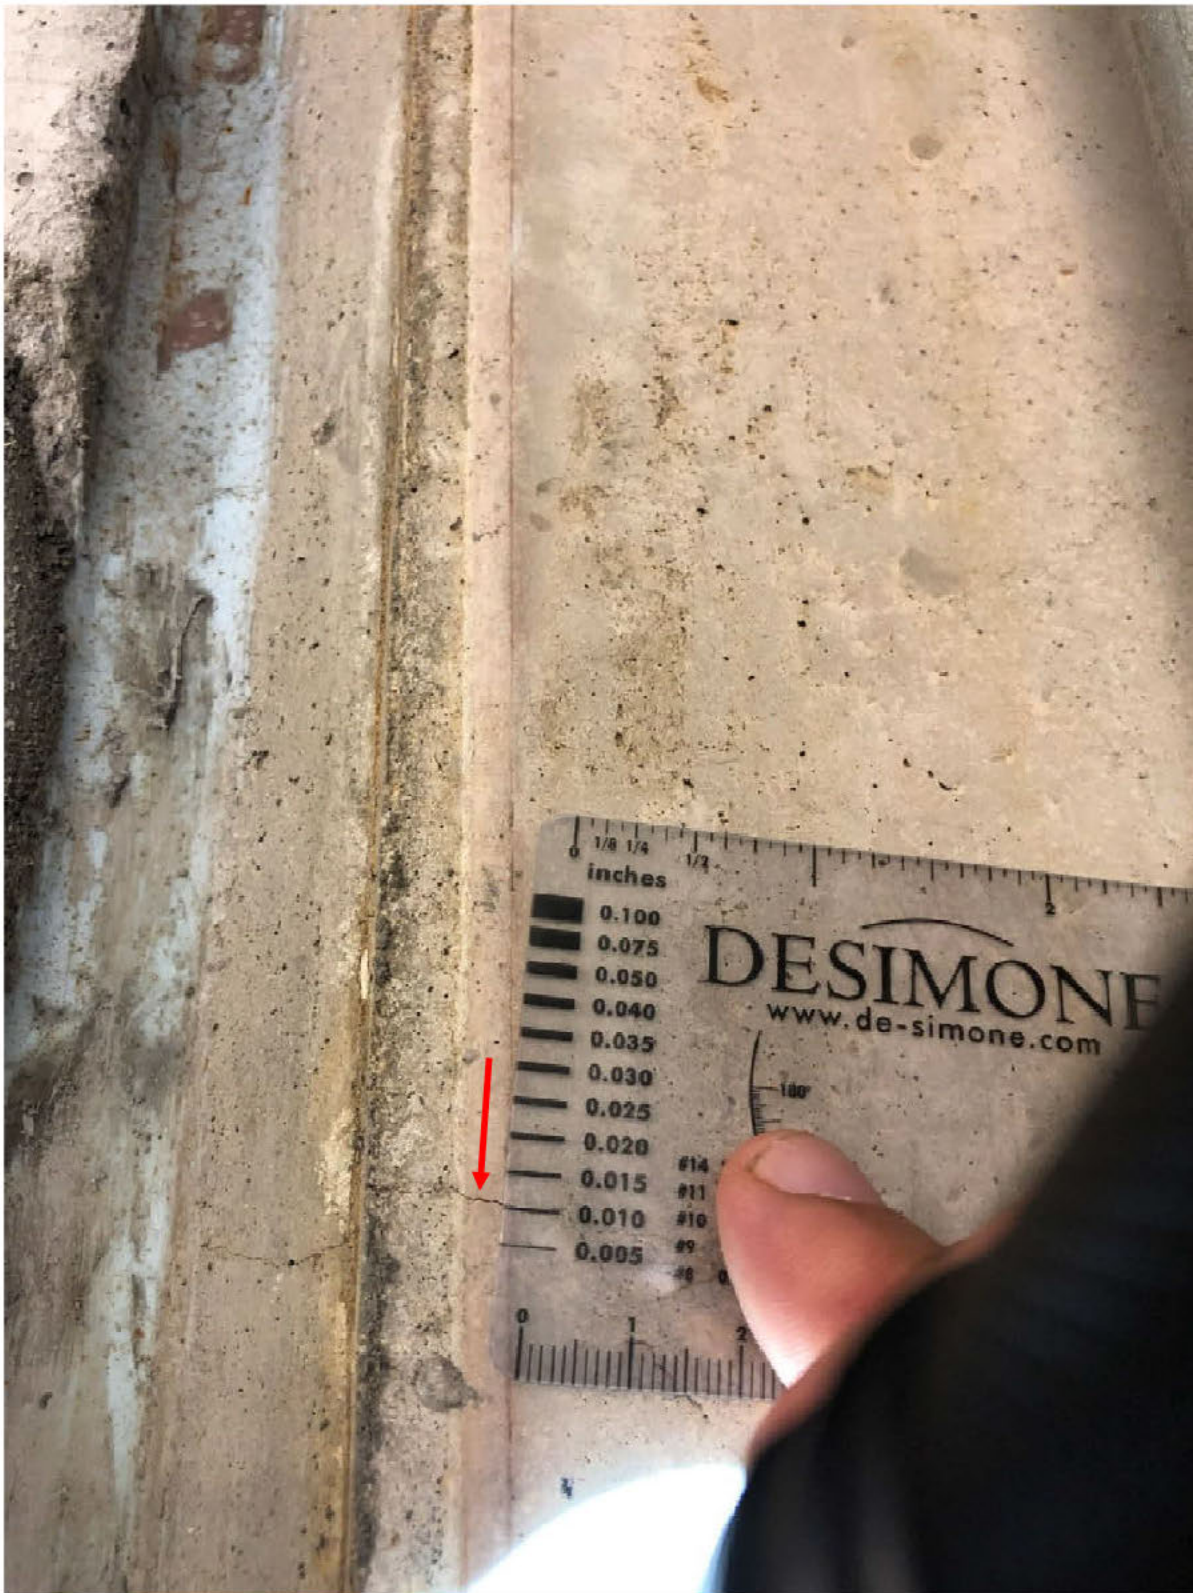
Figure 22: Crack at interior face of Panel 1421. Source: DeSimone.

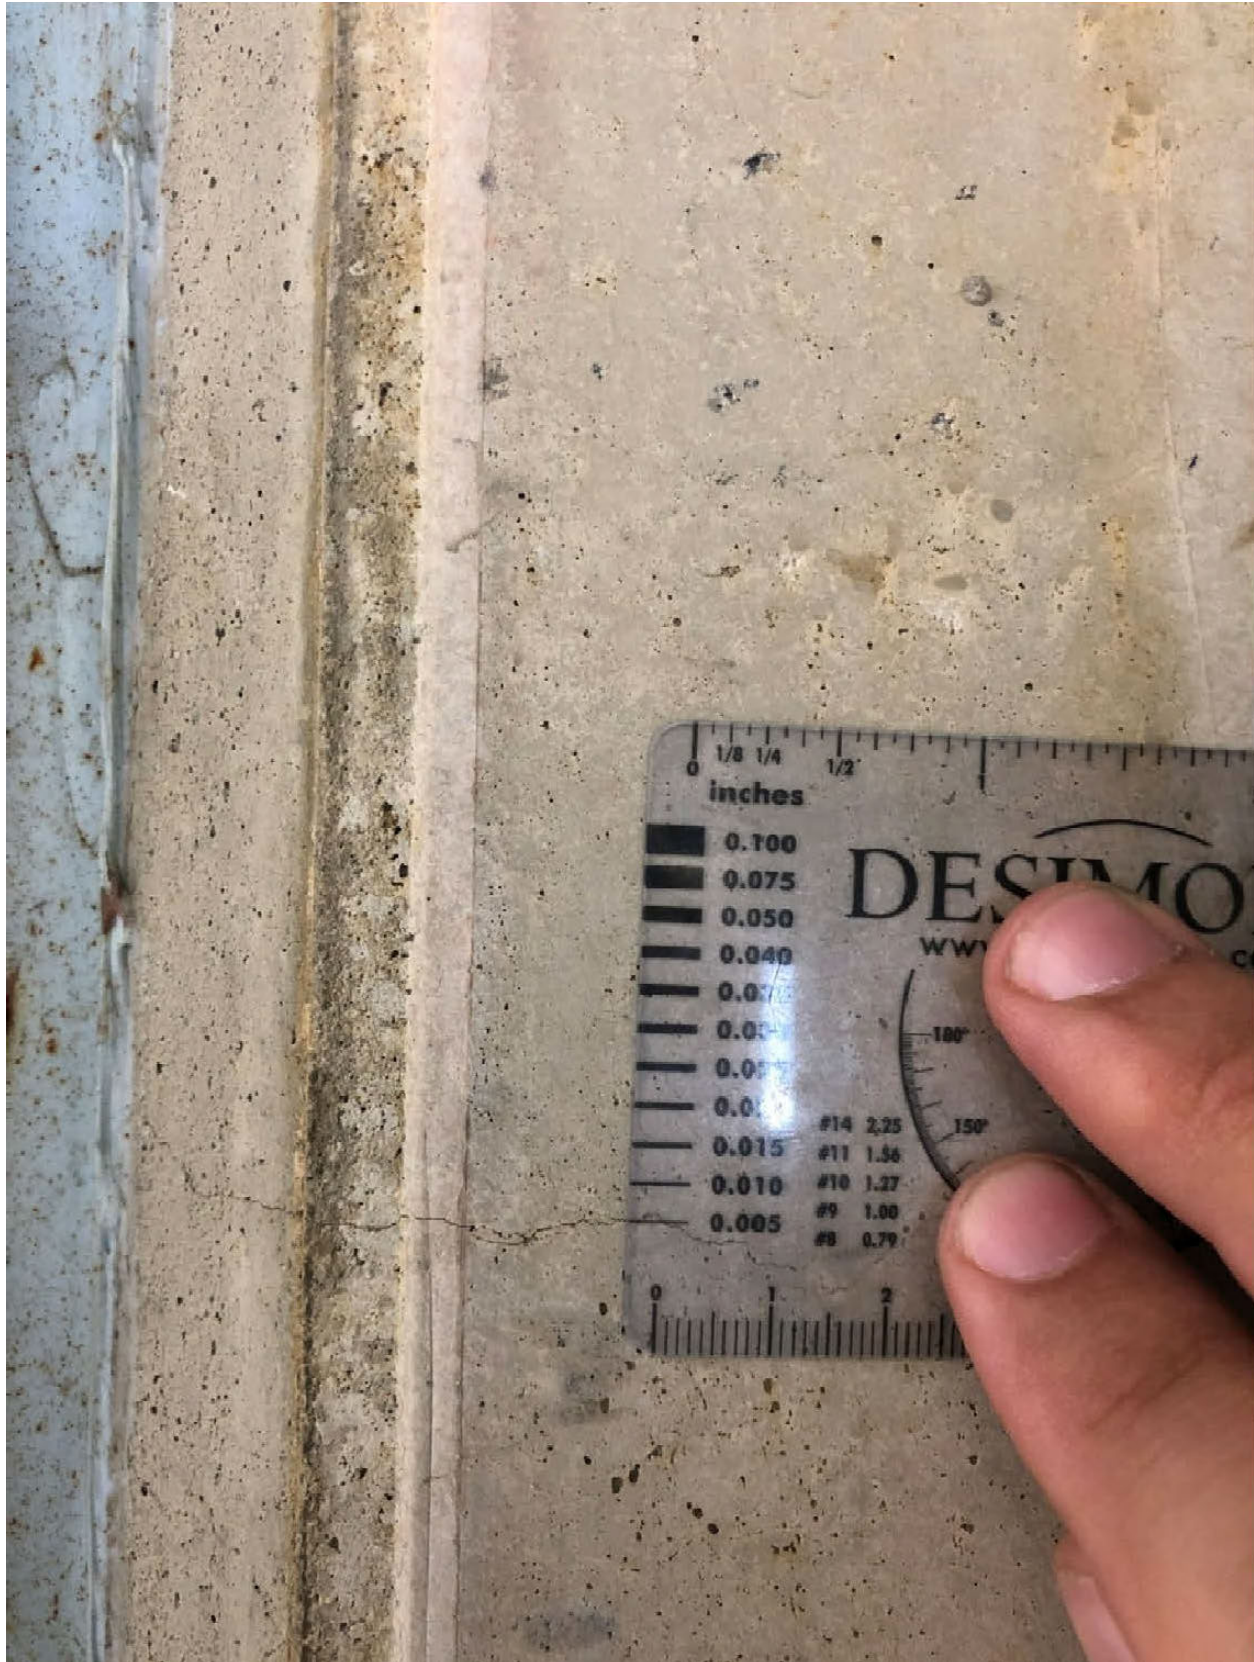
Figure 23: Crack at interior face of Panel 1421. Source: DeSimone.

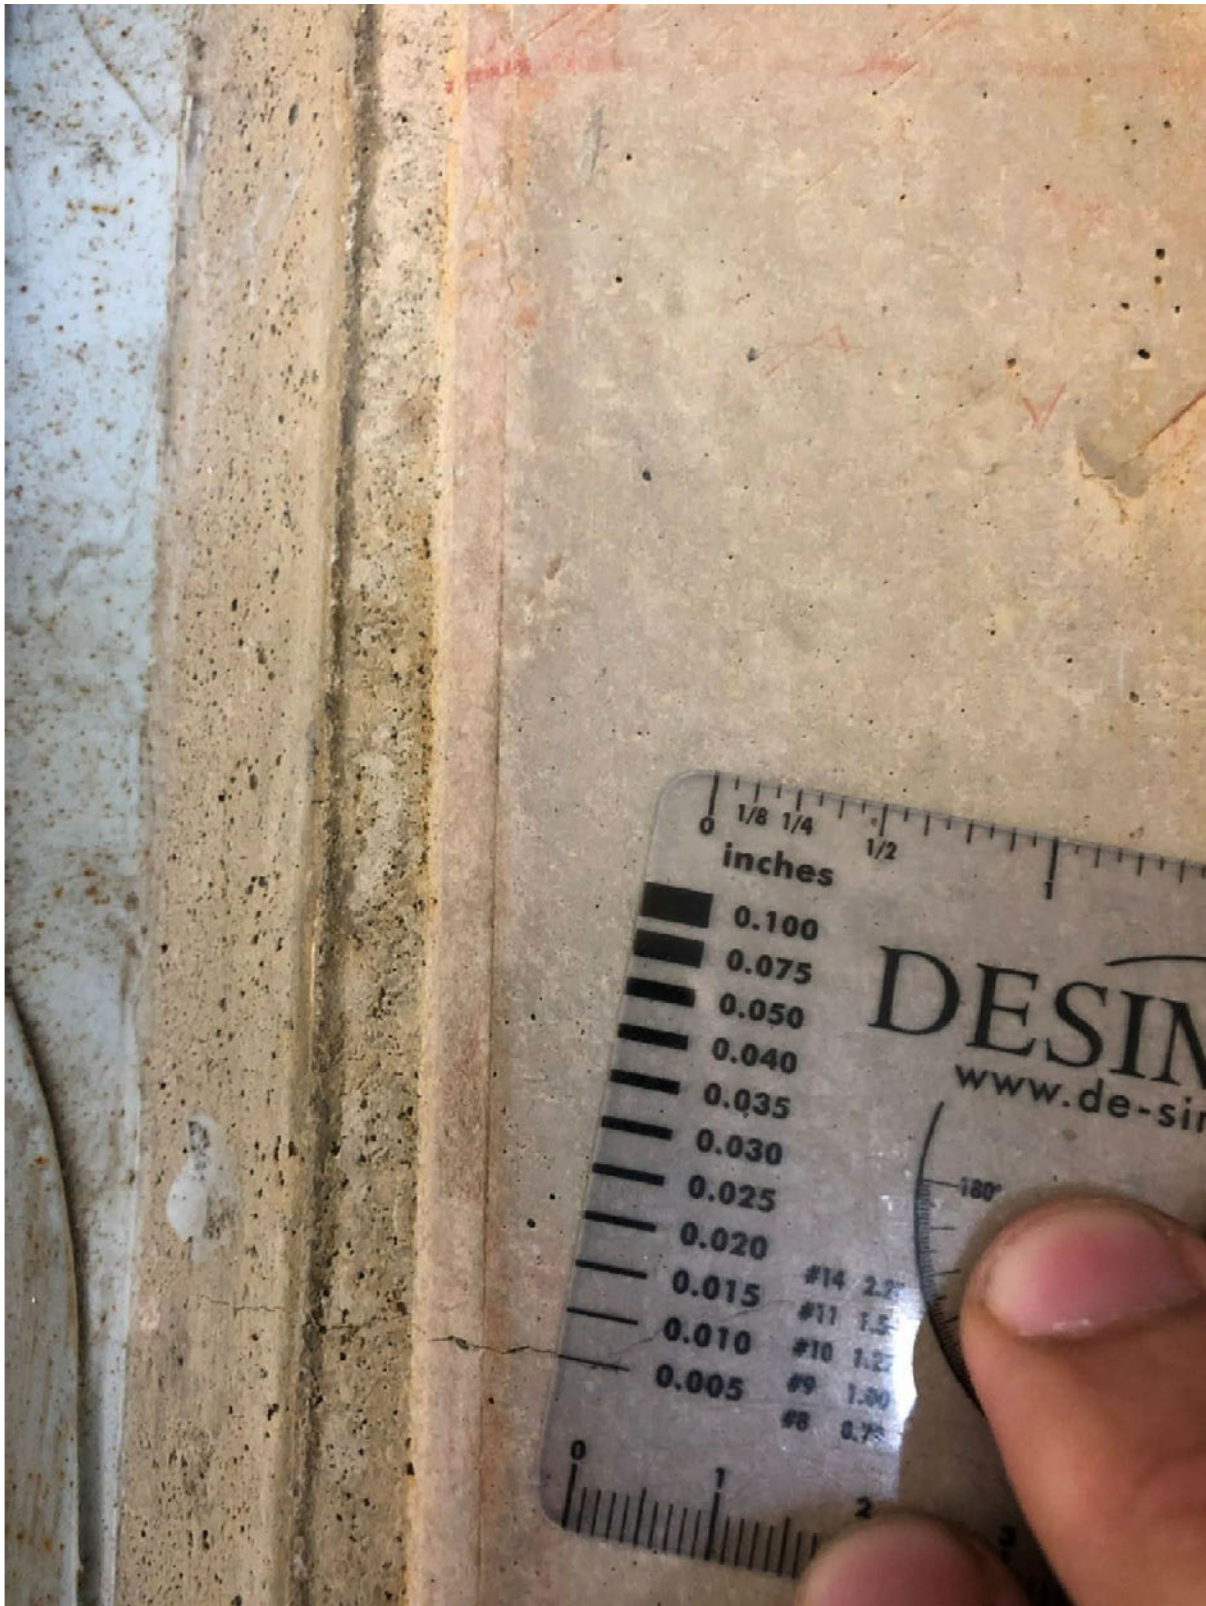
Figure 24: Crack at interior face of Panel 1421. Source: DeSimone.

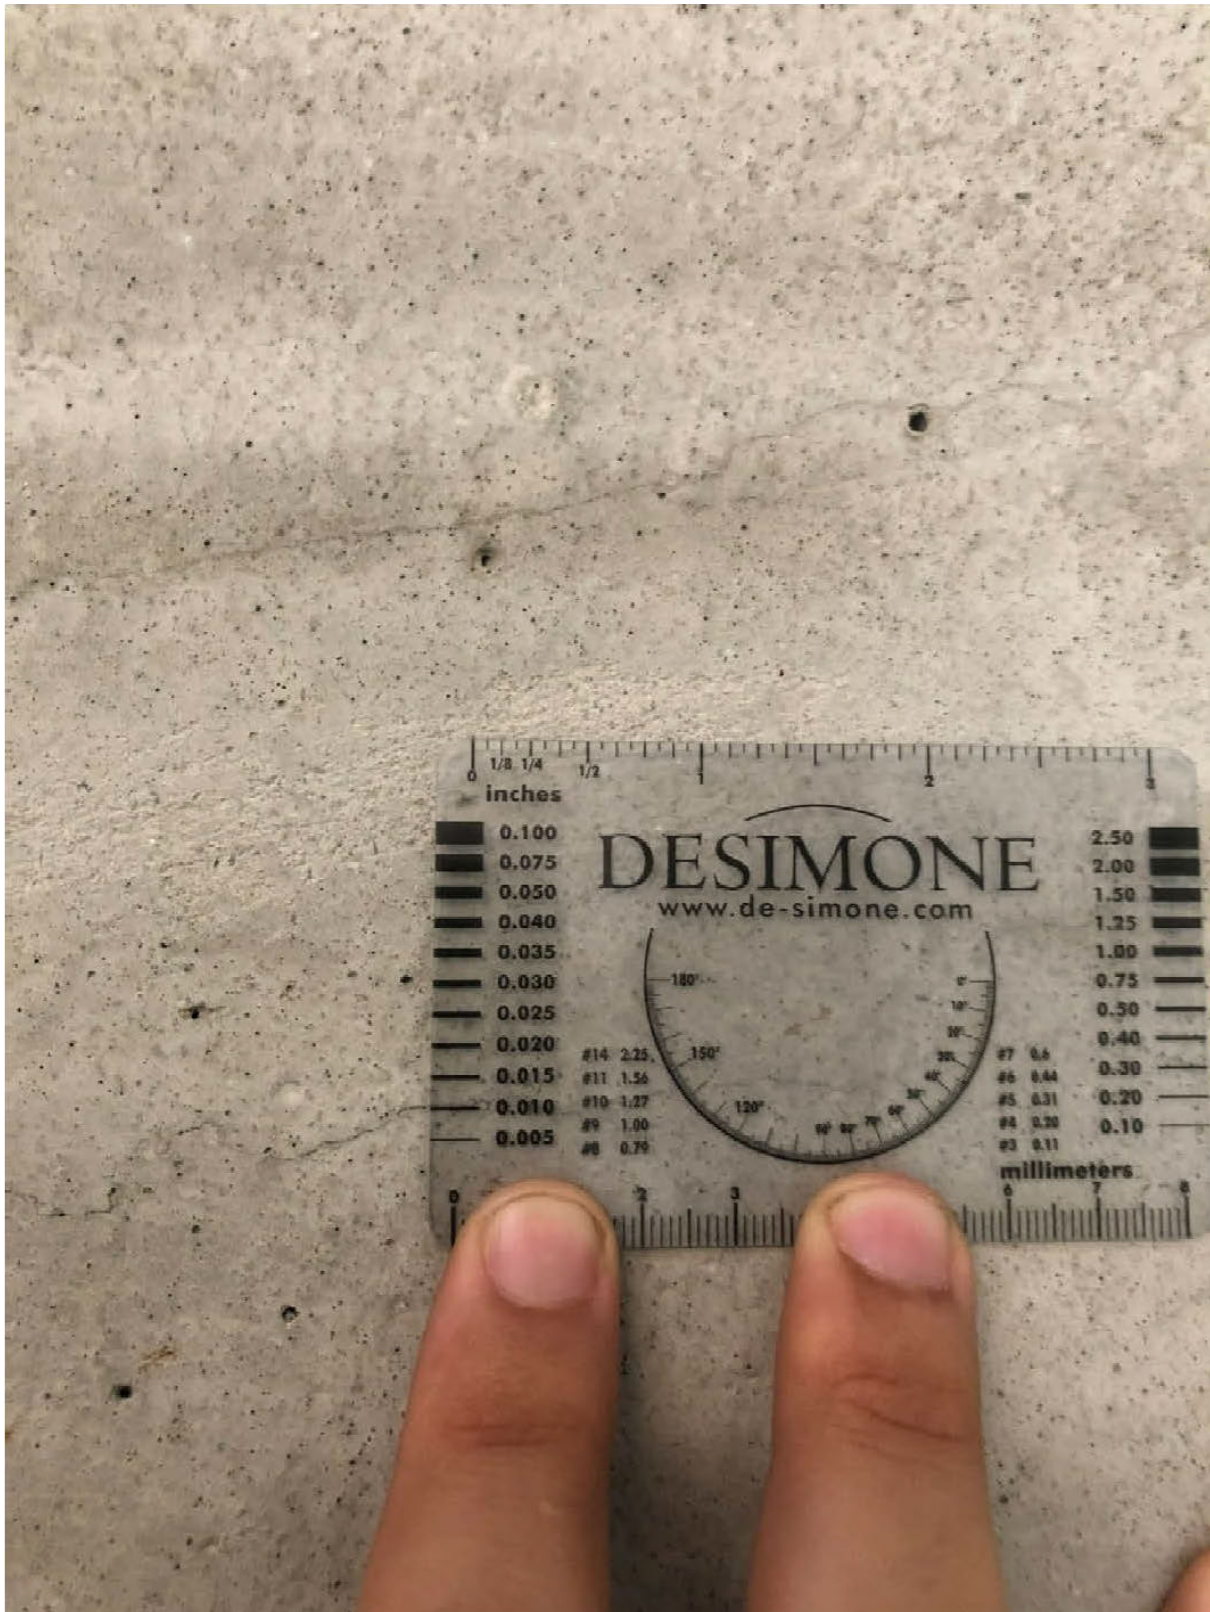
Figure 25: Crack at interior face of Panel 1421. Source: DeSimone.

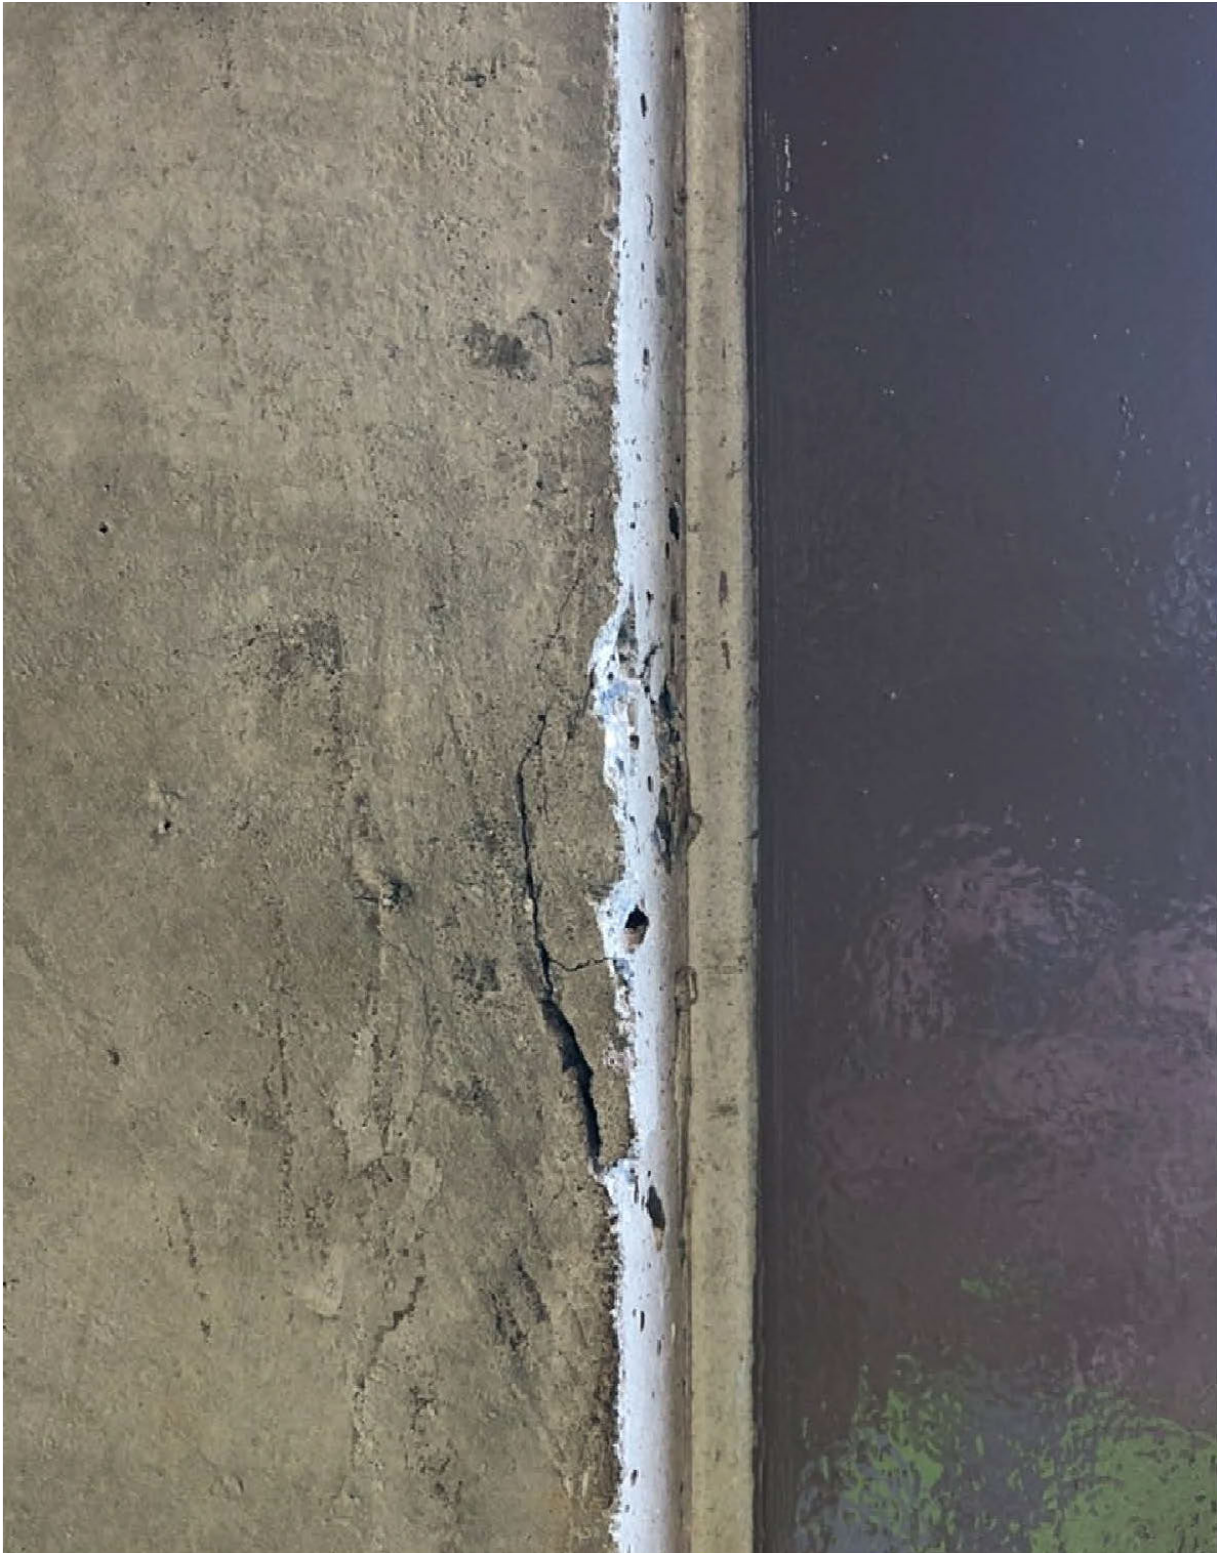
Figure 26: Chipped concrete at interior face of Panel 1420. Source: DeSimone.

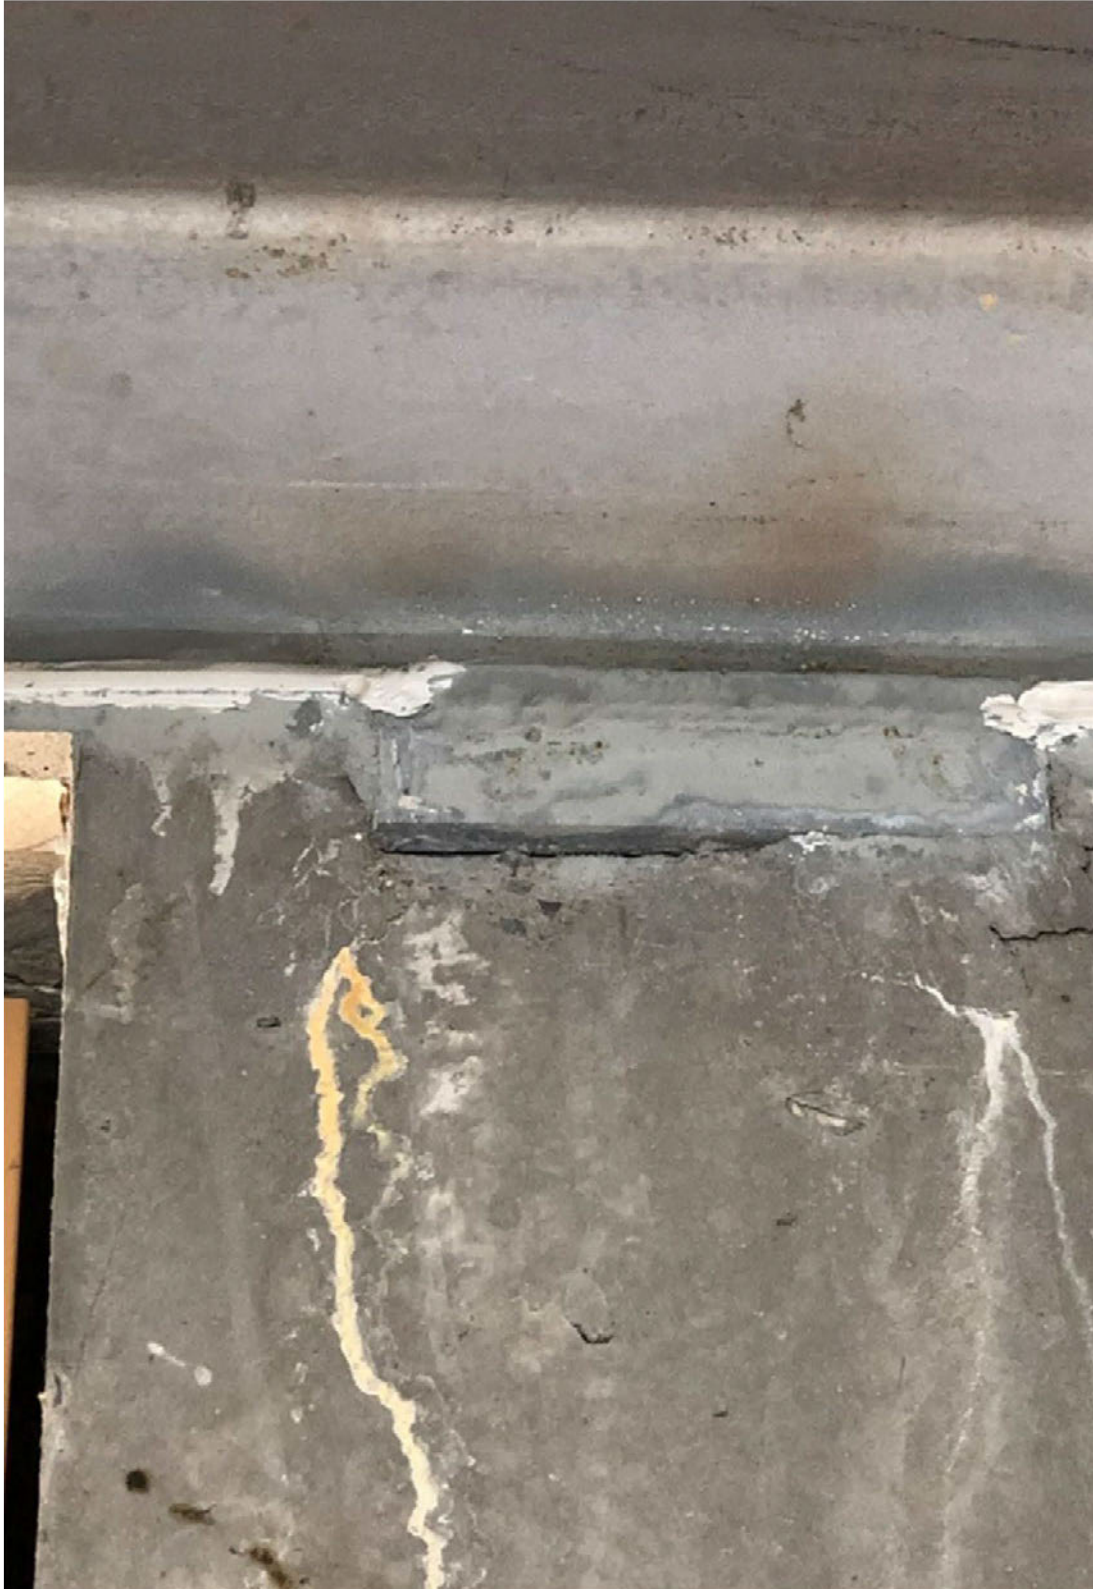
Figure 27: Chipped concrete at interior face of Panel 1901. Source: DeSimone.

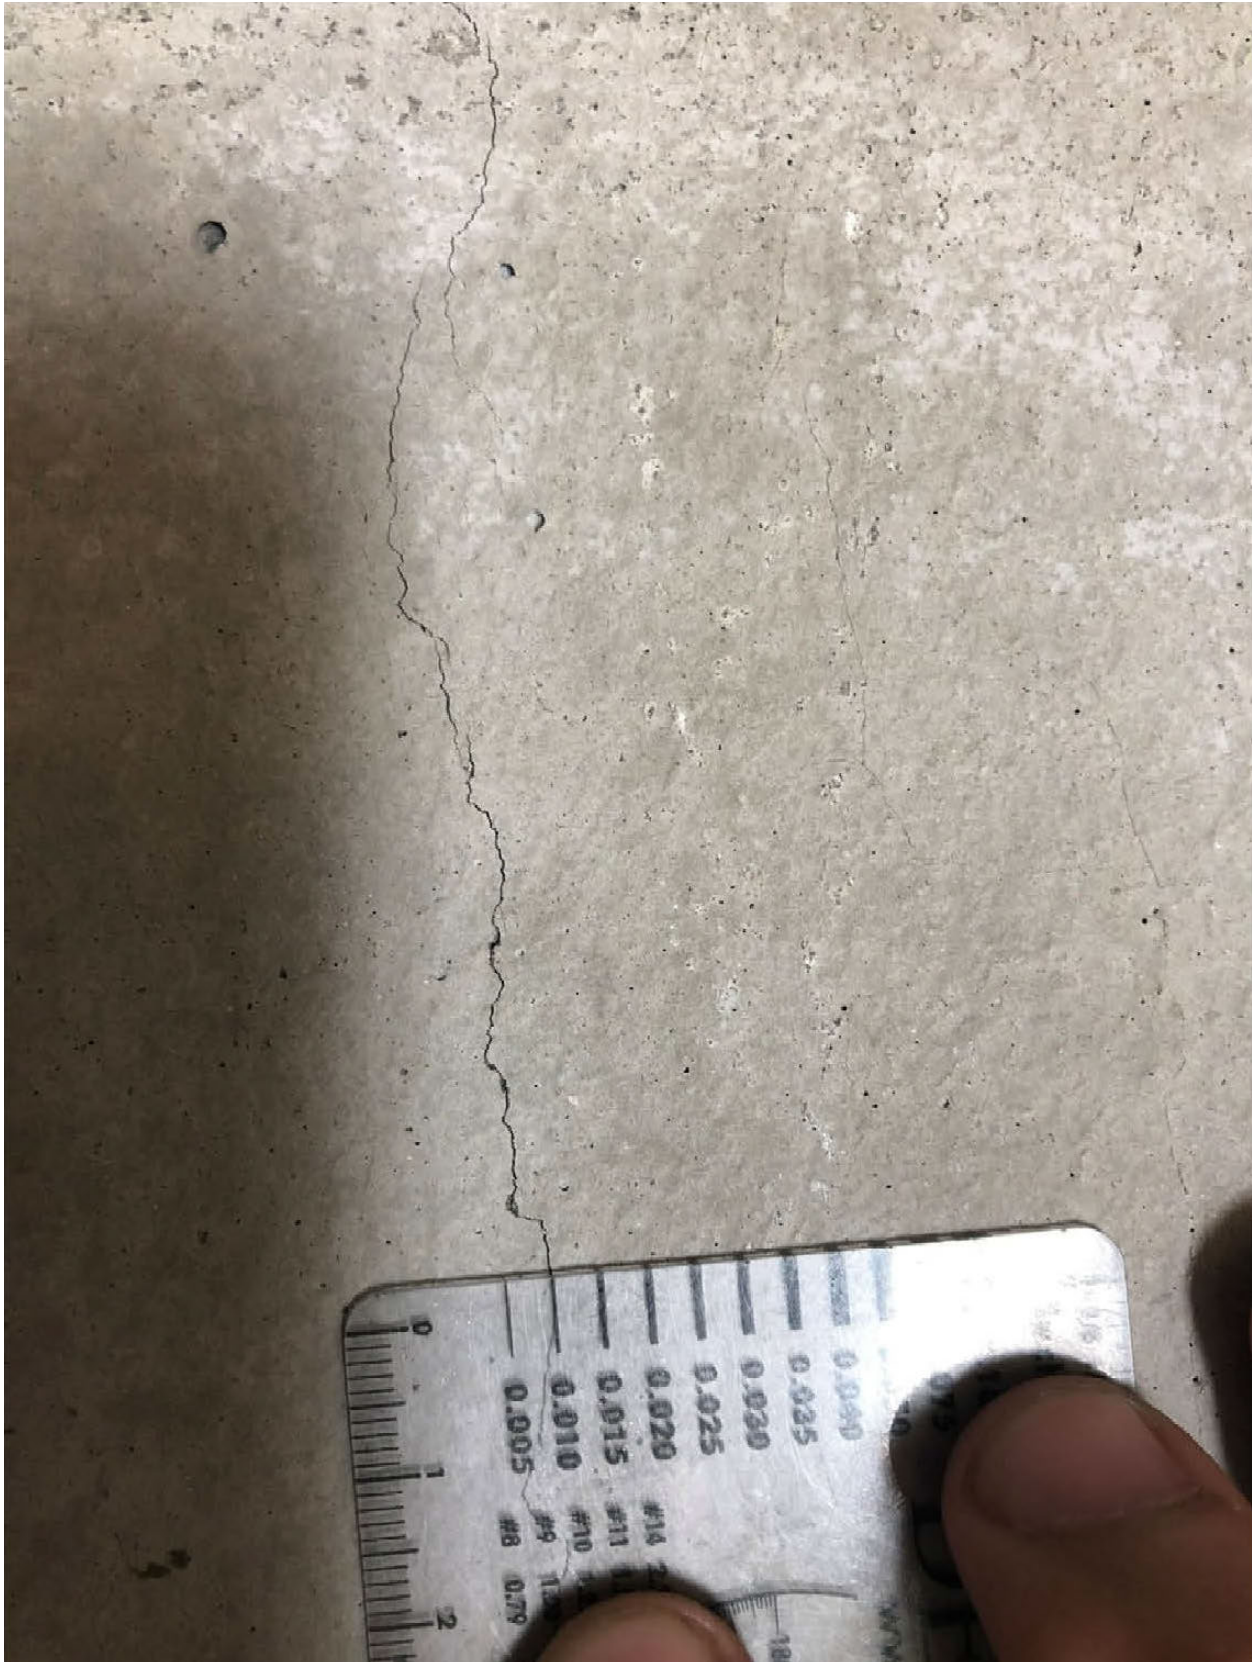
Figure 28: Crack at Interior face of Panel 1904. Source: DeSimone.

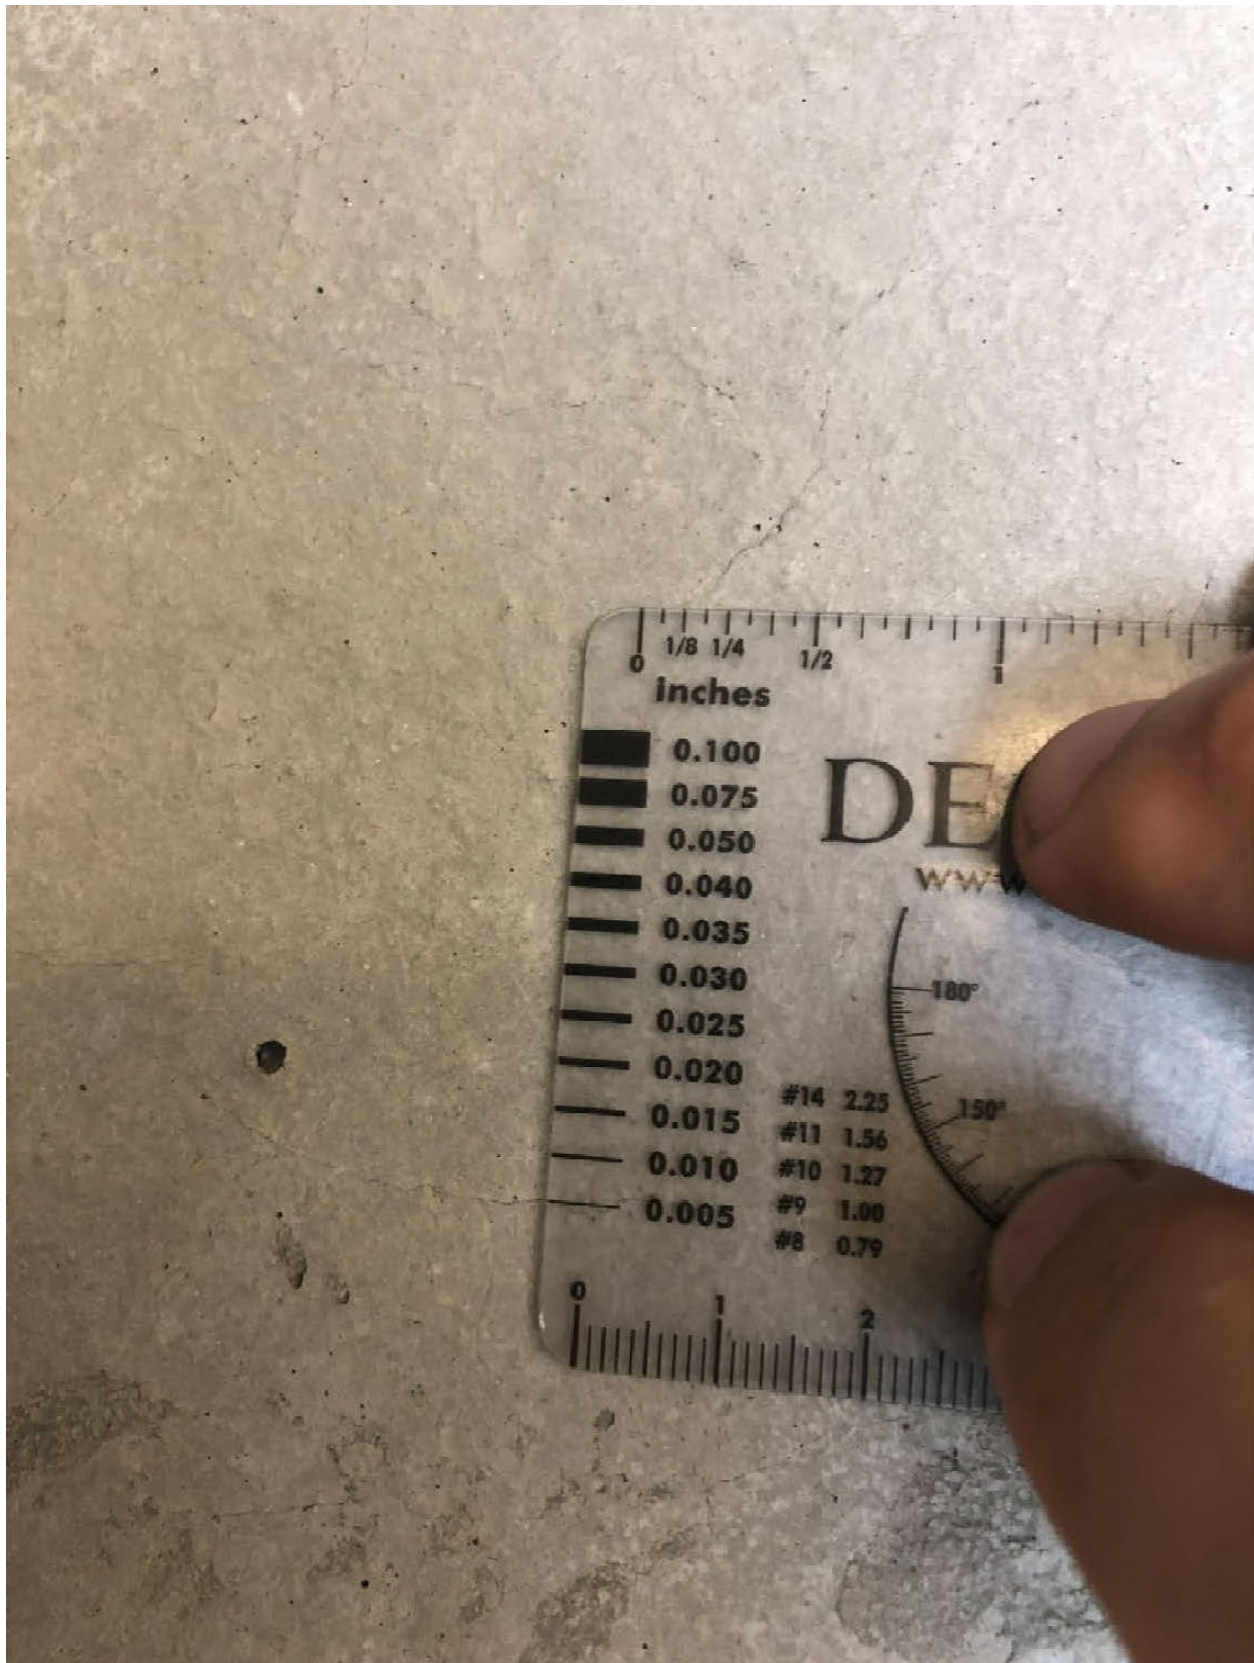
Figure 29: Crack at interior face of Panel 1904. Source: DeSimone.

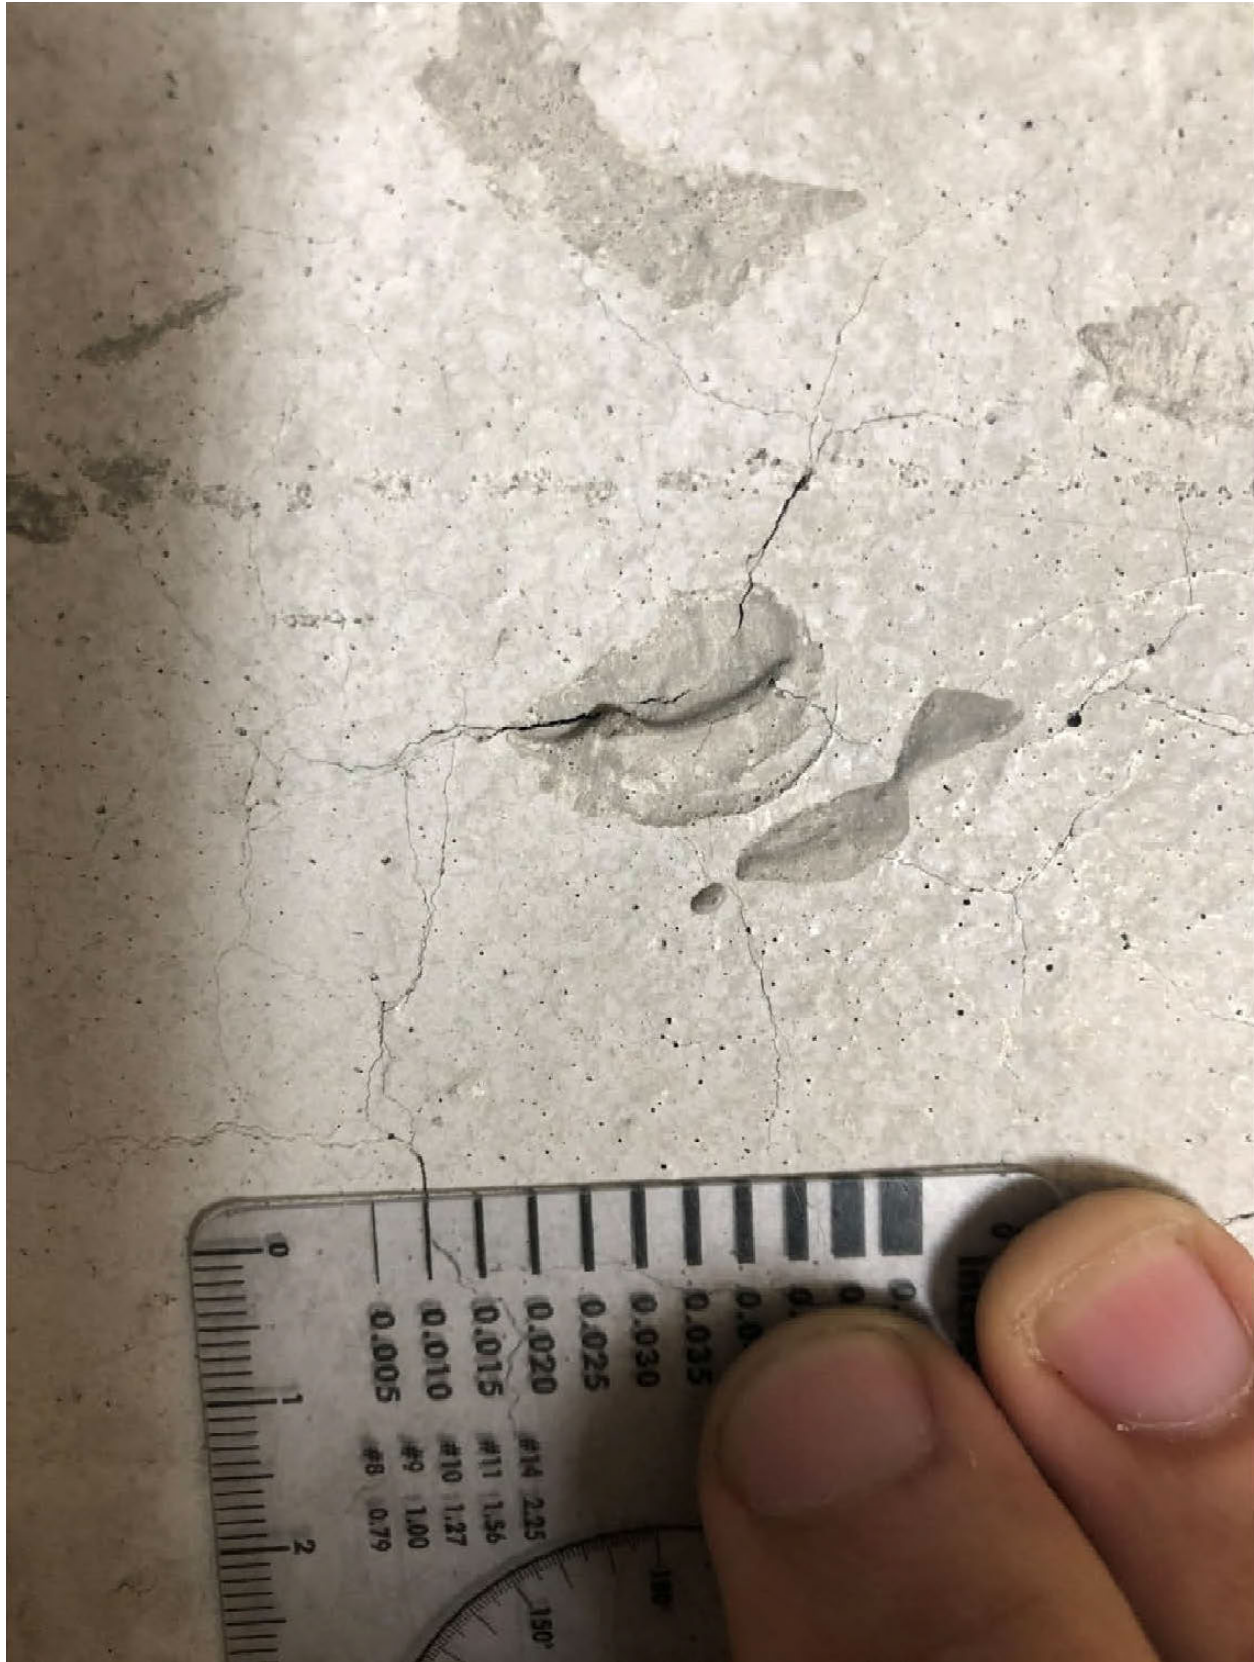
Figure 30: Crack at interior face of Panel 1904. Source: DeSimone.
