**Dulles Metro Silver Line Concrete Panel Assessment  
Innovation Center Station Precast Inspections**  
Herndon, Virginia

**DeSimone Consulting Engineers**

Report Issued: August 24, 2020

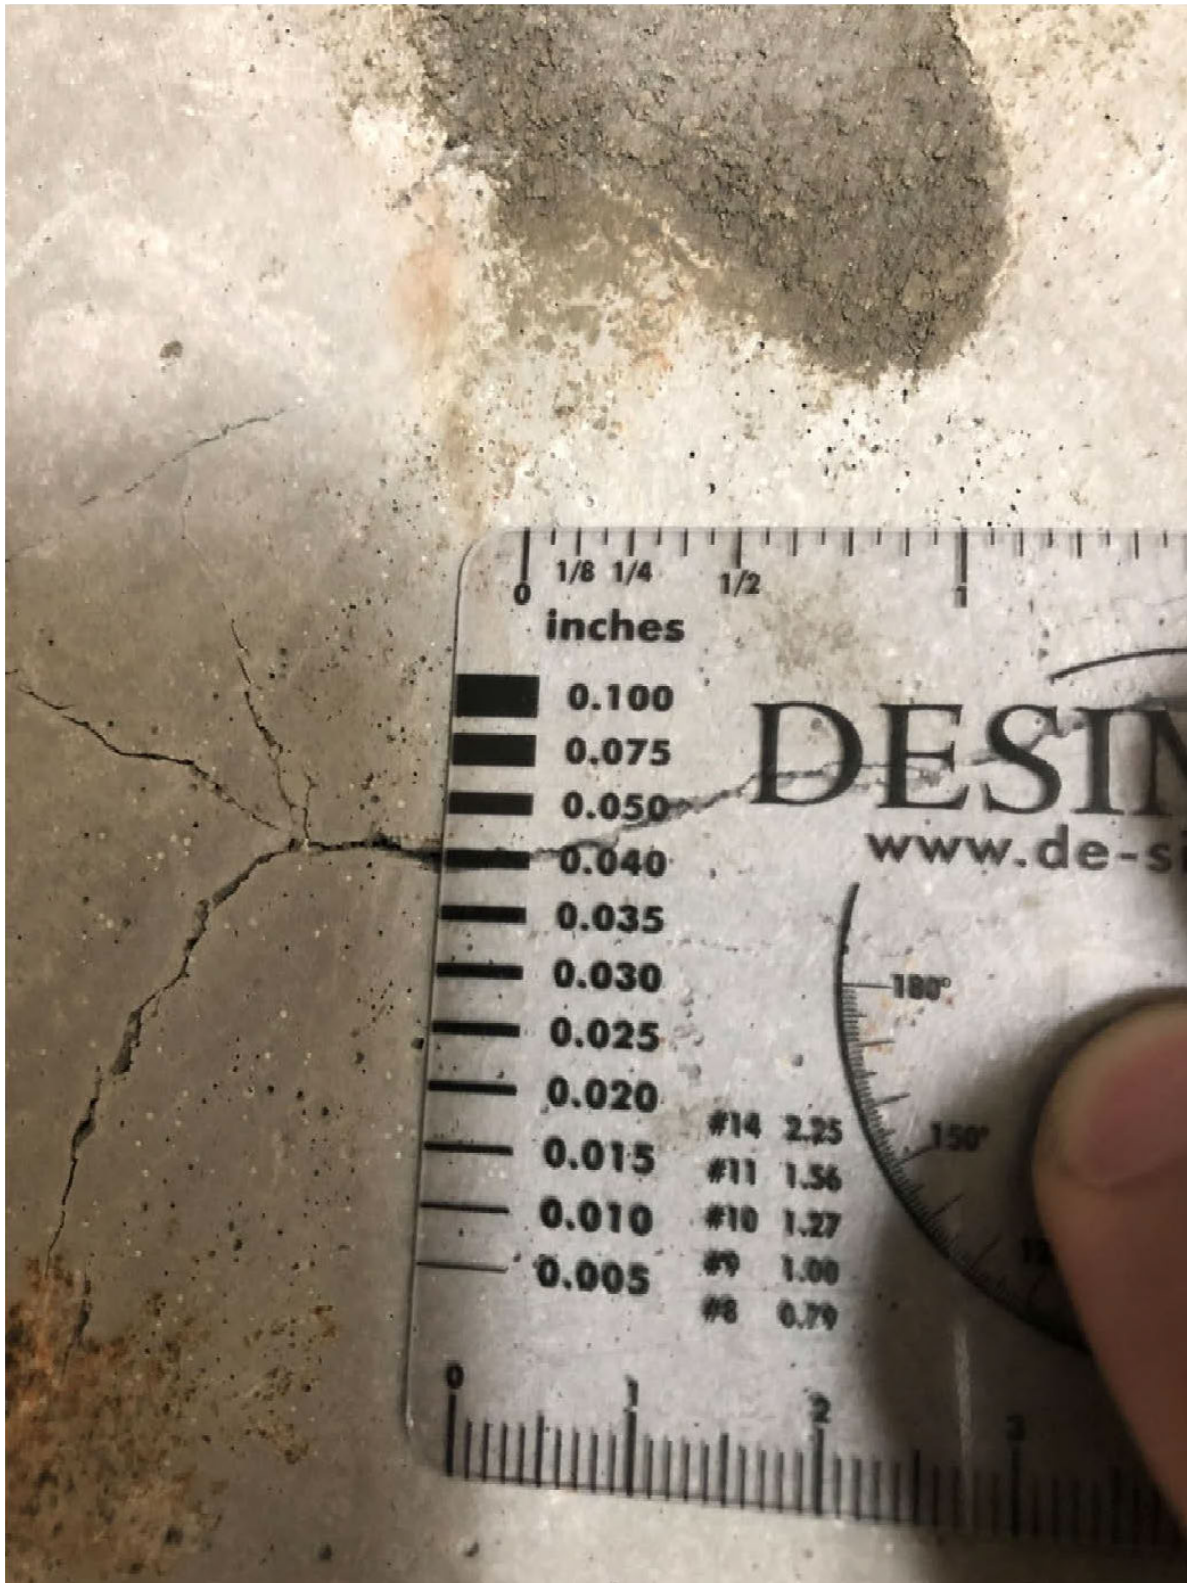
Figure 31: Crack at interior face of Panel 1904. Source: DeSimone.

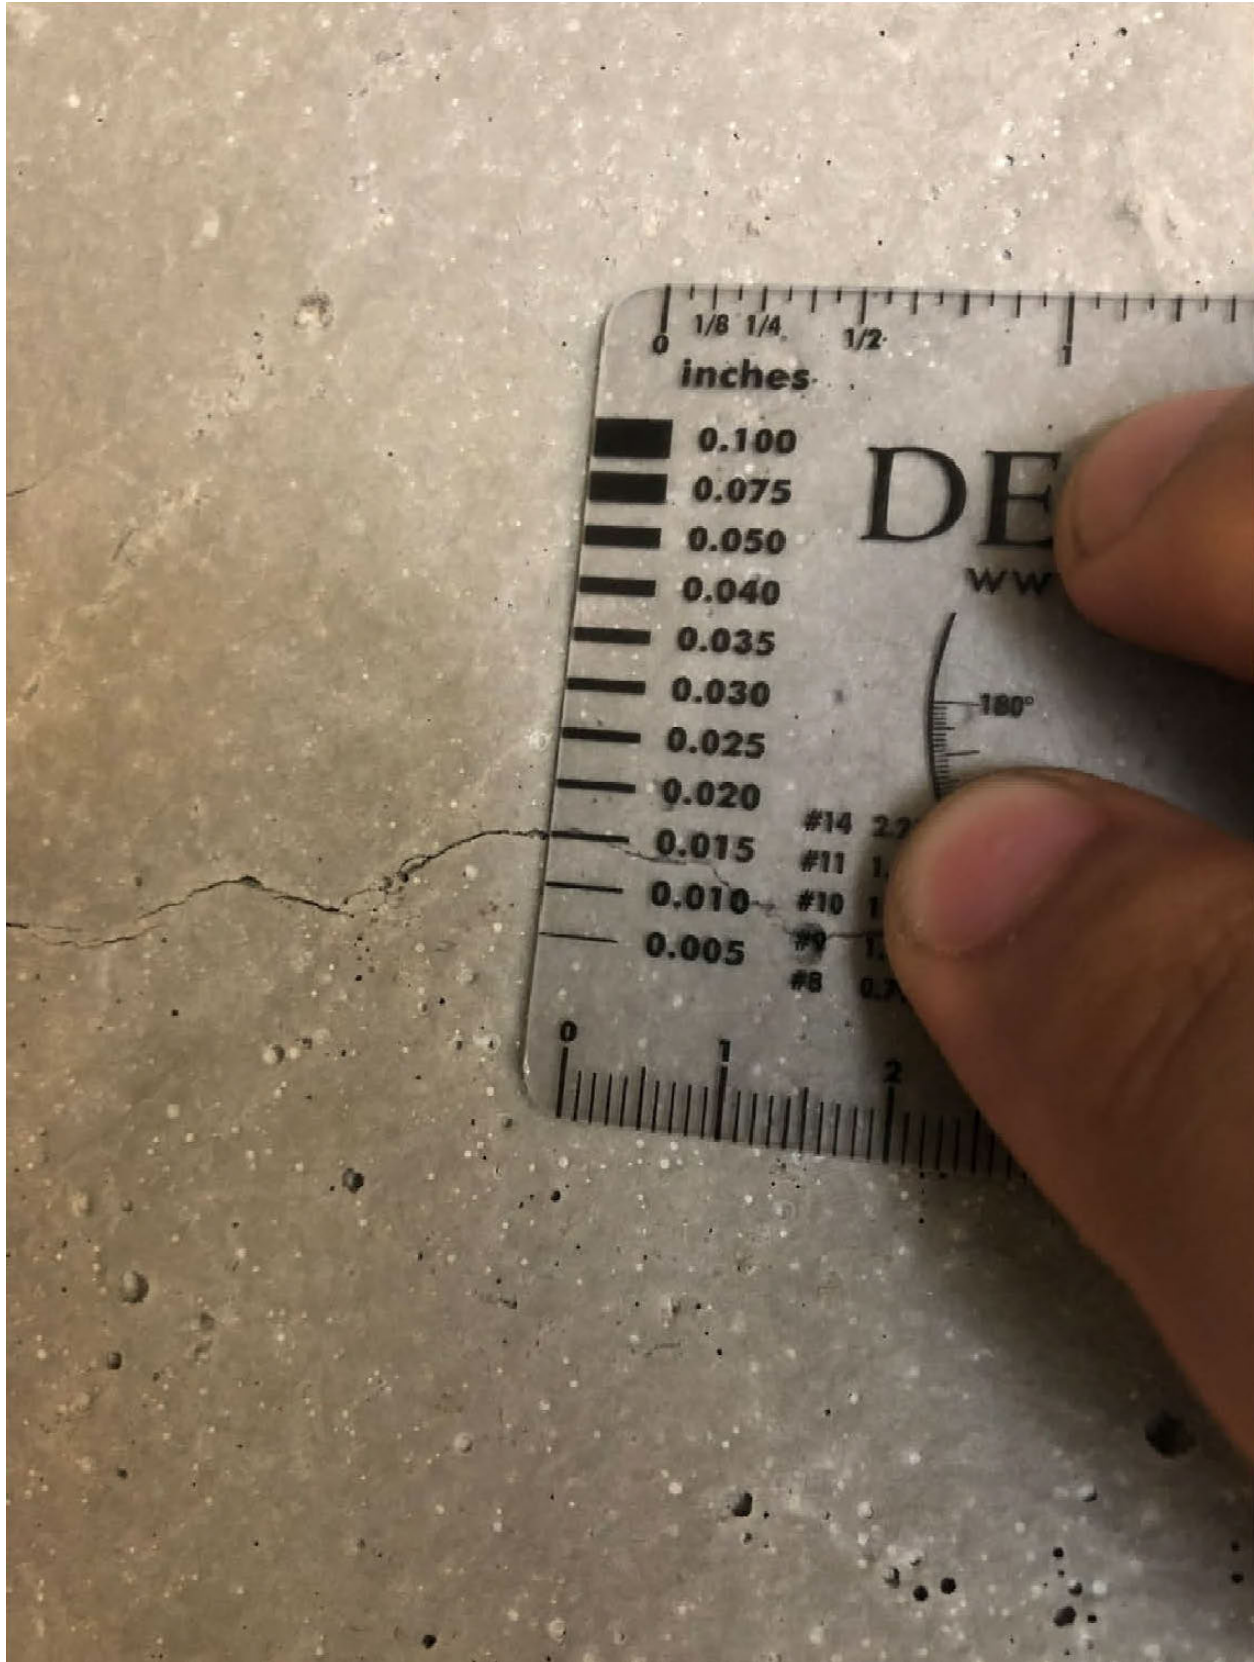
Figure 32: Crack at Interior face of Panel 1904. Source: DeSimone.

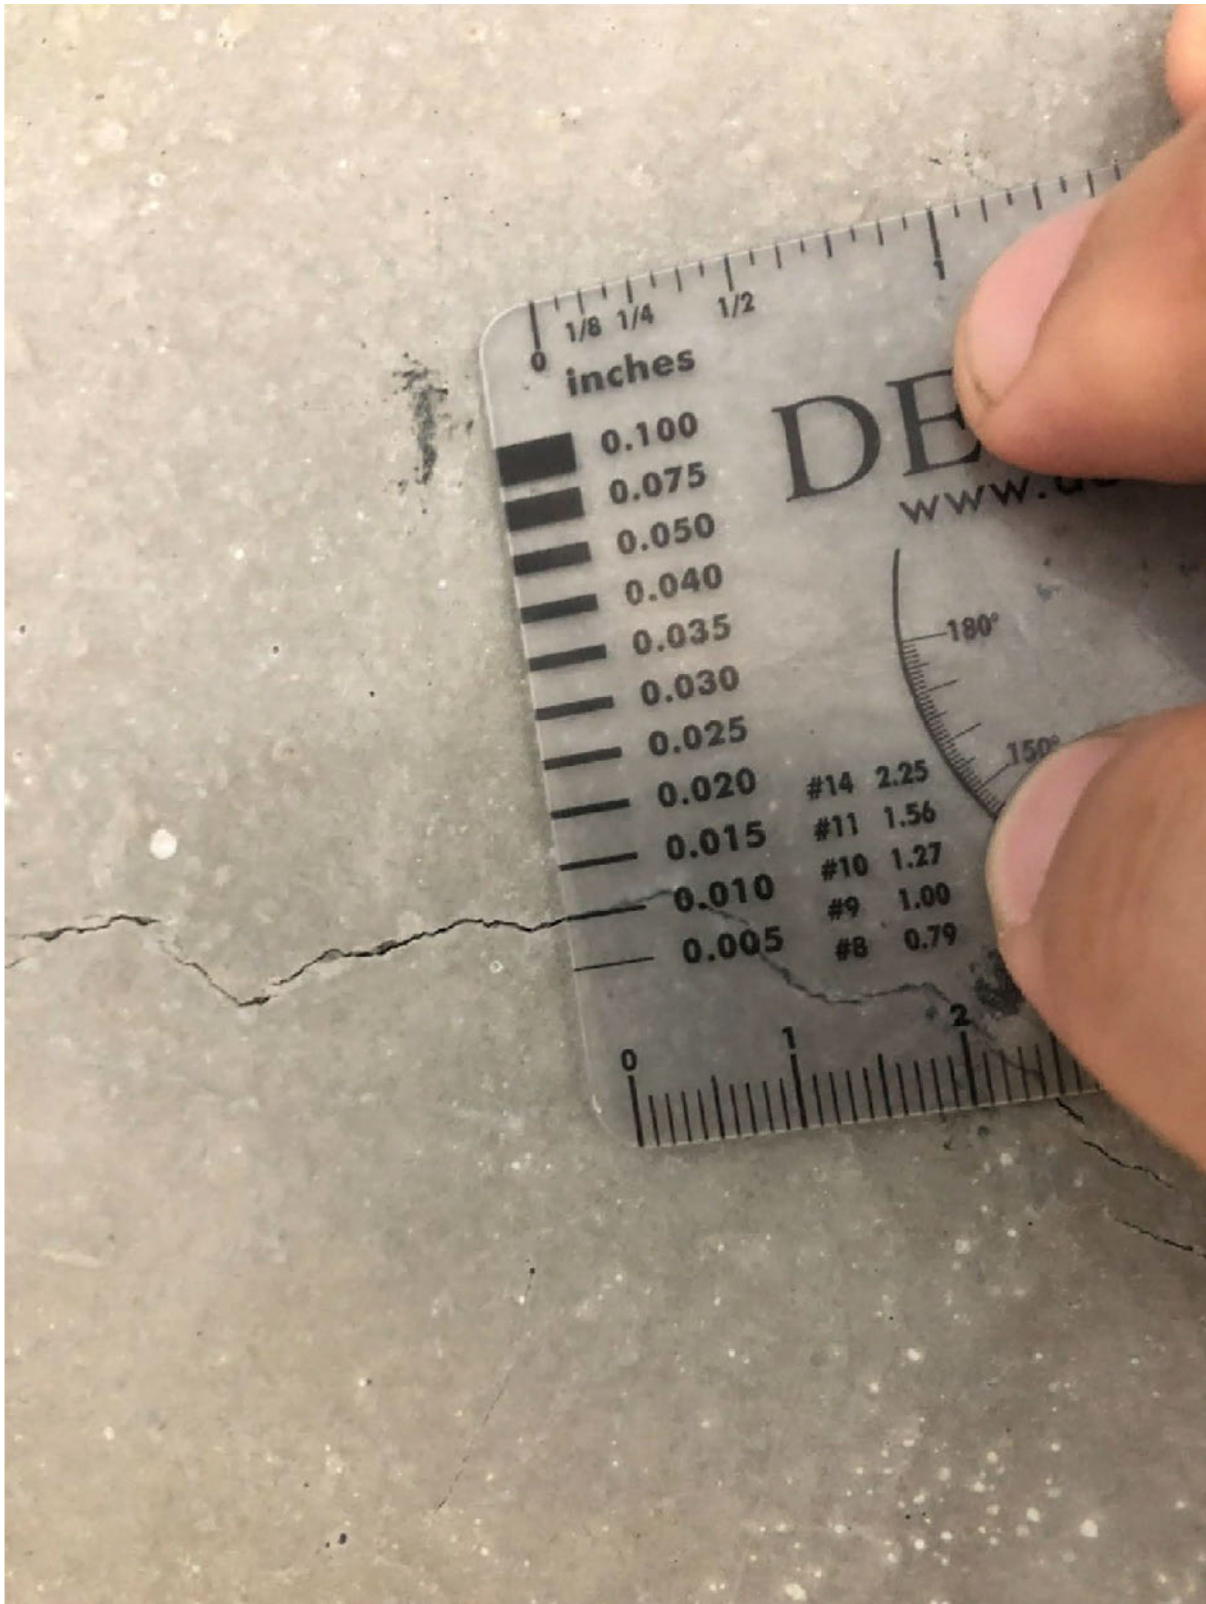
Figure 33: Crack at interior face of Panel 1904. Source: DeSimone.

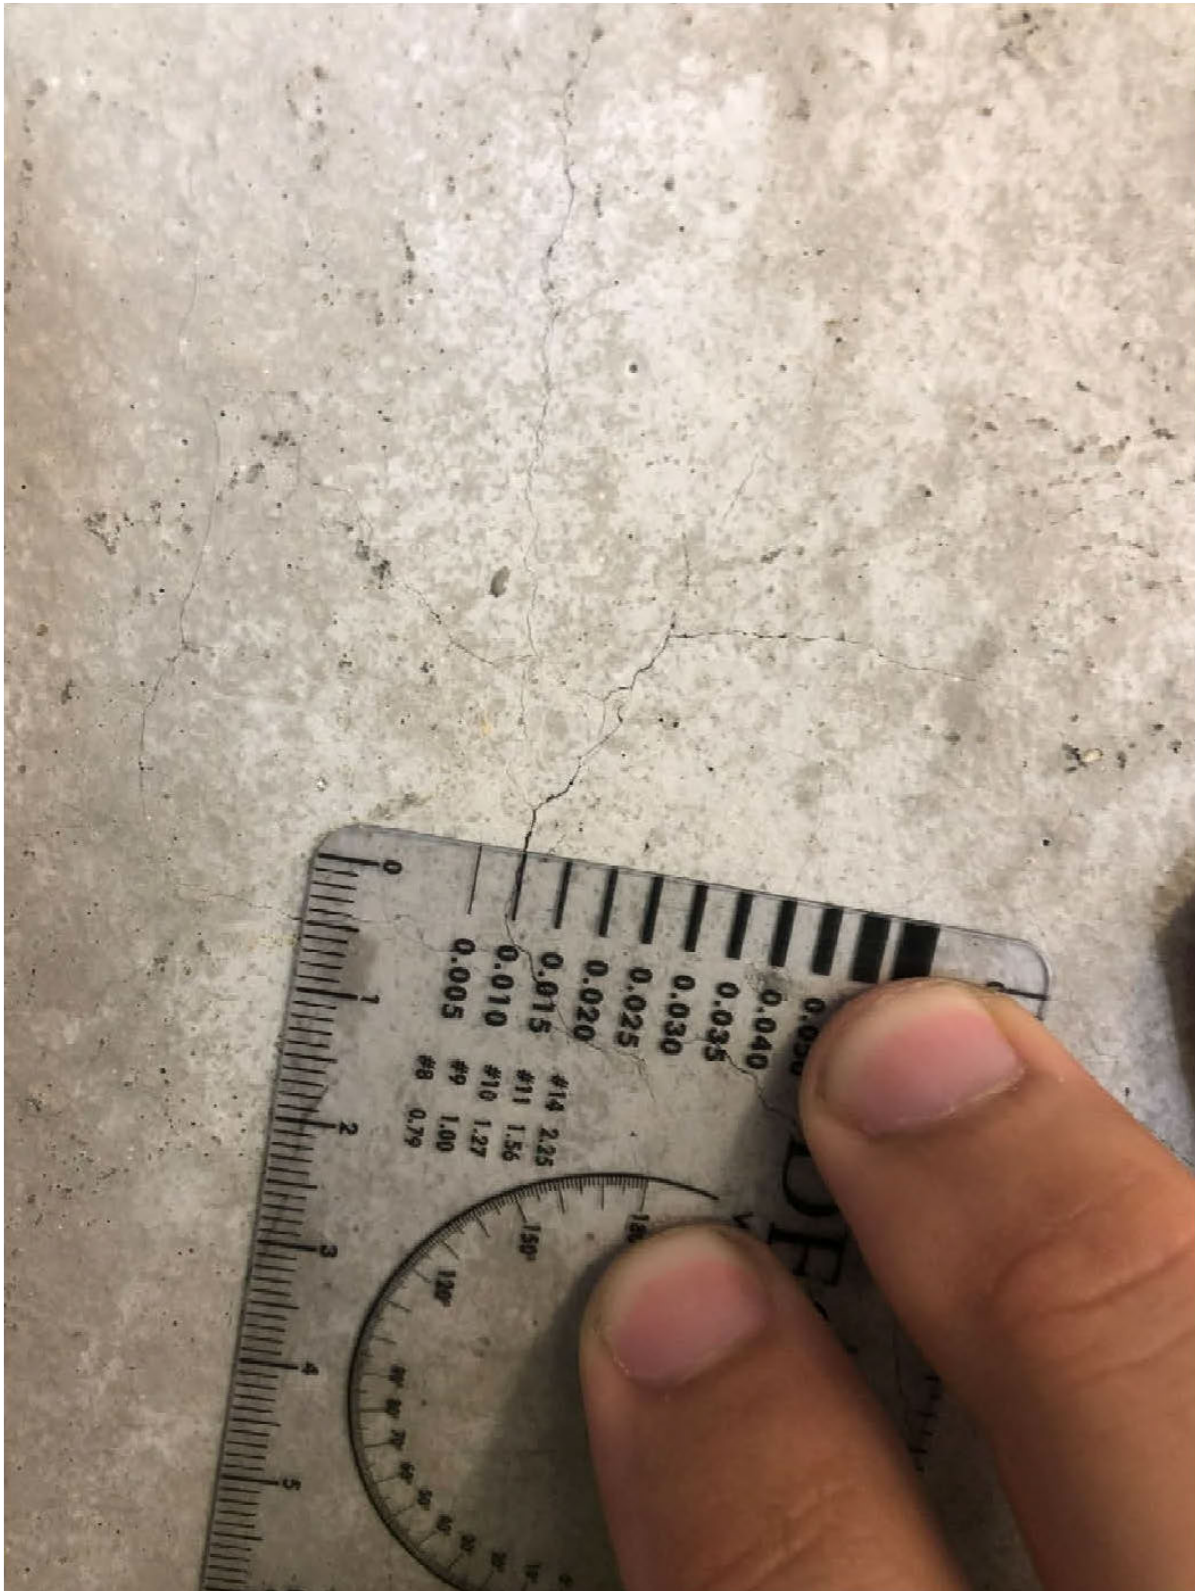
Figure 34: Crack at interior face of Panel 1904. Source: DeSimone.

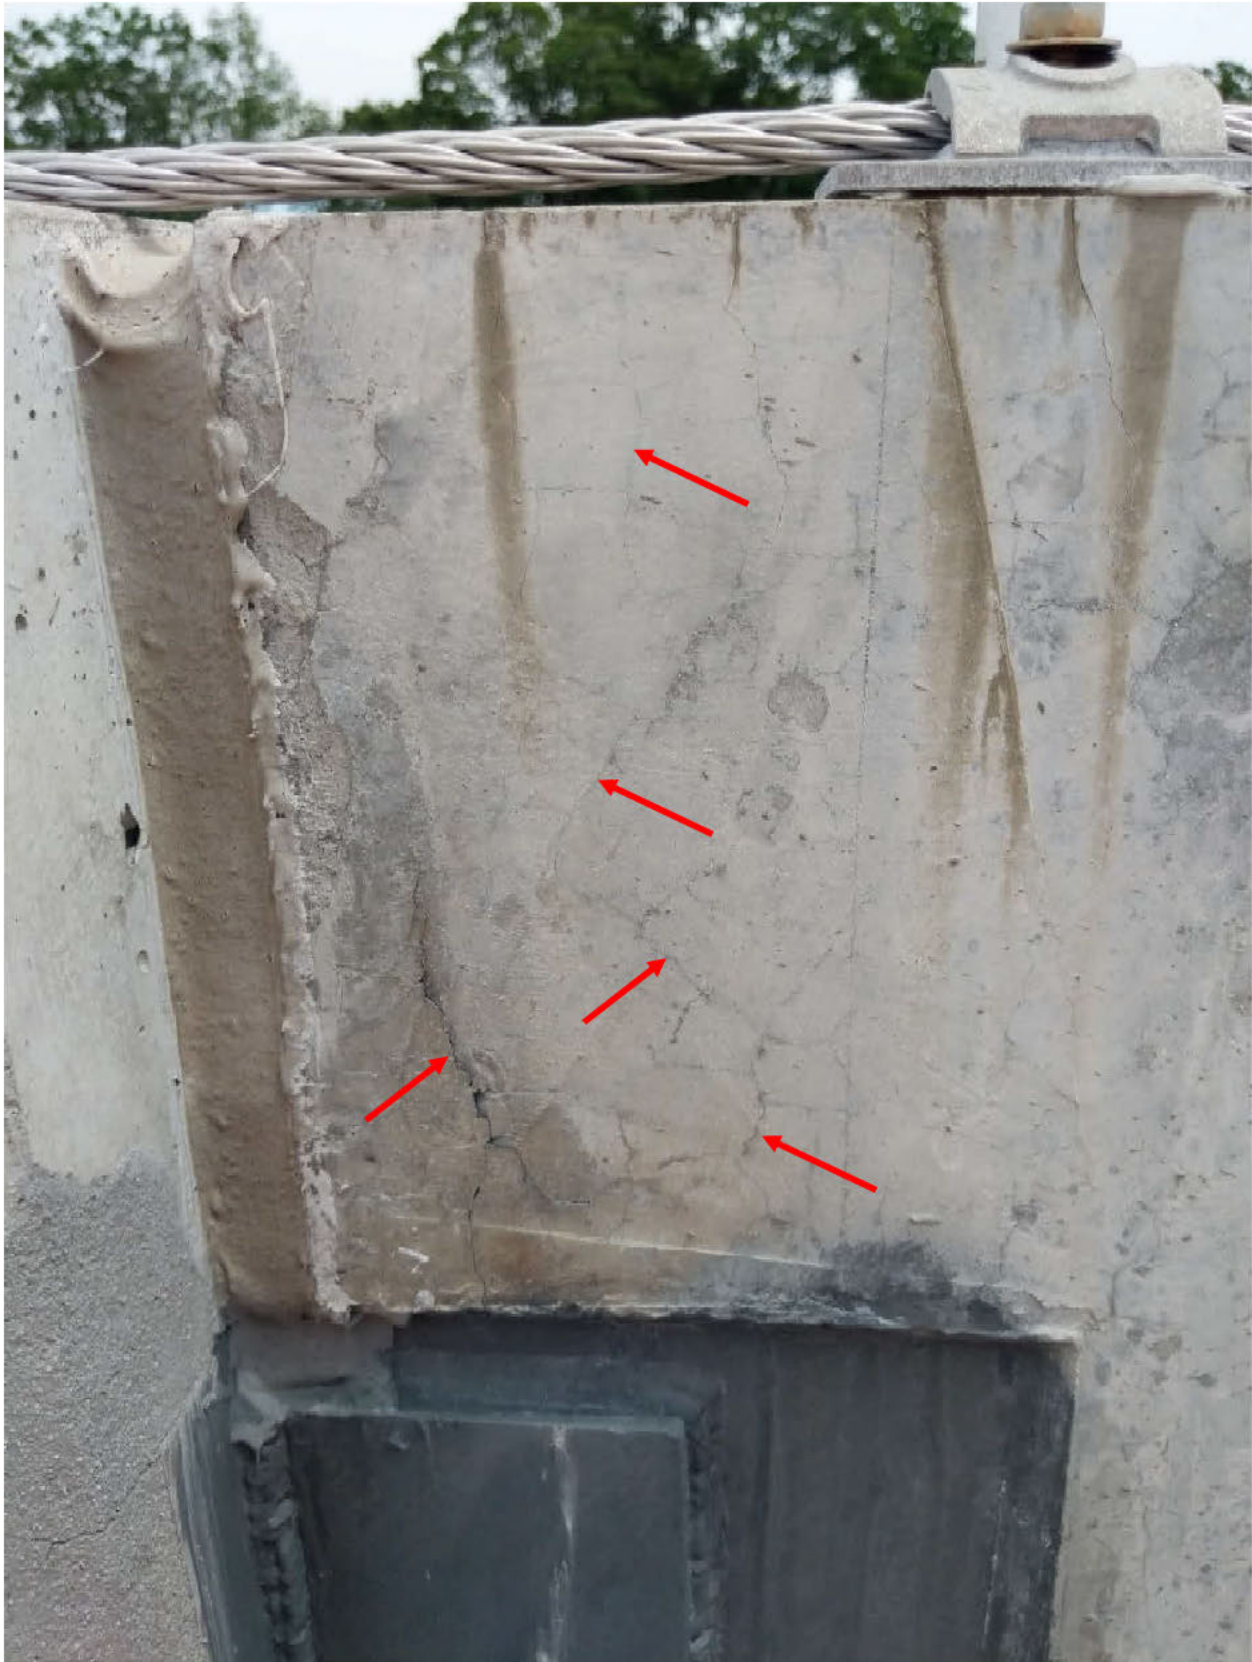
Figure 35: Spider cracks at interior of Panel WP-1328-RI. Source: DeSimone.

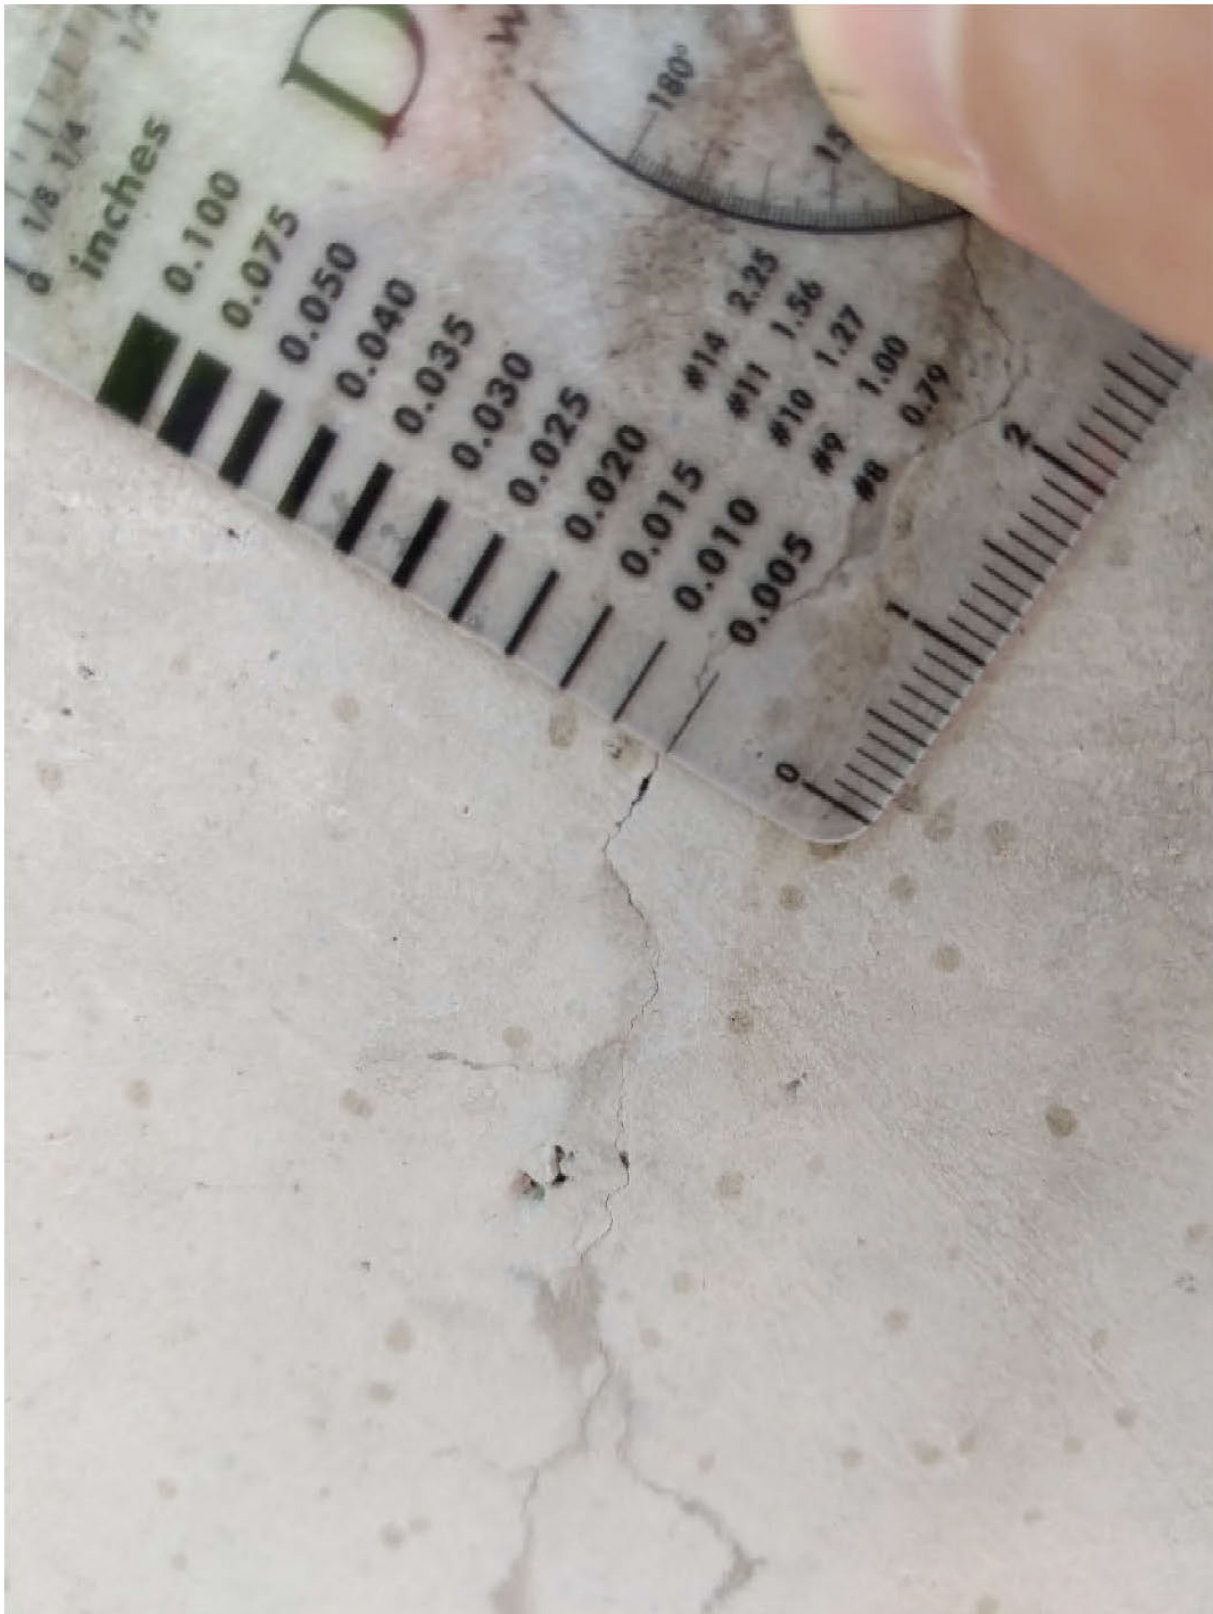
Figure 36: Crack at Interior face of Panel WP-1328-R!. Source: DeSimone.

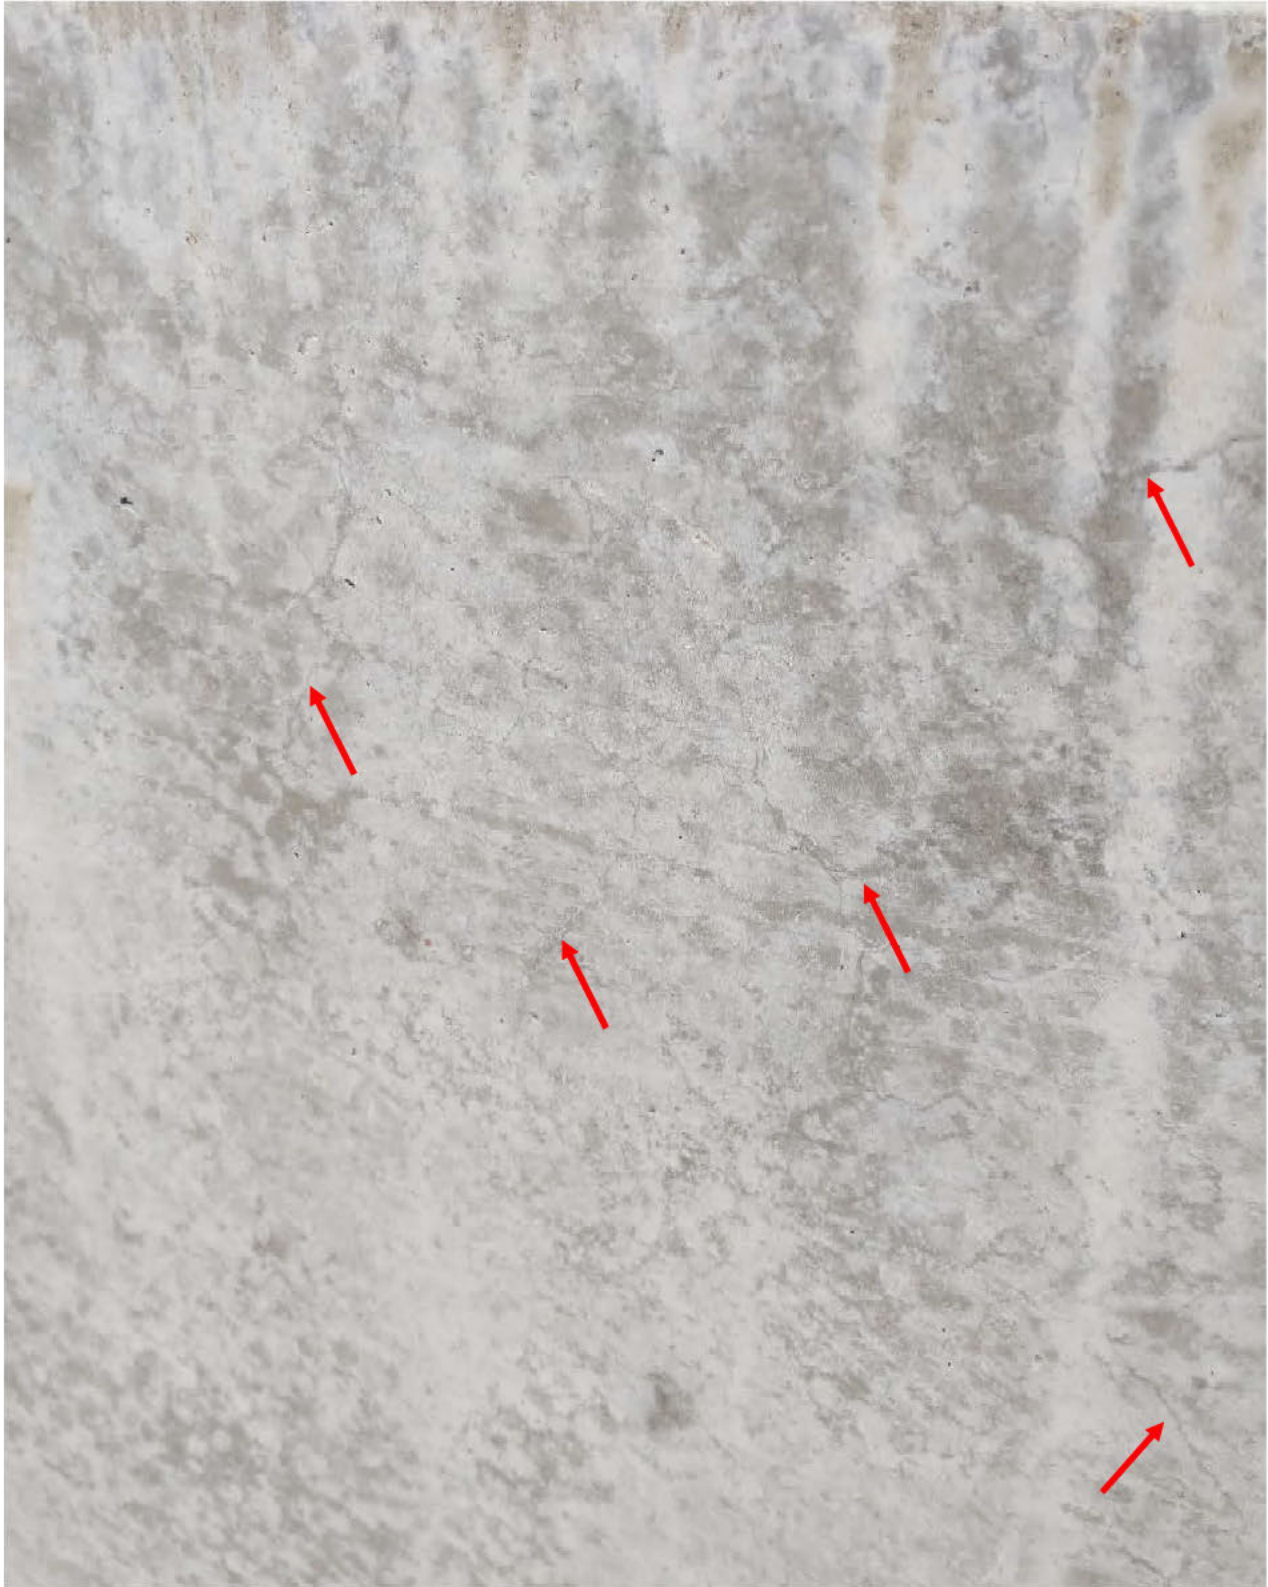
Figure 37: Spider cracks at interior of Panel WP-1321-RI. Source: DeSimone.

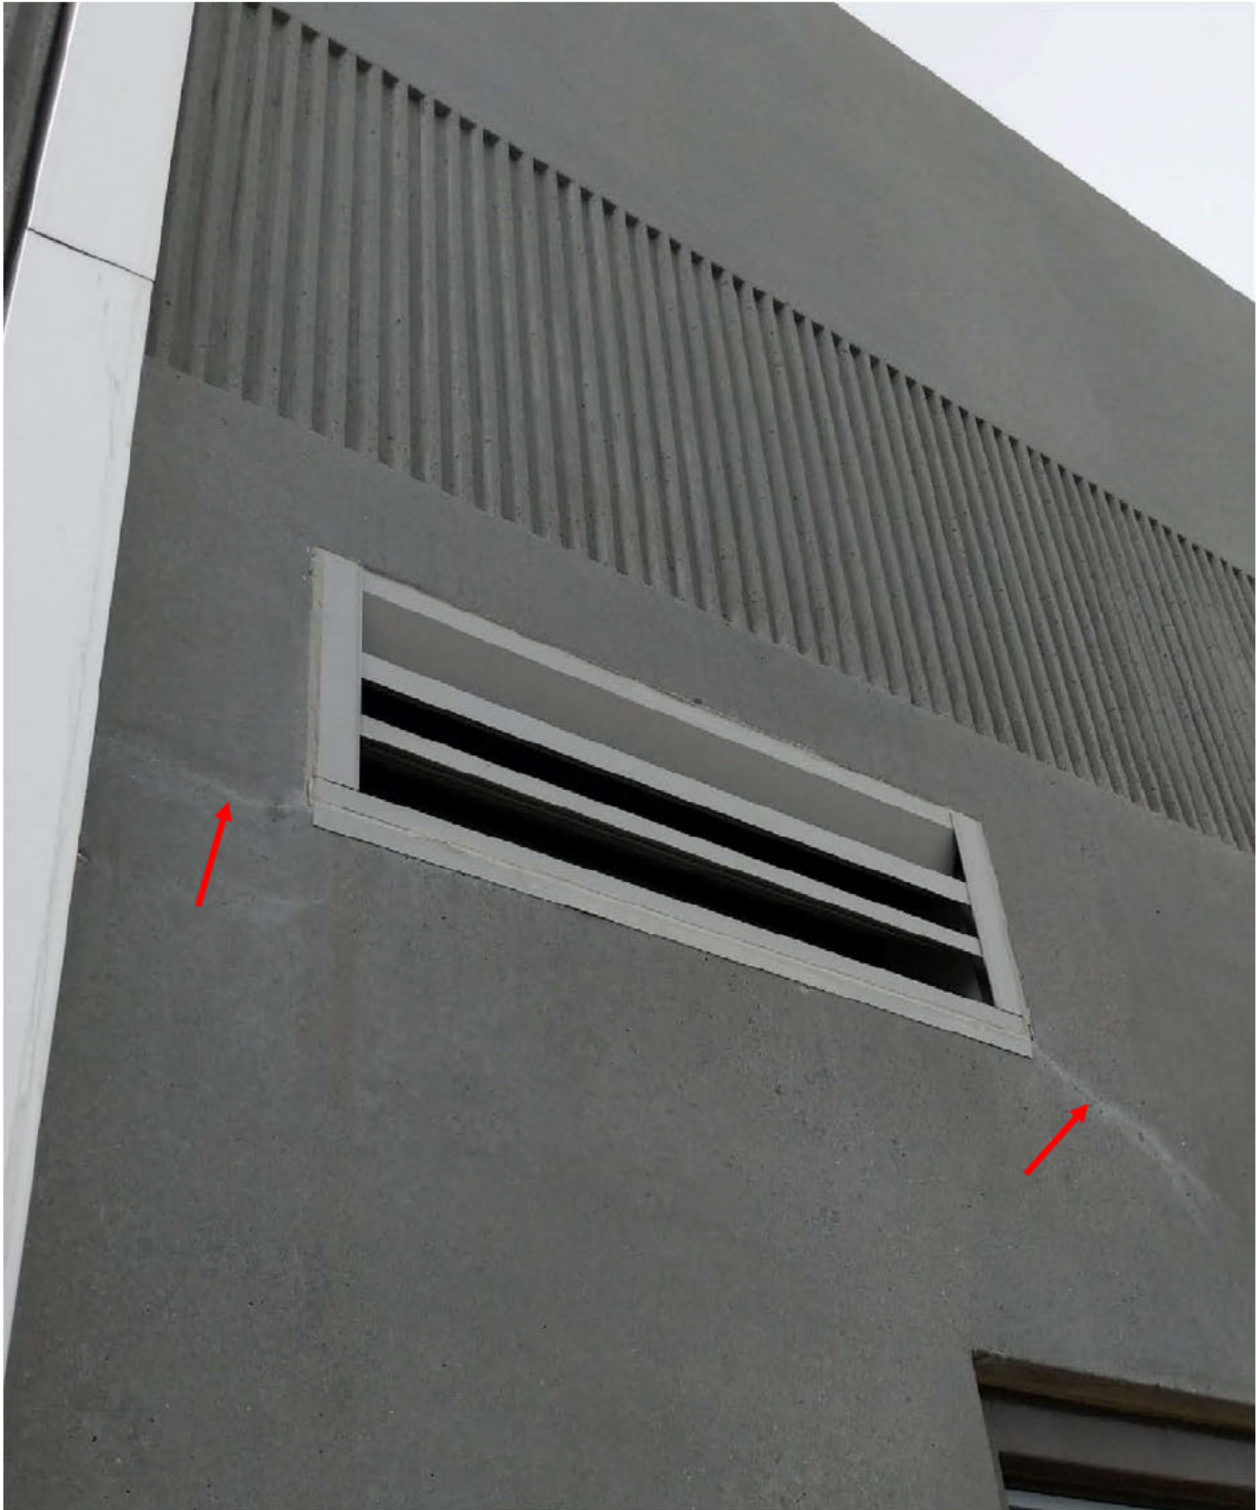
Figure 38: Previously repaired cracks at exterior face of Panel WP-1307-RI. Source: DeSimone.

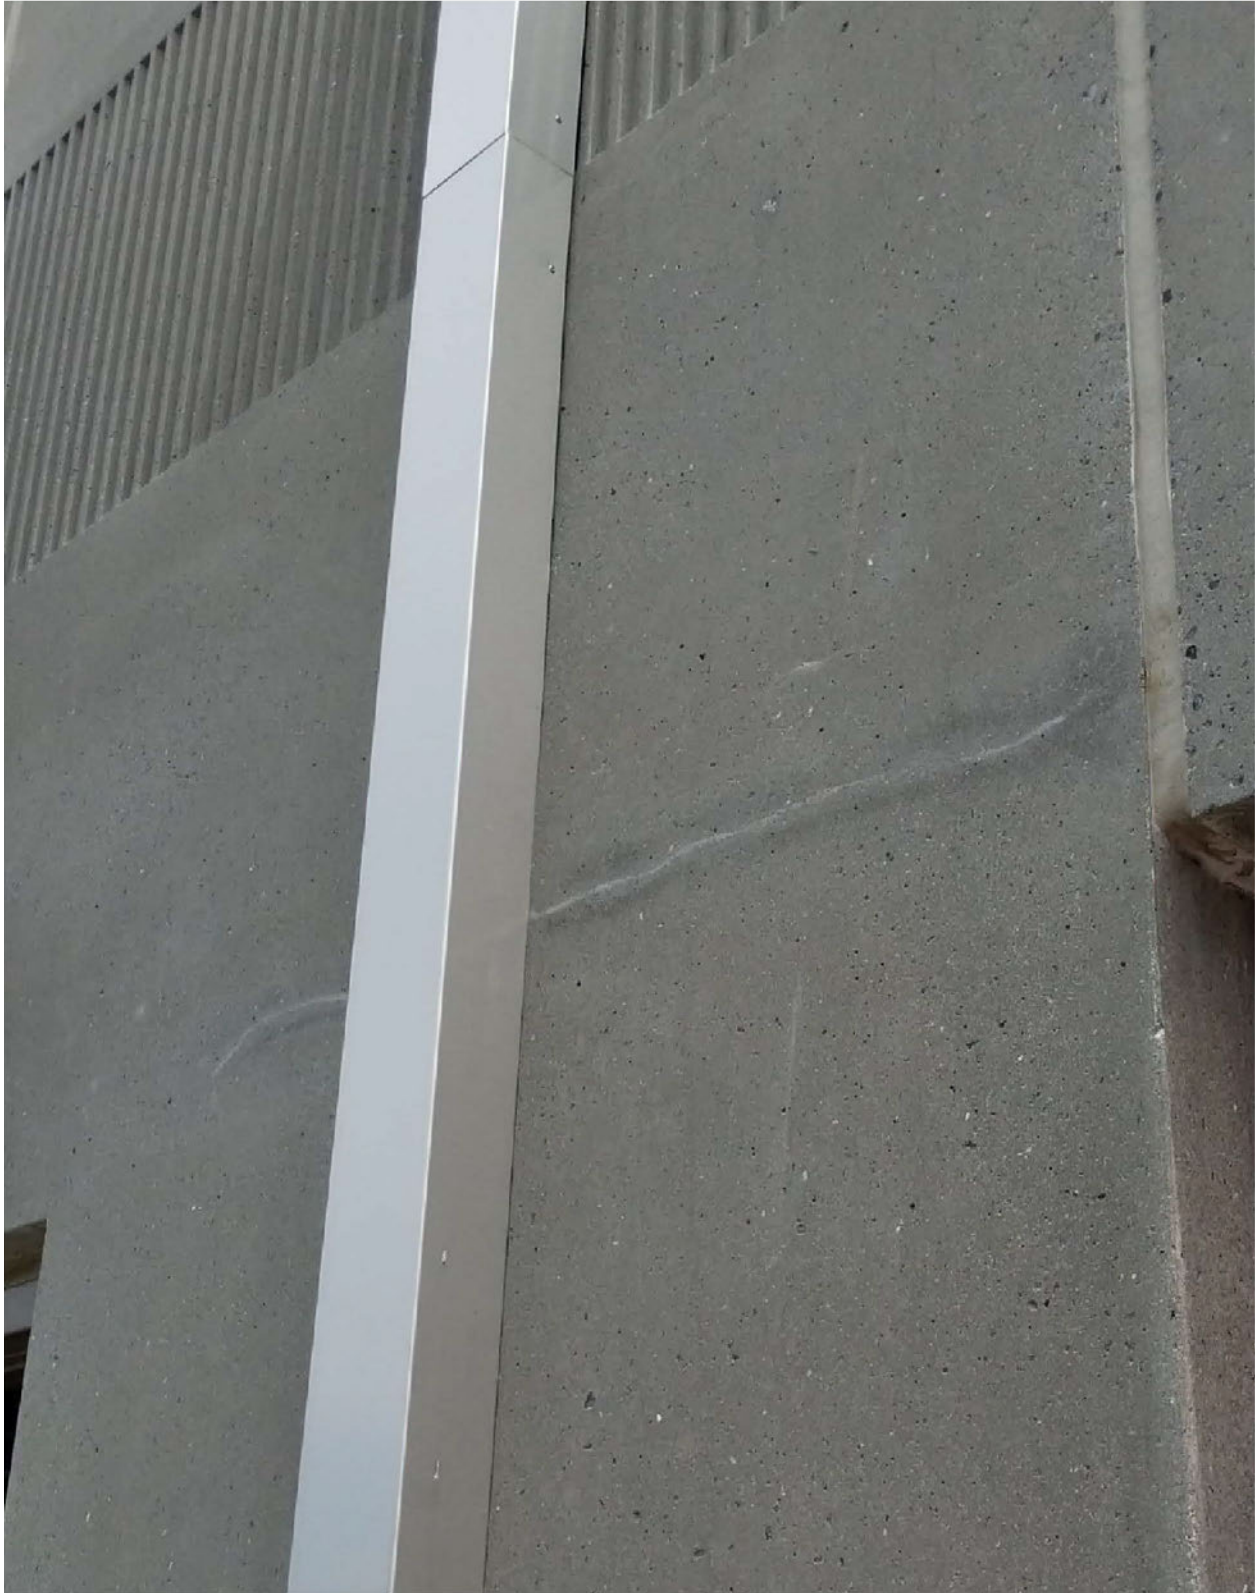
Figure 39: Previously repaired crack at exterior face of Panel WP-1313. Source: DeSimone.

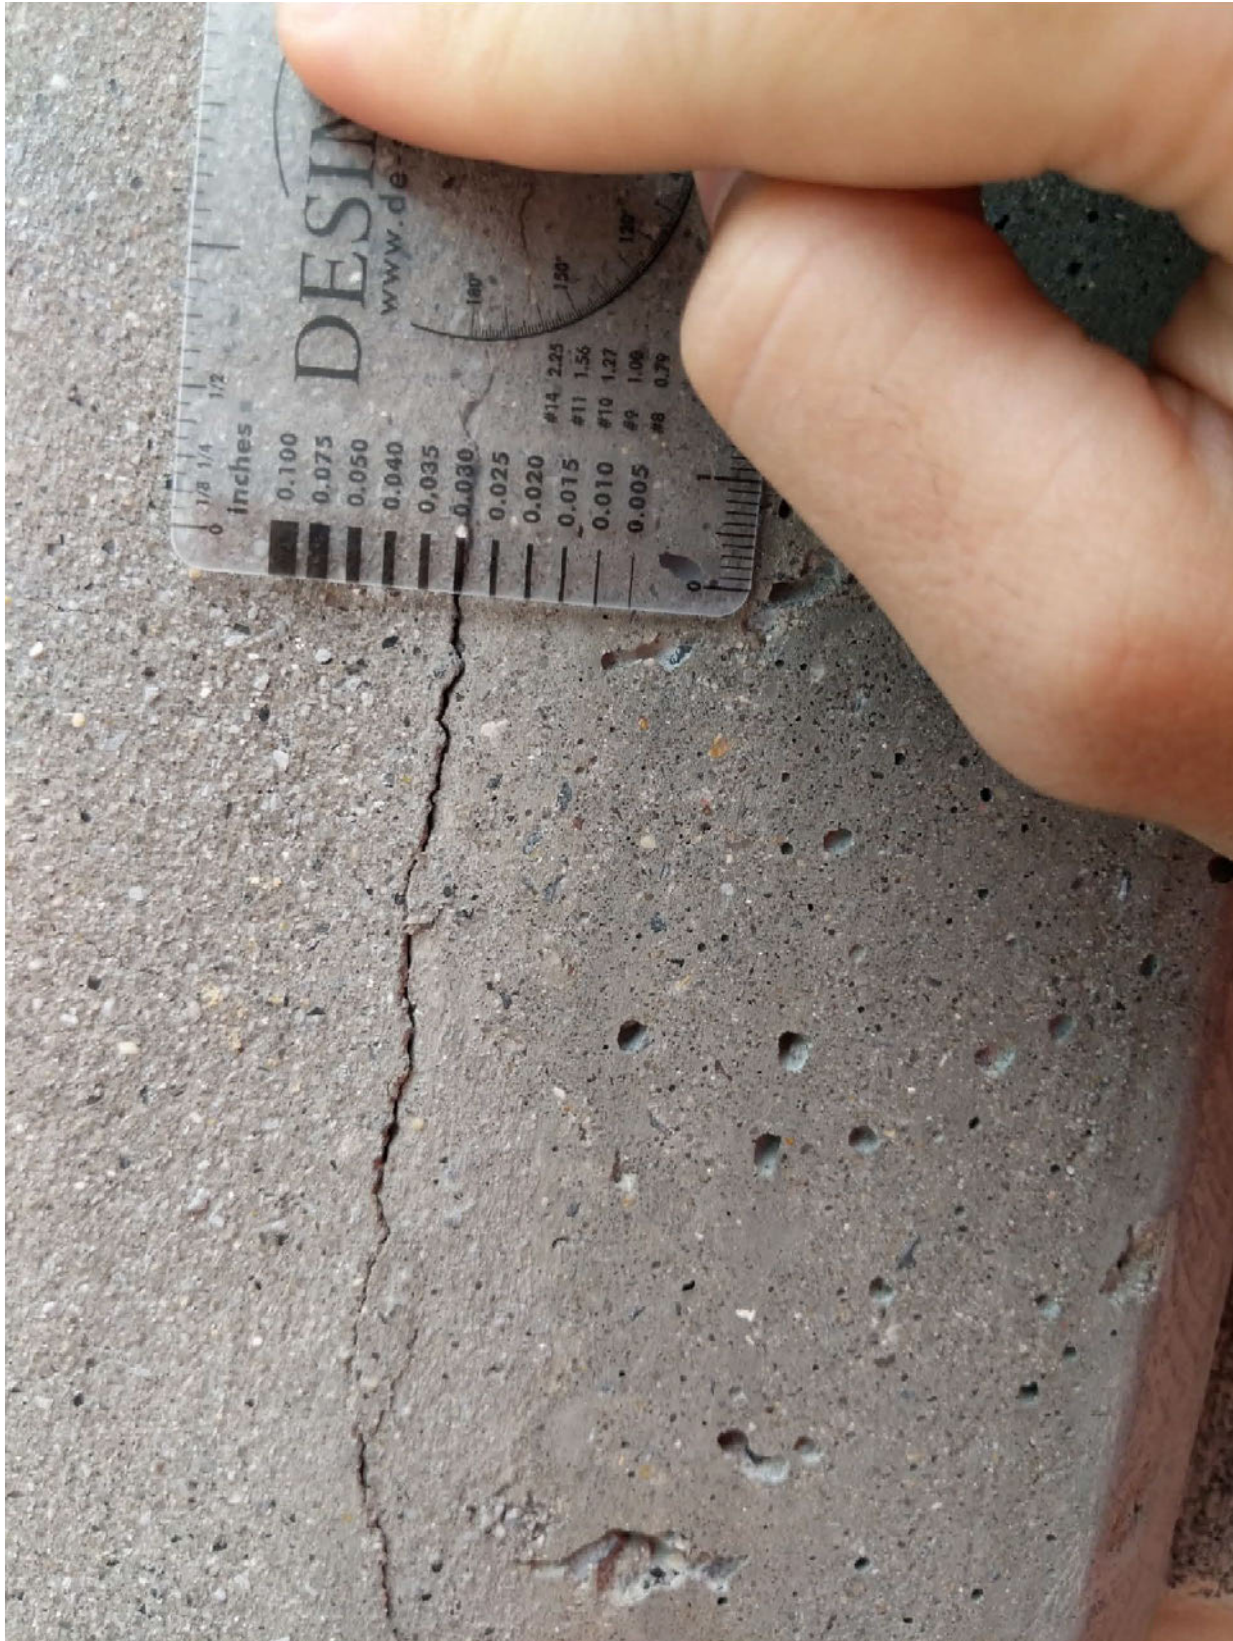
- 5.6 Superficial discoloration was observed by DeSimone at cracked Panel 100 (See Page 9), which was noted to exhibit signs of efflorescence.
- 5.7 Two (2) cracks that appear to previously have been repaired at Panel 206 and Panel WP-1313 appear to have a new crack that has formed in the repair material (See Pages 14 and 27, respectively).

Figure 40: Crack at previous repair location at exterior face of Panel WP-1313. Source: DeSimone.

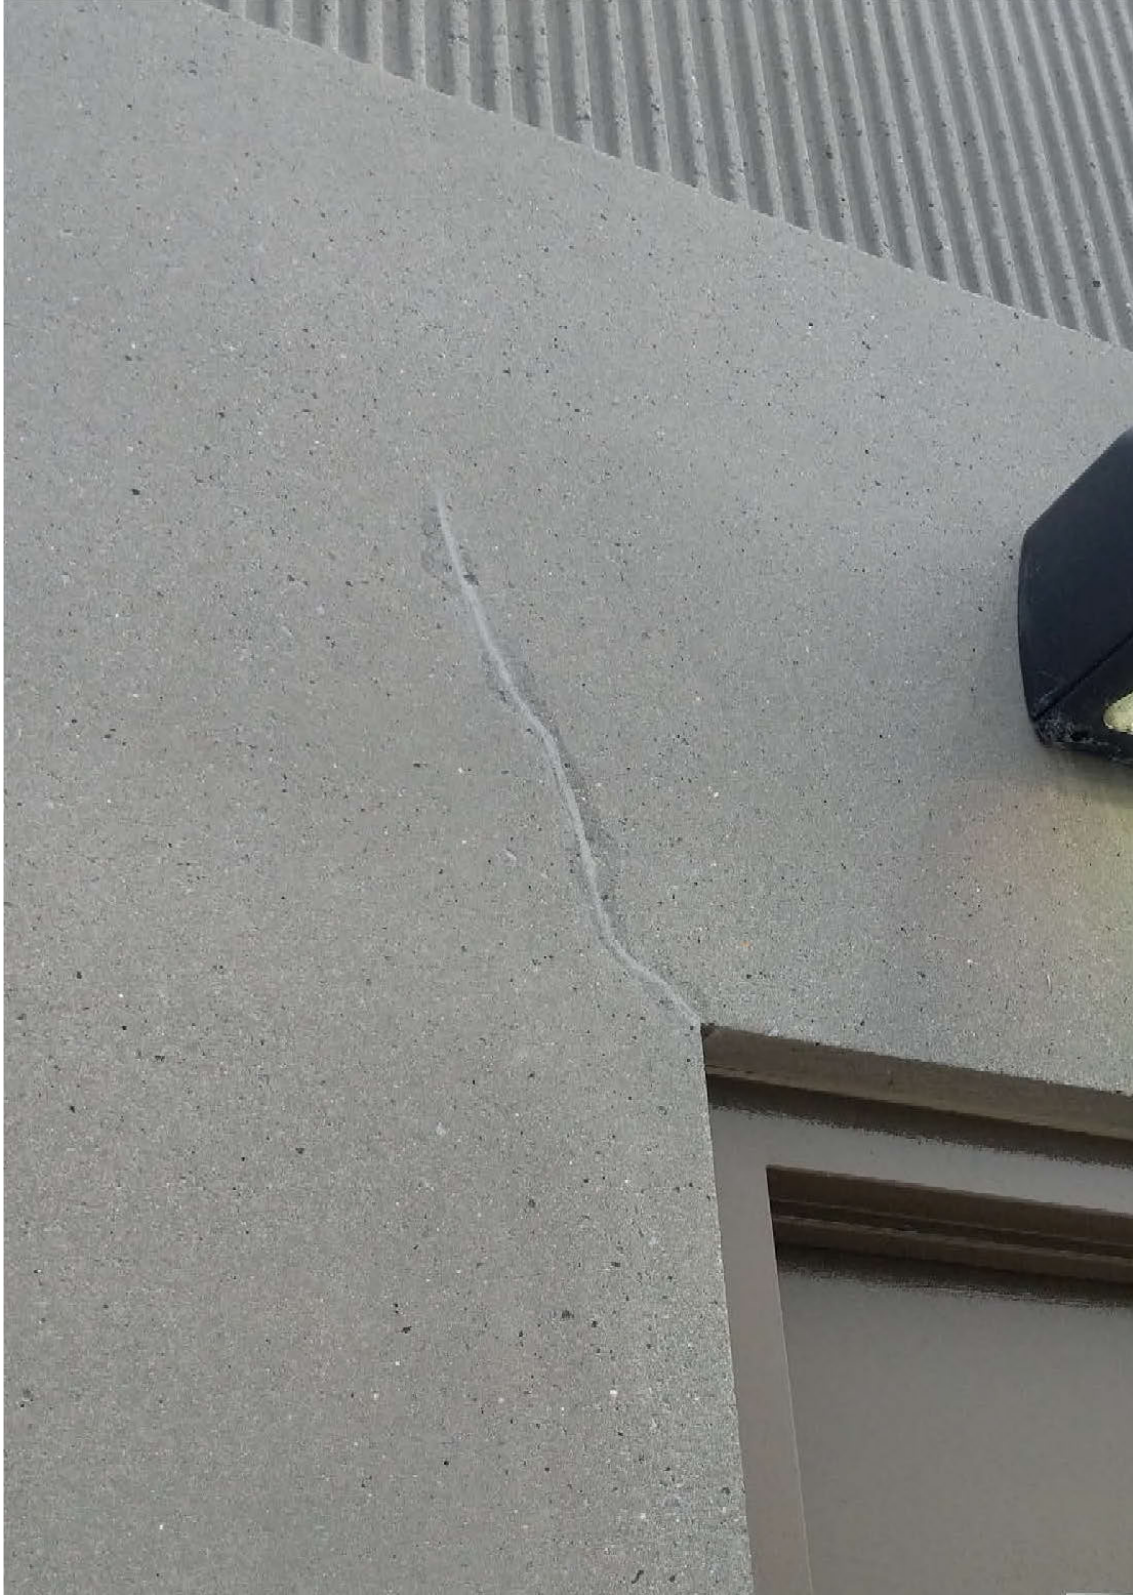
Figure 41: Previously repaired crack at exterior face of Panel WP-1315. Source: DeSimone.
