**Dulles Metro Silver Line Concrete Panel Assessment  
Innovation Center Station Precast Inspections**  
Herndon, Virginia

**DeSimone Consulting Engineers**

Report Issued: August 24, 2020

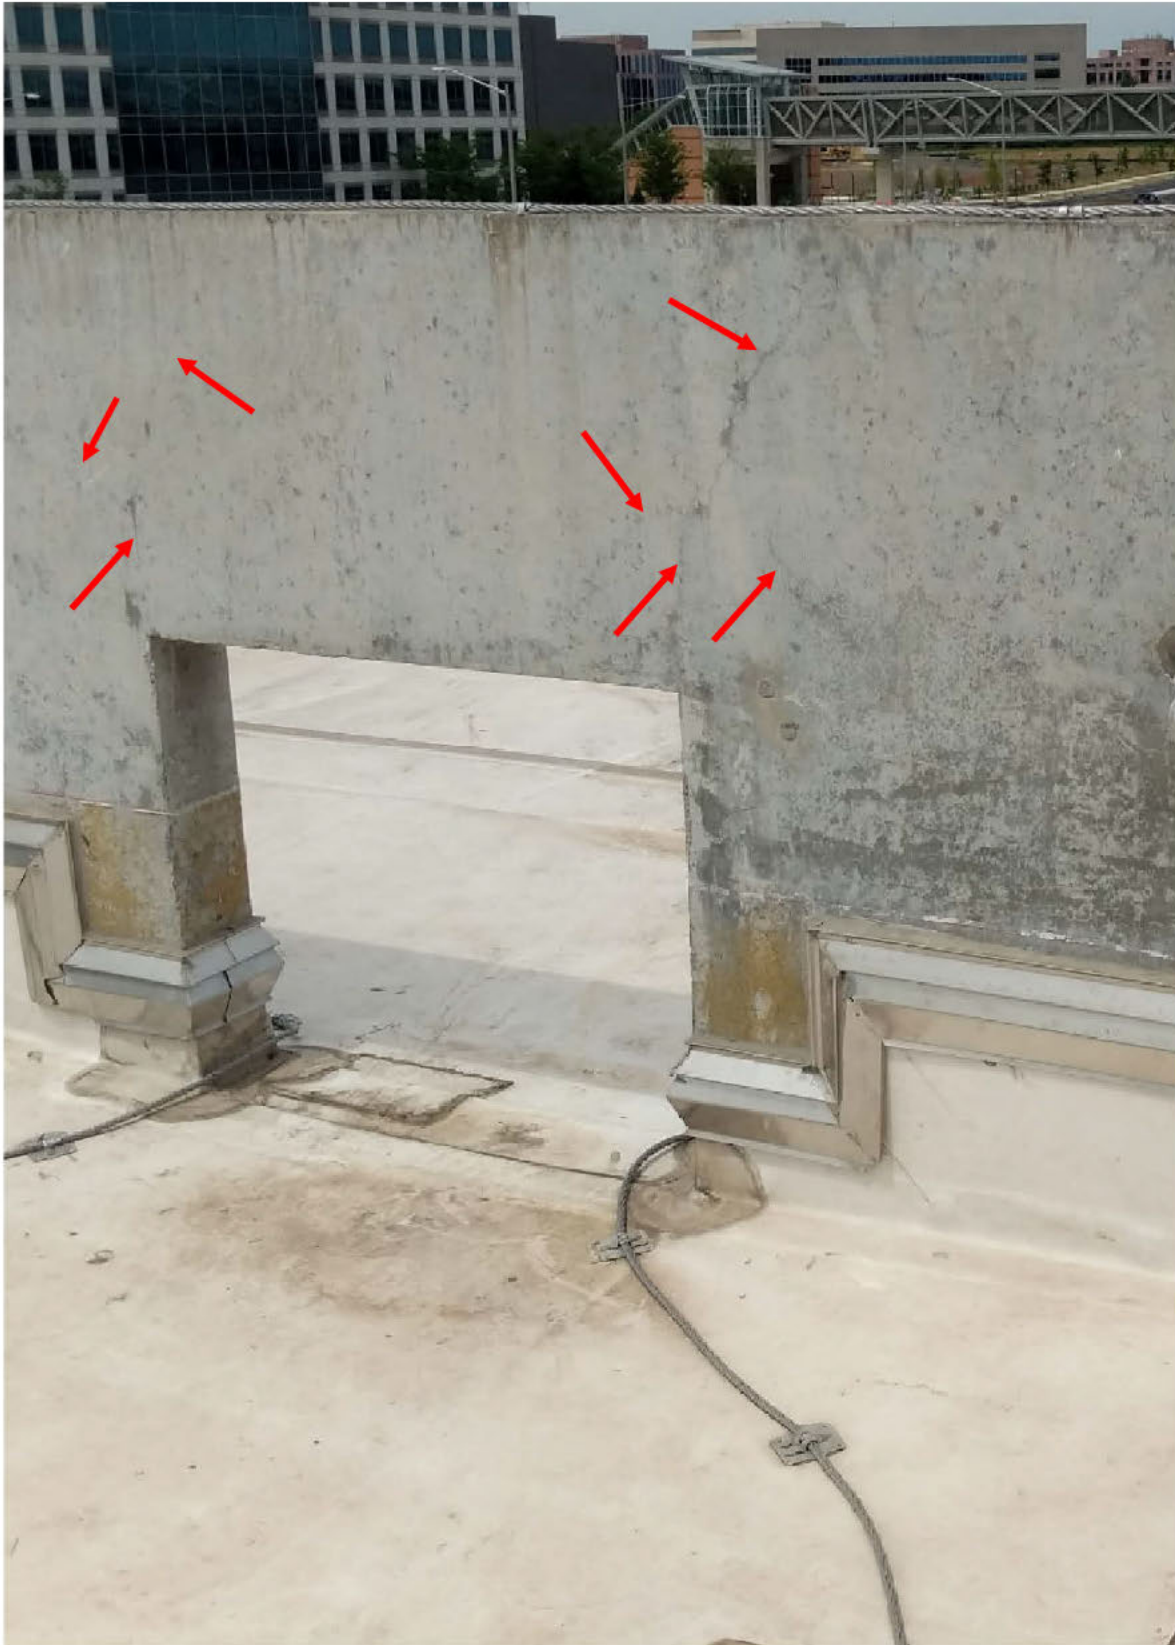
Figure 42: Spider cracks at interior face of Panel WP-1324. Source: DeSimone.

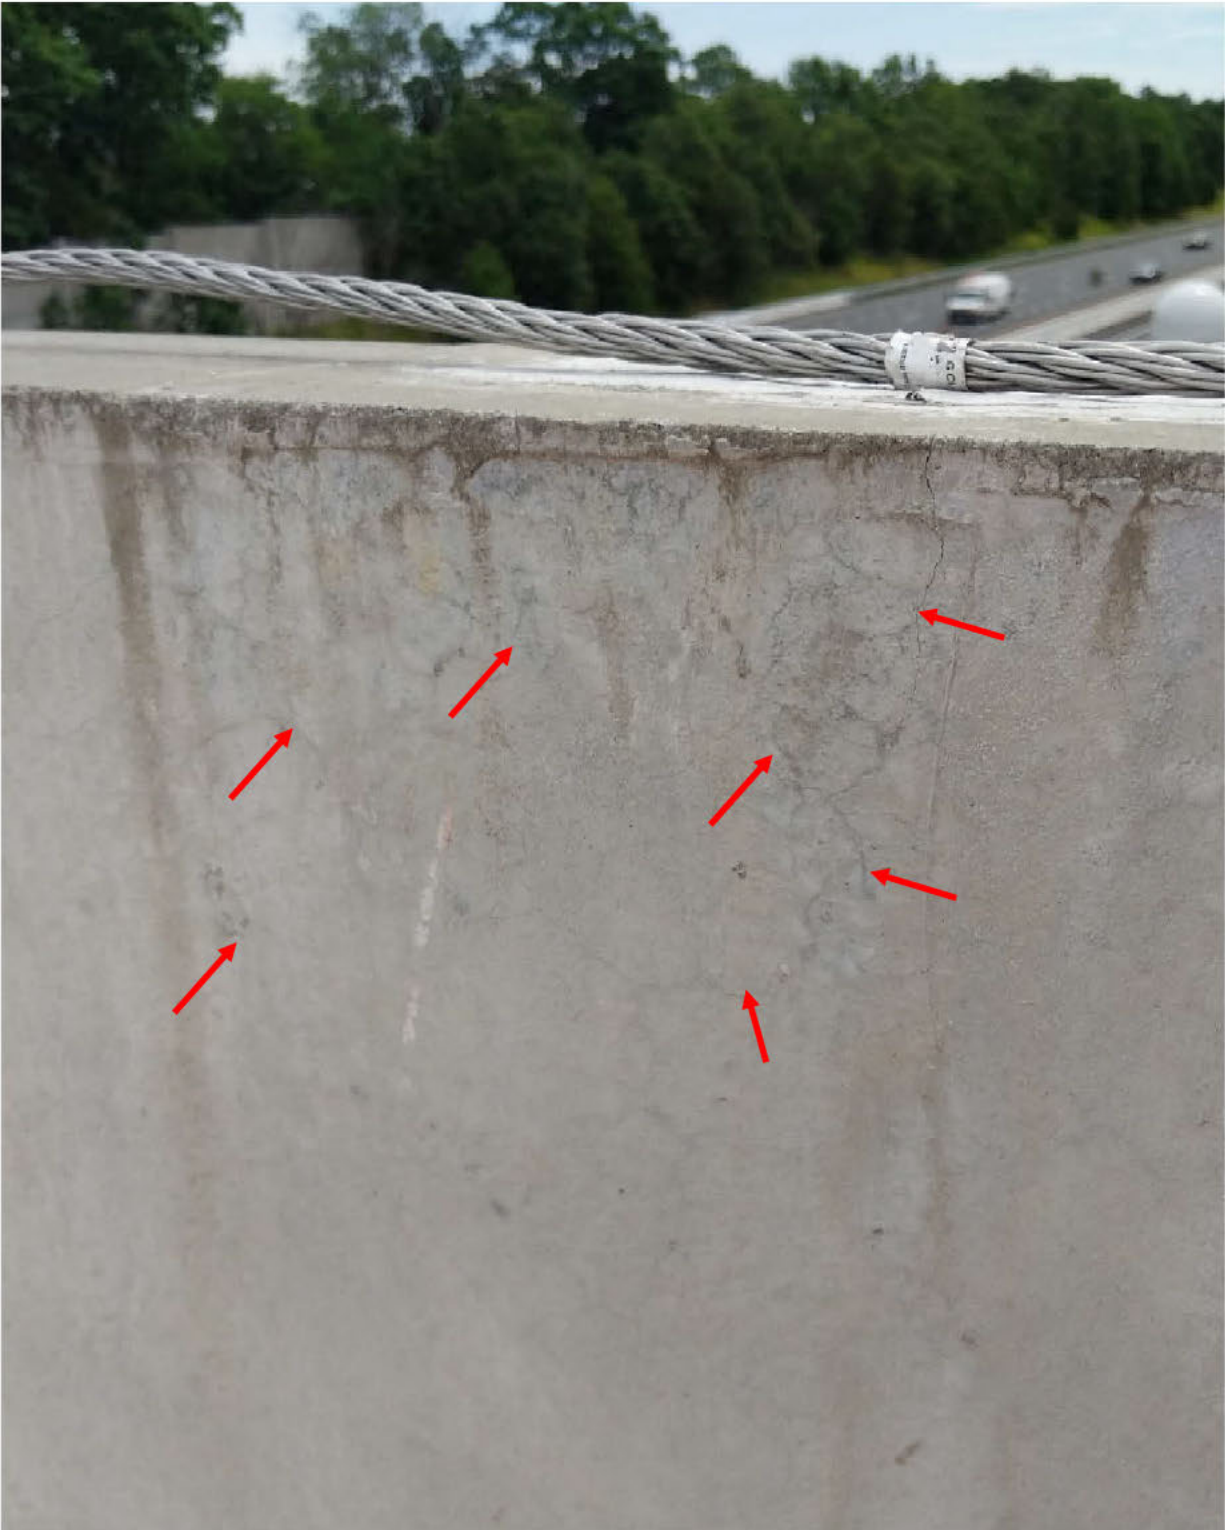
Figure 43: Spider cracks at interior face of Panel WP-1329. Source: DeSimone.

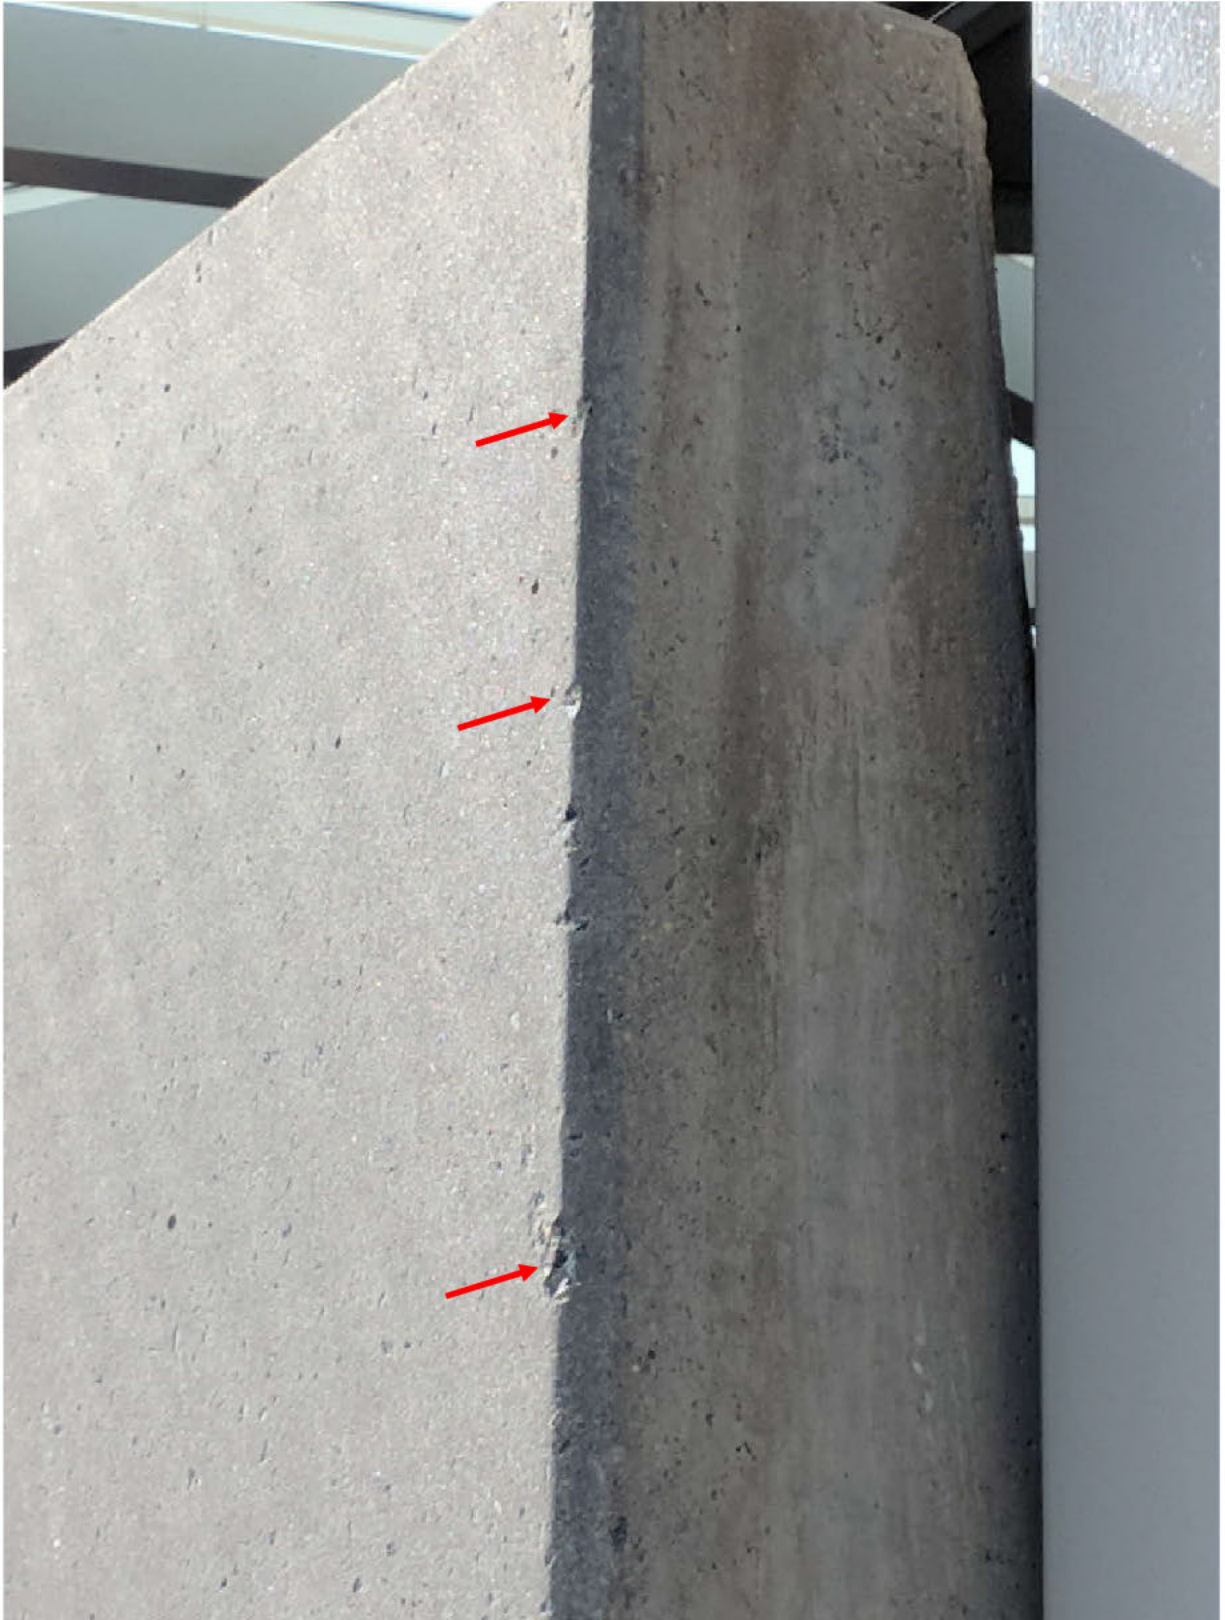
Figure 44: Chipped concrete at exterior face of Panel WP-1206. Source: DeSimone.

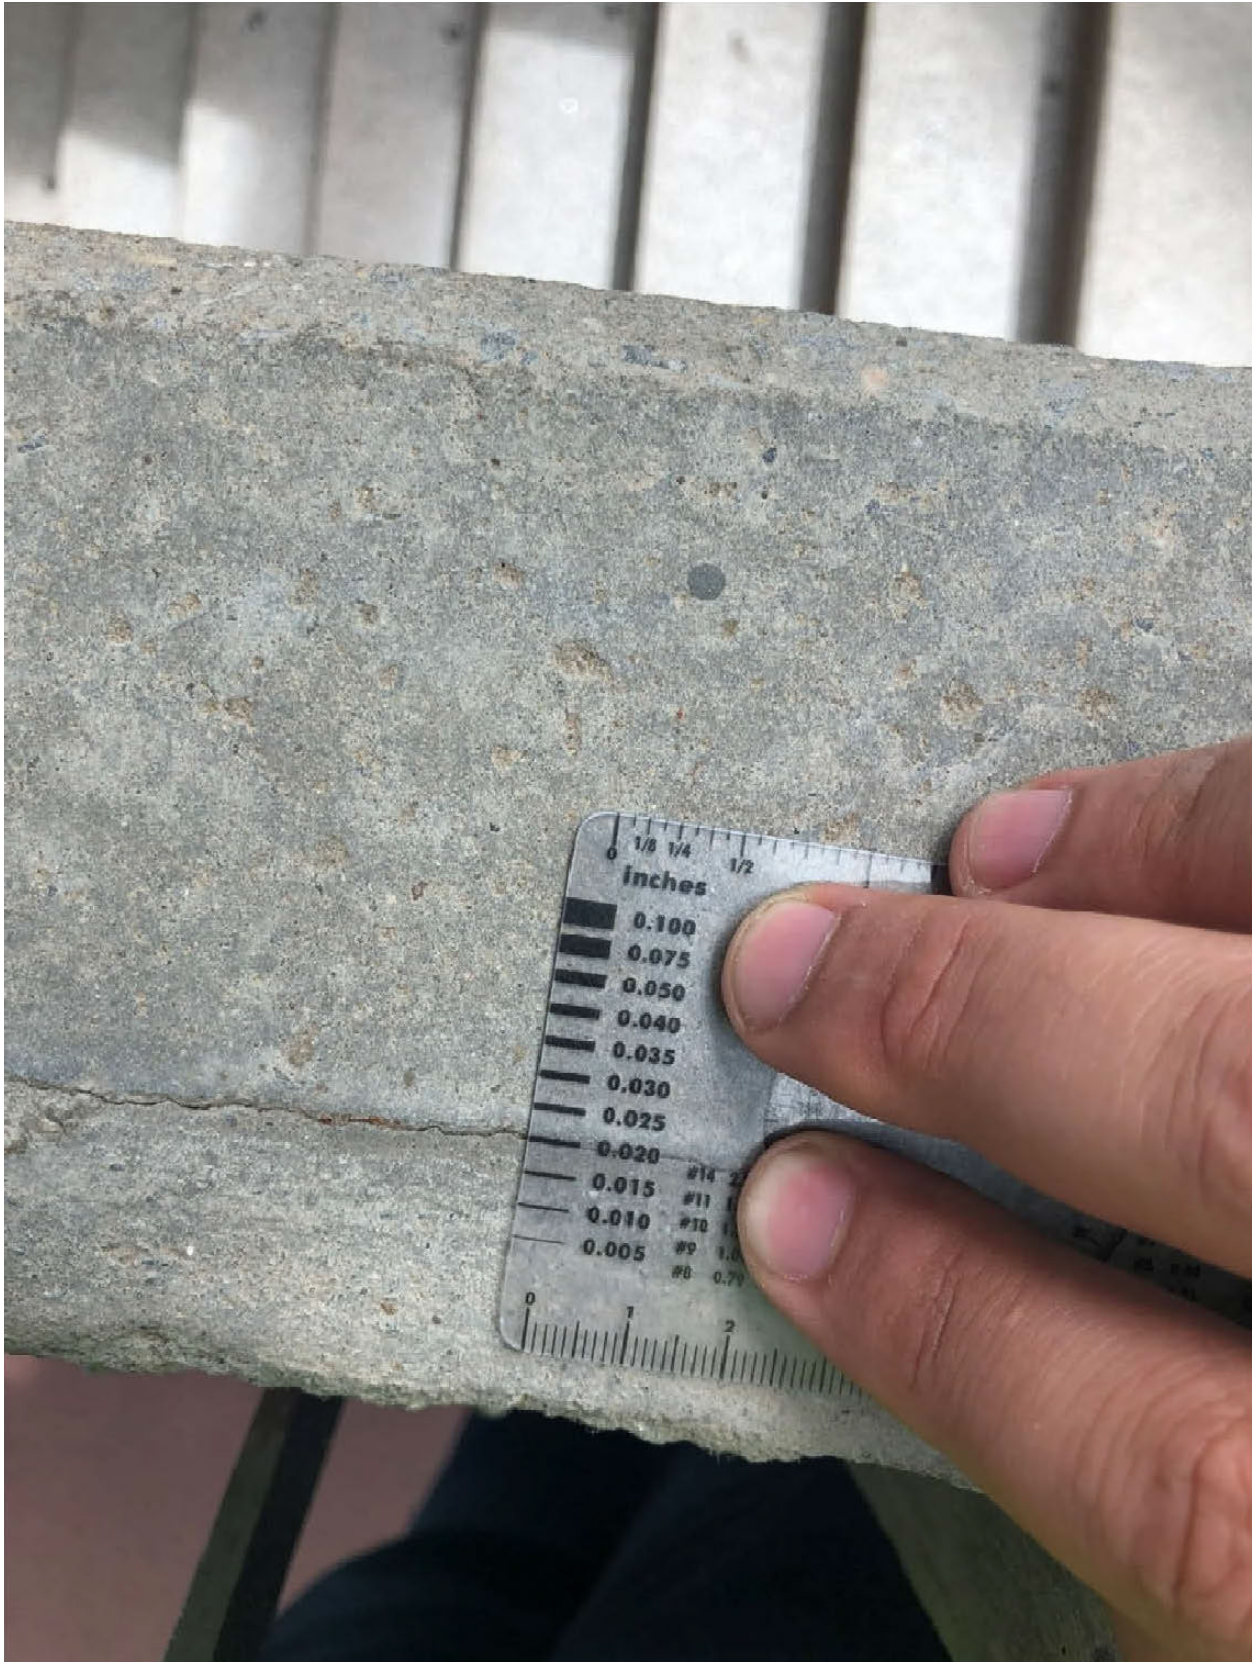
Figure 45: Crack at top face of Panel WP-1235. Source: DeSimone

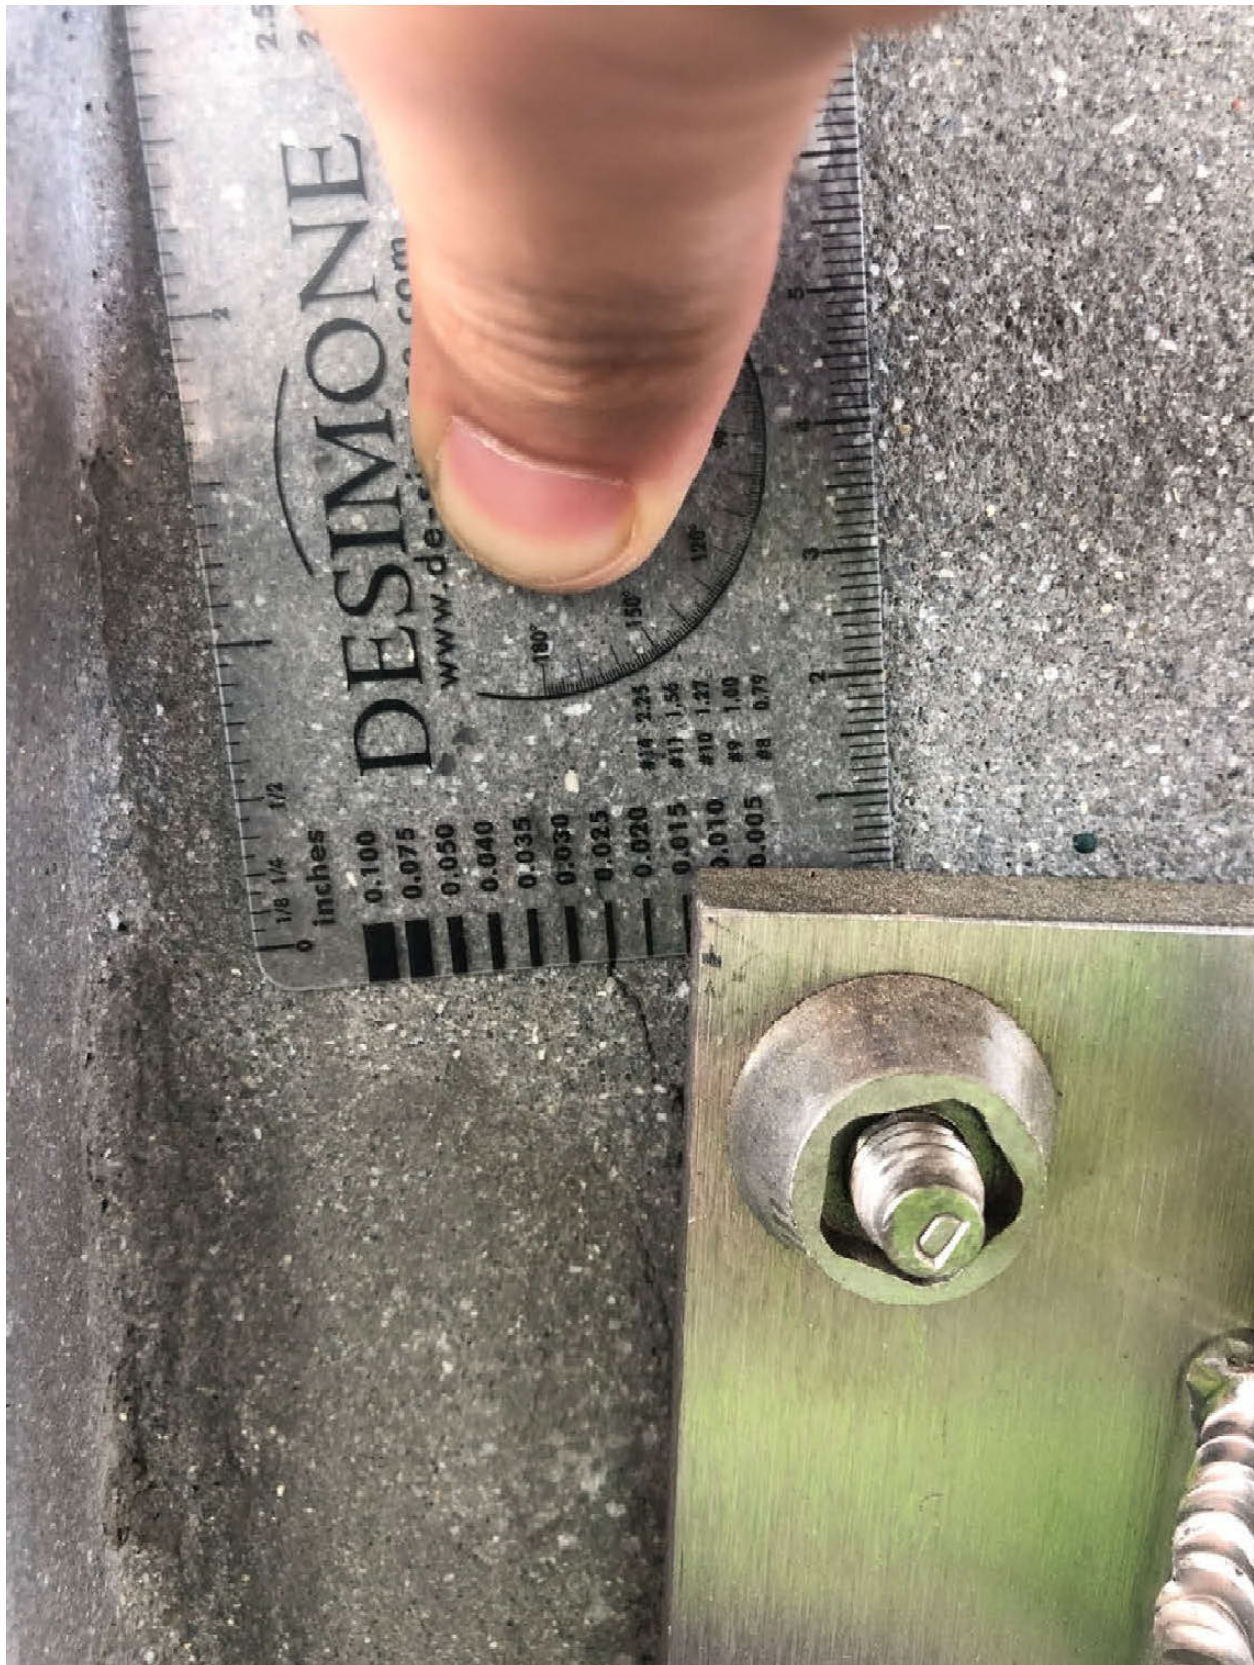
Figure 46: Crack at interior face of Panel WP-1233. Source: DeSimone.

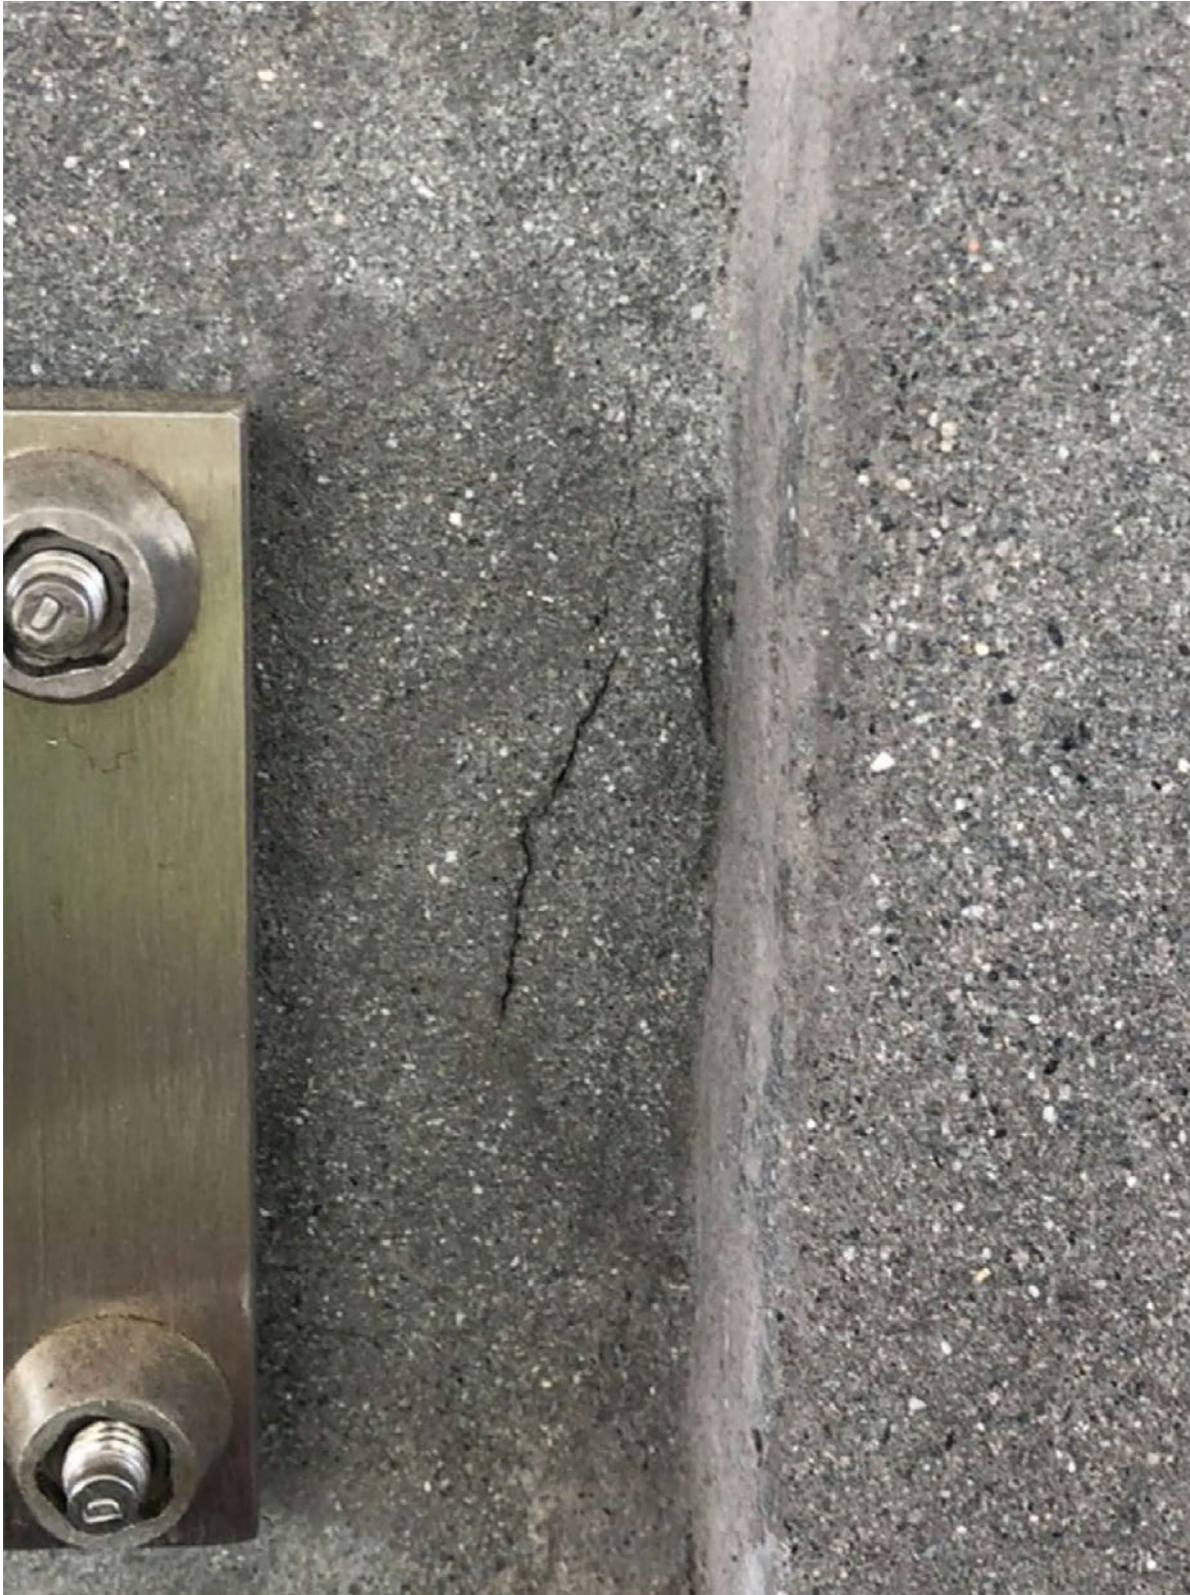
Figure 47: Crack at interior face of Panel WP-1233. Source: DeSimone.

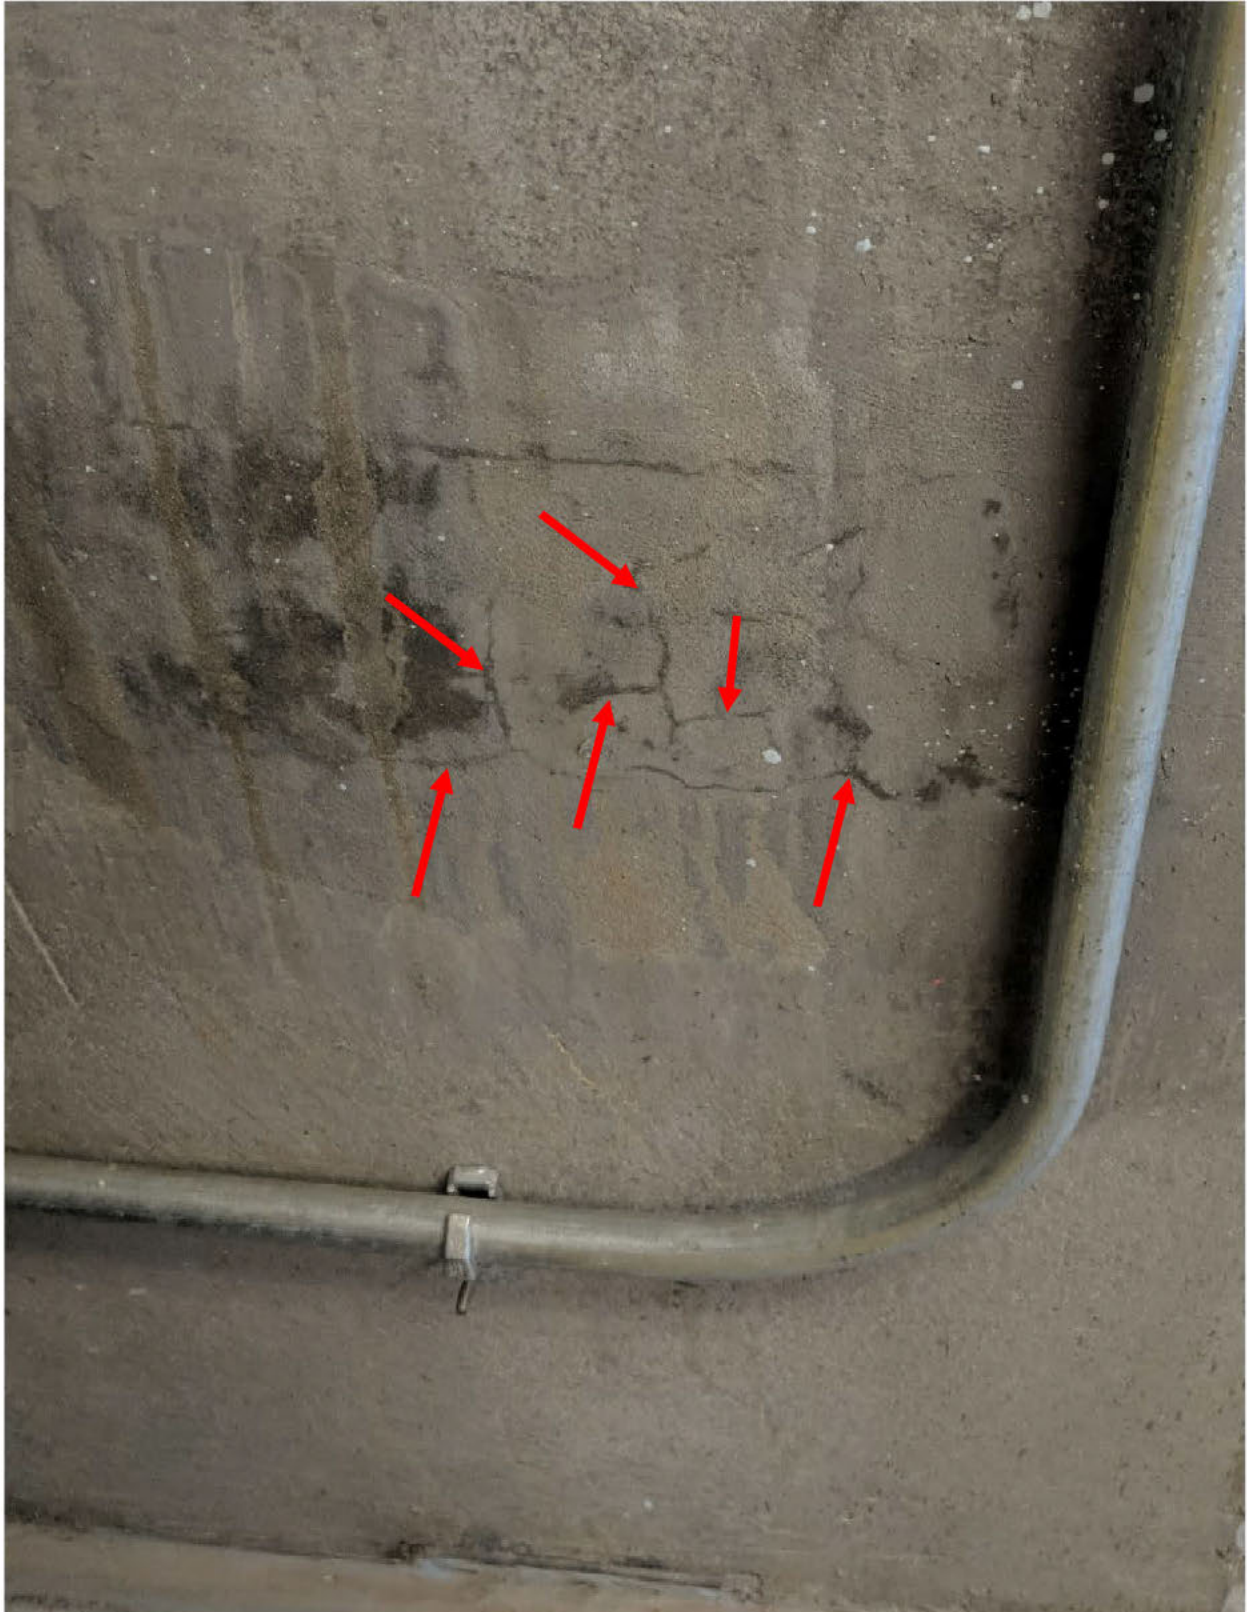
Figure 48: Spider cracks at interior face of Panel WP-1239. Source: DeSimone.

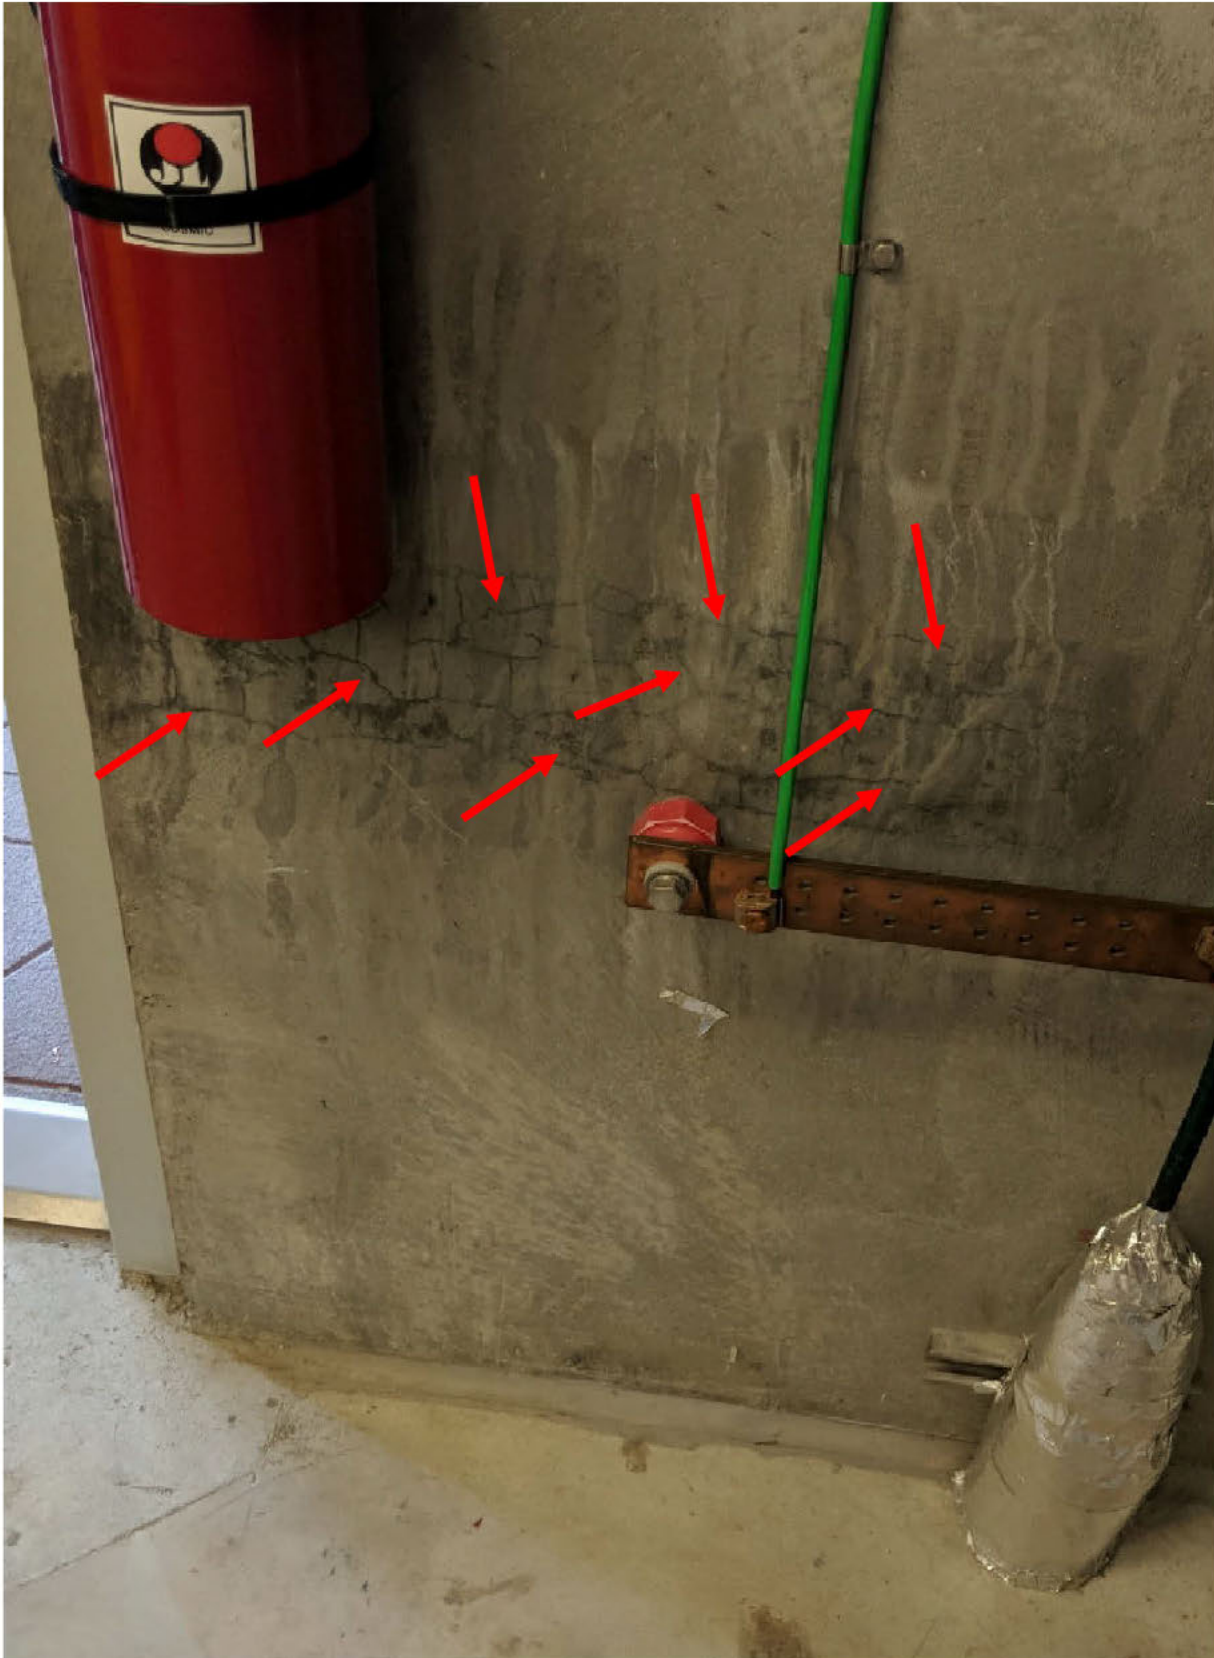
Figure 49: Spider cracks at interior face of Panel WP-1239. Source: DeSimone.

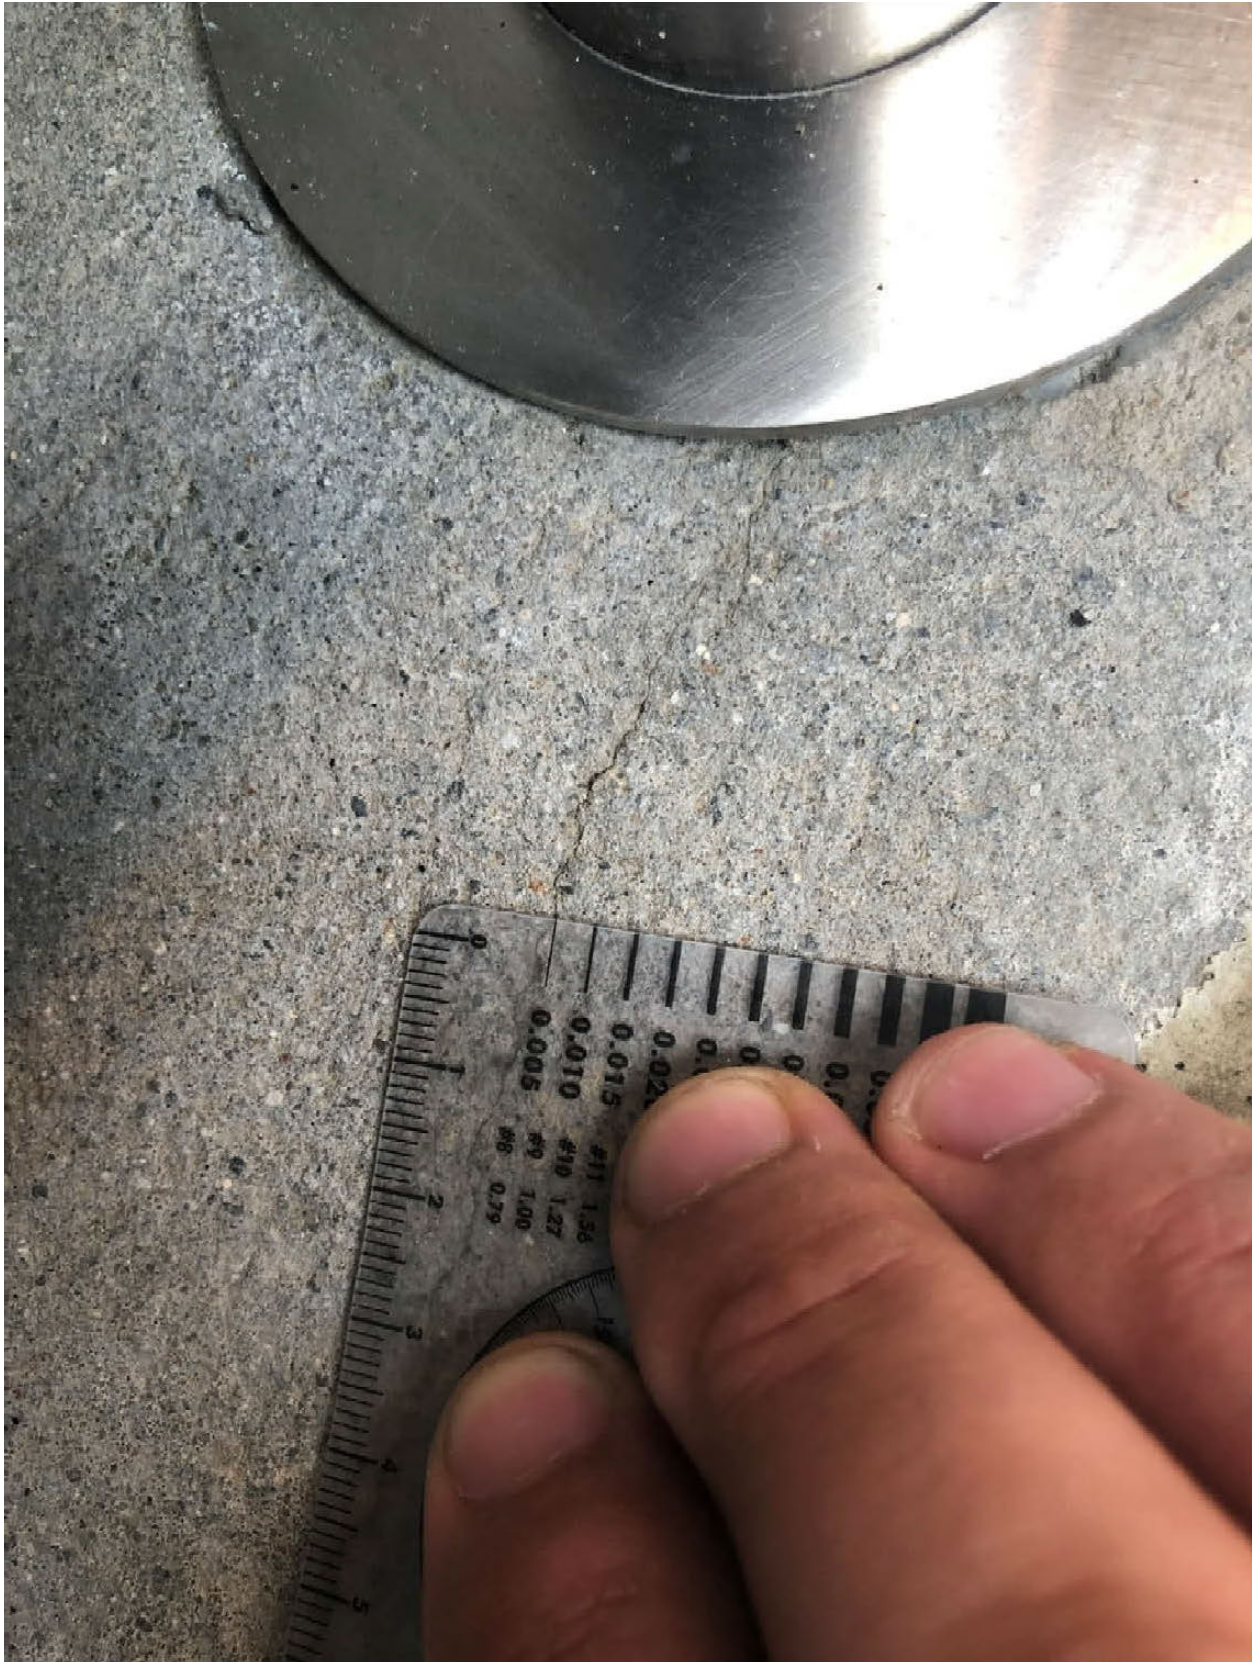
Figure 50: Crack at top face of Panel ST-1264. Source: DeSimone.
