SPECIAL PROJECT INTERIM REPORT

MARCH 5, 2020

SILVER LINE PHASE 2 REVIEW

OIG Interim Report of Findings & Recommendations

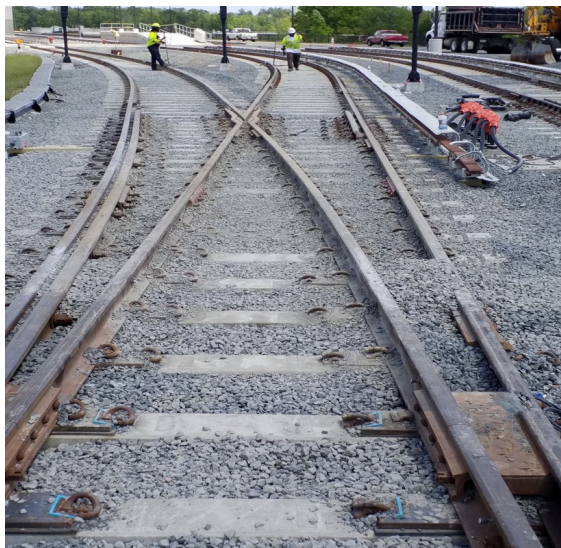
Turn-outs/Switches (Package B)

On August 12, 2019 the OIG team met with the WMATA Project staff and contract Subject Matter Expert co-located at the Rail Yard. The staff and technical advisor expressed specific concerns about the chronic failures of turnouts (#8) failing to meet required track geometry standards and exhibiting ‘tight gage’ conditions.

When the rails leading into the switch cannot be properly aligned, the distance between the rails (gauge) may be adversely affected. In the Rail Yard, there have been repeated issues with a narrower than acceptable distance where the rails are too close together, called a tight gauge condition.

During an April 11-12, 2018 field inspection, MWAA documented improper placement of the concrete ties leading into the switch and turnout. When a train approaches a turnout, the distance between ties is reduced to provide further support for the rail as more loading forces are applied. Adequate space must also be allowed for movement of the rods that physically move the rail. MWAA noted that although the track construction was a “work in progress,” there were several locations where the tie spacing was too proximate to the moveable switch rods that this fact contributed to the problem.¹⁸

A tight gauge increases the strain on track fastenings and will cause the flange of the wheel to start grinding against the edge of the rail. This condition causes high flange forces to occur and the flange may ride over the rail, possibly leading to a derailment.

The OIG was also advised that the track subcontractor has been working with the switch manufacturer on adjusting (re-milling) the switch points to facilitate closure and proper operation. As of the date of this report, based on our most recent information the OIG was further advised that the tight gauge at the #4 rod on many of the #8 turnouts, and more recently discovered on some of the #10 turnouts, has recently been further reworked and found by MWAA and WMATA to be acceptable for the purposes of running test trains. This acceptance was conditioned on further inspection after the test train activity and further mitigation efforts as required to achieve compliance with contract requirements. The gauge, as currently exists, is still tighter than allowed by the design tolerance requirement of the contract but is now at least within WMATA maintenance tolerance.
