Invitation For Bid

Electrical and Data Cable Installation

Project Name: 15-NEPP-01 In-Floor Duct Inspections
Task: Mezzanine Inspection Reports
Date of Inspection: August 22, 2014
Mezzanine Inspected: A01 - Metro Center East
Report Includes:
- Mezzanine Inspection Checklist
- Field Photos
- Existing AFC Installation Plan with field notes

Mezzanine Inspection Report (Scoping)

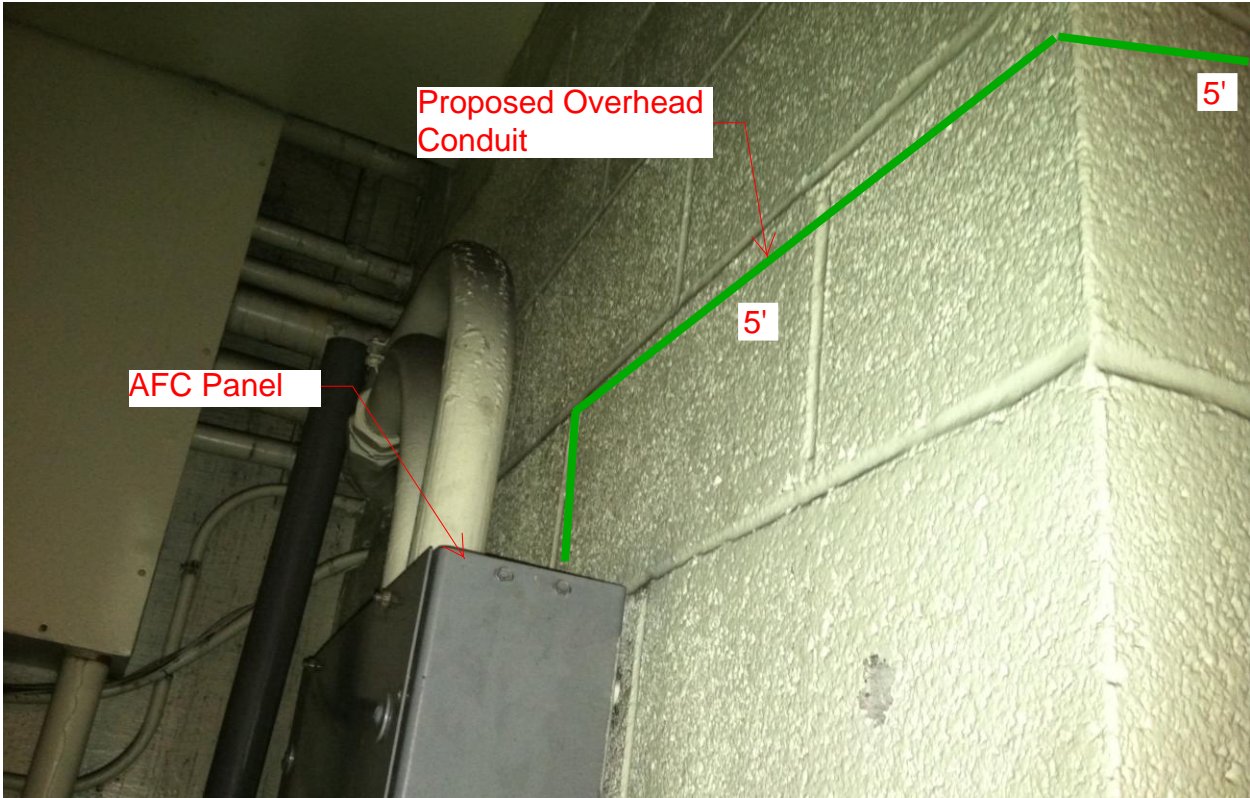
Photo #12: Proposed Overhead Conduit feeding AFC Panel in Room W202.

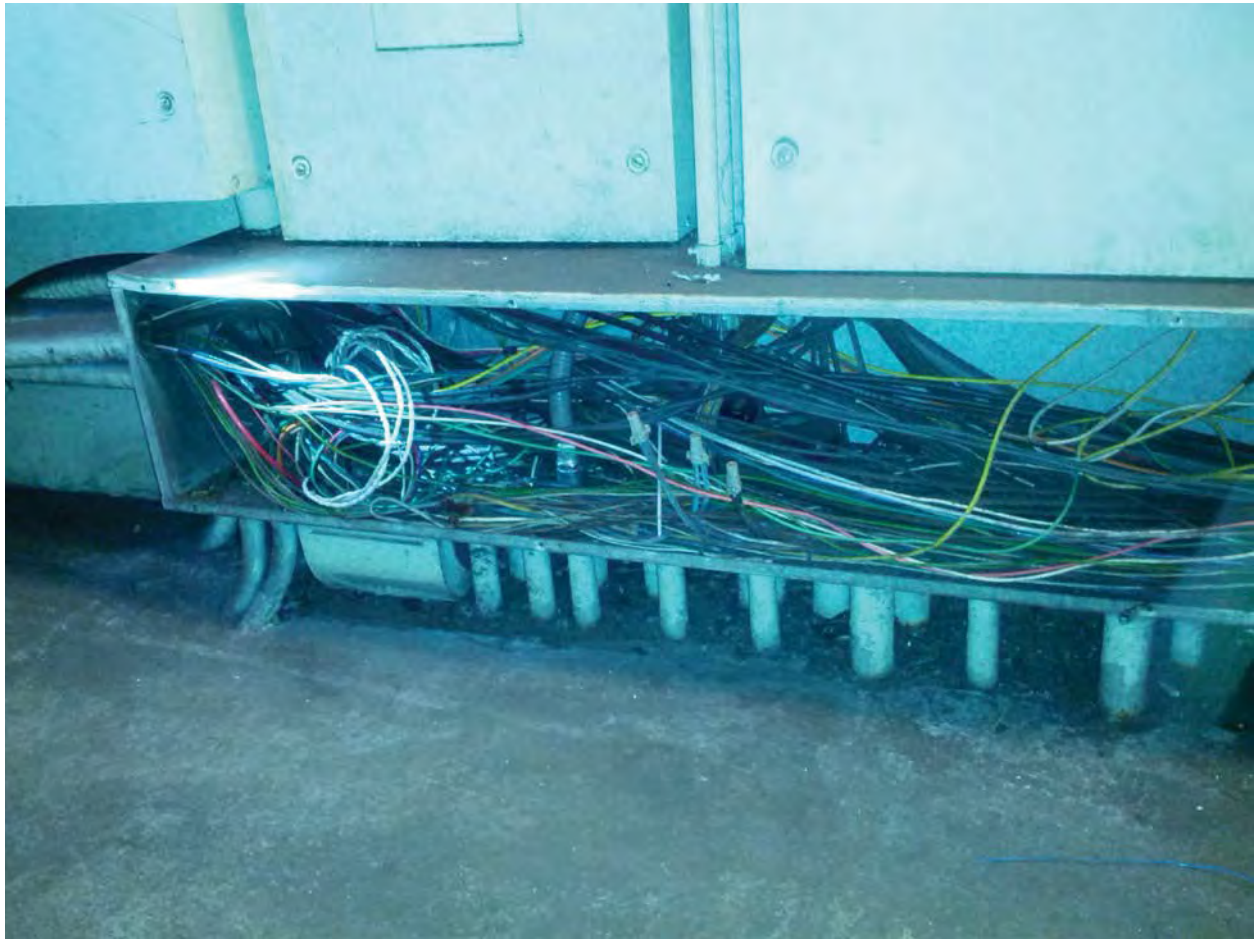
Photo #4: B02 Judiciary Square (East) – Shared cable trough in room 206. Power duct enters trough from the bottom at left.

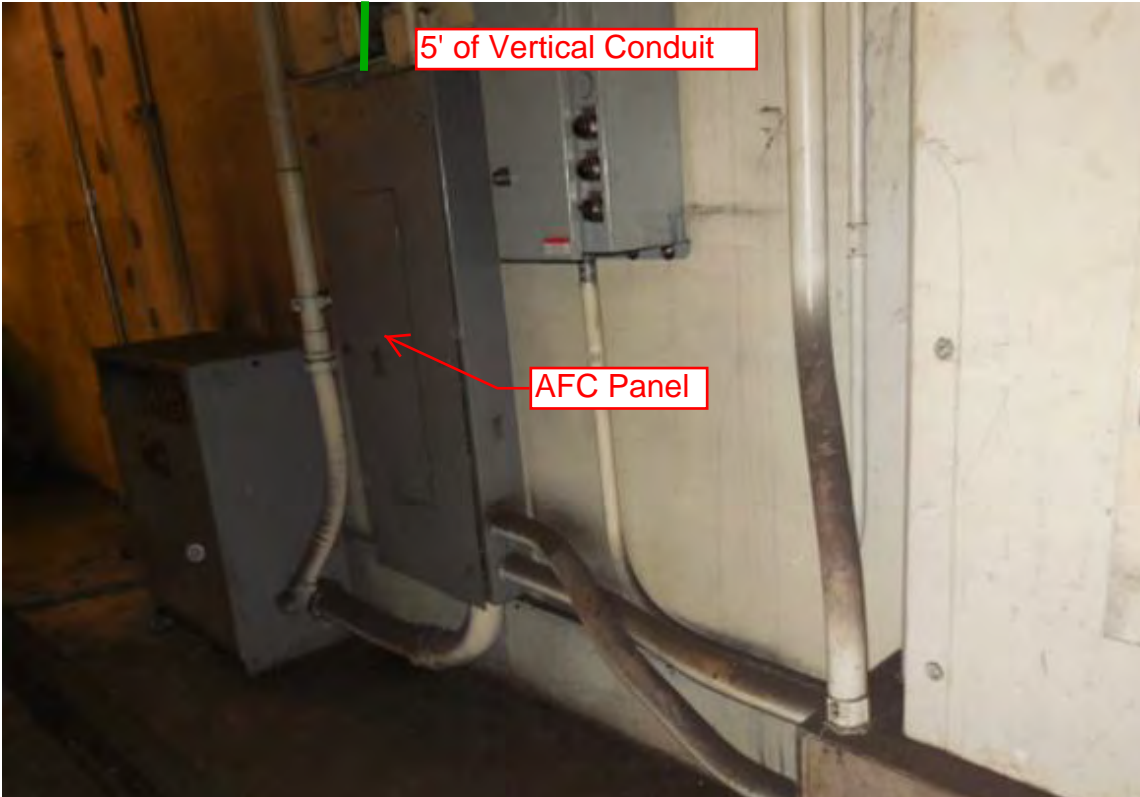
Photo # 10 – Proposed Conduit Run in Room 205

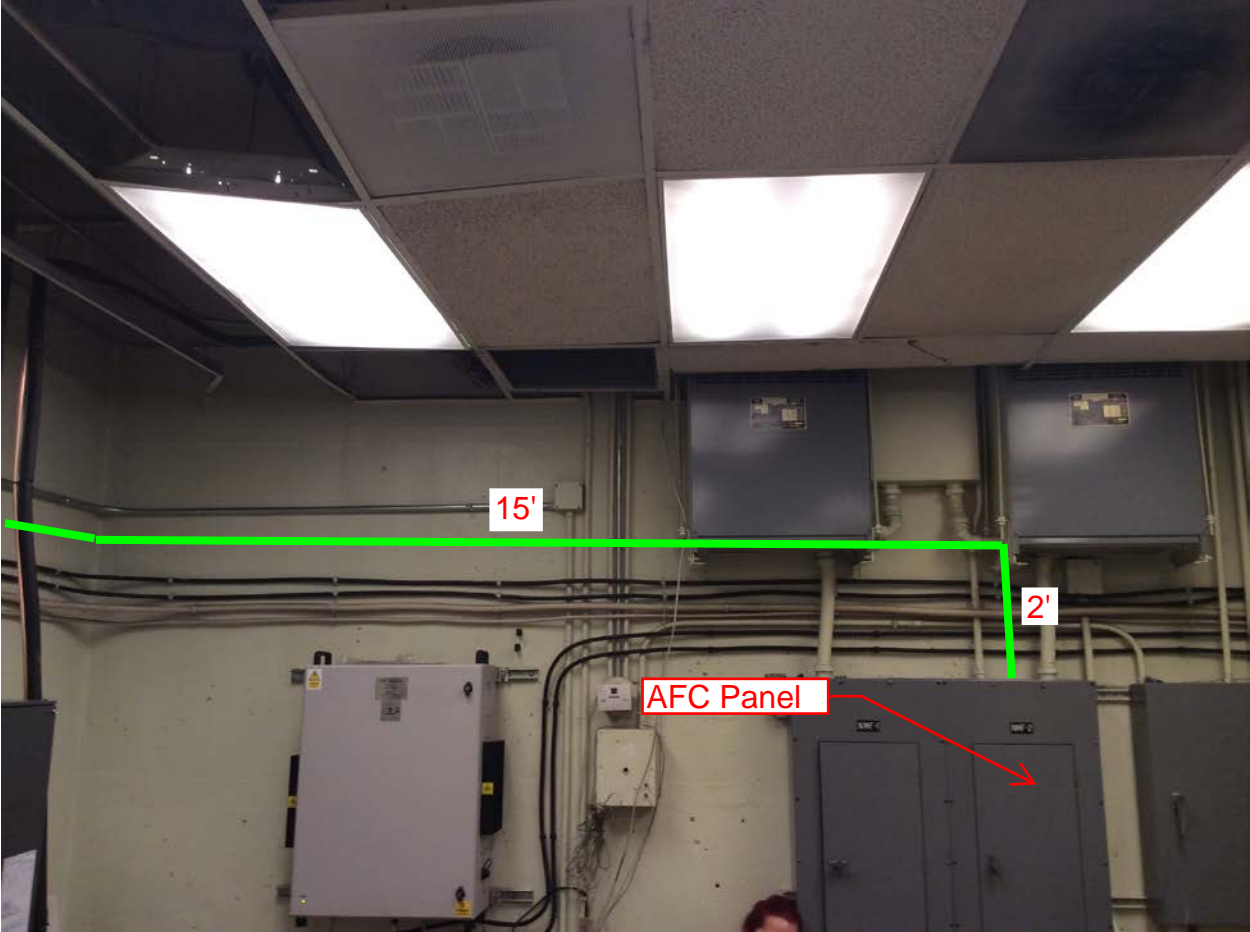
Photo #7 - Proposed conduit run connecting to AFC Panel inside Mechanical Room 214

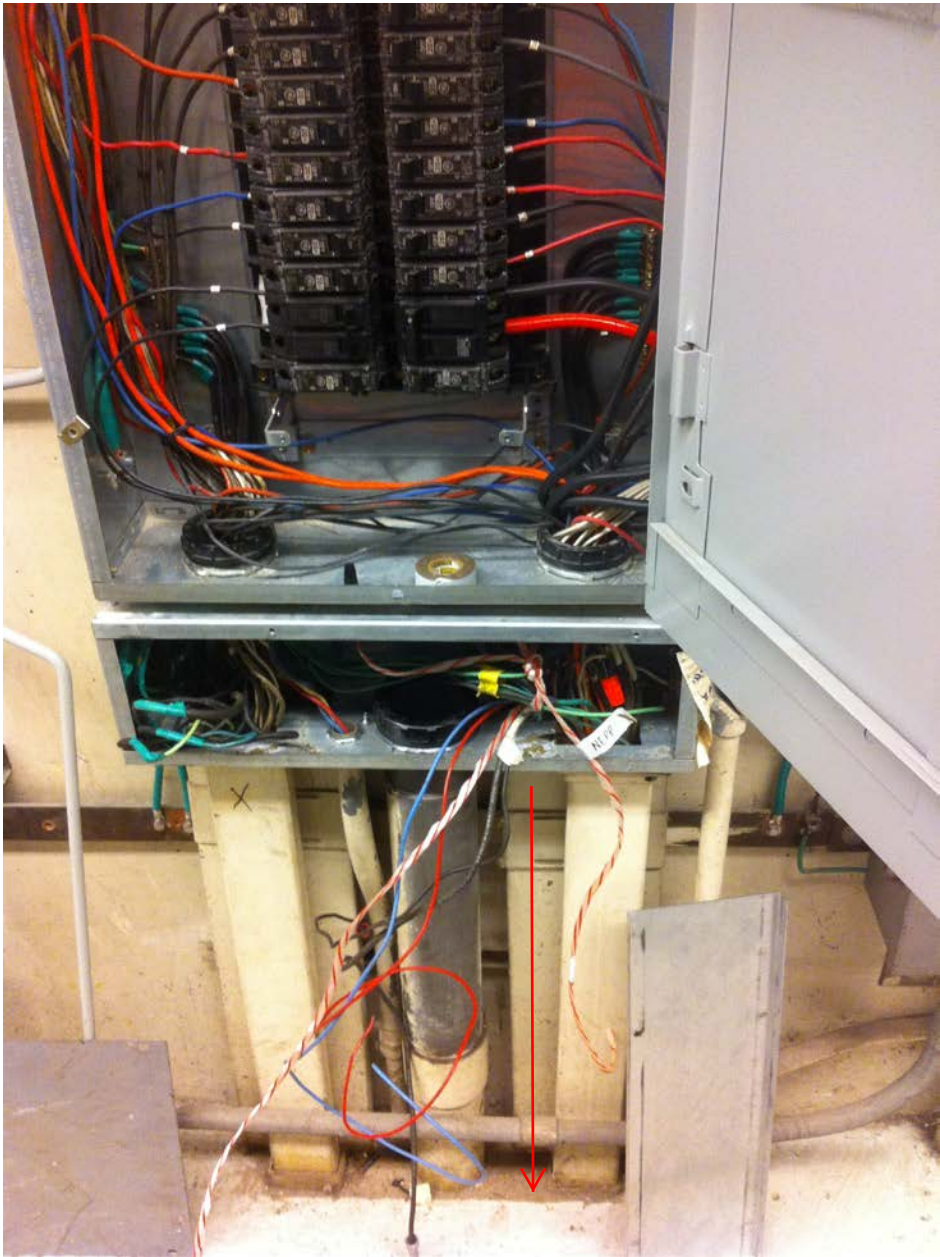
Photo #3: B04 Rhode Island Ave. – Installation of pull string in AFC Panel.

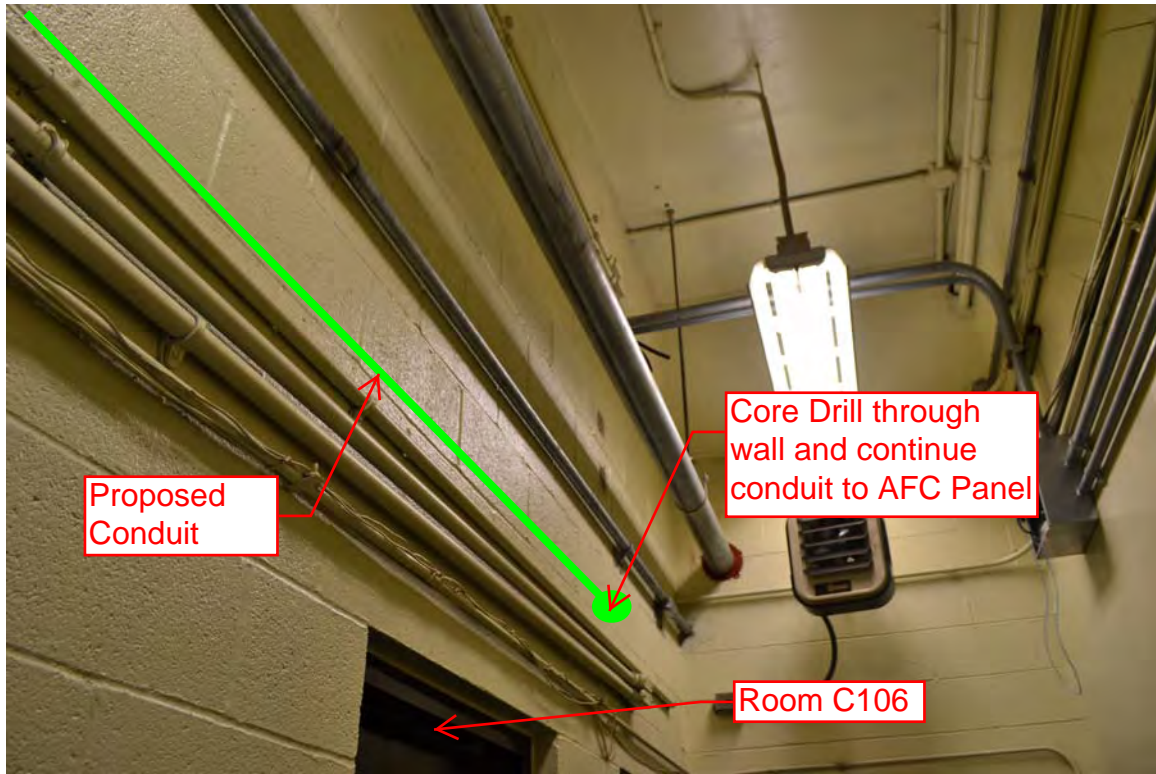
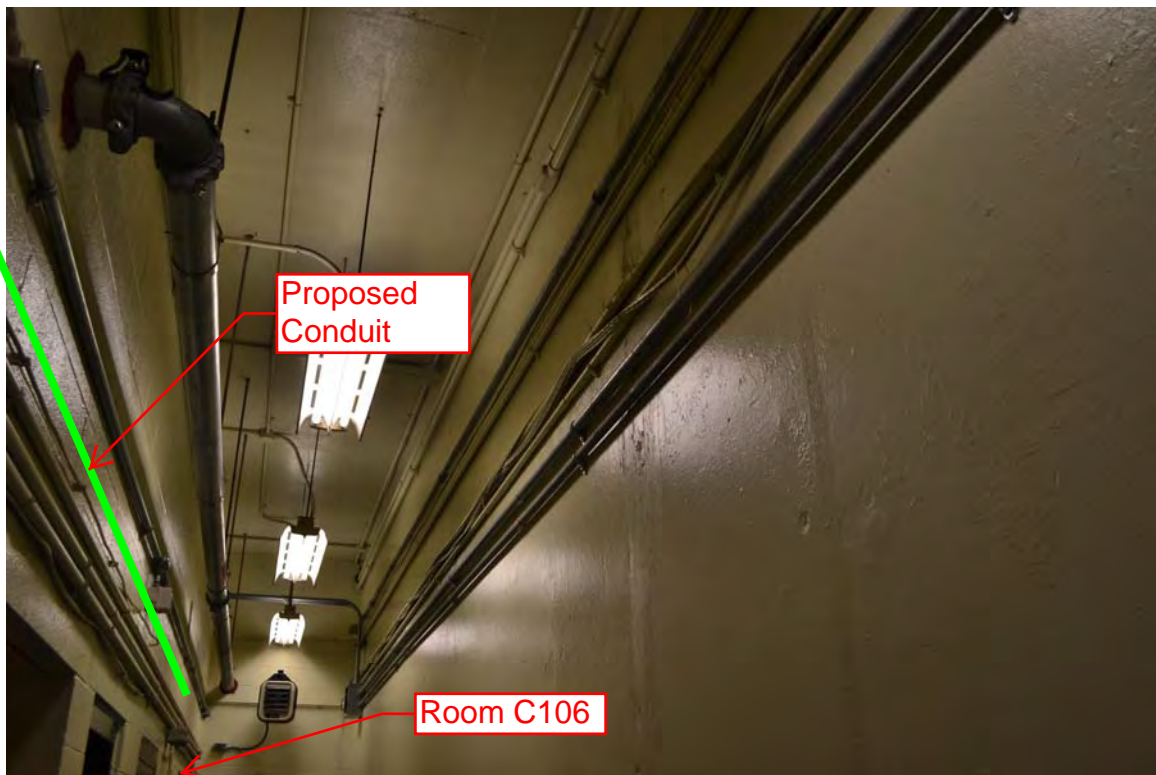
Photo #7 - Proposed conduit along hallway leading to Electrical Equipment Room C106

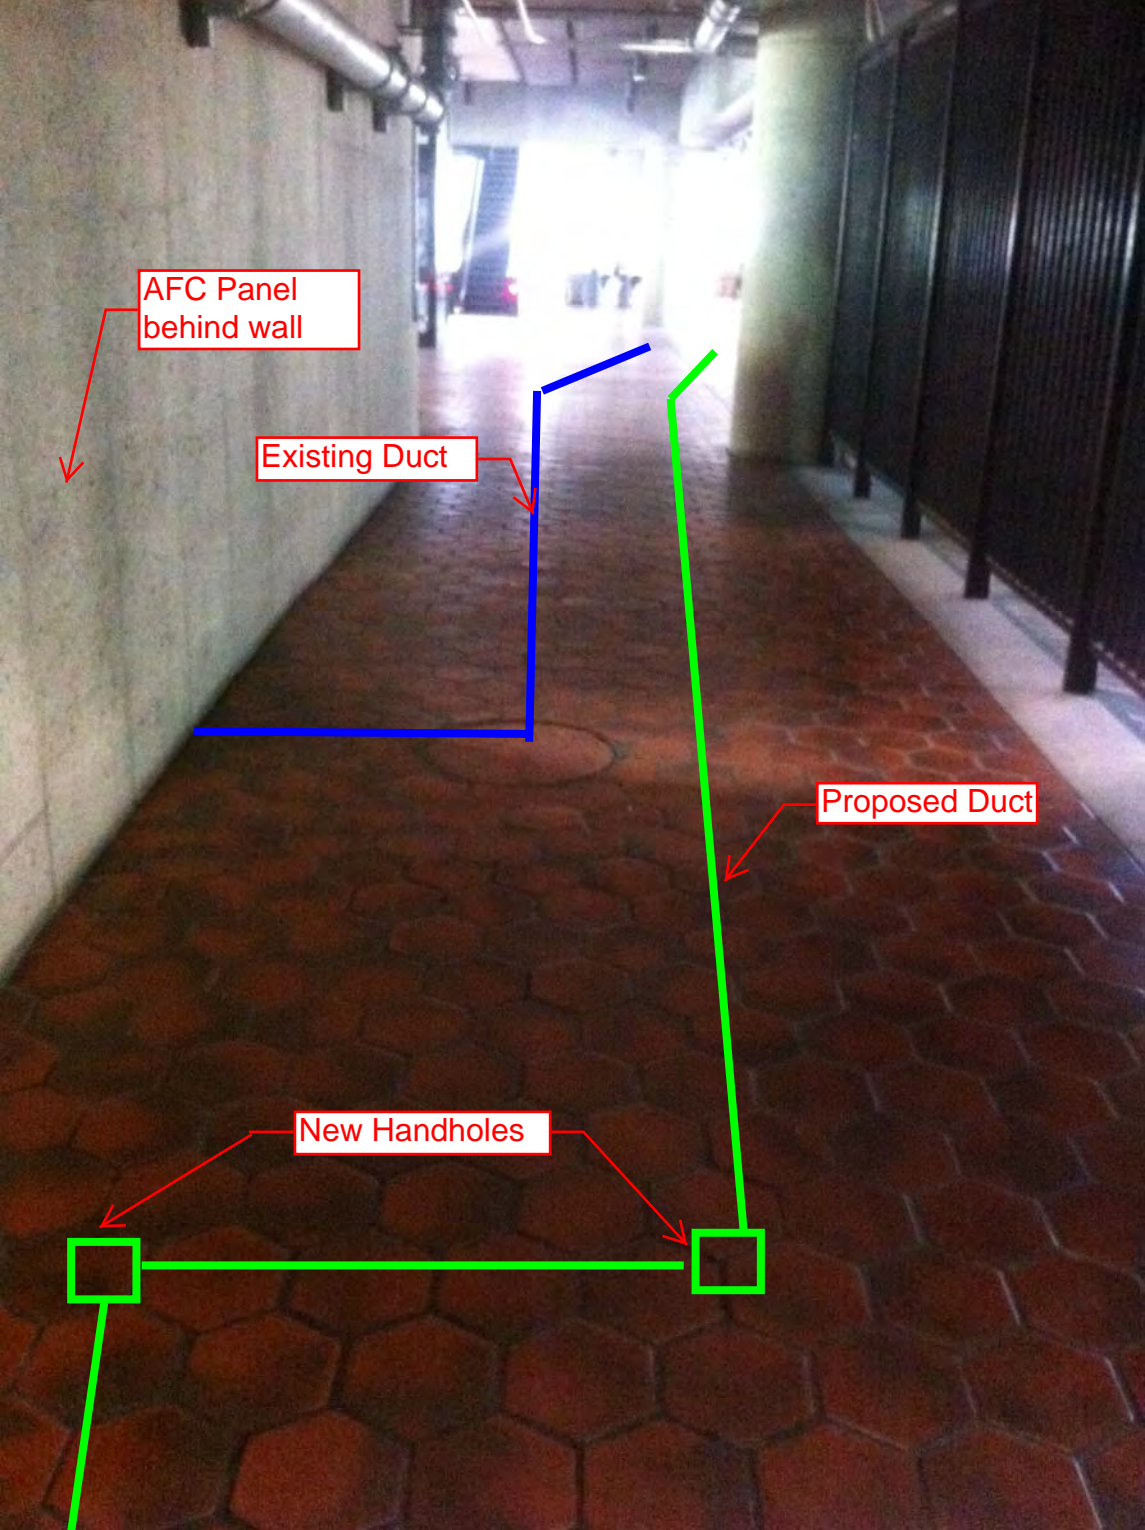
Photo# 2: B06 Fort Totten – Existing and proposed duct runs near AFC Panel

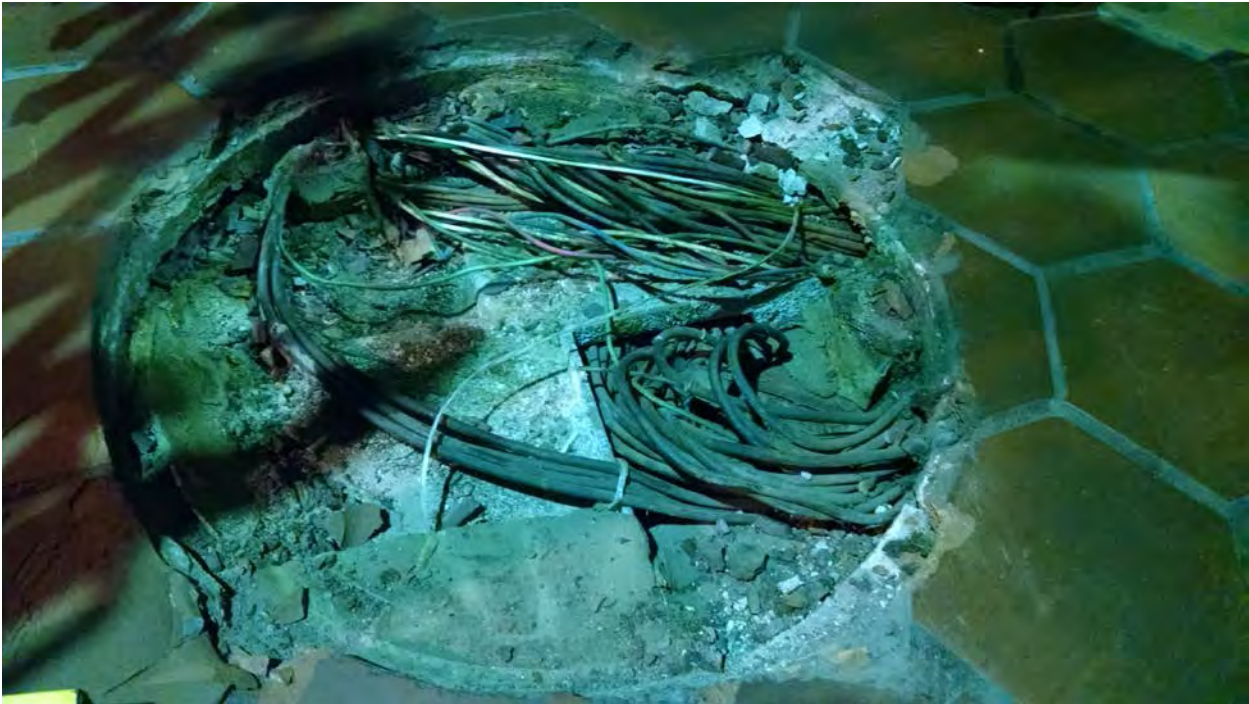
Overall, the walker ducts at this mezzanine are in poor condition due to extensive corrosion caused by water intrusion. Collapses were found both in both the faregate communication and power ducts and the power duct between the Kiosk and AFC Panel. Pull string could not be installed in faregate communication ducts due to collapses and inaccessibility issues. A pull string was installed in the power duct between the Kiosk and Handhole by utilizing an existing pull string, however it is not advisable to re-use this duct as there were multiple collapses found during video scoping.

Photo #3: B06 Fort Totten – Poor condition of Handhole on mezzanine floor

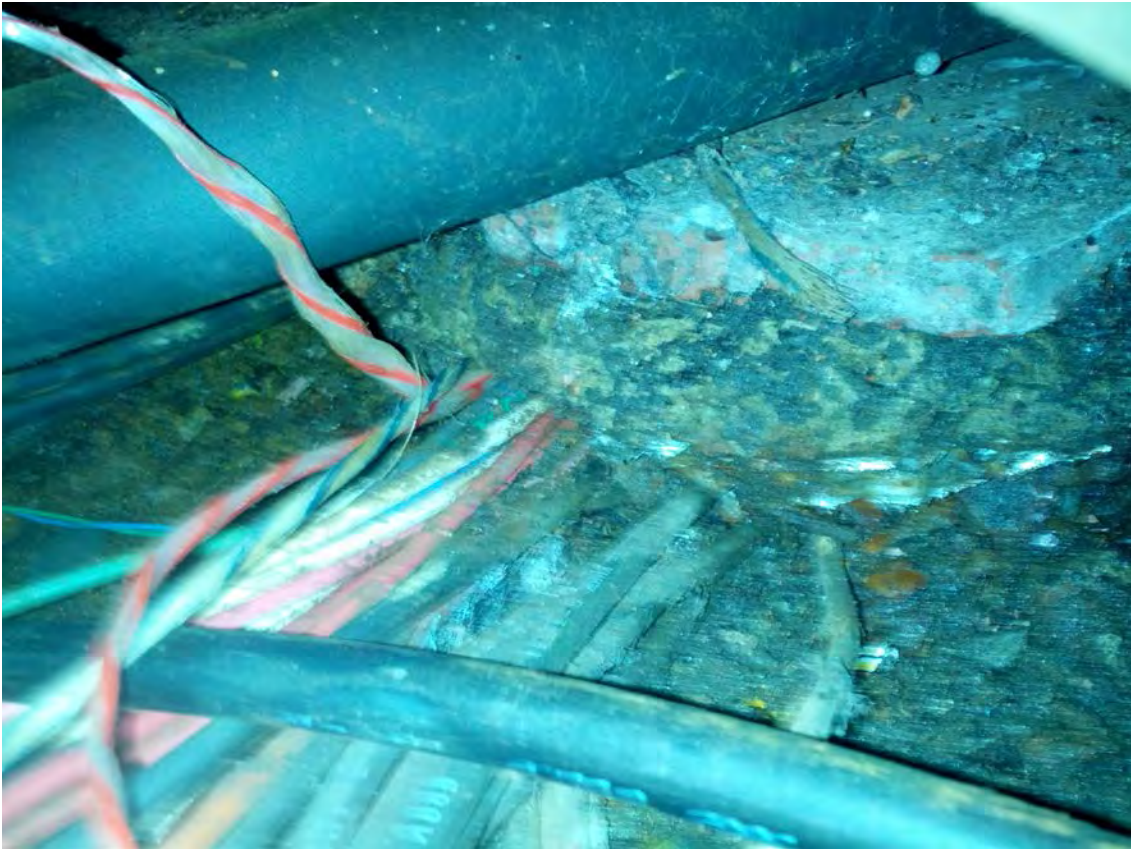
Photo #4: B06 Fort Totten – Pull string installed in power duct run from handhole to kiosk

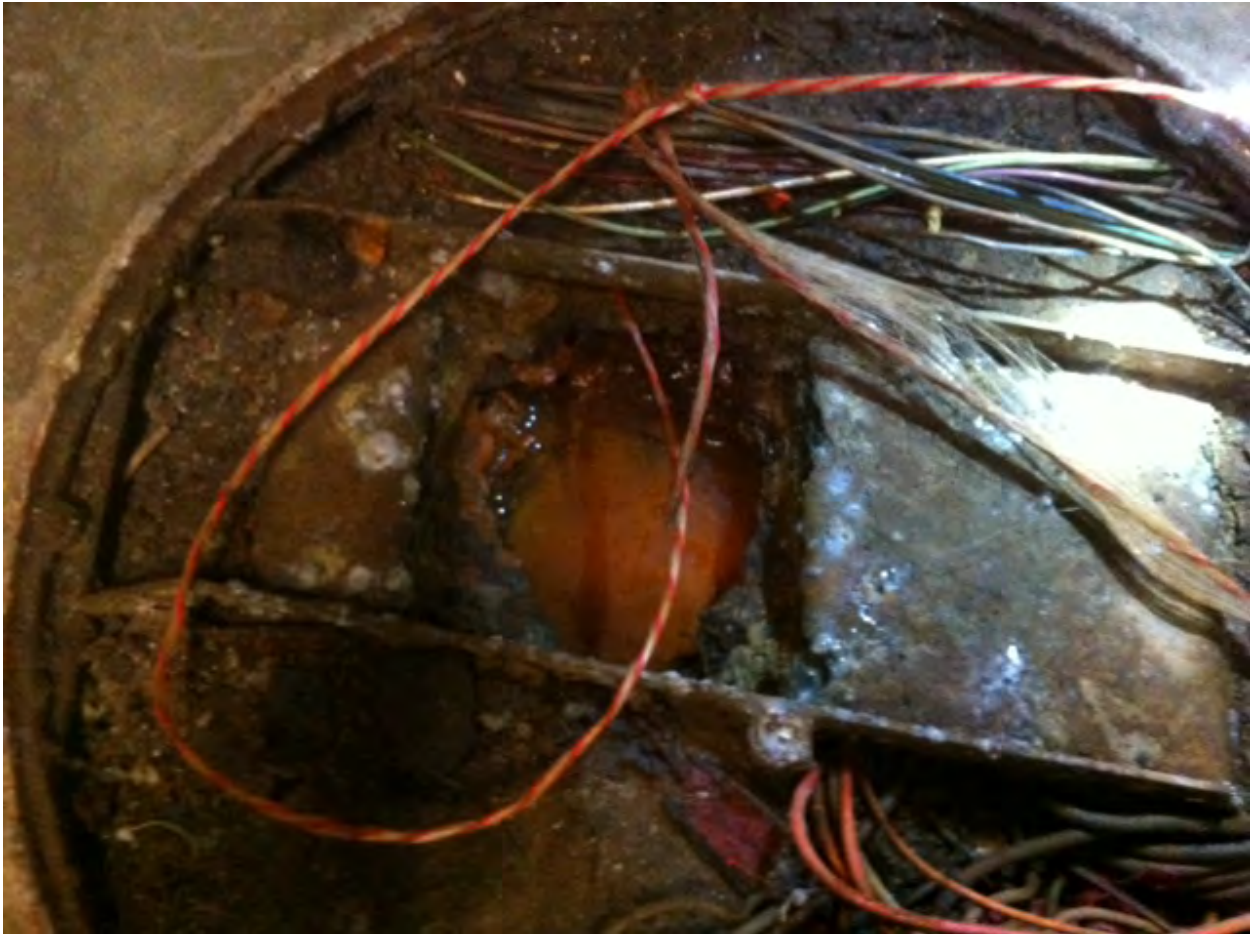
Photo 5: B07 Takoma – Standing water in first handhole

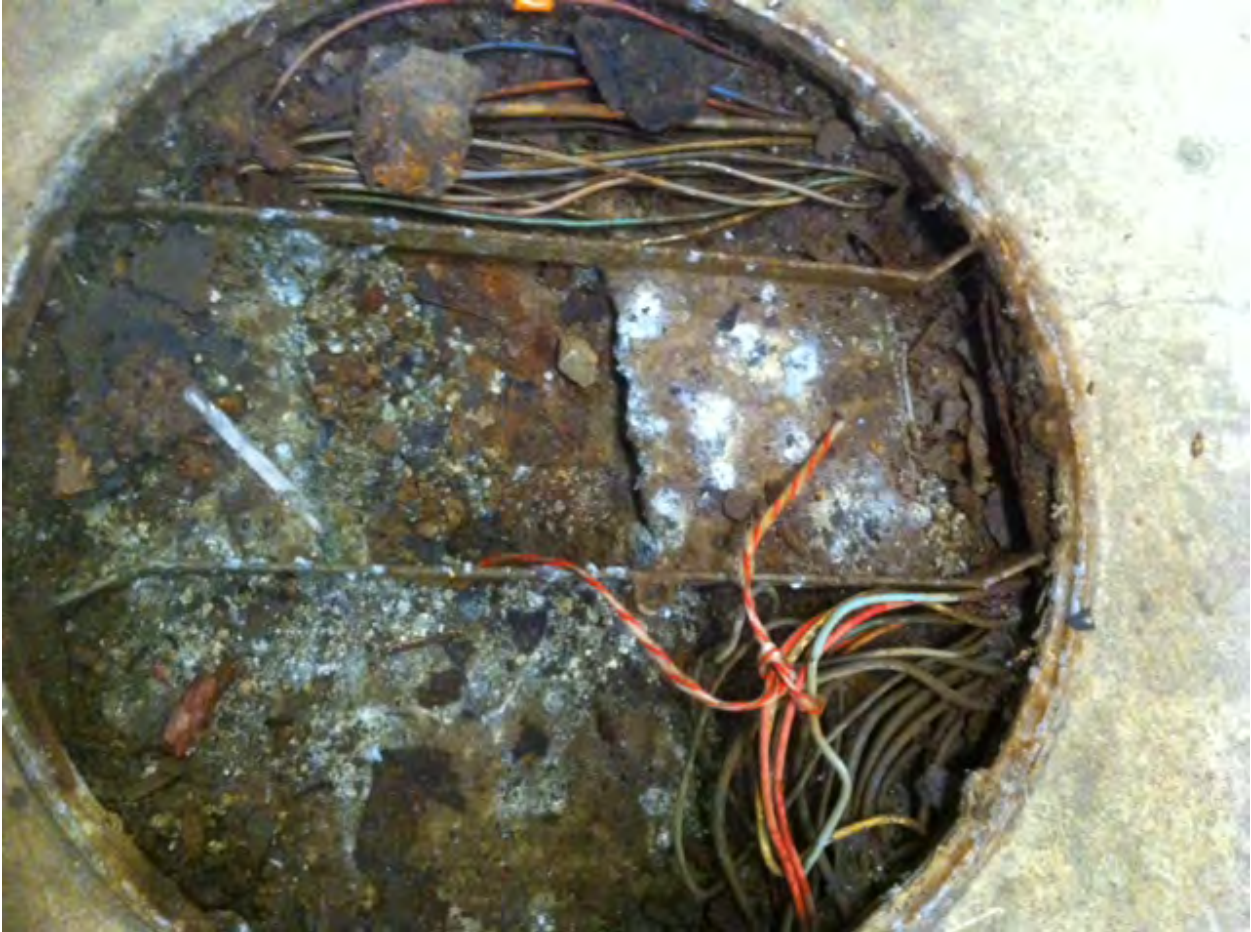
Photo #6: B07 Takoma – Poor conditions in second handhole

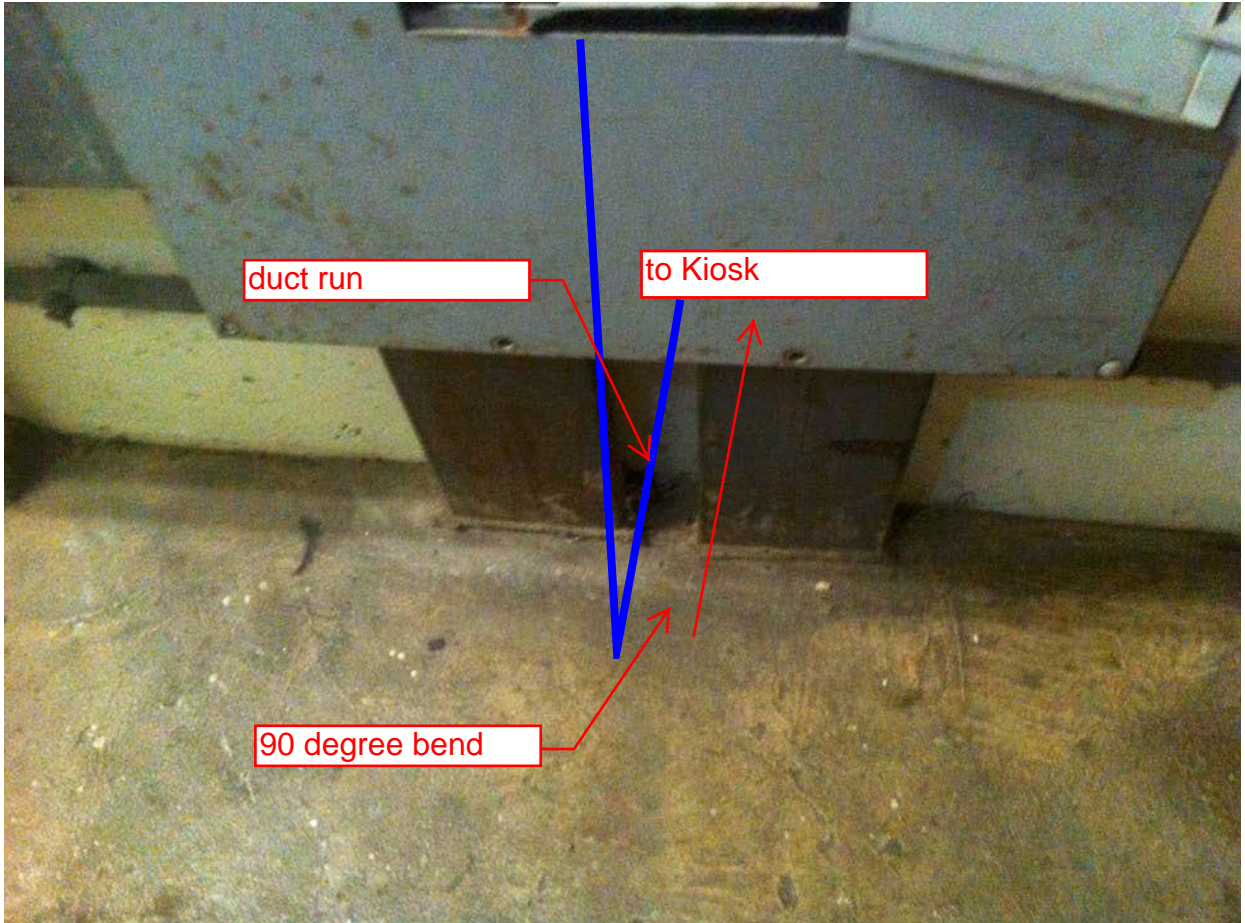
Photo #2 – B08 Silver Spring North: Duct run into AFC Panel

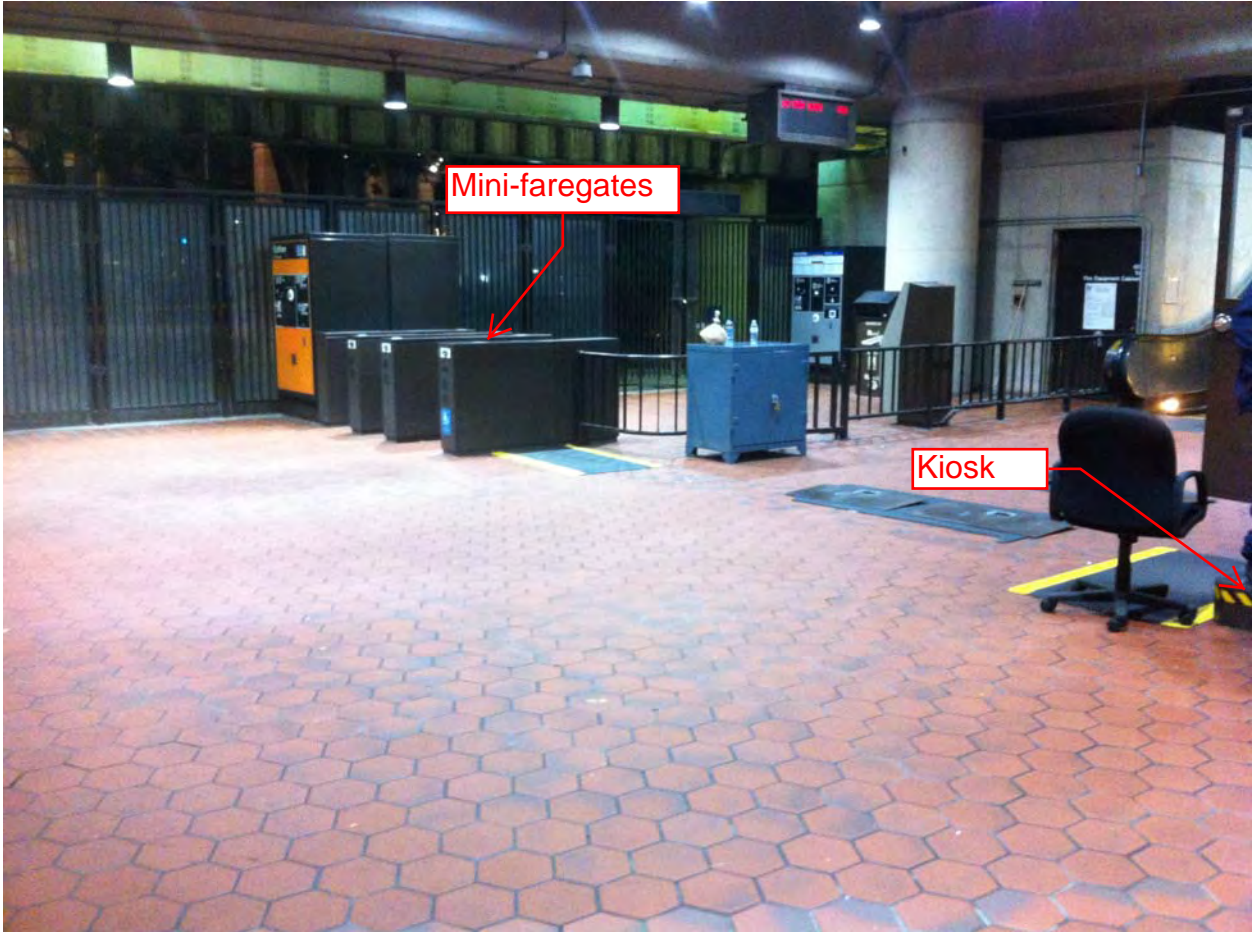
Photo #3 – Mini-faregates on mezzanine floor

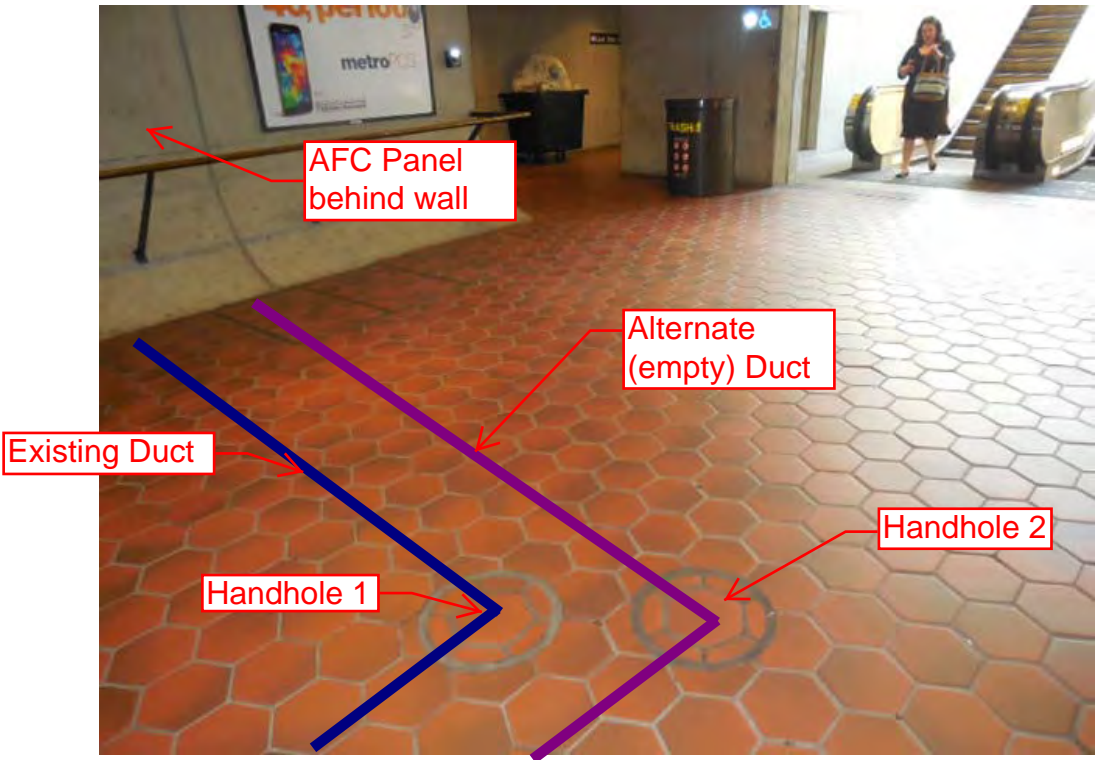
Photo #3: B11 Glenmont – Existing and Alternate Duct Runs from Kiosk to AFC Panel in Room #103, including hand hole locations.

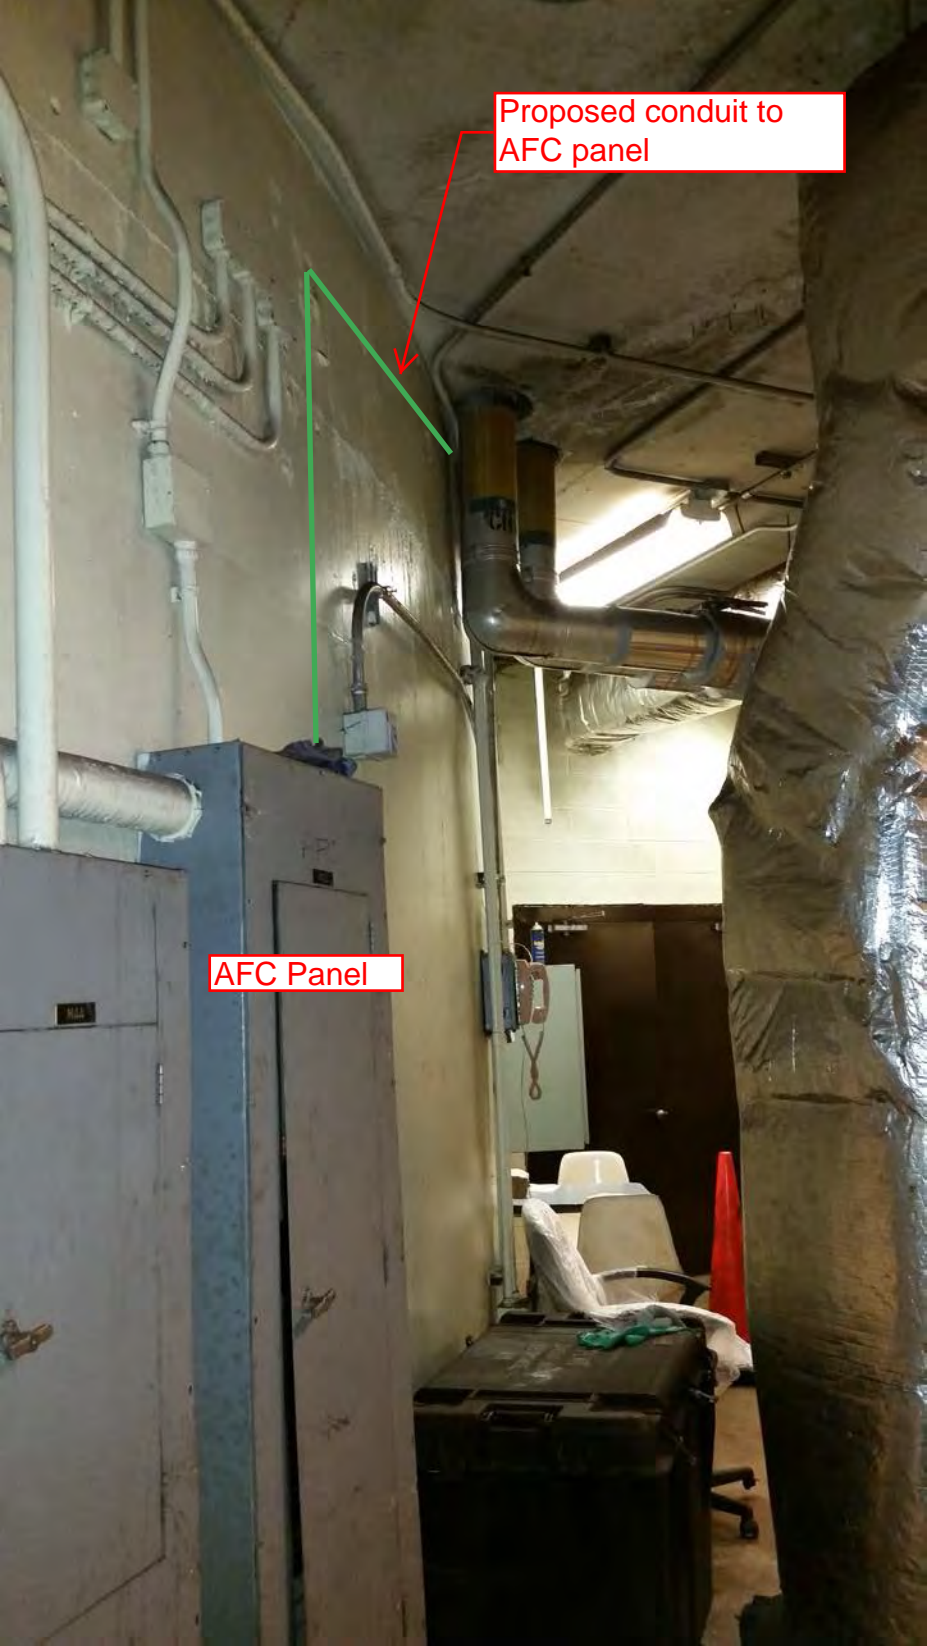
Photo #6: Proposed conduit run to AFC panel

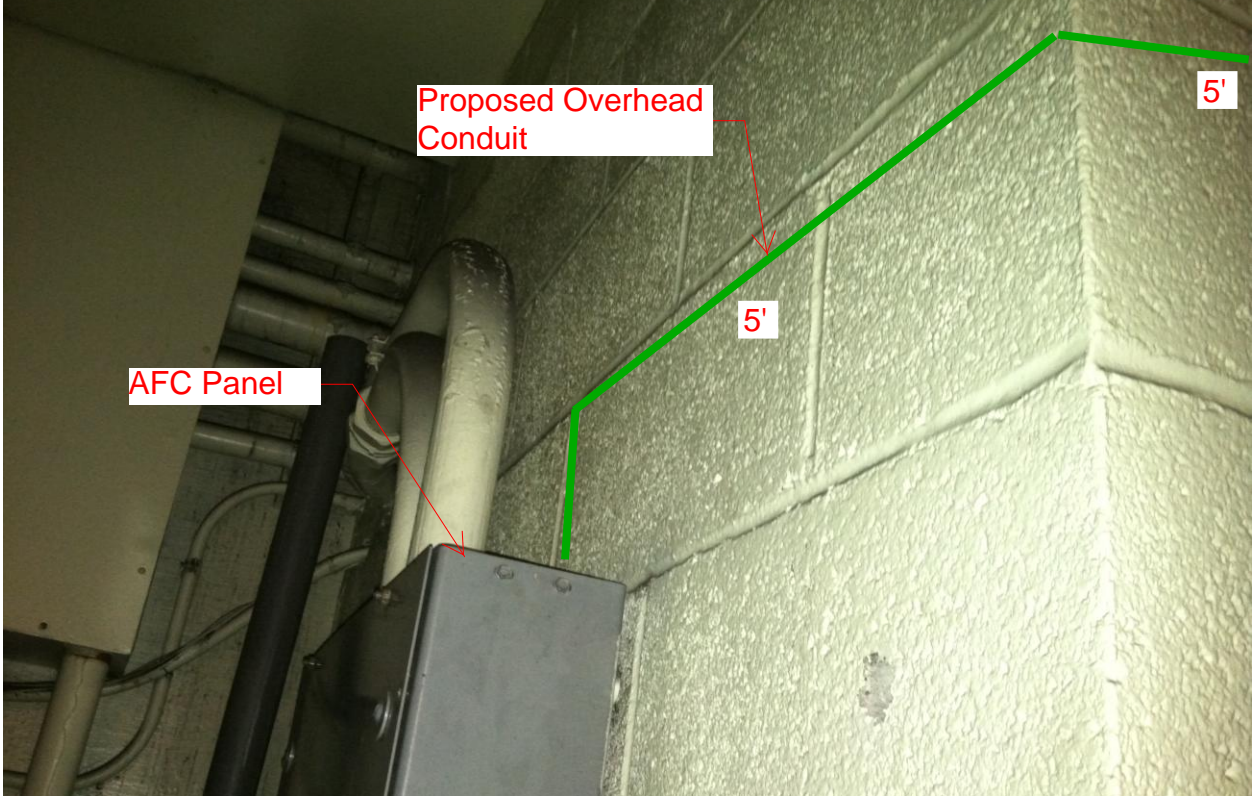
Photo #12: Proposed Overhead Conduit feeding AFC Panel in Room W202.

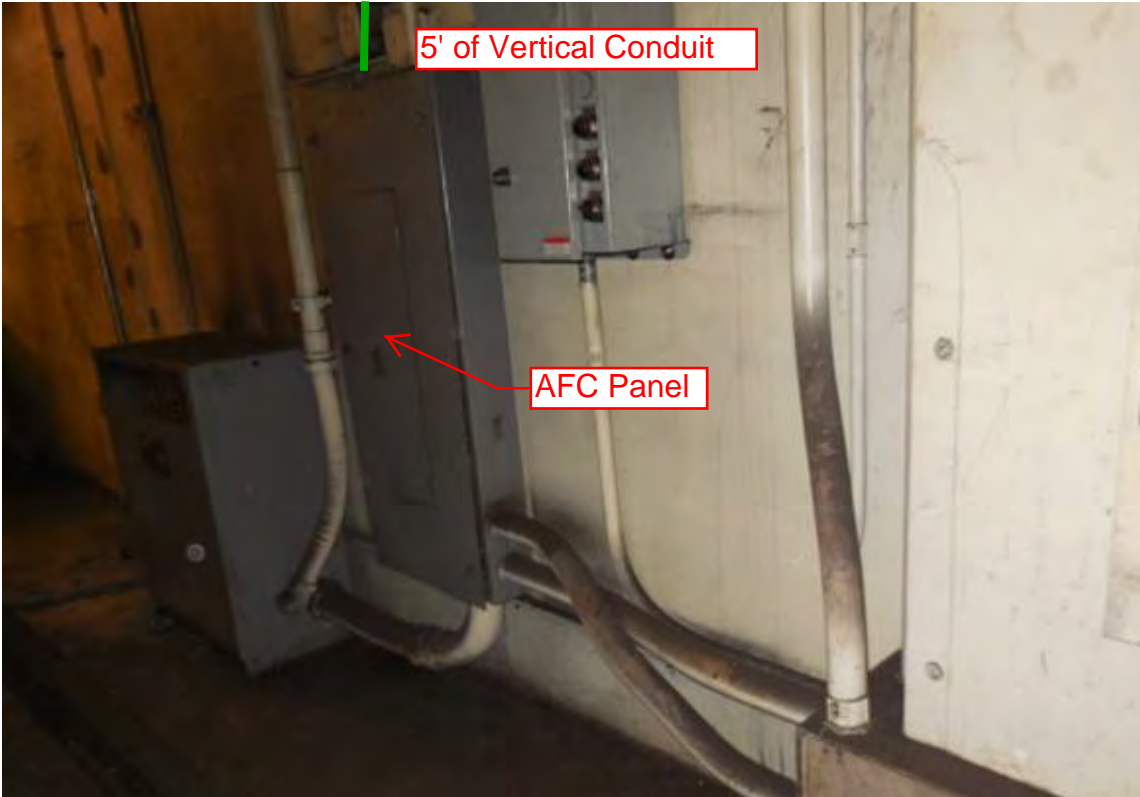
Photo # 10 – Proposed Conduit Run in Room 205

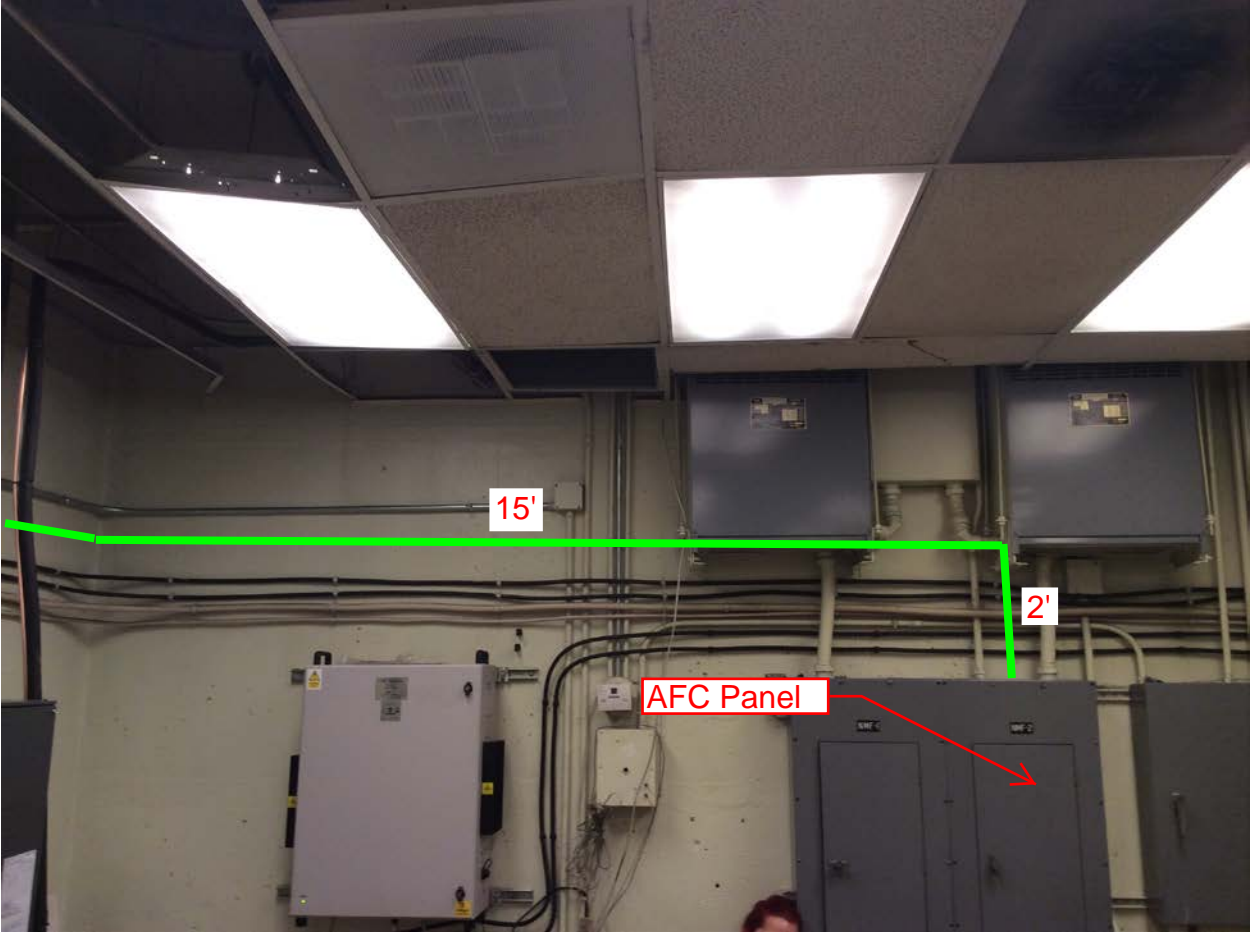
Photo #7 - Proposed conduit run connecting to AFC Panel inside Mechanical Room 214

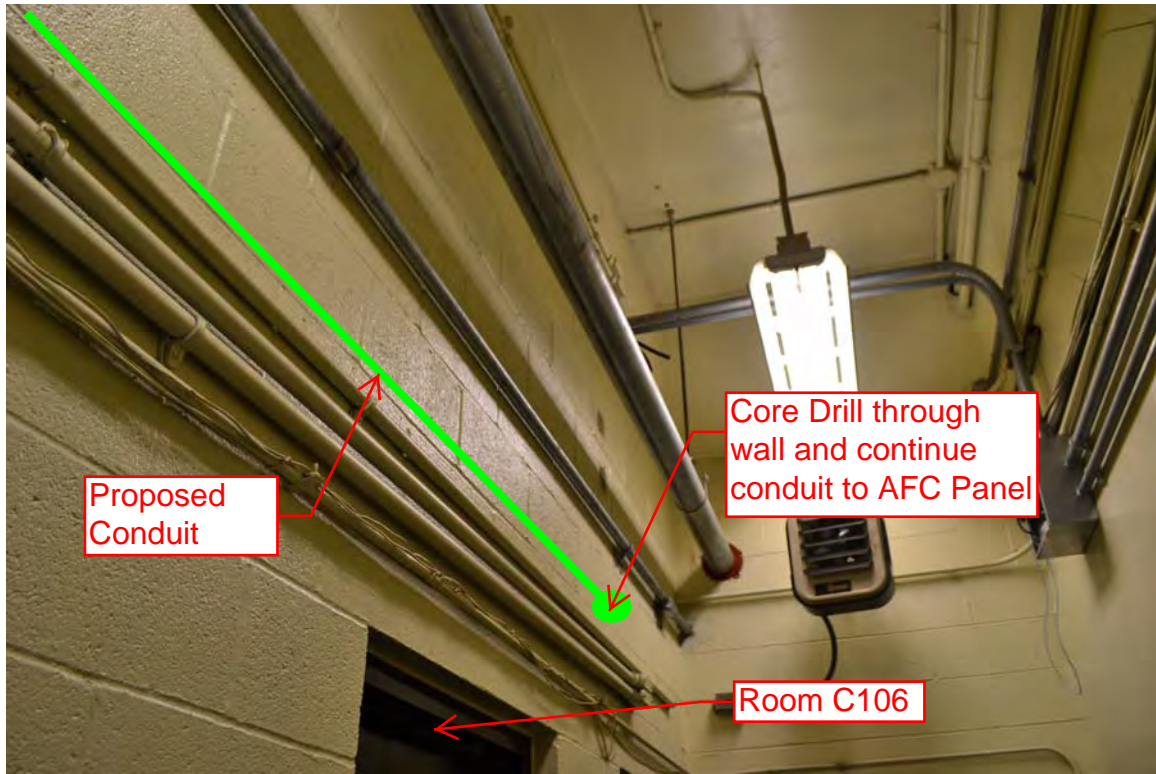
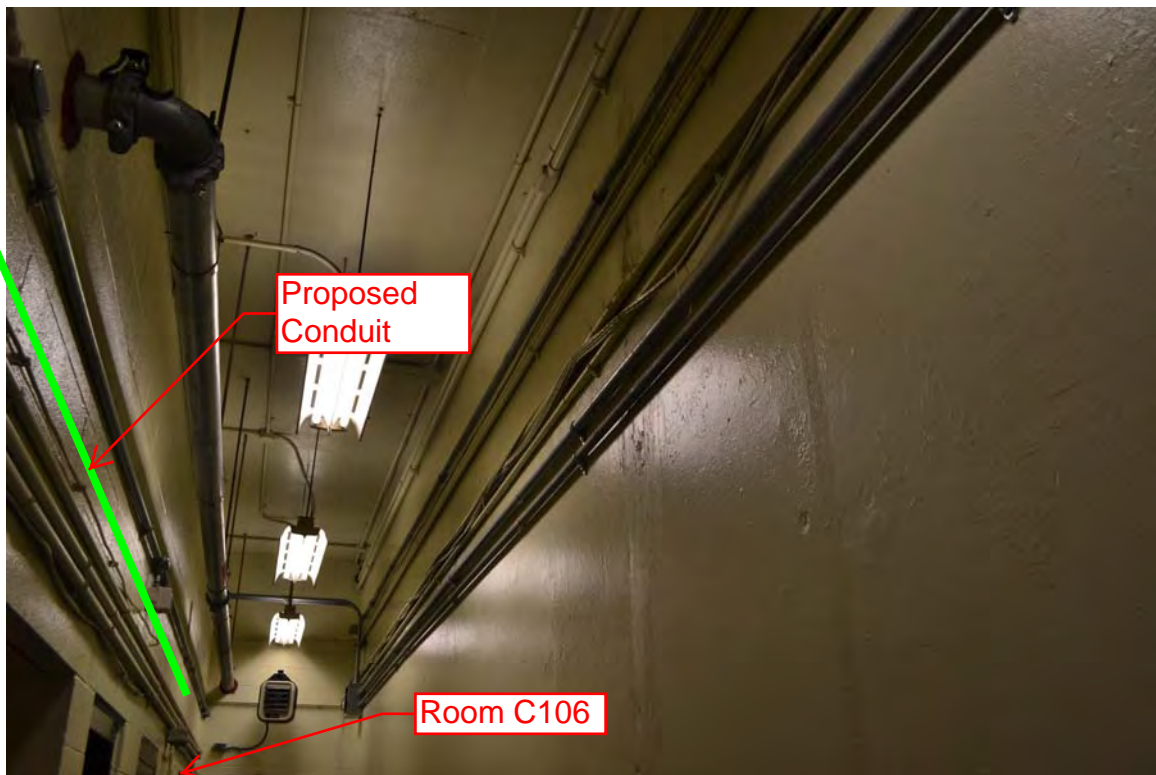
Photo #7 - Proposed conduit along hallway leading to Electrical Equipment Room C106
