Invitation For Bid

Electrical and Data Cable Installation

Project Name: 15-NEPP-01 In-Floor Duct Inspections
Task: Mezzanine Inspection Reports
Date of Inspection: August 22, 2014
Mezzanine Inspected: A01 - Metro Center East
Report Includes:
- Mezzanine Inspection Checklist
- Field Photos
- Existing AFC Installation Plan with field notes

Mezzanine Inspection Report (Scoping)

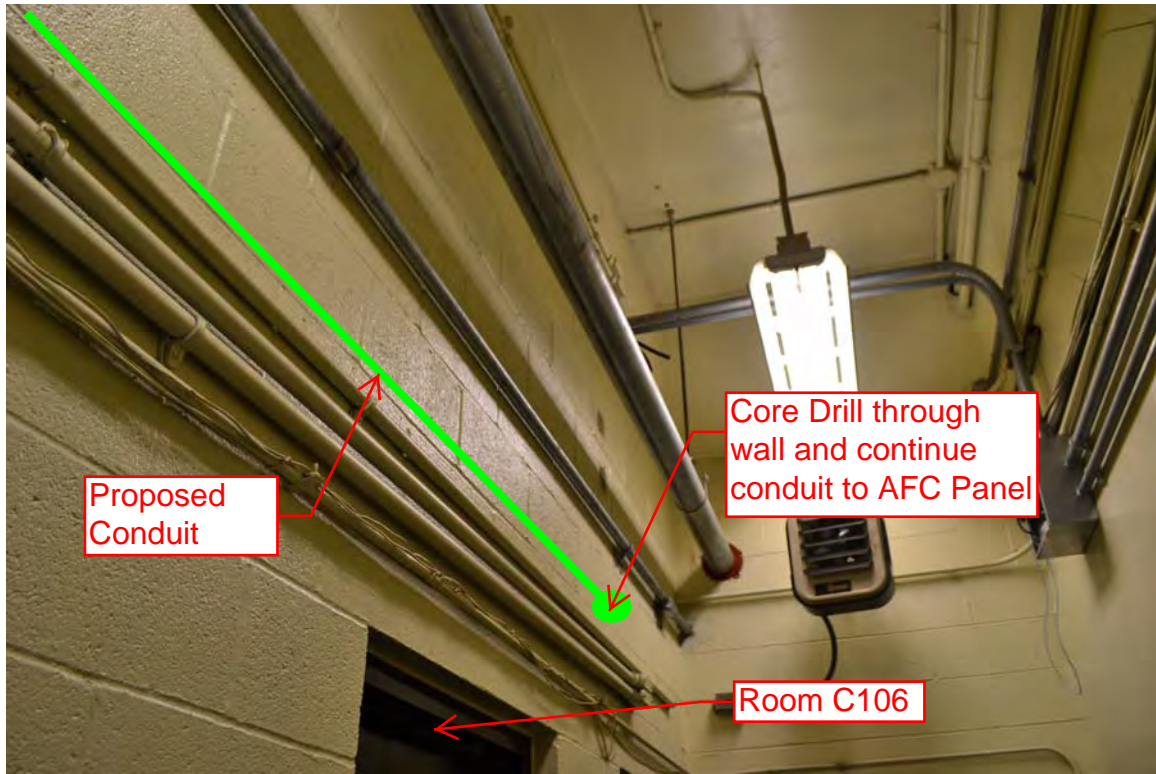
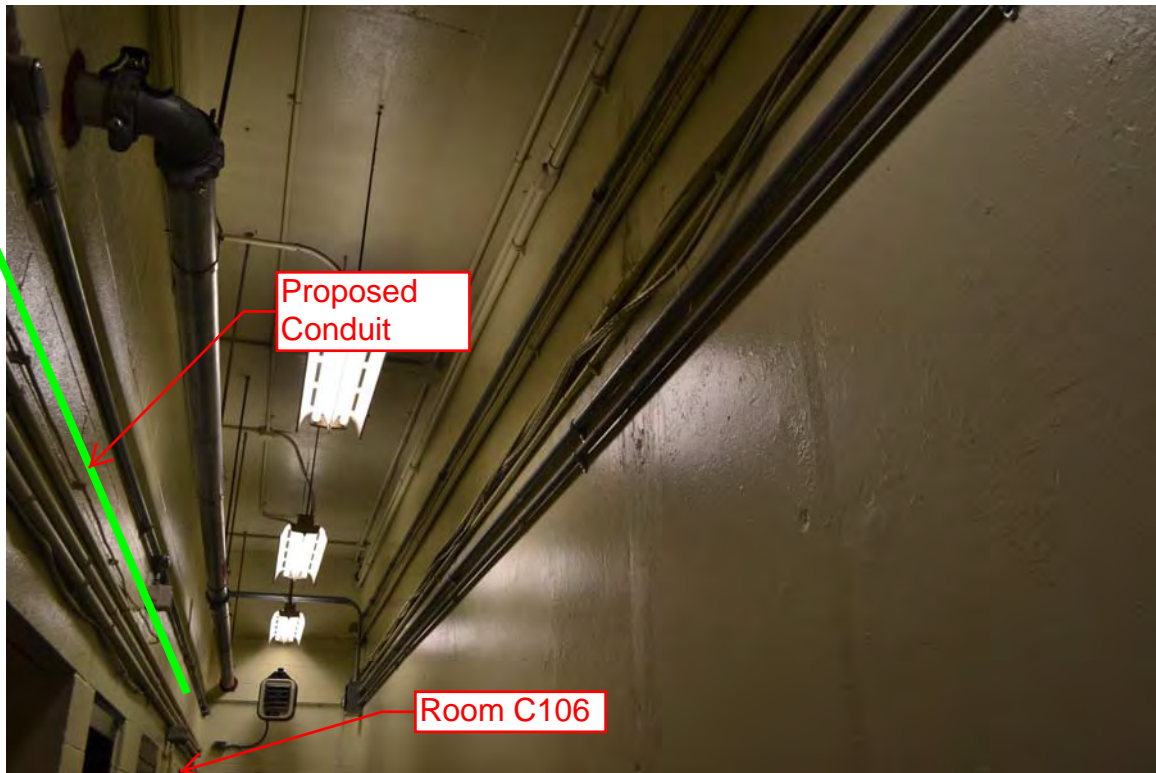
Photo #7 - Proposed conduit along hallway leading to Electrical Equipment Room C106

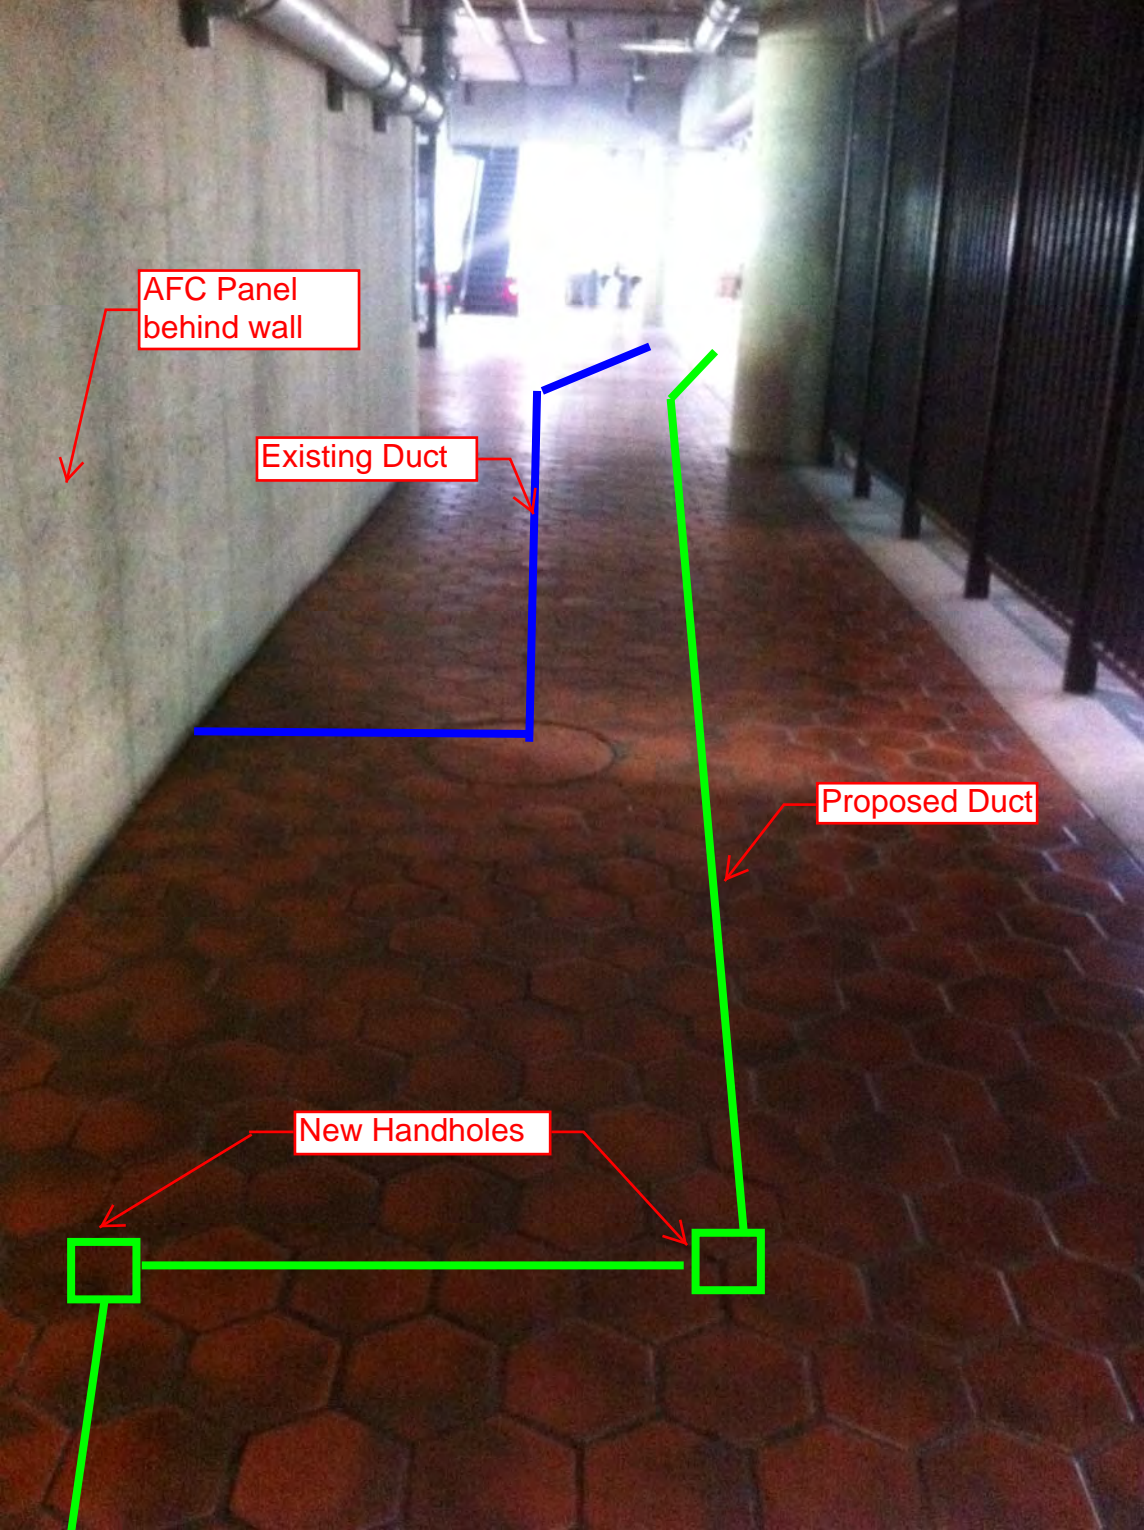
Photo# 2: B06 Fort Totten – Existing and proposed duct runs near AFC Panel

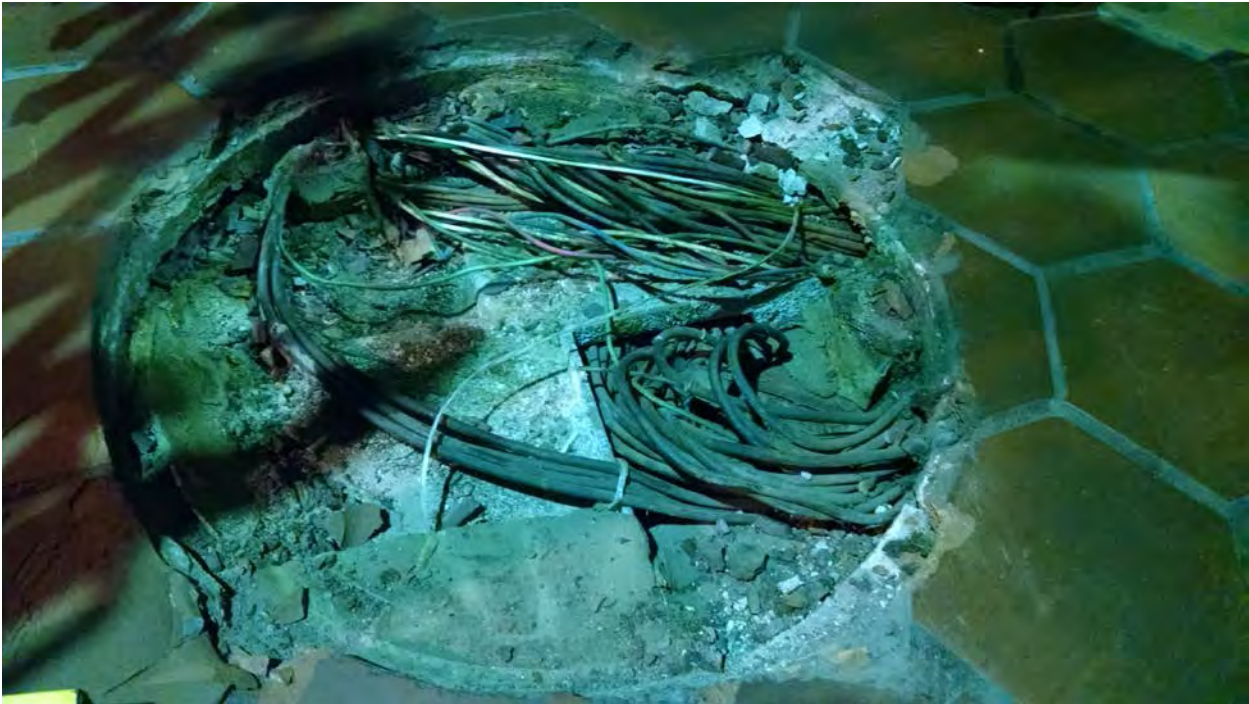
Photo #3: B06 Fort Totten – Poor condition of Handhole on mezzanine floor

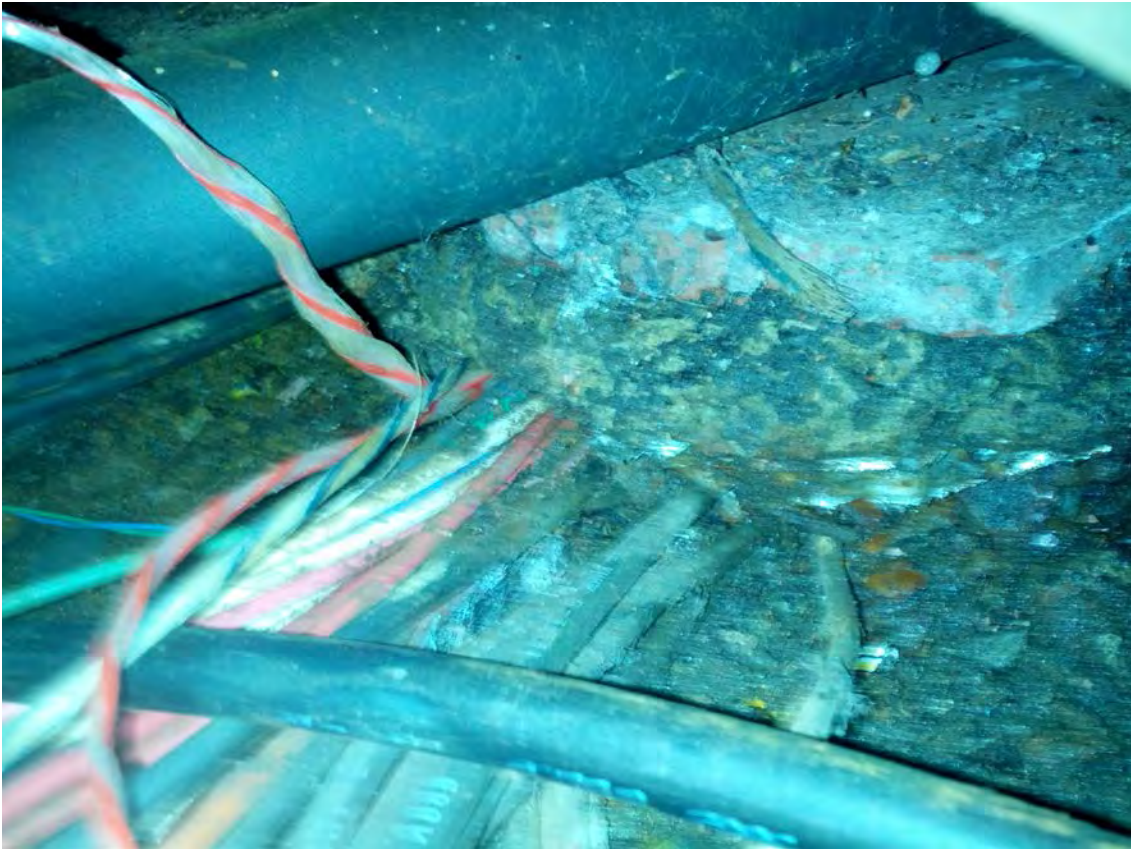
Photo #4: B06 Fort Totten – Pull string installed in power duct run from handhole to kiosk

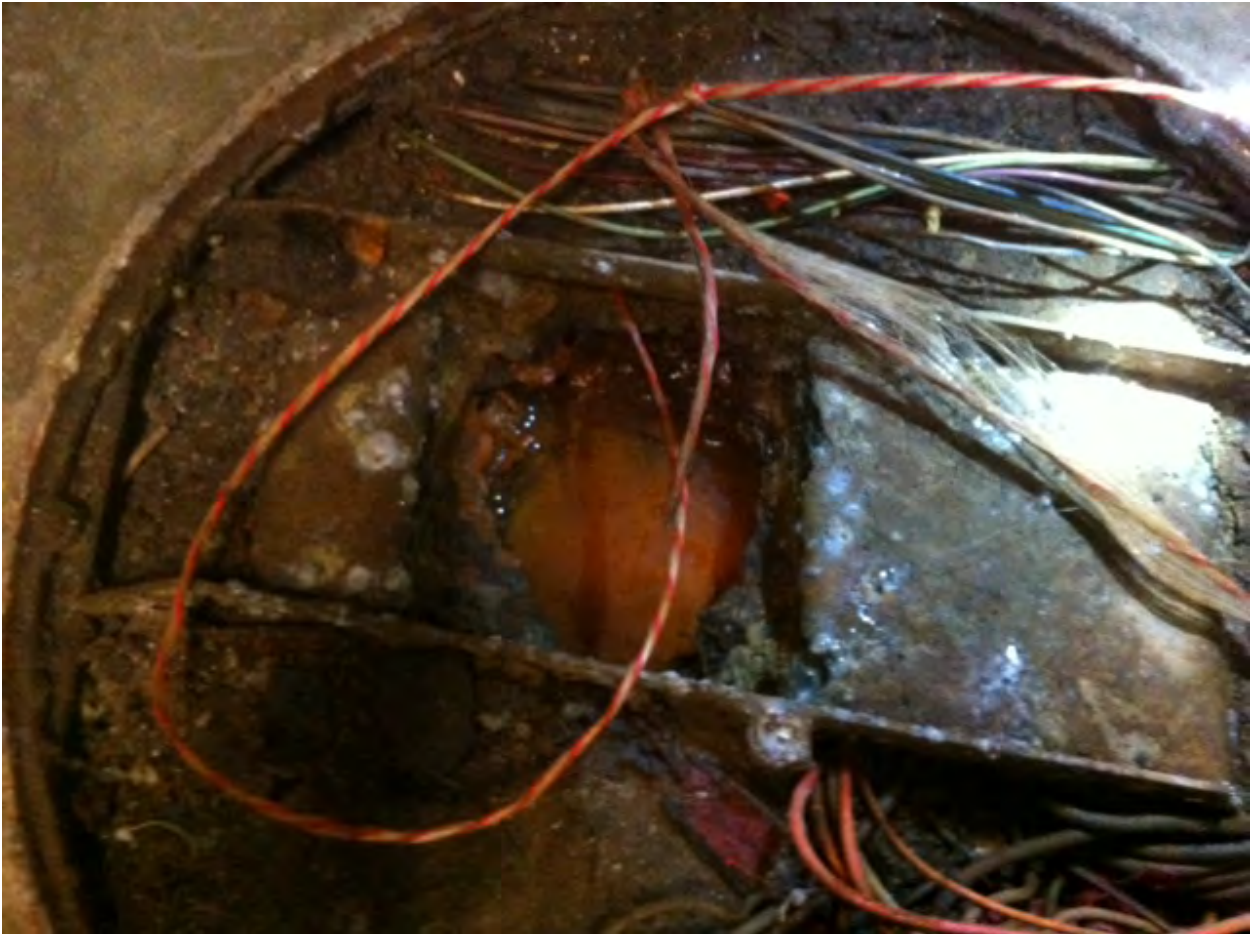
Photo 5: B07 Takoma – Standing water in first handhole

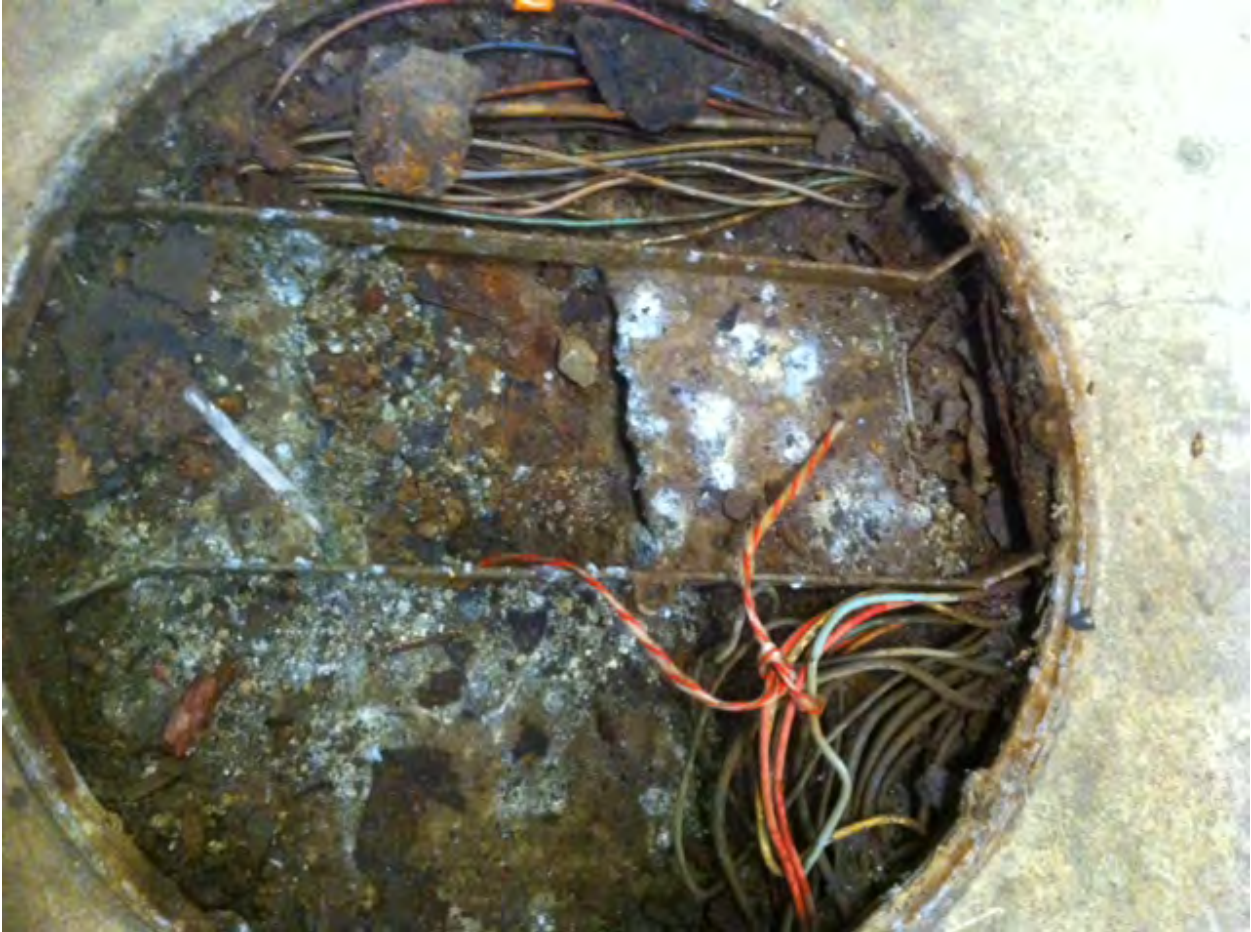
Photo #6: B07 Takoma – Poor conditions in second handhole

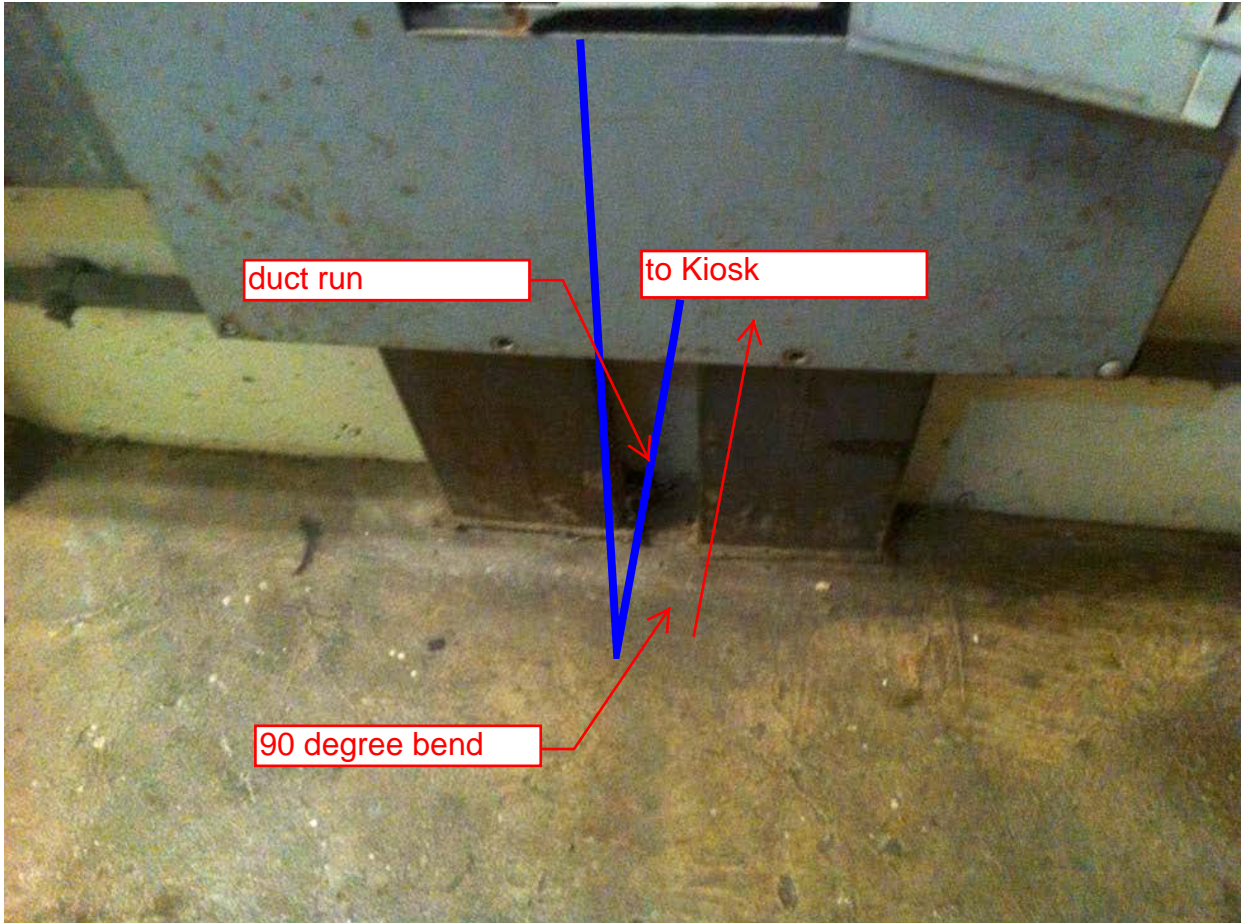
Photo #2 – B08 Silver Spring North: Duct run into AFC Panel

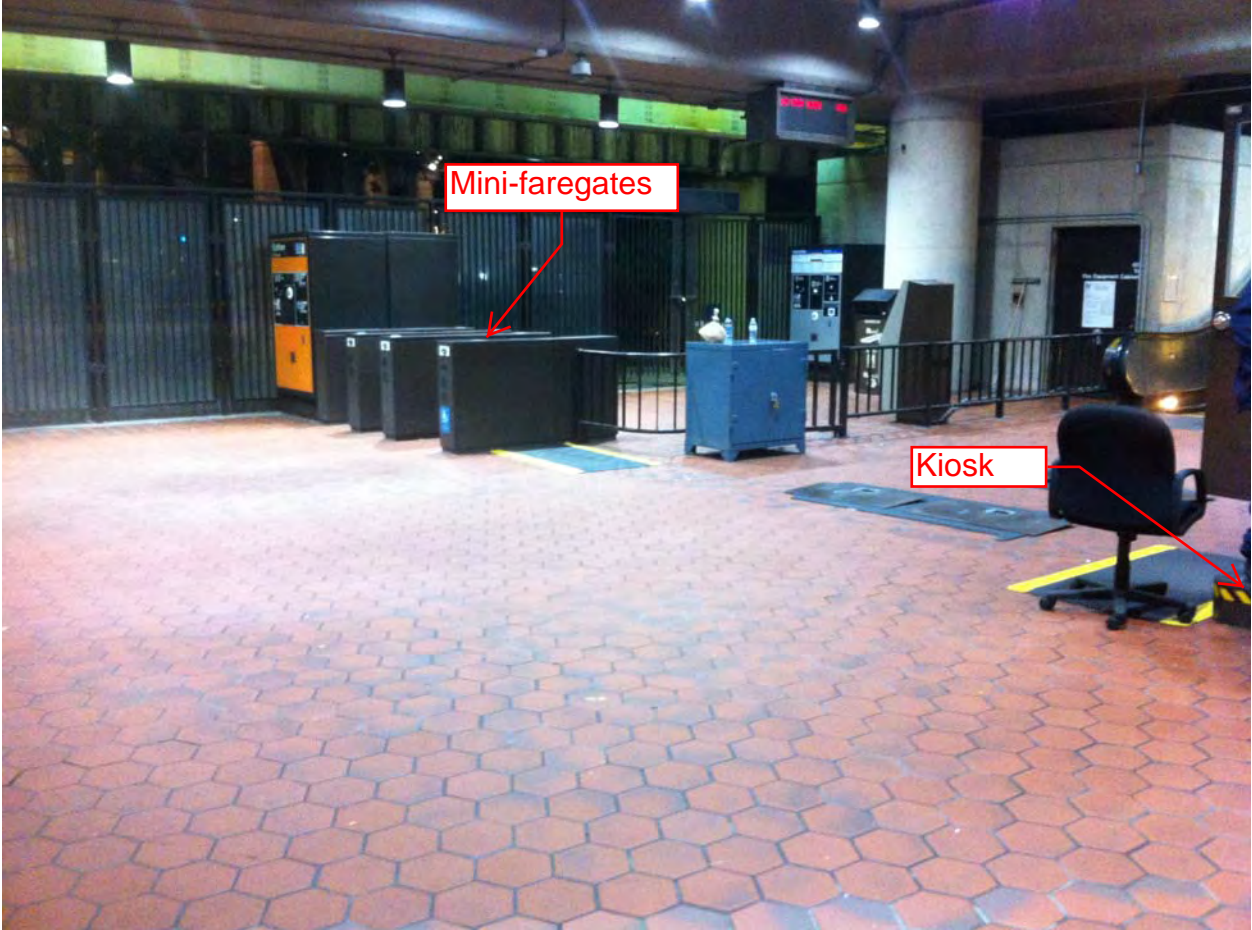
Photo #3 – Mini-faregates on mezzanine floor
