**Asset Management Plan
WMATA Parking Garages
Volume 1 of 3
February 2015
Walker Restoration Consultants**

ASSET MANAGEMENT PLAN

WASHINGTON AREA
METROPOLITAN TRANSIT
AUTHORITY PARKING GARAGES

FEBRUARY, 2015
VOLUME 1 OF 3

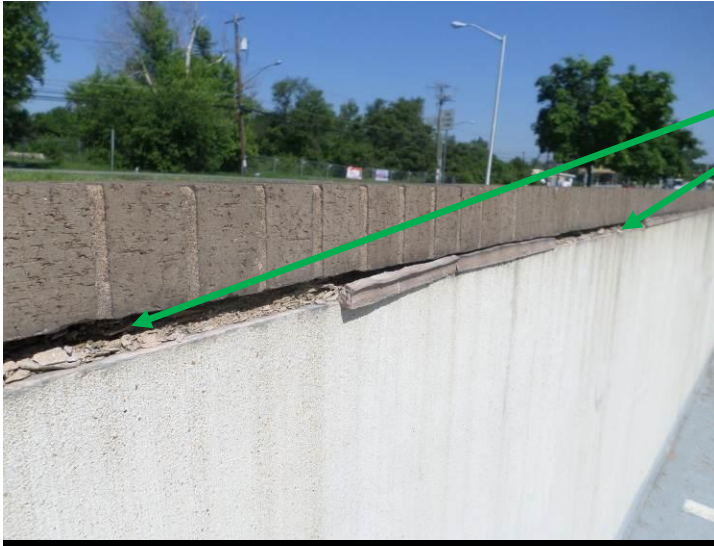
Photo 10

Deteriorated sealant at mortar joint in concrete spandrel.

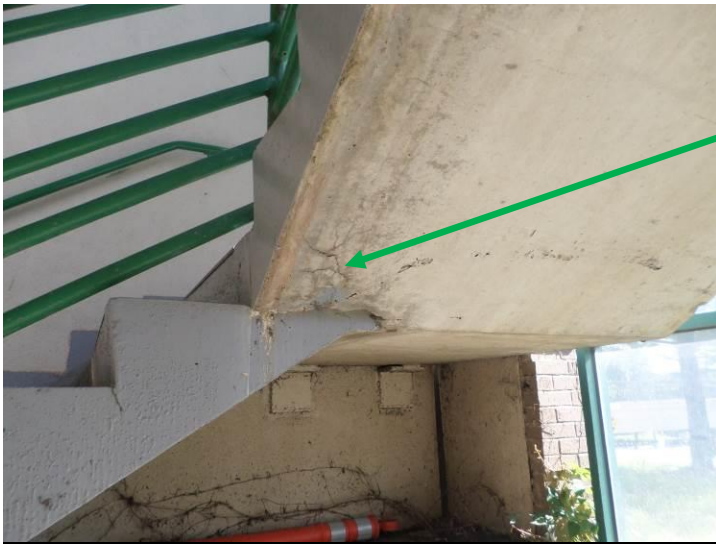
Photo 15

Cracking and spalls underneath stairs.

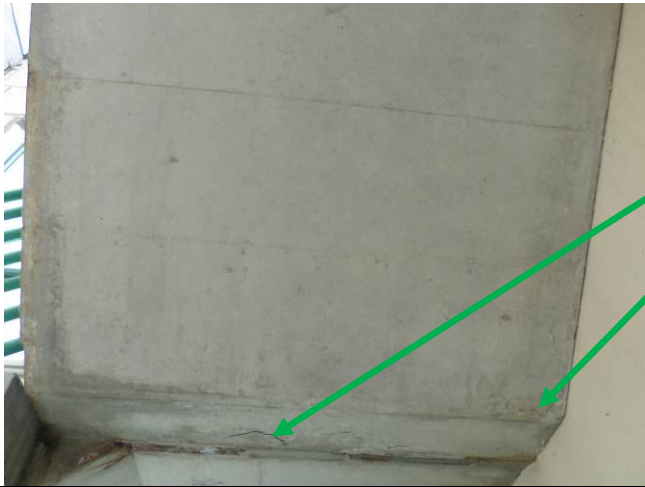
Photo 16

Spalls underneath stairs.

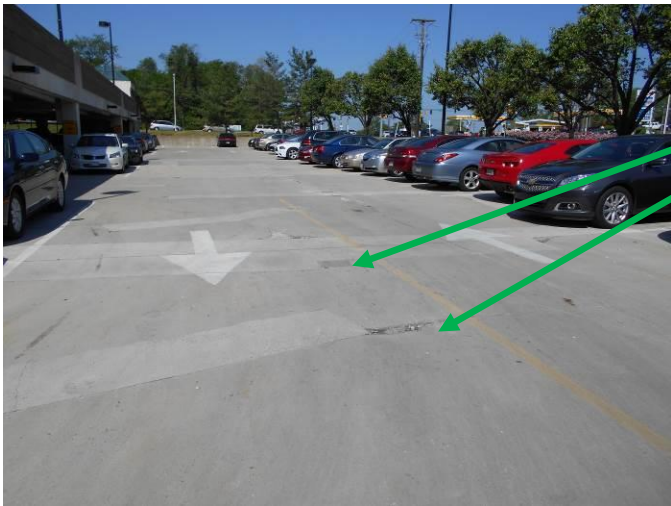
Photo 18

Slab on grade pavement is heavily spalled.

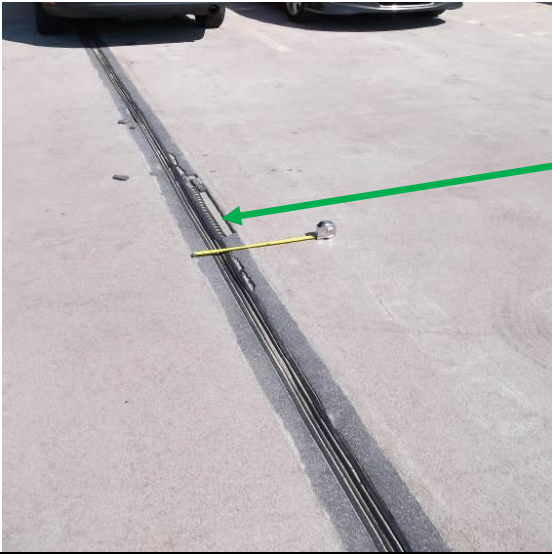
Photo 1

Deteriorated expansion joint gland and header at roof level.

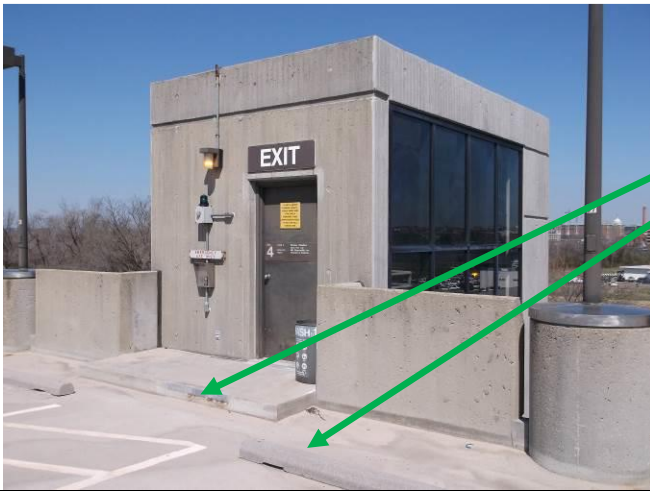
Photo 2

Unpainted curb and wheel stops along pedestrian path. Curbs are recommended to be painted yellow.

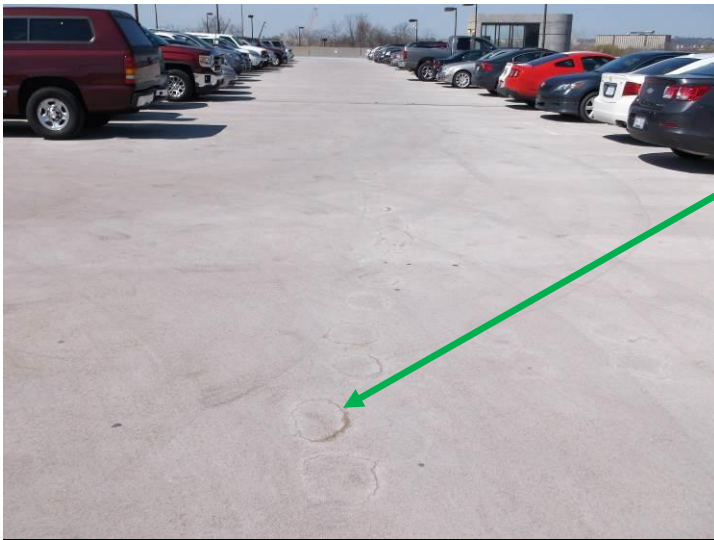
Photo 3

Localized infrequent spalls on top level.

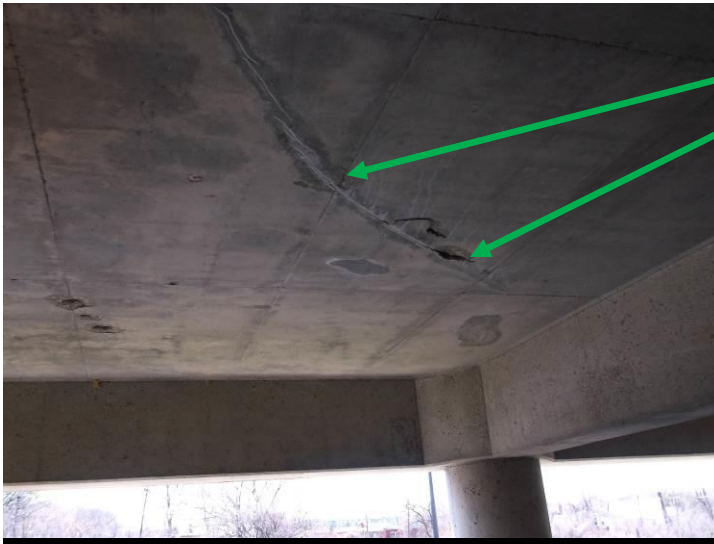
Photo 4

Leaching and spalls in soffit.

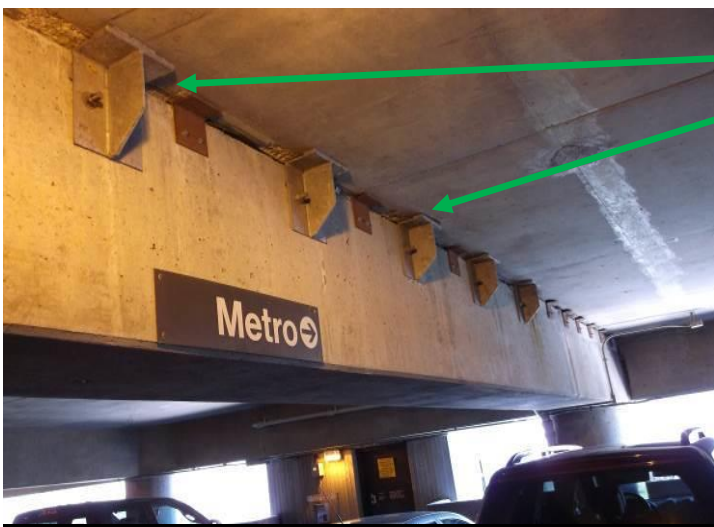
Photo 5

Previous repair at expansion joint soffit.

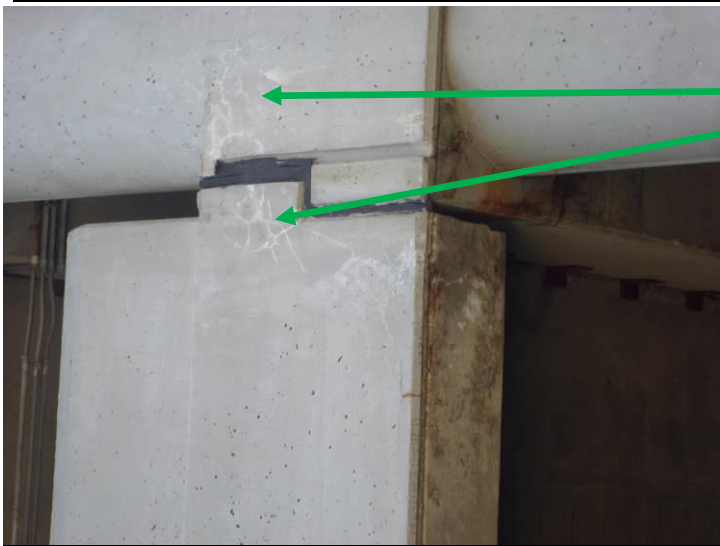
Photo 6

Cracking and leaching at beam /column connection.

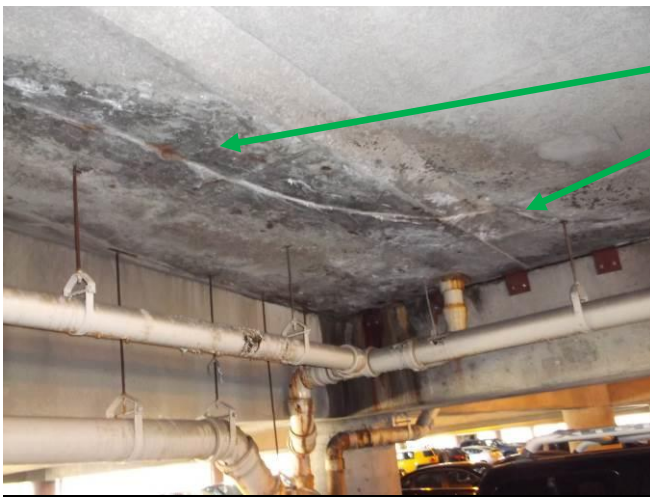
Photo 8

Spalling, moisture staining and efflorescence under concrete trench drain shown in Photo 7.

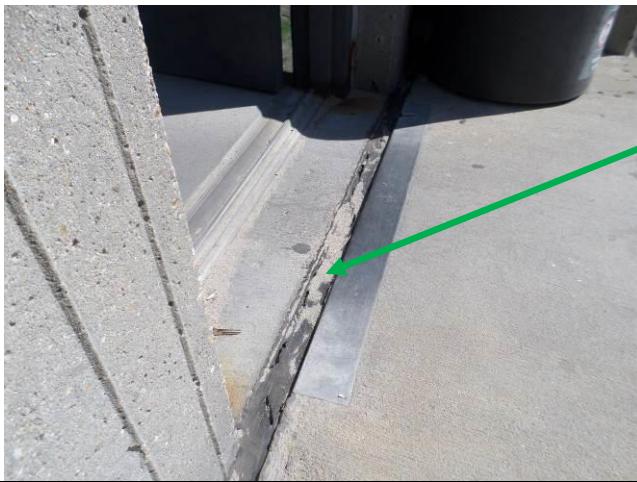
Photo 11

Deteriorated expansion joint at stair towers.

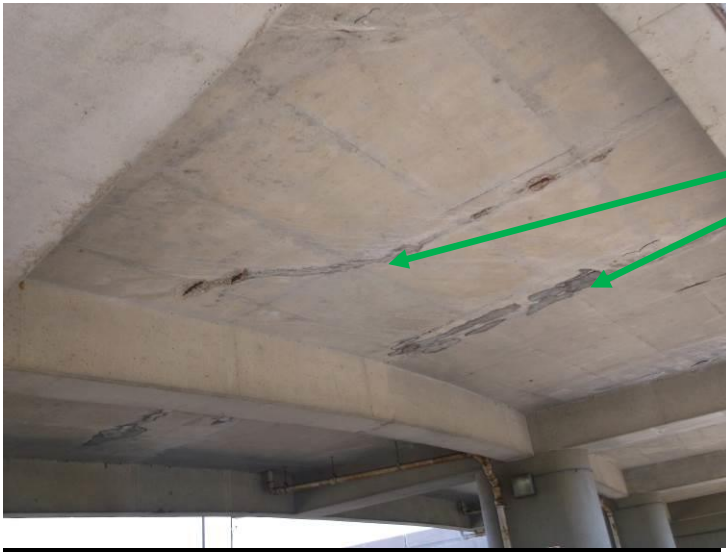
Photo 13

Cracking, leaching and spalls on underside of bridge over entrance drive and parking area.

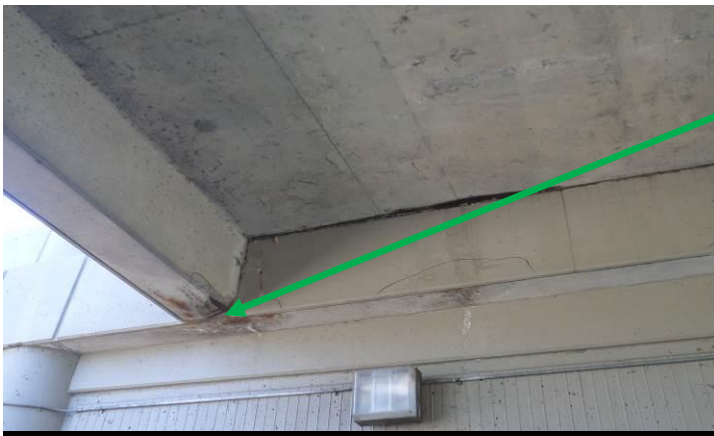
Photo 14

Spall with exposed reinforcing at beam connection at expansion joint.

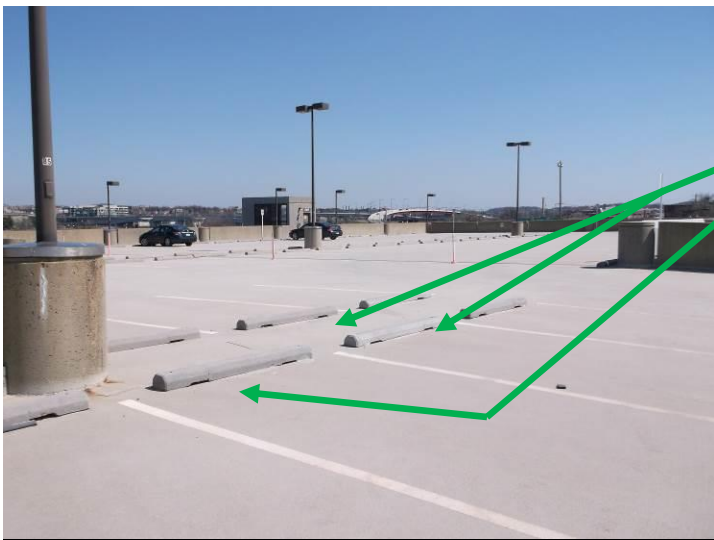
Photo 15

Unpainted wheel stops in pedestrian and vehicular paths. Wheel stops are recommended to be painted yellow or removed.

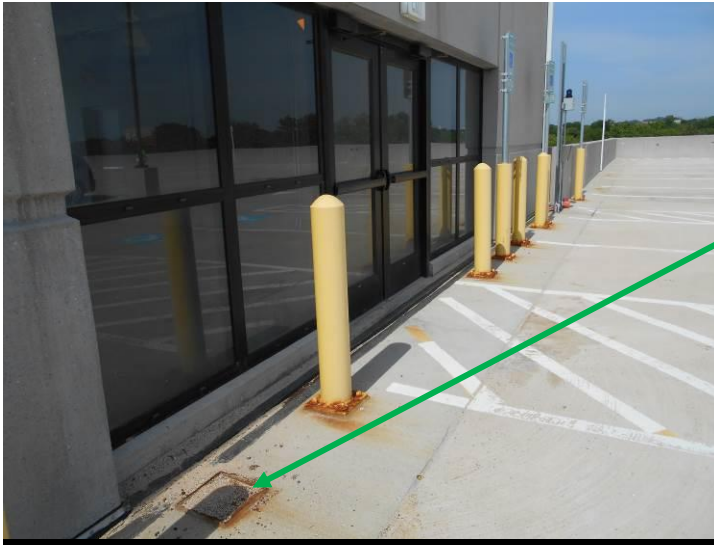
Photo 1

Missing Bollard at stair tower.

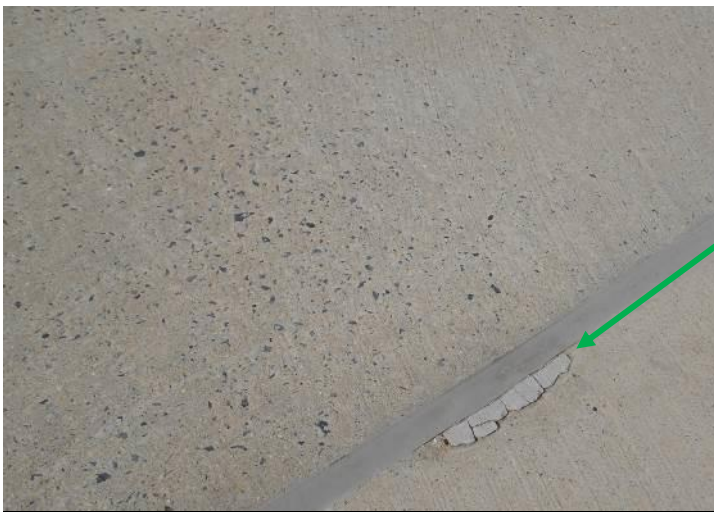
Photo 3

Typical cracked concrete and sealant failure at tee to tee welded connector.

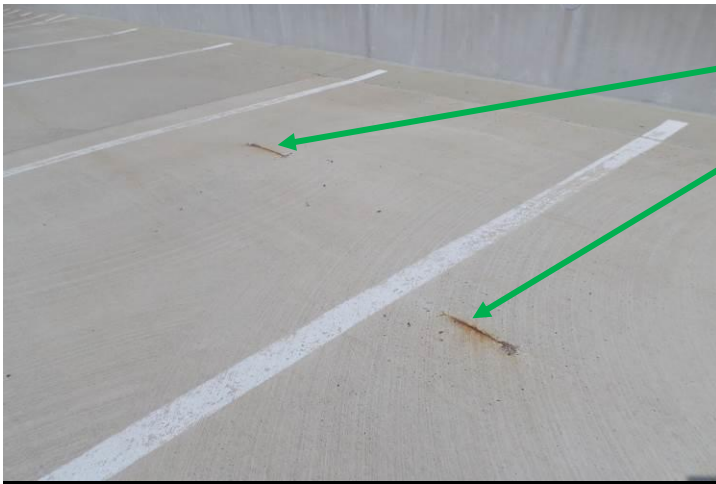
Photo 5

Exposed reinforcing due to inadequate cover in precast tee floor slab.

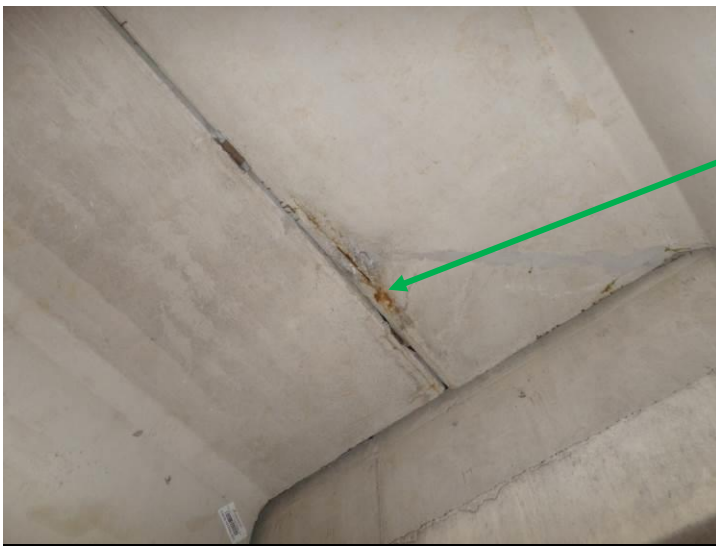
Photo 6

Tee cracked corner flange.

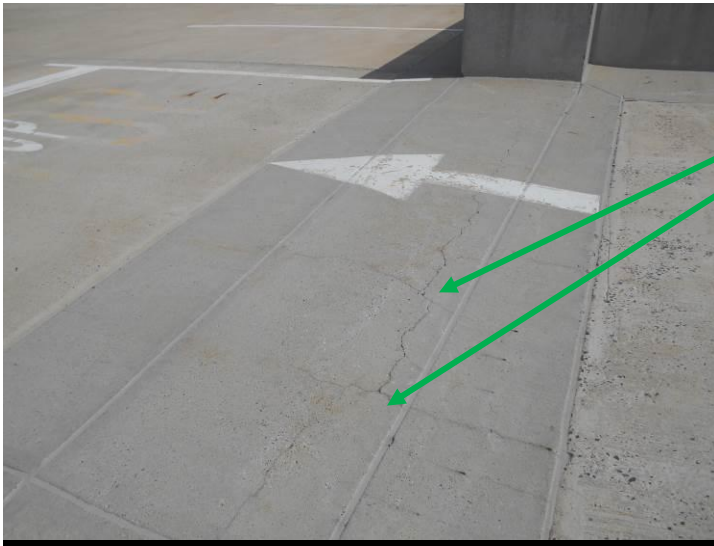
Photo 7

Cracking in wash.

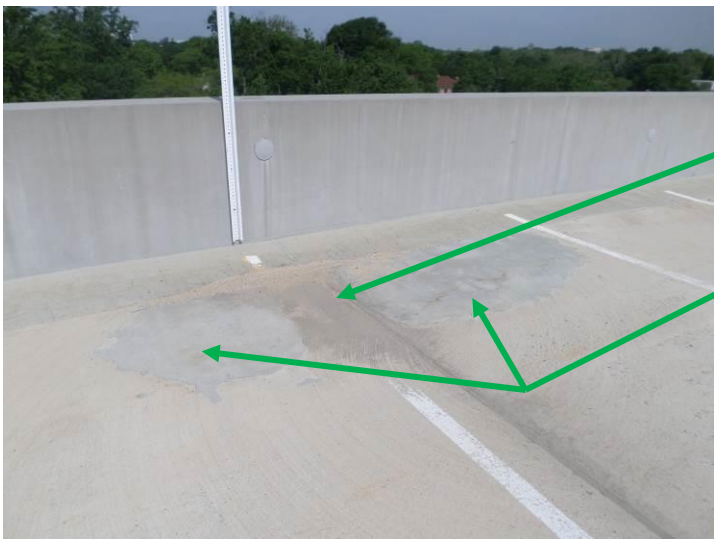
Staining indicates ponding on top level.

Thin cementitious parge coat on tee ends may indicate attempt to alleviate ponding.

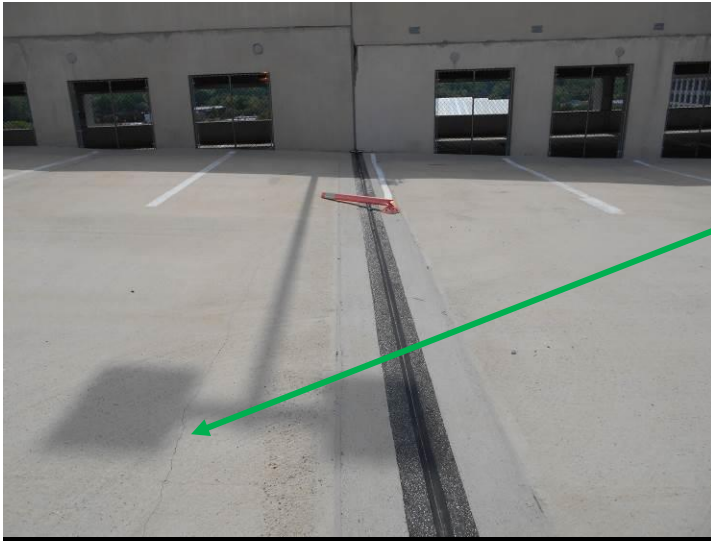
Photo 10

Cracked floor slab above tee stem.

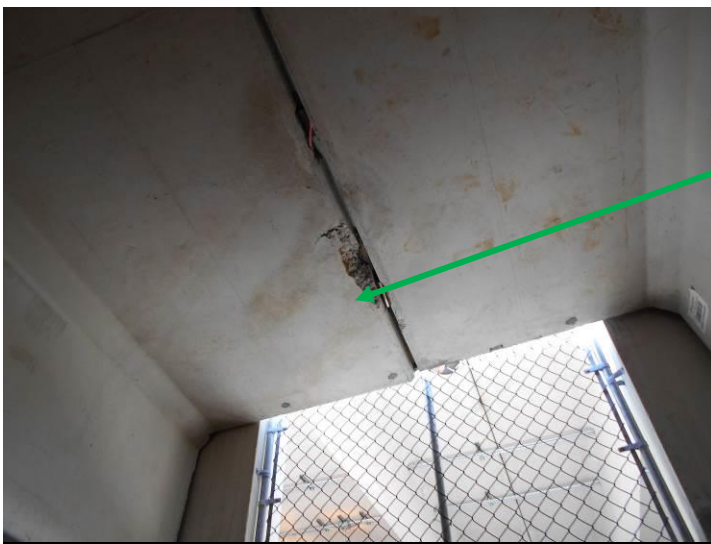
Photo 11

Spalled concrete at the underside of tee to tee joint.

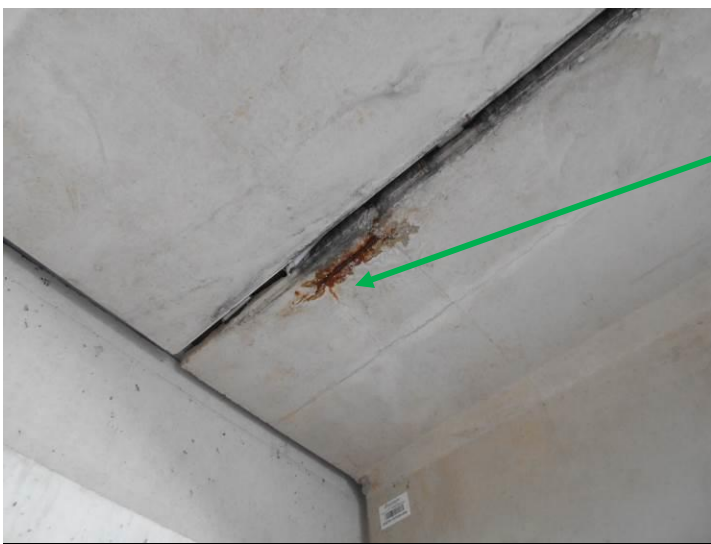
Photo 12

Spalled concrete with exposed reinforcing at tee flange soffit.

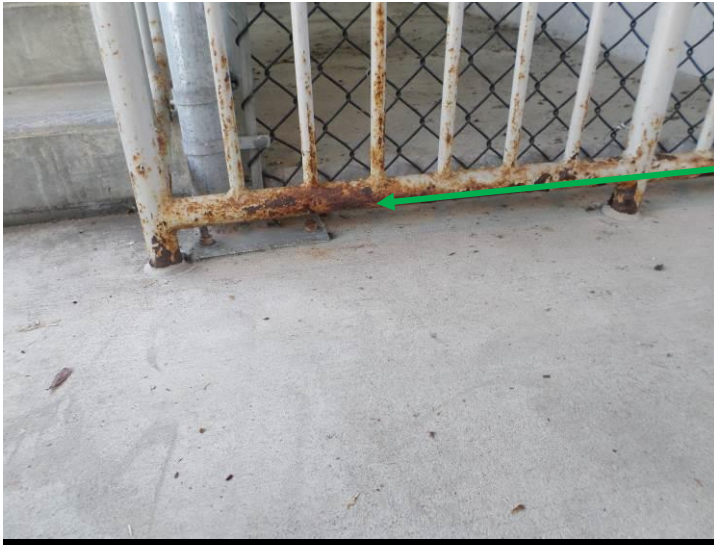
Photo 13

Rusted railing.

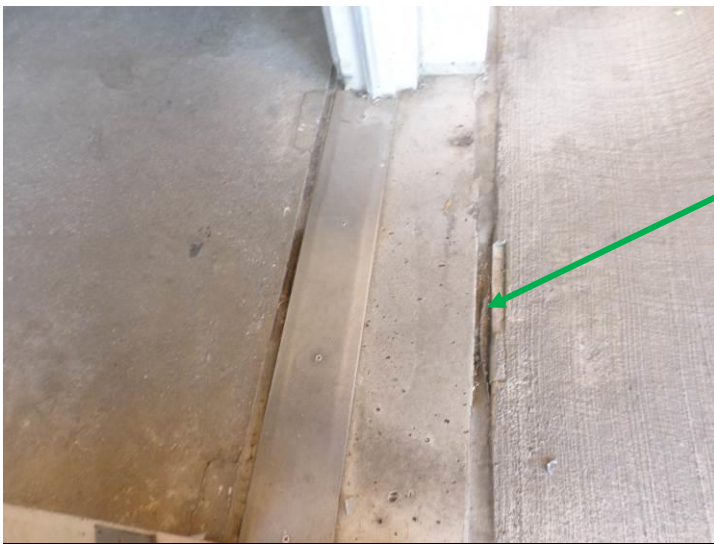
Photo 15

Failing sealant at stair tower floor joint.

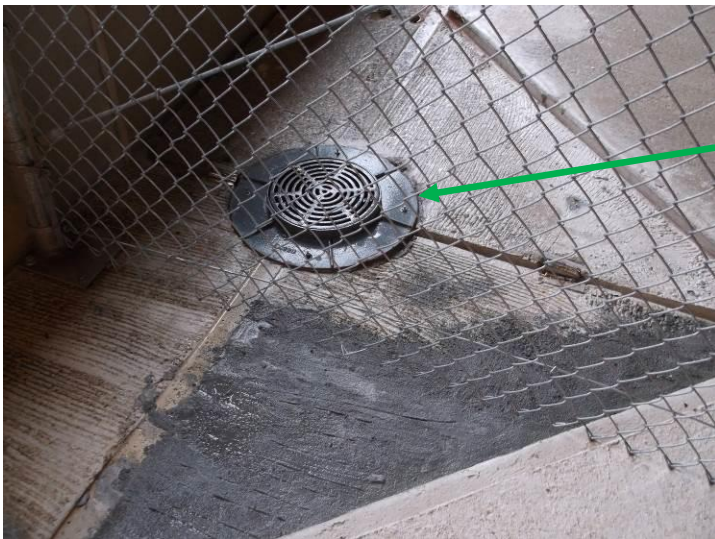
Photo 6

Floor drains not yet cast into wash.

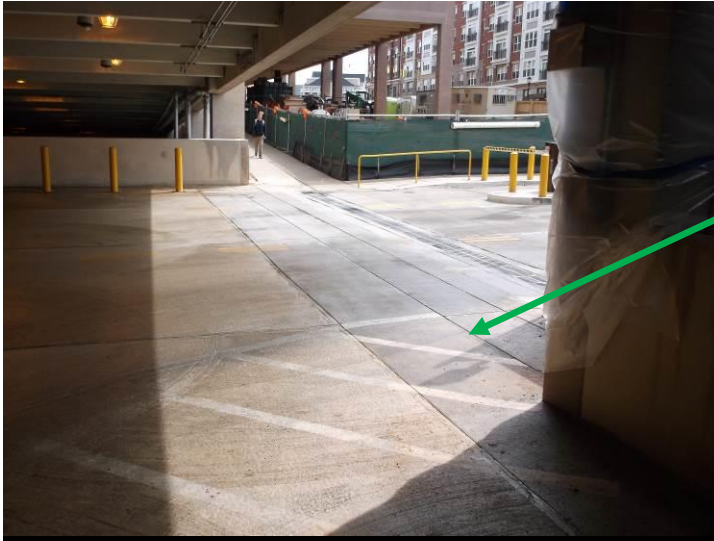
Photo 10

Cracked concrete L-beam and wash at main entrance.

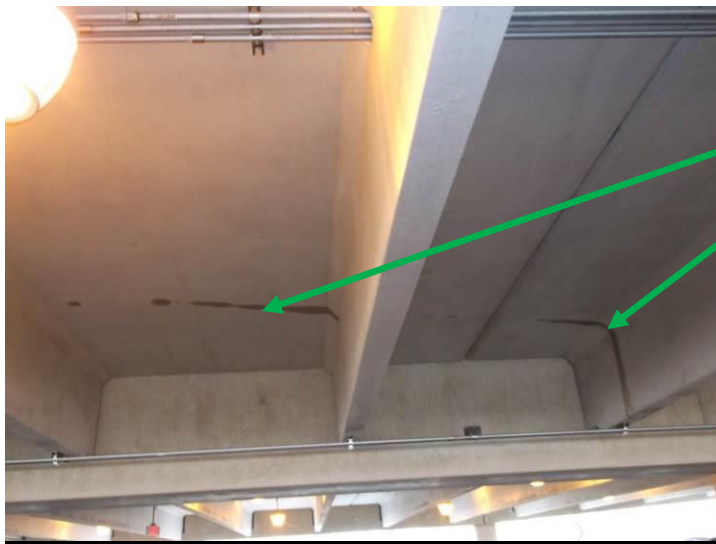
Photo 15

Leaking at cast-in-place wash to tee boundary.

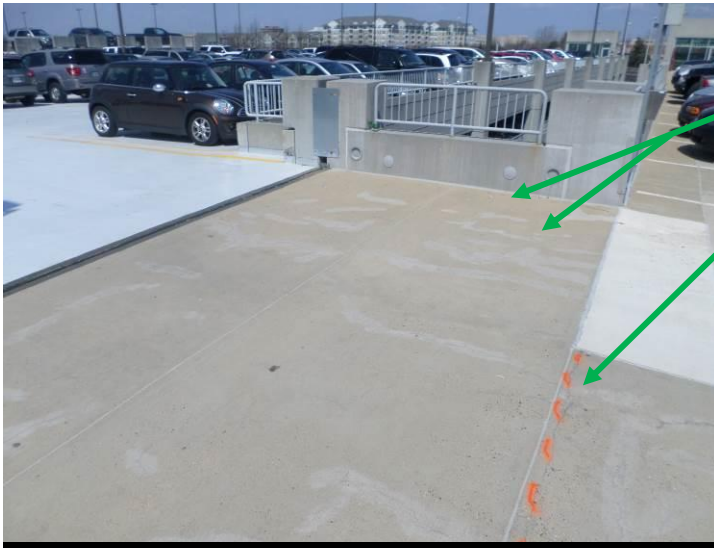
Photo 1

Significant cracking and debonding in cast-in-place topping on bridge between original garage and expansion.

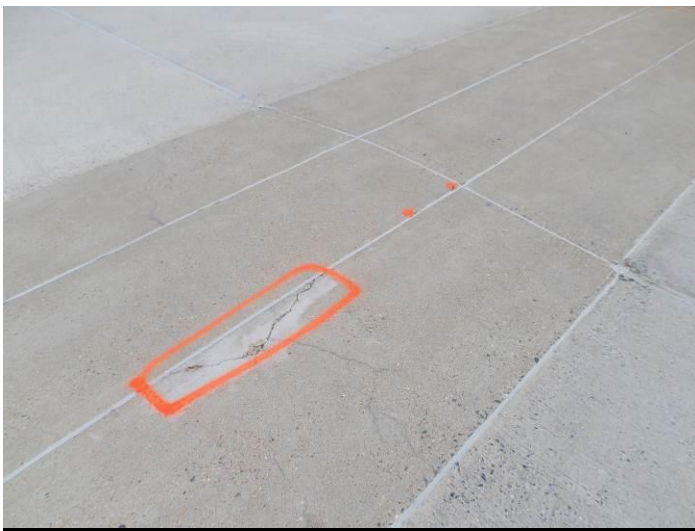
Photo 2

Spall at cast-in-place wash.

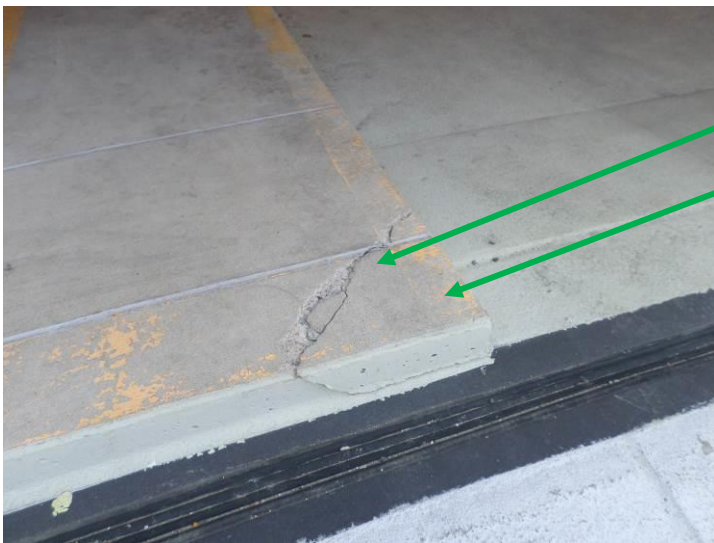
Damaged curb.

Curbs are recommended to be painted yellow.

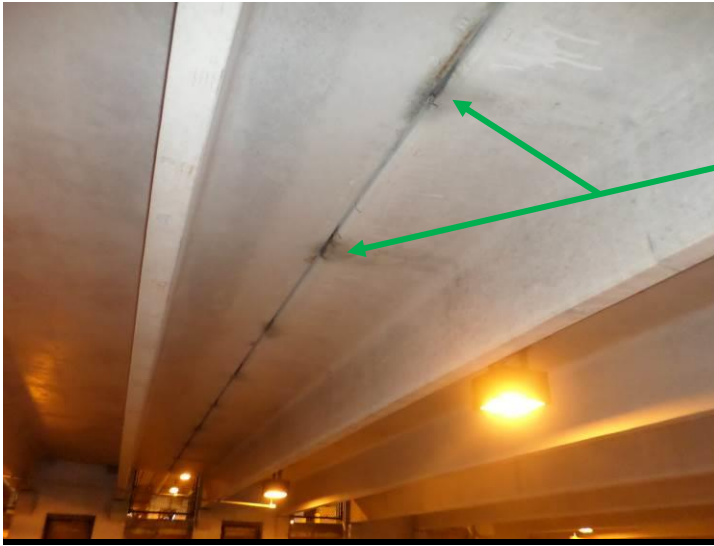
Photo 4

Leaking and rusting at tee to tee connections is typical.

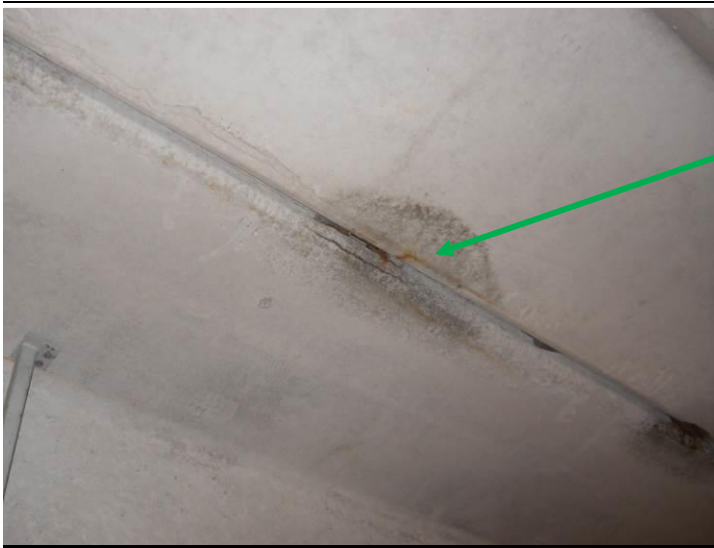
Photo 5

Spall and rust damage in soffit at leaking tee to tee connections.

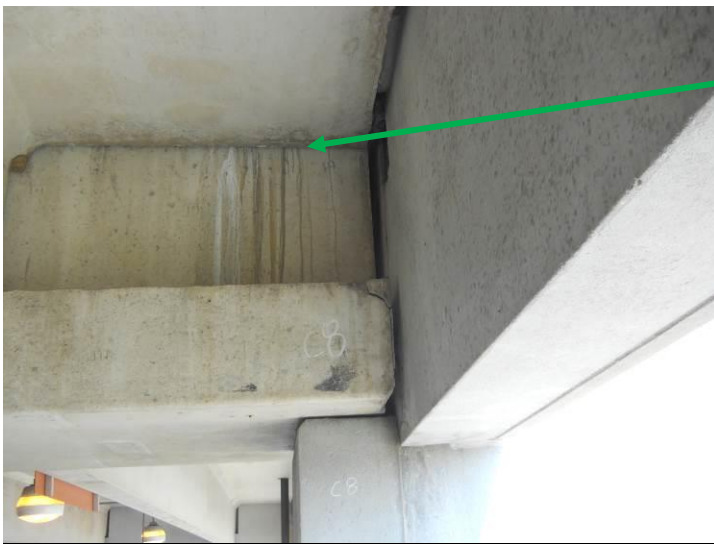
Photo 6

Leaking and leaching through expansion joint.

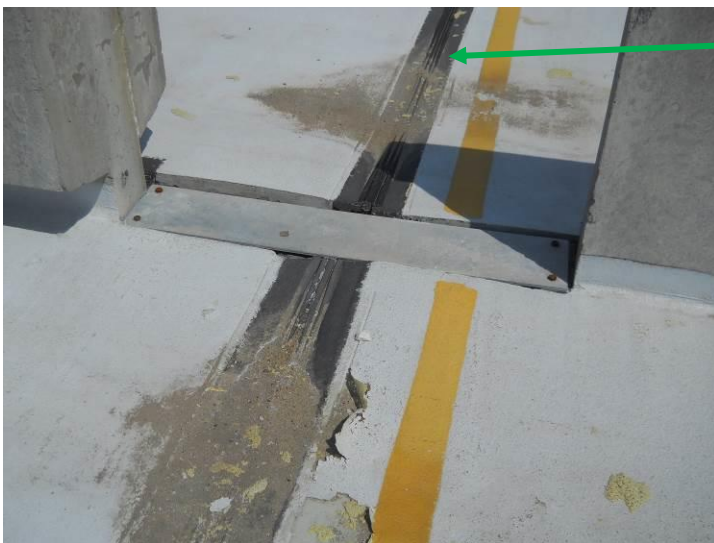
Photo 3

Expansion joint in good condition but should exist in a cruciform joint beneath cover plate.

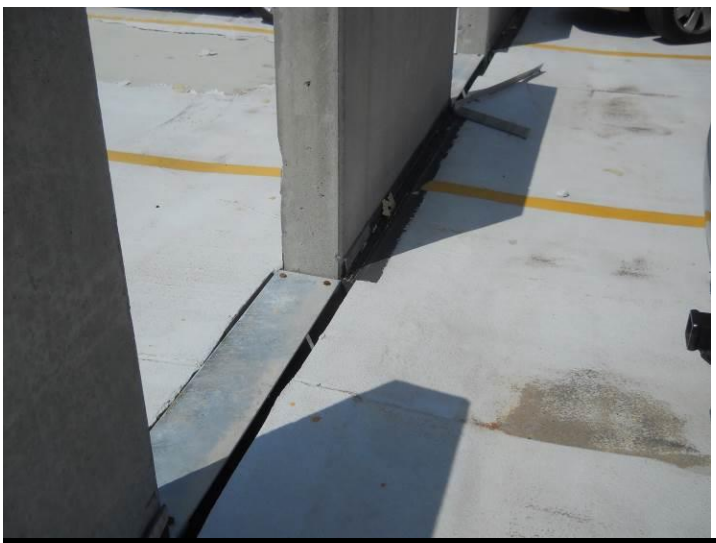
Photo 5

Expansion joint along lightwall interrupted at each lightwall gap and recommended to be continuous at roof level.

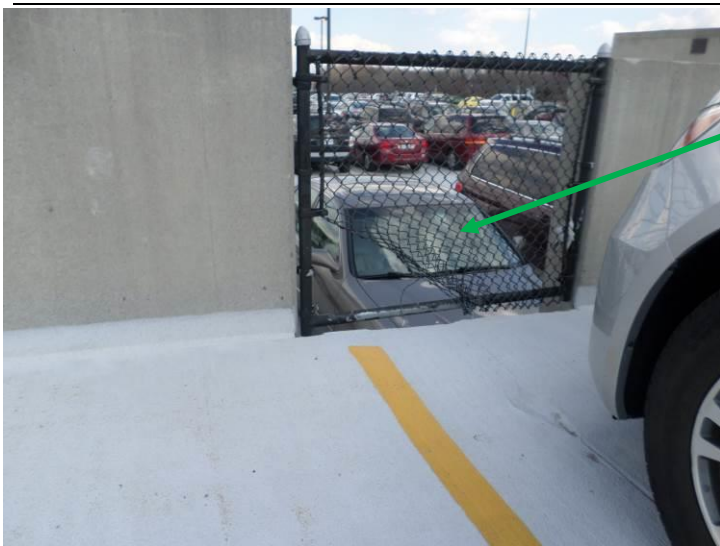
Photo 6

Fencing detached from railing.

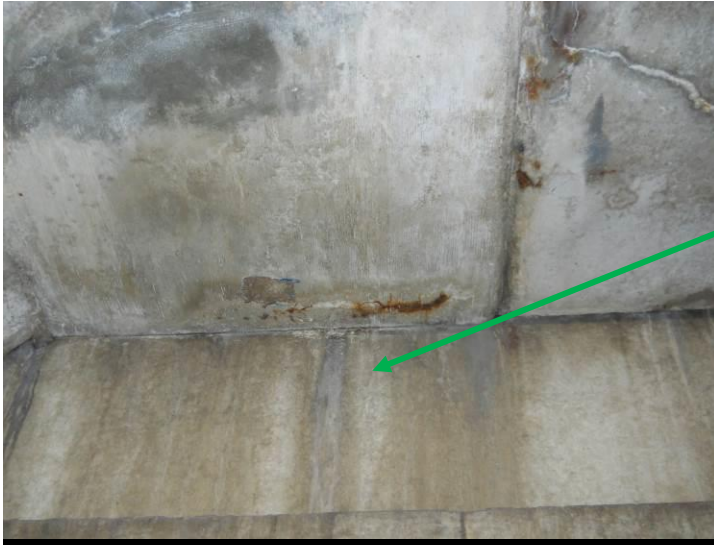
Photo 7

Leaching and rusting at tee to inverted tee beam joints.

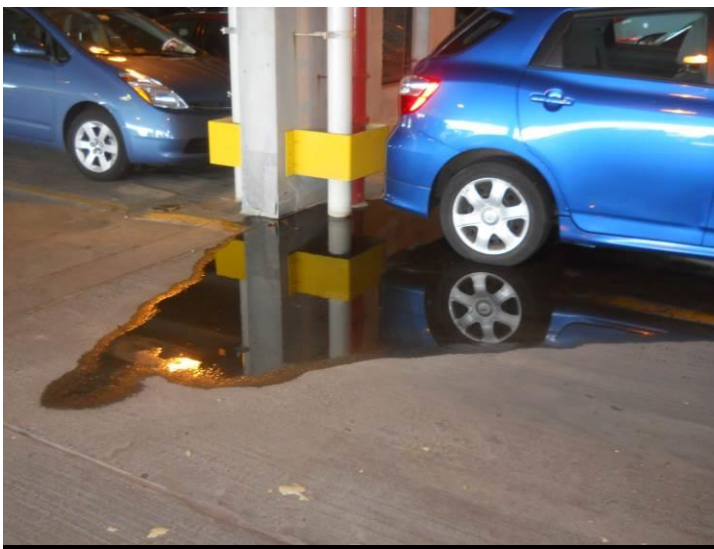
Photo 8

Ponding at clogged drain.

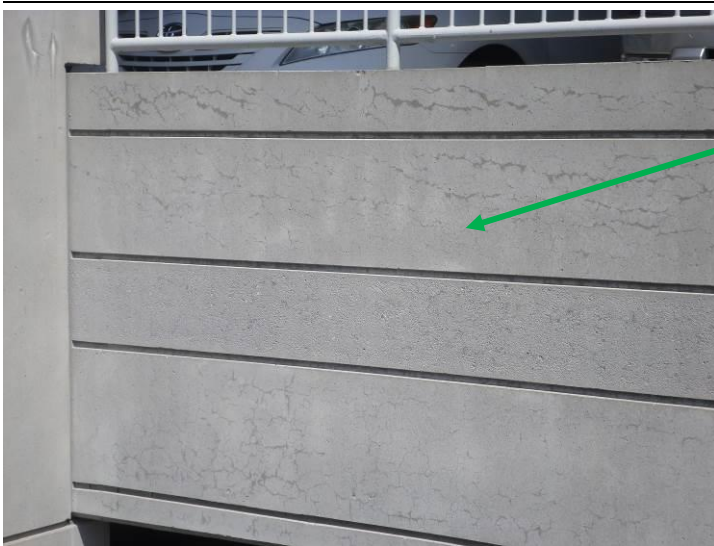
Photo 9

Crack pattern indicative of ASR in original garage spandrels.

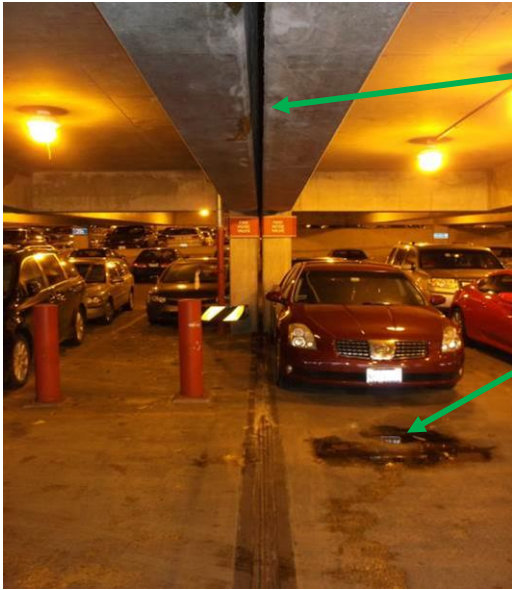
Photo 4

Lower level expansion joint is leaking.

Ponding at slab-on-grade.

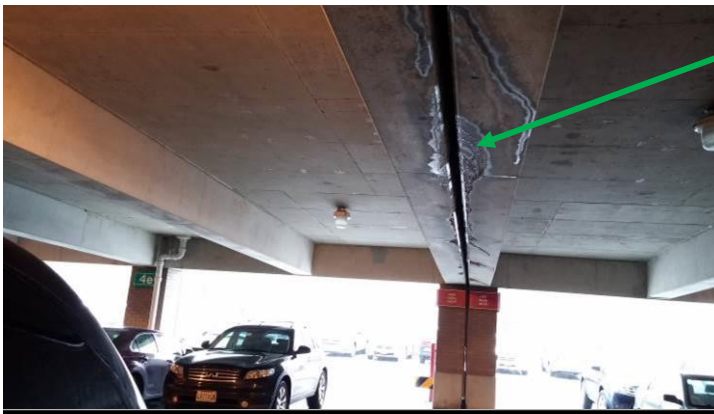
Photo 5

Roof level expansion joint is leaking.

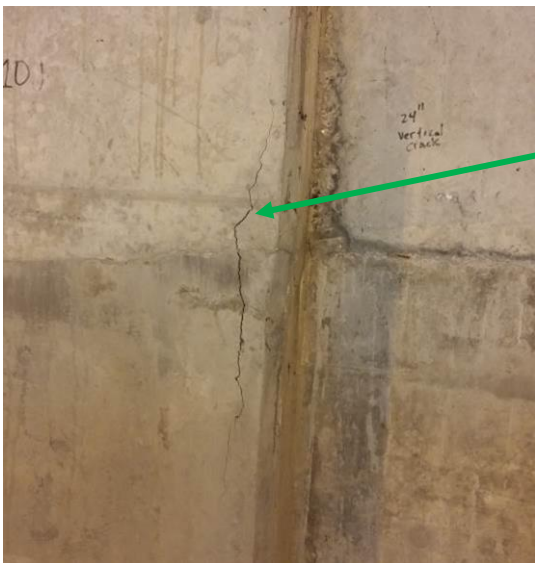
Photo 6

Vertical crack in wall at expansion joint.

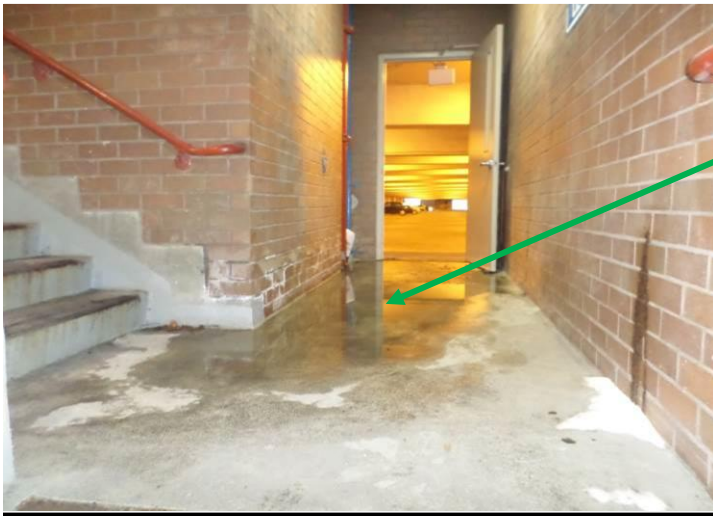
Photo 17

Ponding in stair tower.

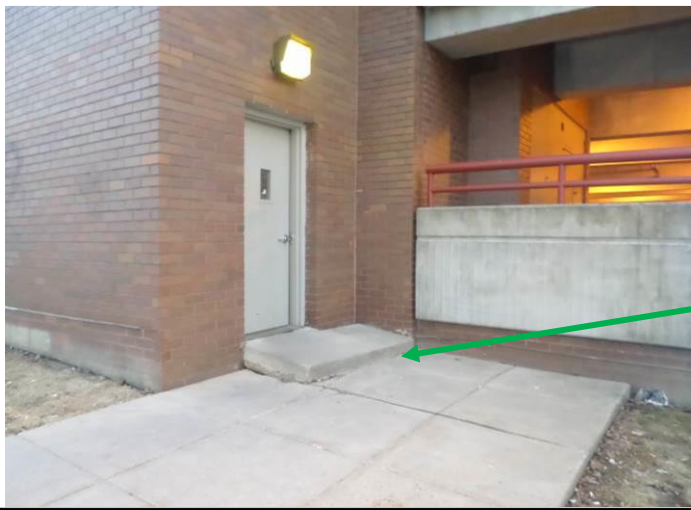
Photo 20

Excessive settlement at secondary stairs exit creates tripping hazard.

Curbs are recommended to be painted yellow.

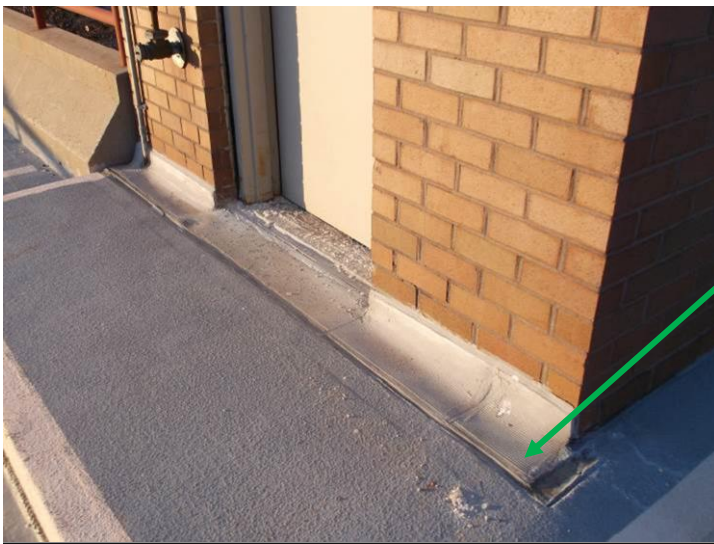
Photo 21

Roof level expansion joint occurs only for a portion of stair tower.

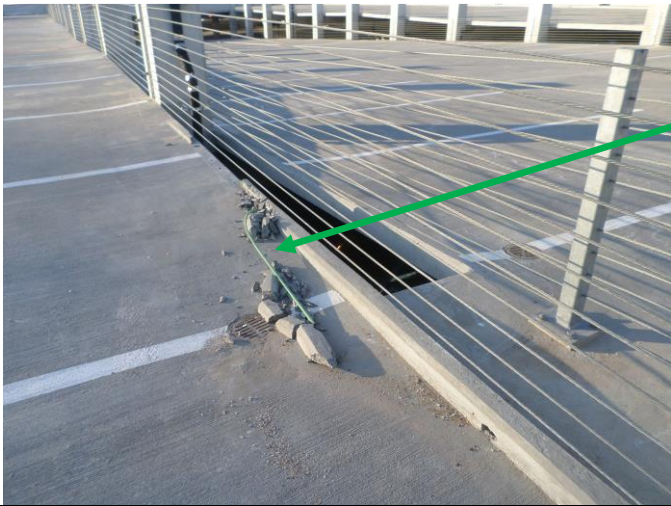
Photo 2

Localized damaged curb.

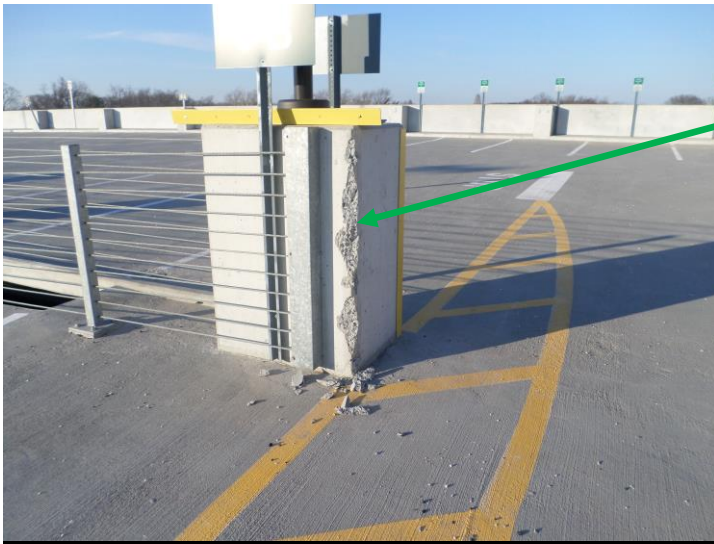
Photo 3

Localized damaged column.

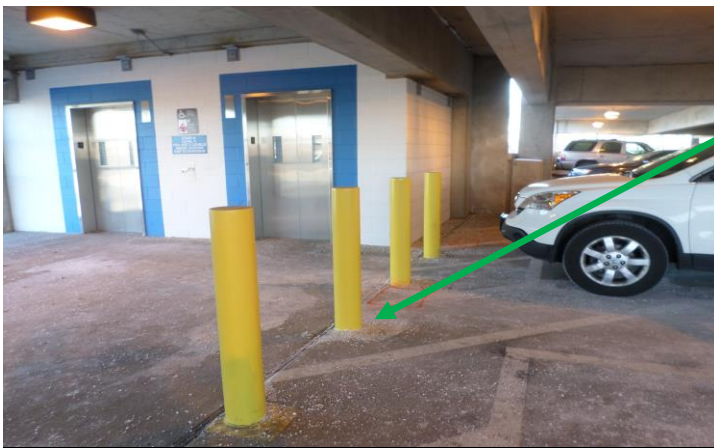
Photo 5

Bollards around elevator access are often locations of minor spalls.

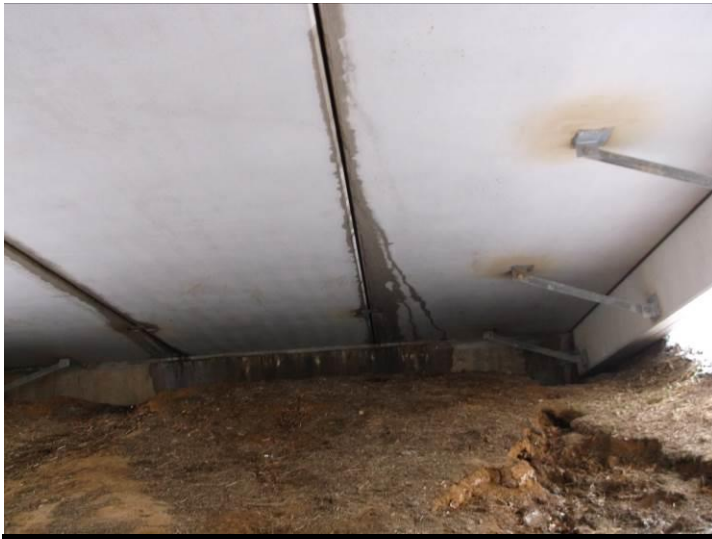
Photo 4

Vehicular bridge floor slab joints typically leak

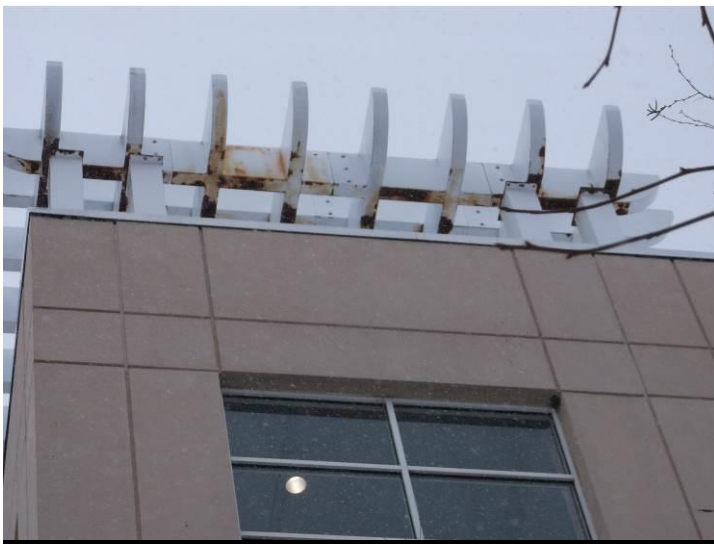
Photo 8

Rusted metal on top of stair towers.

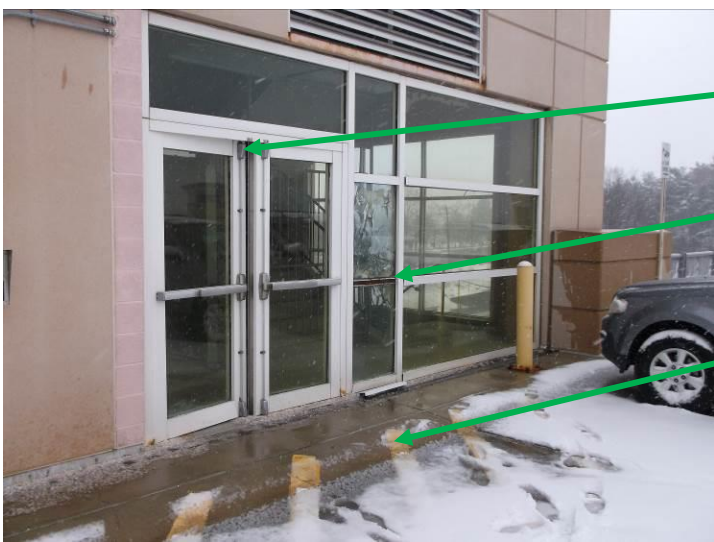
Photo 9

Damaged panic hardware at top level.

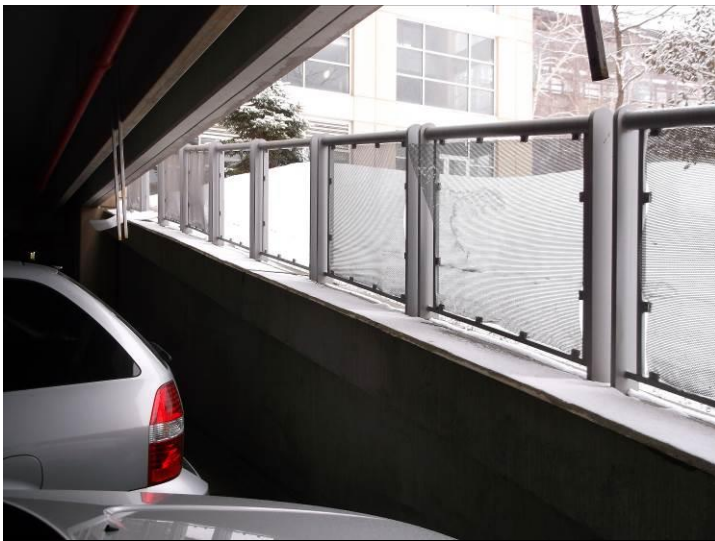
Photo 13

Fencing missing from railing.

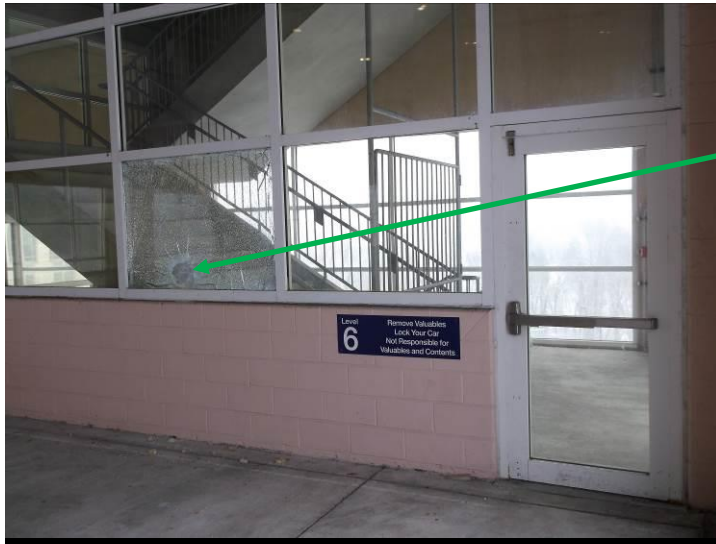
Photo 14

Broken window.

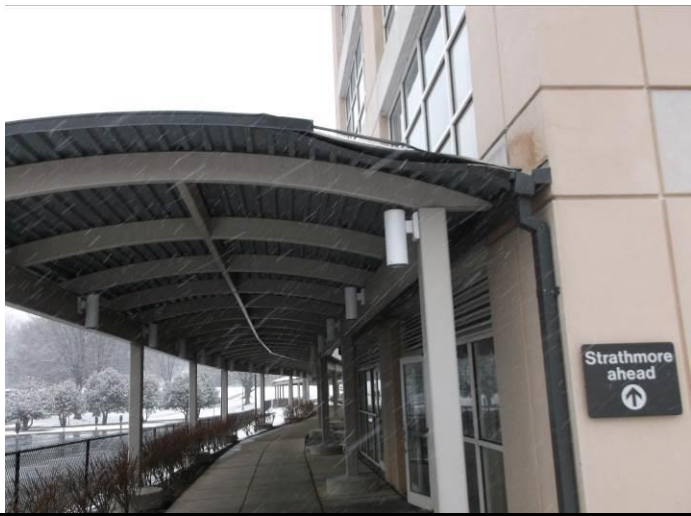
Photo 18

Damaged roof.
