**Asset Management Plan  
WMATA Parking Garages  
Volume 2 of 3  
February 2015  
Walker Restoration Consultants**

ASSET MANAGEMENT PLAN

WASHINGTON AREA  
METROPOLITAN TRANSIT  
AUTHORITY PARKING GARAGES

FEBRUARY, 2015  
VOLUME 2 OF 3

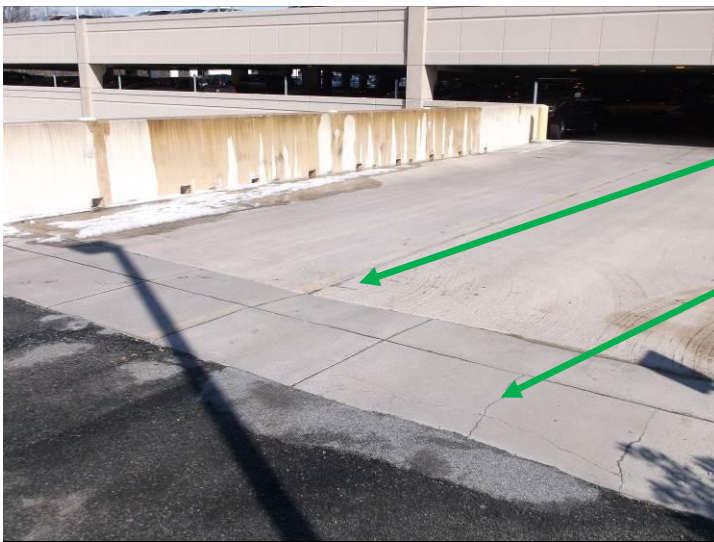
Photo 3

Tee flange corner cracking.

Cracking in wash.

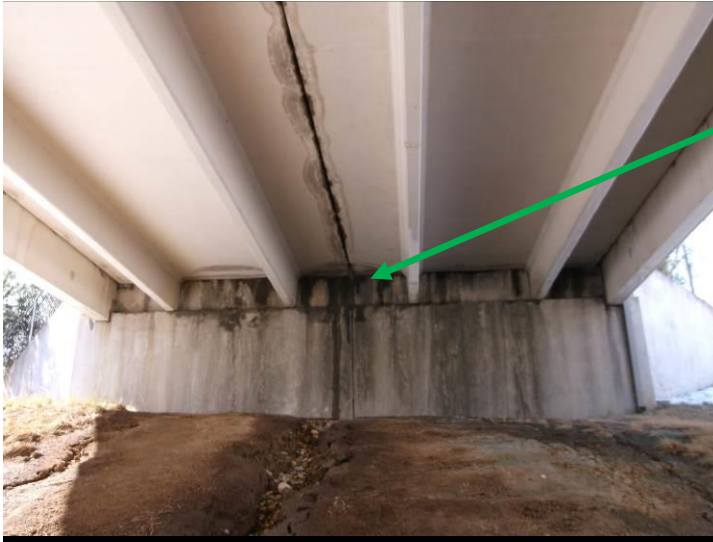
Photo 4

Tee to tee joint leaking on bridge soffit.

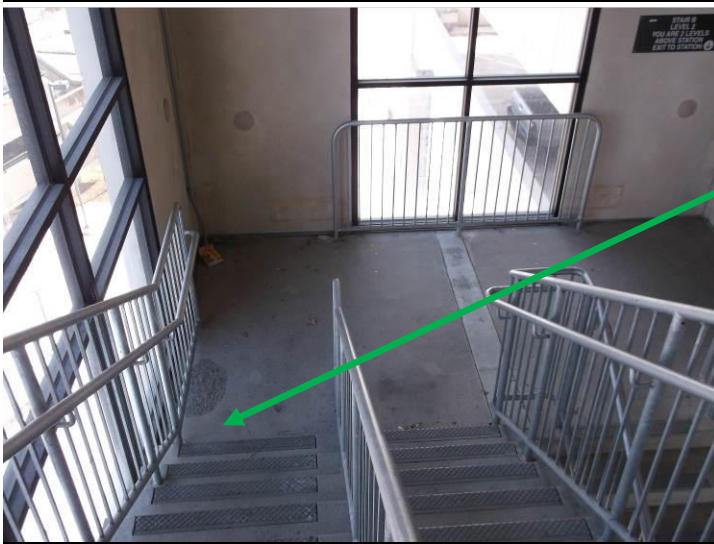
Photo 11

5. Stair treads and landings were observed to have spalls which require repair now to eliminate trip hazards. (Photo 11, 12)
6. The south vehicular bridge double tee soffits were observed to have extensive leaching cracks and moderate efflorescence which require structural repair and waterproofing to address deterioration (Photo 1, 2, 3, 4, 5)

Spall on stair landing. Black stair nosings provide color contrast so no yellow paint is recommended.

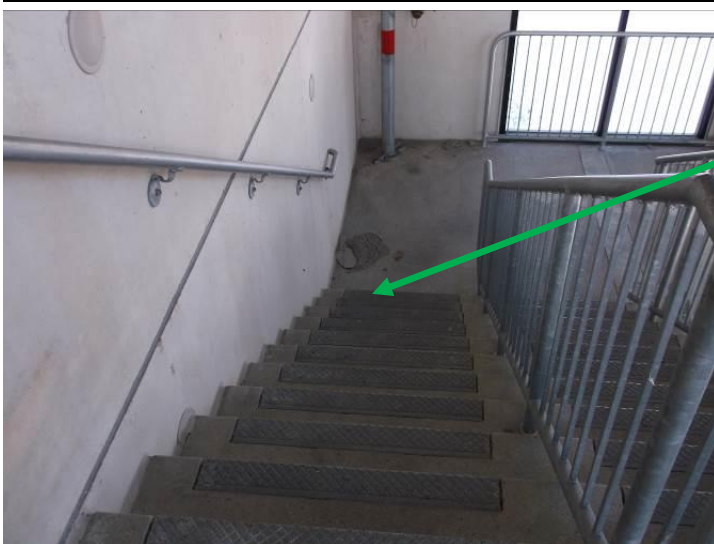
Photo 12

Spall on stair landing. Black stair nosings provide color contrast so no yellow paint is recommended.

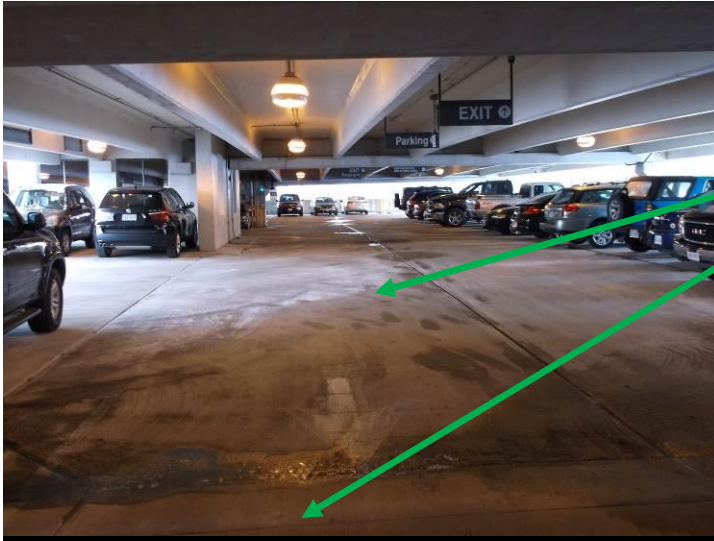
Photo 16

10. Many pendant mounted lights at the north entrance have fallen the large distance to grade and as these will be replaced shortly, need to have modified anchoring to properly support the lights. (Photo 10)
11. A minor amount of localized ponding was observed and new supplemental drains need to be installed. (Photo 16, 17, 18)

Ponding at leaking joints between double tees and inverted tee beams

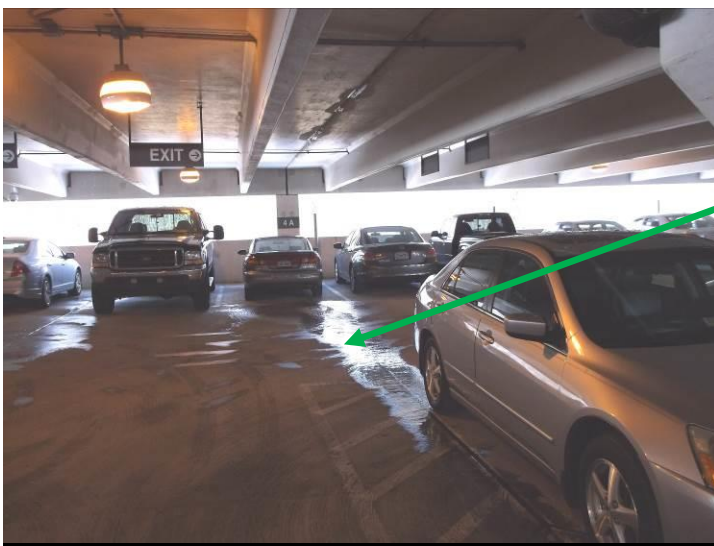
Photo 17

Ponding at locations of leaking joints between double tees.

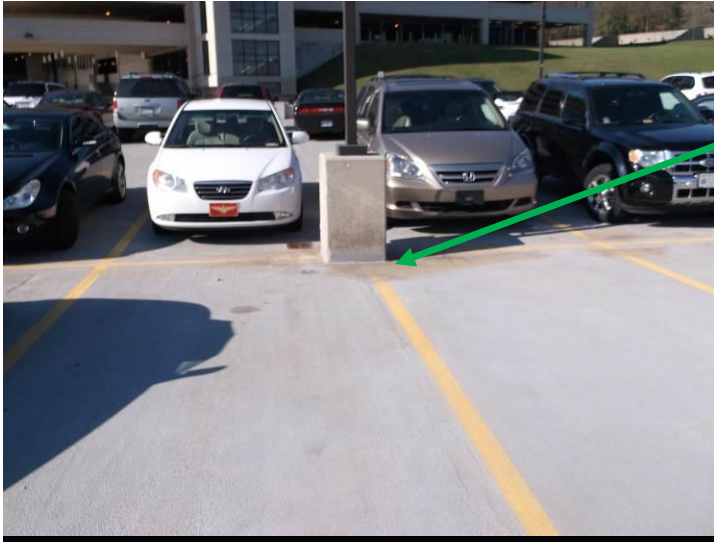
Photo 4

Staining indicates ponding at roof level.

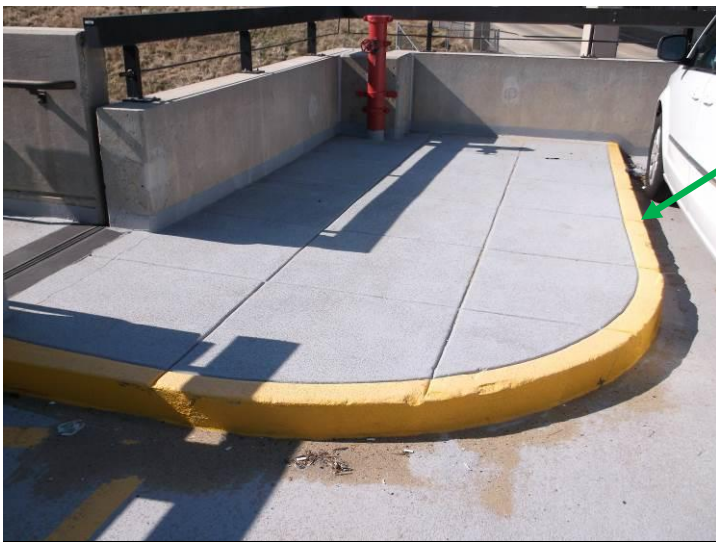
Photo 6

Curbs are painted yellow.

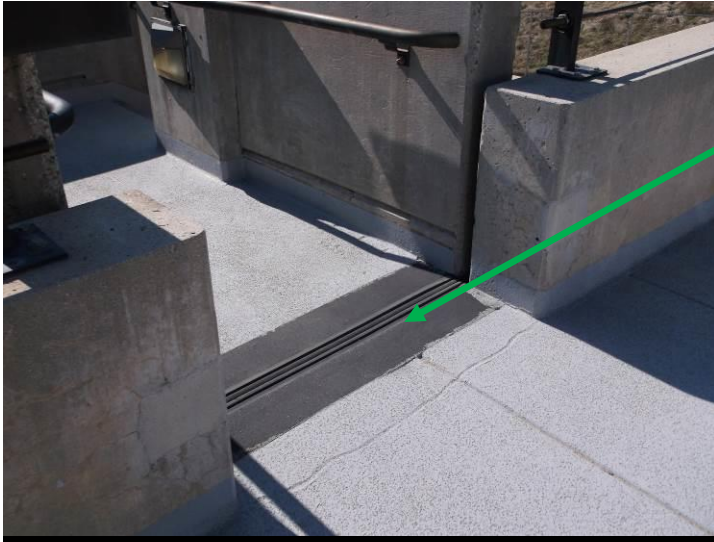
Photo 7

Expansion joint is in good condition.

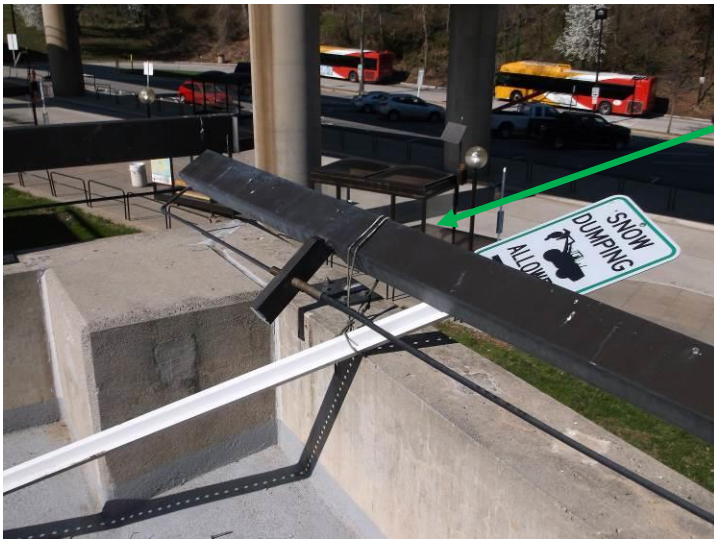
Photo 9

Damaged railing and sign.

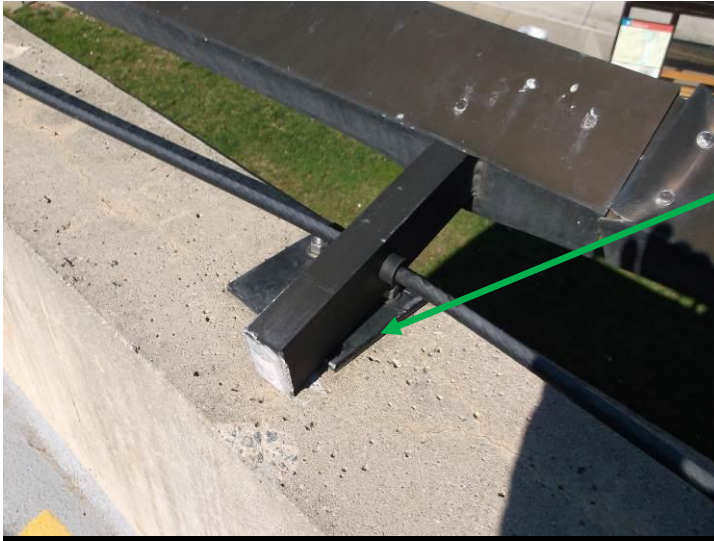
Photo 10

Damaged railing.

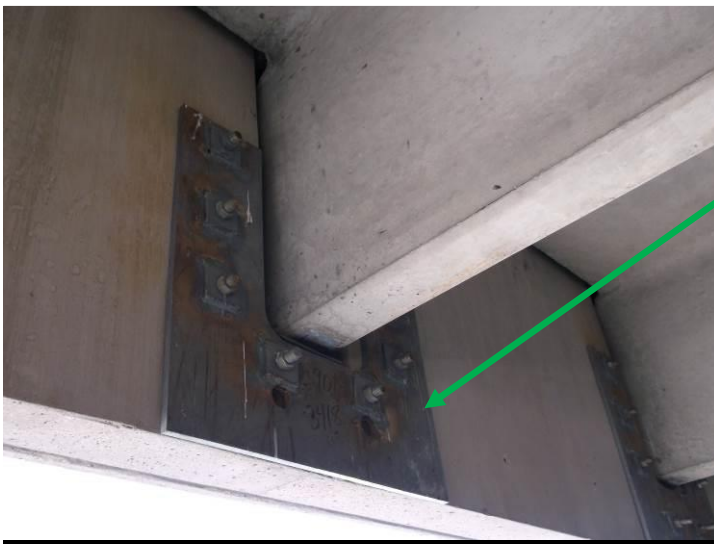
Photo 11

Previously repaired tee bearing pocket.

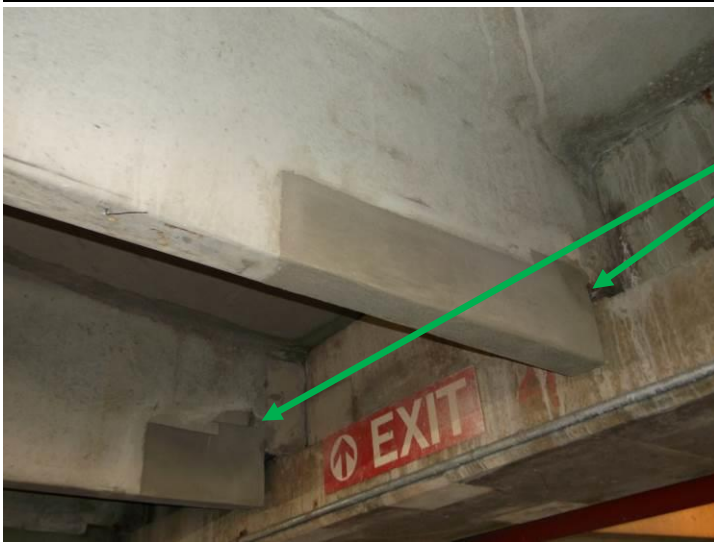
Photo 12

Previously repaired tee stems.

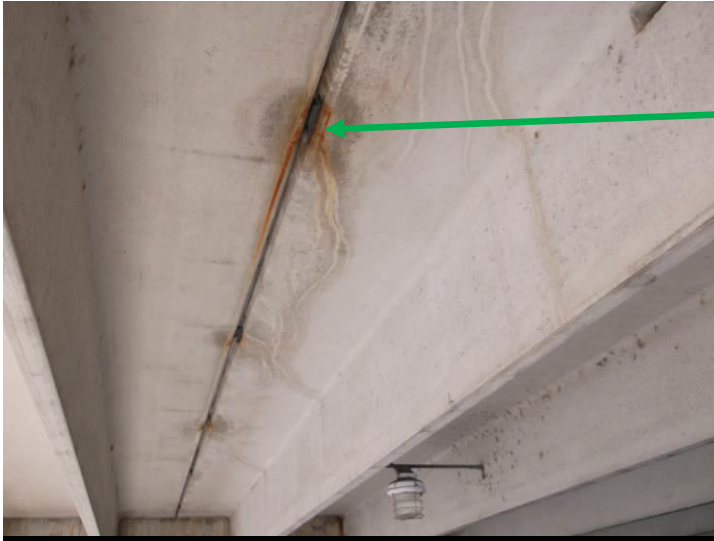
Photo 13

Leaching and rusting at tee to tee connection.

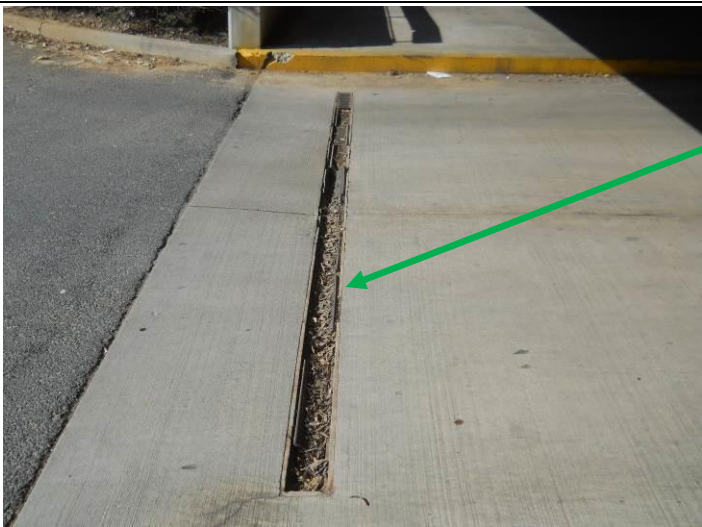
Photo 15

Trench drain cover is missing.

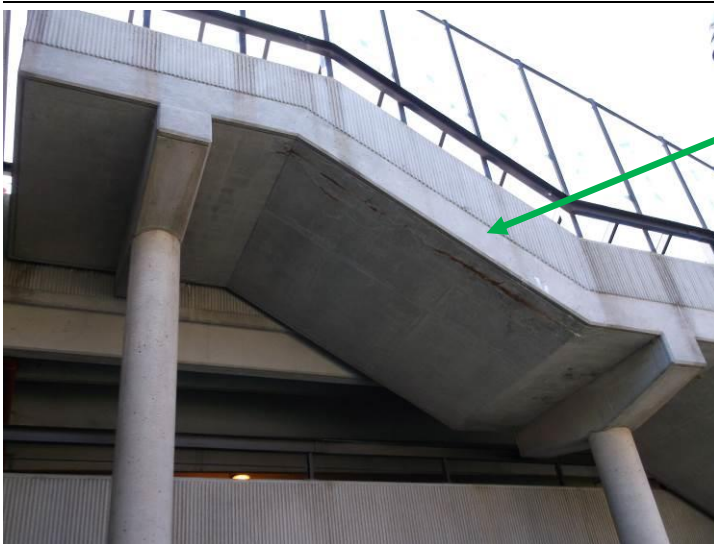
Photo 18

Leaching and rusting on underside of stairs.

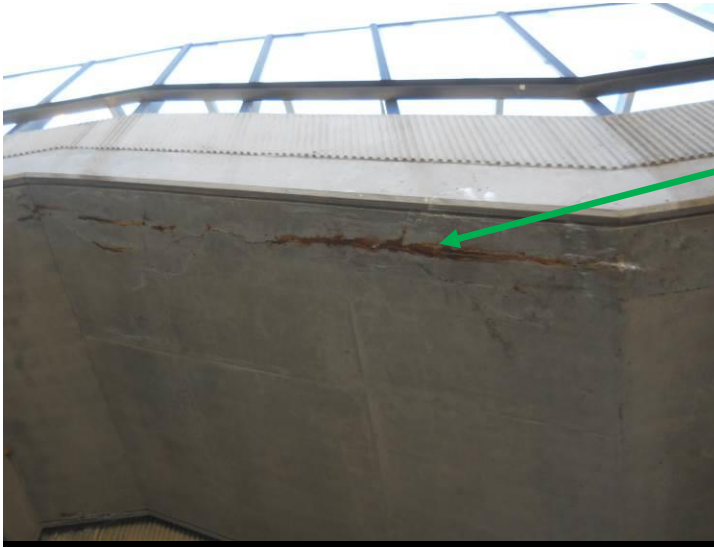
Photo 19

Leaching and rusting on underside of stairs.

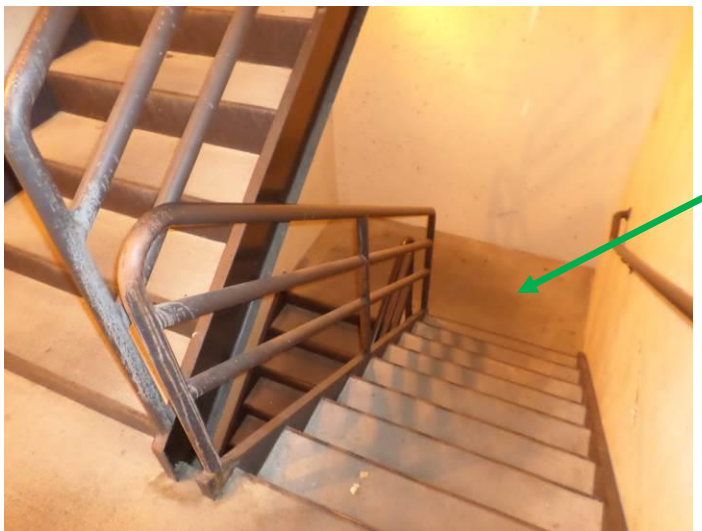
Photo 3

Ponding on stair landing. Black stair nosings provide color contrast so no yellow paint is recommended.

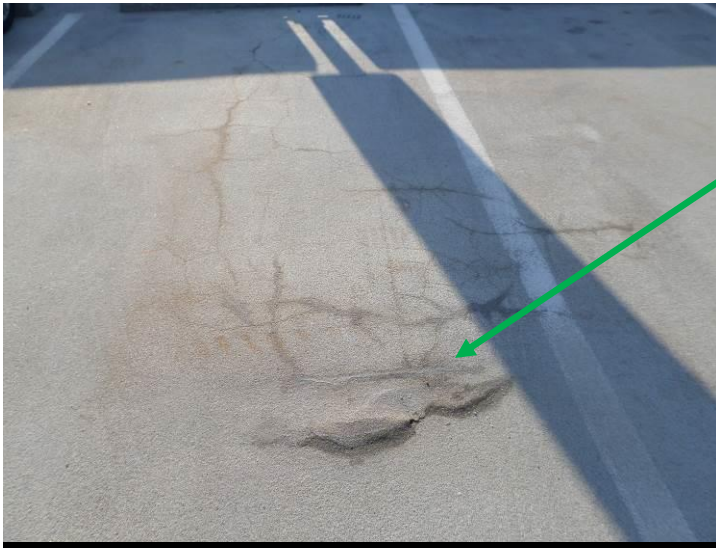
Photo 4

Delaminated traffic topping over spalled concrete.

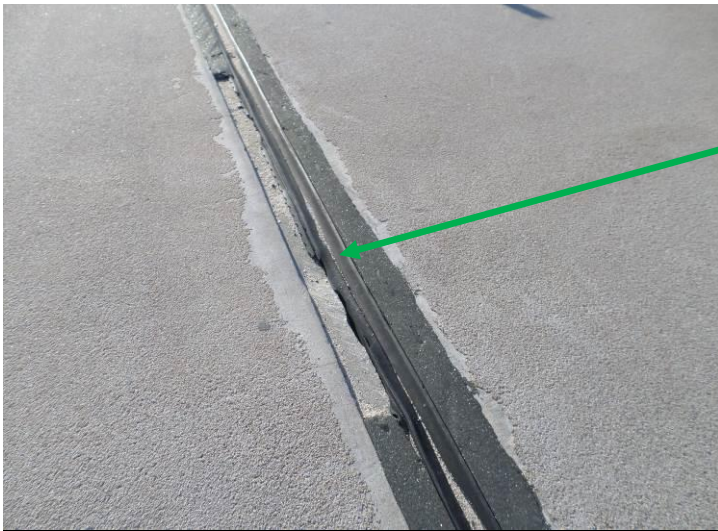
Photo 6

Damaged expansion joint.

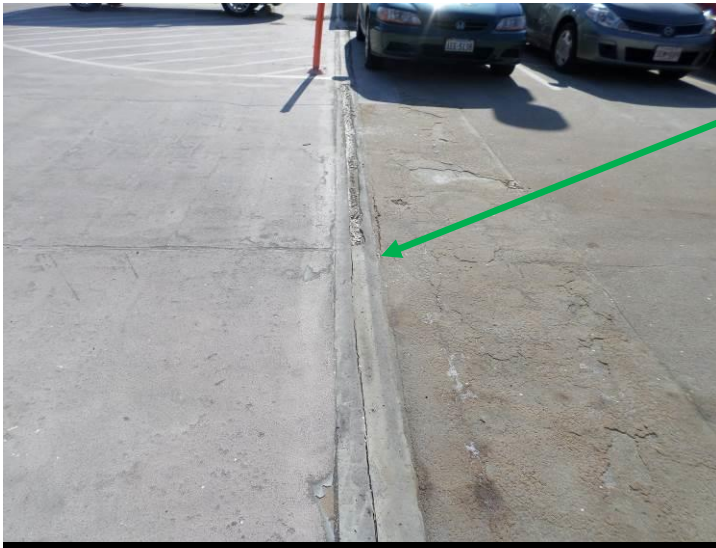
Photo 7

Deteriorated expansion joint topping.

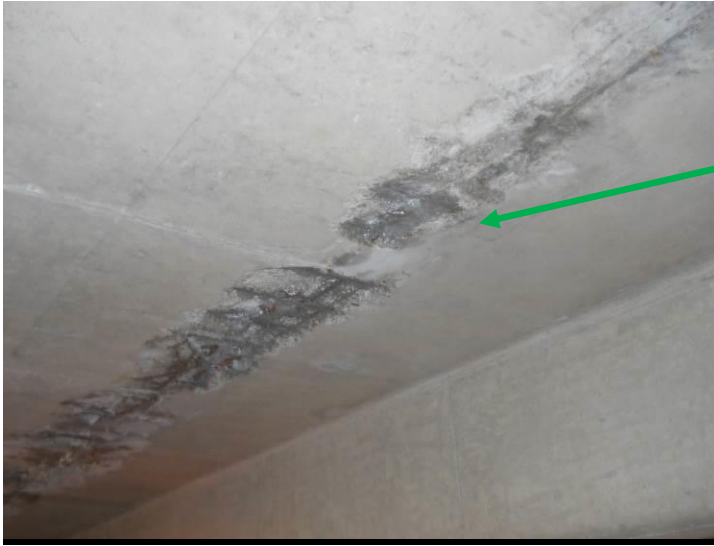
Photo 10

Slab soffit spalling at construction joint.

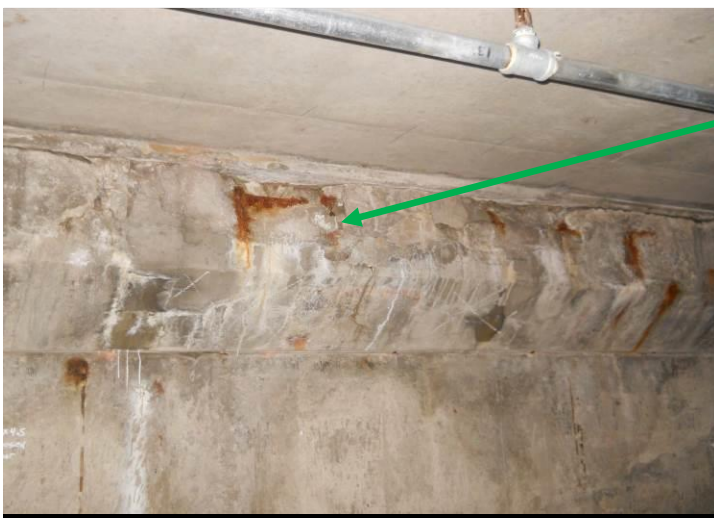
Photo 11

Corbel leaching and spalling at rusting reinforcing.

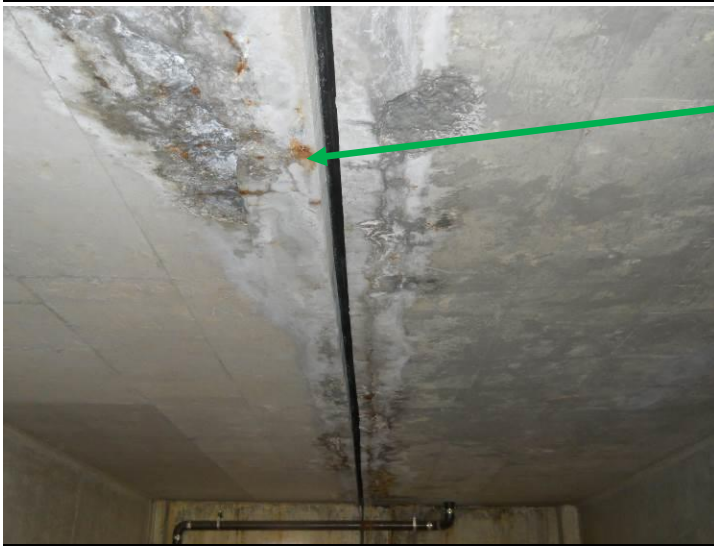
Photo 12

Spalling and exposed reinforcing adjacent expansion joint.

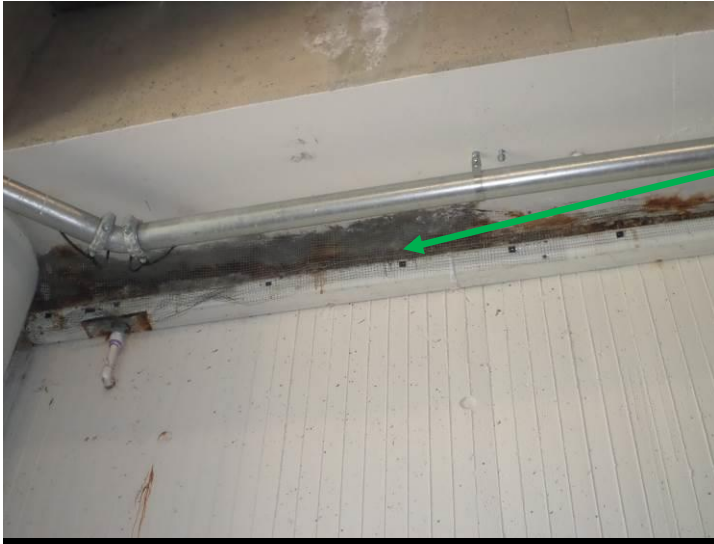
Photo 13

Leaking and soffit spalling in adjacent station.

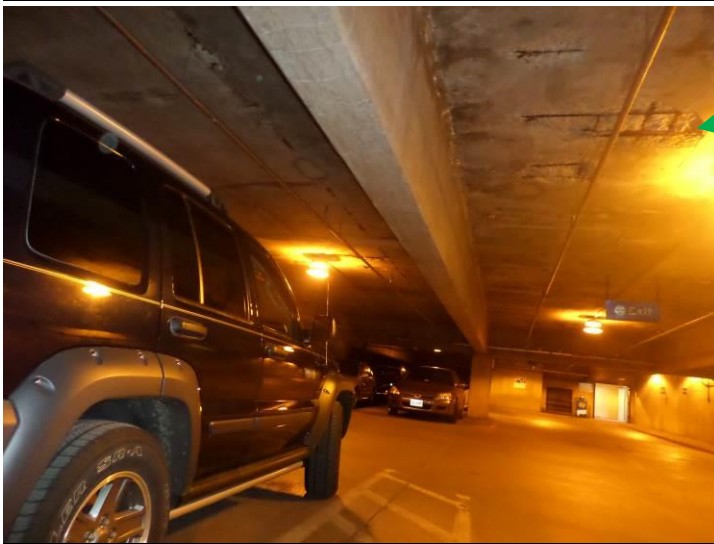
Photo 15

Spalling with exposed reinforcing and P/T tendons.

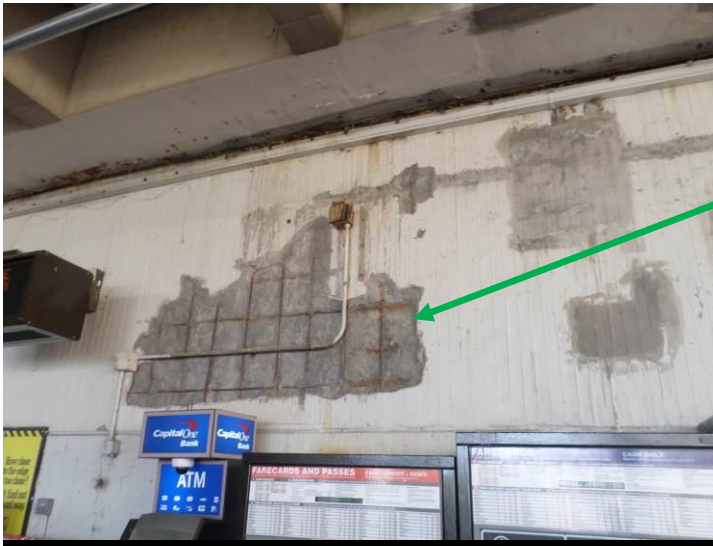
Photo 16

Spalling and exposed reinforcing in adjacent station.

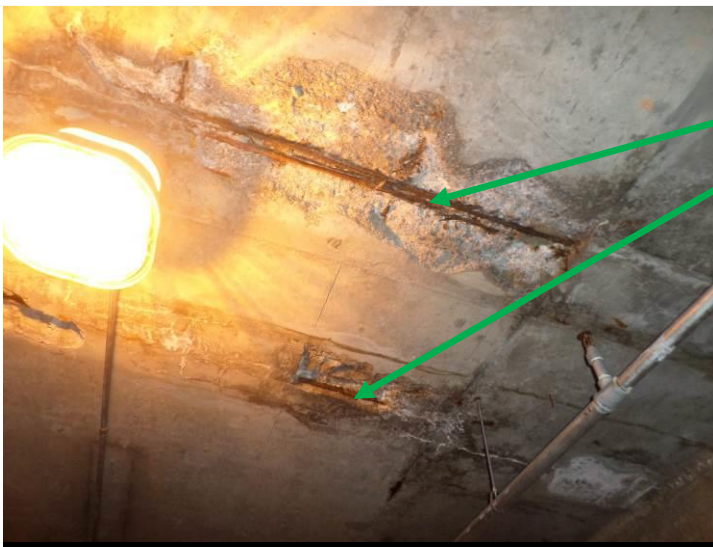
Photo 17

Spalling with exposed reinforcing and P/T tendons.

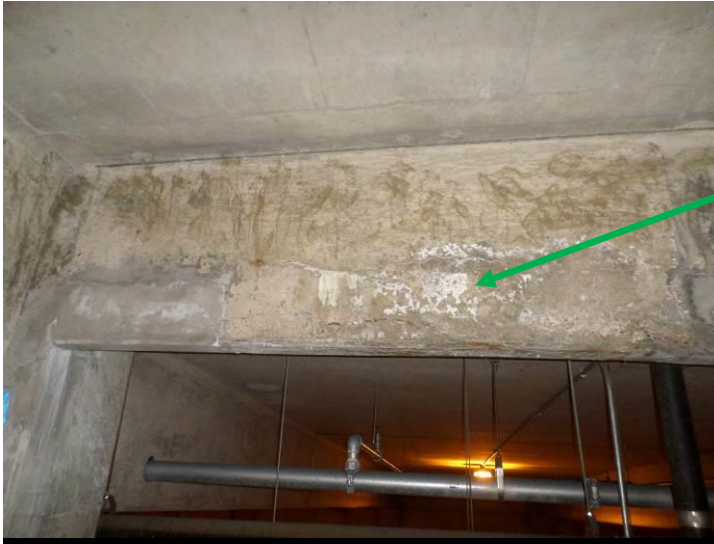
Photo 19

Spalling and leaching on beam.

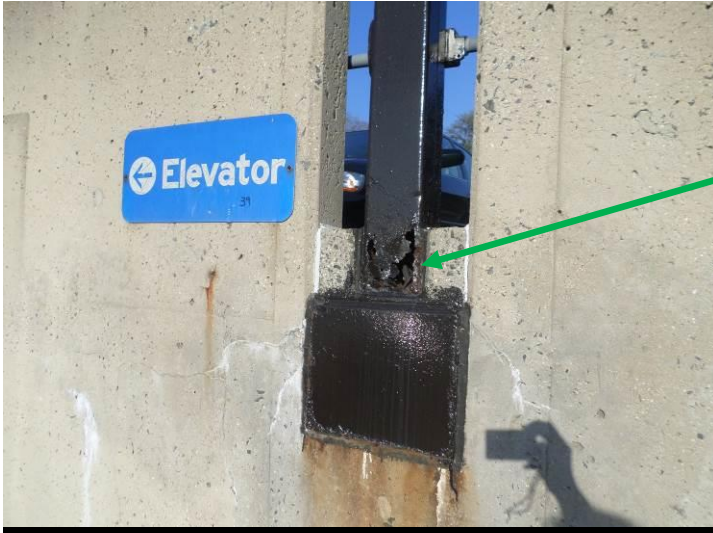
Photo 22

Rusted metal light pole.

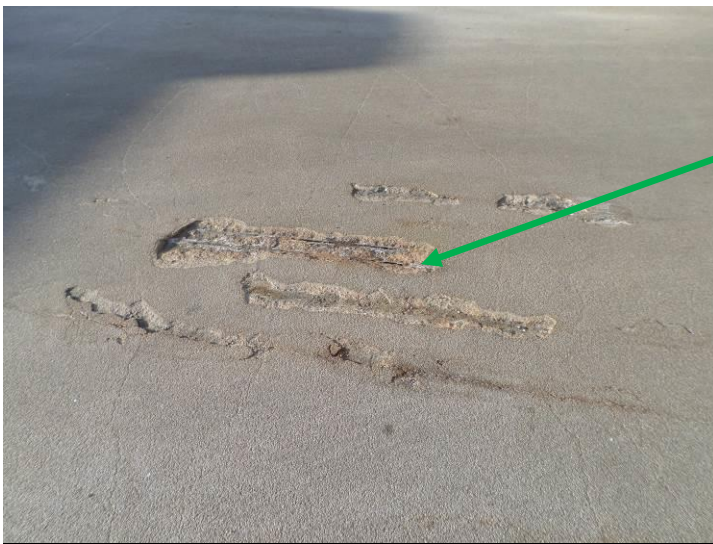
Photo 24

Spalling slab and damaged traffic topping.

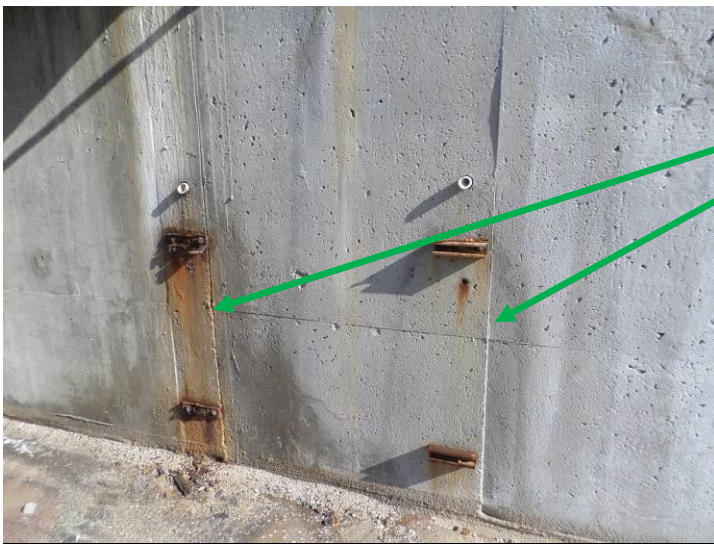
Photo 27

Rusted metal brackets beneath thru-wall drains.

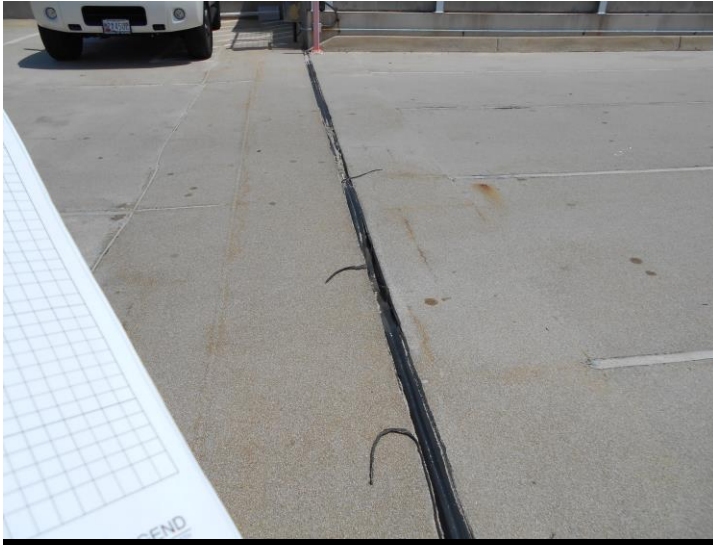
Photo 1

Damaged roof level expansion joint.

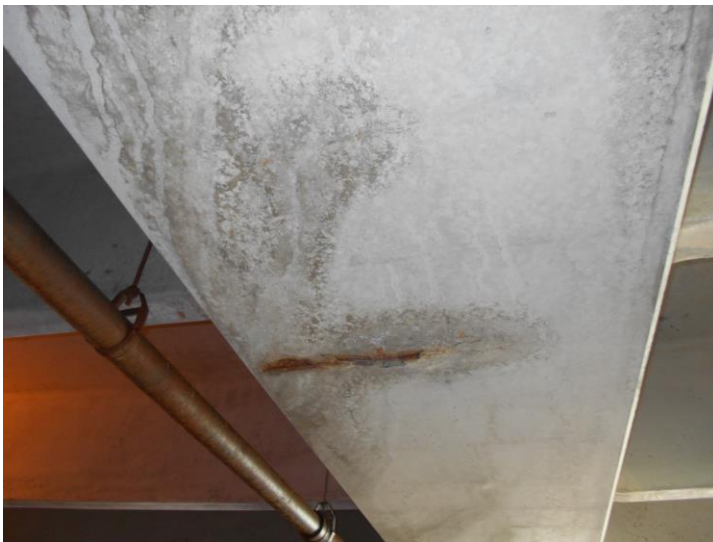
Photo 3

Spalled inverted tee beam with exposed reinforcing.

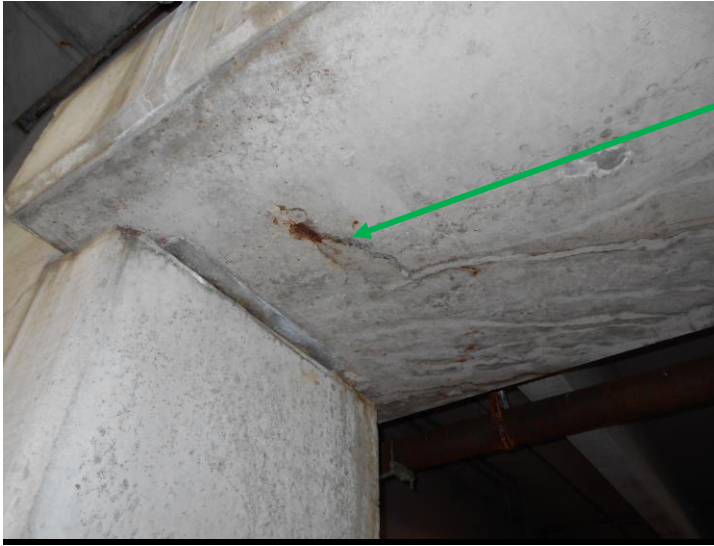
Photo 4

Spalled inverted tee beam with exposed reinforcing.

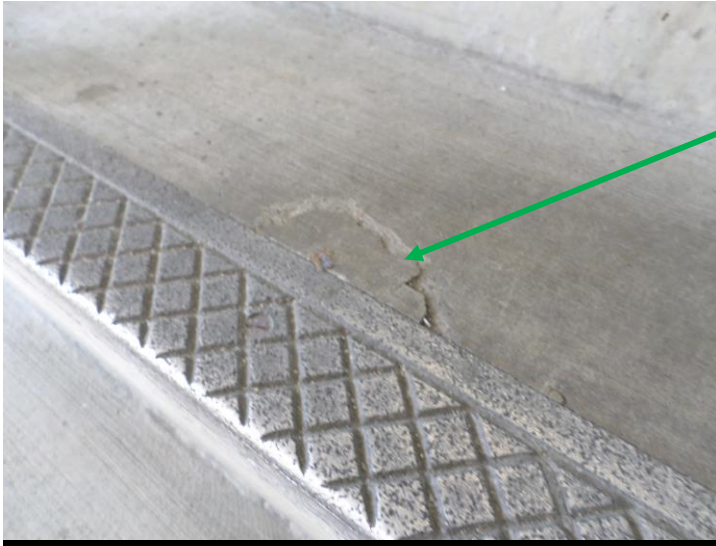
Photo 7

Stair nosing spall.

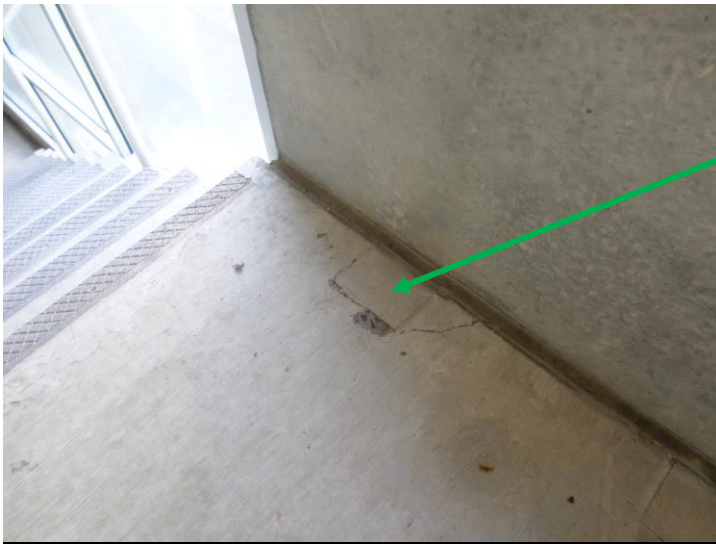
Photo 9

Stair landing spall at connection.

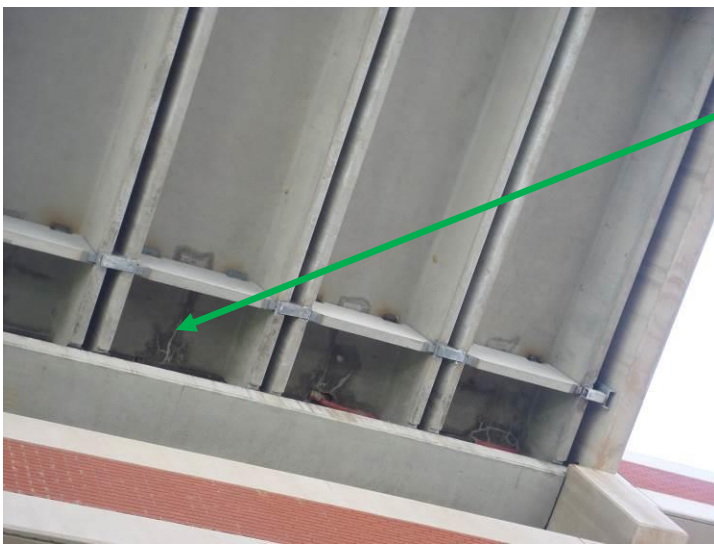
Photo 3

Leaching cracks on underside of vehicular bridge over station.

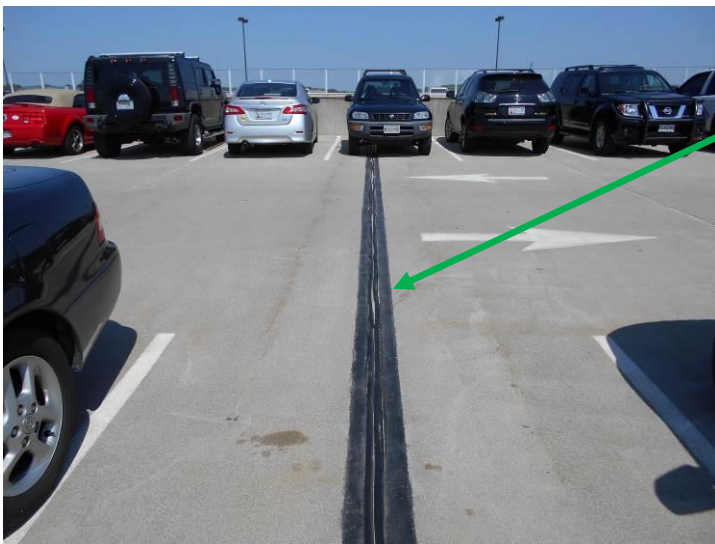
Photo 6

Roof level expansion joint in fair condition.

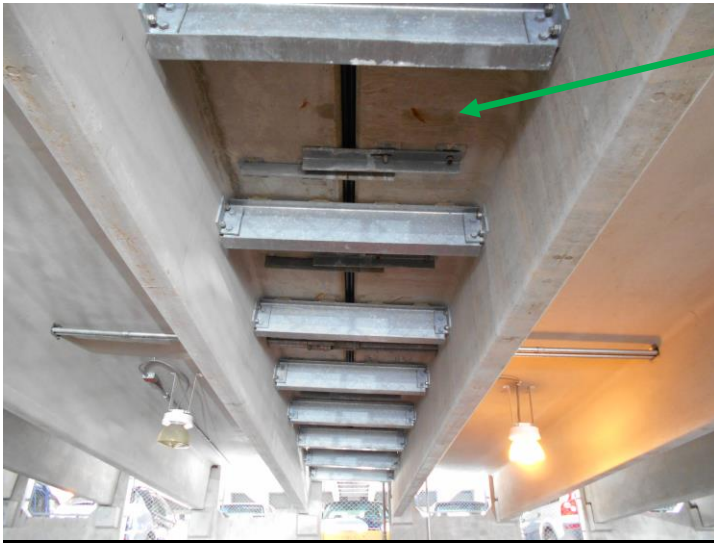
Photo 7

Shear transfer devices in good condition.

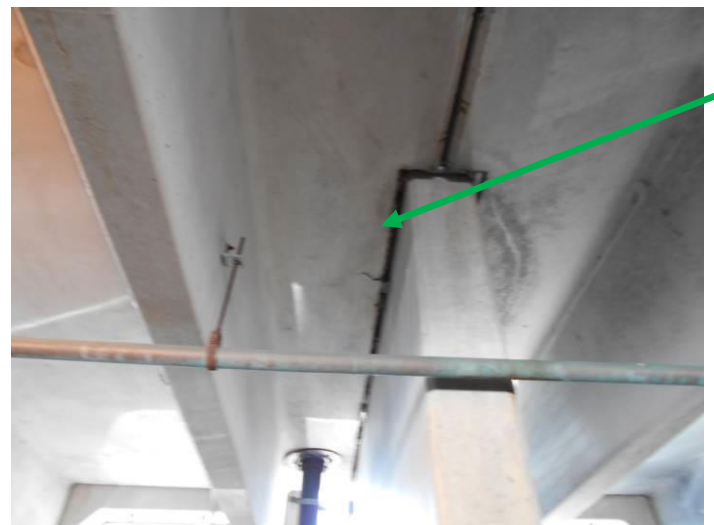
Photo 9

Soffit spall in tee at shear wall.

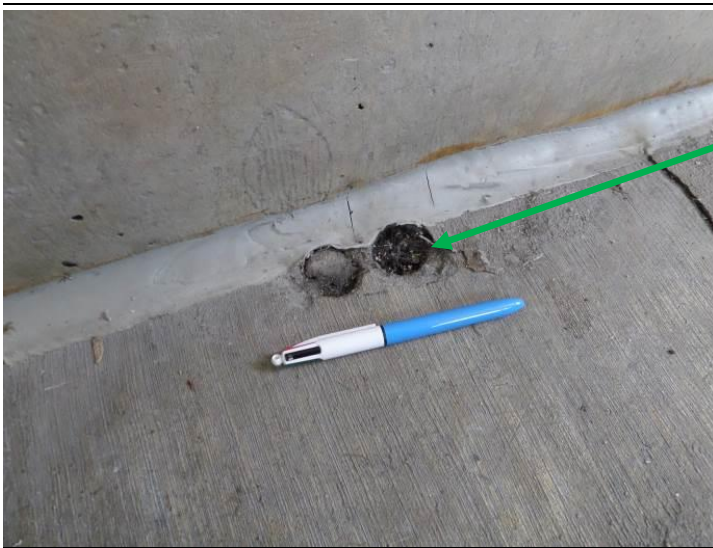
Photo 12

Conduit holes in stair landing.

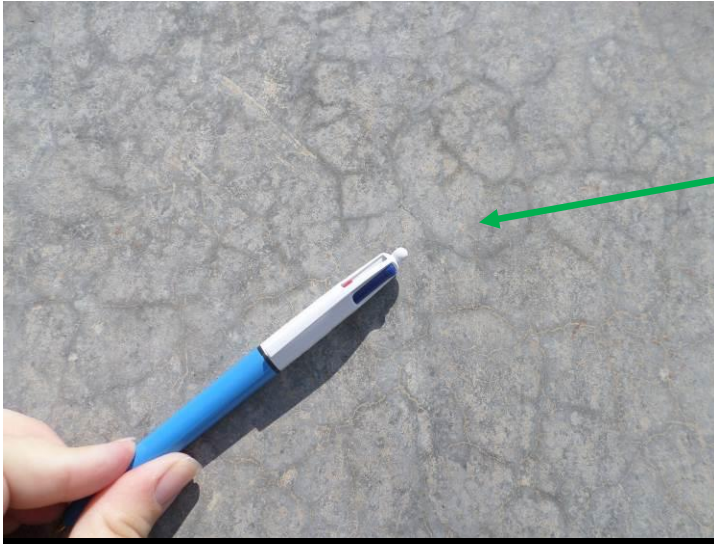
Photo 16

Cracking pattern  
indication of ASR on  
lightwall.

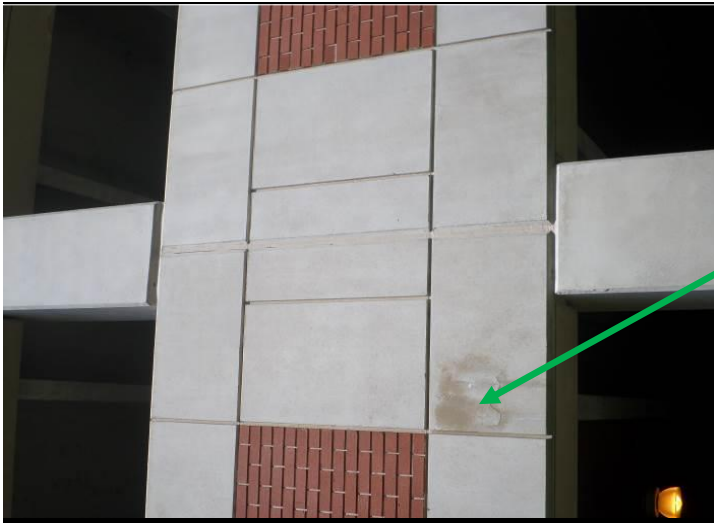
Photo 17

Leaching at shear wall  
spall.

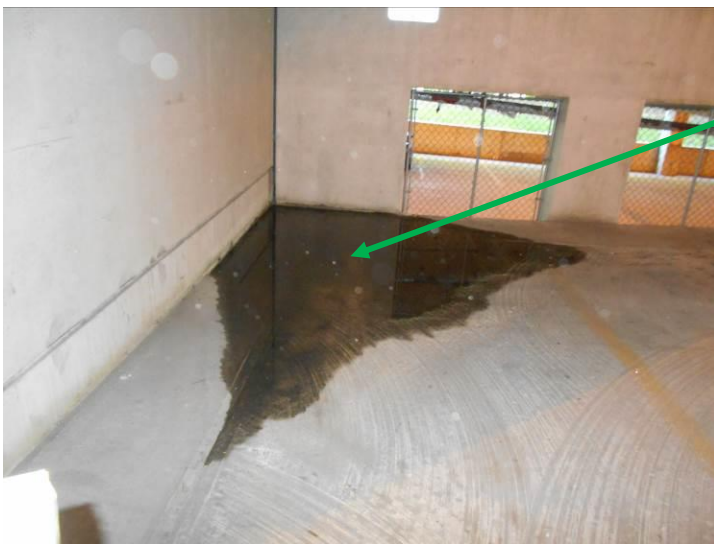
Photo 3

Ponding at shearwall.

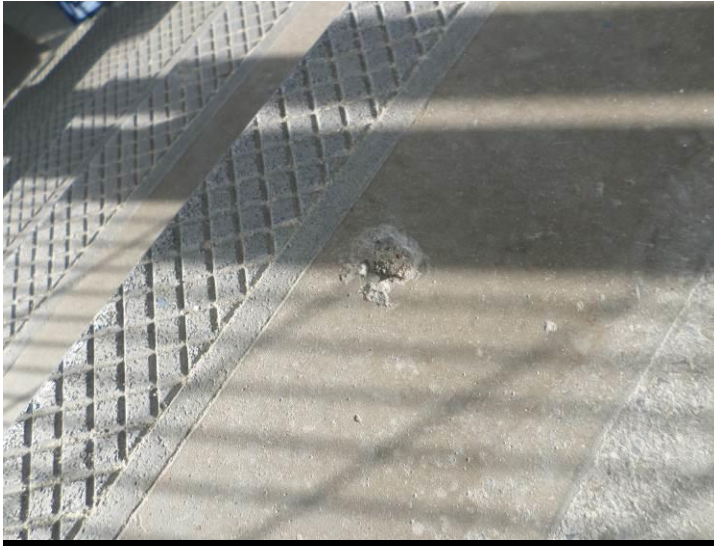
Photo 7

Spall on stair tread.

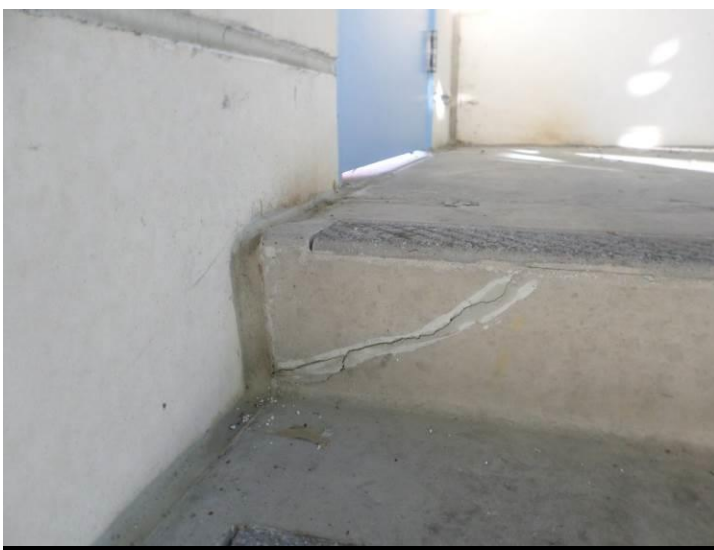
Photo 8

Damaged stair.

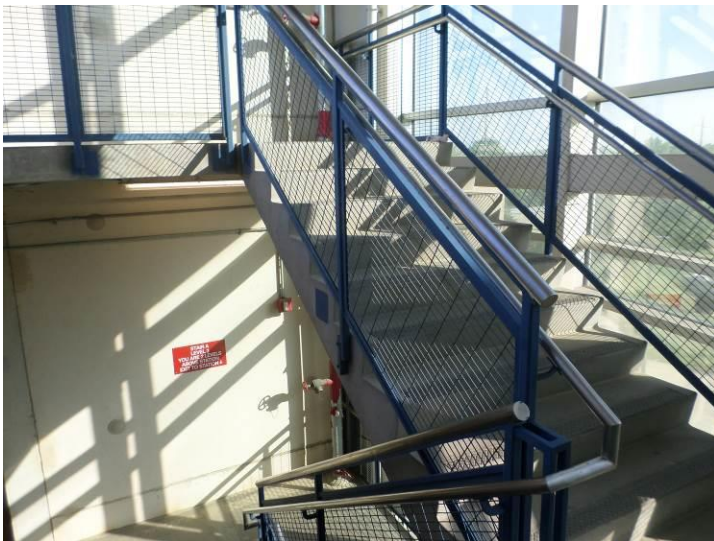
Photo 12

Black stair nosings provide  
color contrast so no yellow  
paint is recommended.

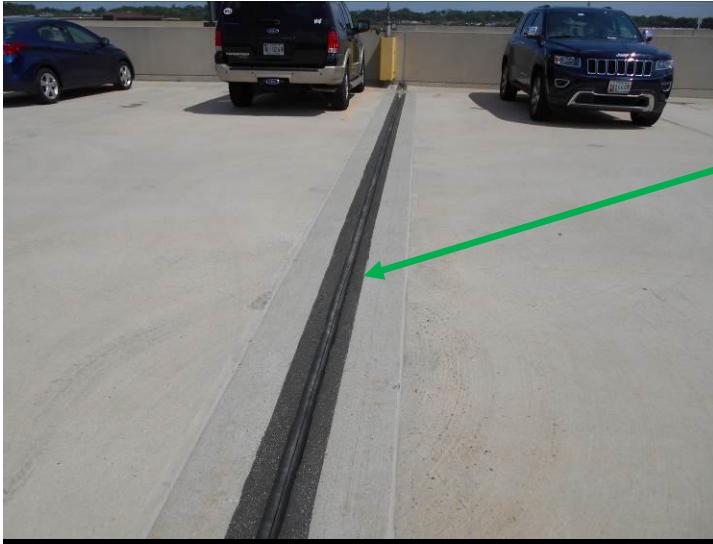
Photo 1

Expansion joint in good condition.

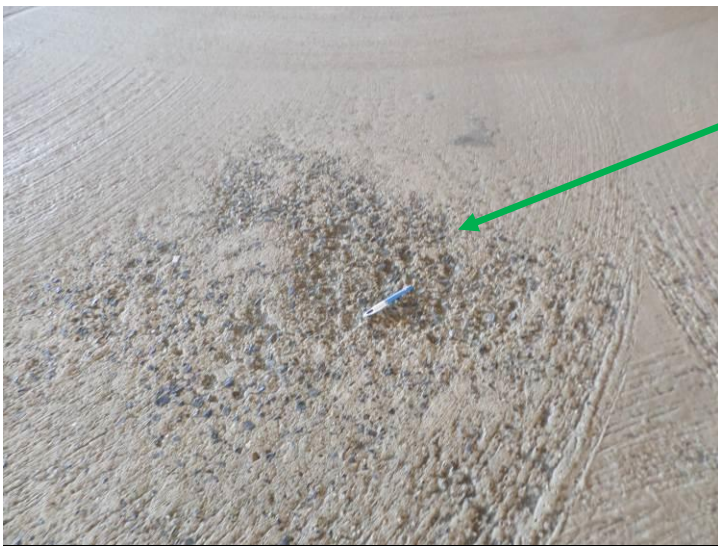
Photo 6

Scaling of slab surface.

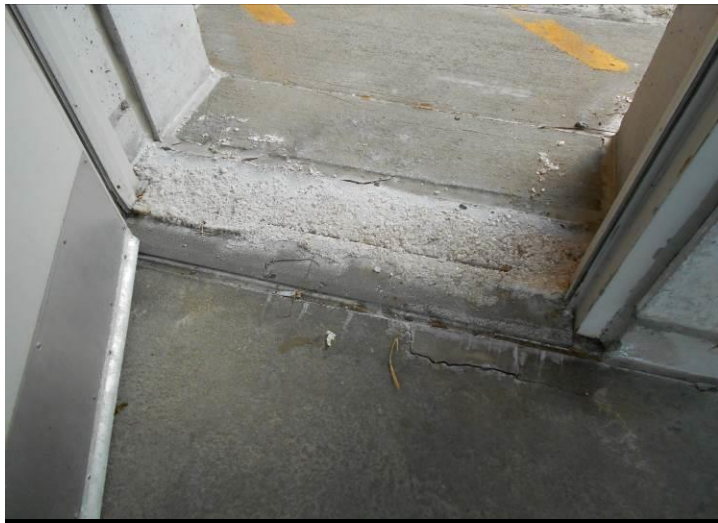
Photo 9

Accumulation of salt and debris at doorway.

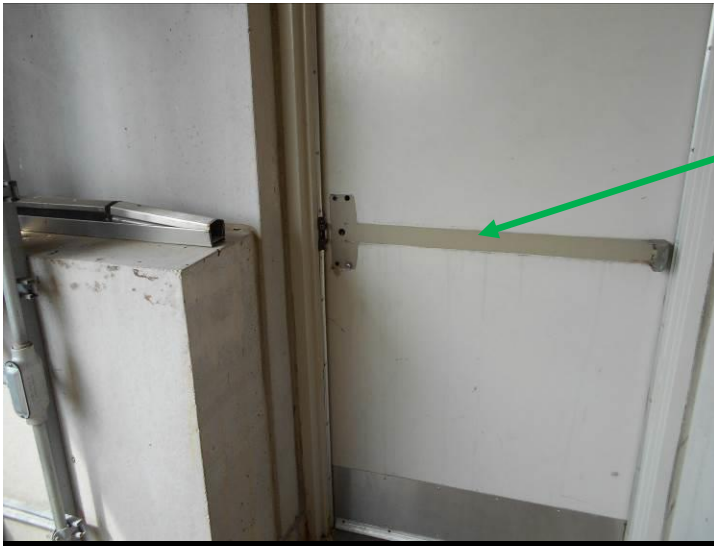
Photo 10

Broken panic hardware.

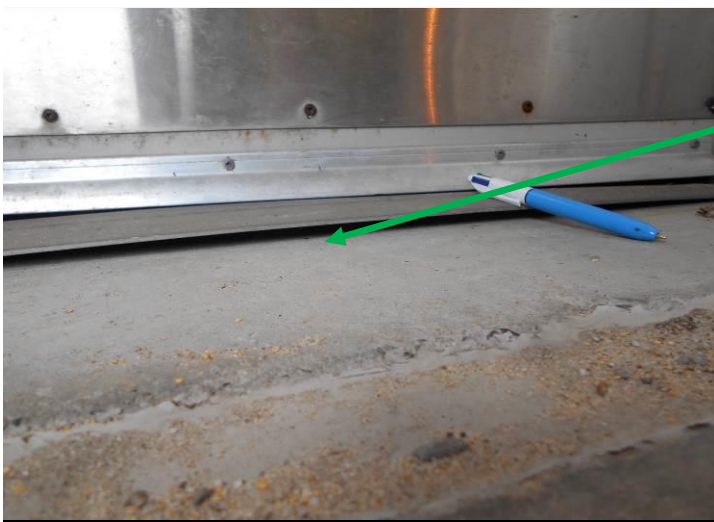
Photo 11

Damaged threshold.

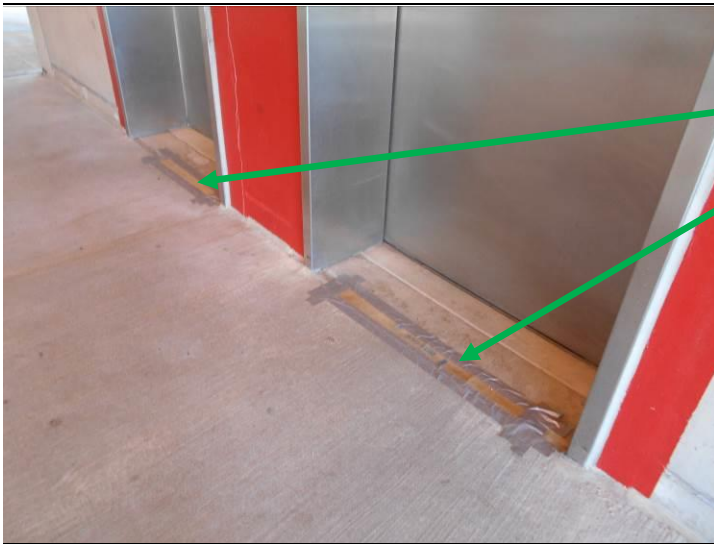
Photo 12

Temporary patching of joint in elevator threshold.

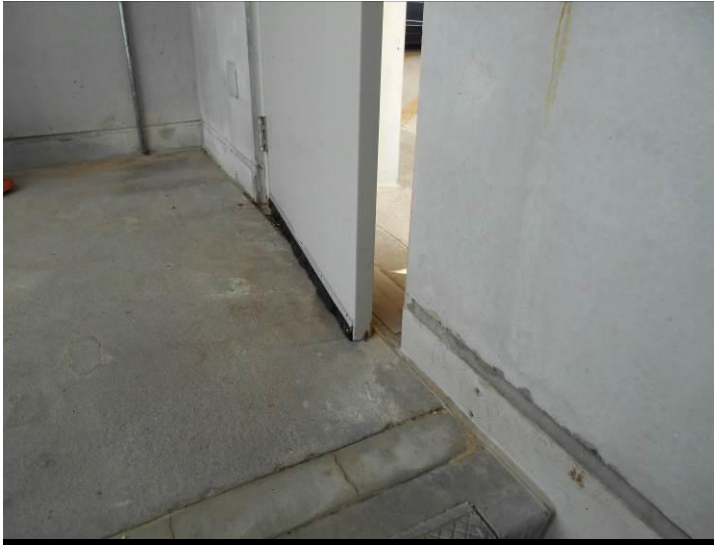
Photo 13

Damaged door.

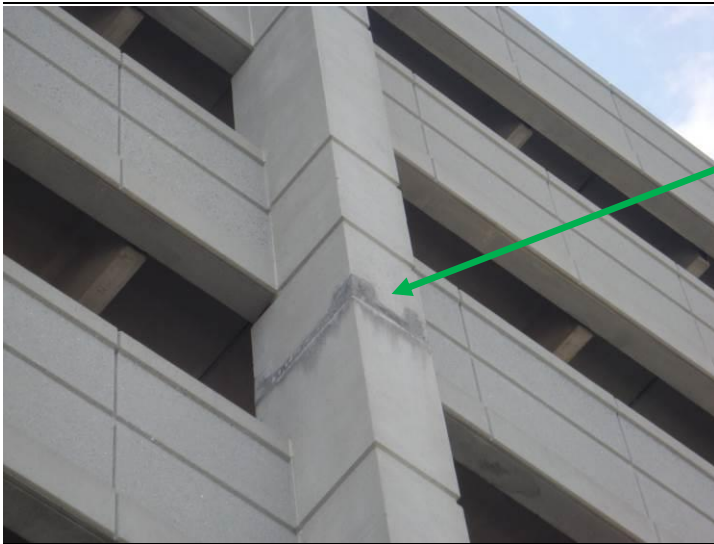
Photo 15

Leaching at grouted column connection.

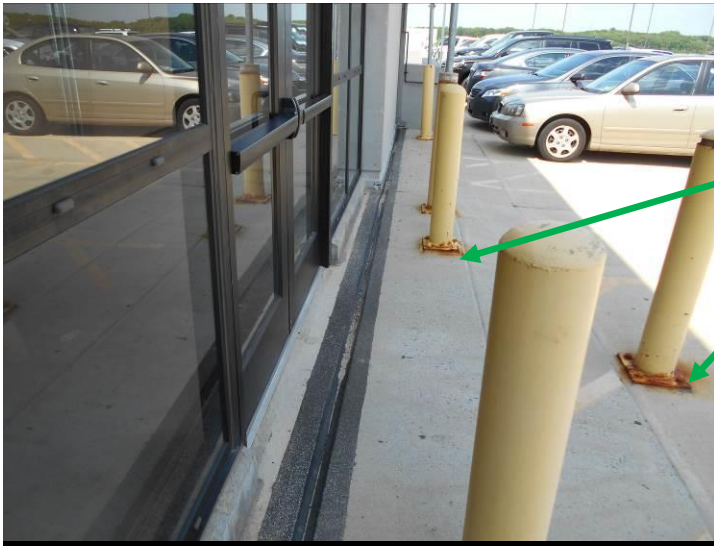
Photo 16

Rusting bollard at base.
