**Asset Management Plan  
WMATA Parking Garages  
Volume 2 of 3  
February 2015  
Walker Restoration Consultants**

ASSET MANAGEMENT PLAN

WASHINGTON AREA  
METROPOLITAN TRANSIT  
AUTHORITY PARKING GARAGES

FEBRUARY, 2015  
VOLUME 2 OF 3

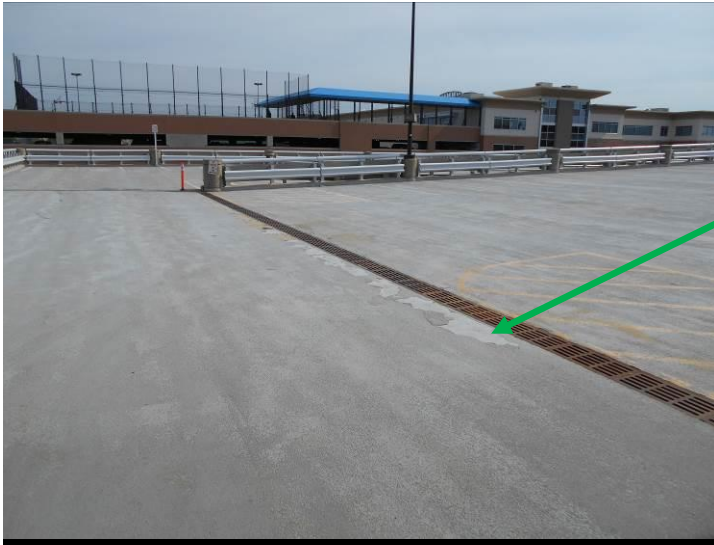
Photo 1

Damaged traffic topping at trench drain.

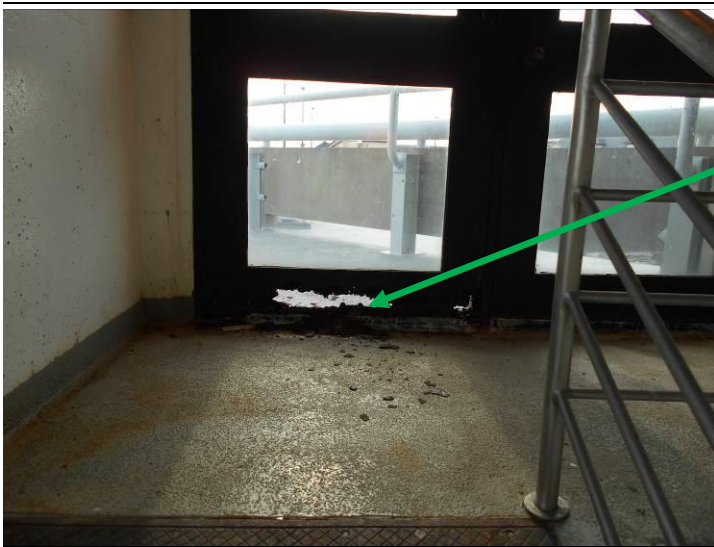
Photo 12

Heavily rusted stair tower door.

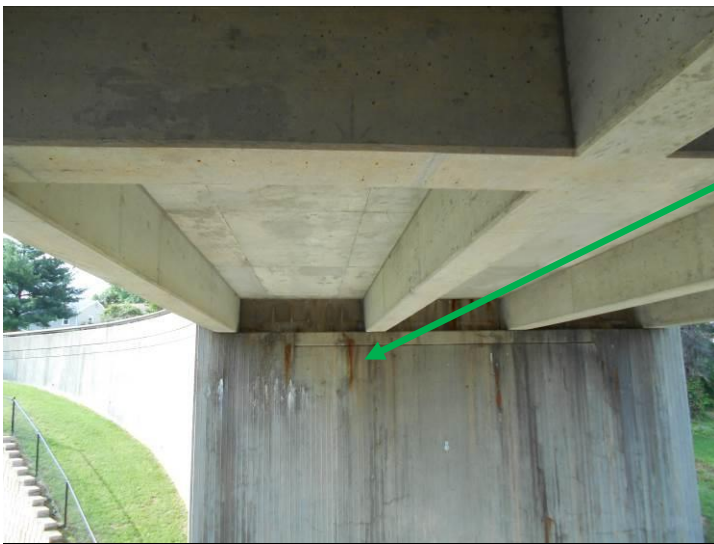
Photo 15

Rusting and leaching at bridge abutment.

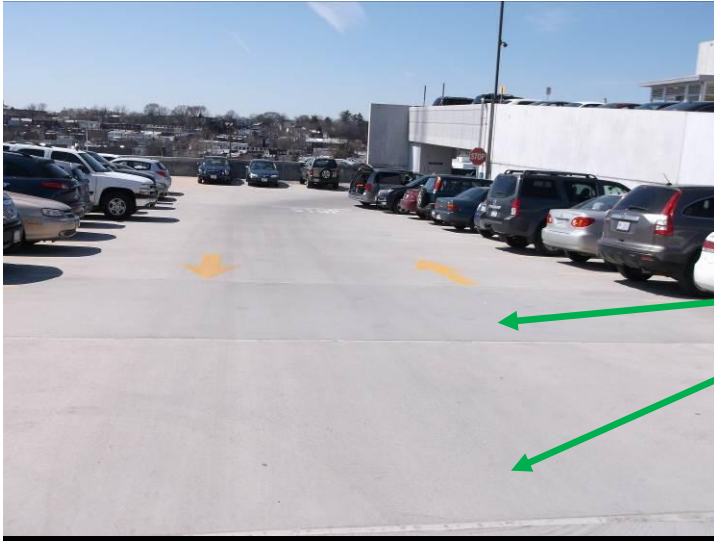
Photo 1

Top level sealant in good condition

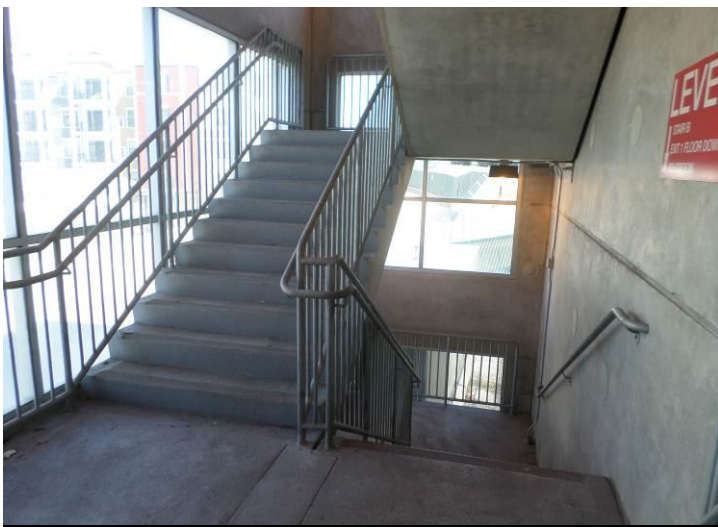
Photo 6

Stairs are in good condition. Black stair nosings provide color contrast so no yellow paint is recommended.

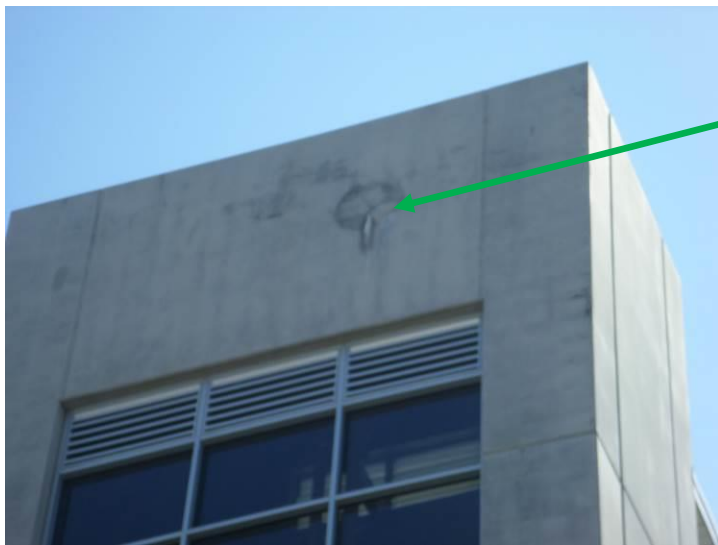
Photo 9

Leaching through façade, spall on stair tower.
