Northern Bus Garage

Noise, Vibration, and Dust Monitoring Report (December 2023)

WMATA Bus Garage Monthly Report

December 2023

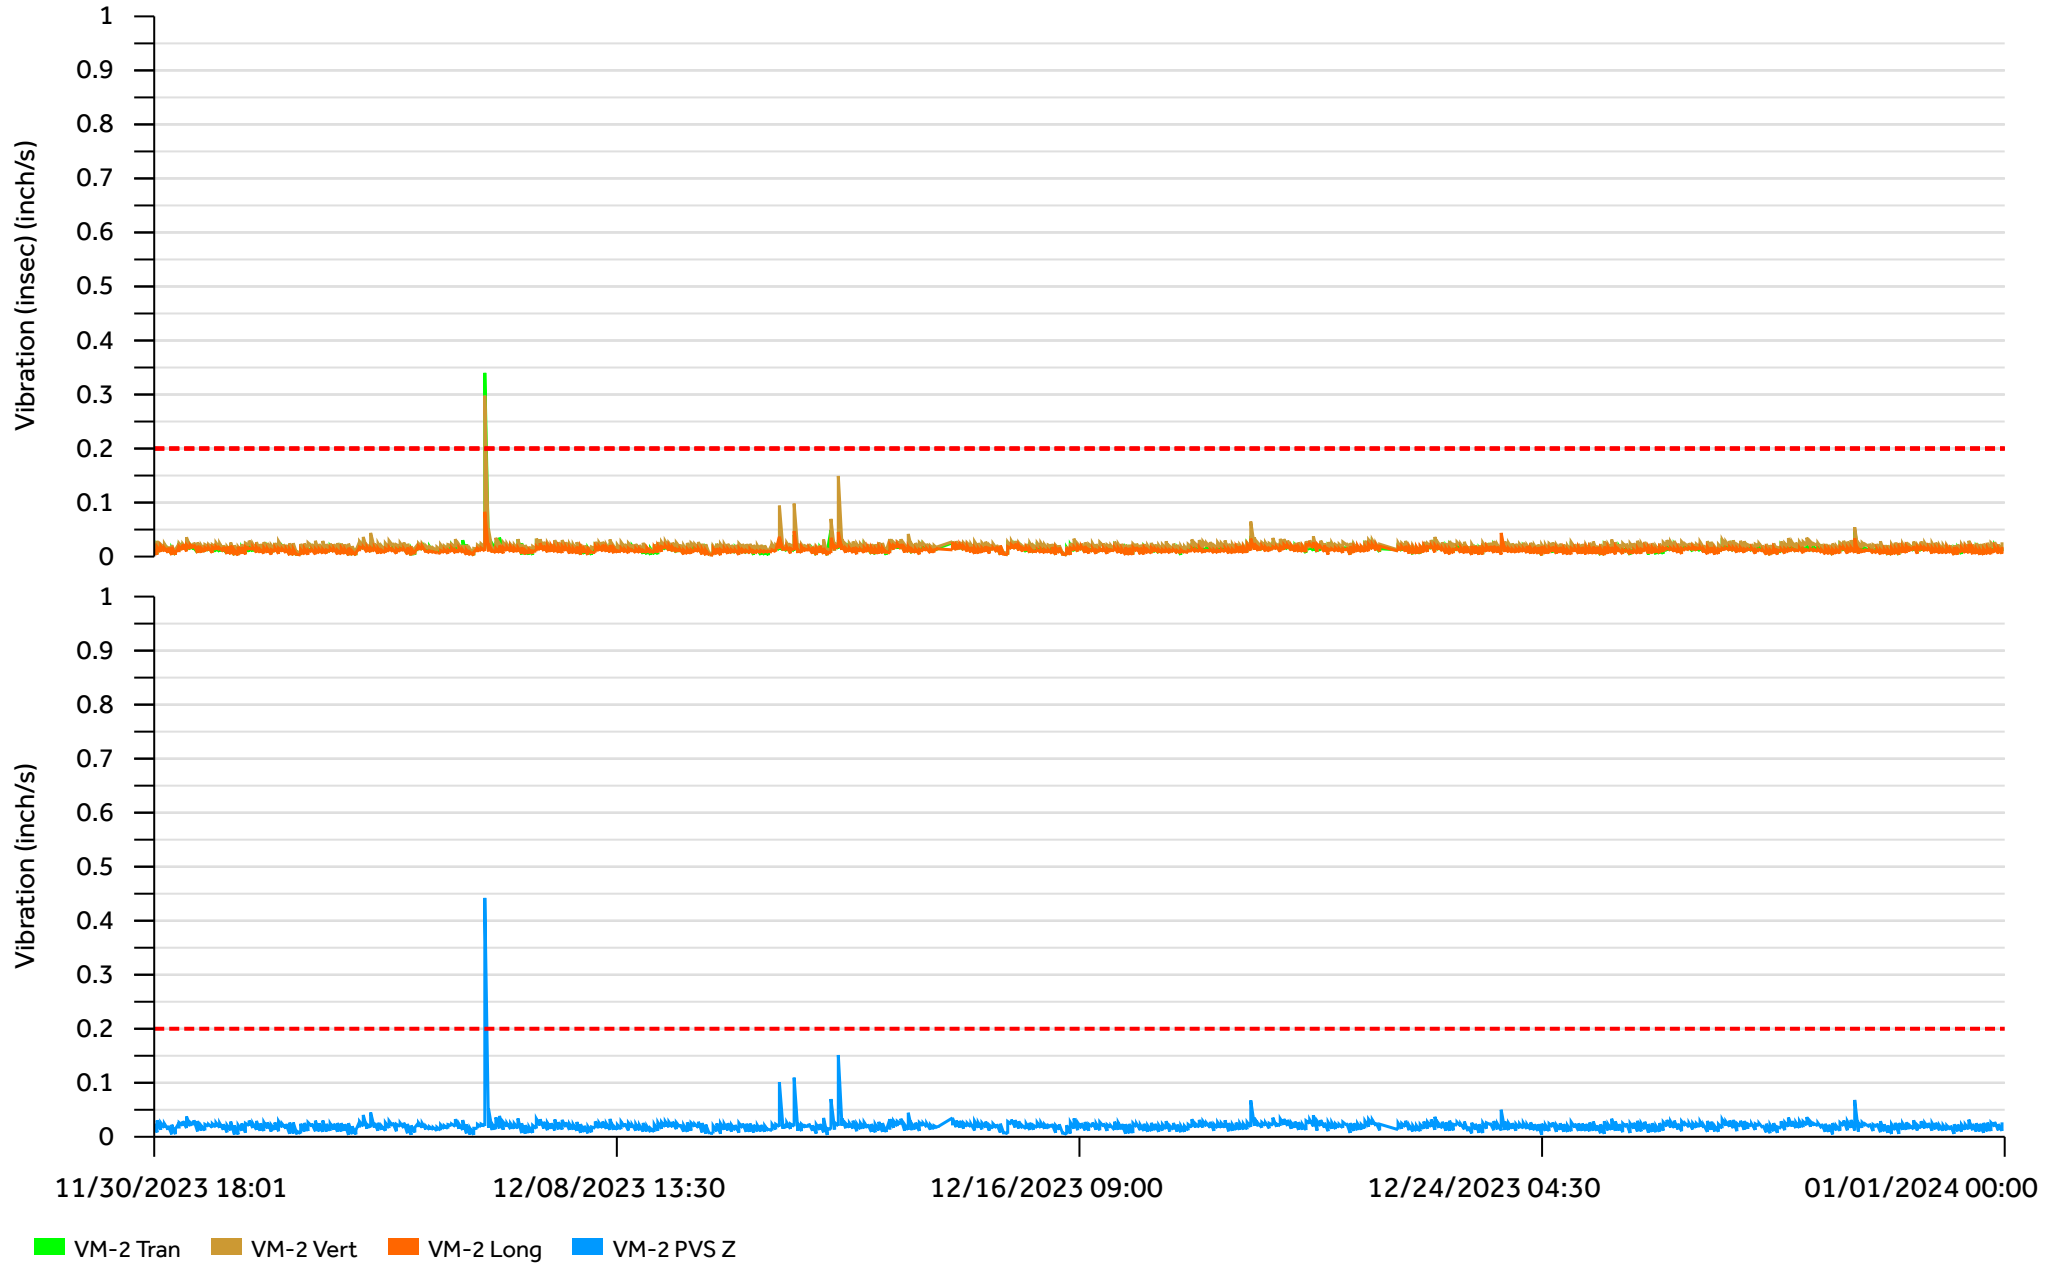
Graph 2:
VM-2- Vibration Monitor

A single vibration spike of 0.34 in/sec occurred at the VM2 location on December 6 at 09:25 am due to the monitor being bumped by a piece of equipment.

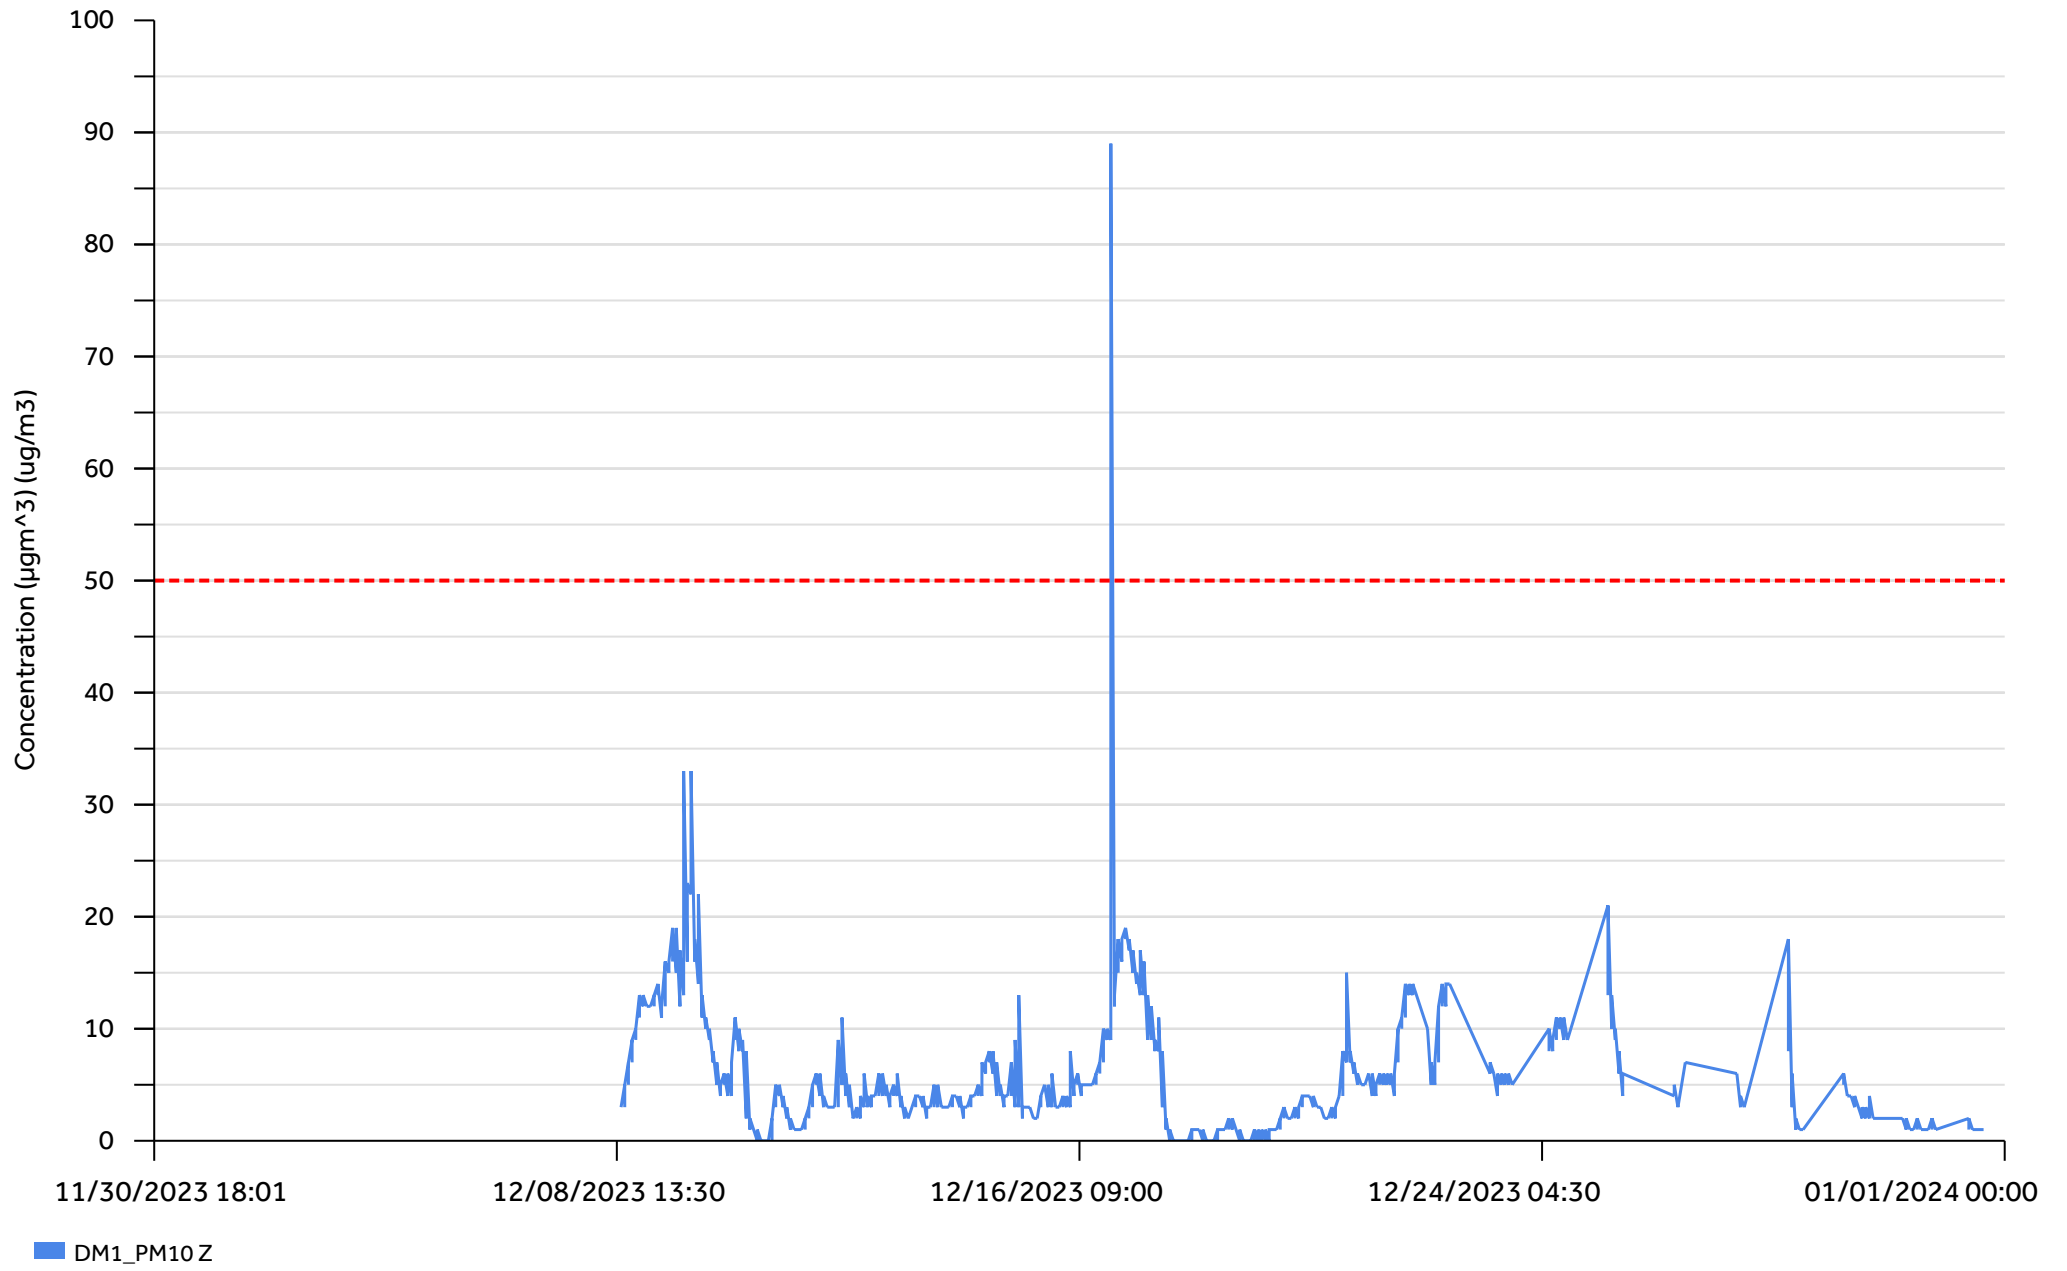
Graph 6:
DM1 - PM10

Higher winds in the evening of December 2 caused exceedances from 9:36pm to 9:47 pm. DM2 recorded a PM2.5 of 41. DM3 recorded a PM2.5 of 51 and a PM10 of 53. More winds on the evening of December 16 caused an exceedance at 11:12 pm. DM1 recorded a PM2.5 of 65 and a PM10 of 89.
