Northern Bus Garage

Noise, Vibration, and Dust Monitoring Report (November 2023)

WMATA Bus Garage Monthly Report

November 2023

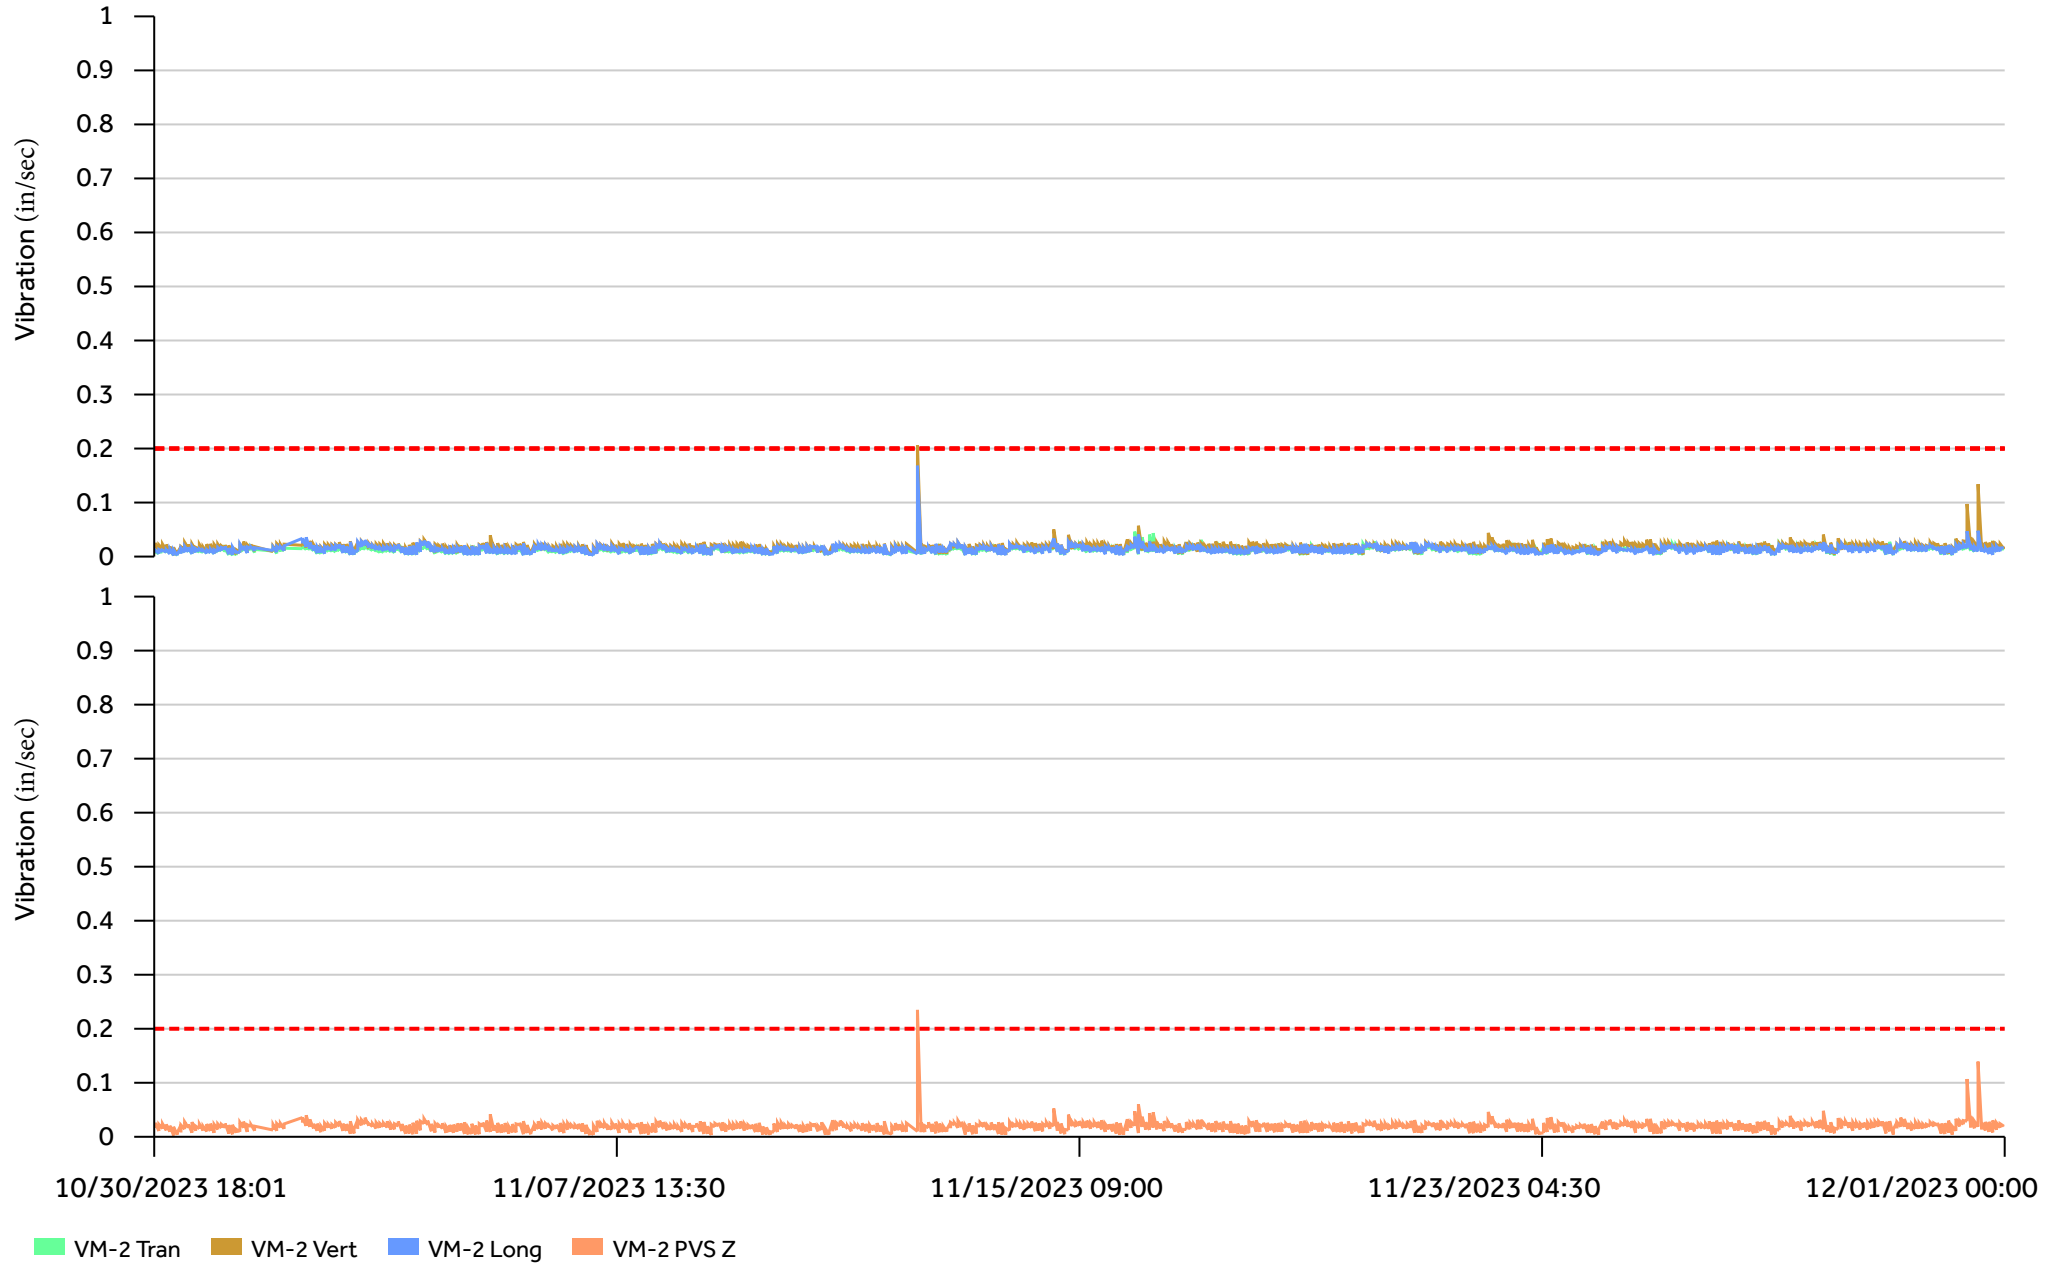
Graph 2:
VM-2- Vibration Monitor

There was one vibration exceedances in the month of November 2023 due to a battery swap of the equipment. A single vibration spike occurred at the VM2 location at 0.21in/sec on 11/12 at 4:06pm.

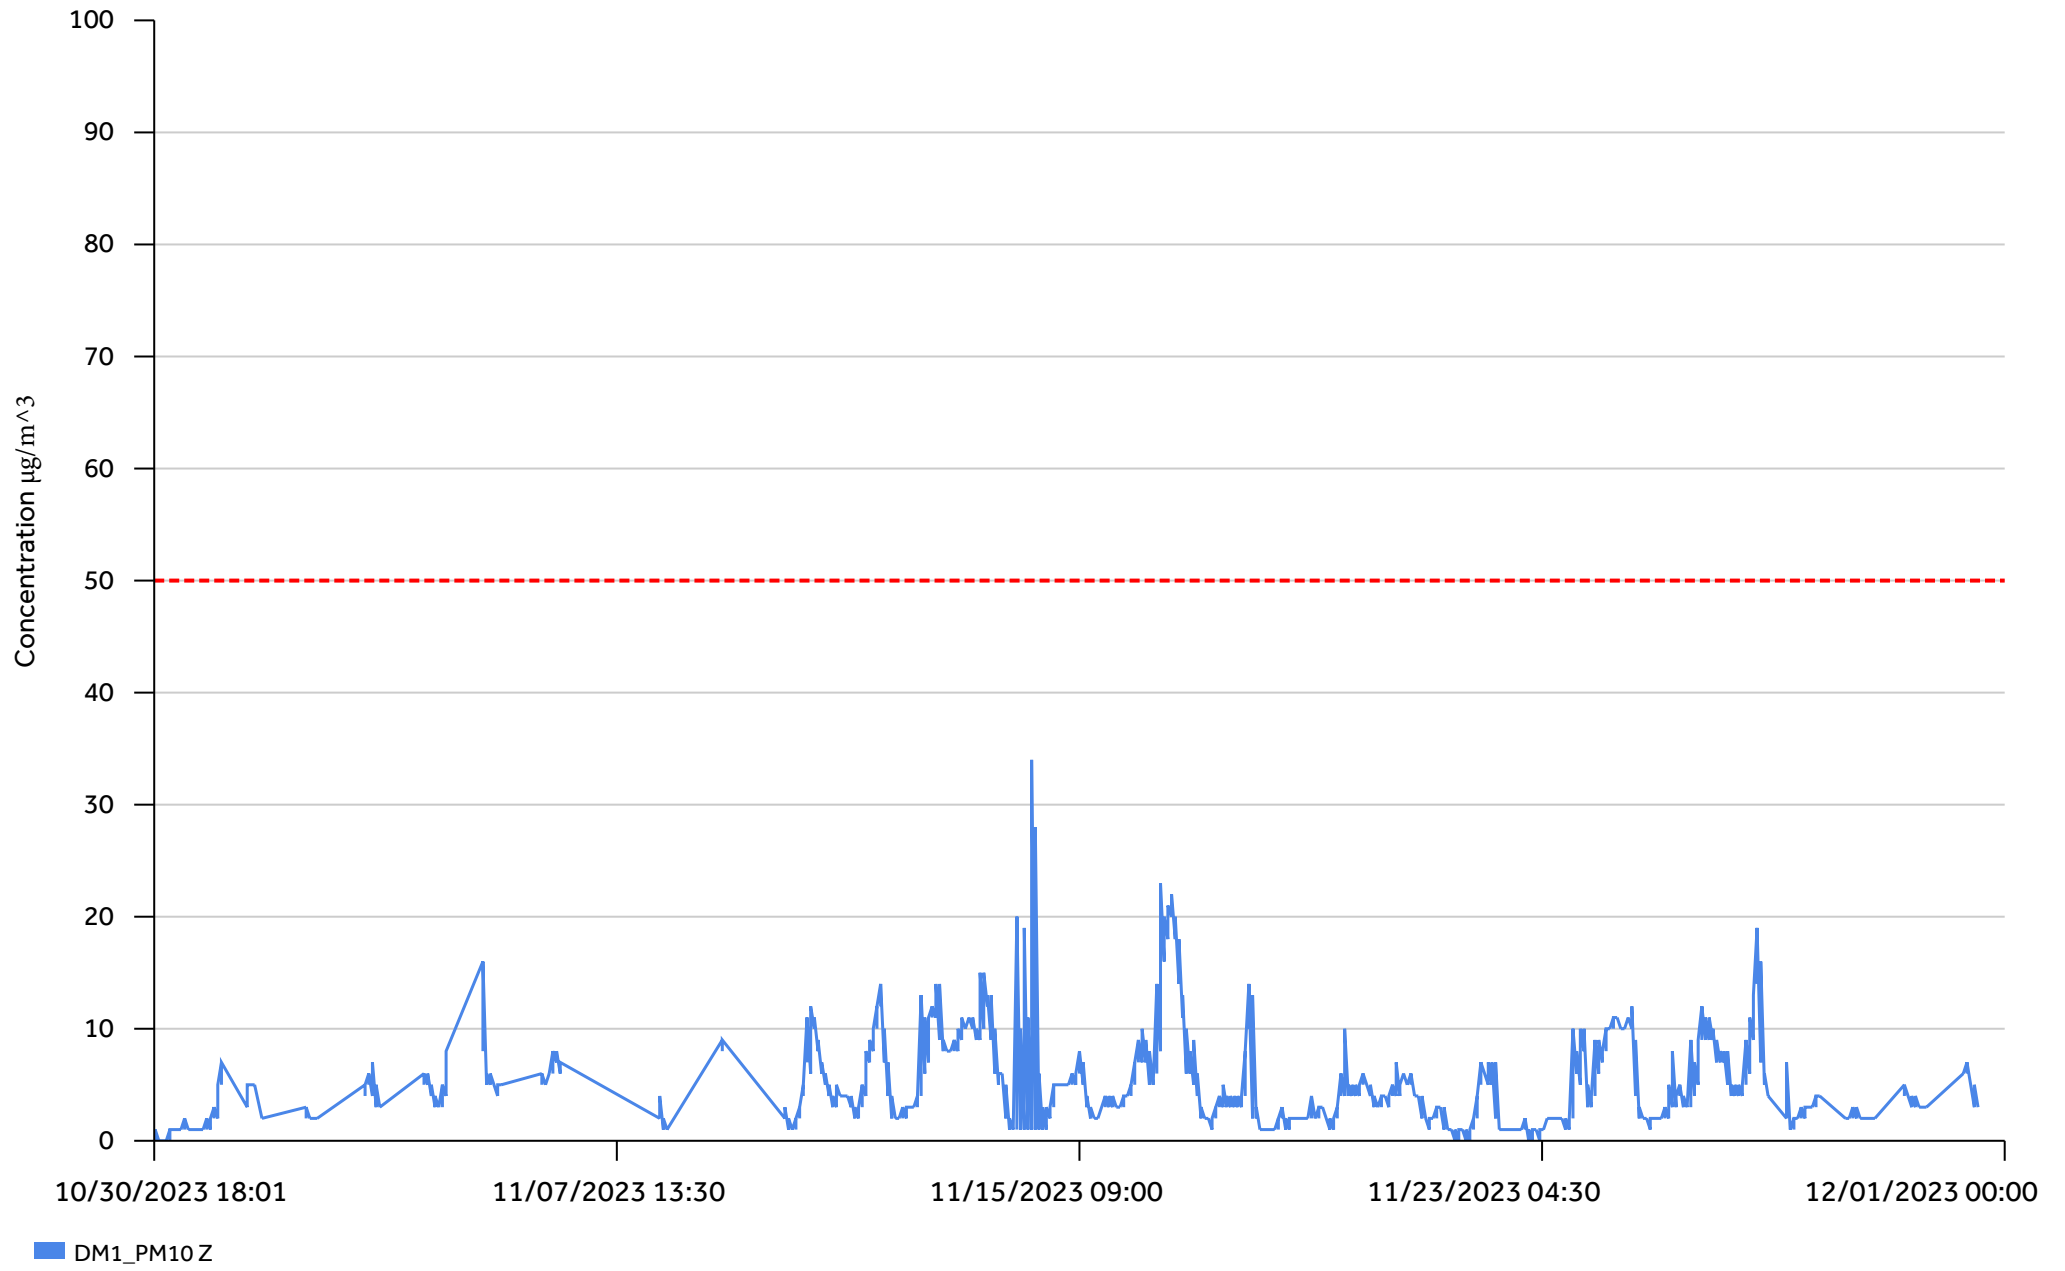
Graph 6:
DM1 - PM10

DM1 began experiencing power interruptions until the battery was exchanged on November 10. Two of the units have been fitted with hardware that allows tracking and alarming upon low voltage. Due to site restrictions, DM1 cannot be plugged into main power so continued battery swaps will be the interim solution until site conditions change.

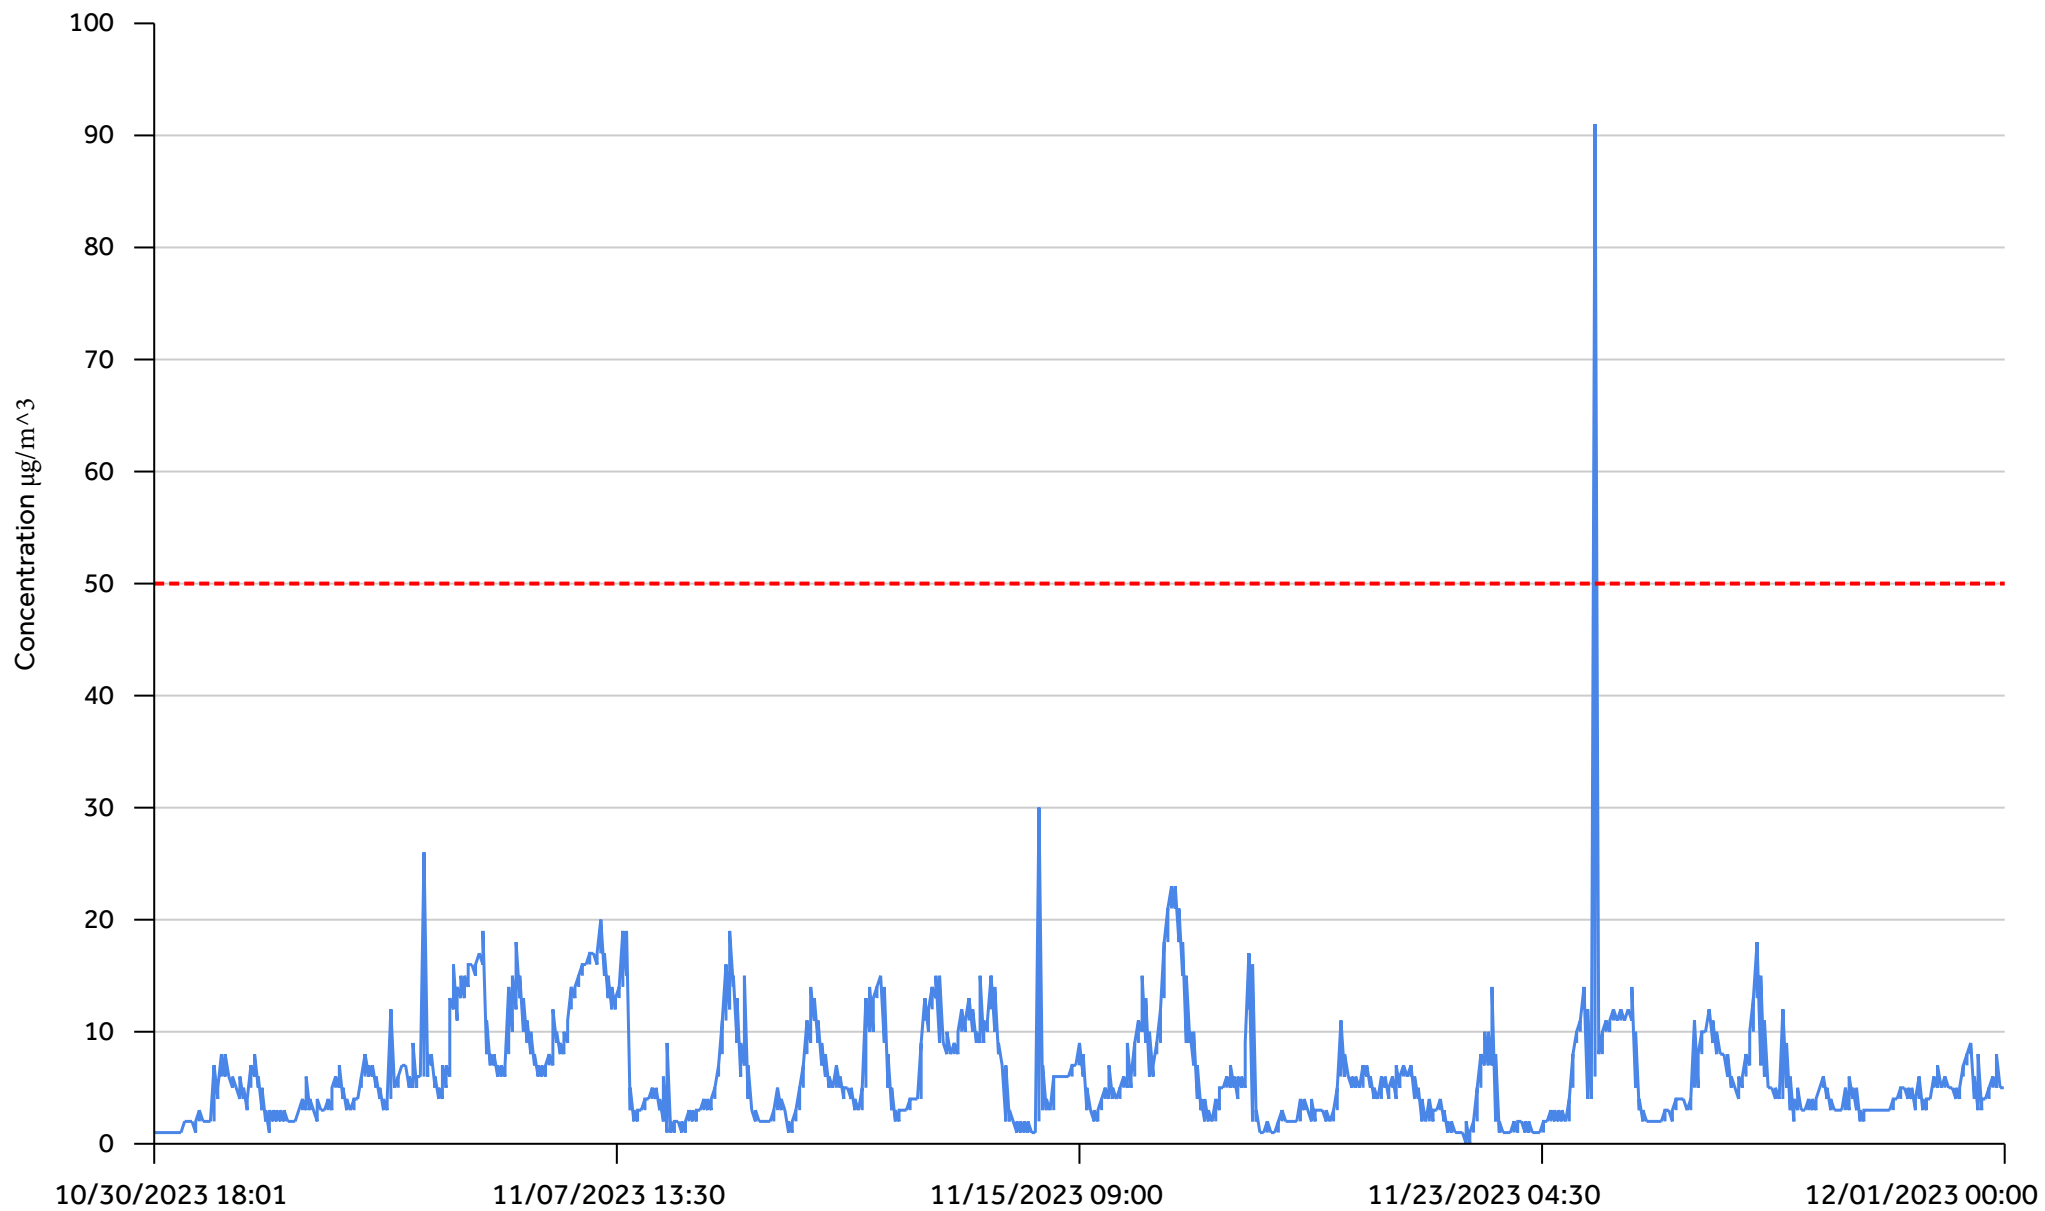
Graph 8:

There was one air quality exceedance in the month of November 2023. DM3 recorded a PM_{2.5} of 82 µg/m³ and a PM₁₀ of 91 µg/m³ on November 24 at 3:02 am due to higher winds.
