Northern Bus Garage

Noise, Vibration, and Dust Monitoring Report (July 2025)

Noise, Vibration, and Dust levels were monitored as part of the reconstruction of Northern Bus Garage, 4615 14th Street, NW, Washington, DC, for the month of July 2025.

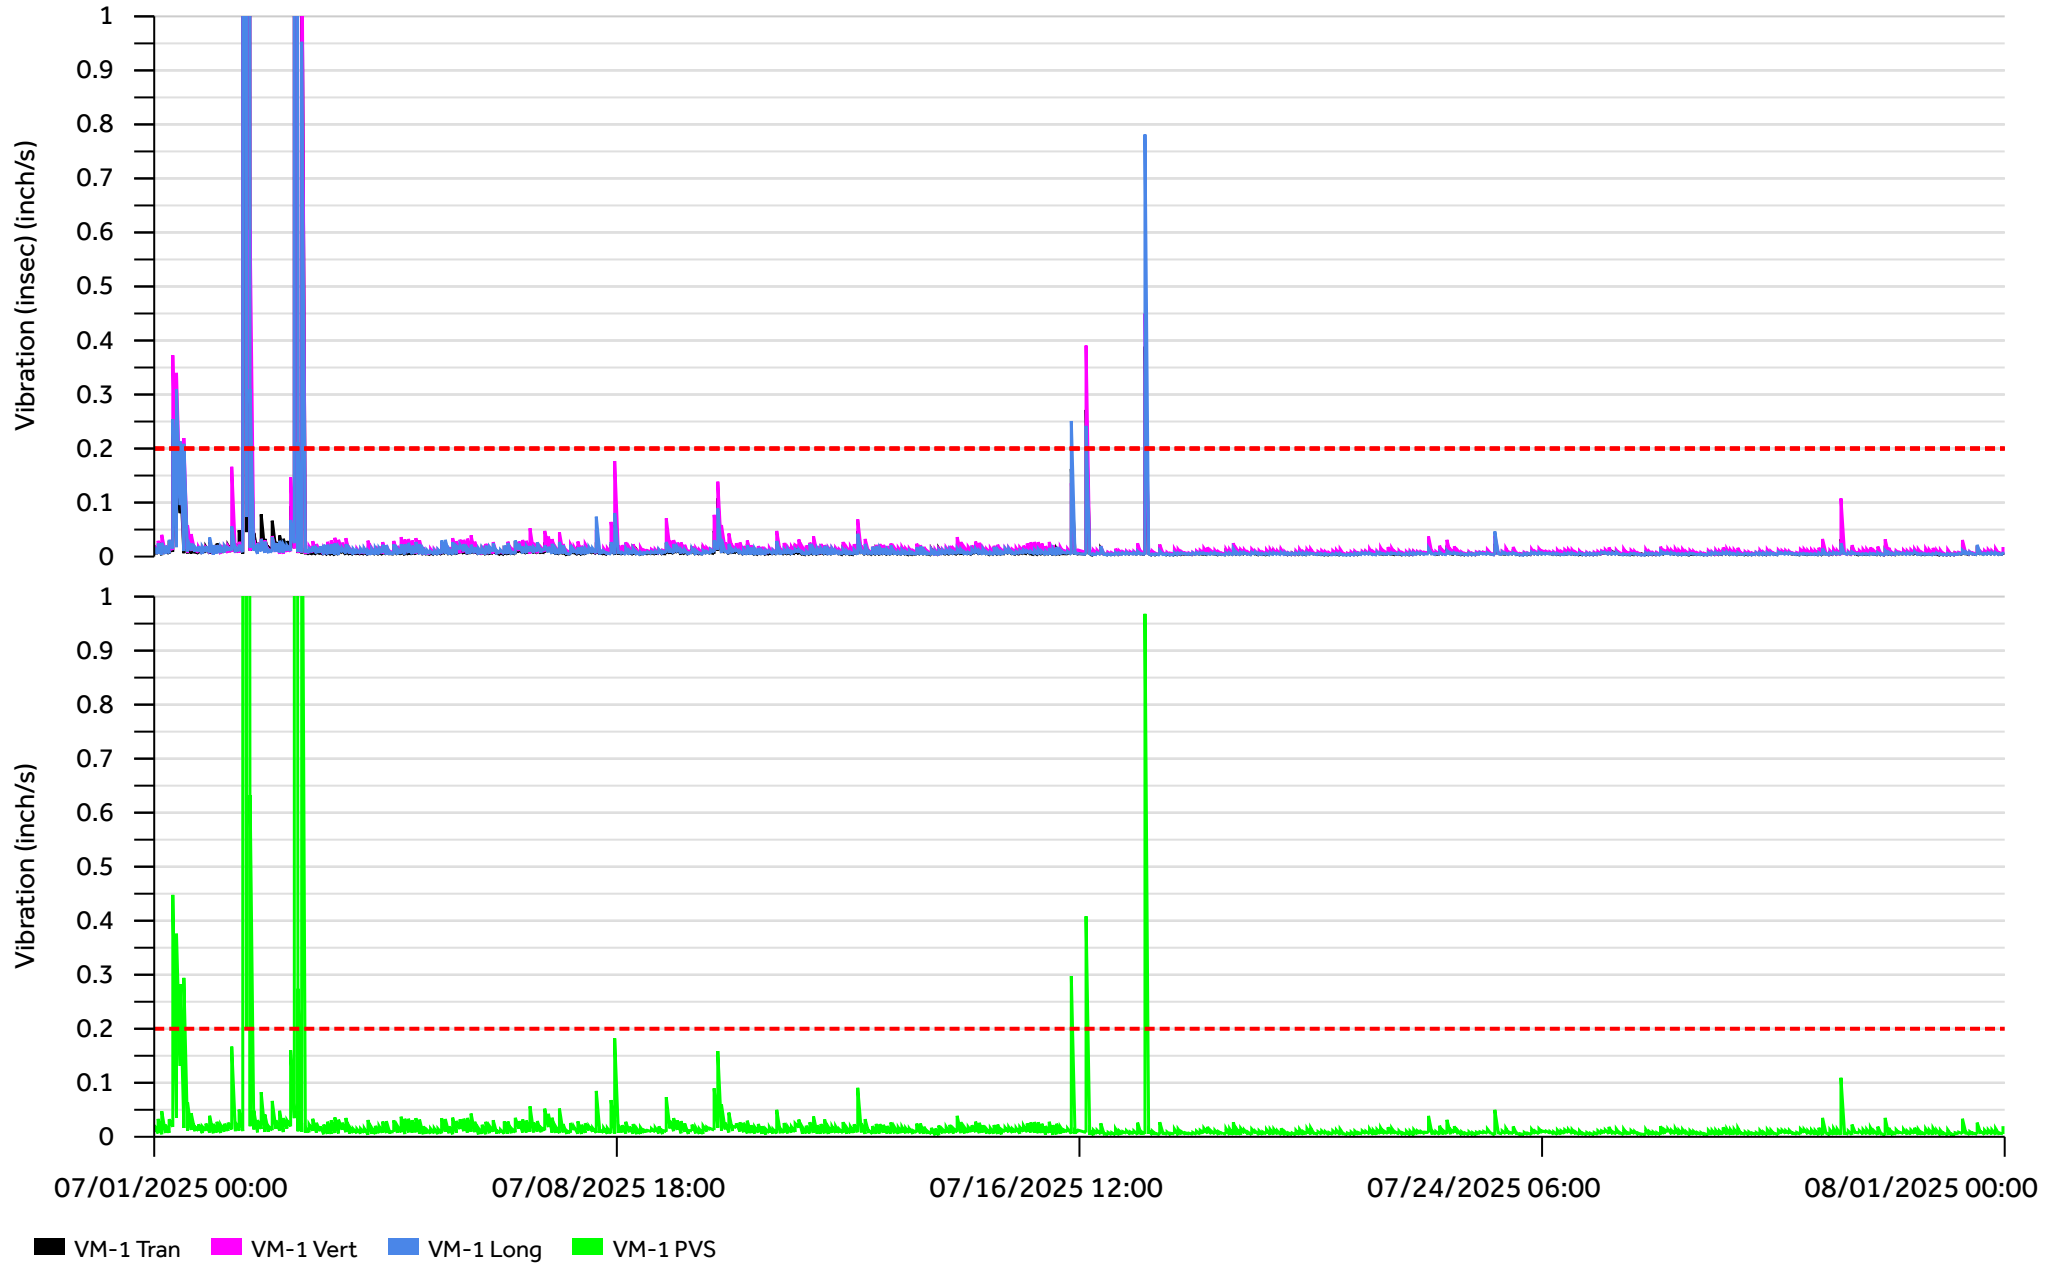
Graph 1

Ninety-four (94) vibration exceedances were recorded at VM1, and two (2) more at VM2 during the month of July. The large number of events on July 1, July 2, and July 16 were caused by a subcontractor pavement breaking outside of the project fence adjacent to the VM1 vibration monitor. In at least two cases they moved our equipment causing 7.0 to 10.0 in/sec false readings. The VM2 exceedances were both short single impact events of unknown origin. A sample of the Waveform reports may be found in Attachments B and C.

- VM1 – Exceedance with a reading of 0.23 in/sec on July 1 at 08:09.
- VM1 – A concentrated series of 24 exceedances caused by an impact breaker or similar equipment with typical values from 0.20-0.28 in/sec with a few peaks from 0.31 to 0.37 in/sec on July 1 from 08:39 to 09:07.

- VM1 – Exceedance with a reading of 0.21 in/sec on July 1 at 10:54.
- VM1 – Exceedance with a reading of 0.20 in/sec on July 1 at 11:32.
- VM1 – Exceedance with a reading of 0.20 in/sec on July 1 at 11:34.

- VM1 – Exceedance with a reading of 0.20 in/sec on July 1 at 11:50.
- VM1 – Exceedance with a reading of 0.22 in/sec on July 1 at 12:15.
- VM1 – A concentrated series of 50 exceedances caused by an impact breaker or similar equipment with typical values from 0.20-0.83 in/sec with a few peaks from 8.02 to 10.0 in/sec on July 2 from 13:02 to 14:58.

- VM1 – Exceedance with a reading of 9.3 in/sec on July 3 at 09:18. This was due to moving of equipment.
- VM1 – Exceedance with a reading of 0.21 in/sec on July 3 at 10:40.

- VM1 – Exceedance with a reading of 1.27 in/sec on July 3 at 11:51.
- VM1 – Exceedance with a reading of 0.25 in/sec on July 16 at 09:00.
- VM1 – A concentrated series of 9 exceedances caused by an impact breaker or similar equipment with values from 0.24-0.39 in/sec on July 16 from 14:47 to 14:58.
- VM1 – Exceedance with a reading of 0.78 in/sec on July 17 at 14:58.
- VM2 – Exceedance with a reading of 0.472 in/sec on July 3 at 09:20.
- VM2 – Exceedance with a reading of 0.298 in/sec on July 28 at 11:33.

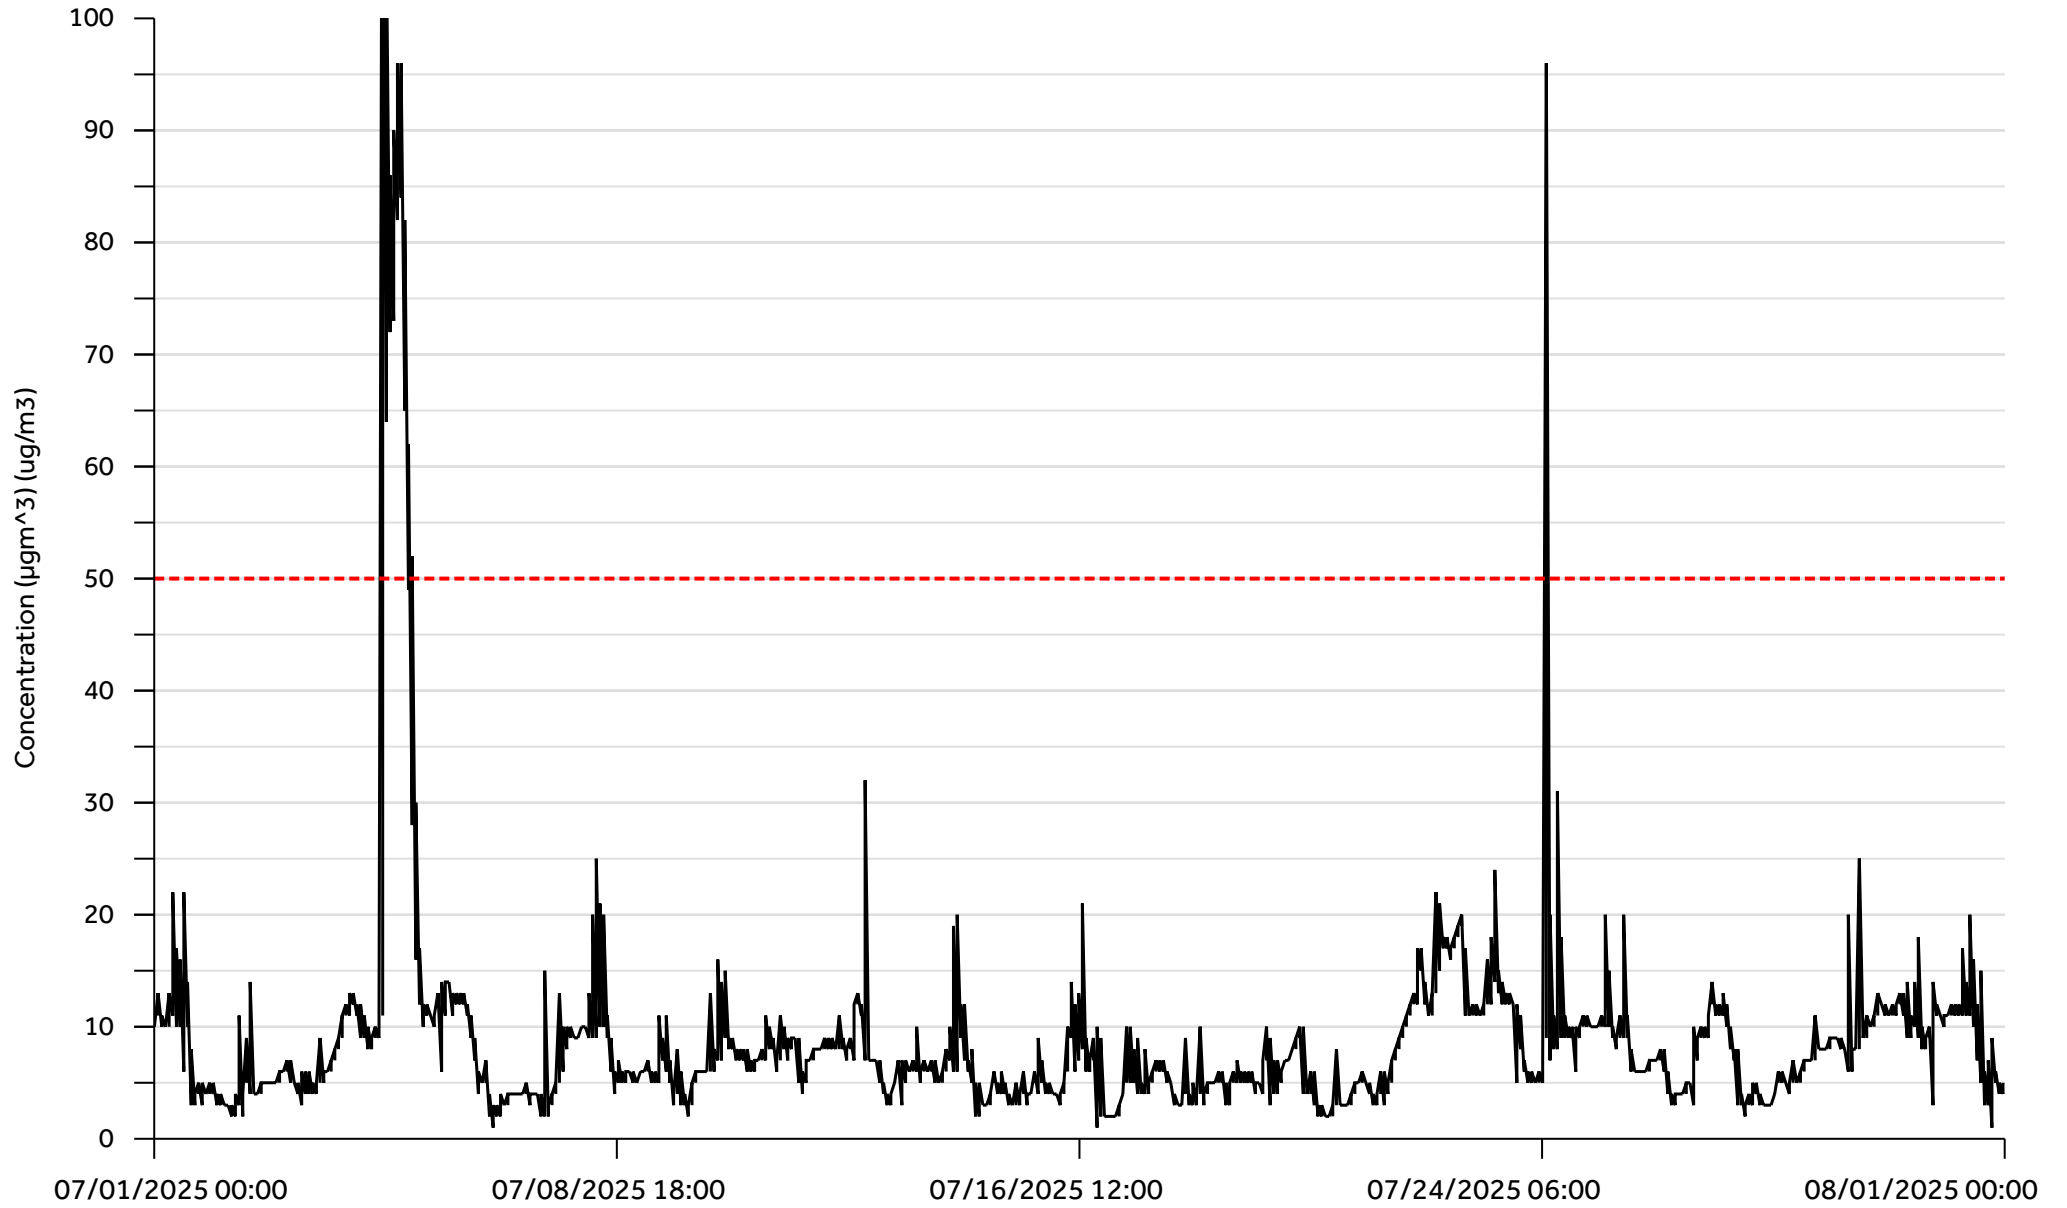
Graph 6

Several air quality exceedances occurred during the month of July 2025. All three units recorded poor air quality on the evening of 7/4, likely caused by fireworks for local Independence Day celebrations. DM1 also recorded an emission the morning of July 24. DM2 also recorded an emission the morning of July 7.

- DM1 – The PM2.5 limit was exceeded with a peak reading of 145 µg/m³ from July 4 from 20:00 – July 5 08:13. The PM10 limit was exceeded with a peak reading of 145 µg/m³ on from July 4 from 20:00 – July 5 08:13. The peak was at 21:13.
- DM2 – The PM2.5 limit was exceeded with a peak reading of 135 µg/m³ from July 4 from 20:53 – July 5 06:38. The PM10 limit was exceeded with a peak reading of 135 µg/m³ on from July 4 from 20:00 – July 5 06:38. The peak was at 21:38.
- DM3 – The PM2.5 limit was exceeded with a peak reading of 194 µg/m³ from July 4 from 20:00 – July 5 08:01. The PM10 limit was exceeded with a peak reading of 194 µg/m³ on from July 4 from 20:00 – July 5 08:01. The peak was at 22:16.

- DM1 – Exceedance of the PM2.5 limit with a reading of 57 µg/m³ on July 24 at 07:58.
- DM1 – Exceedance of the PM10 limit with a reading of 96 µg/m³ on July 24 at 07:58.
- DM2 – Exceedance of the PM2.5 limit with a reading of 73 µg/m³ on July 7 at 08:08.
- DM2 – Exceedance of the PM10 limit with a reading of 132 µg/m³ on July 7 at 08:08.
