Northern Bus Garage

Noise, Vibration, and Dust Monitoring Report (June 2025)

Noise, Vibration, and Dust levels were monitored as part of the reconstruction of Northern Bus Garage, 4615 14th Street, NW, Washington, DC, for the month of June 2025.

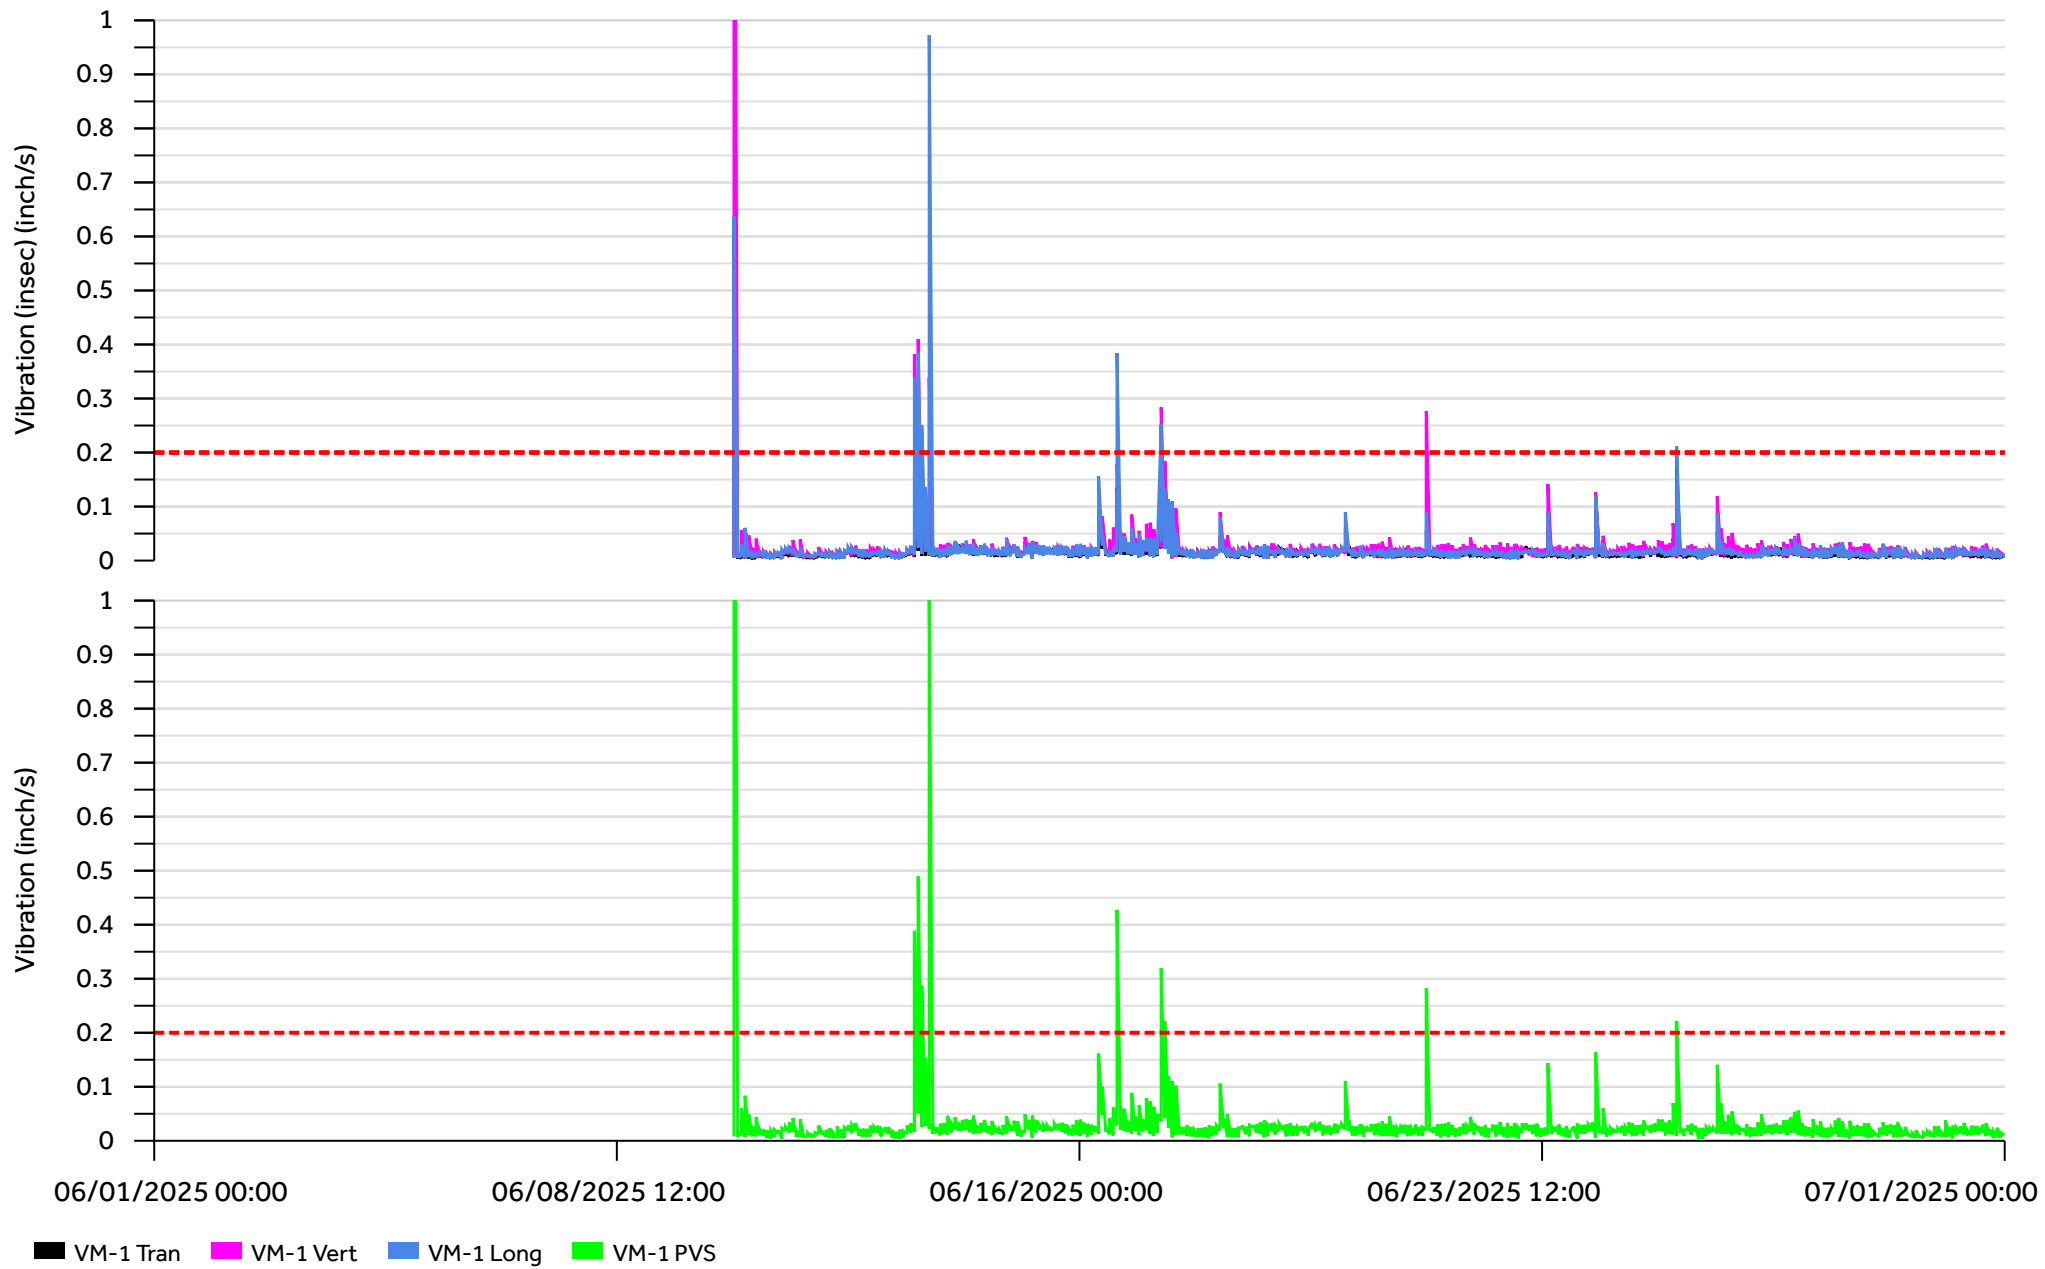
Graph 1

Twenty-three (23) vibration exceedances were recorded at VM1, and seven (7) more at VM2 during the month of June. These exceedances have been reviewed. The VM1 exceedances contain legitimate vibration measurements that appear to be pavement breaking activities performed by Pepco's DC Plug Contractors. The VM2 exceedances were short events indicative of disturbance near the sensor such as equipment staging or other ancillary activities. Waveform reports may be found in Attachments B and C.

- VM1 – Exceedance with a reading of 1.90 in/sec on June 10 at 10:31. Reinstall. Bump test.
- VM1 – Exceedance with a reading of 0.23 in/sec on June 10 at 10:43.
- VM1 – Exceedance with a reading of 0.25 in/sec on June 13 at 09:07.
- VM1 – Exceedance with a reading of 0.22 in/sec on June 13 at 09:08.
- VM1 – Exceedance with a reading of 0.38 in/sec on June 13 at 09:09.
- VM1 – Exceedance with a reading of 0.25 in/sec on June 13 at 09:10.

- VM1 – Exceedance with a reading of 0.22 in/sec on June 13 at 09:11.
- VM1 – Exceedance with a reading of 0.22 in/sec on June 13 at 09:12.
- VM1 – Exceedance with a reading of 0.25 in/sec on June 13 at 09:13.

- VM1 – Exceedance with a reading of 0.40 in/sec on June 13 at 09:14.
- VM1 – Exceedance with a reading of 0.29 in/sec on June 13 at 09:15.
- VM1 – Exceedance with a reading of 0.22 in/sec on June 13 at 09:16.

- VM1 – Exceedance with a reading of 0.20 in/sec on June 13 at 09:18.
- VM1 – Exceedance with a reading of 0.25 in/sec on June 13 at 09:43.
- VM1 – Exceedance with a reading of 0.38 in/sec on June 13 at 09:44.

- VM1 – Exceedance with a reading of 0.25 in/sec on June 13 at 11:05.
- VM1 – Exceedance with a reading of 0.97 in/sec on June 13 at 14:41.
- VM1 – Exceedance with a reading of 0.38 in/sec on June 16 at 15:24.

- VM1 – Exceedance with a reading of 0.25 in/sec on June 17 at 07:53.
- VM1 – Exceedance with a reading of 0.28 in/sec on June 17 at 08:51.
- VM1 – Exceedance with a reading of 0.28 in/sec on June 21 at 15:28.

- VM1 – Exceedance with a reading of 0.22 in/sec on June 21 at 15:38.
- VM1 – Exceedance with a reading of 0.21 in/sec on June 25 at 16:30.
- VM2 – Exceedance with a reading of 0.21 in/sec on June 3 at 06:44.

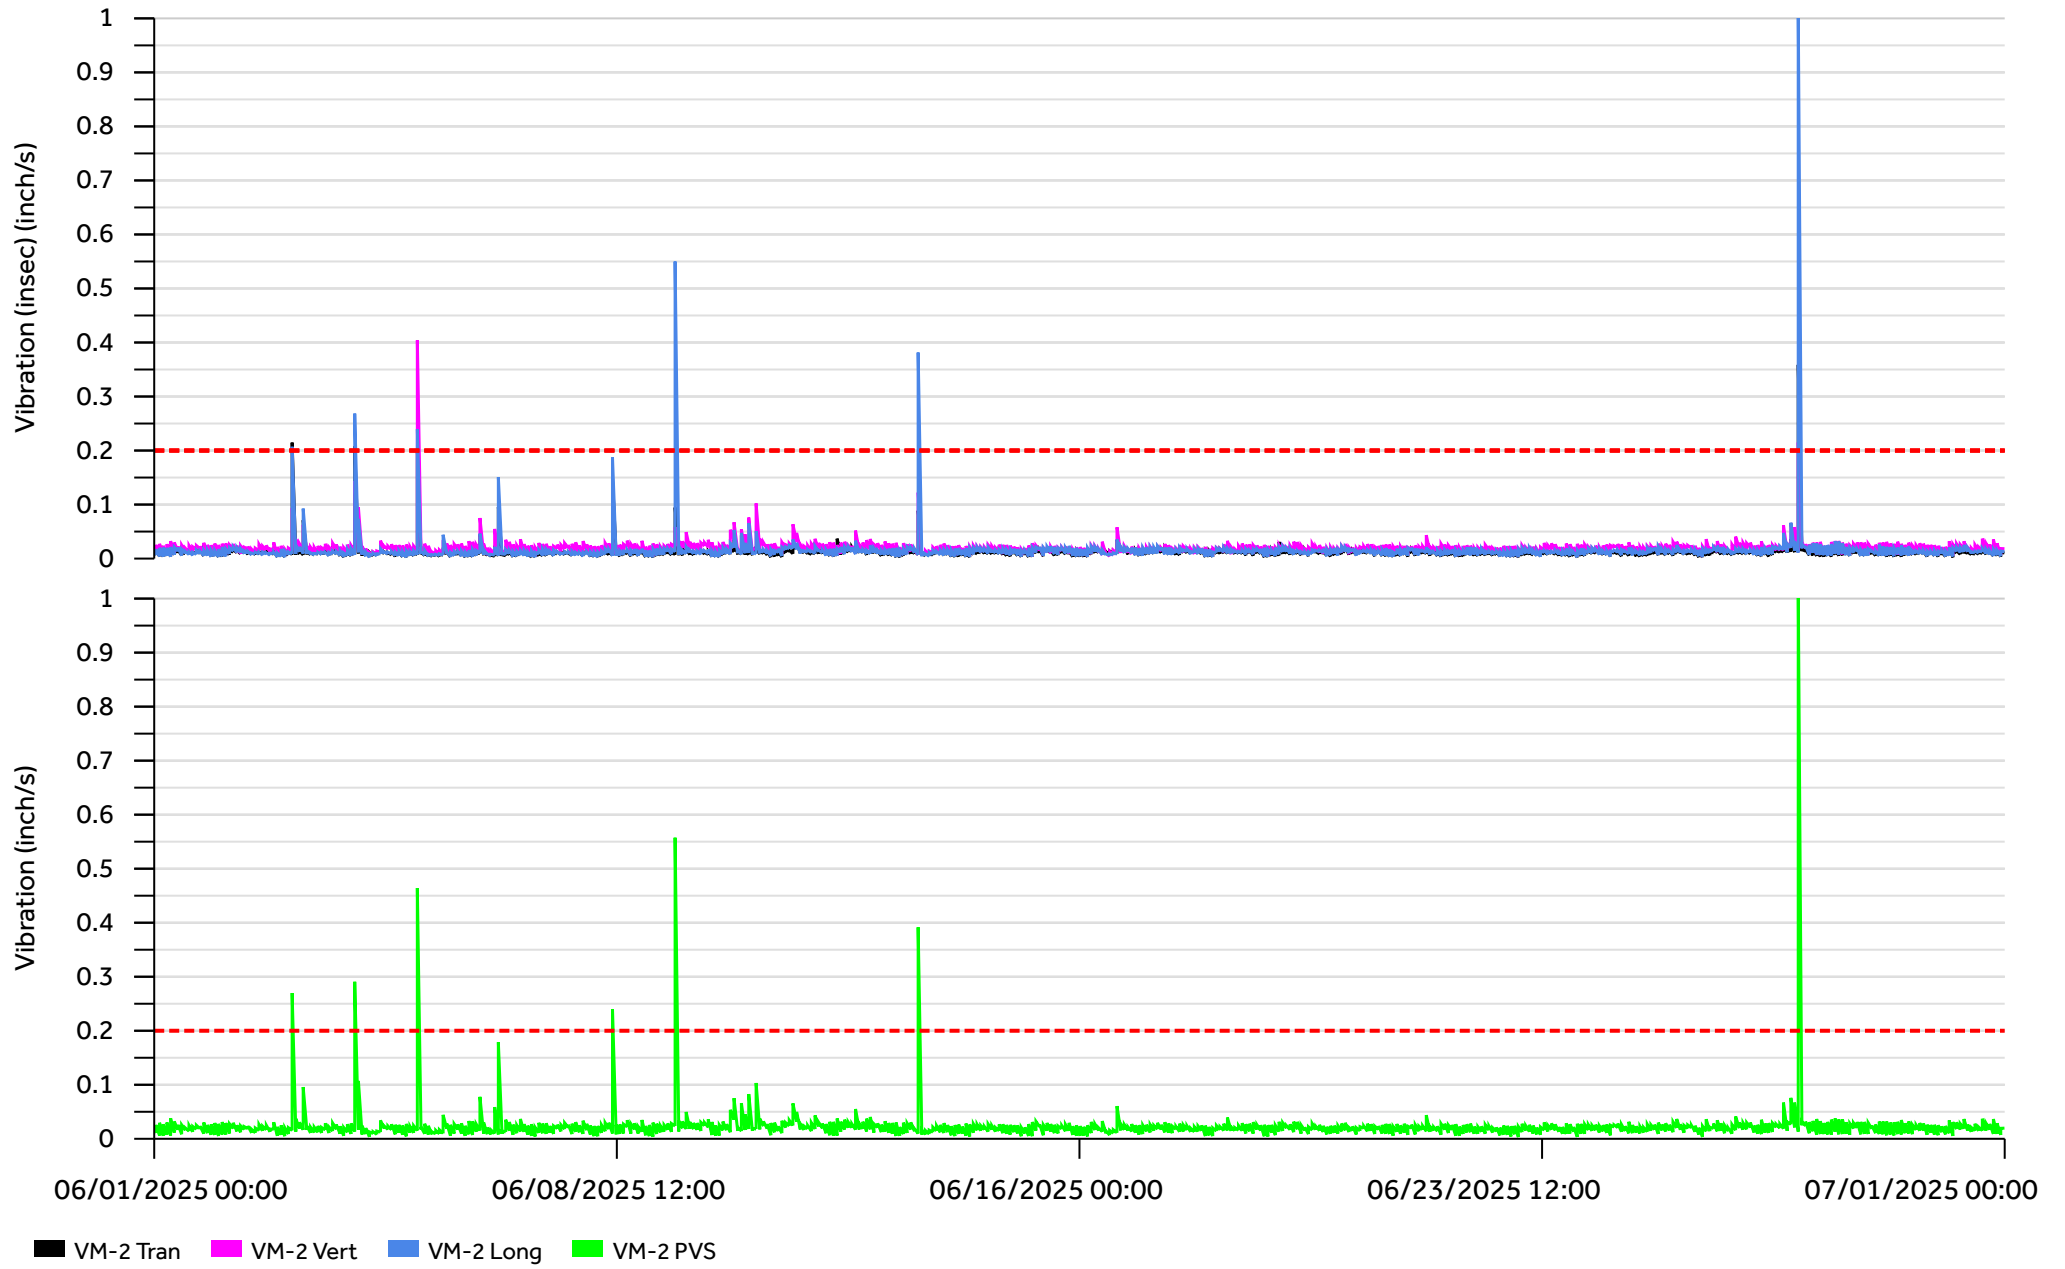
Graph 2

- VM2 – Exceedance with a reading of 0.23 in/sec on June 4 at 06:58.
- VM2 – Exceedance with a reading of 0.27 in/sec on June 4 at 07:11.
- VM2 – Exceedance with a reading of 0.40 in/sec on June 5 at 06:42.

- VM2 – Exceedance with a reading of 0.55 in/sec on June 9 at 11:48.
- VM2 – Exceedance with a reading of 0.38 in/sec on June 13 at 09:31.
- VM2 – Exceedance with a reading of 1.02 in/sec on June 27 at 15:59.

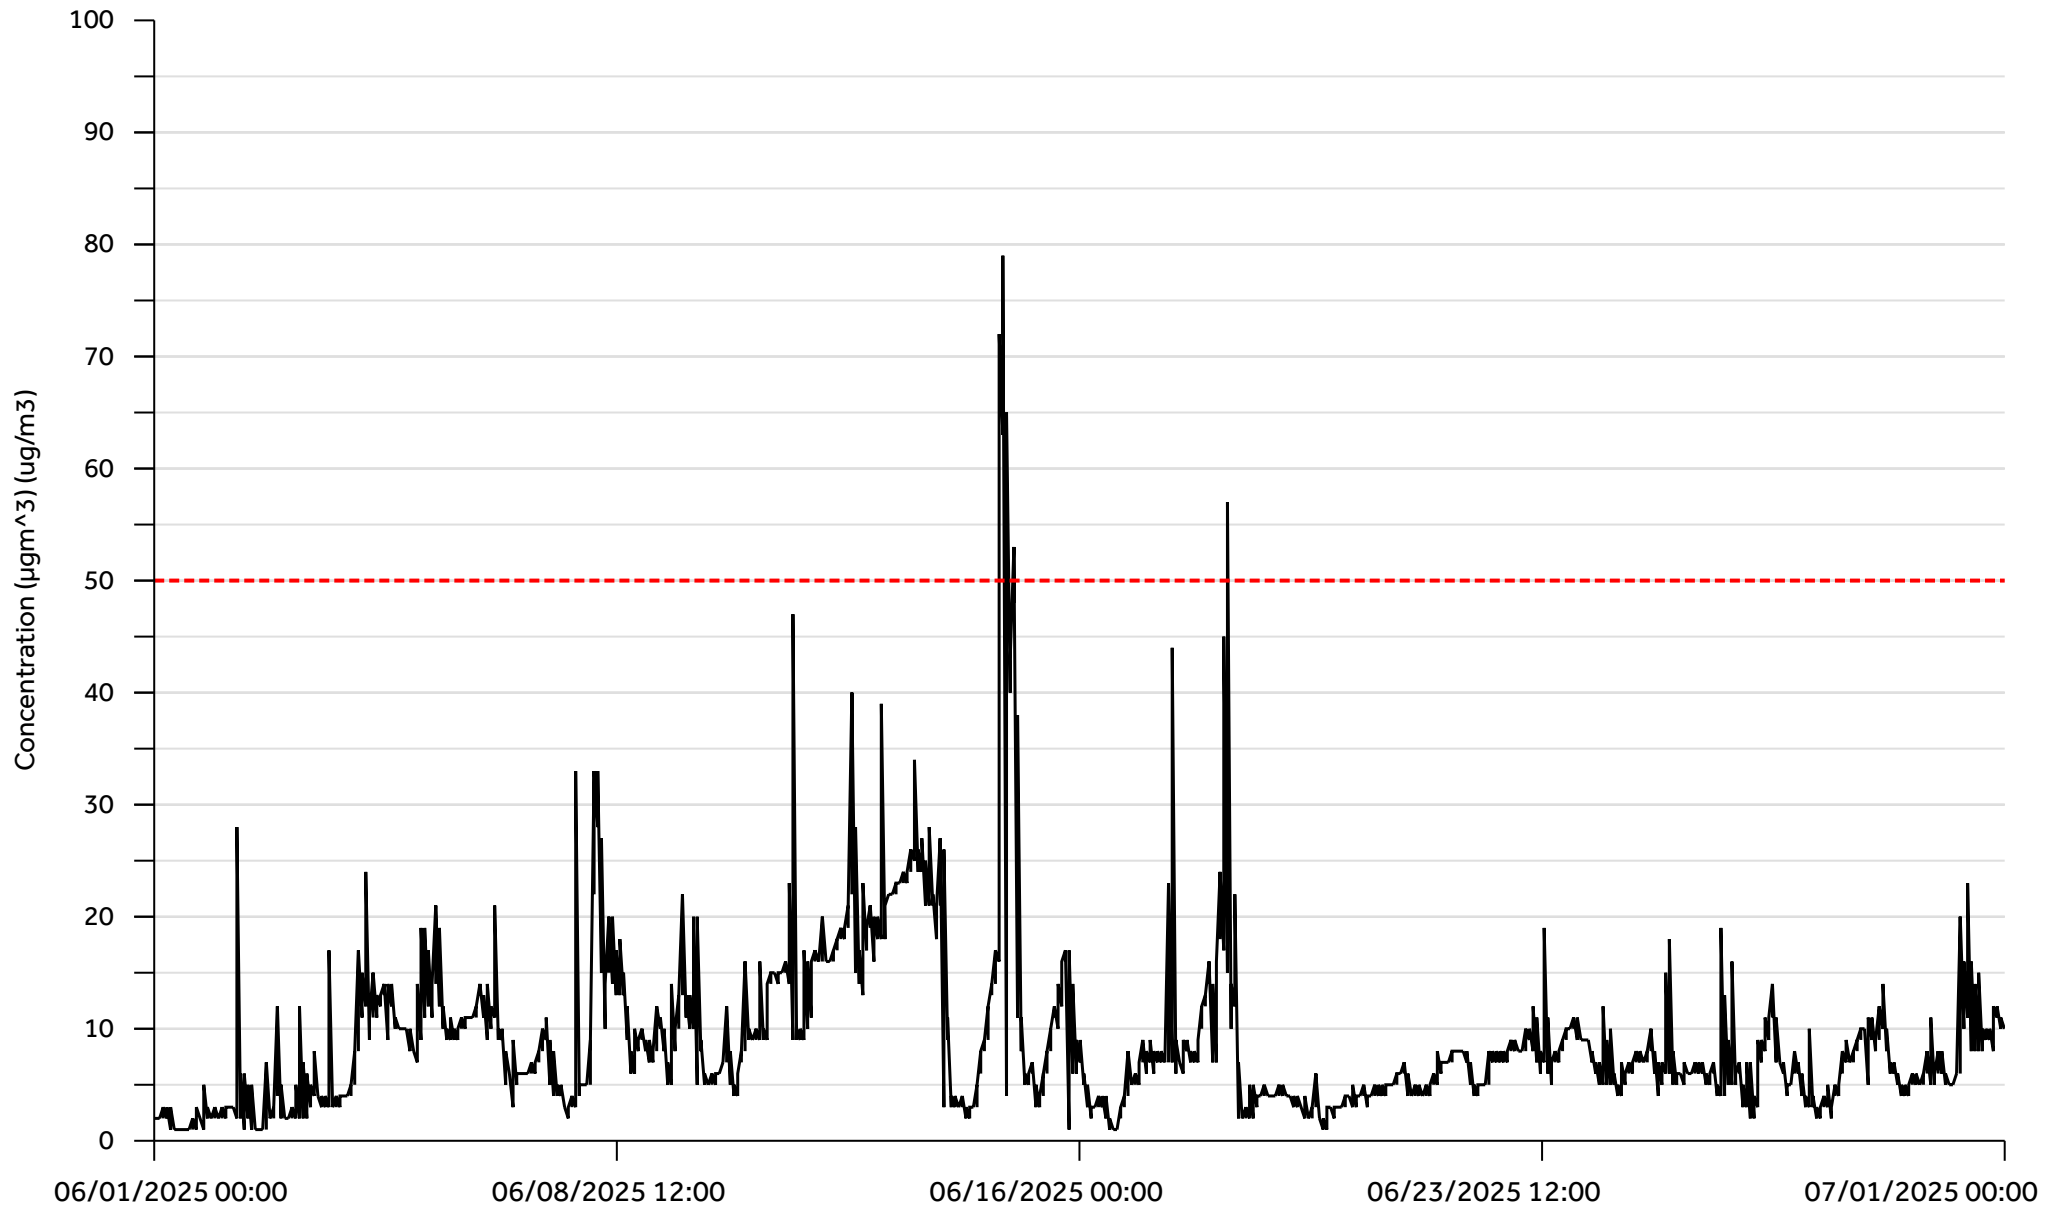
Graph 6

- DM1 – The PM2.5 limit was exceeded with a peak reading of 79 µg/m³ on June 14 from 17:56-23:56. The PM10 limit was exceeded with a peak reading of 79 µg/m³ on June 14 from 17:56-23:41. The peak was at 18:11.
- DM2 – The PM2.5 limit was exceeded with a peak reading of 67 µg/m³ on June 14 from 17:53-23:38. The PM10 limit was exceeded with a peak reading of 67 µg/m³ on June 14 from 18:08-19:53. The peak was at 18:23.
- DM3 – The PM2.5 limit was exceeded with a peak reading of 93 µg/m³ on June 14 from 17:45-23:45. The PM10 limit was exceeded with a peak reading of 93 µg/m³ on June 14 from 17:45-23:45. The peak was at 18:15.

- DM1 – Exceedance of the PM10 limit with a reading of 54 $\mu\text{g}/\text{m}^3$ on June 18 at 09:41.
- DM1 – Exceedance of the PM2.5 limit with a reading of 57 $\mu\text{g}/\text{m}^3$ on June 18 at 09:56.

- DM1 – Exceedance of the PM10 limit with a reading of 57 $\mu\text{g}/\text{m}^3$ on June 18 at 09:56.
- DM2 – Exceedance of the PM2.5 limit with a reading of 70 $\mu\text{g}/\text{m}^3$ on June 4 at 09:38.

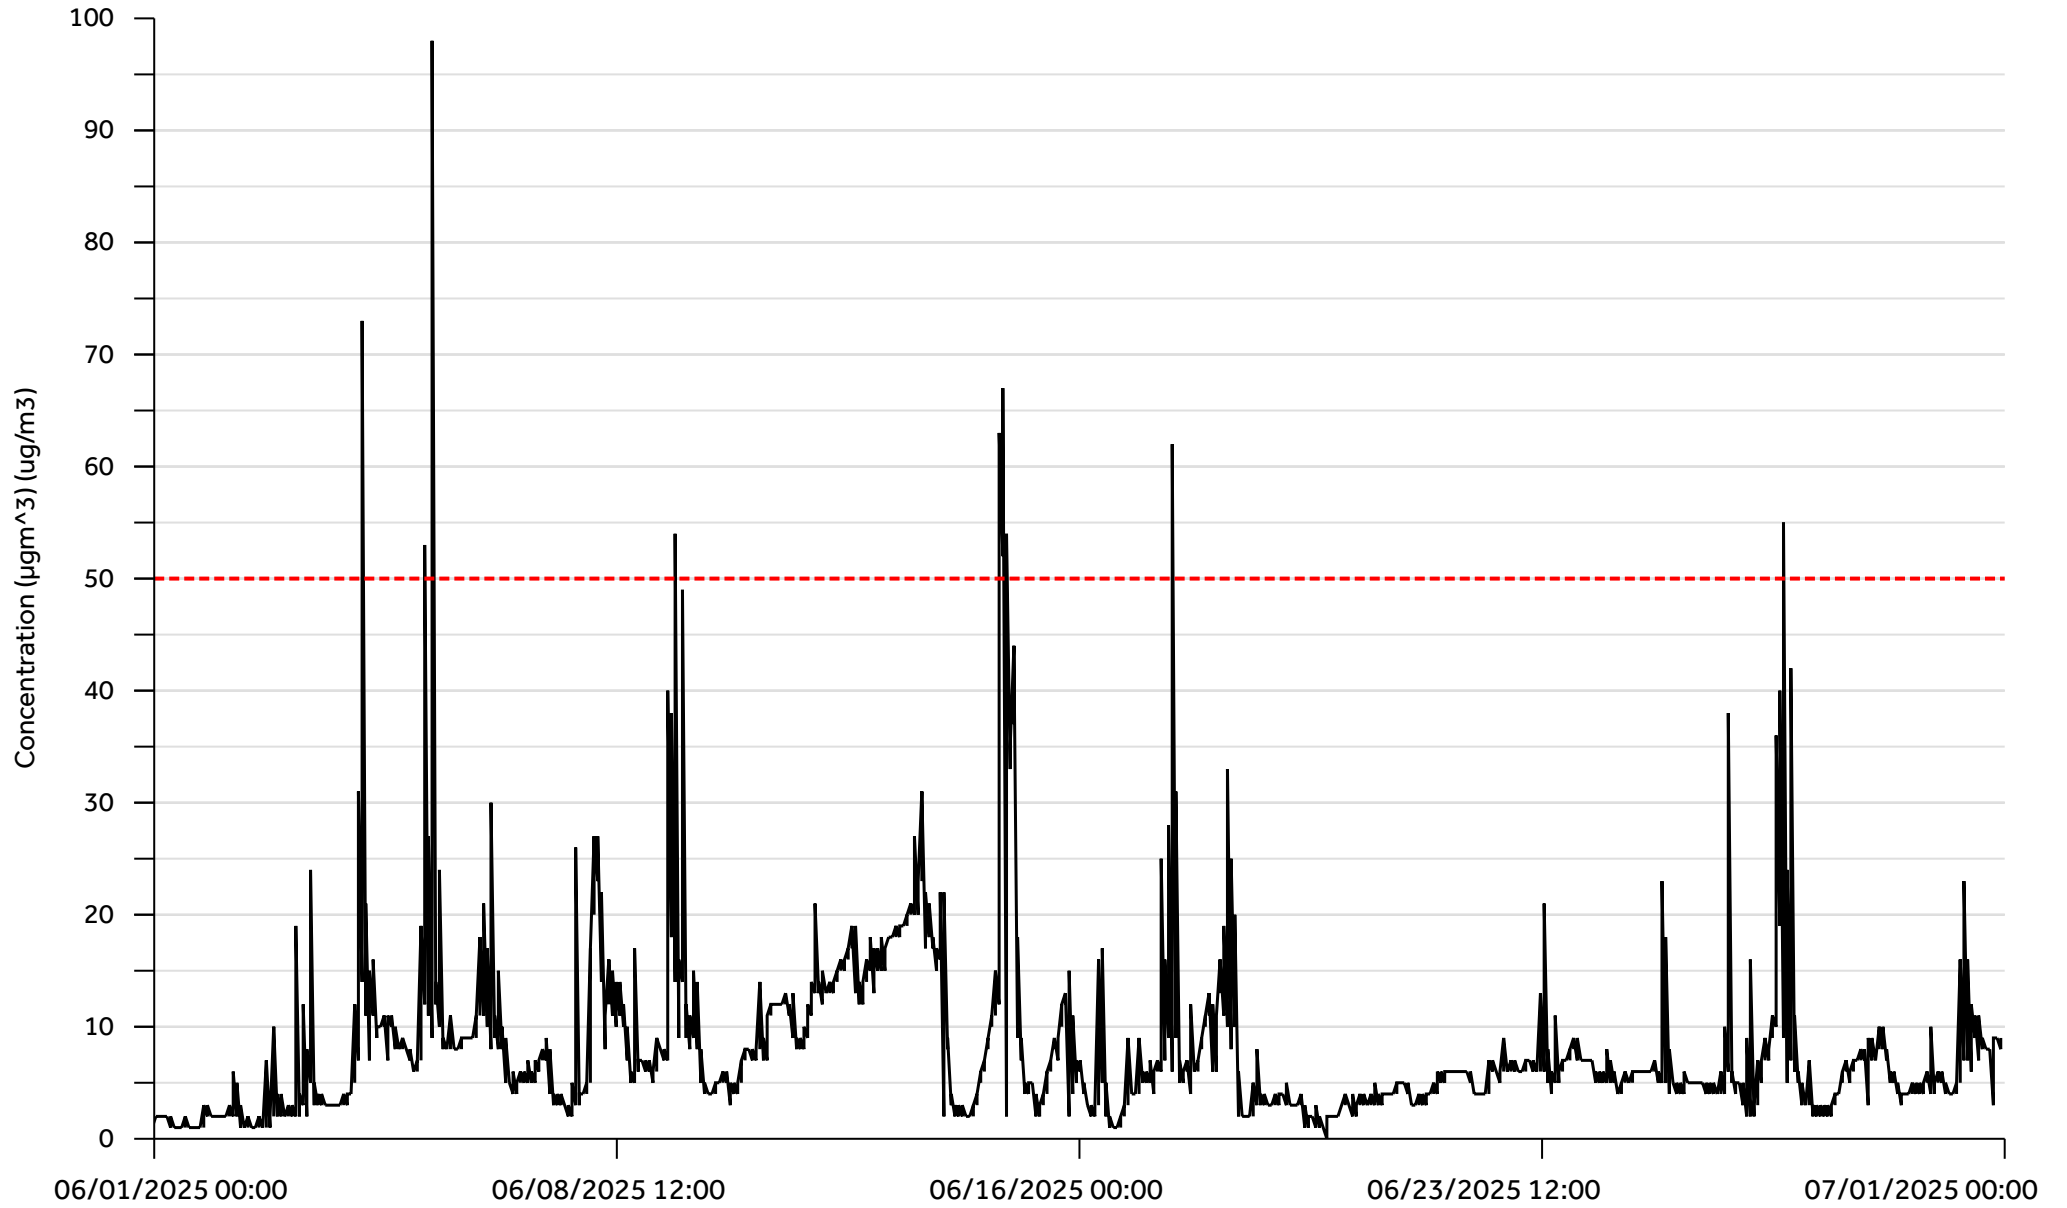
Graph 7

- DM2 – Exceedance of the PM10 limit with a reading of 73 $\mu\text{g}/\text{m}^3$ on June 4 at 09:38.
- DM2 – Exceedance of the PM2.5 limit with a reading of 53 $\mu\text{g}/\text{m}^3$ on June 5 at 09:53.

- DM2 – Exceedance of the PM10 limit with a reading of 53 $\mu\text{g}/\text{m}^3$ on June 5 at 09:53.
- DM2 – Exceedance of the PM2.5 limit with a reading of 97 $\mu\text{g}/\text{m}^3$ on June 5 at 12:53.

- DM2 – Exceedance of the PM10 limit with a reading of 98 $\mu\text{g}/\text{m}^3$ on June 5 at 12:53.
- DM2 – Exceedance of the PM2.5 limit with a reading of 52 $\mu\text{g}/\text{m}^3$ on June 9 at 10:53.

- DM2 – Exceedance of the PM10 limit with a reading of 54 $\mu\text{g}/\text{m}^3$ on June 9 at 10:53.
- DM2 – Exceedance of the PM2.5 limit with a reading of 46 $\mu\text{g}/\text{m}^3$ on June 9 at 11:08.

- DM2 – Exceedance of the PM10 limit with a reading of 62 $\mu\text{g}/\text{m}^3$ on June 17 at 13:08.
- DM2 – Exceedance of the PM2.5 limit with a reading of 49 $\mu\text{g}/\text{m}^3$ on June 27 at 10:38.

- DM2 – Exceedance of the PM10 limit with a reading of 55 $\mu\text{g}/\text{m}^3$ on June 27 at 10:38.

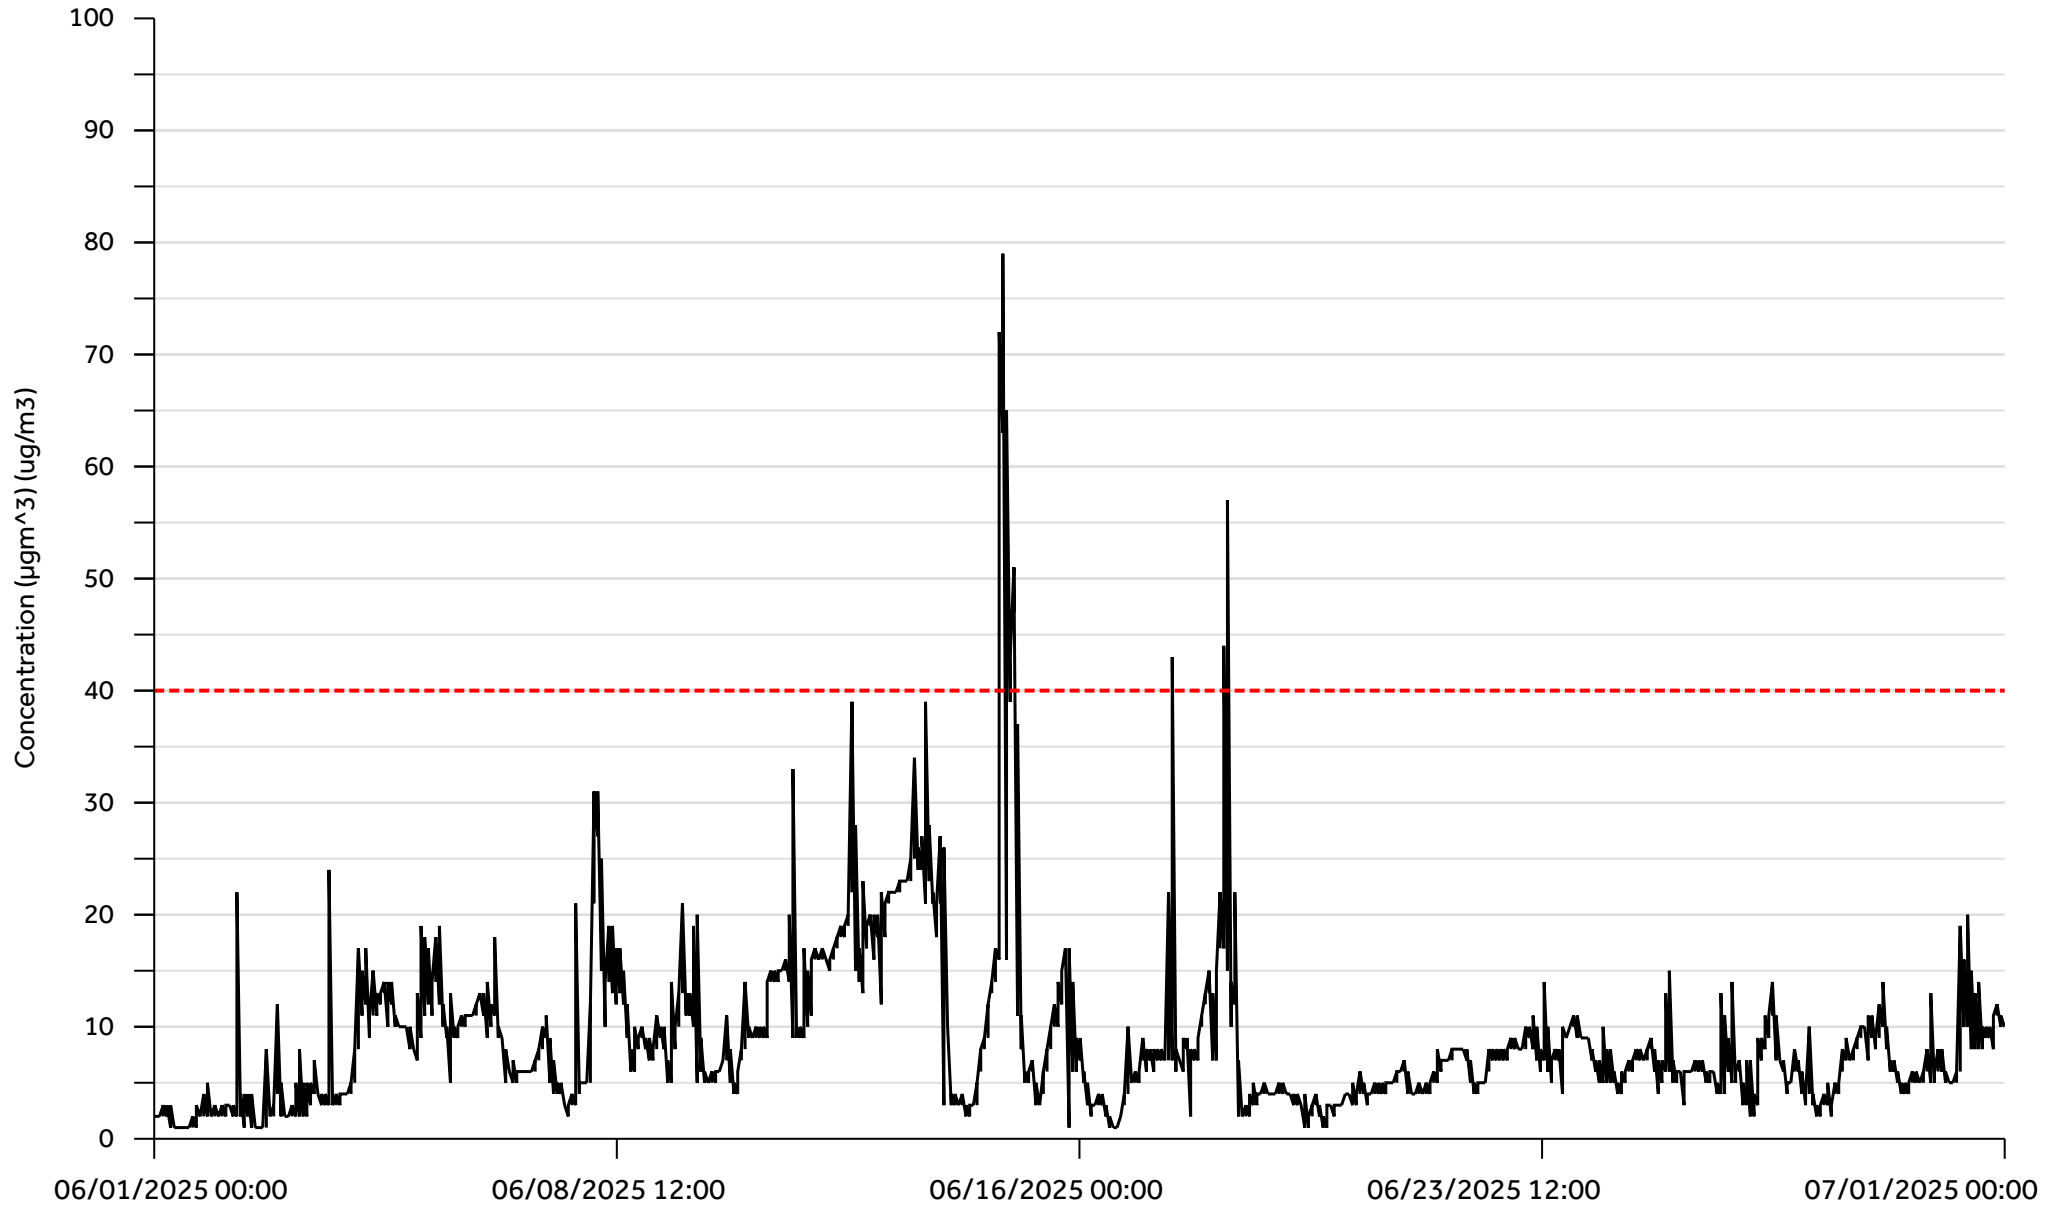
Graph 9

- DM1 – Exceedance of the PM2.5 limit with a reading of 43 µg/m³ on June 17 at 12:56.

- DM1 – Exceedance of the PM2.5 limit with a reading of 44 $\mu\text{g}/\text{m}^3$ on June 18 at 08:41.
- DM1 – Exceedance of the PM2.5 limit with a reading of 54 $\mu\text{g}/\text{m}^3$ on June 18 at 09:41.

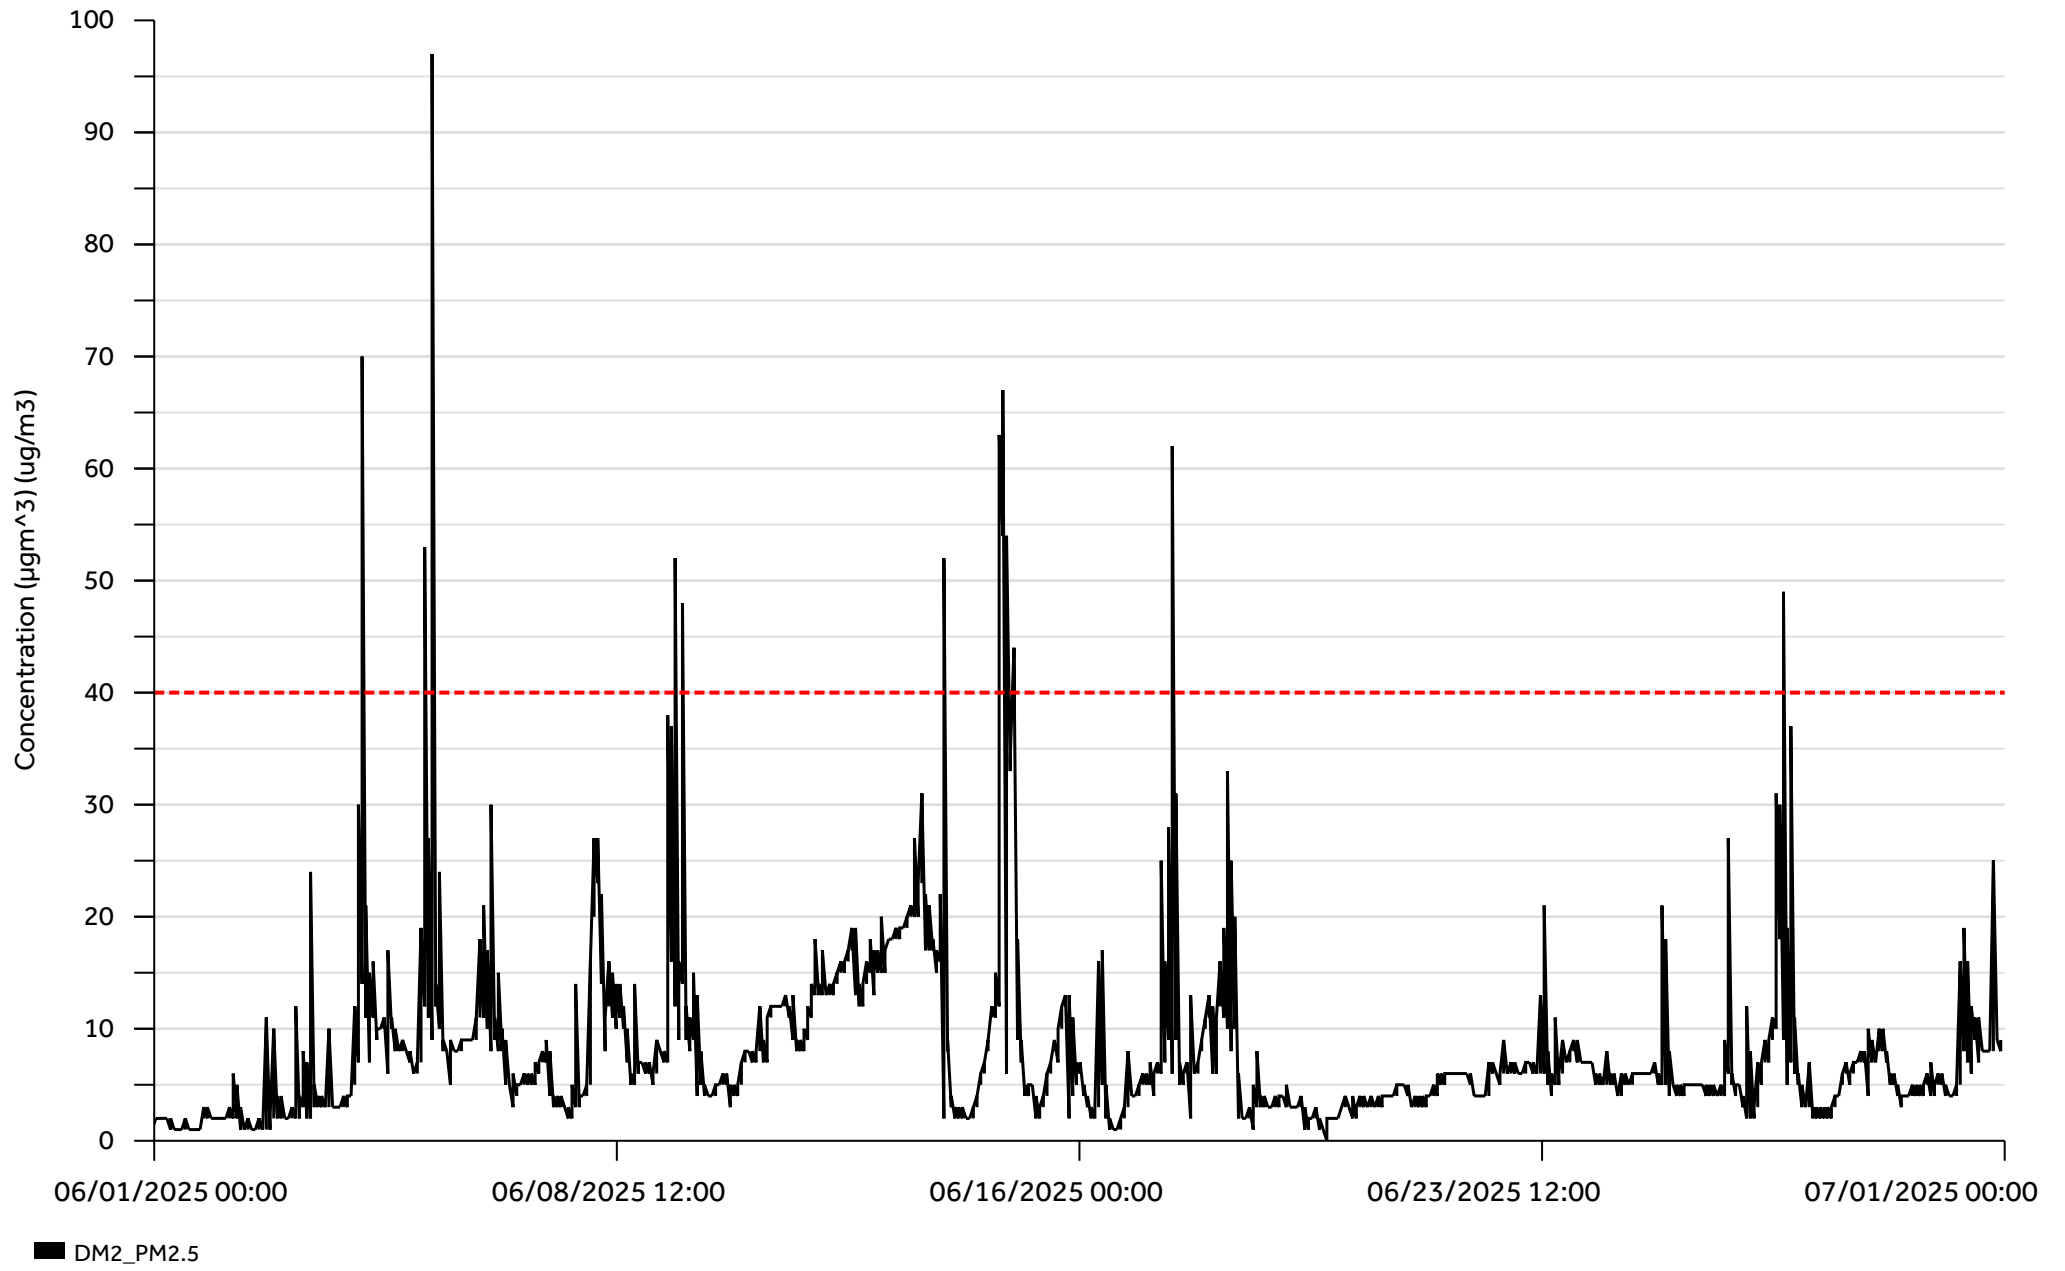
Graph 10

- DM2 – Exceedance of the PM2.5 limit with a reading of 48 $\mu\text{g}/\text{m}^3$ on June 9 at 14:23.
- DM2 – Exceedance of the PM2.5 limit with a reading of 62 $\mu\text{g}/\text{m}^3$ on June 17 at 13:08.
