Monitoring Report

WMATA Bus Garage Monthly Report

**July 2023**

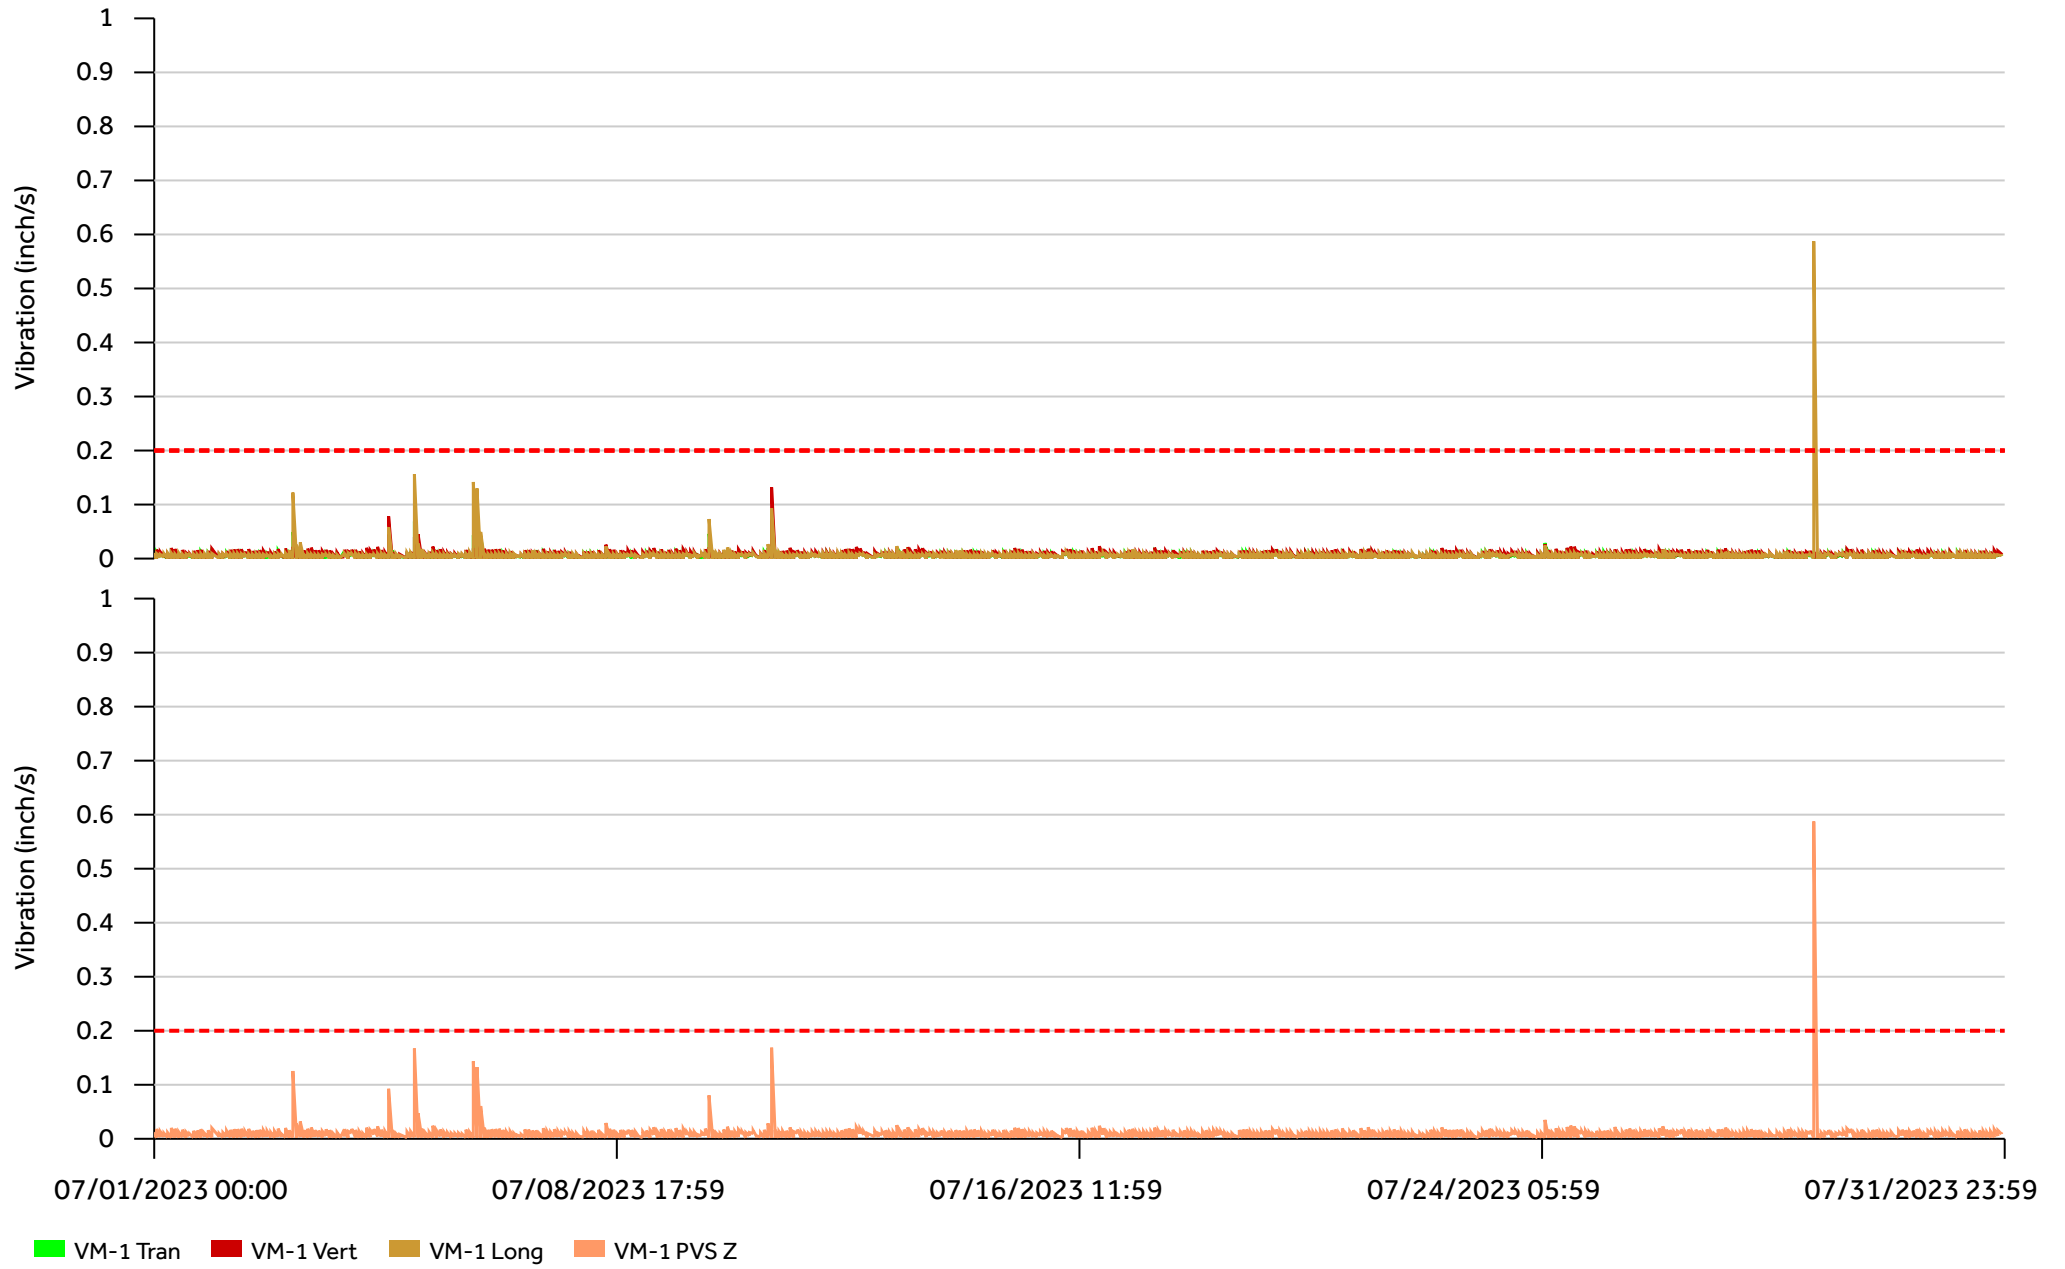
VM-1- Vibration Monitor

VM1 – 7/28 2005h. 0.59 in/sec on the Transverse channel. Appears to be electrical not physical vibration.

The 0.59 in/sec event does not appear to be caused by physical vibration, but rather electrical noise. While not an exceedance, VM4 and VM5 also recorded measurements of 0.1 and 0.32 in/sec at the same time as the 7/28 2005h recording at VM1. These also appear to be electrical in nature. The single event that triggered all three units may have been a lightning strike or other electrical anomaly at the site. VM2 had the appearance of vibration exceedances in the first half of the month. Upon further review during the compiling of this report it was discovered that the VM2 geophone was malfunctioning at the time. The unit was exchanged on July 12 and the new unit is operating normally.

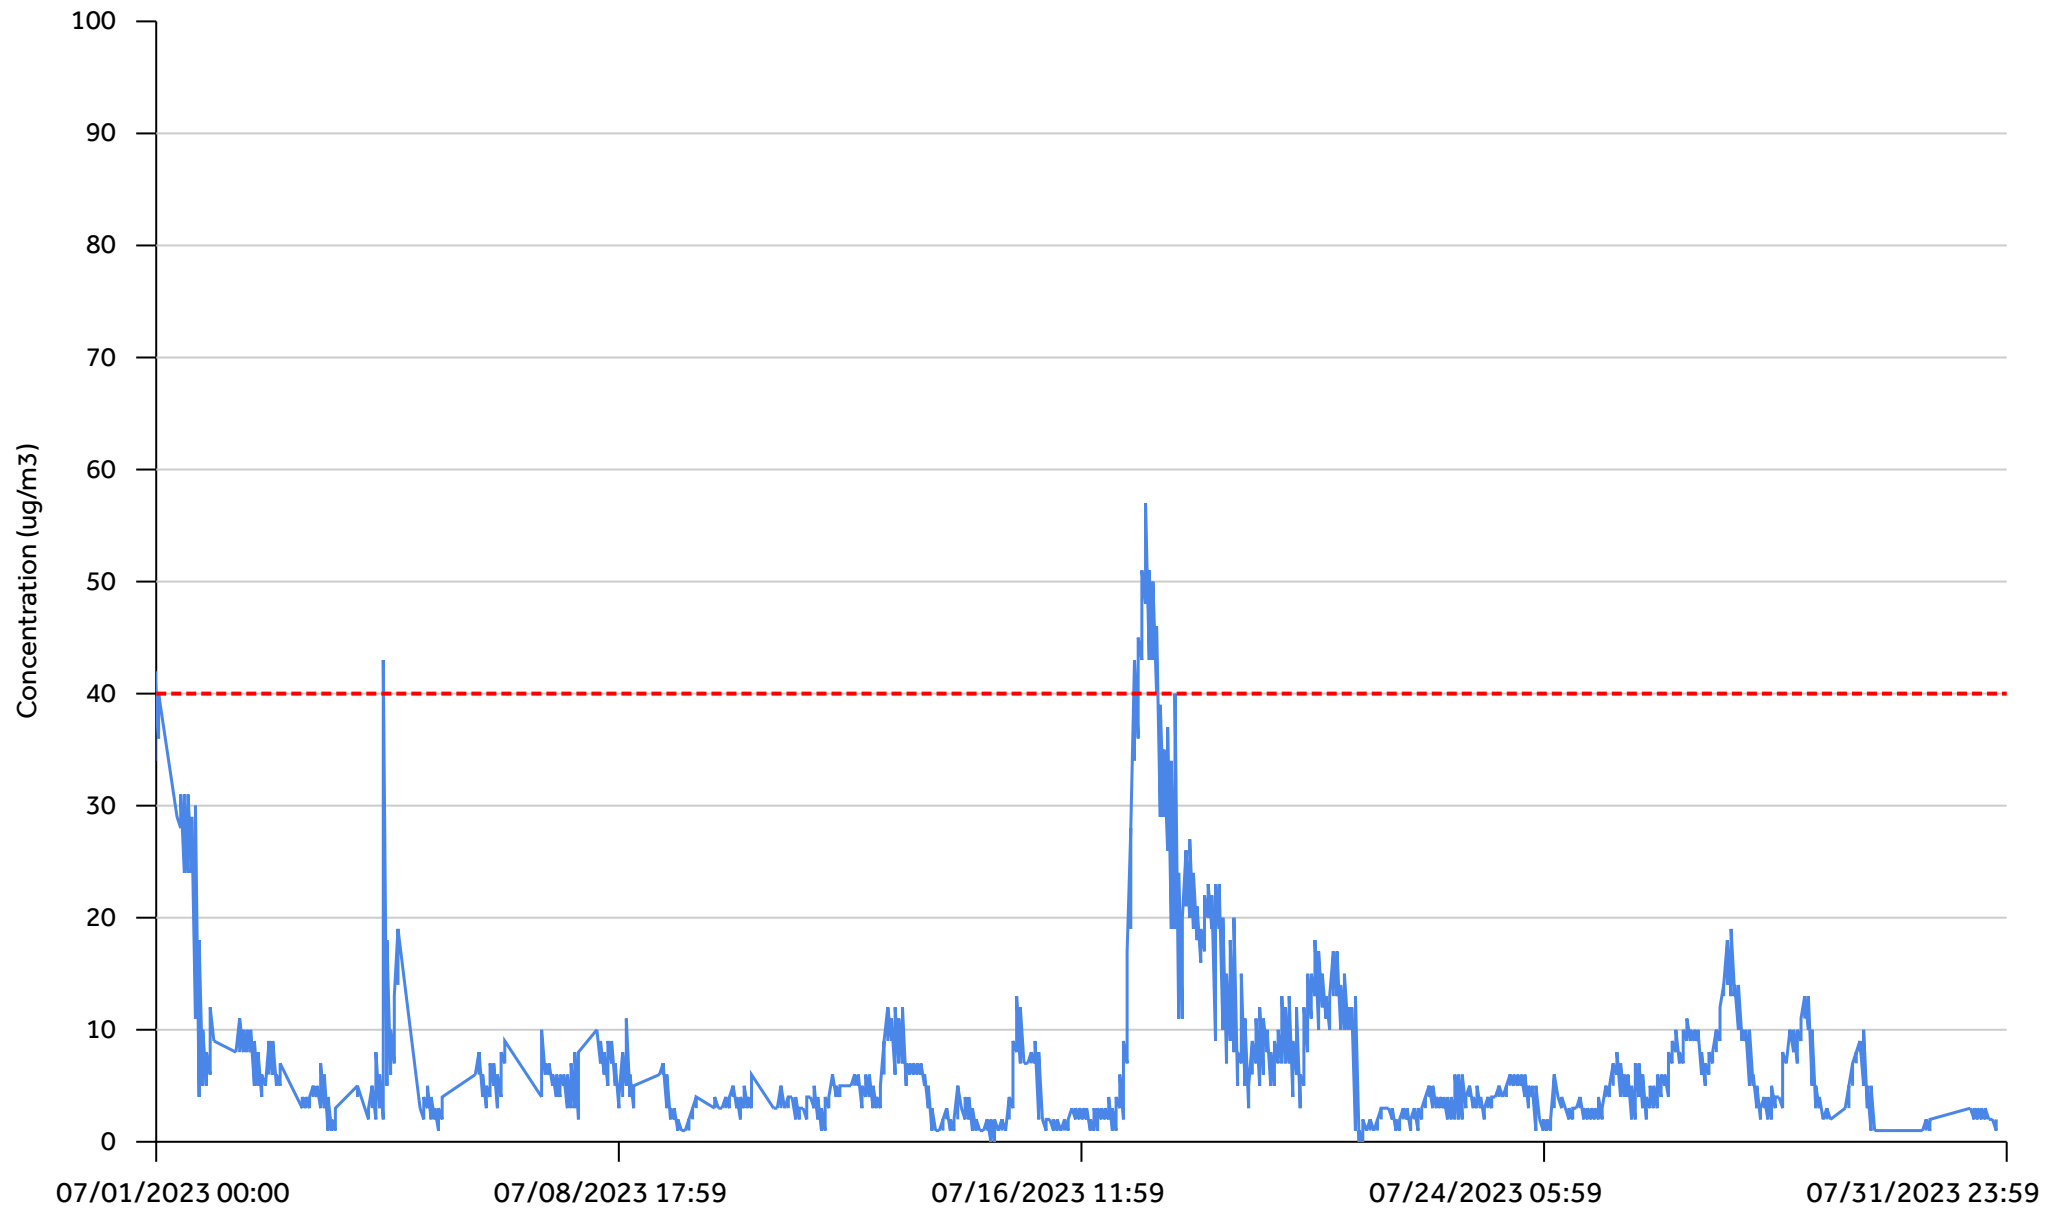
DM1-PM2.5

DM1 – 7/4 2036h, 43  $\mu\text{g}/\text{m}^3$ .

DM1 – 7/17 1432h. 57  $\mu\text{g}/\text{m}^3$ .

A review of the data reveals threshold exceedances from regional poor air quality events on July 4th and 17th as found on [www.CleanAirPartners.net](http://www.CleanAirPartners.net). DM2 experienced power failure during most of the July 21 through 31 period. DM3 also experienced power failure from July 14 through 19 and from July 20 through 22. These units require a lot of power and DM3 has now been moved to mains power to ensure reliability. New modems are being sourced now that will allow us to measure incoming voltage and set alarms if it drops below a certain threshold.

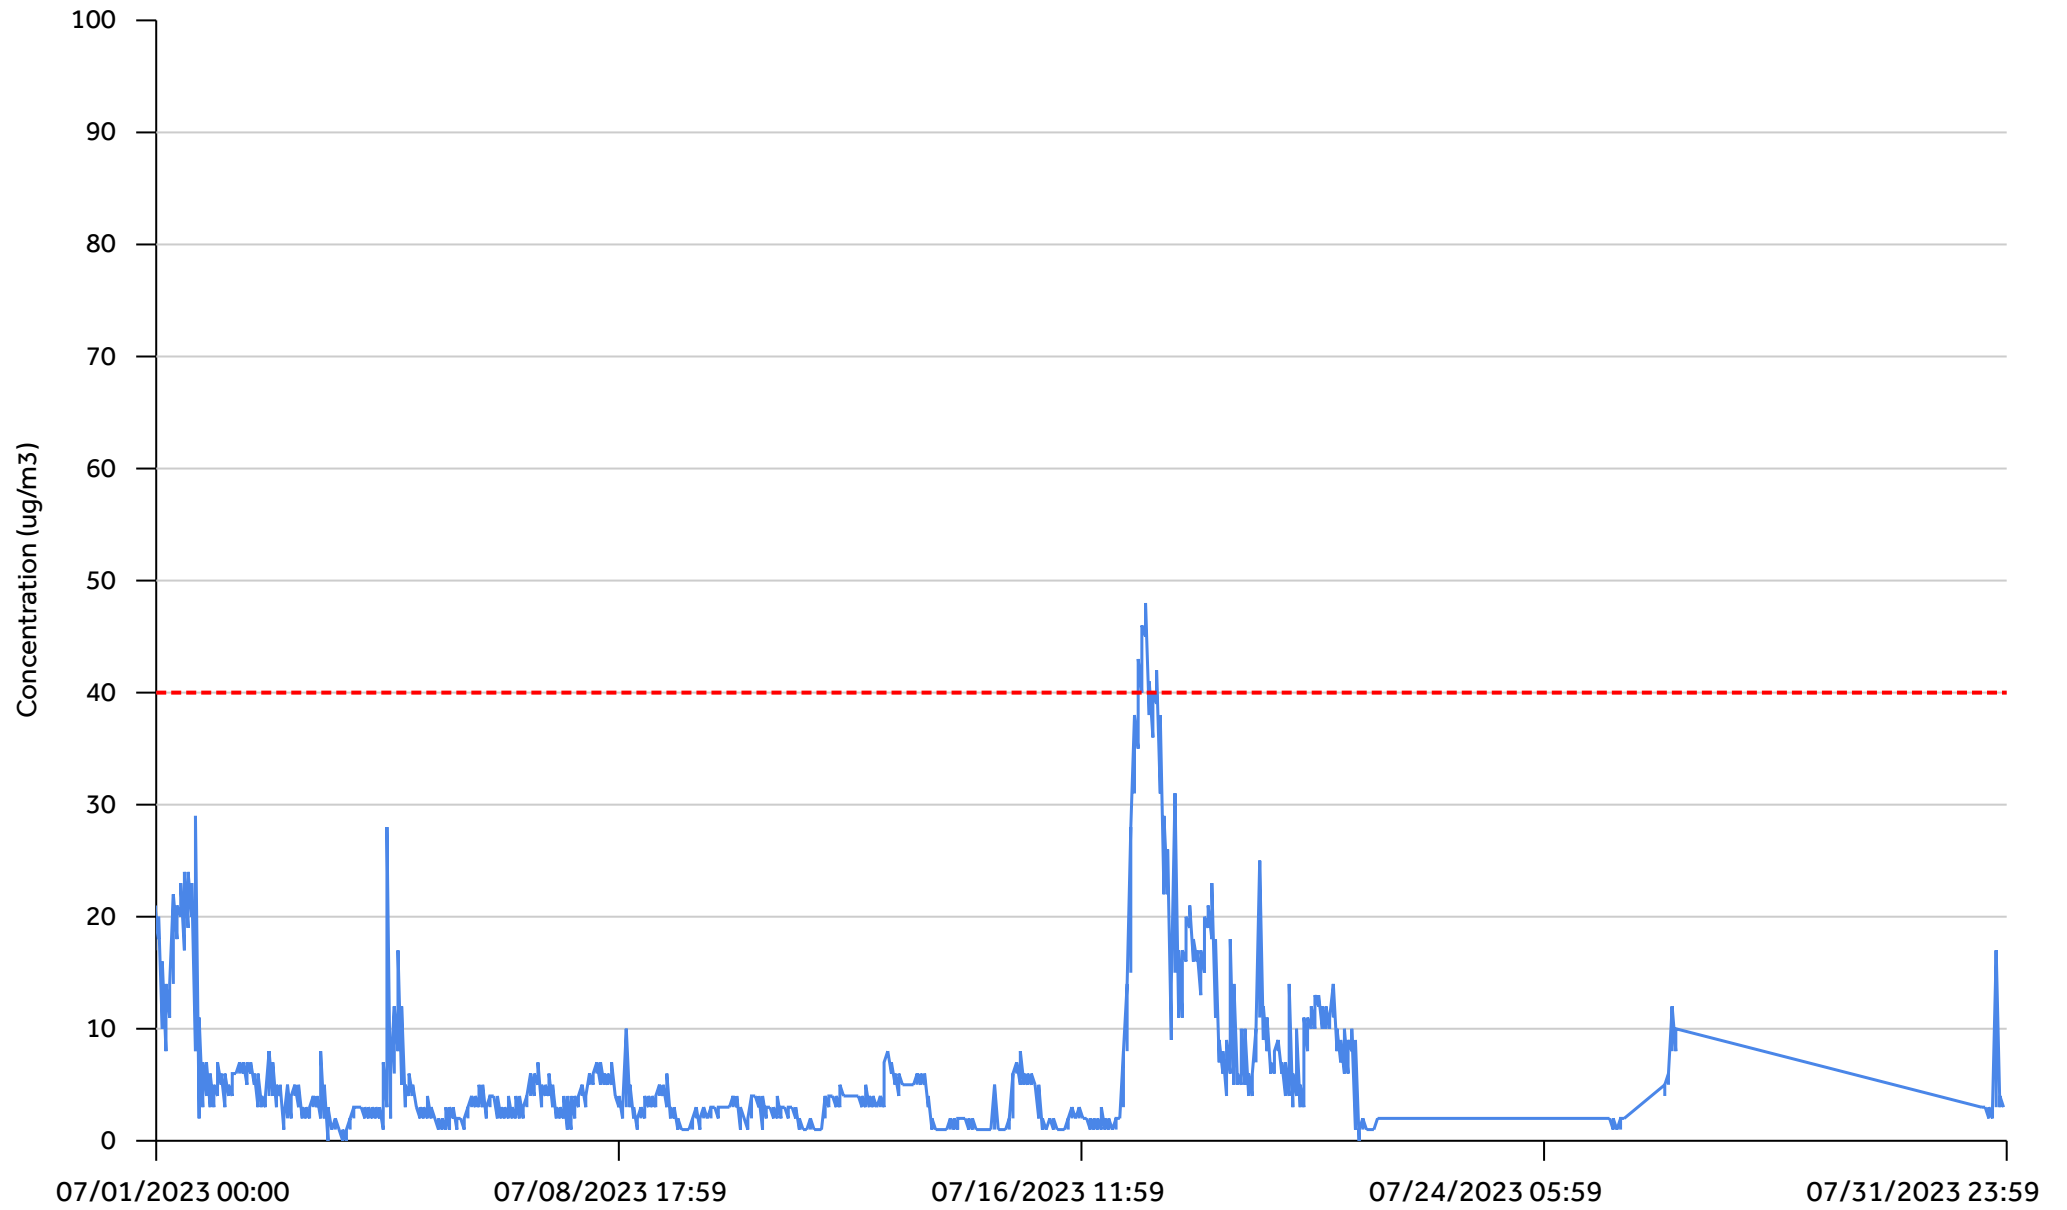
DM2-PM2.5

DM2 – 7/17 1116-1930h, 48  $\mu\text{g}/\text{m}^3$ .

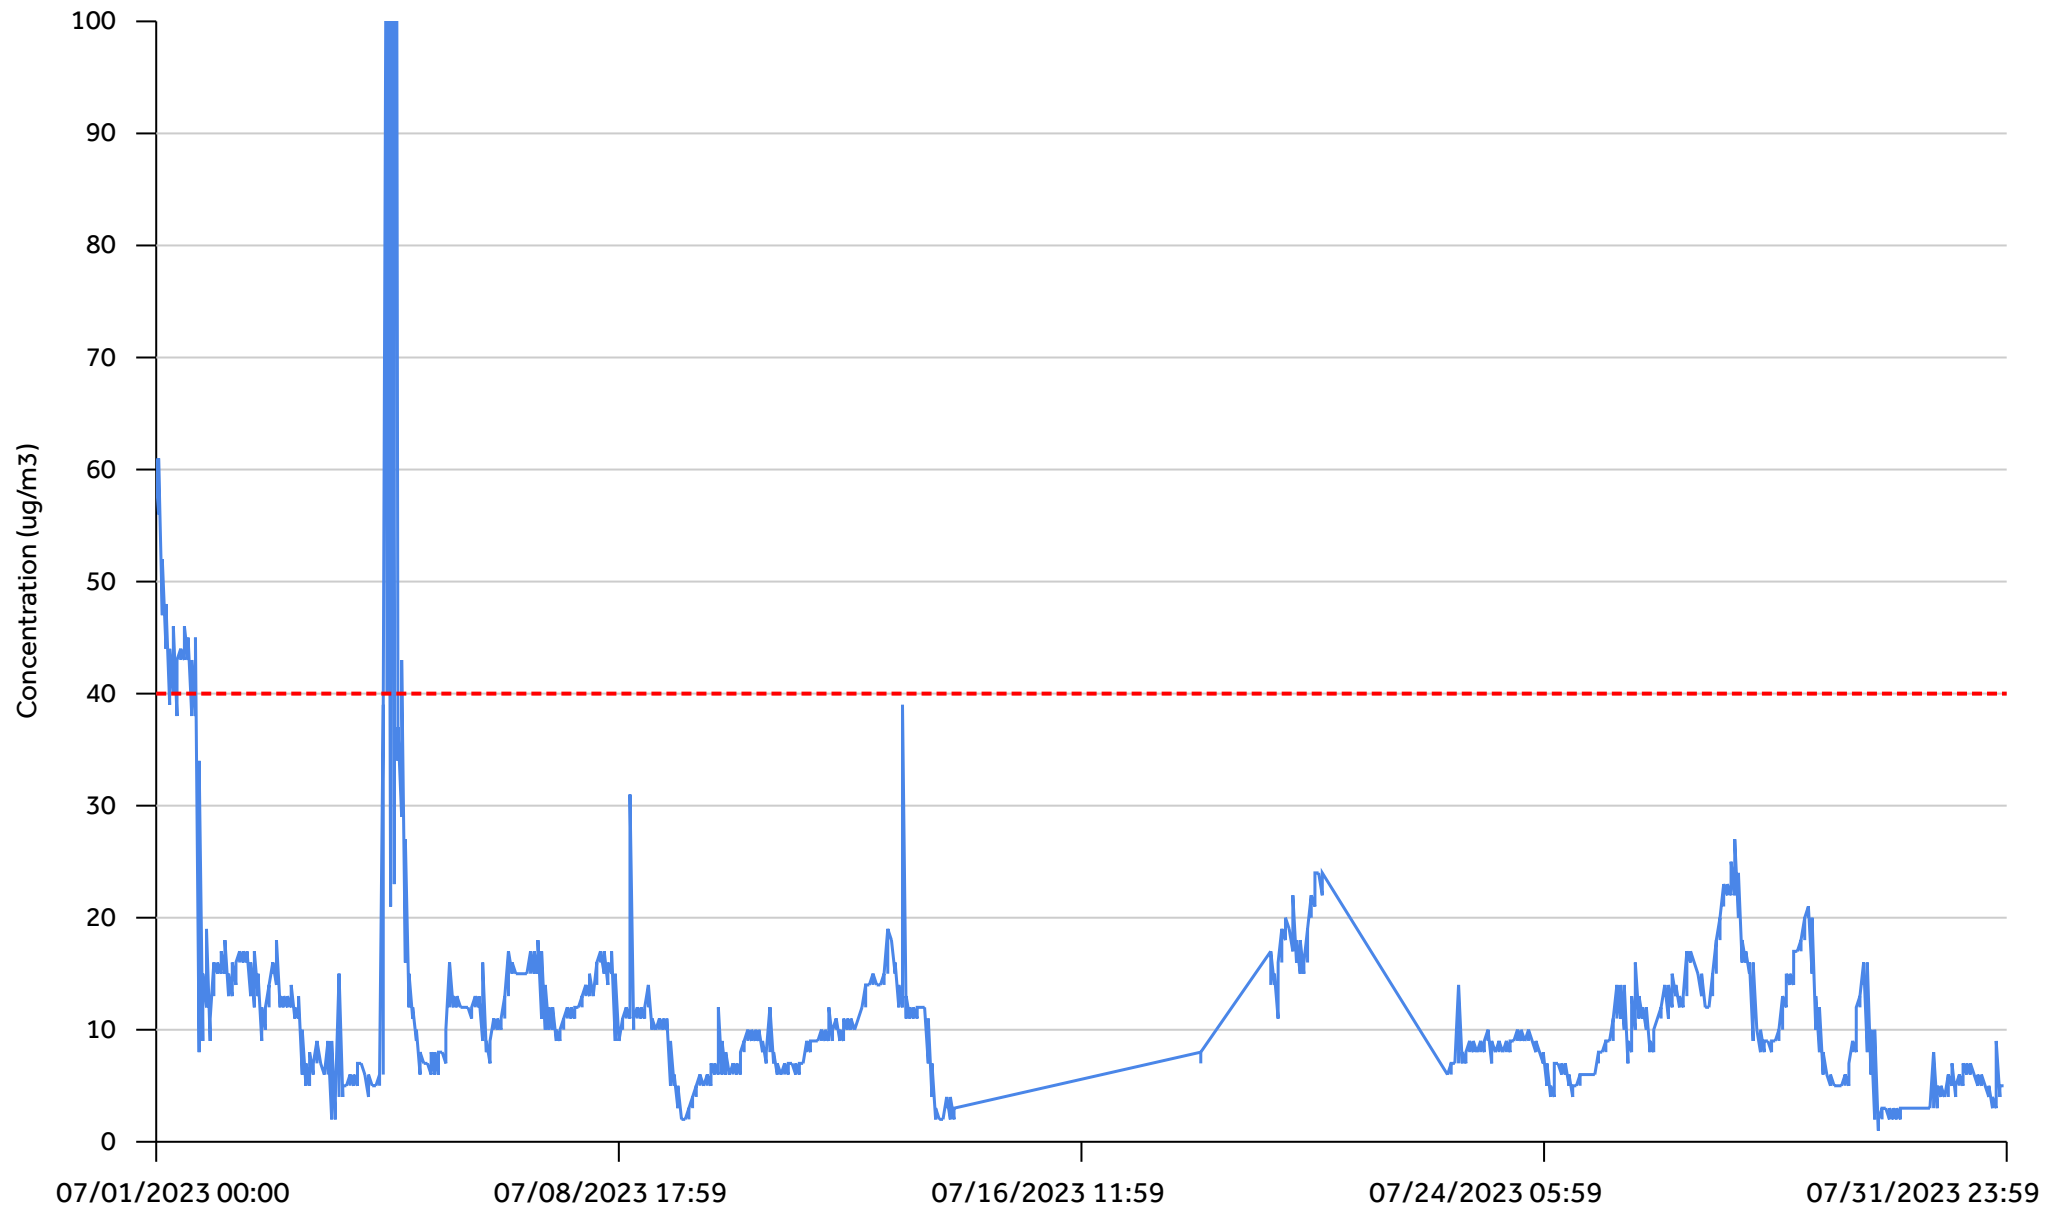
DM3-PM2.5

DM3 – 7/4 2126h, 130  $\mu\text{g}/\text{m}^3$ .

DM3 – 7/5 0026h, 250  $\mu\text{g}/\text{m}^3$ .
