## Northern Bus Garage Noise, Vibration, and Dust Monitoring Report (September 2023)

Noise, Vibration, and Dust levels were monitored as part of the reconstruction of Northern Bus Garage, 4615 14<sup>th</sup> Street, NW, Washington, DC, for the month of September 2023.

WMATA Bus Garage Monthly Report

**September 2023**

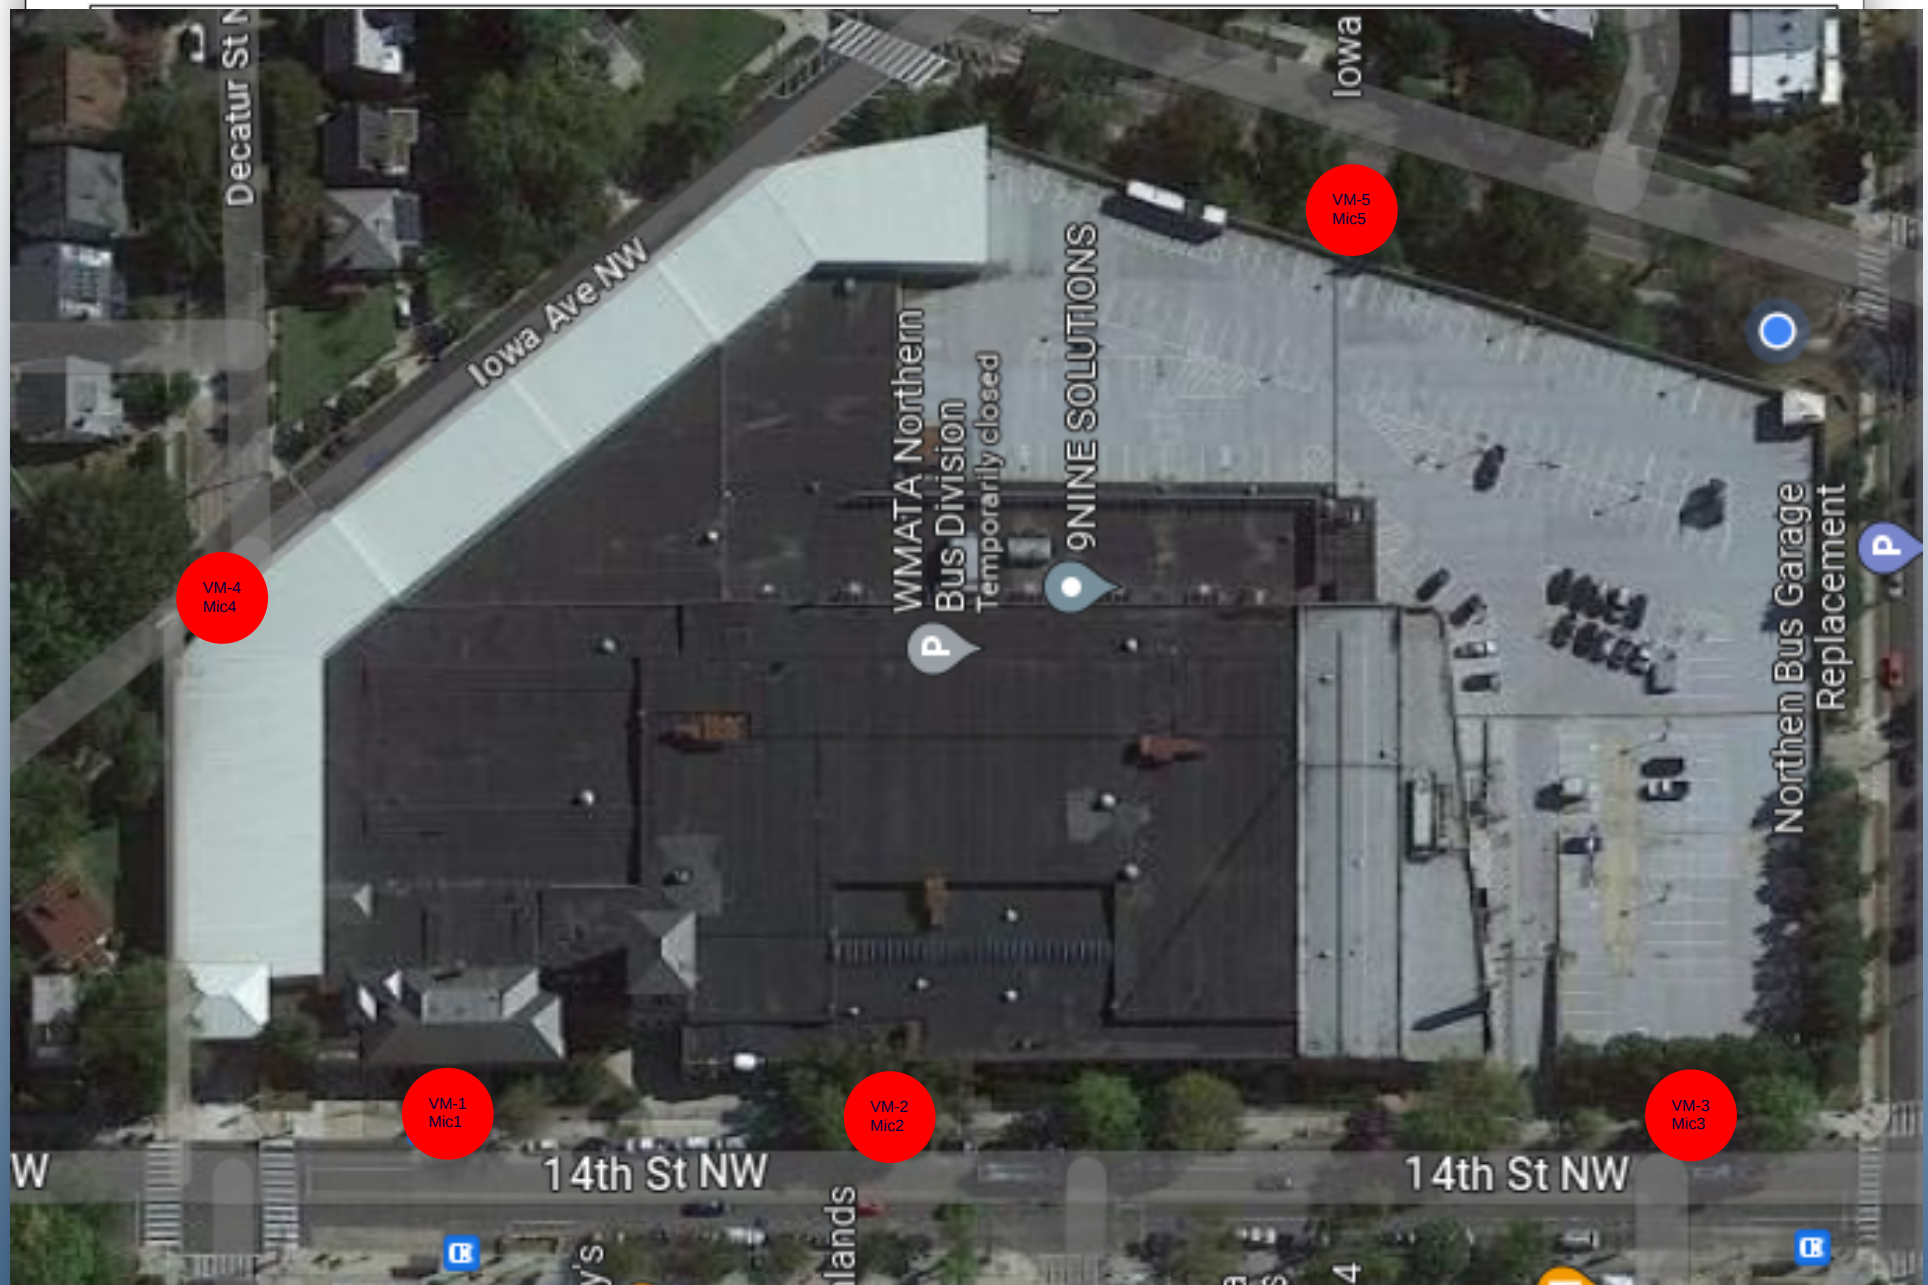
# Figure 1: Vibration and Noise Monitor Location Plan

Five noise monitors are positioned around the perimeter of the project site. (See Figure 1) Under DC regulations, the regulatory standard is 80 dBA, measured 25 ft from the property line (20 DCMR 2802.1). Because the noise monitoring devices are placed on the property line (rather than a 25 ft offset), the monitoring threshold for site activities is adjusted to 85 dBA (assuming the noise level will dissipate). Noise levels and vibration levels were measured automatically with Micromate and Geophone Instrument.

Five vibration monitors are positioned around the perimeter of the project site. (See Figure 1) Vibration thresholds are based the WMATA Design Criteria. Monitors VM-1 and VM-2 are set at a lower vibration threshold due to their proximity to the historic façade, which is more sensitive to any movement. Noise levels and vibration levels were measured automatically with Micromate and Geophone Instrument.

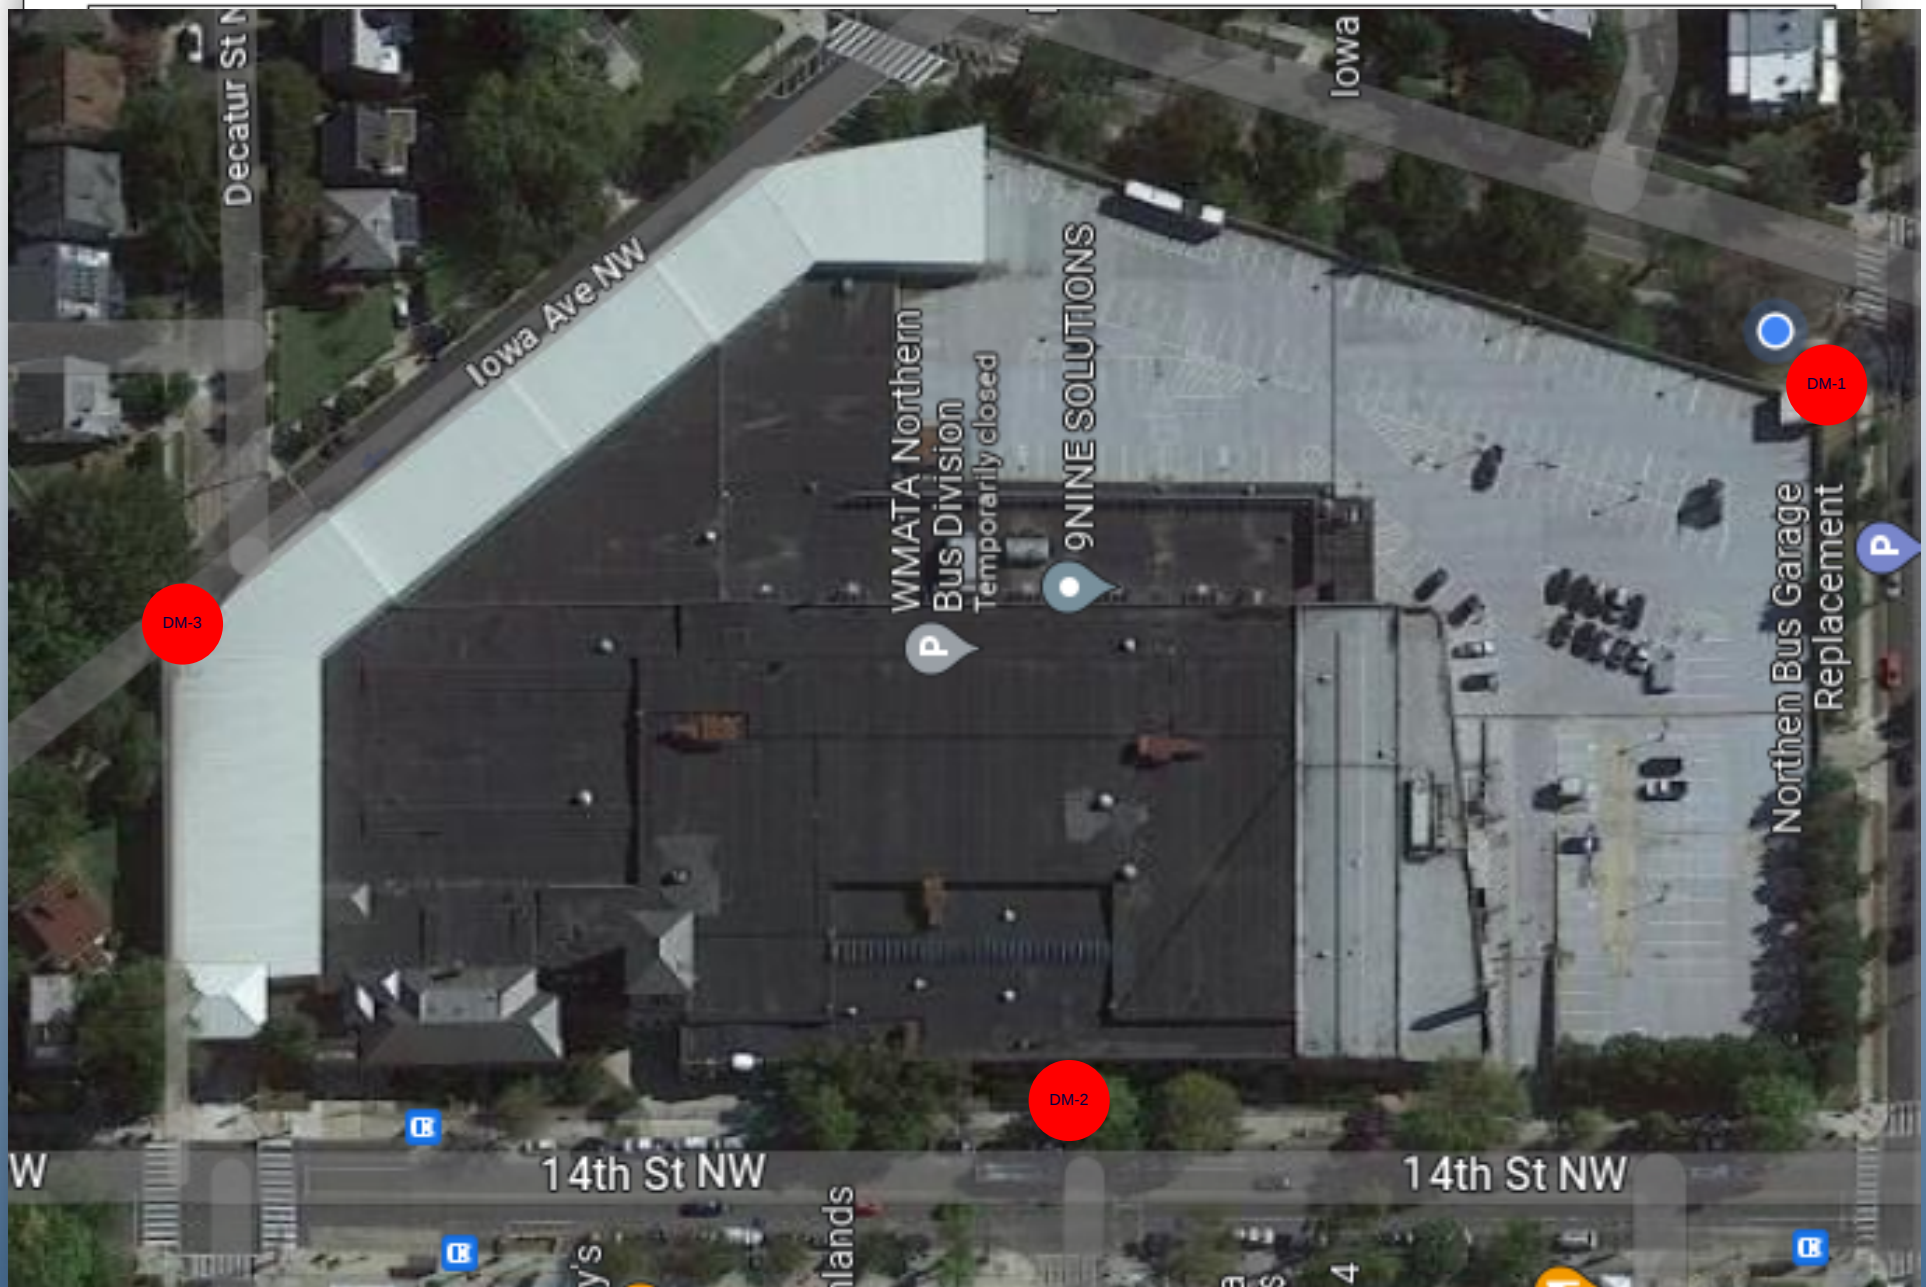
# Figure 2: Dust Monitor Location Plan

Three dust monitors are positioned at the project site. (See Figure 2) EPA regulatory thresholds are based on a 24-hour monitoring period; the project has adopted thresholds to monitor site levels and provide an indication of when EPA

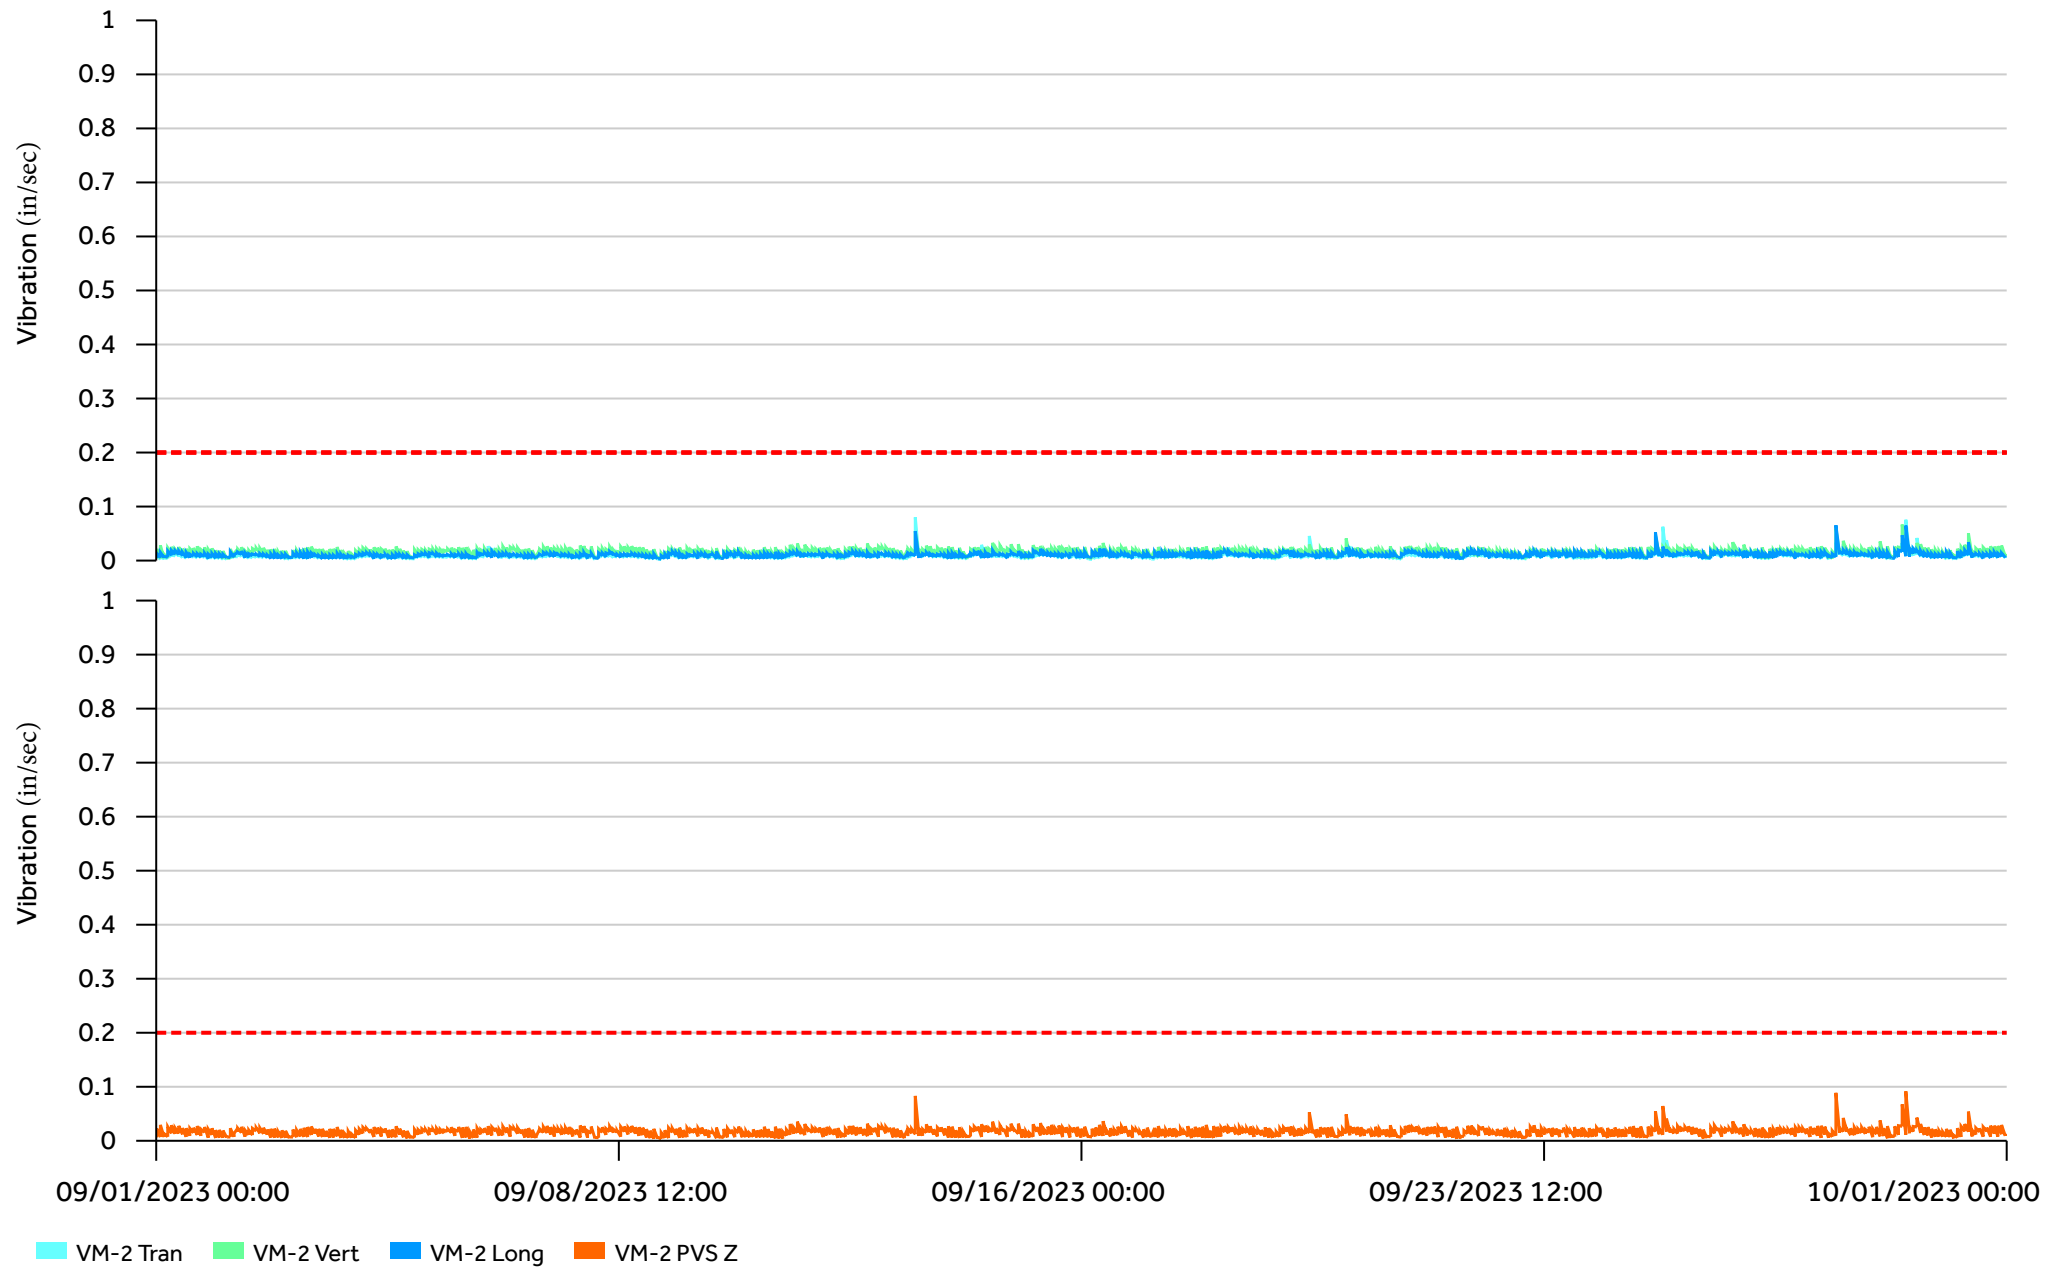
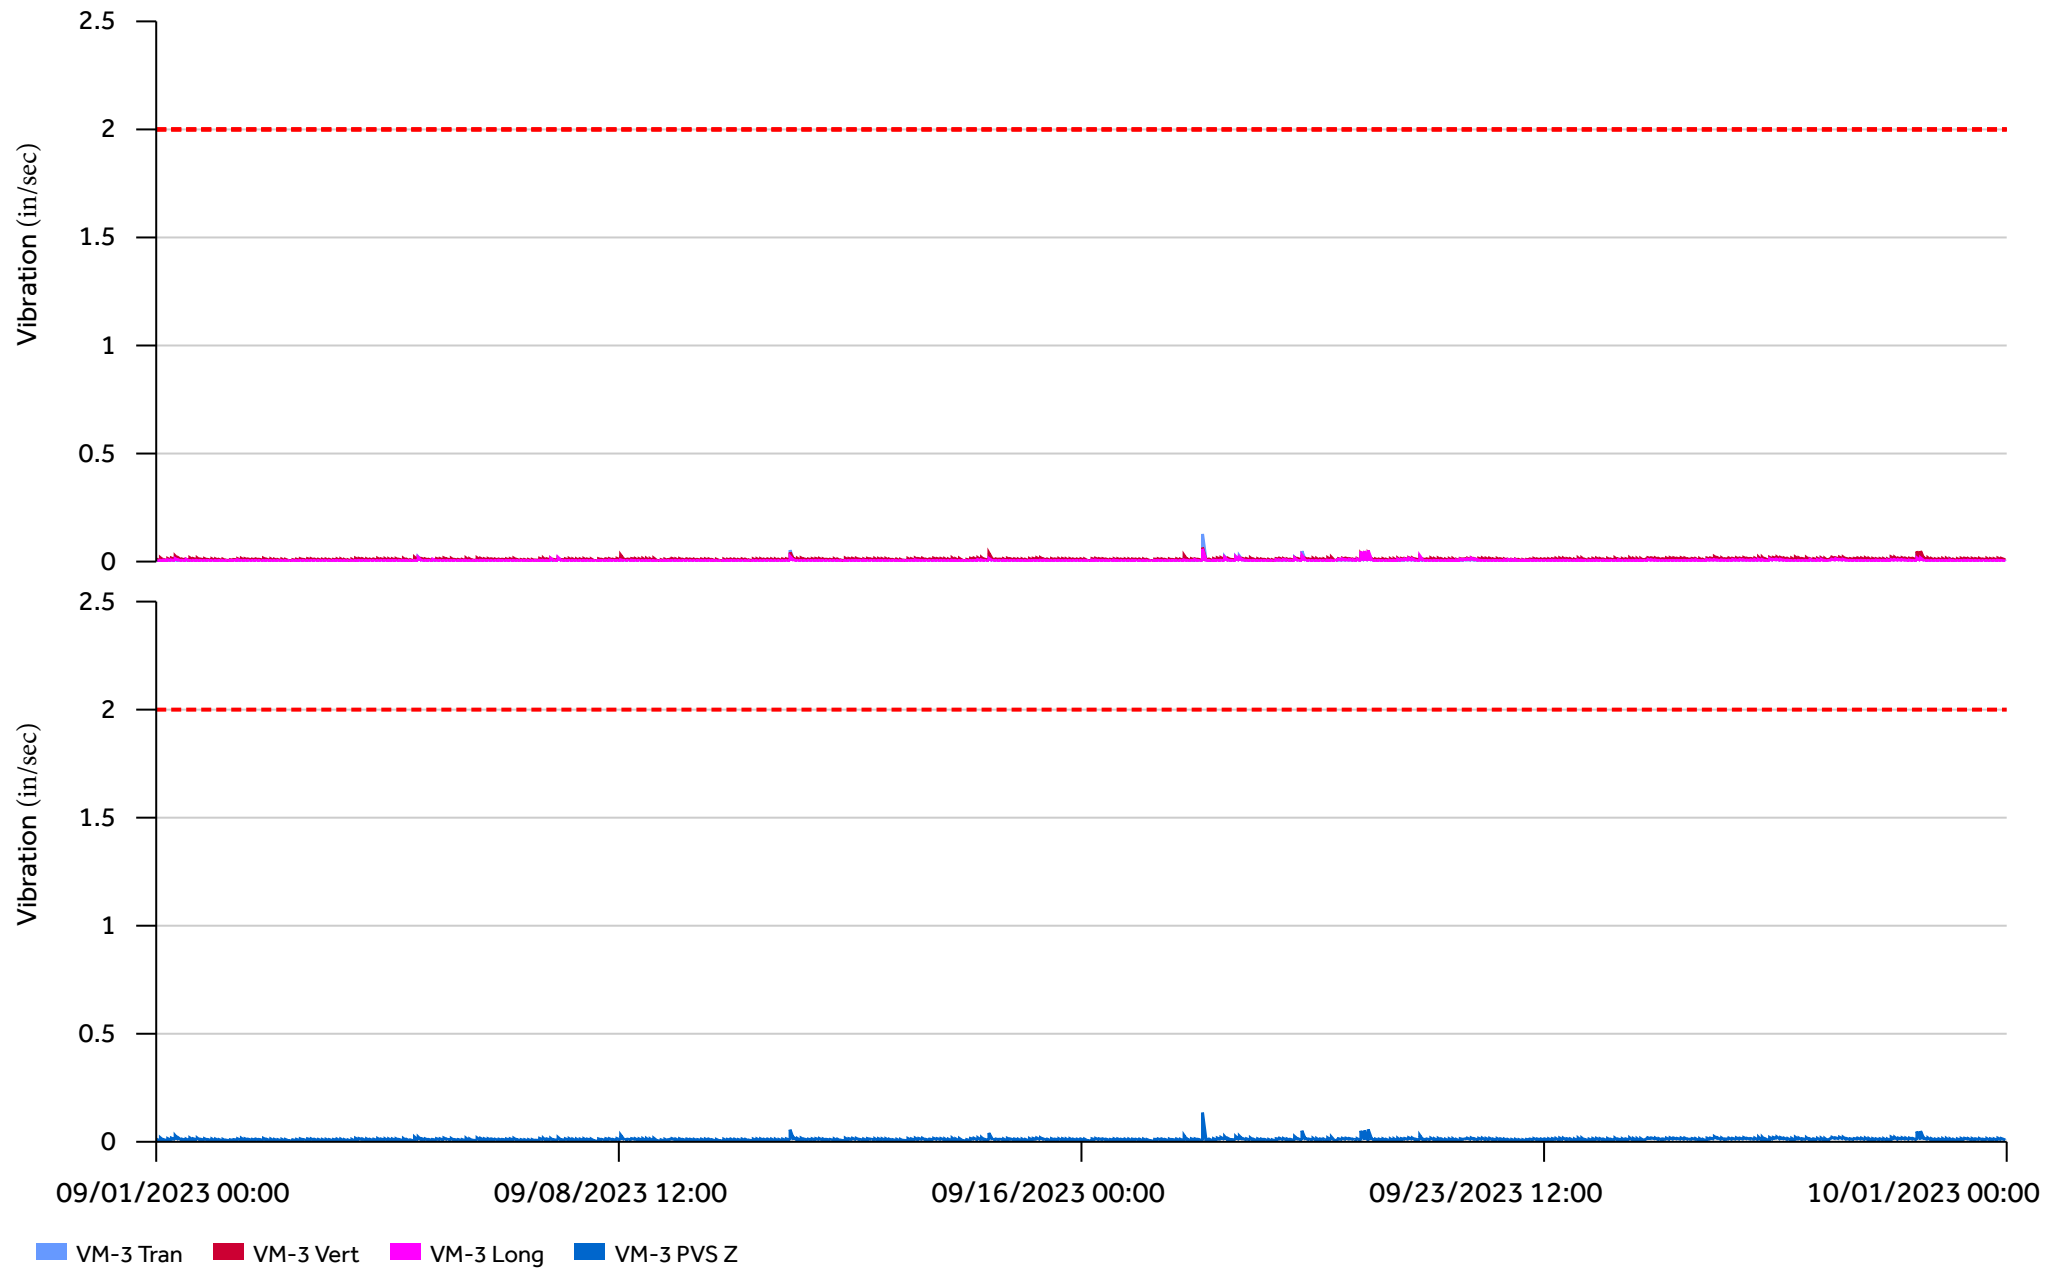
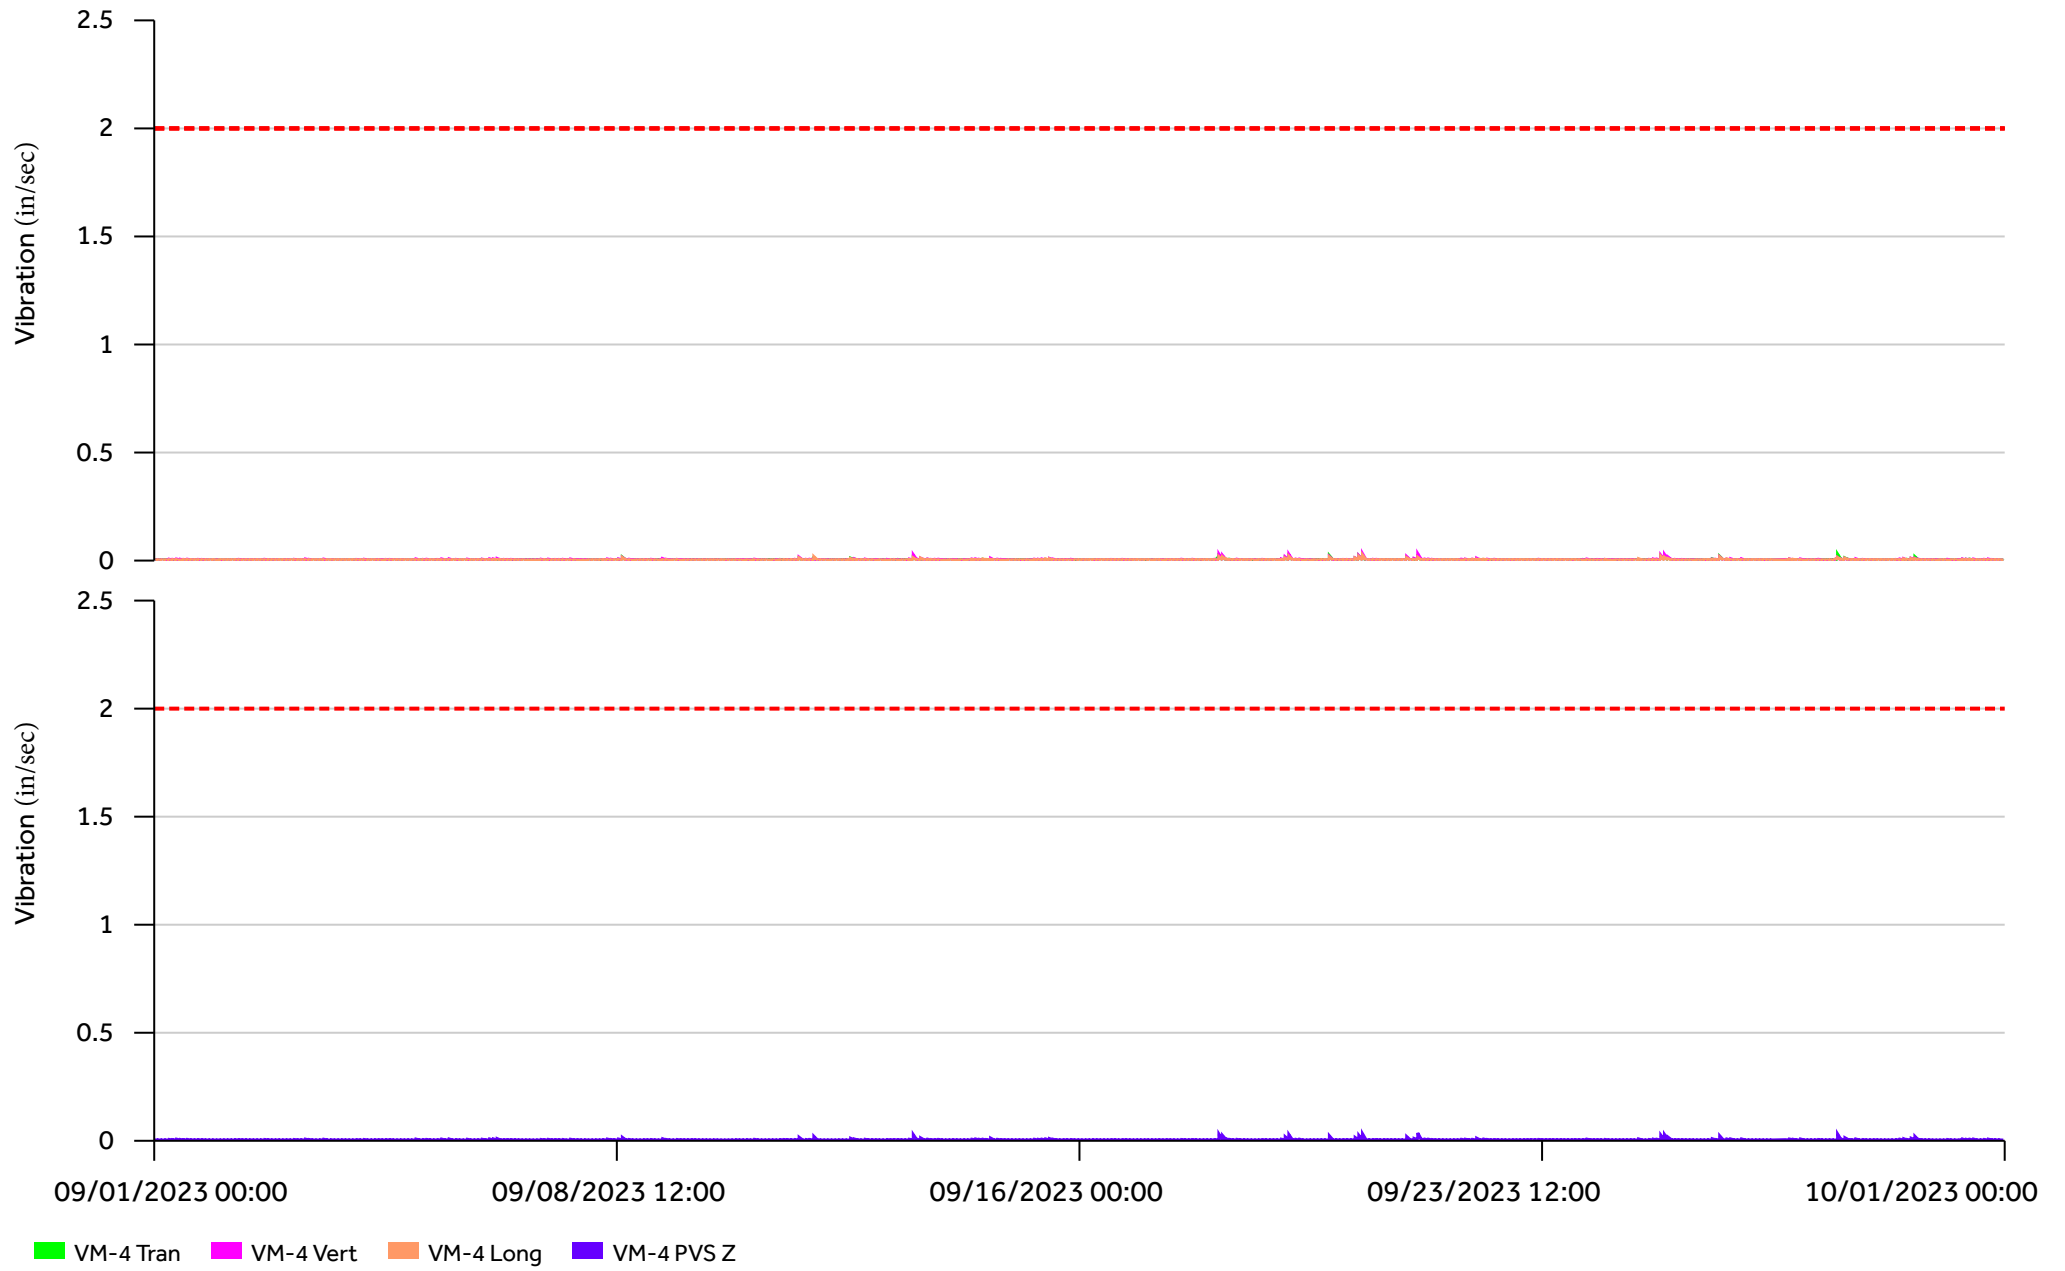
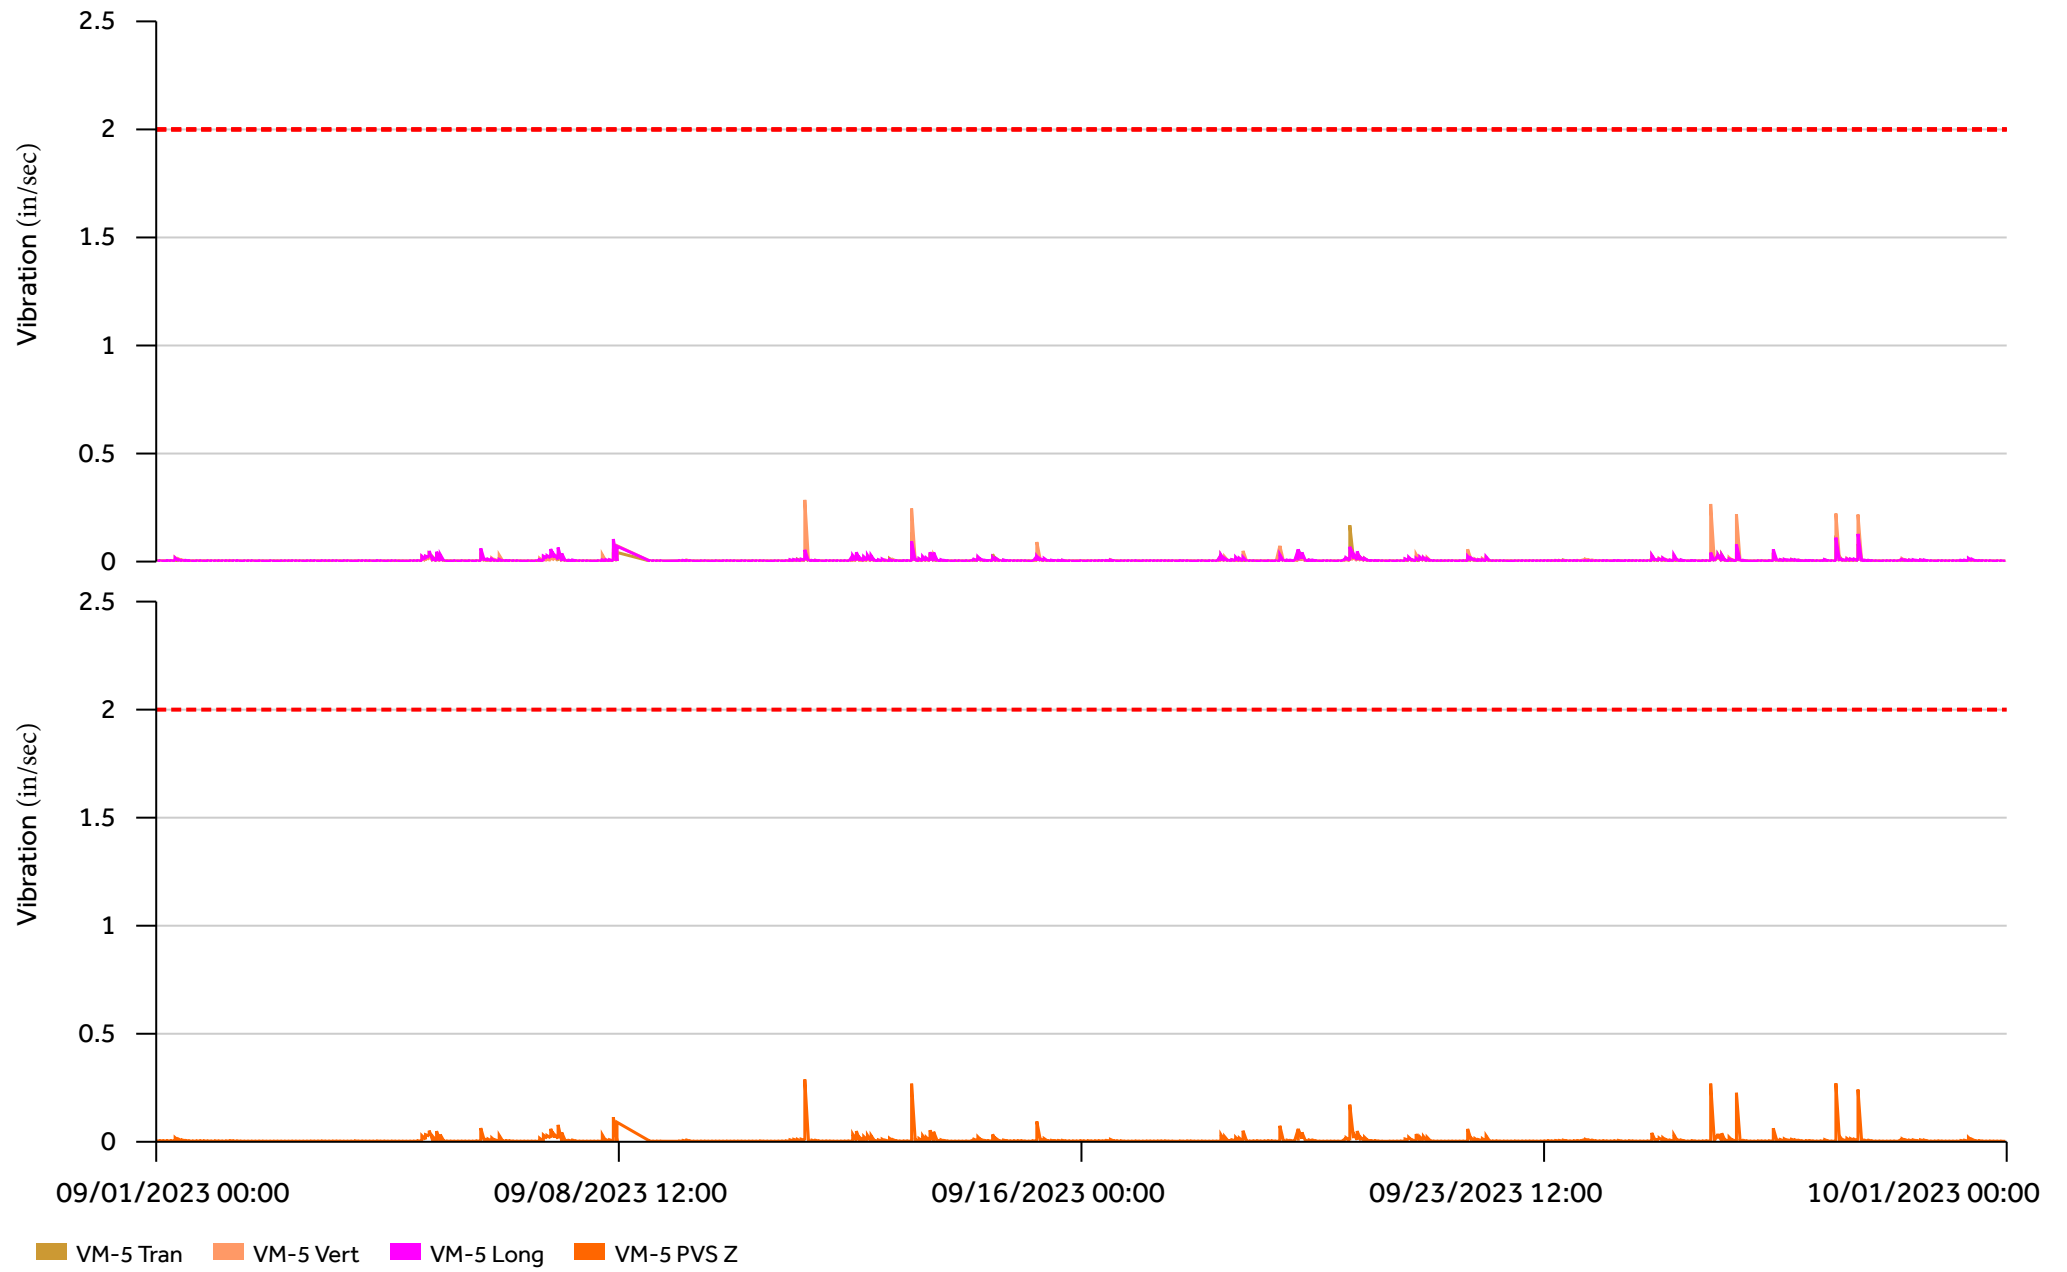
Graphs showing monitoring results are presented in Graphs 1 to 5.

No vibration exceedance was reported during the month.
