## Northern Bus Garage Noise, Vibration, and Dust Monitoring Report (September 2023)

Noise, Vibration, and Dust levels were monitored as part of the reconstruction of Northern Bus Garage, 4615 14<sup>th</sup> Street, NW, Washington, DC, for the month of September 2023.

WMATA Bus Garage Monthly Report

**September 2023**

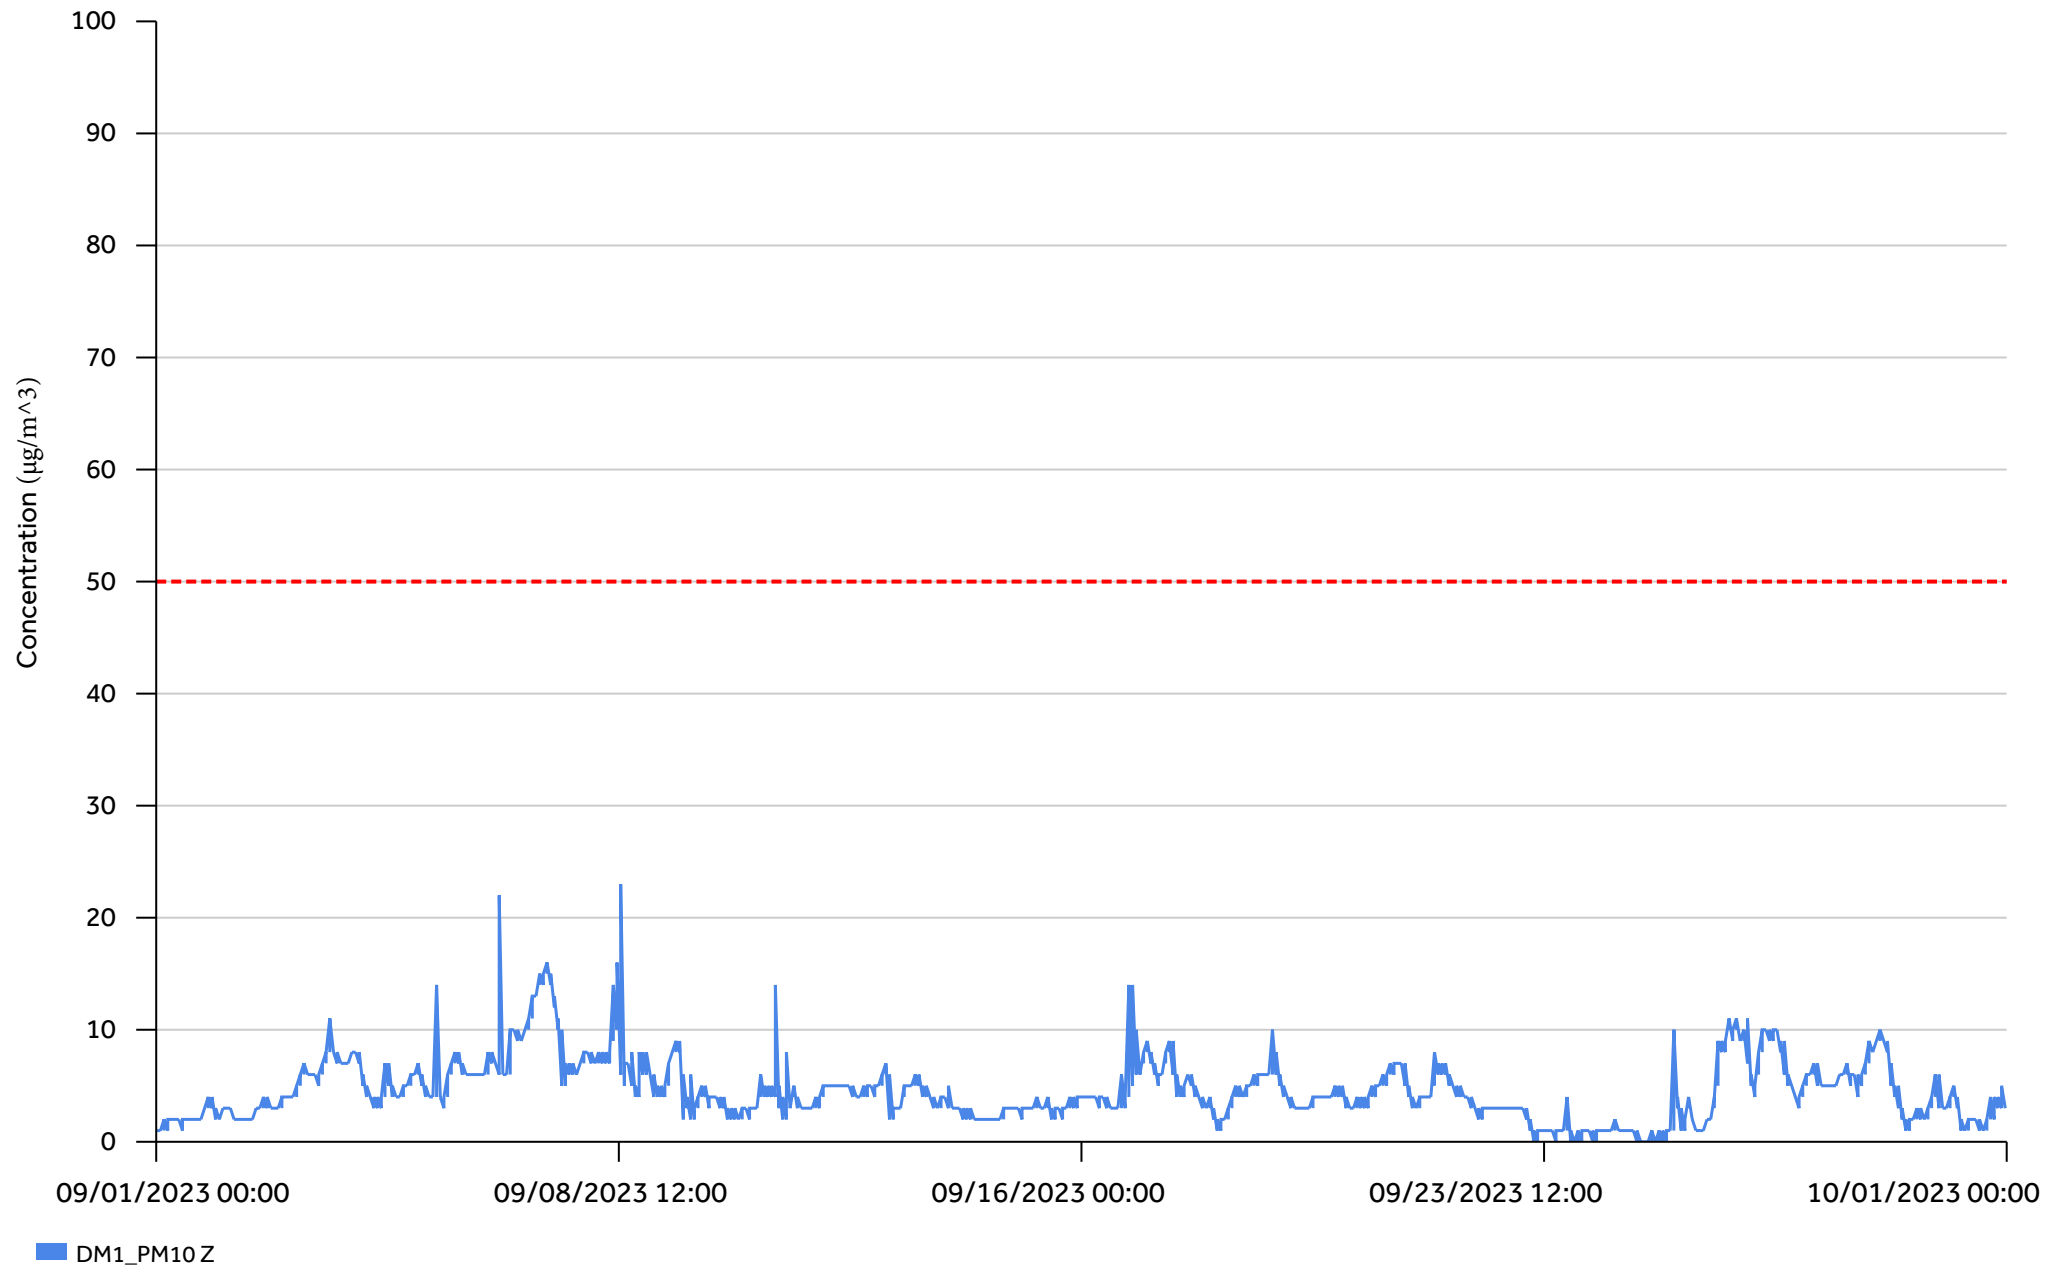
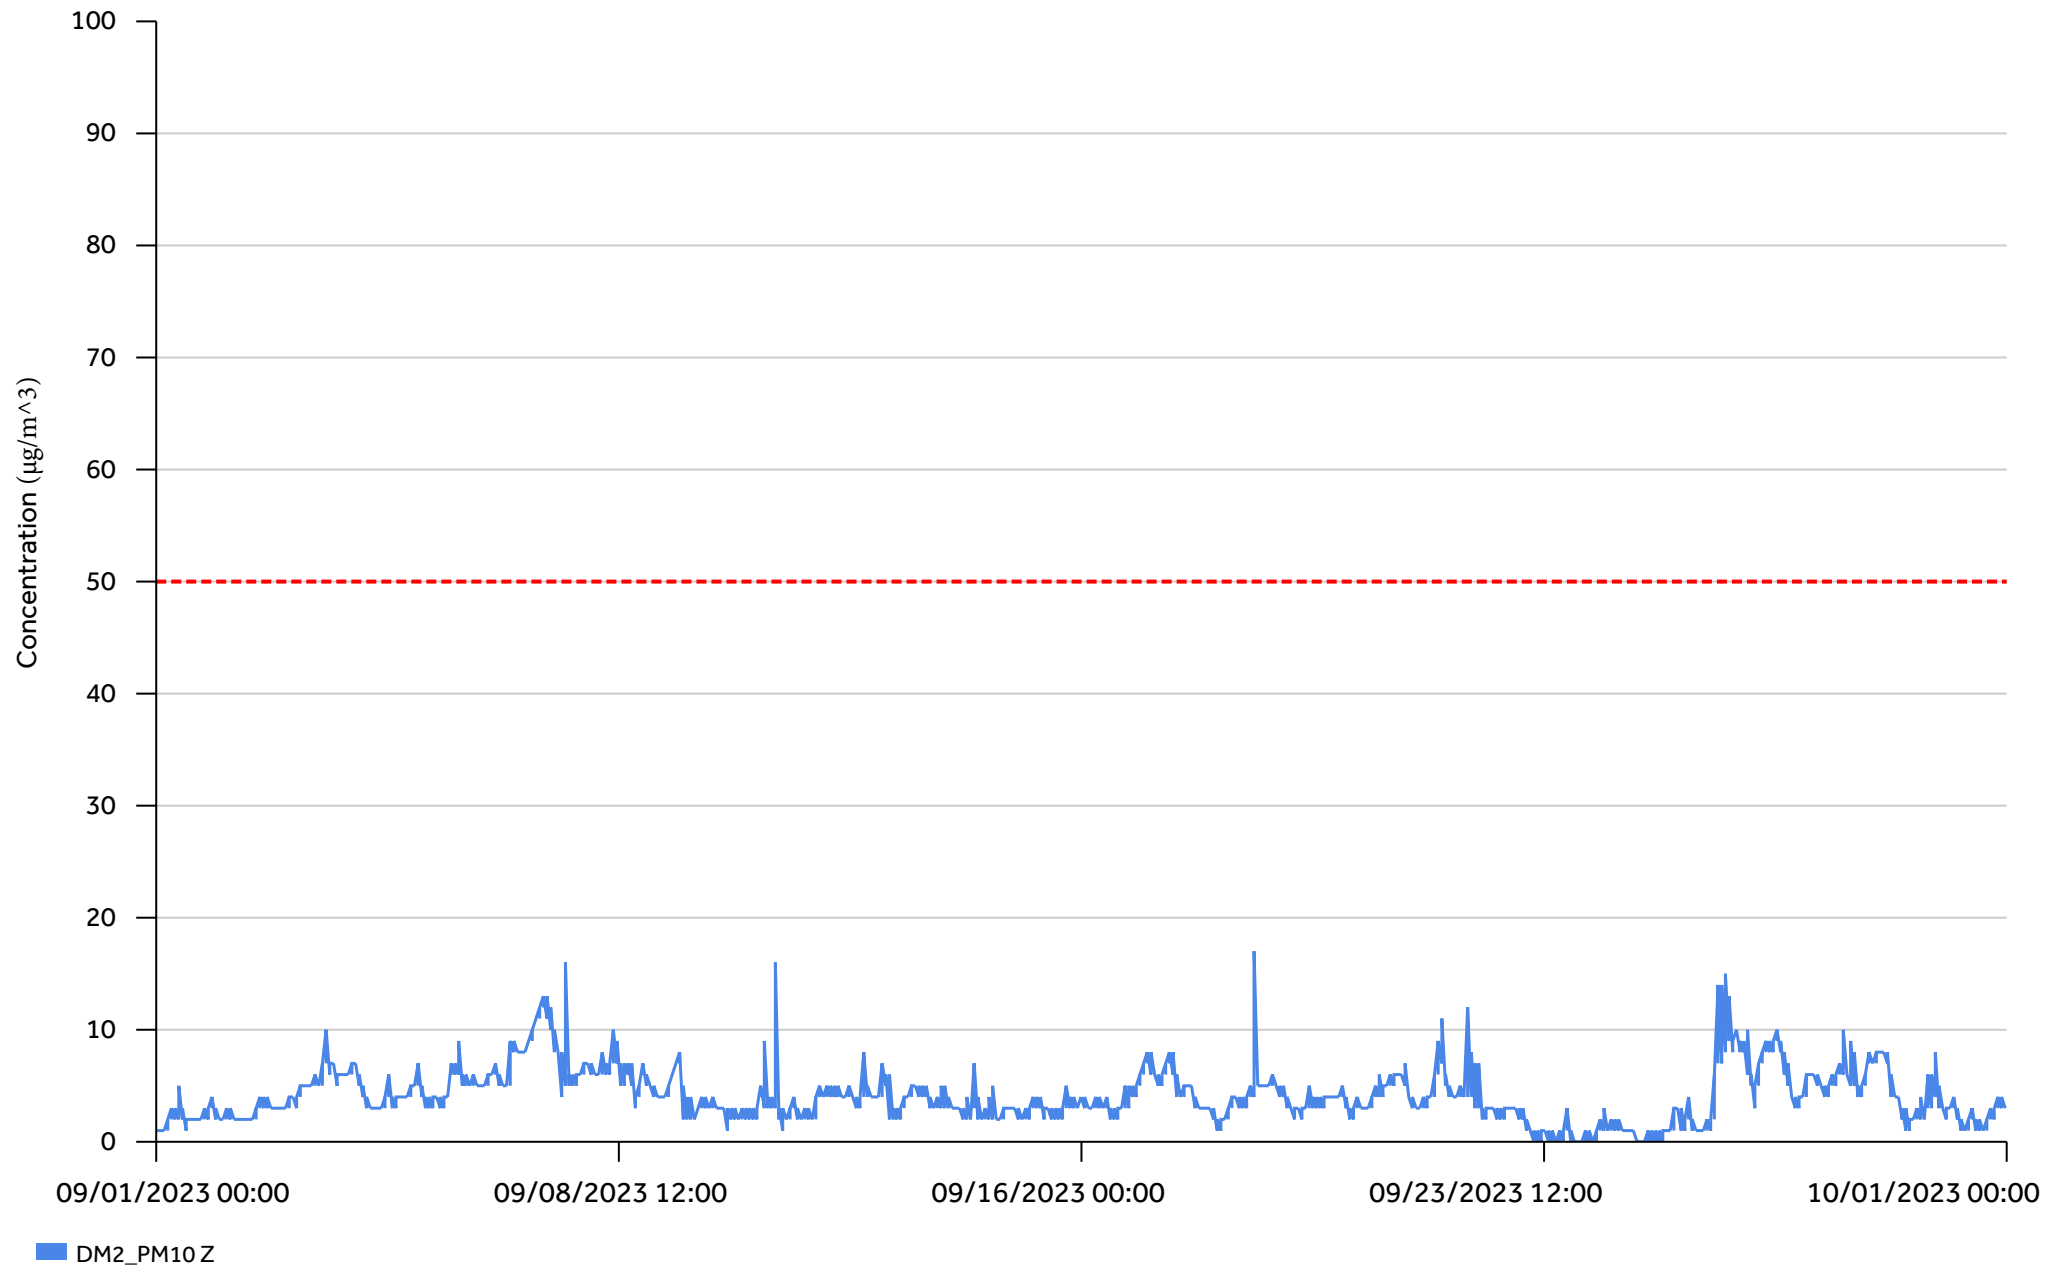
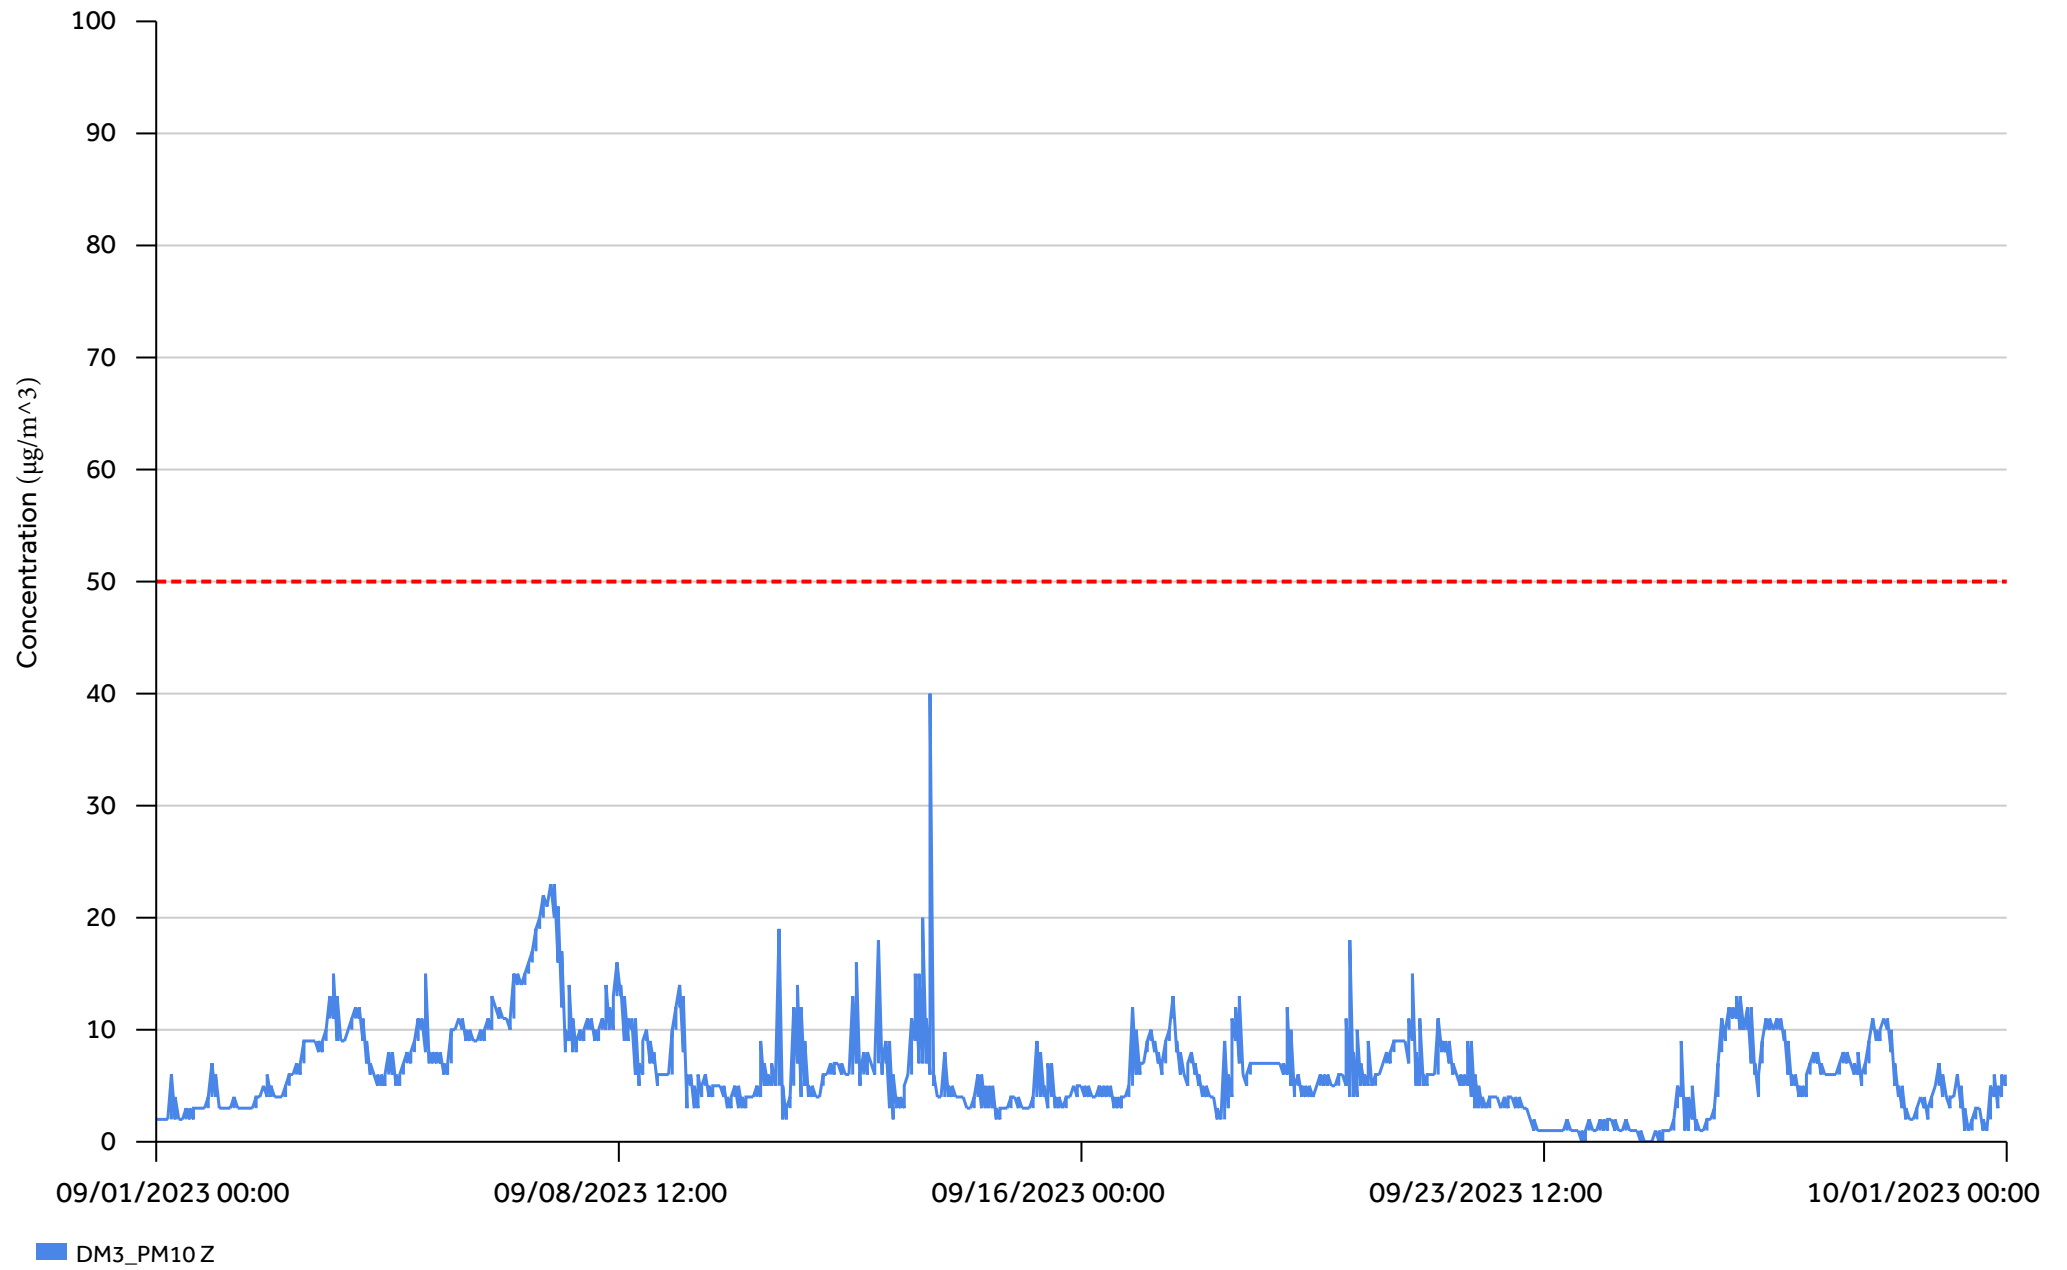
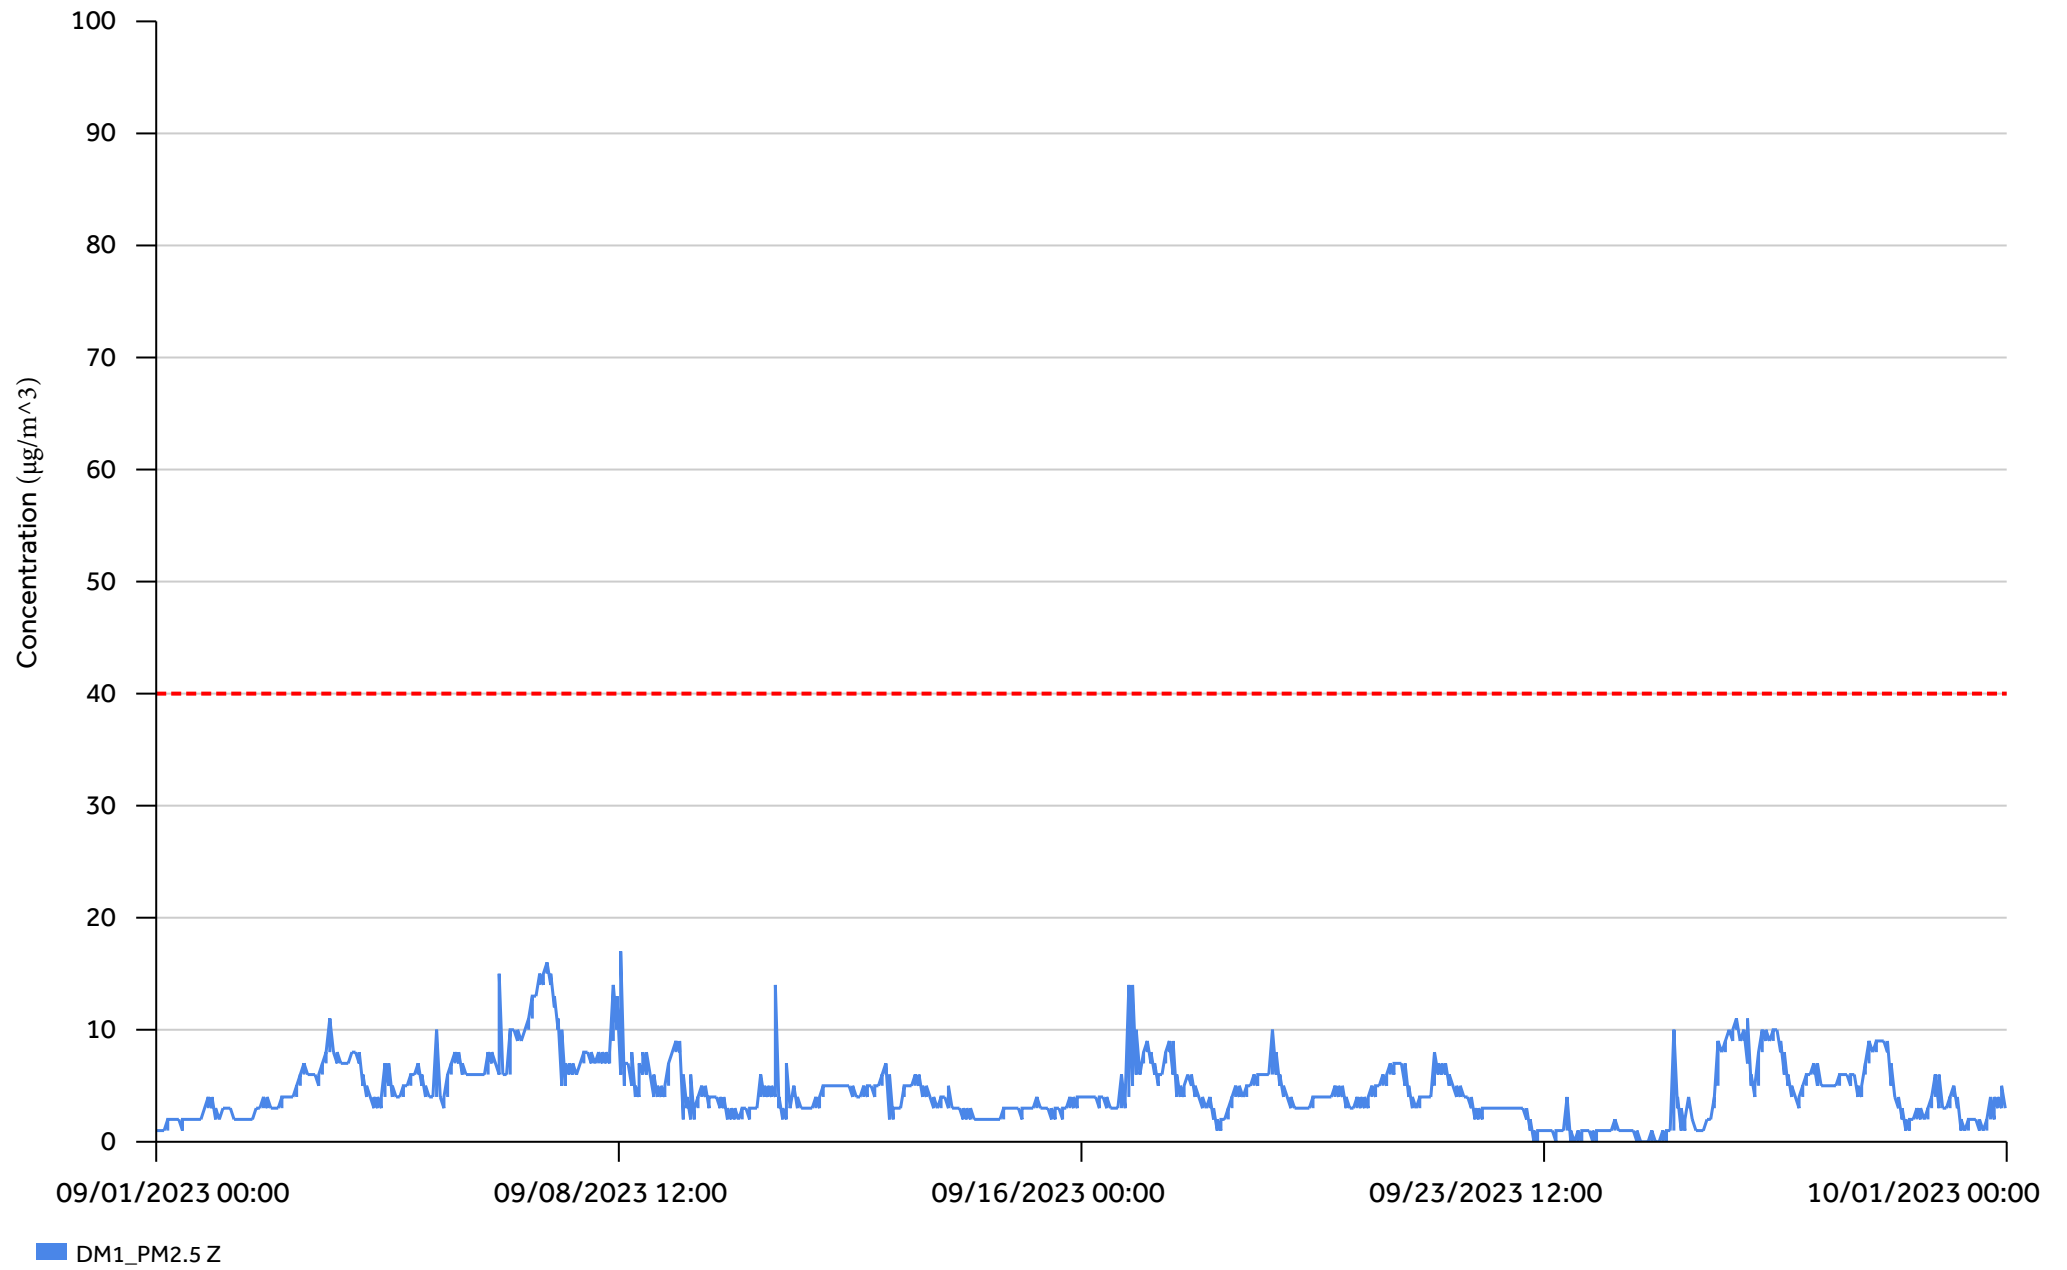
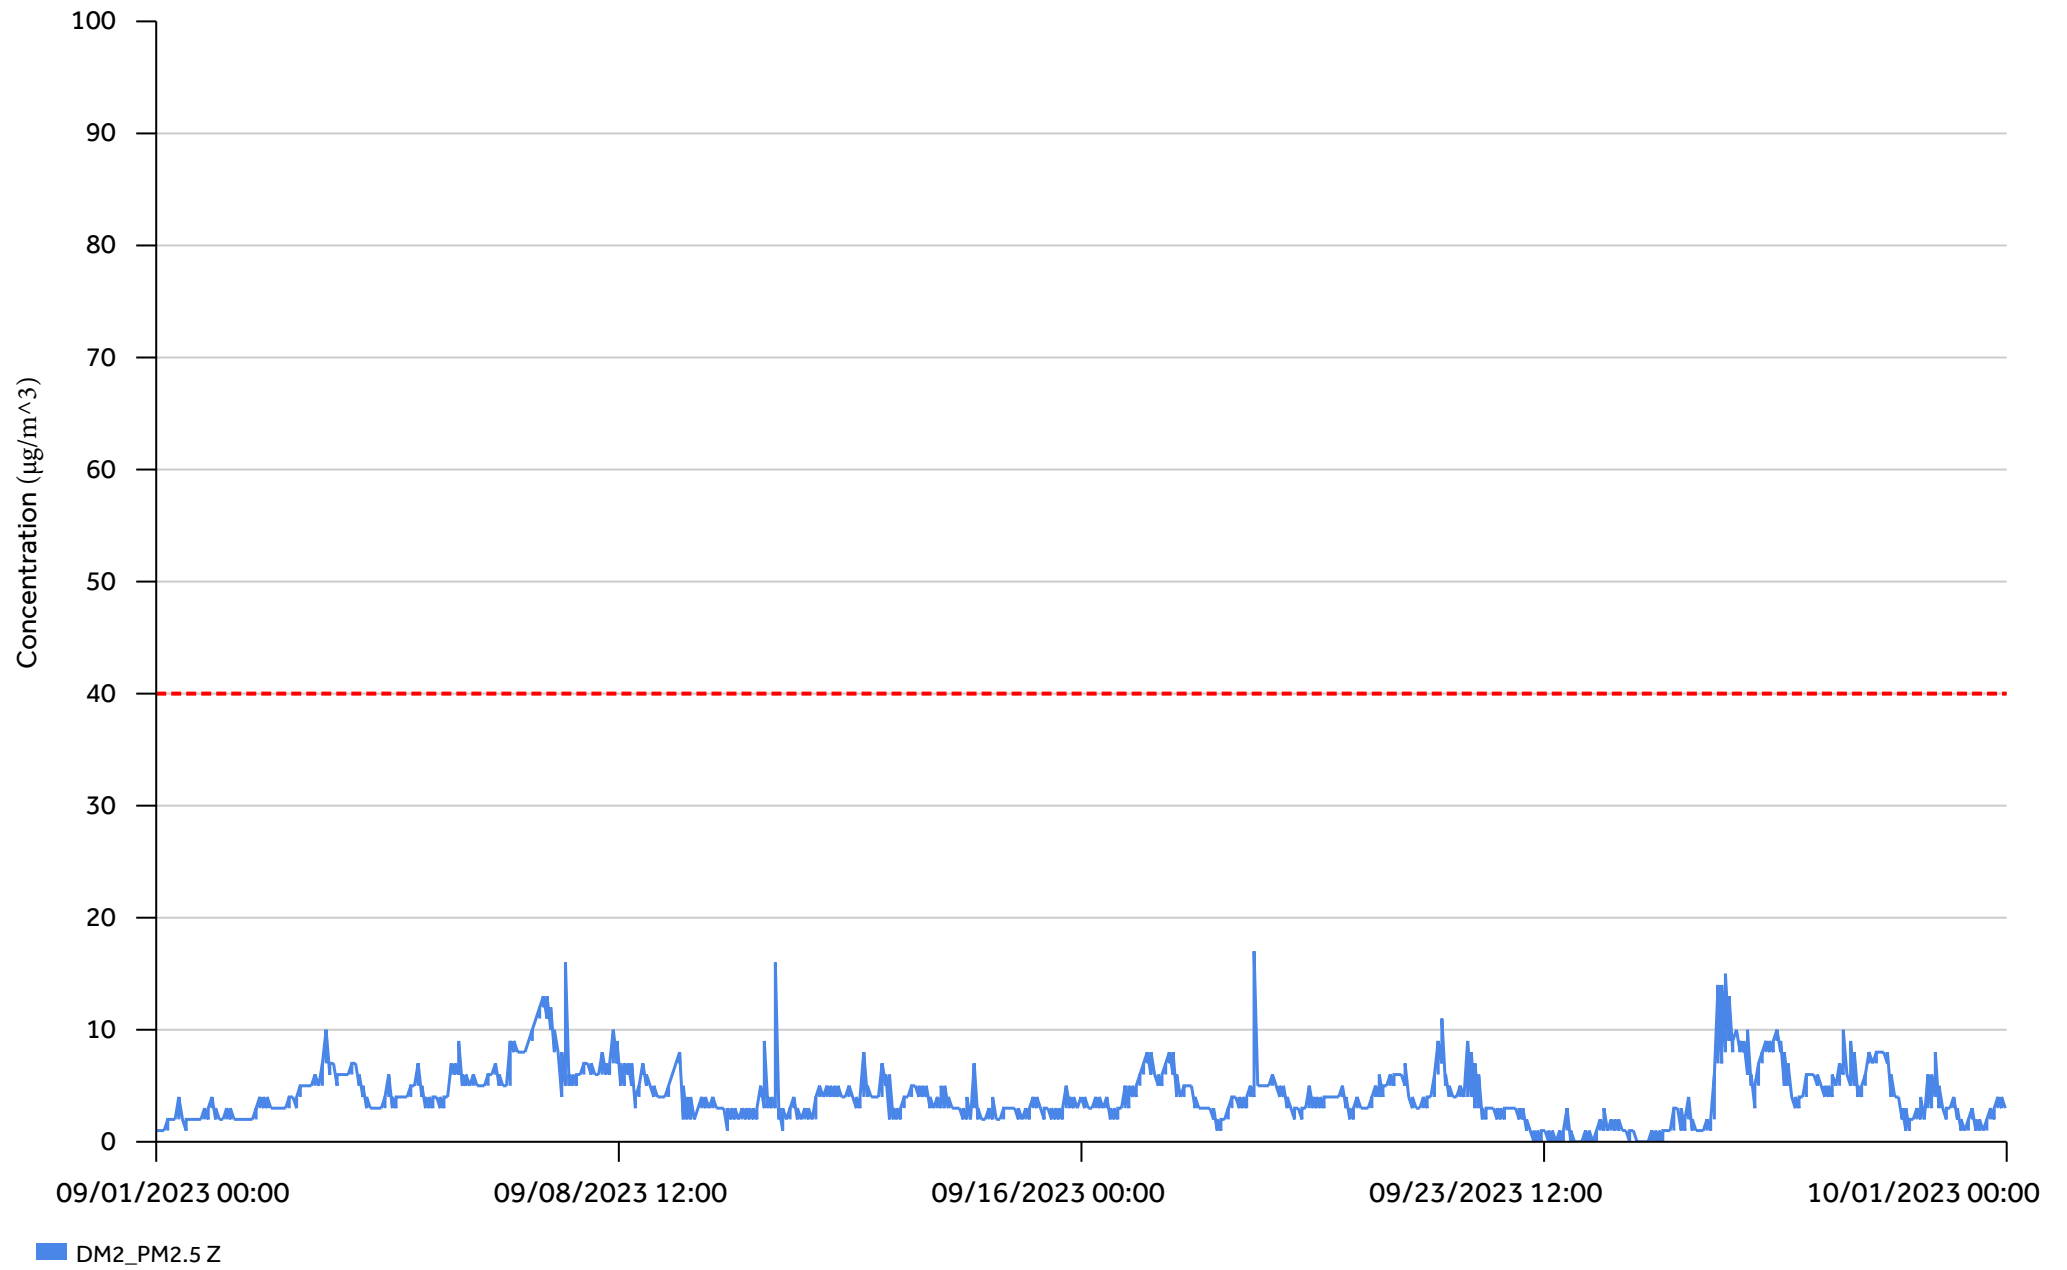
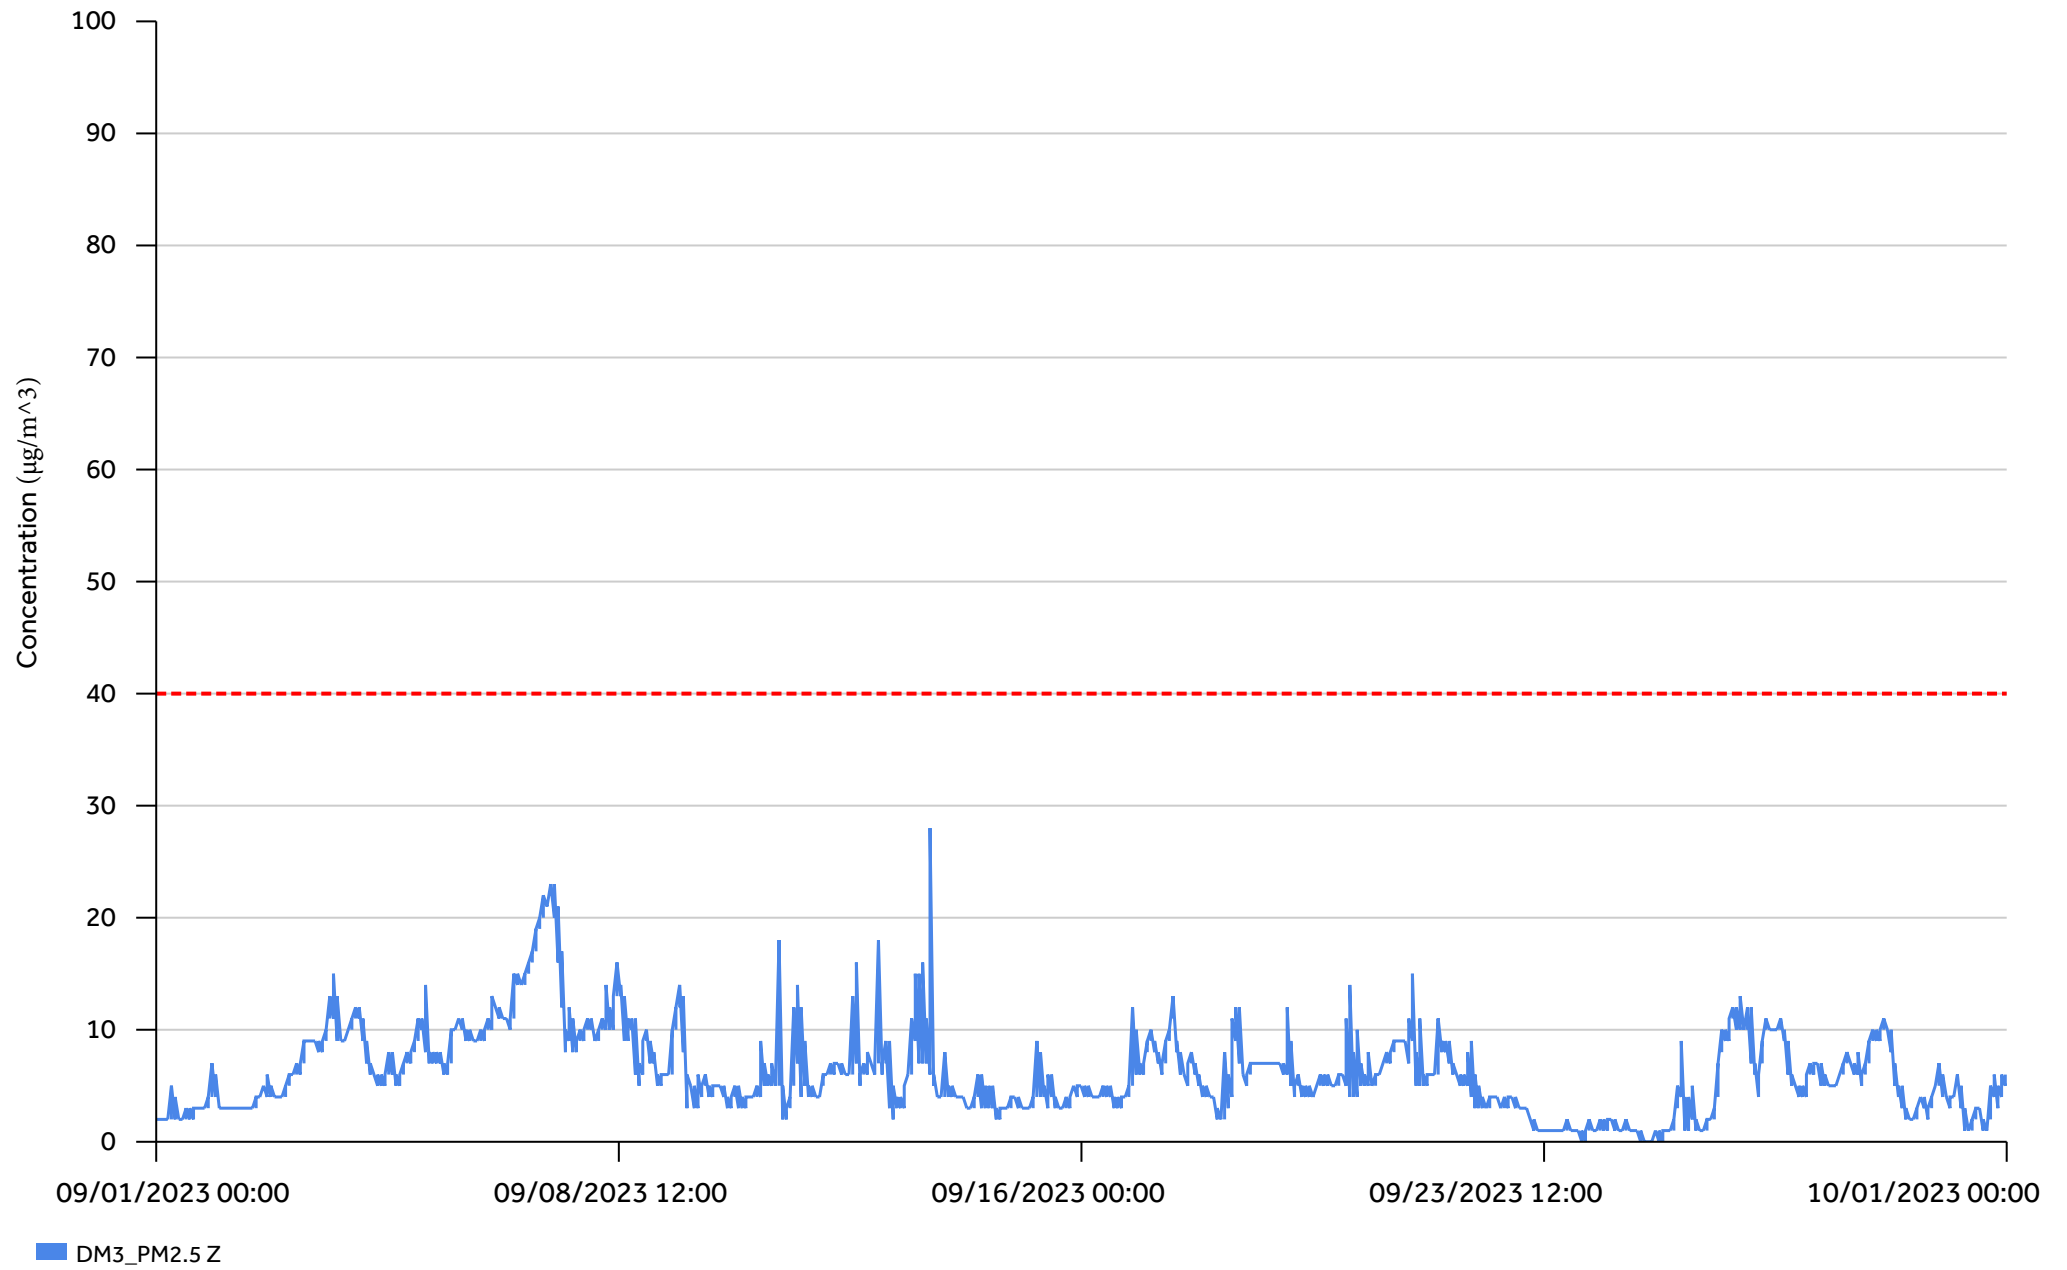
Graphs showing monitoring results are presented in Graphs 6-11.

No dust monitoring exceedance was reported during the month.
