# ASSET (BUS SHELTER) IMPROVEMENT EVALUATION STUDY

**Final Report**

**June 2013**

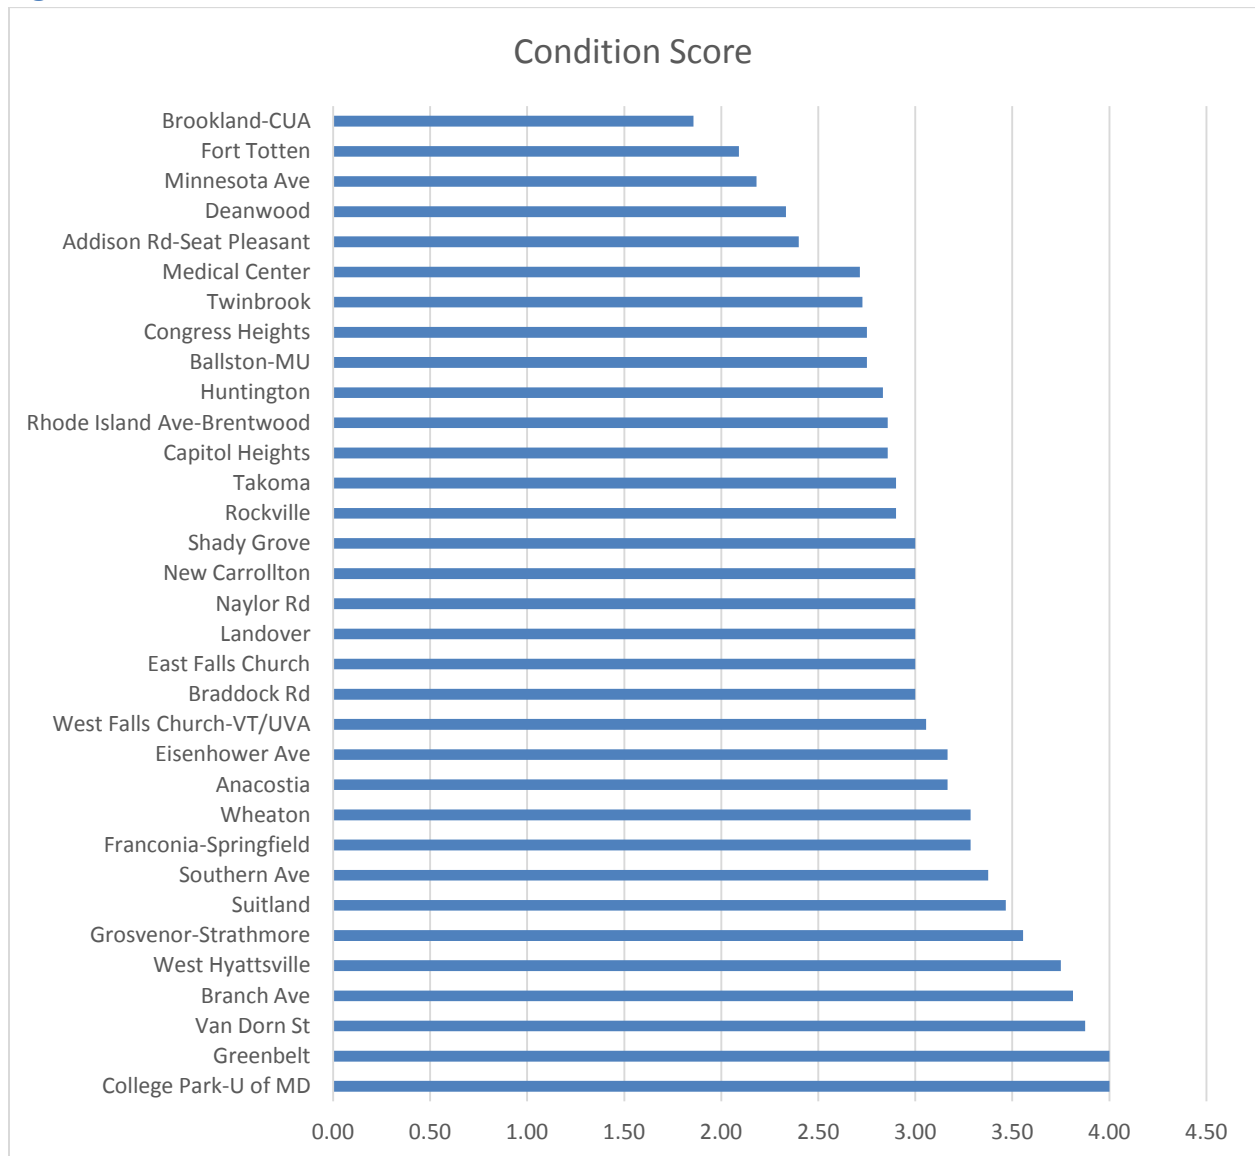
**Figure 1 - Overall Station Condition Scores**

Once each shelter at a station was evaluated and given a score based on the conditions described in **Table 2**, the shelter scores were averaged by station to give each station a final score from 1 to 5. Station scores ranged from 1.86 at Brookland-CUA to 4.0 at Greenbelt and College Park. **Table 3** lists the overall score for each station. **Figure 1** displays these results graphically.

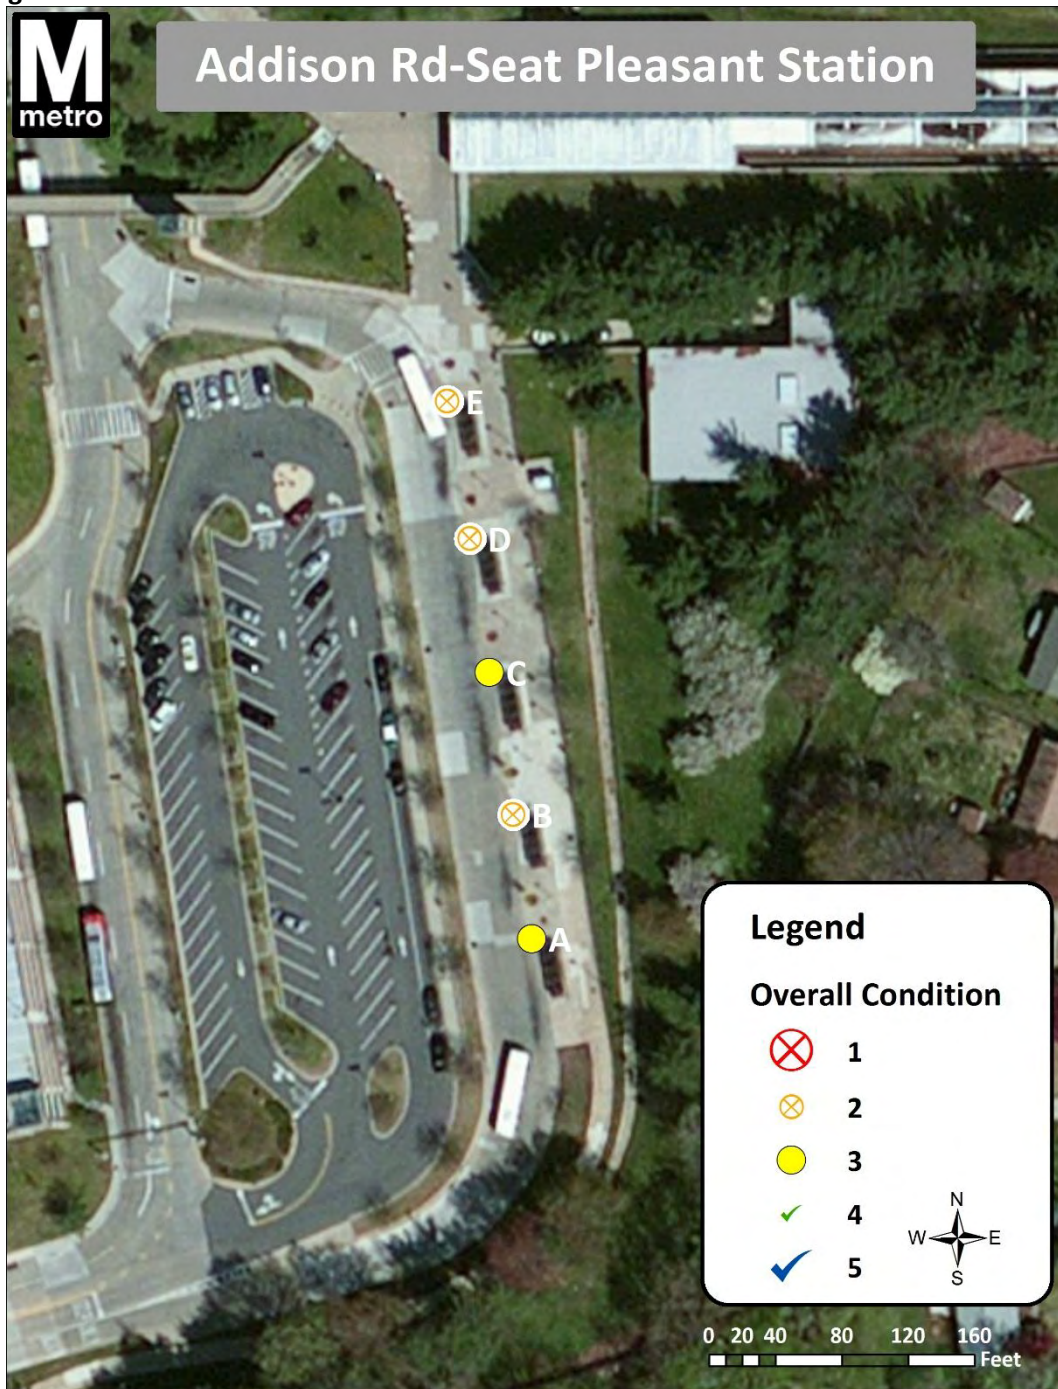
Figure 6: Overall Condition Score of Addison Road-Seat Pleasant Metrorail Station Shelters

Overall, shelter conditions at the station are poor, with a station condition score of 2.4. Table 1 summarizes conditions for each individual shelter. The shelters, as a whole, scored the lowest in frame

and panel condition, with most shelters showing rust and warped or broken panels. Shelters B and D are in the worst condition, with poor pads and significant rust on their frames. Shelter A is the only shelter without significant rust on its frame. Shelter E has damaged panels, including one popping out of the frame. Dome tops at the station are slightly below average, with fading and cracking present. **Figures 2 through 5** illustrate the different shelter conditions at the station, while **Figure 6** summarizes each shelter’s overall condition score.

Overall, the station was ranked 7<sup>th</sup> for replacement based on shelter condition and demand. Based on shelter condition only, the station ranked 6<sup>th</sup> for replacement. A federal grant to reconstruct the bus bays and shelters at the station is in place and therefore, this station should be WMATA's top priority for replacement.

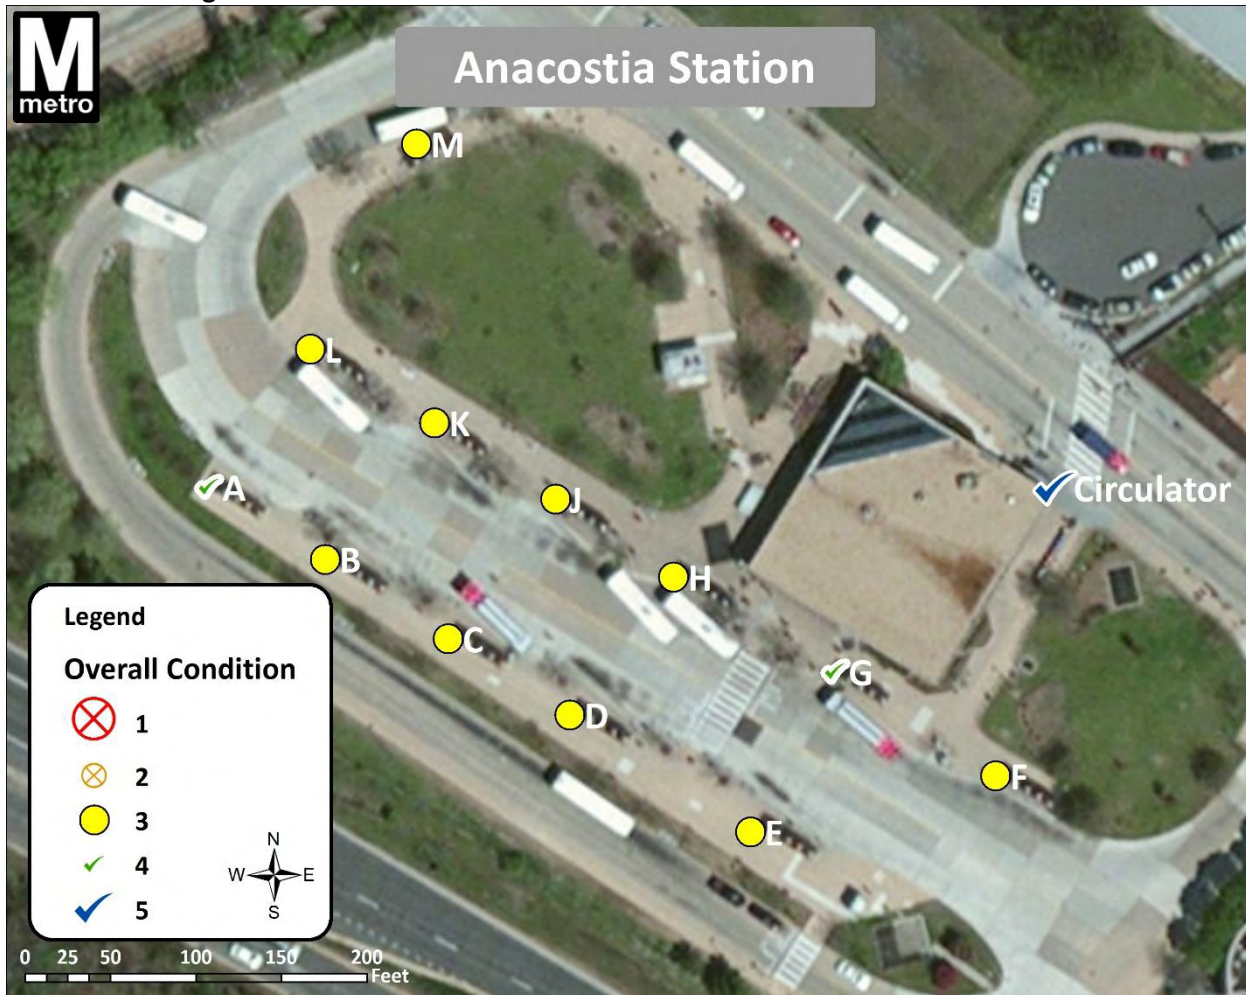
Figure 12: Overall Condition Score of Anacostia Metrorail Station Shelters

Overall, shelter conditions at the station are above average, with a station condition score of 3.2. **Table 2** summarizes conditions for each individual shelter. The shelters as a whole scored the lowest in panels and dome tops. Shelters B, C, D, E, F, H, J, L and M all had damaged panels with smearing, glossing, and

cracking. Shelters C and L also had some cracking damage to their dome tops. Benches and pads at the station were in above average shape, and frames had minimal rust with the exception of shelters B, C, K, and L.

Overall, the station was ranked 12<sup>th</sup> for replacement based on shelter condition and demand. Based on shelter condition only, the station ranked 22<sup>nd</sup> for replacement.

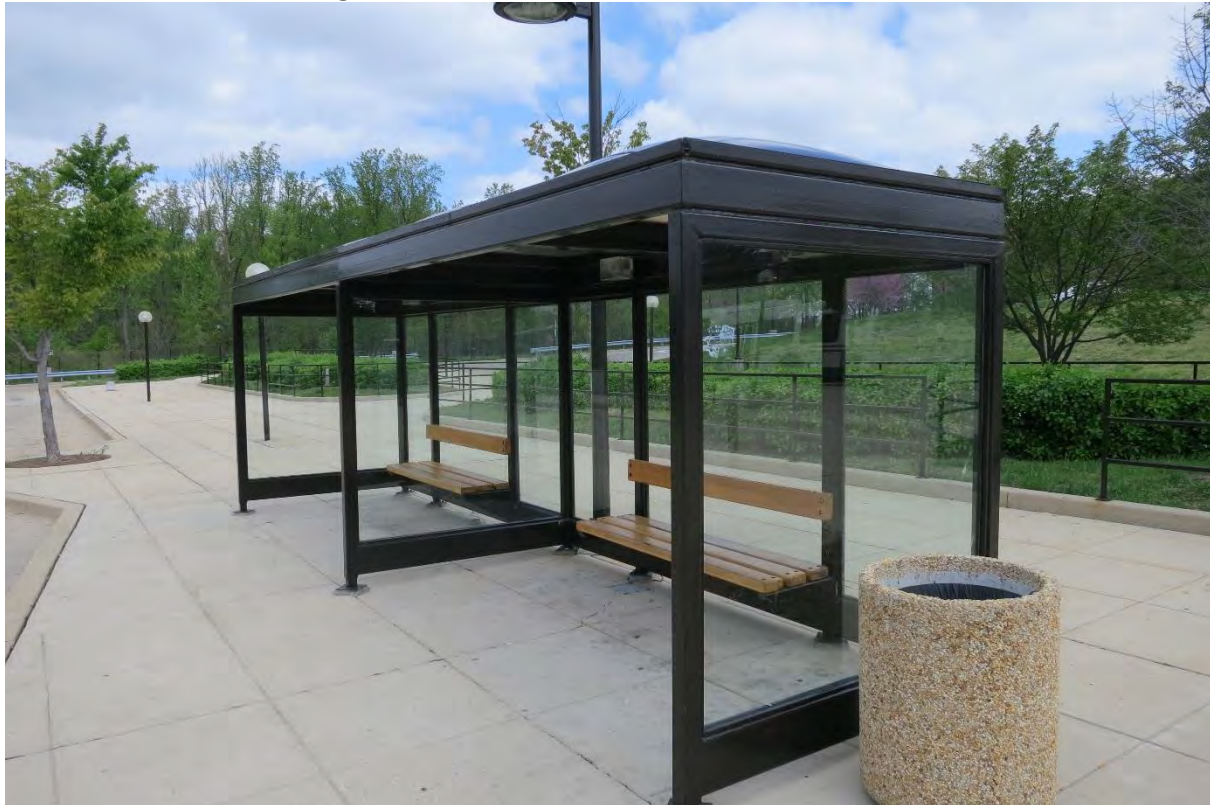
**Figure 155: Cracked Dome Top, Shelter C**
