Northern Bus Garage

Noise, Vibration, and Dust Monitoring Report (August 2025)

Noise, Vibration, and Dust levels were monitored as part of the reconstruction of Northern Bus Garage, 4615 14th Street, NW, Washington, DC, for the month of August 2025.

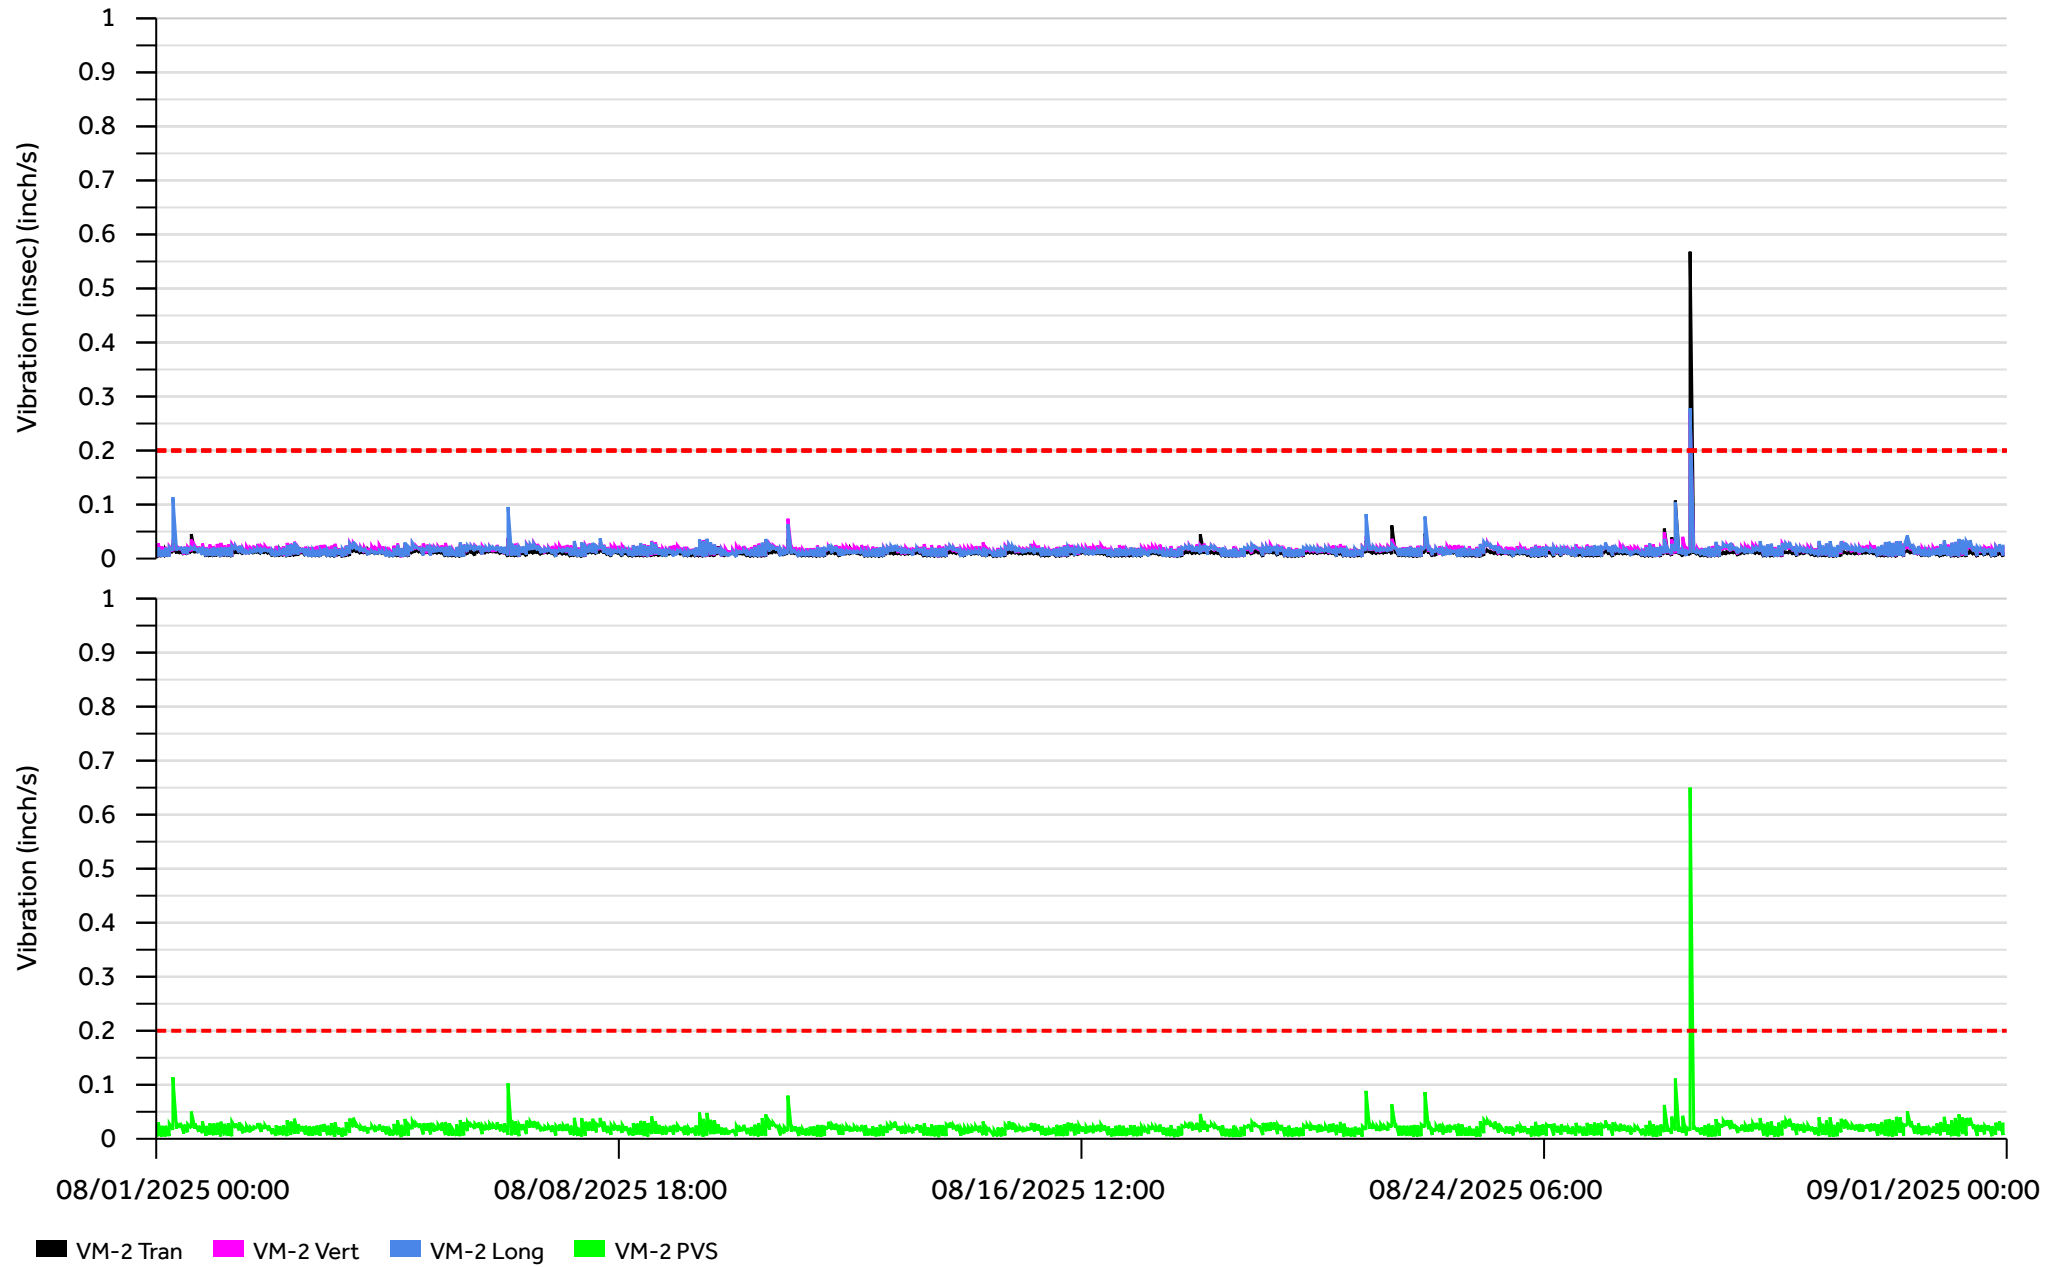
Graph 2

One vibration exceedance occurred at VM2 on August 26 at 16:54. The source of the minor event is unknown but appears as a couple of bumps likely within 10 feet of the sensor. The Waveform report may be found in Attachment B.

- VM2 – Exceedance with a reading of 0.57 in/sec on August 26 at 16:54.

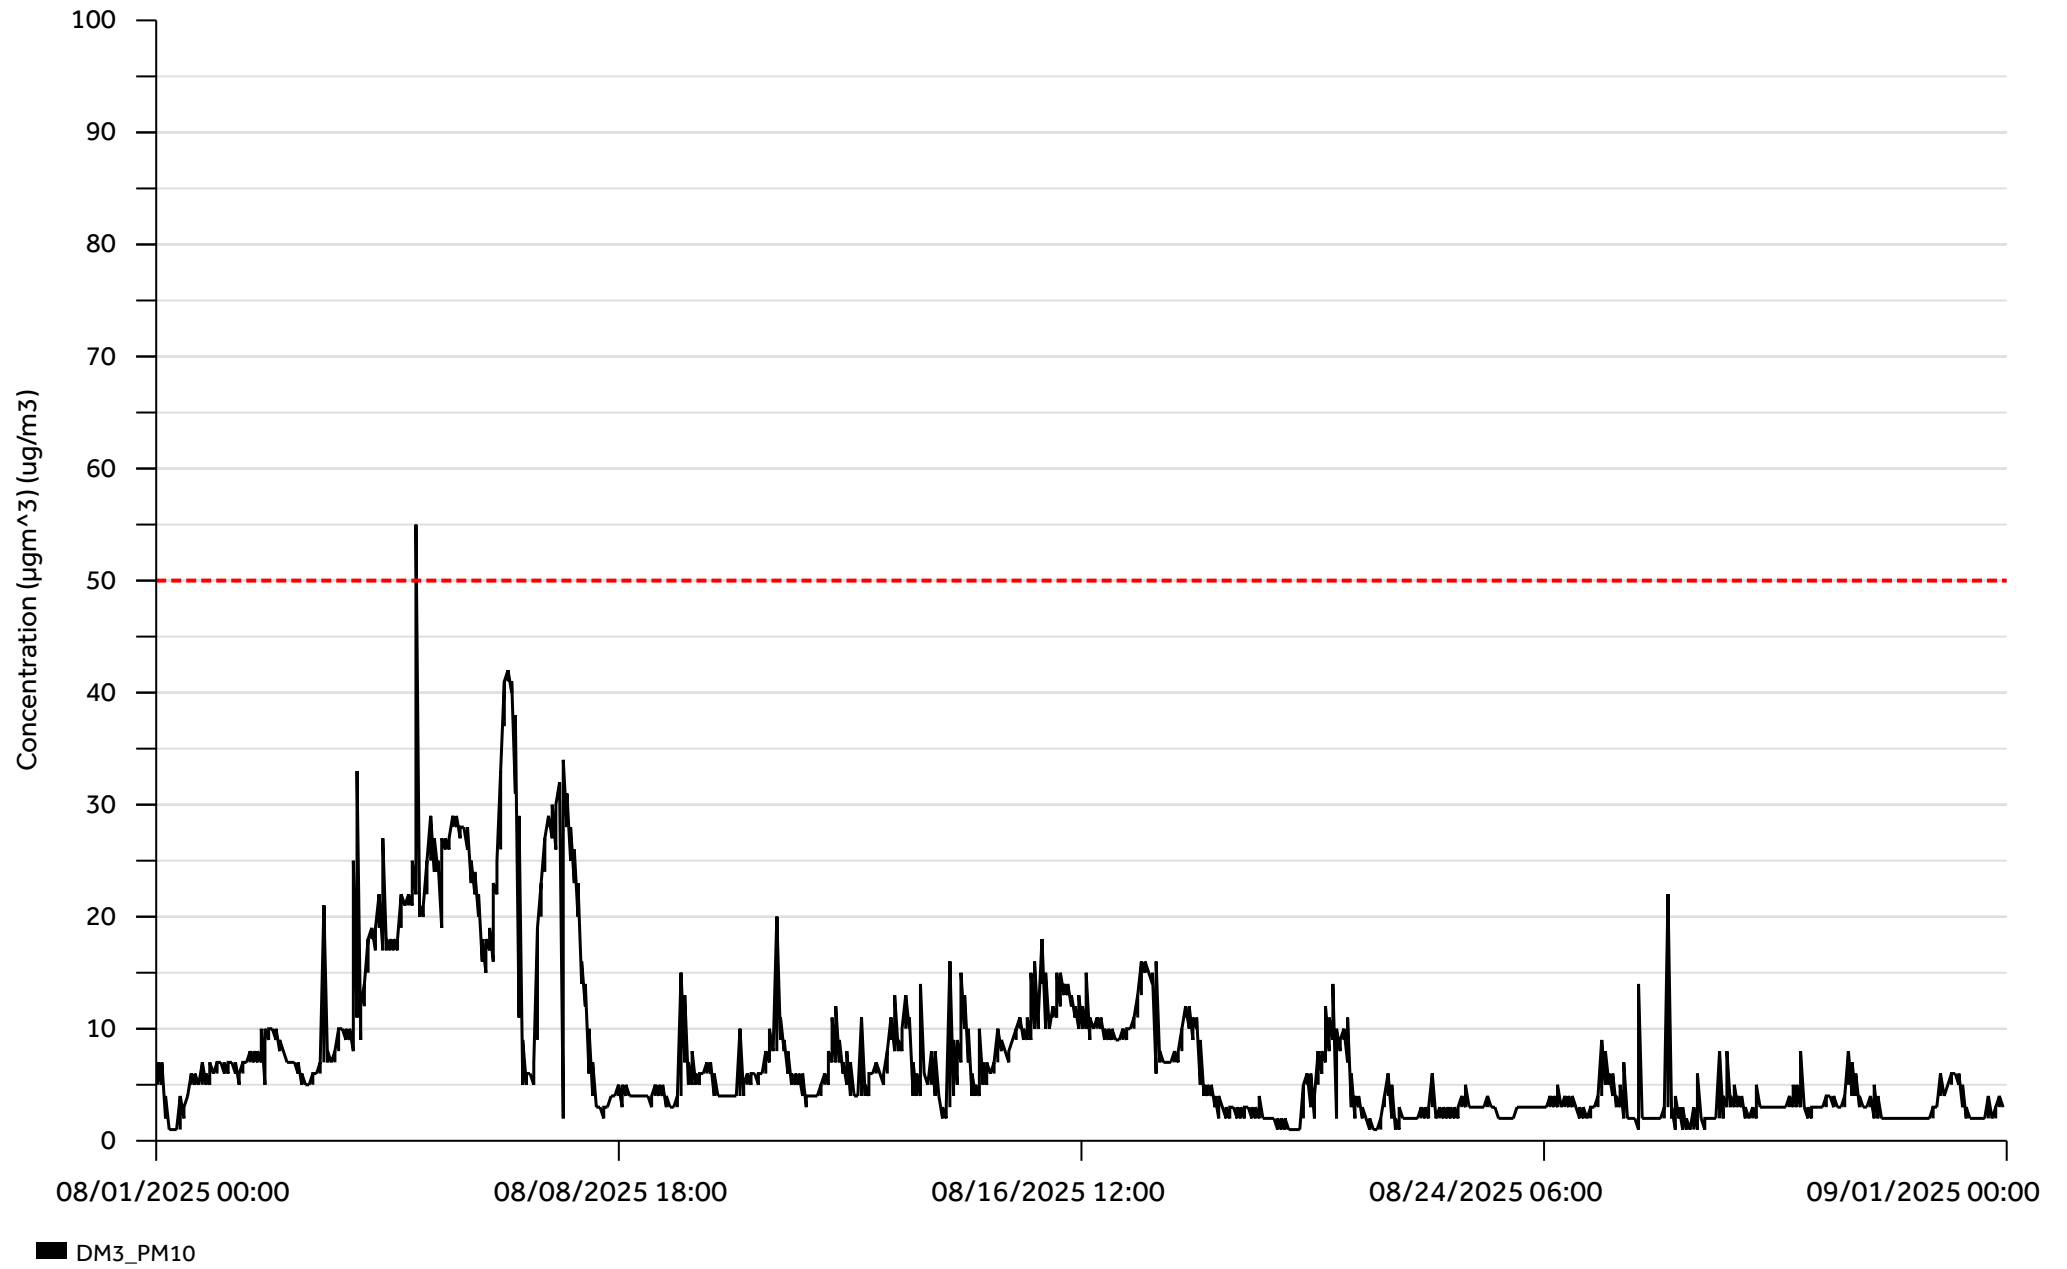
Graph 8

- DM3 – Exceedance of the PM2.5 limit with a reading of 43 µg/m³ on August 5 at 09:18.
- DM3 – Exceedance of the PM10 limit with a reading of 55 µg/m³ on August 5 at 09:18.
- DM3 – Exceedance of the PM2.5 limit on August 6 from 21:18 to midnight. The peak reading was 41 µg/m³.

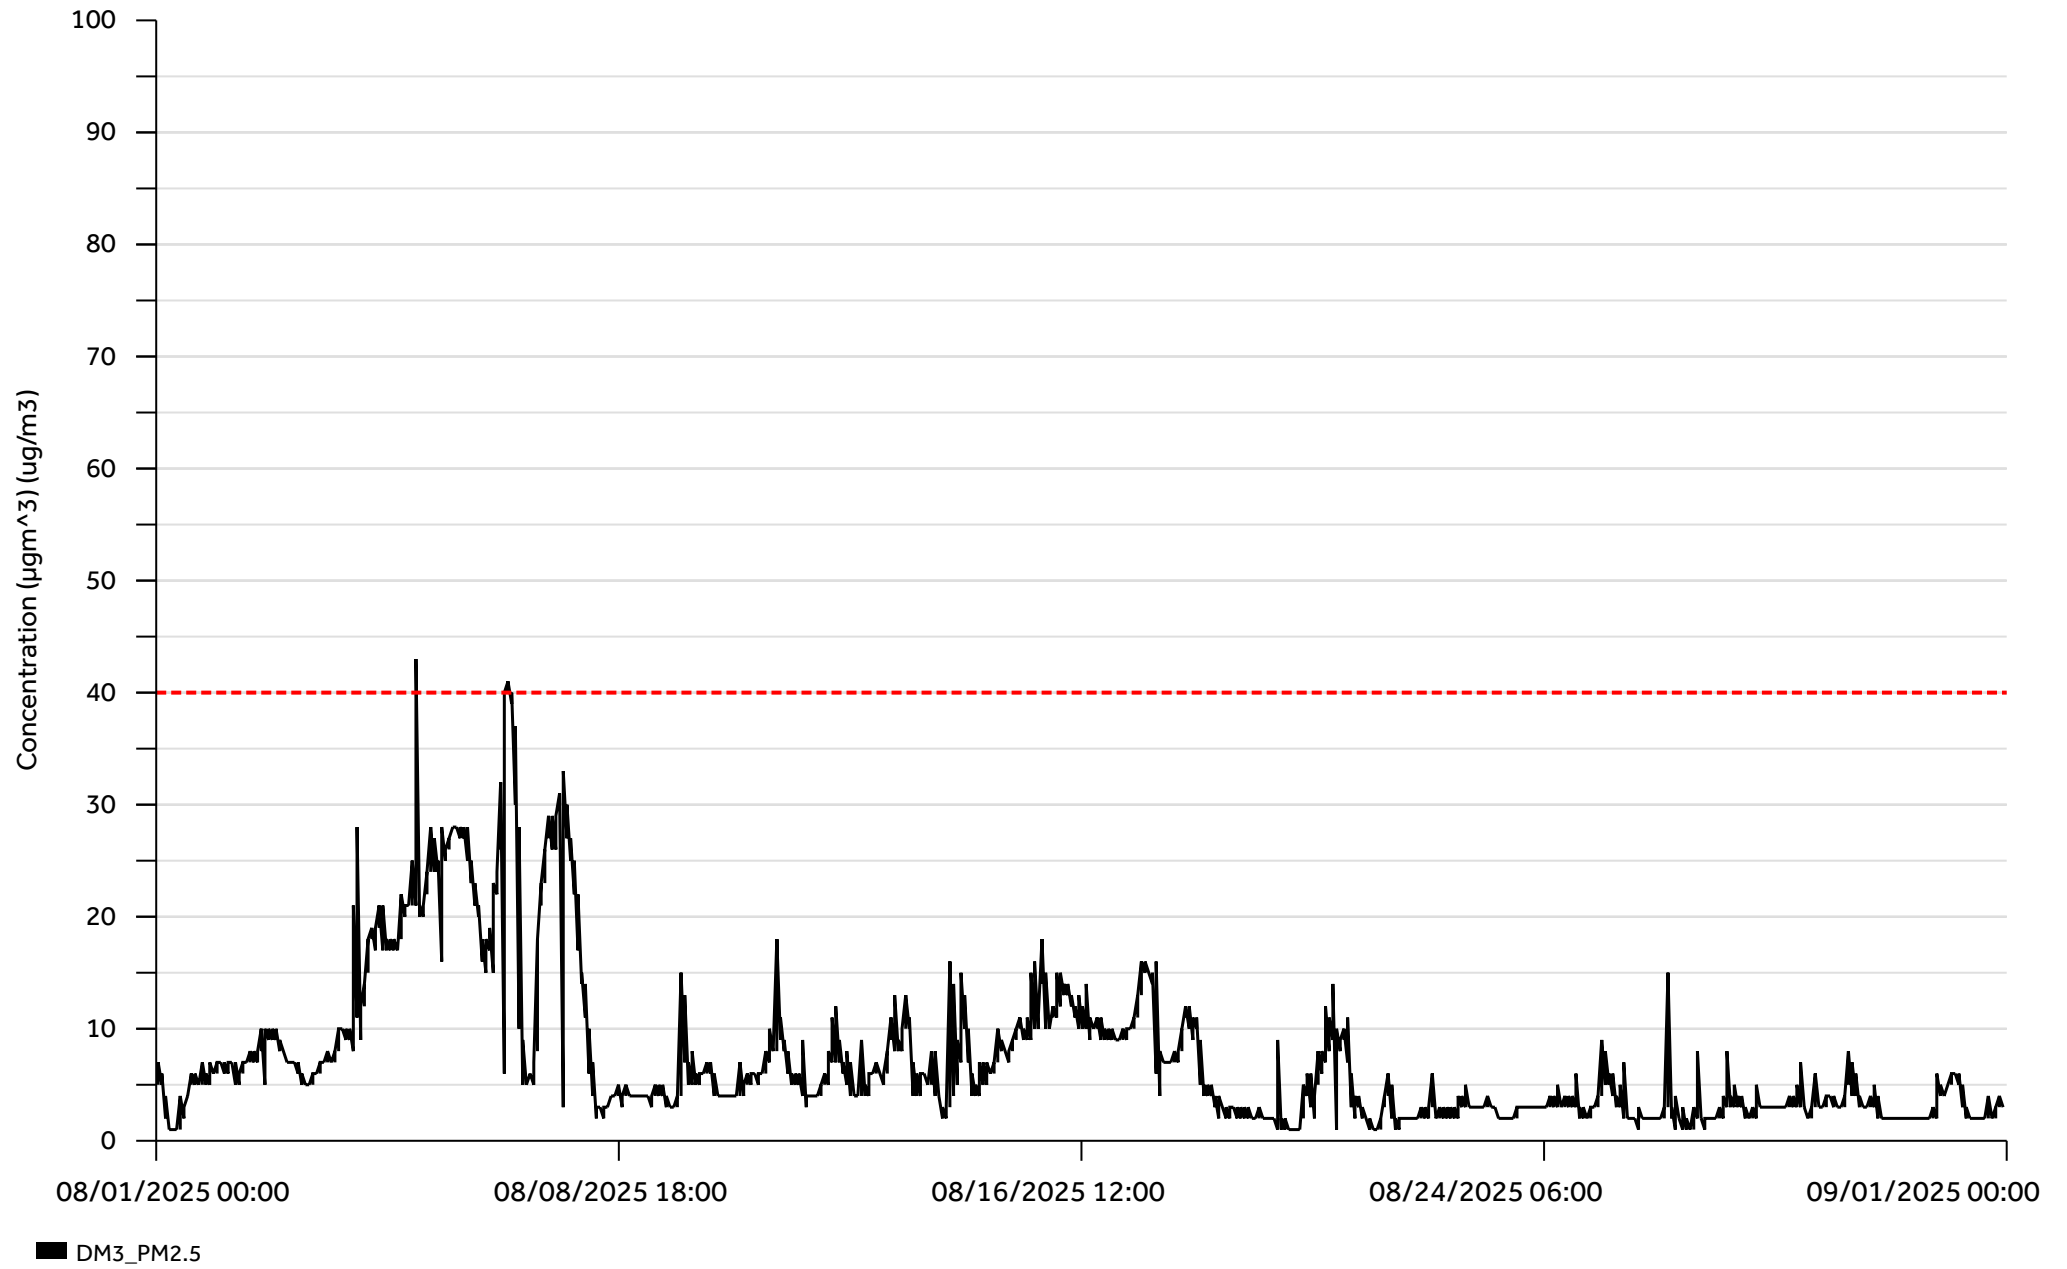
Graph 11

Three air quality exceedances occurred during the month of August 2025. Details of these air quality exceedances can be found below. It is important to note that there was no work on site during the August 6th exceedance.
