Northern Bus Garage

Noise, Vibration, and Dust Monitoring Report (December 2024)

Noise, Vibration, and Dust levels were monitored as part of the reconstruction of Northern Bus Garage, 4615 14th Street, NW, Washington, DC, for the month of December 2024.

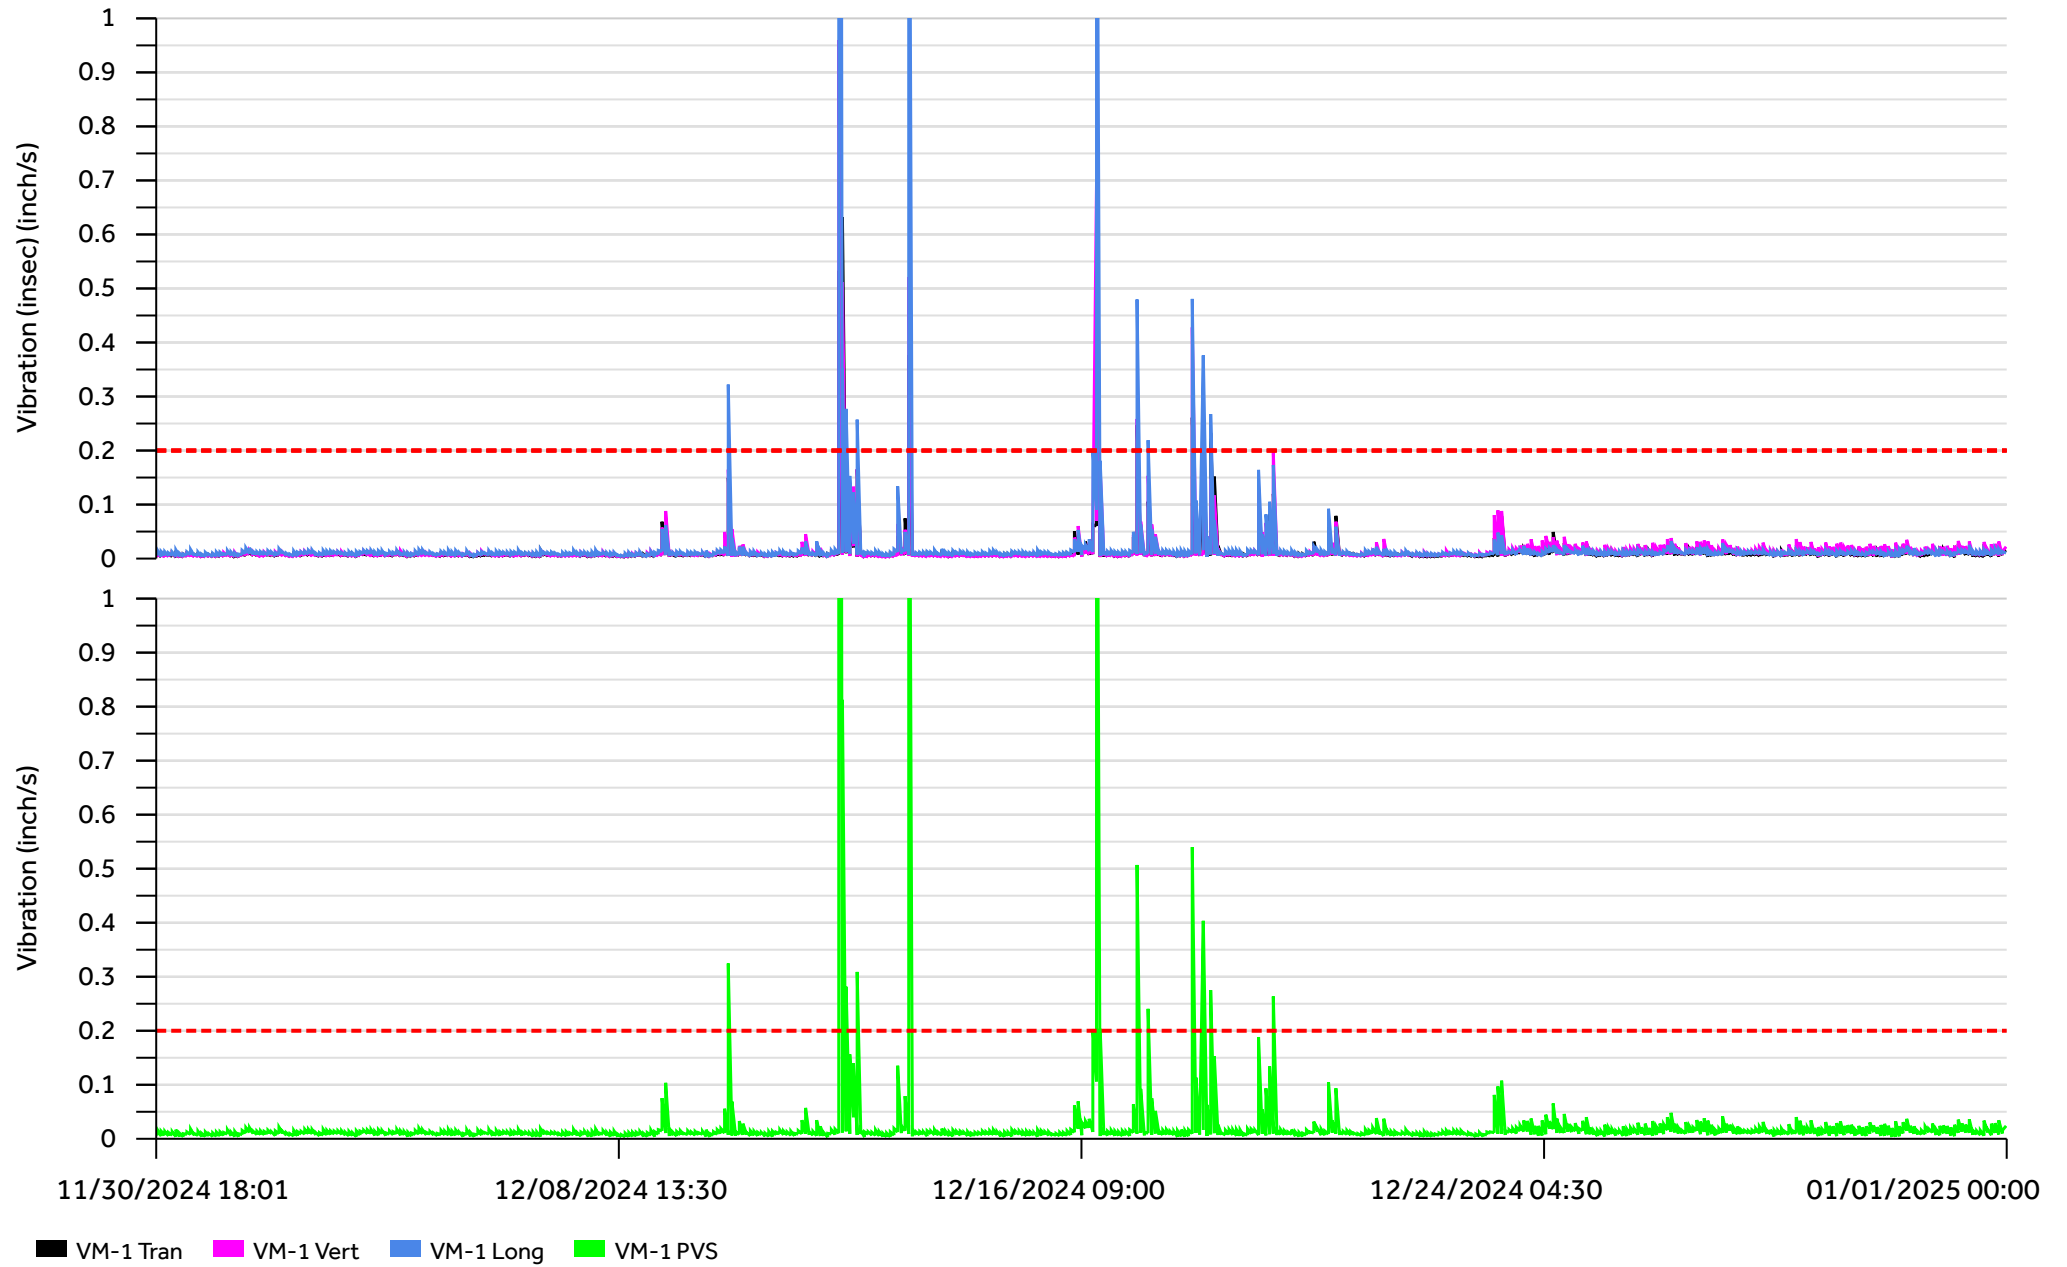
Graph 1

- VM1 – Exceedance with a reading of 0.32 in/sec on December 10 at 11:08.
- VM1 – Exceedance with a reading of 0.23 in/sec on December 12 at 07:23.
- VM1 – Exceedance with a reading of 0.24 in/sec on December 12 at 07:24.
- VM1 – Exceedance with a reading of 0.34 in/sec on December 12 at 07:25.
- VM1 – Exceedance with a reading of 0.23 in/sec on December 12 at 07:27.
- VM1 – Exceedance with a reading of 0.78 in/sec on December 12 at 07:28.
- VM1 – Exceedance with a reading of 4.59 in/sec on December 12 at 07:30.
- VM1 – Exceedance with a reading of 0.35 in/sec on December 12 at 08:57.

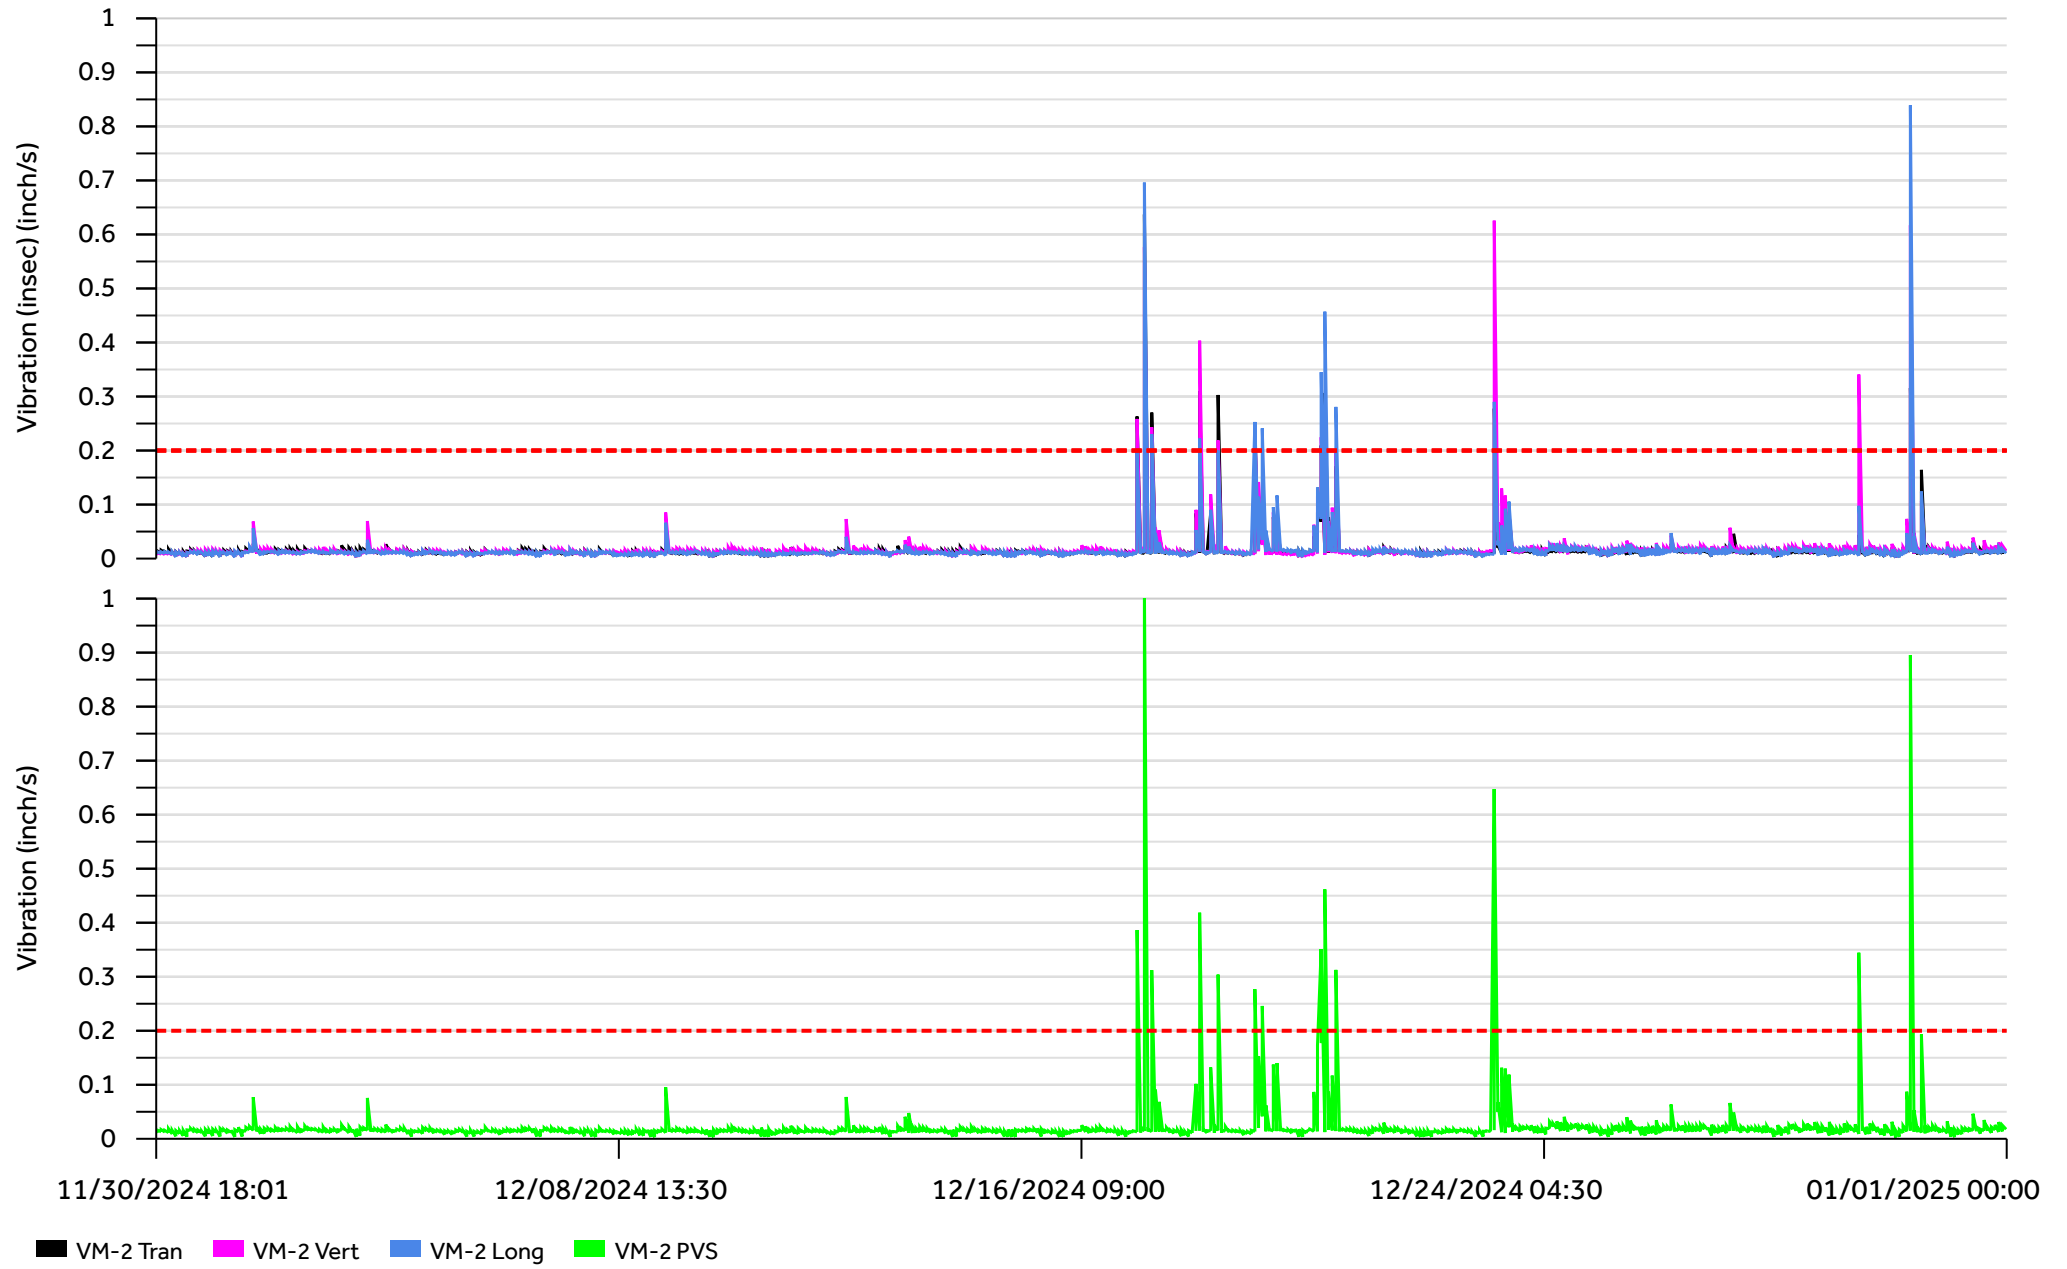
Graph 2
VM-2- Vibration Monitor

- VM2 – Exceedance with a reading of 0.20 in/sec on December 20 at 11:25.
- VM2 – Exceedance with a reading of 0.26 in/sec on December 20 at 11:33.
- VM2 – Exceedance with a reading of 0.20 in/sec on December 20 at 11:35.

- VM2 – Exceedance with a reading of 0.26 in/sec on December 20 at 11:37.
- VM2 – Exceedance with a reading of 0.29 in/sec on December 20 at 11:43.
- VM2 – Exceedance with a reading of 0.24 in/sec on December 20 at 11:43.

- VM2 – Exceedance with a reading of 0.20 in/sec on December 20 at 11:44.
- VM2 – Exceedance with a reading of 0.27 in/sec on December 20 at 11:44.
- VM2 – Exceedance with a reading of 0.46 in/sec on December 20 at 11:47.

- VM2 – Exceedance with a reading of 0.28 in/sec on December 20 at 16:35.
- VM2 – Exceedance with a reading of 0.63 in/sec on December 23 at 09:45.
- VM2 – Exceedance with a reading of 0.34 in/sec on December 29 at 12:21.

- VM2 – Exceedance with a reading of 0.84 in/sec on December 30 at 08:59.

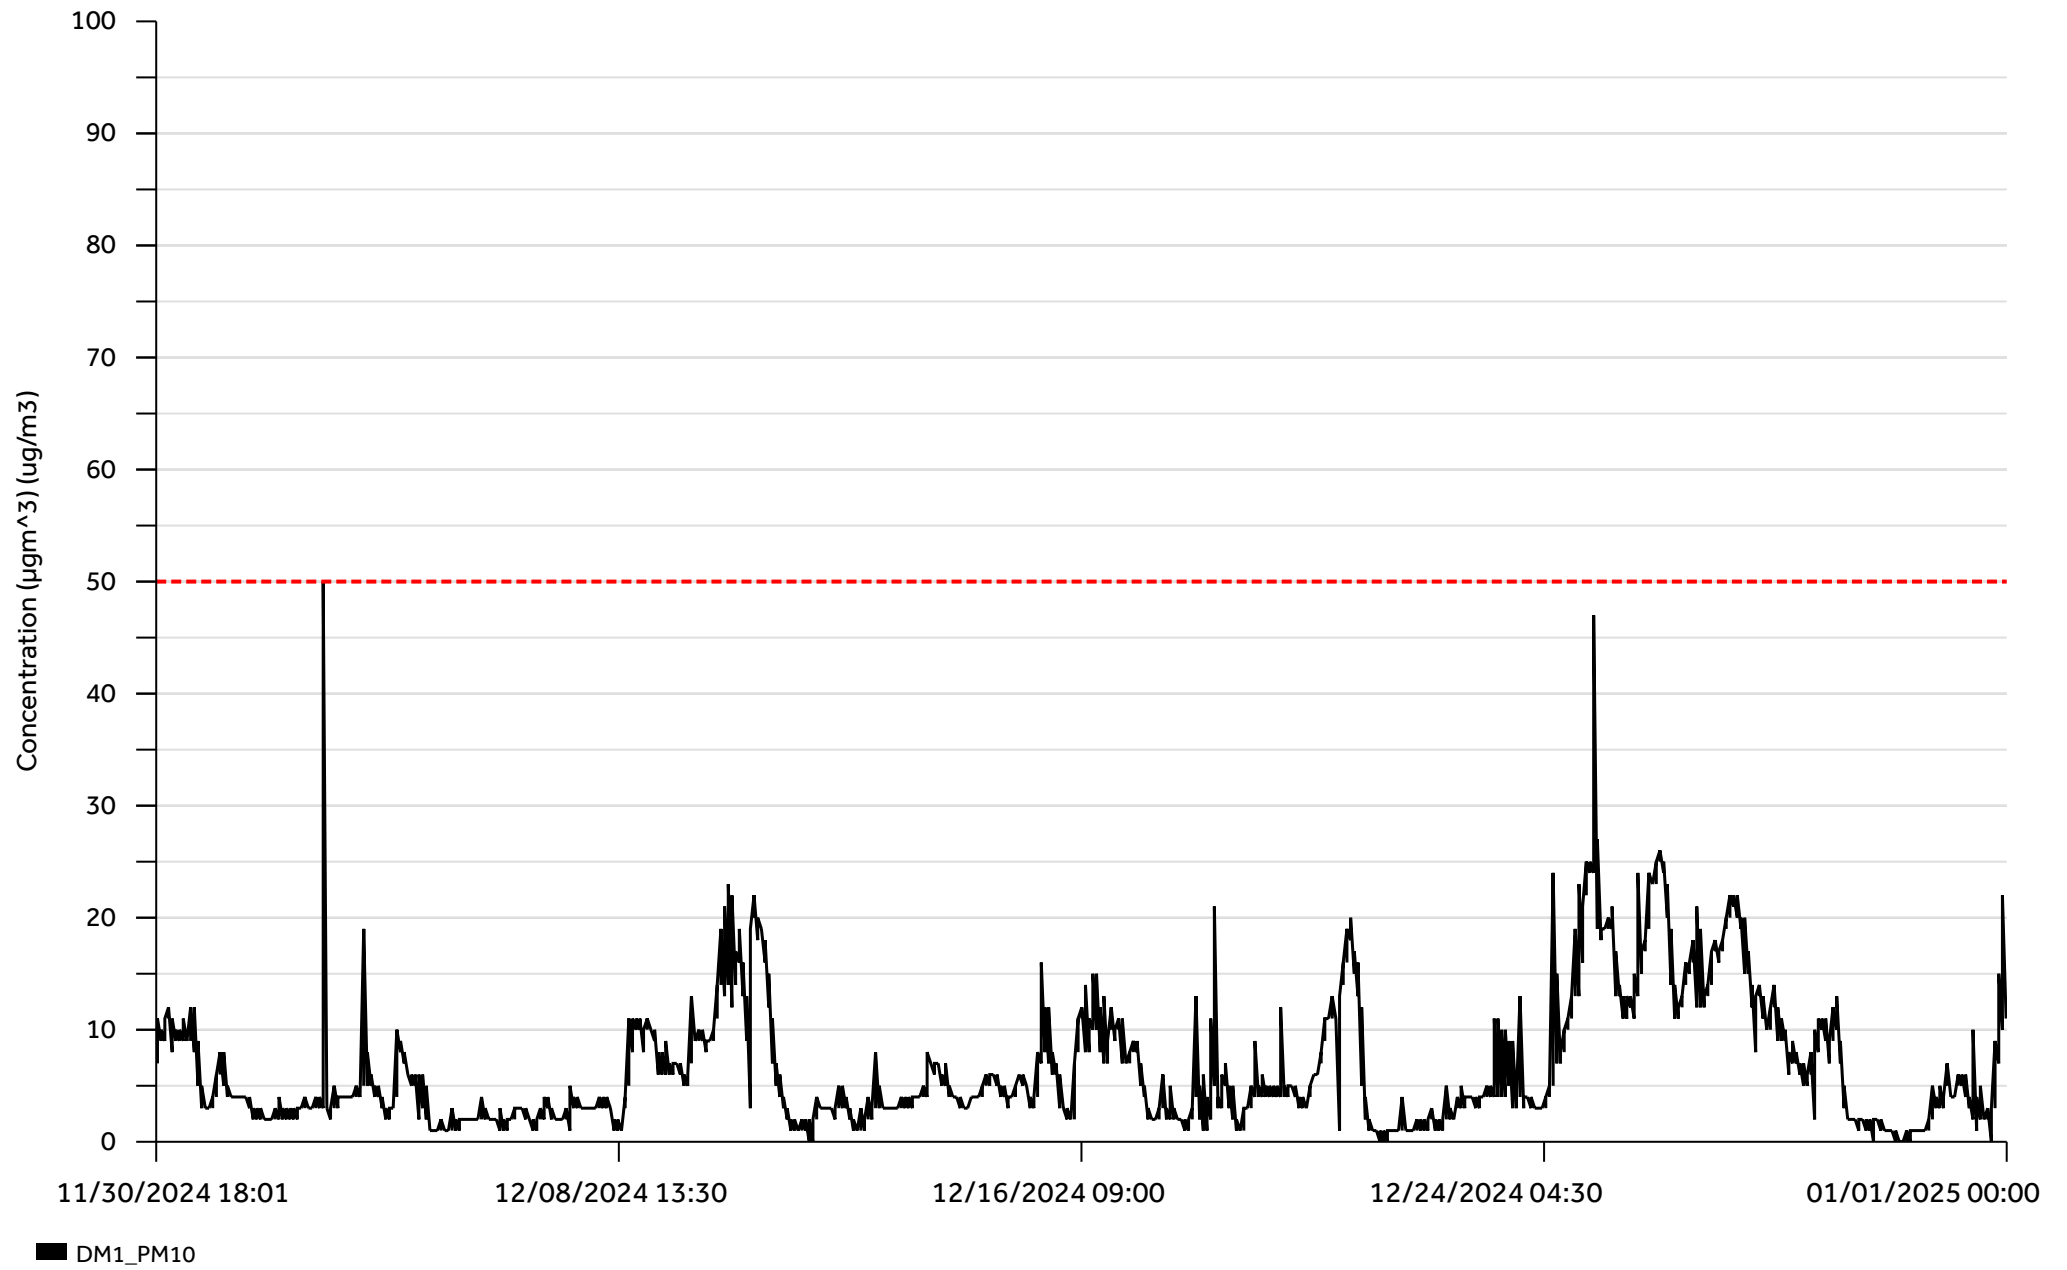
Graph 6
DM1 - PM10

- DM1 – Exceedance of the PM2.5 limit on 12/3 at 14:46 with a reading of 50 µg/m³.
 - Weather history shows sustained wind and gusts of 25 MPH during this period.
- DM1 – Exceedance of the PM2.5 limit on 12/25 at 01:48 with a reading of 47 µg/m³.
 - Site was closed at this time.
- DM1 – Met the PM10 limit on 12/3 at 14:46 with a reading of 50 µg/m³.
 - Weather history shows sustained wind and gusts of 25 MPH during this period.
