## Northern Bus Garage Noise, Vibration, and Dust Monitoring Report (August 2024)

Noise, Vibration, and Dust levels were monitored as part of the reconstruction of Northern Bus Garage, 4615 14<sup>th</sup> Street, NW, Washington, DC, for the month of August 2024.

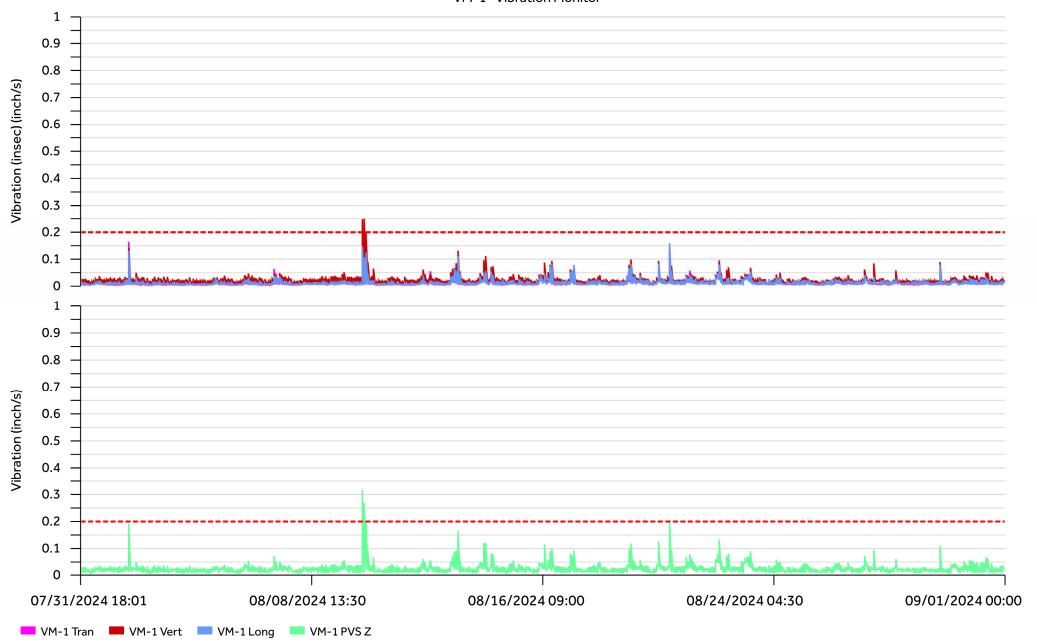
Graph 1
VM-1- Vibration Monitor

- VM1 exhibited a vibration exceedance of 0.25 in/sec on August 10 at 07:47. Clark notes that a subcontractor was excavating for a water line on 14th Street near the monitoring unit at that time.

- VM1 exhibited a vibration exceedance of 0.25 in/sec on August 10 at 08:46. Clark notes that a subcontractor was excavating for a water line on 14th Street near the monitoring unit at that time.

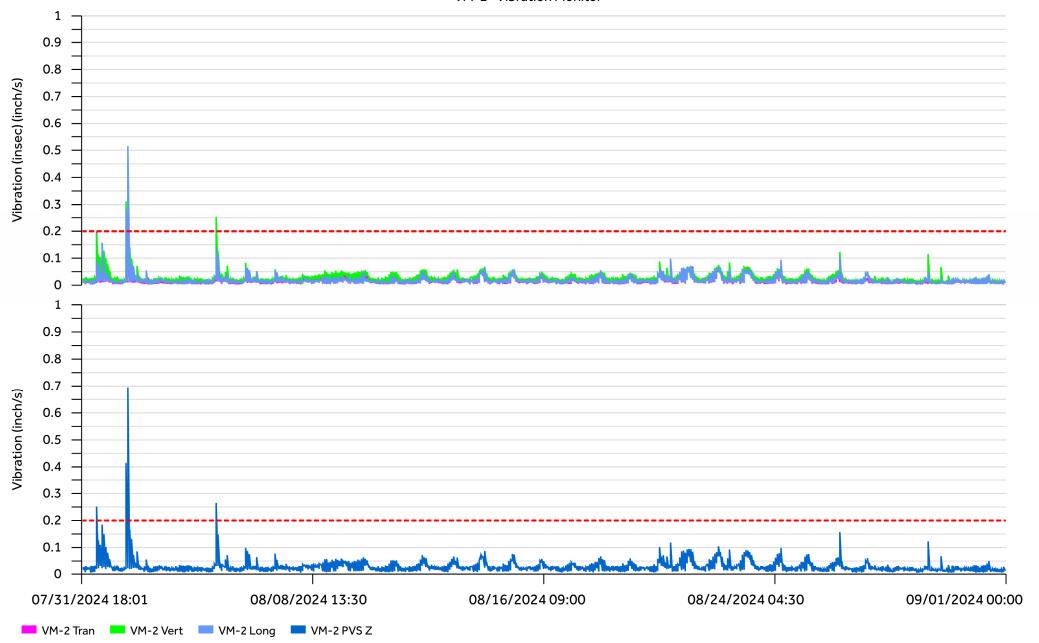
Graph 2
VM-2- Vibration Monitor

- VM2 exhibited a vibration exceedance of 0.31 in/sec on August 2 at 07:32. Clark notes that a subcontractor was excavating for a water line on 14th Street near the monitoring unit at that time.

- VM2 exhibited a vibration exceedance of 0.52 in/sec on August 2 at 08:59. Clark notes that a subcontractor was excavating for a water line on 14th Street near the monitoring unit at that time.

- VM2 exhibited a vibration exceedance of 0.25 in/sec on August 5 at 07:23. Clark notes that a subcontractor was excavating for a water line on 14th Street near the monitoring unit at that time.

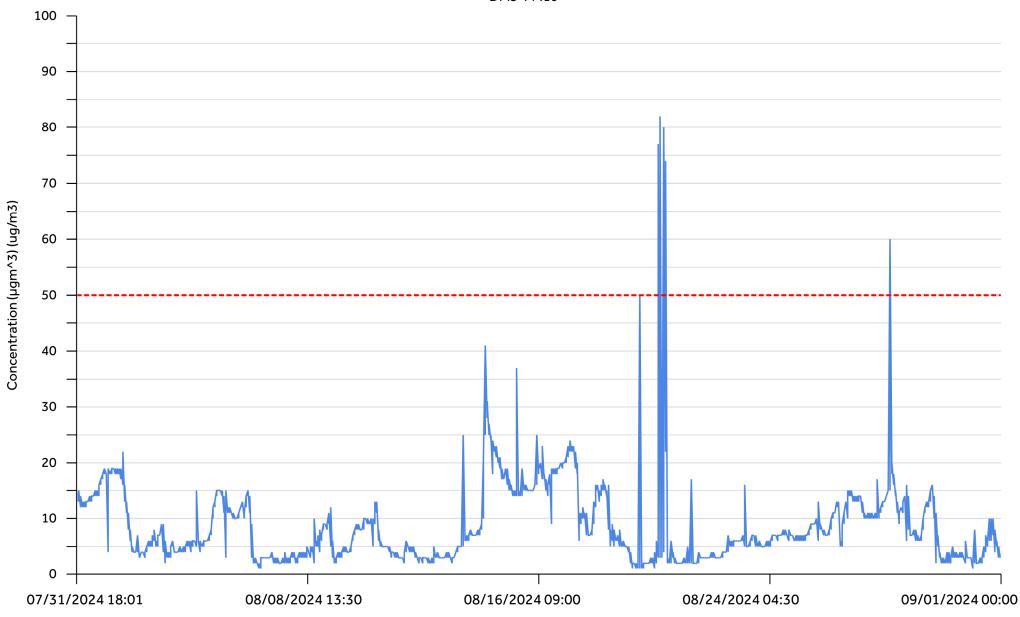
- DM3 Exceedance of the PM10 limit on 8/19 at 20:00 with a reading of 50 μg/m<sup>3</sup>.
  - O Weather history shows gust of 23mph during this time.
    - Exceedance was recorded outside of working hours.

- DM3 Exceedance of the PM10 limit on 8/20 from about 10:30 to 12:15 with readings up to 82 μg/m<sup>3</sup>.
  - O Weather history shows sustained gusts of 24mph during this time.

- DM3 Exceedance of the PM10 limit on 8/20 from about 15:15 to 17:15 with readings up to 80 μg/m<sup>3</sup>.
  - Weather history shows sustained gusts of 24mph during this time.

- DM3 Exceedance of the PM10 limit on 8/28 at 07:00 with a reading of 60 μg/m<sup>3</sup>.
  - o Exceedance due to truck traffic, dust control procedures were implemented shortly after.

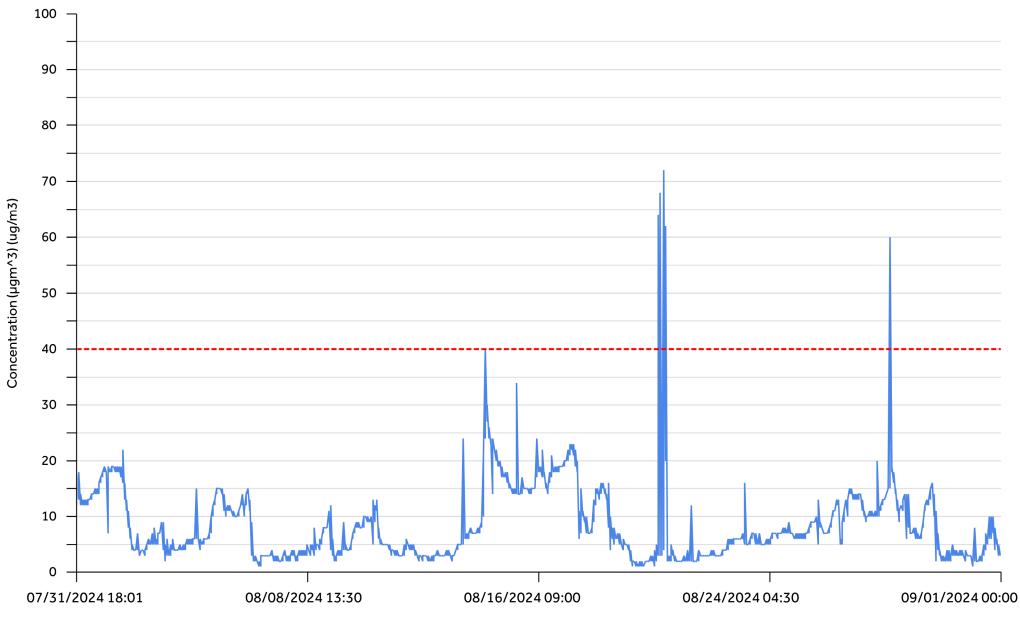
- DM3 Exceedance of the PM2.5 limit on 8/14 at 14:09 with a reading of  $40 \mu g/m^3$ .
  - Weather history shows gusts ranging from 20-24mph during this time.

- DM3 Exceedance of the PM2.5 limit on 8/20 from about 10:30 to 12:15 with readings up to 68 μg/m<sup>3</sup>.
  - Weather history shows sustained gusts of 24mph during this time.

- DM3 Exceedance of the PM2.5 limit on 8/20 from about 15:15 to 17:15 with readings up to 72 μg/m<sup>3</sup>.
  - O Weather history shows sustained gusts of 24mph during this time.

- DM3 Exceedance of the PM2.5 limit on 8/28 at 07:00 with a reading of 60 μg/m<sup>3</sup>.
  - o Exceedance due to truck traffic on-site, dust control procedures were implemented shortly after.
