Northern Bus Garage

Noise, Vibration, and Dust Monitoring Report (January 2024)

WMATA Bus Garage Monthly Report

January 2024

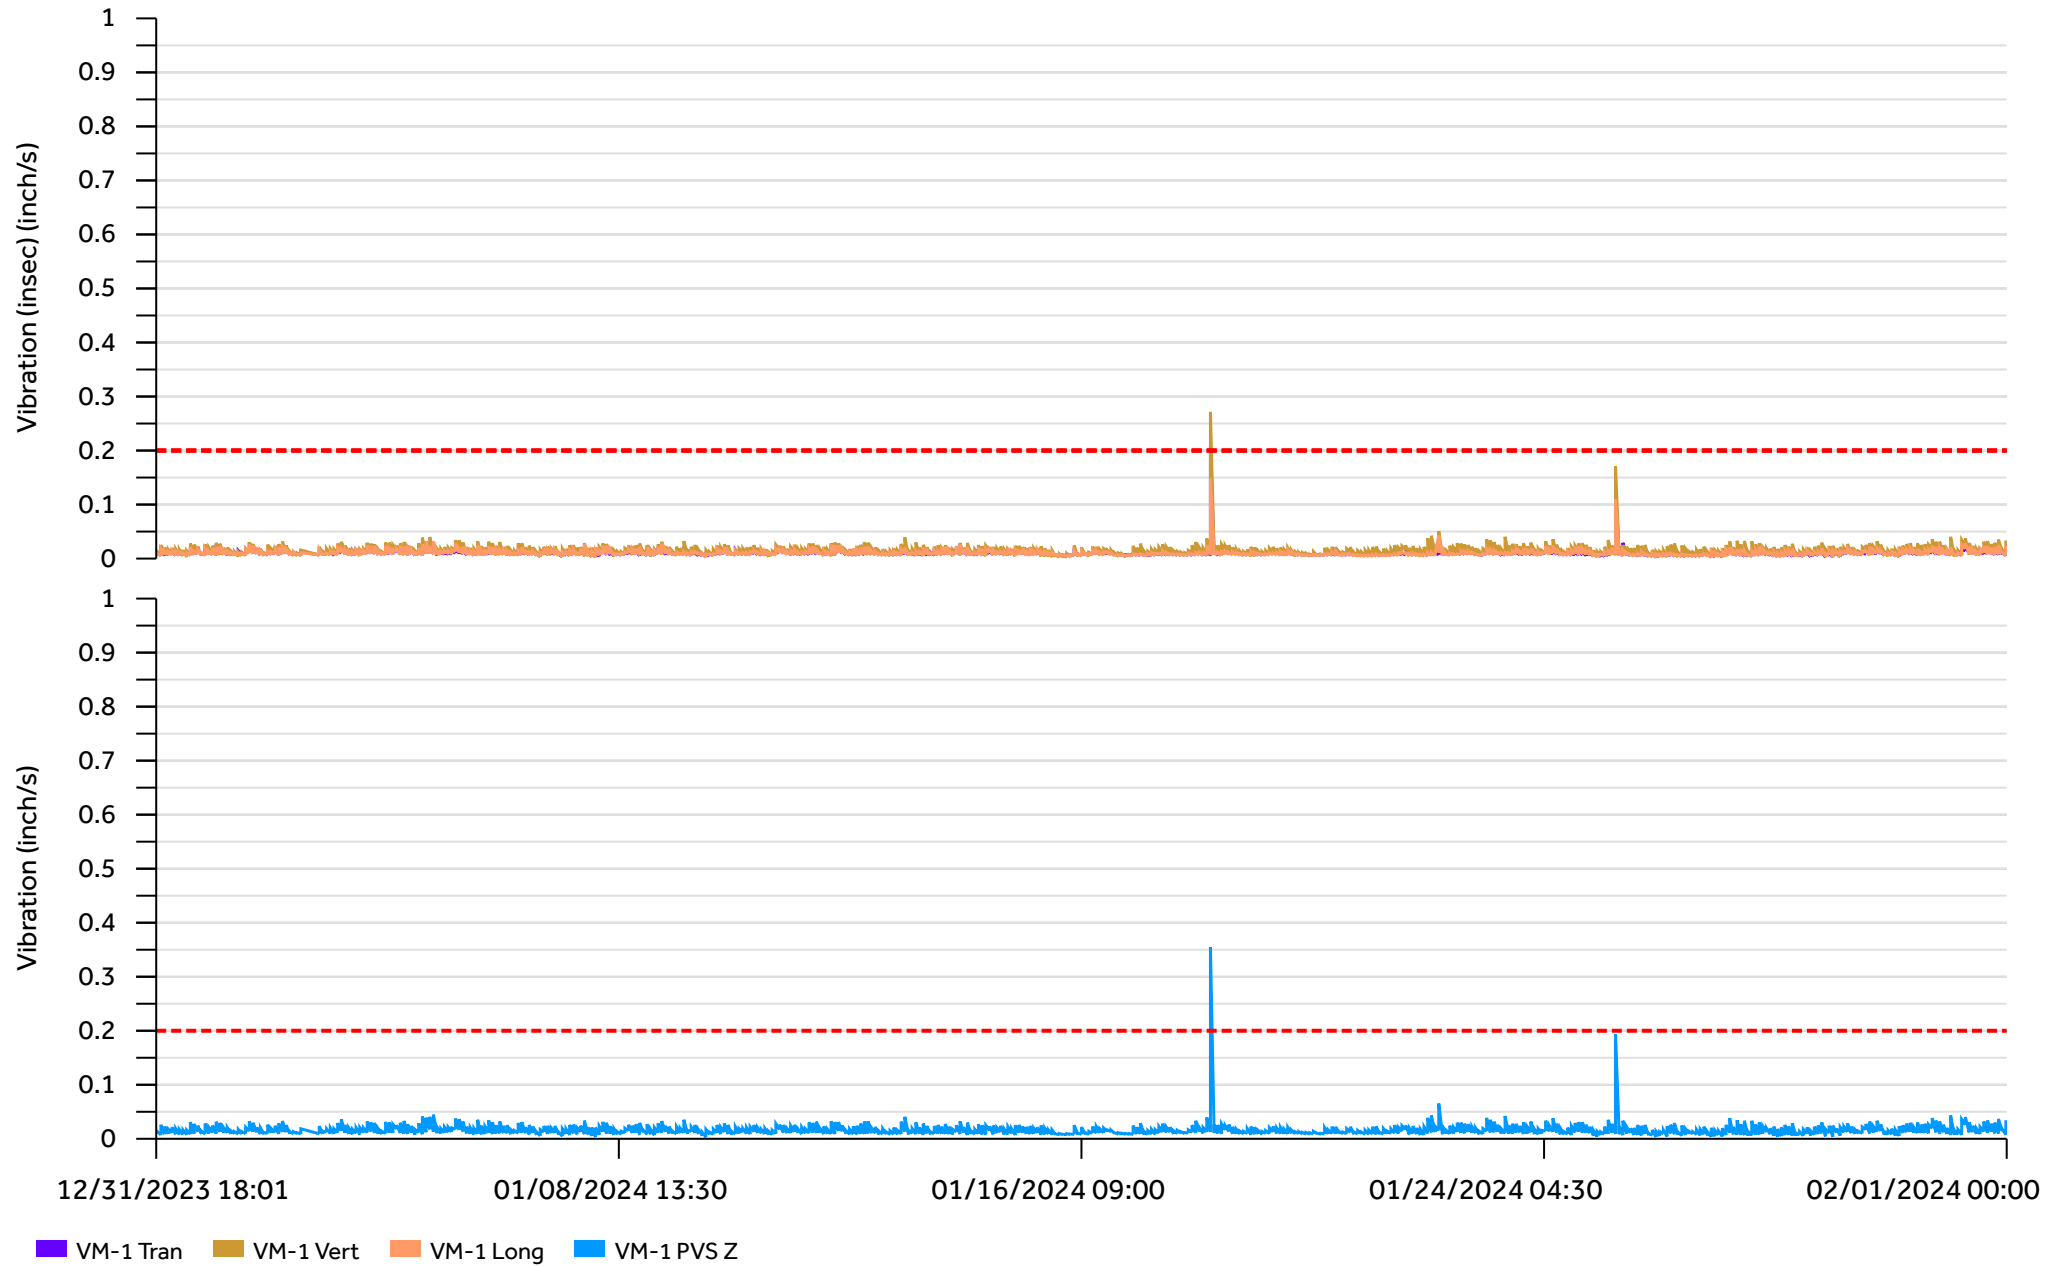
Graph 1:
VM-1- Vibration Monitor

A single vibration spike of 0.27 in/sec occurred at the VM1 location on January 18th at 1:40 pm due to the monitor being bumped by a piece of equipment.

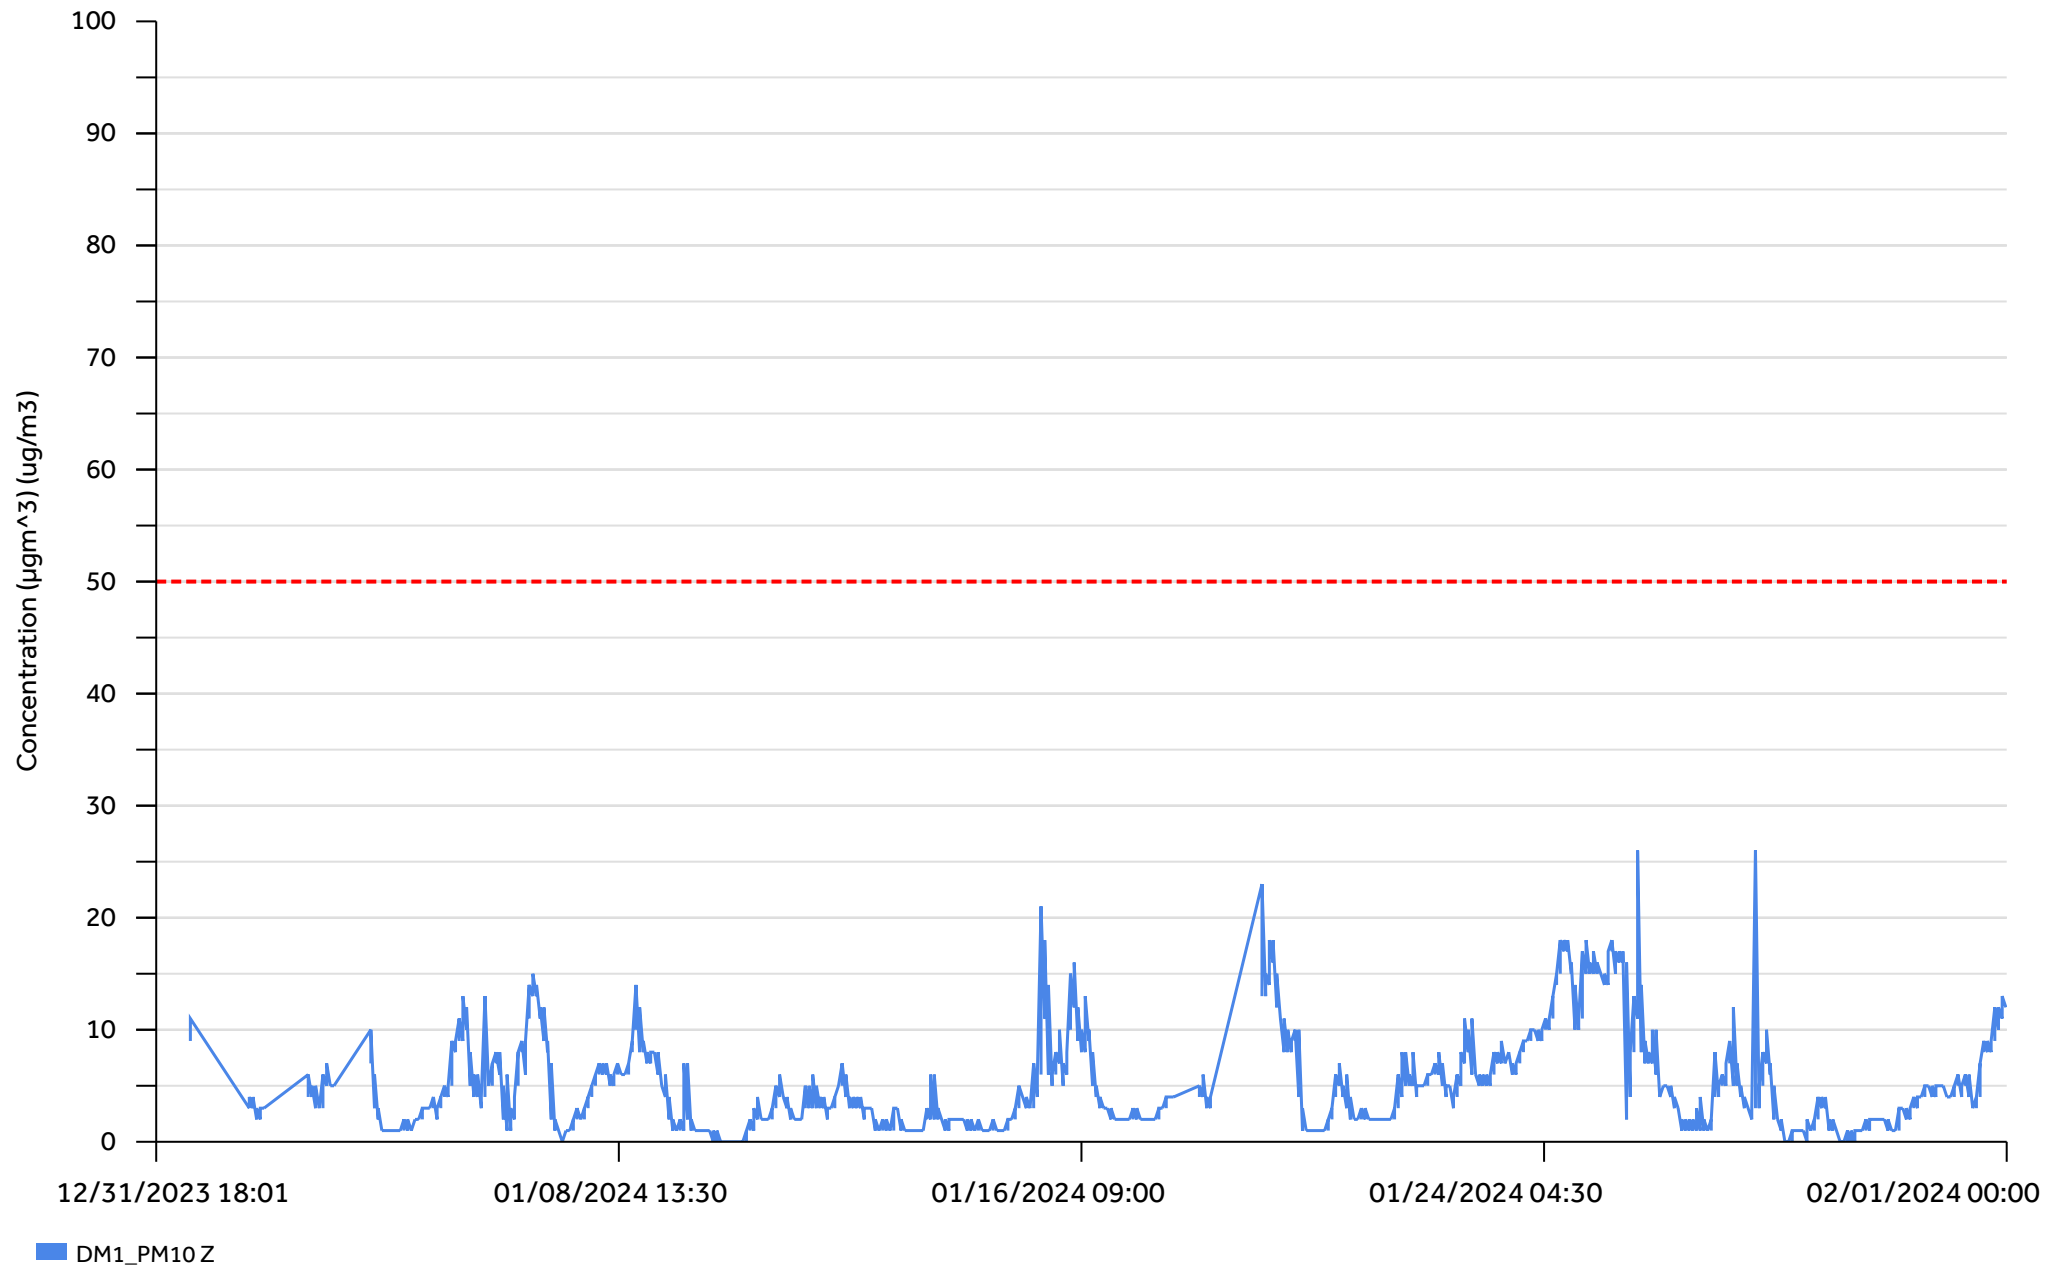
Graph 6:
DM1 - PM10

DM1 began experiencing power interruptions on January 1, 2024. The solar panel was relocated and replaced with a larger one on January 4. DM1 lost power again on January 18 and the battery was exchanged on the 19th. All three of the units have been fitted with hardware that allows tracking and alarming upon low voltage. It is not possible to plug the DM1 unit into mains power and the structure wall left in place shades the solar panel much of the day. Continued battery swaps will be the interim solution until site

conditions change.
