Northern Bus Garage

Noise, Vibration, and Dust Monitoring Report (December 2023)

WMATA Bus Garage Monthly Report

December 2023

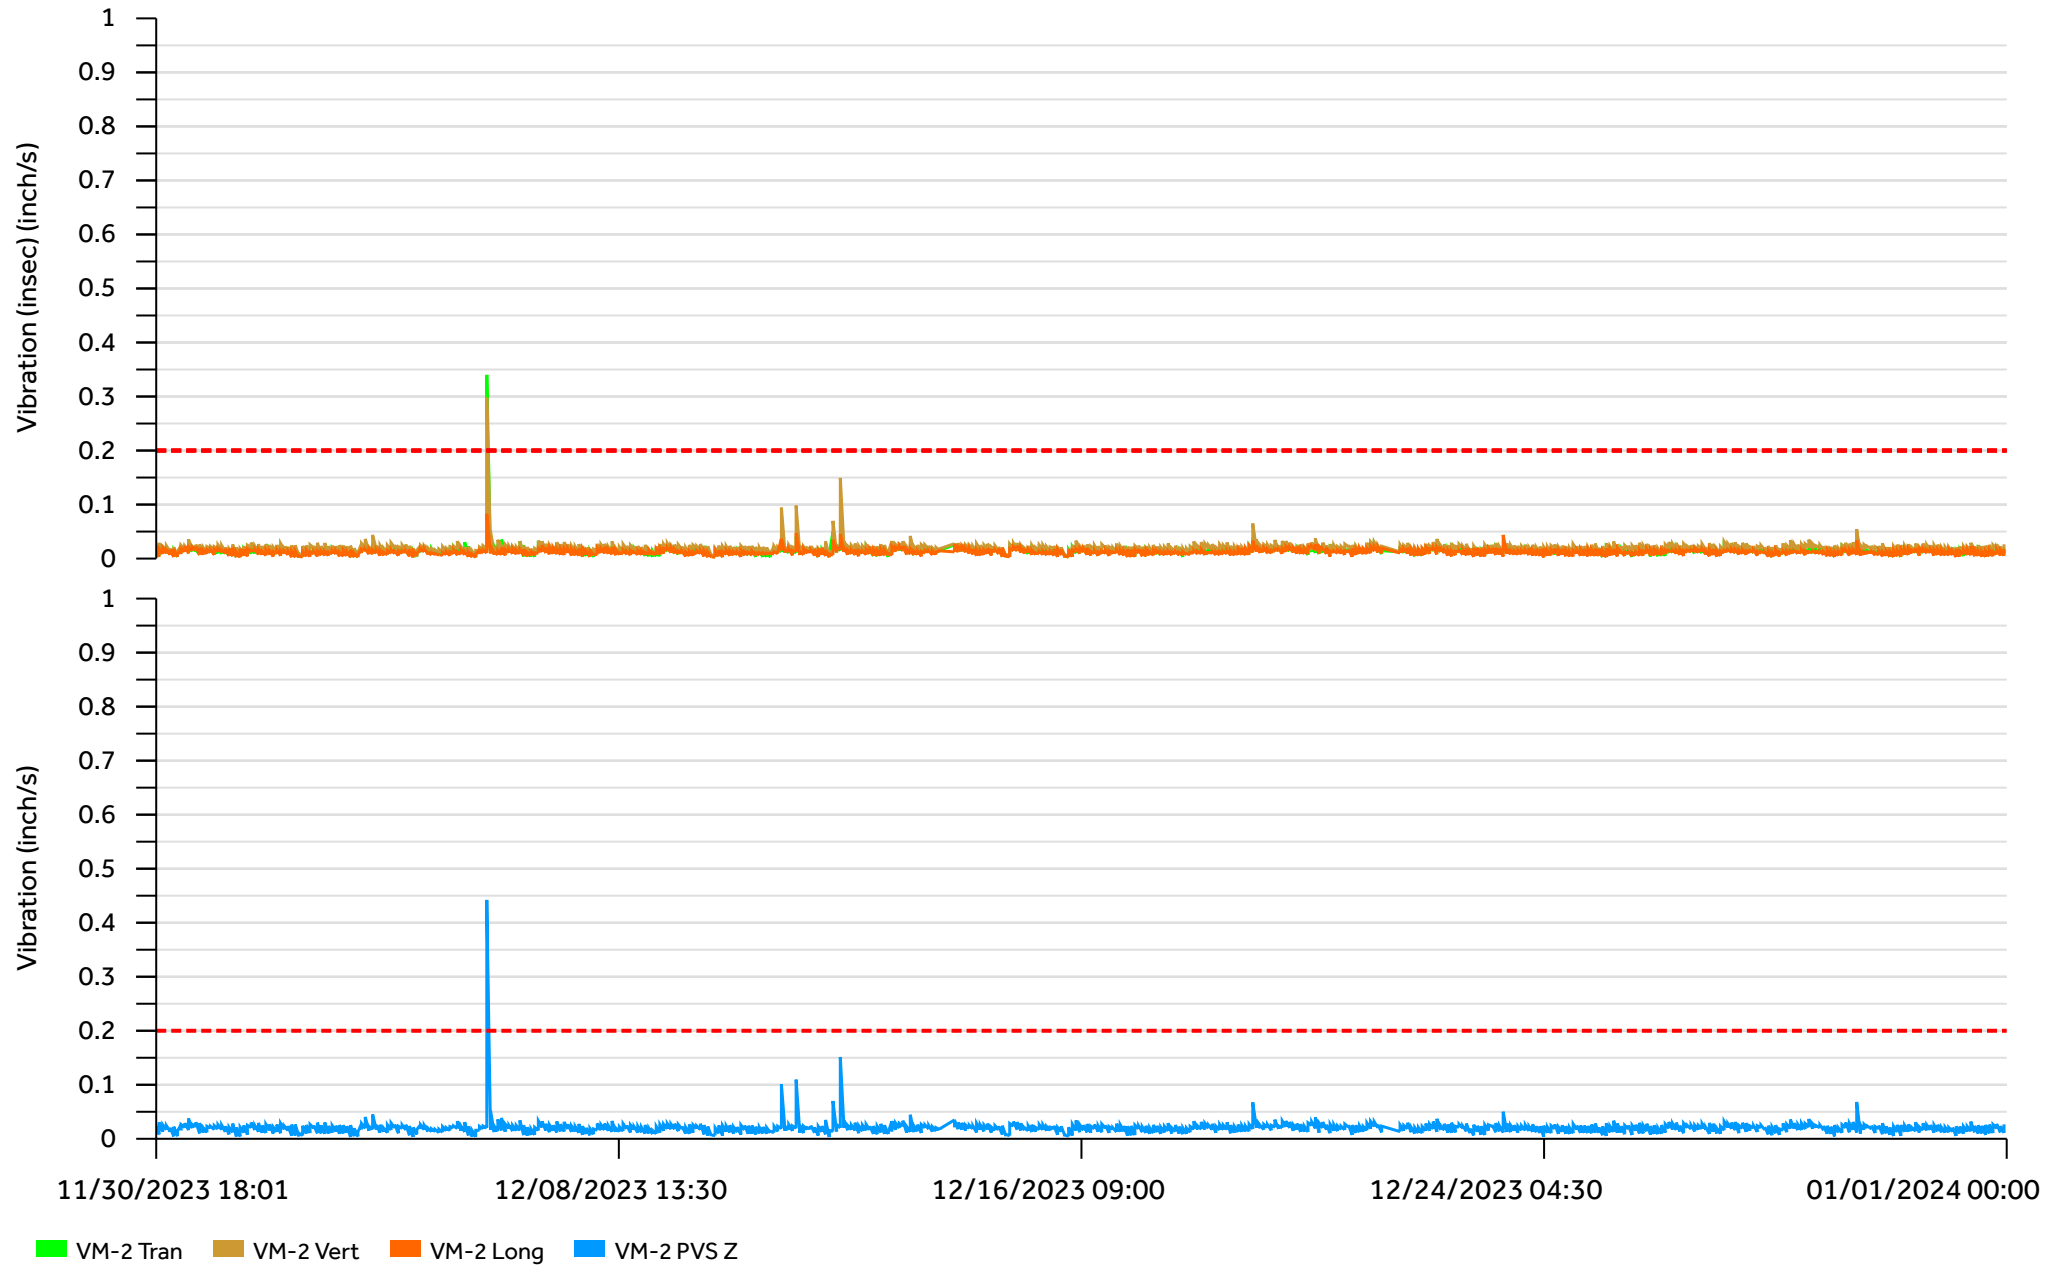
Graph 2:
VM-2- Vibration Monitor

A single vibration spike of 0.34 in/sec occurred at the VM2 location on December 6 at 09:25 am due to the monitor being bumped by a piece of equipment.

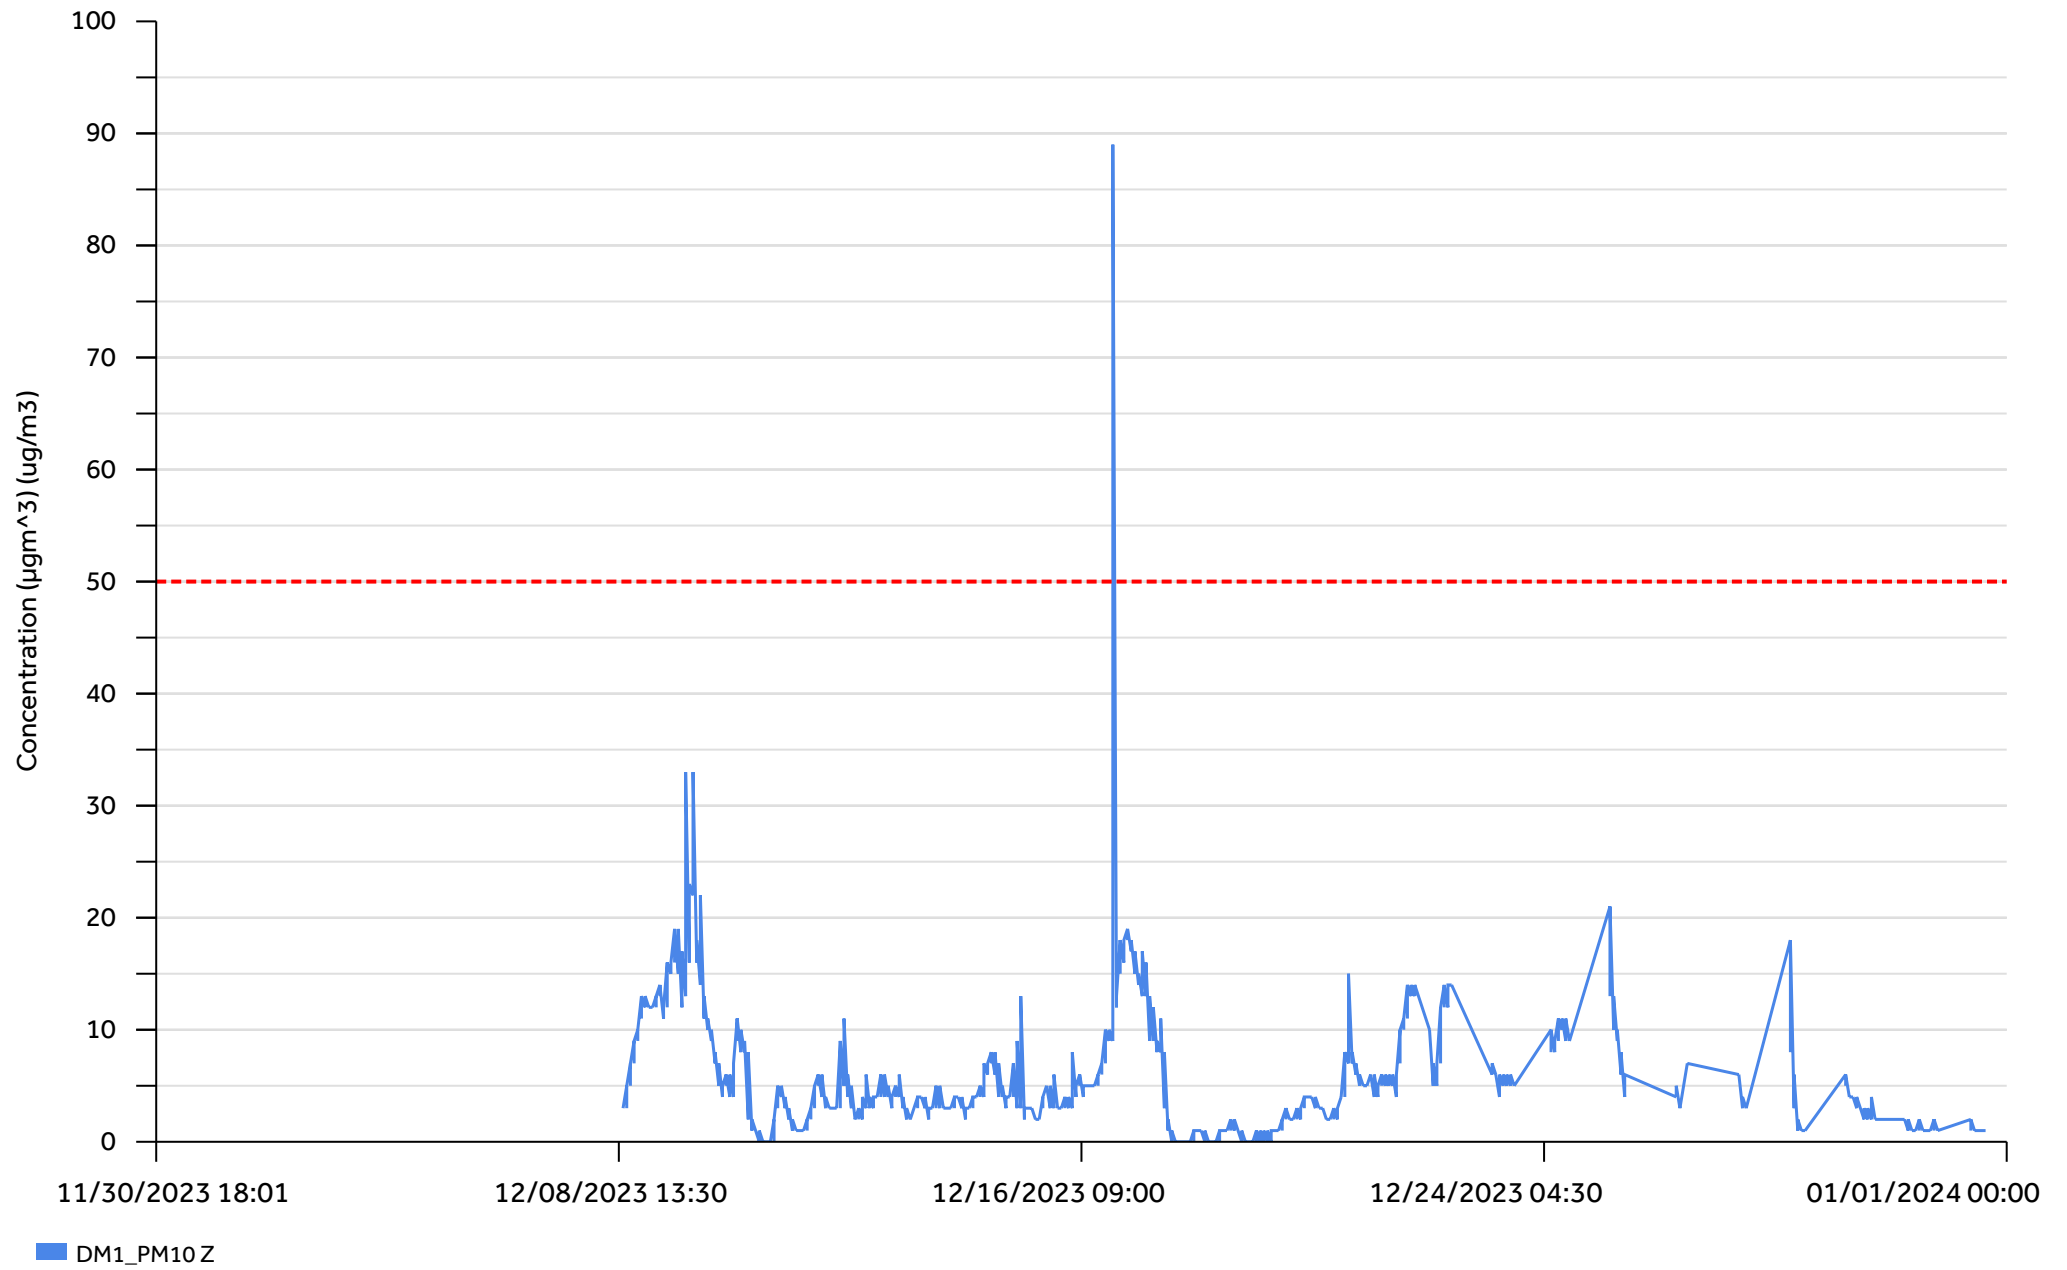
Graph 6:
DM1 - PM10

DM1 began experiencing power interruptions on November 30, 2023. The battery was exchanged but the modem would not power up. A replacement unit was installed on December 8. All three of the units have been fitted with hardware that allows tracking and alarming upon low voltage. Due to site restrictions, DM1 cannot be plugged into main power so continued battery swaps will be the interim solution until site conditions change.

Higher winds in the evening of December 2 caused exceedances from 9:36pm to 9:47 pm. DM2 recorded a PM2.5 of 41. DM3 recorded a PM2.5 of 51 and a PM10 of 53. More winds on the evening of December 16 caused an exceedance at 11:12 pm. DM1 recorded a PM2.5 of 65 and a PM10 of 89.
