Monitoring Report

WMATA Bus Garage Monthly Report

July 2023

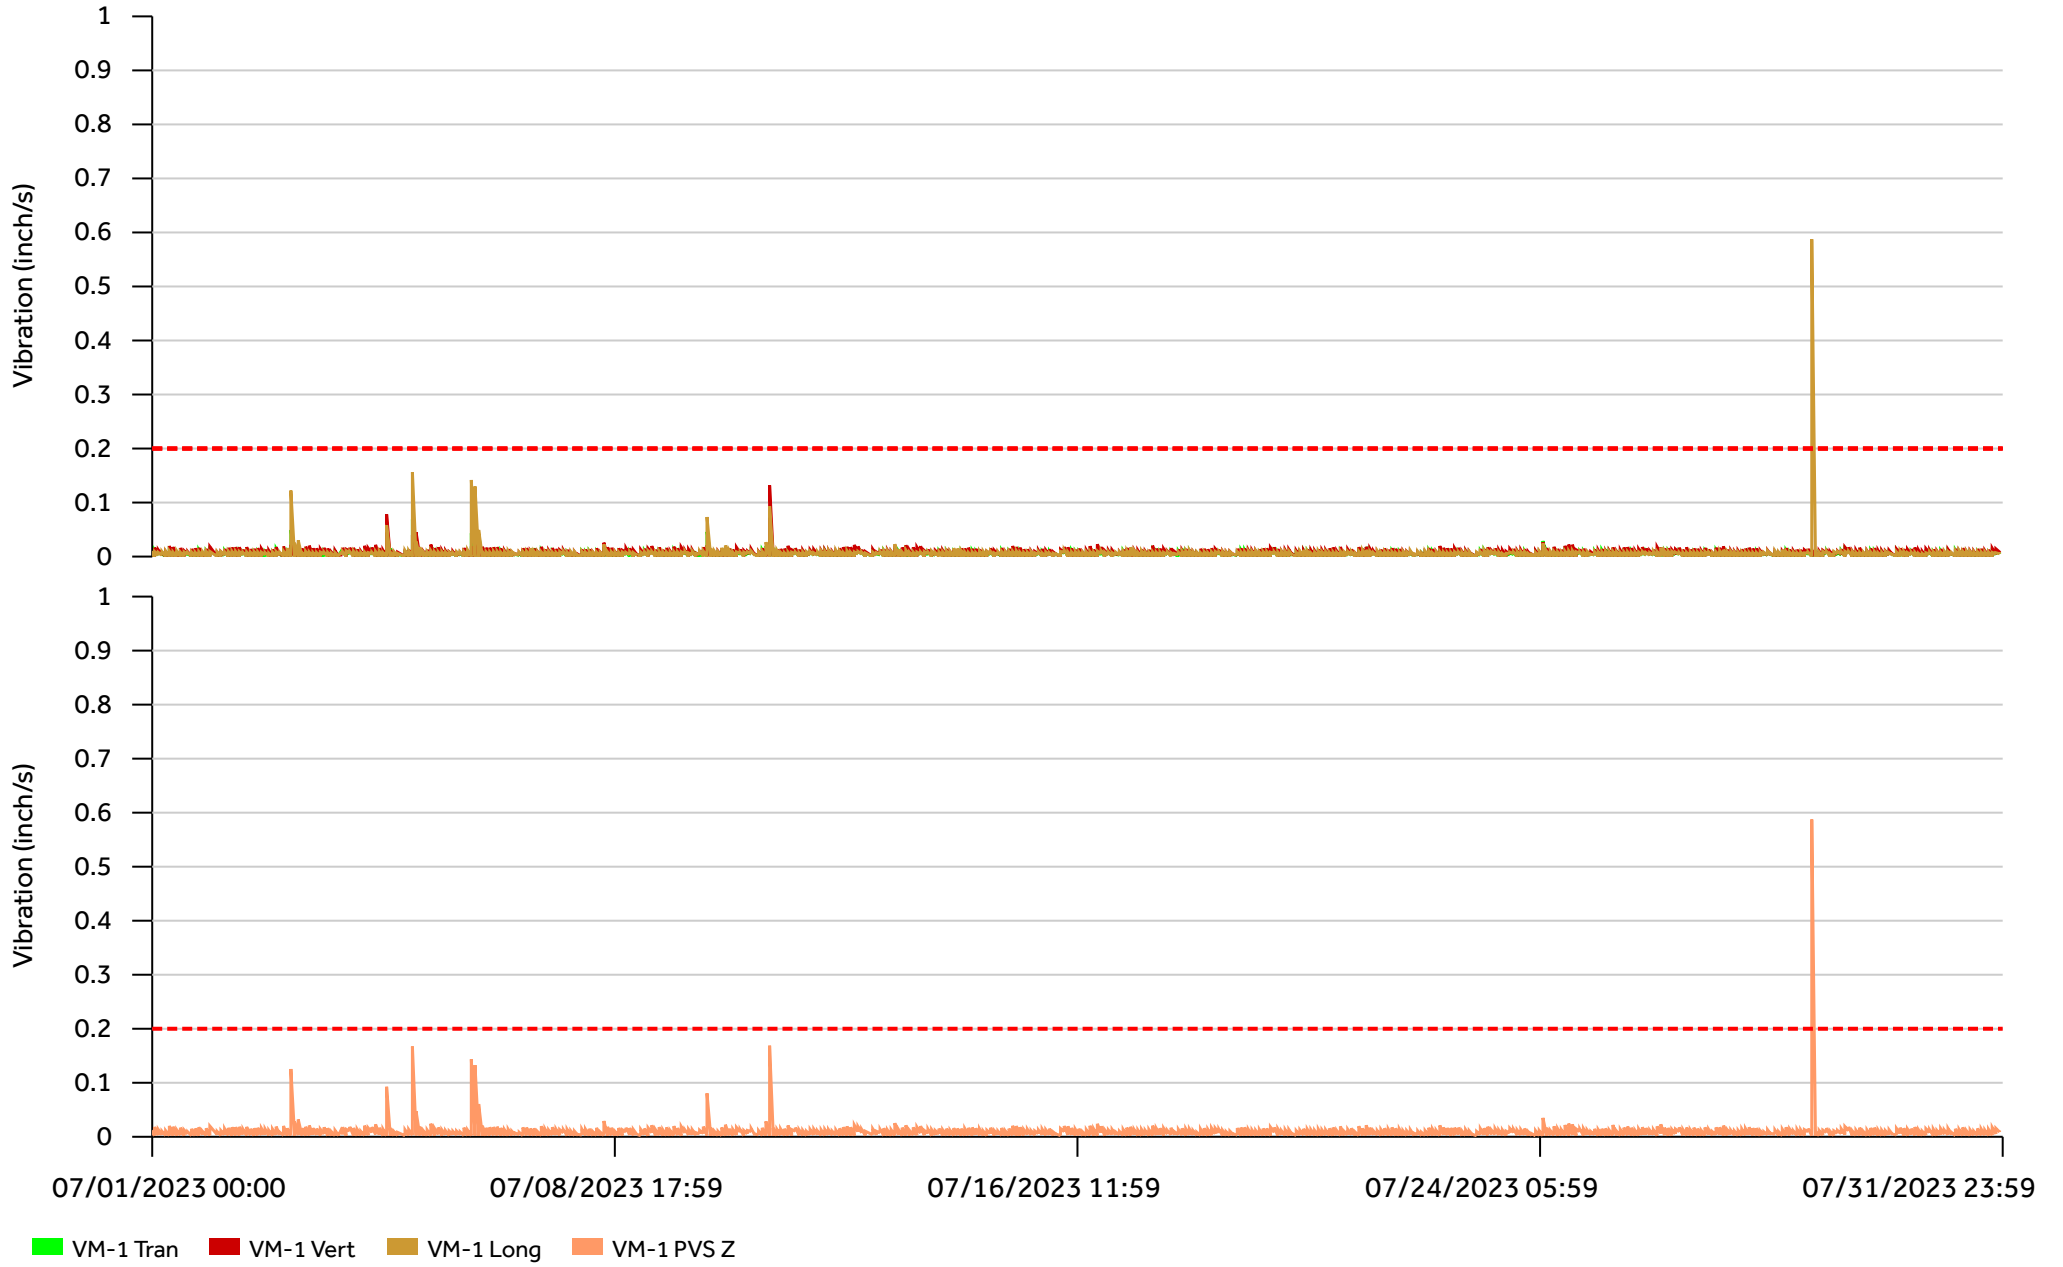
VM-1- Vibration Monitor

VM1 – 7/28 2005h. 0.59 in/sec on the Transverse channel. Appears to be electrical not physical vibration.

The 0.59 in/sec event does not appear to be caused by physical vibration, but rather electrical noise. While not an exceedance, VM4 and VM5 also recorded measurements of 0.1 and 0.32 in/sec at the same time as the 7/28 2005h recording at VM1. These also appear to be electrical in nature. The single event that triggered all three units may have been a lightning strike or other electrical anomaly at the site. VM2 had the appearance of vibration exceedances in the first half of the month. Upon further review during the compiling of this report it was discovered that the VM2 geophone was malfunctioning at the time. The unit was exchanged on July 12 and the new unit is operating normally.

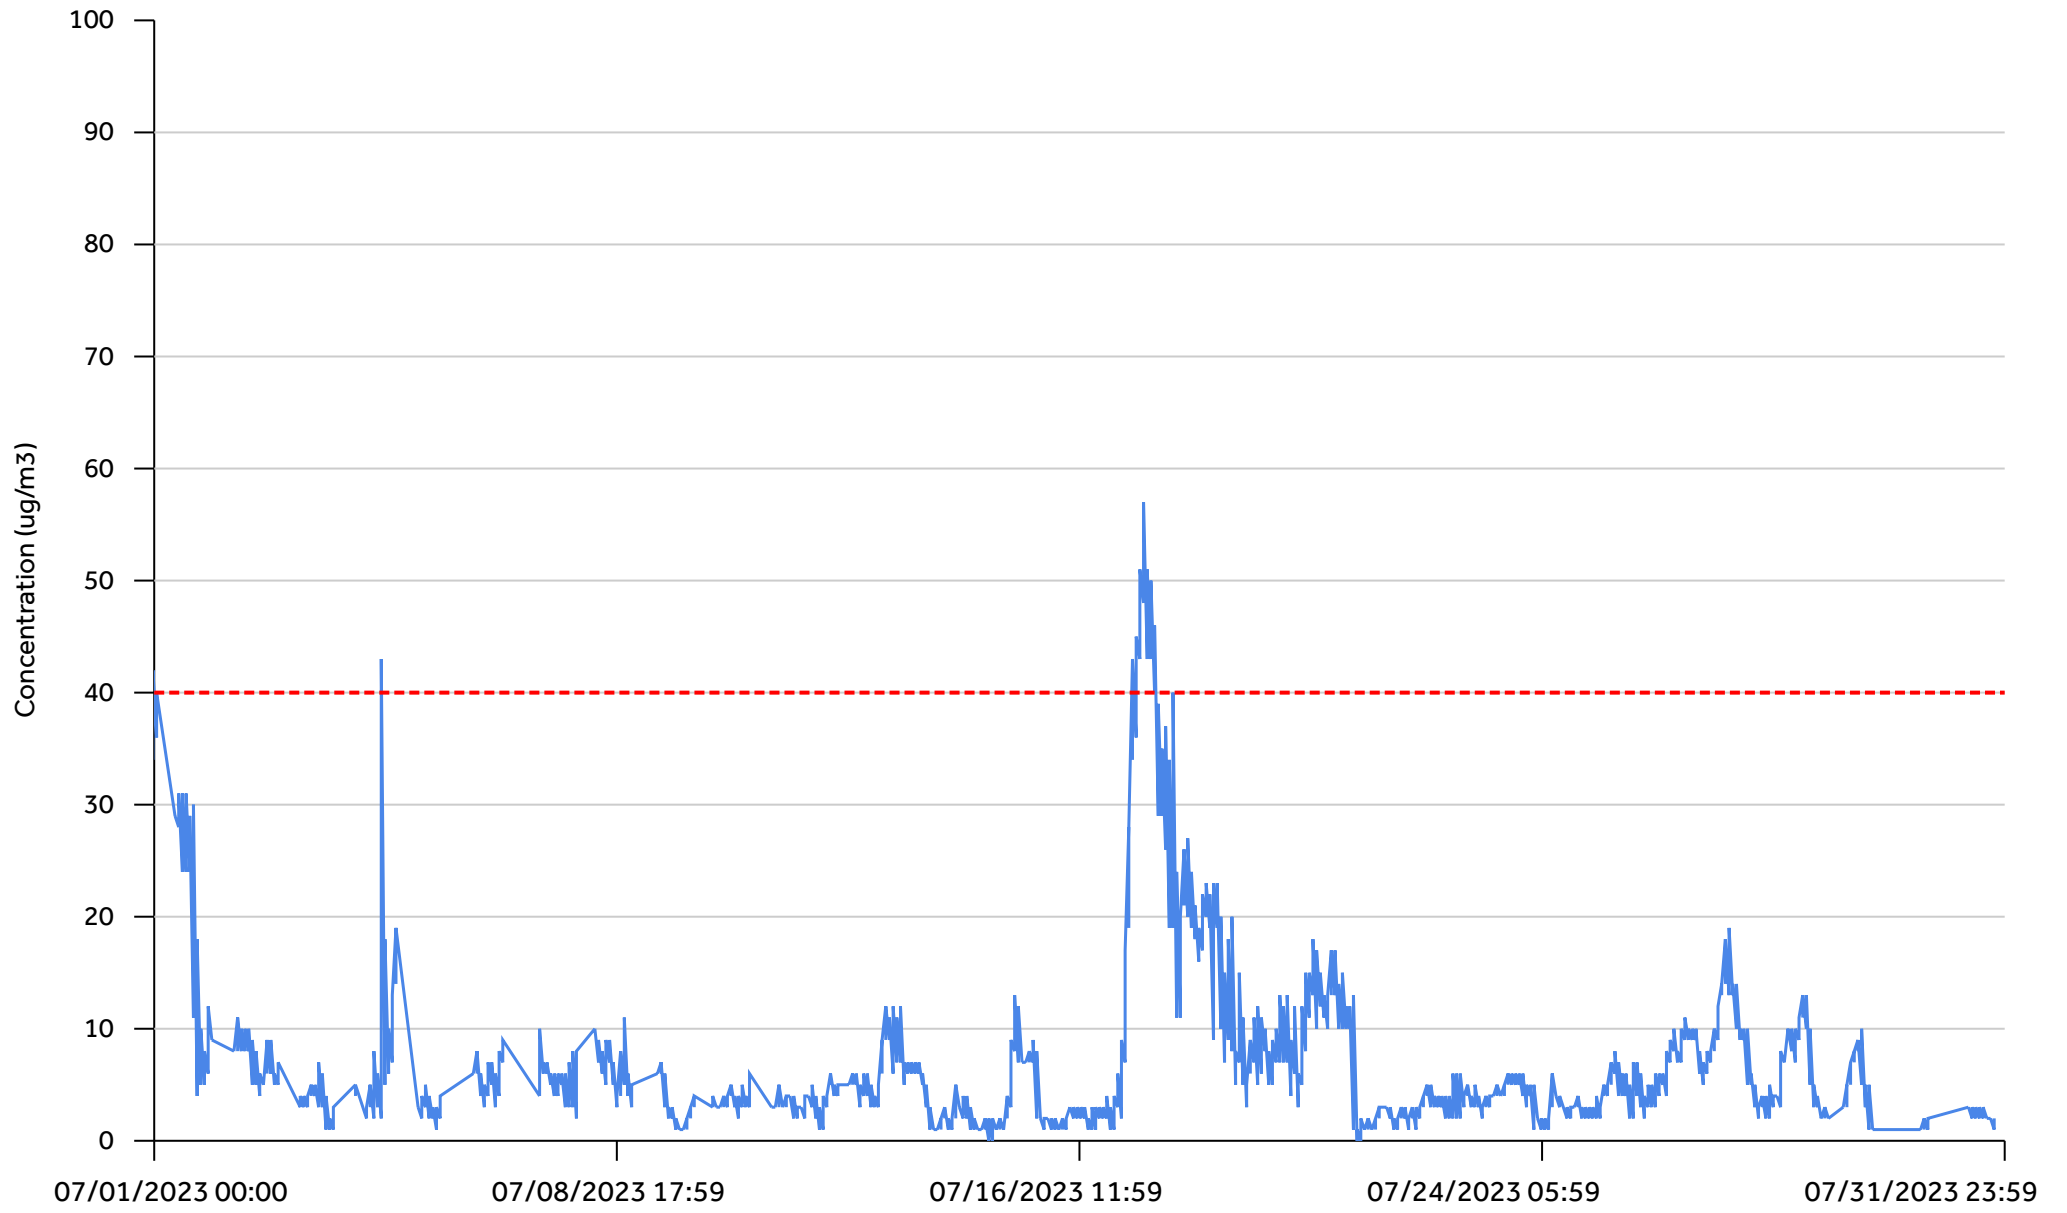
DM1-PM2.5

DM1 – 7/4 2036h, 43 $\mu\text{g}/\text{m}^3$.

DM1 – 7/17 1432h. 57 $\mu\text{g}/\text{m}^3$.

A review of the data reveals threshold exceedances from regional poor air quality events on July 4th and 17th as found on www.CleanAirPartners.net. DM2 experienced power failure during most of the July 21 through 31 period. DM3 also experienced power failure from July 14 through 19 and from July 20 through 22. These units require a lot of power and DM3 has now been moved to mains power to ensure reliability. New modems are being sourced now that will allow us to measure incoming voltage and set alarms if it drops below a certain threshold.

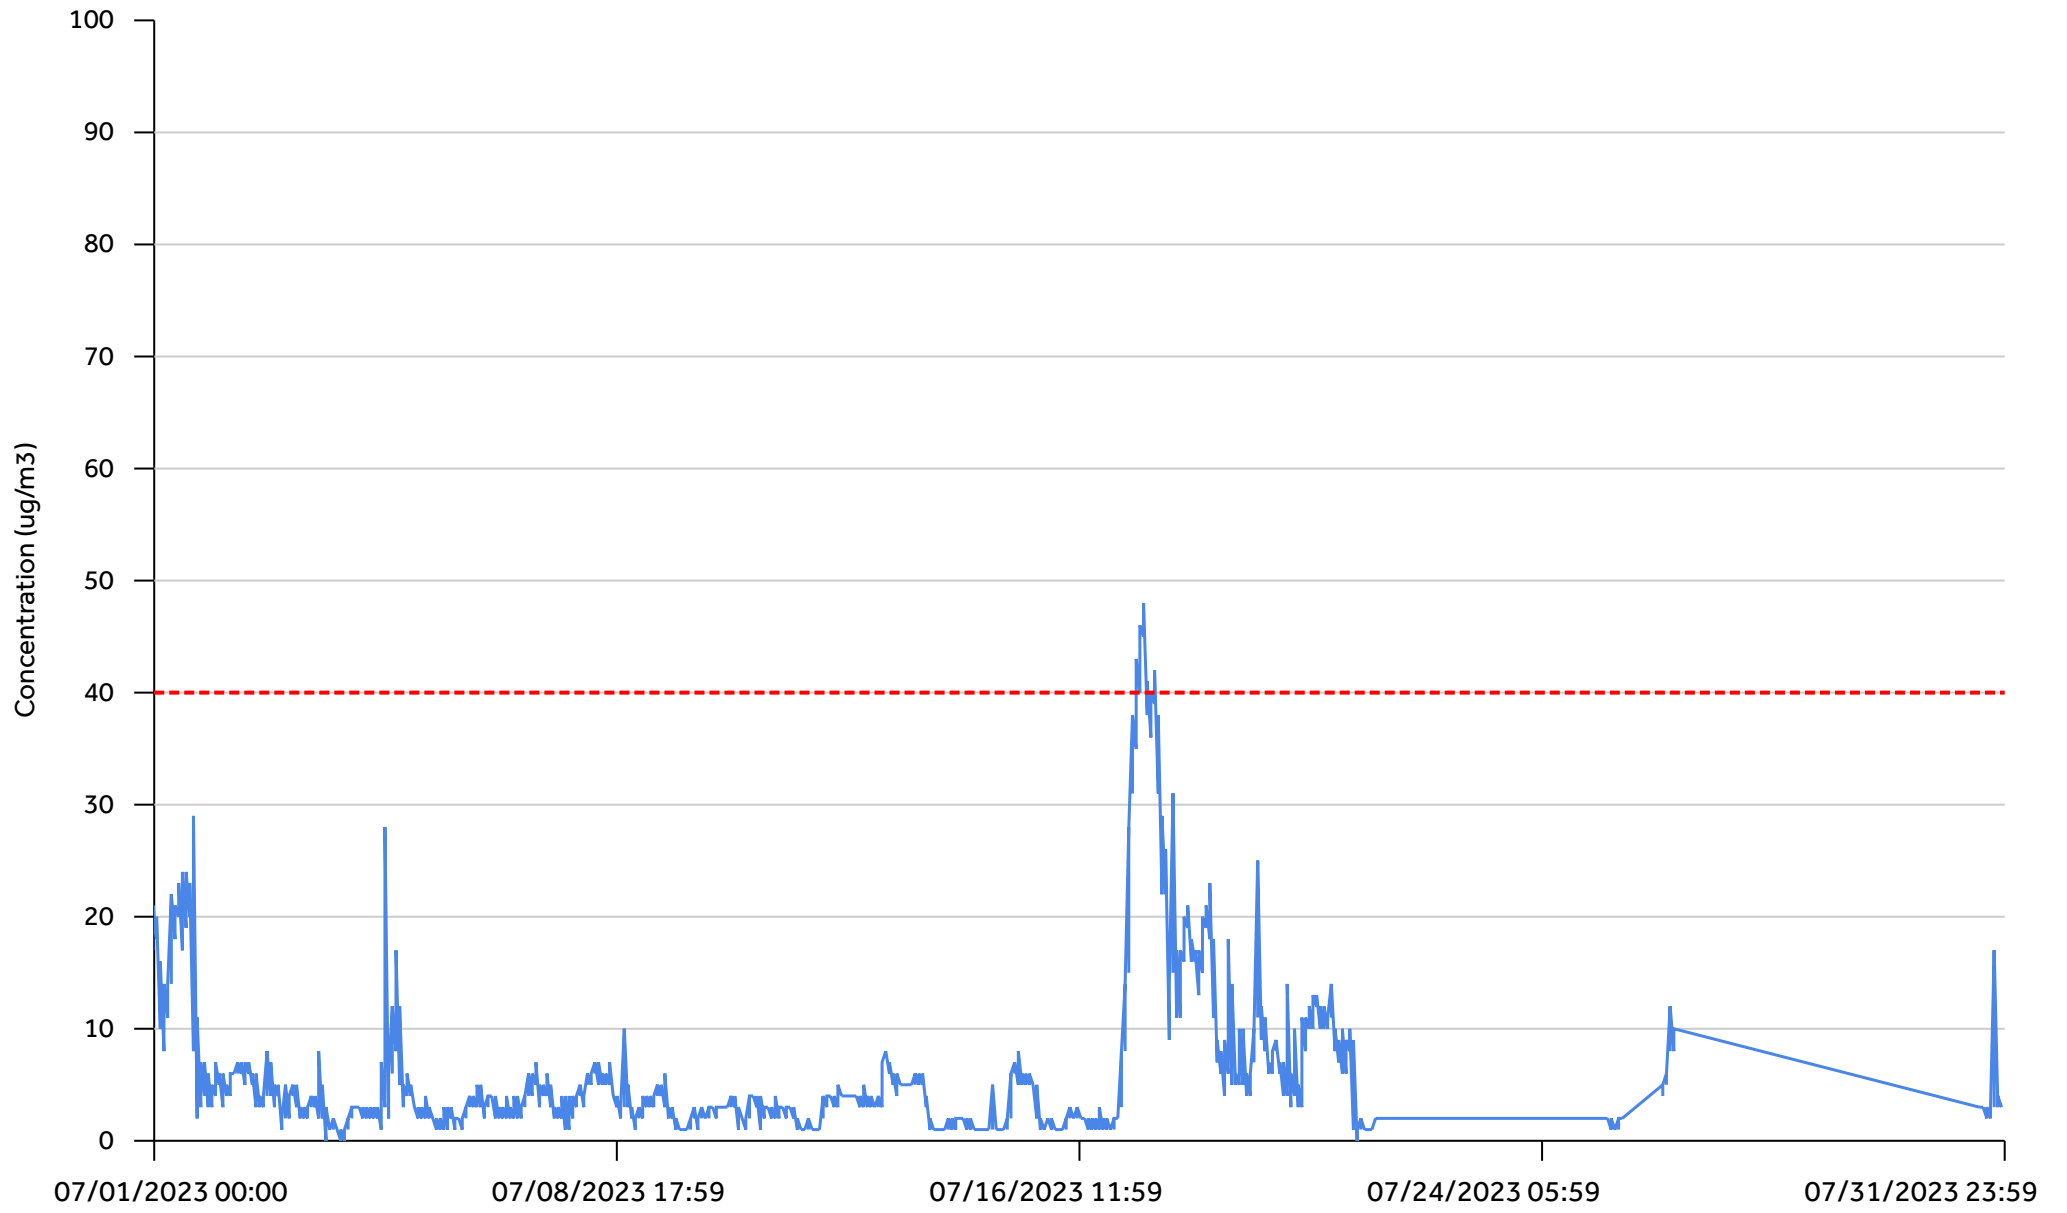
DM2-PM2.5

DM2 – 7/17 1116-1930h, 48 $\mu\text{g}/\text{m}^3$.

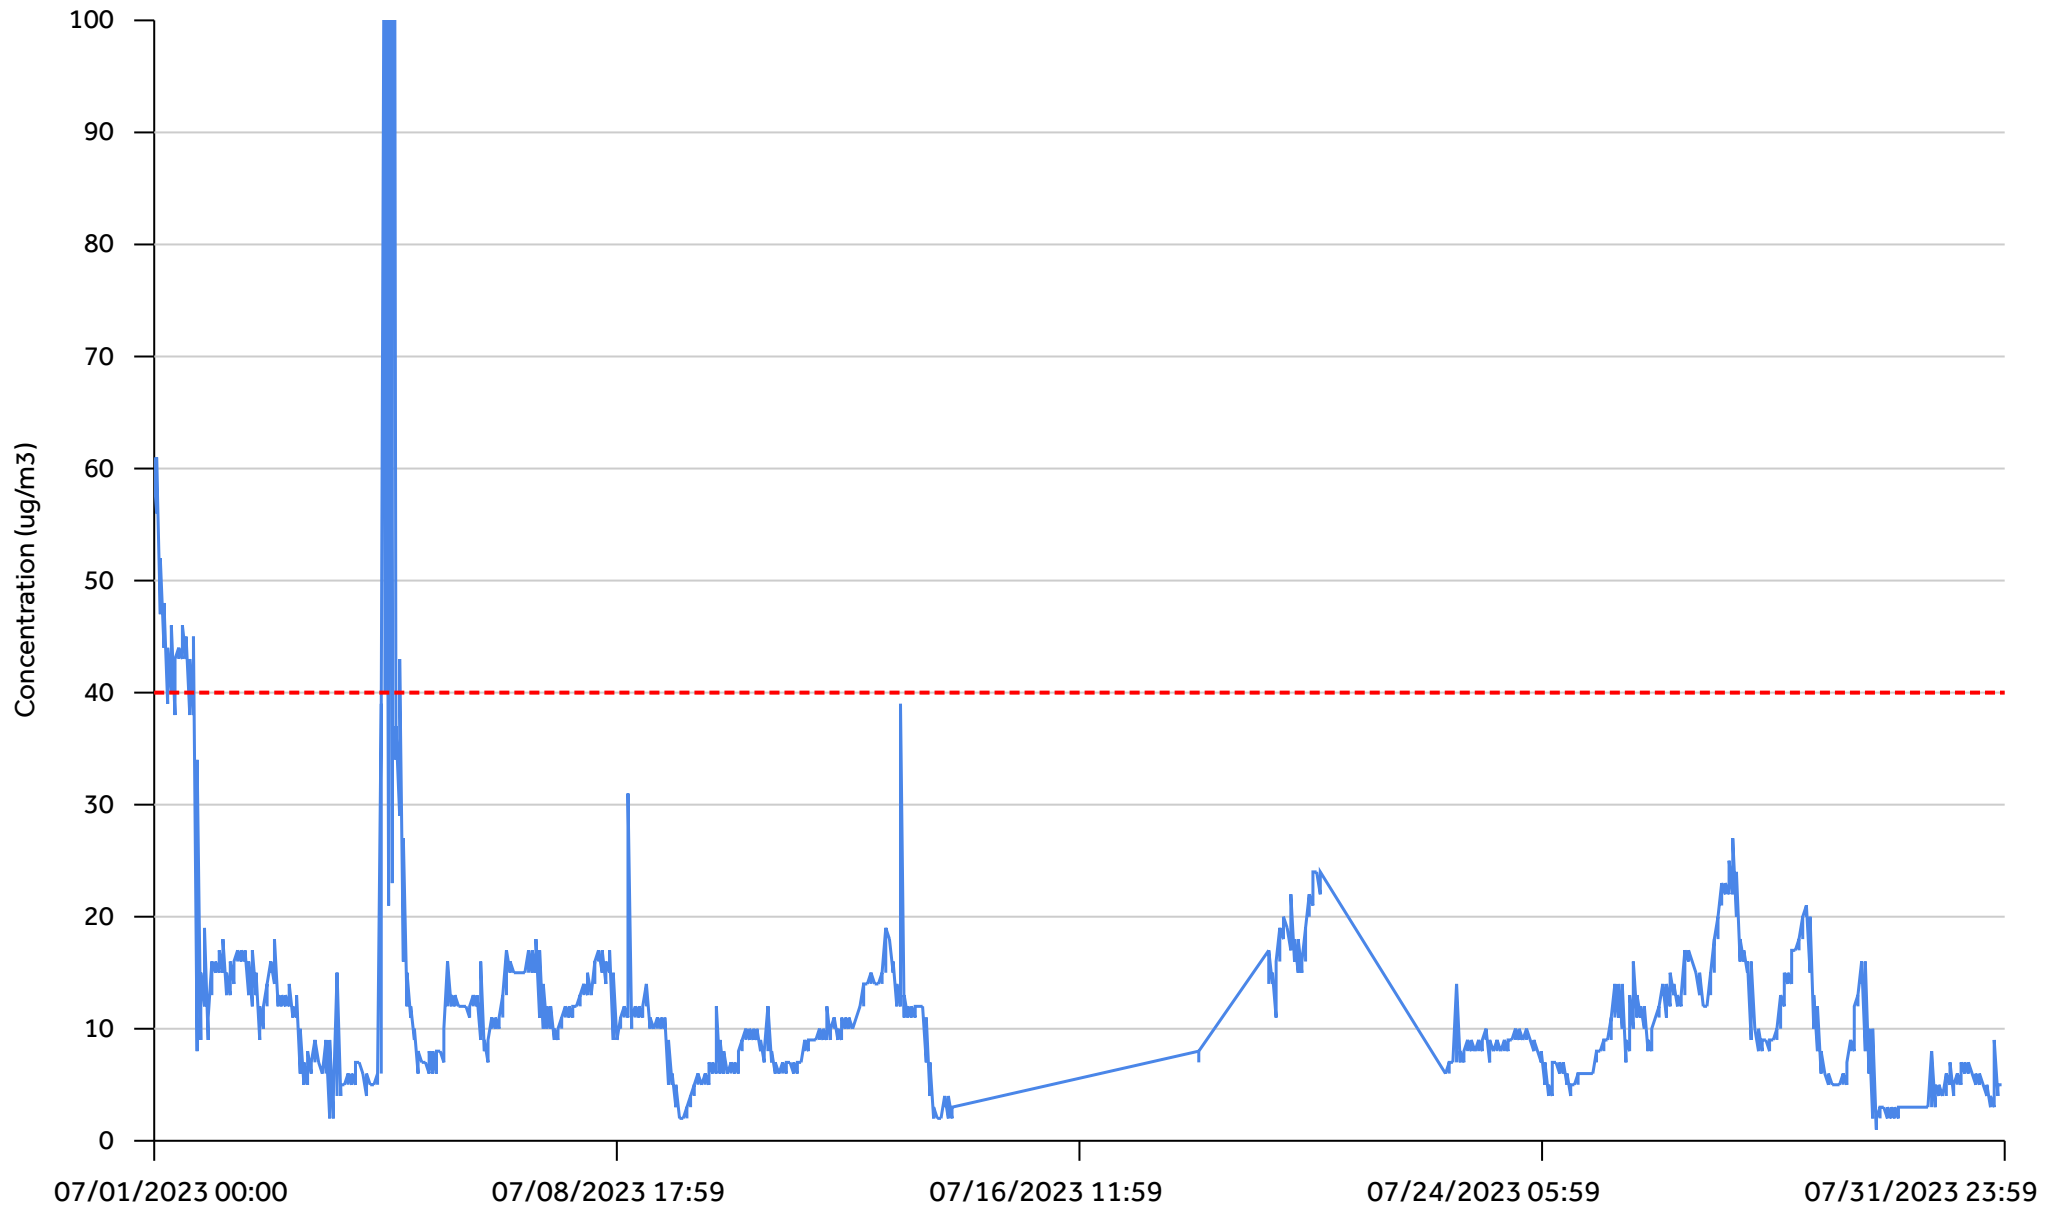
DM3-PM2.5

DM3 – 7/4 2126h, 130 $\mu\text{g}/\text{m}^3$.

DM3 – 7/5 0026h, 250 $\mu\text{g}/\text{m}^3$.
