Northern Bus Garage

Noise, Vibration, and Dust Monitoring Report (November 2023)

WMATA Bus Garage Monthly Report

November 2023

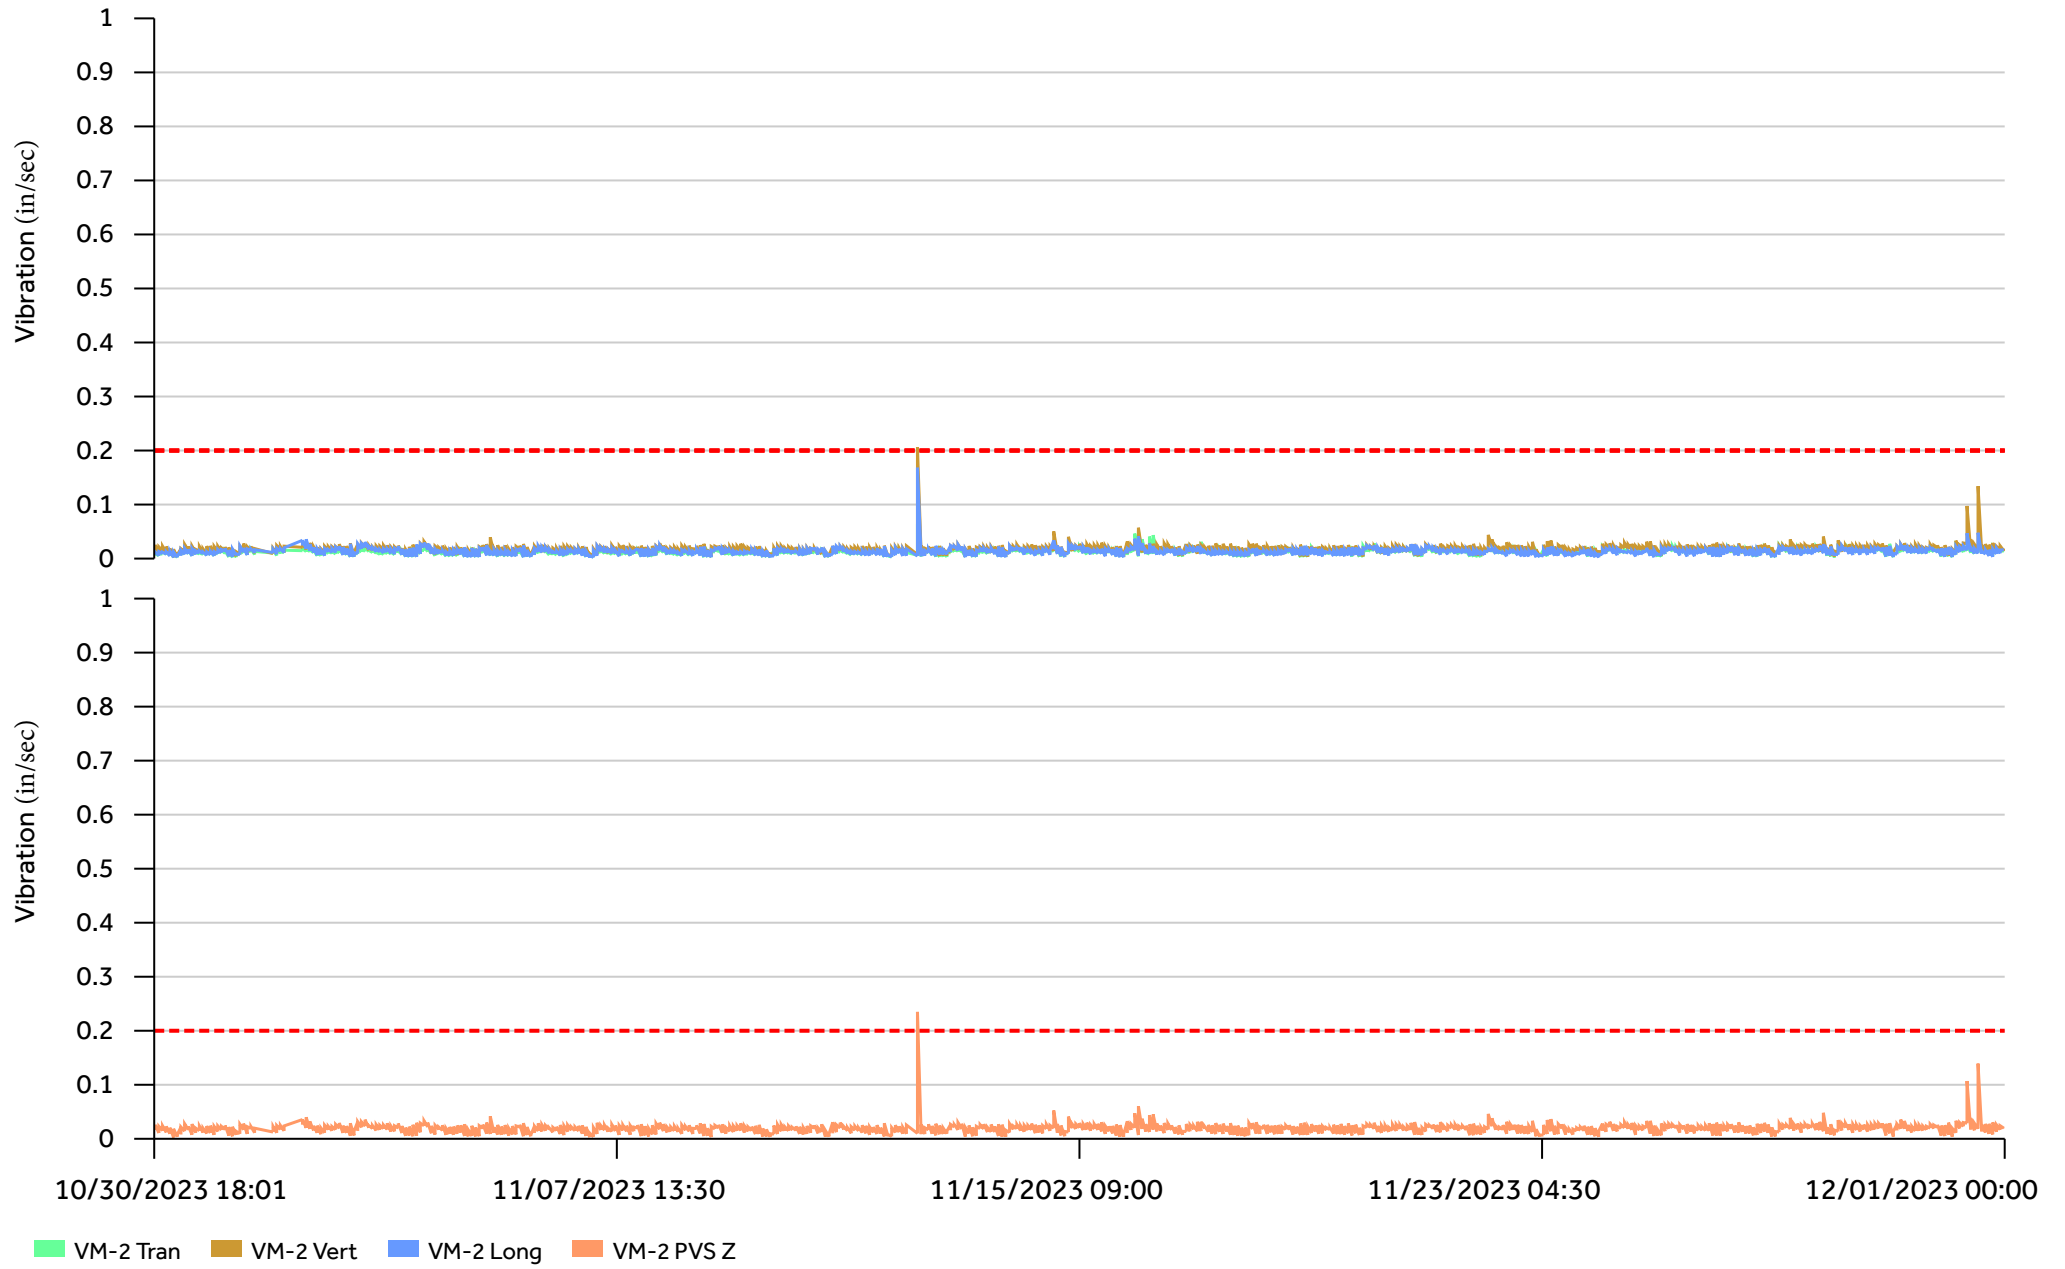
Graph 2:
VM-2- Vibration Monitor

There was one vibration exceedances in the month of November 2023 due to a battery swap of the equipment. A single vibration spike occurred at the VM2 location at 0.21in/sec on 11/12 at 4:06pm.

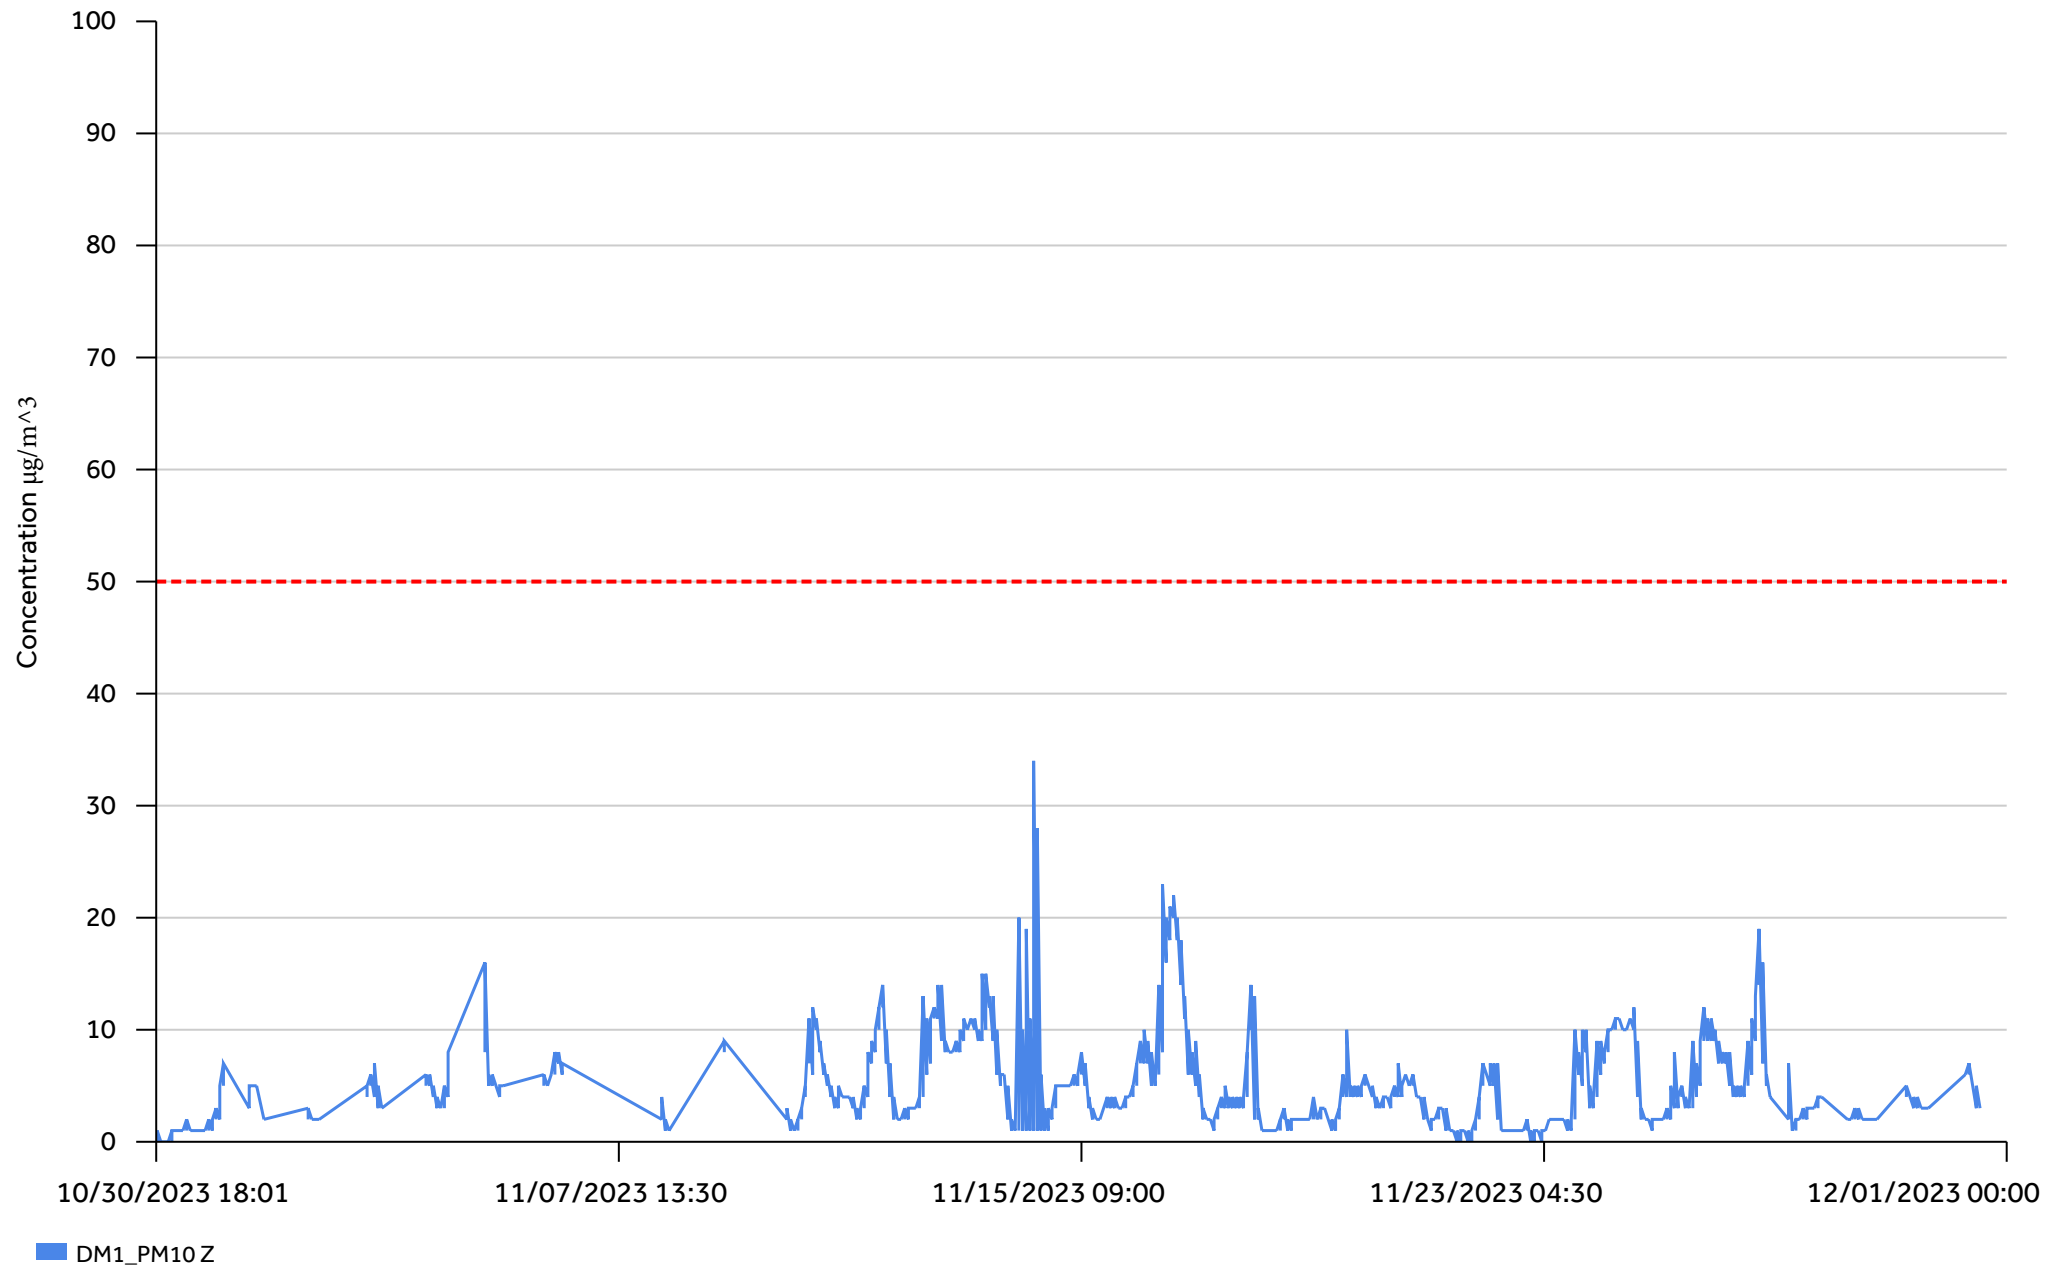
Graph 6:
DM1 - PM10

DM1 began experiencing power interruptions until the battery was exchanged on November 10. Two of the units have been fitted with hardware that allows tracking and alarming upon low voltage. Due to site restrictions, DM1 cannot be plugged into main power so continued battery swaps will be the interim solution until site conditions change.

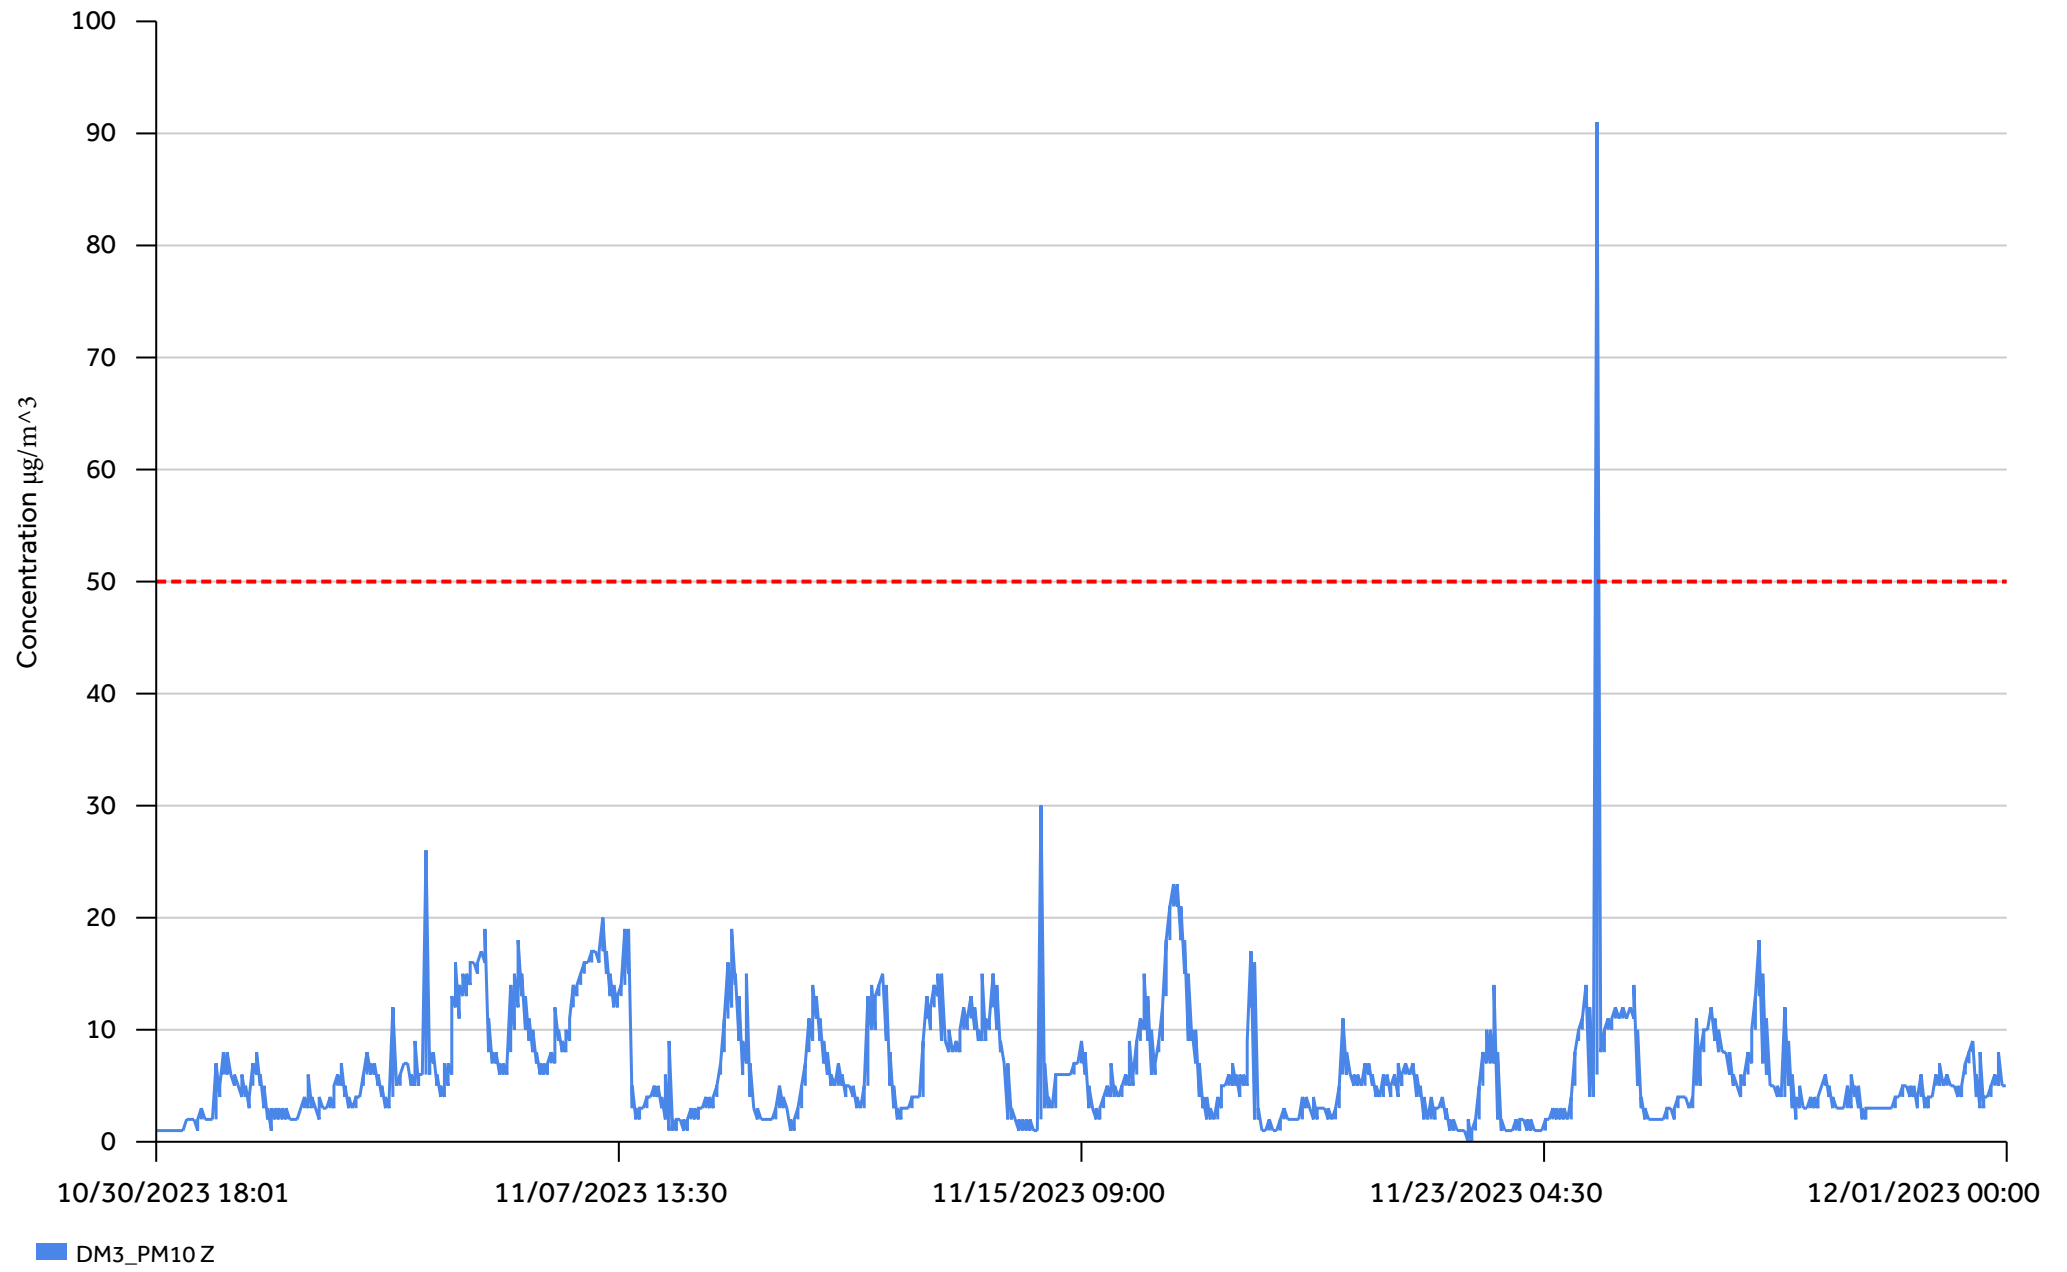
Graph 8:
DM3-PM10

There was one air quality exceedances in the month of November 2023. DM3 recorded a PM_{2.5} of 82 µg/m³ and a PM₁₀ of 91 µg/m³ on November 24 at 3:02 am due to higher winds.
