Northern Bus Garage Noise, Vibration, and Dust Monitoring Report (October 2023)

Noise, Vibration, and Dust levels were monitored as part of the reconstruction of Northern Bus Garage, 4615 14th Street, NW, Washington, DC, for the month of October 2023.

WMATA Bus Garage Monthly Report

October 2023

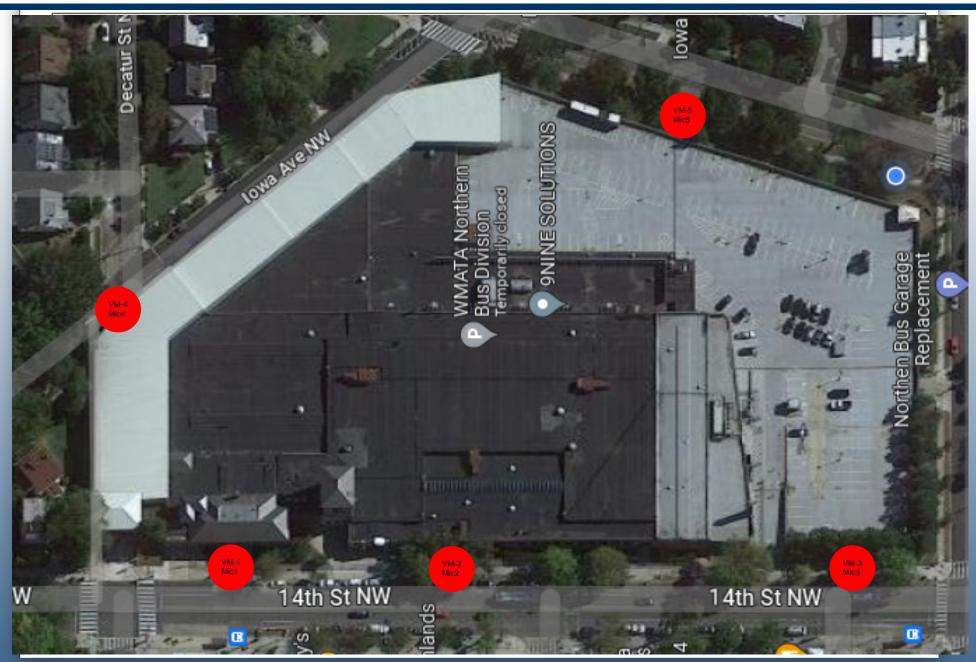
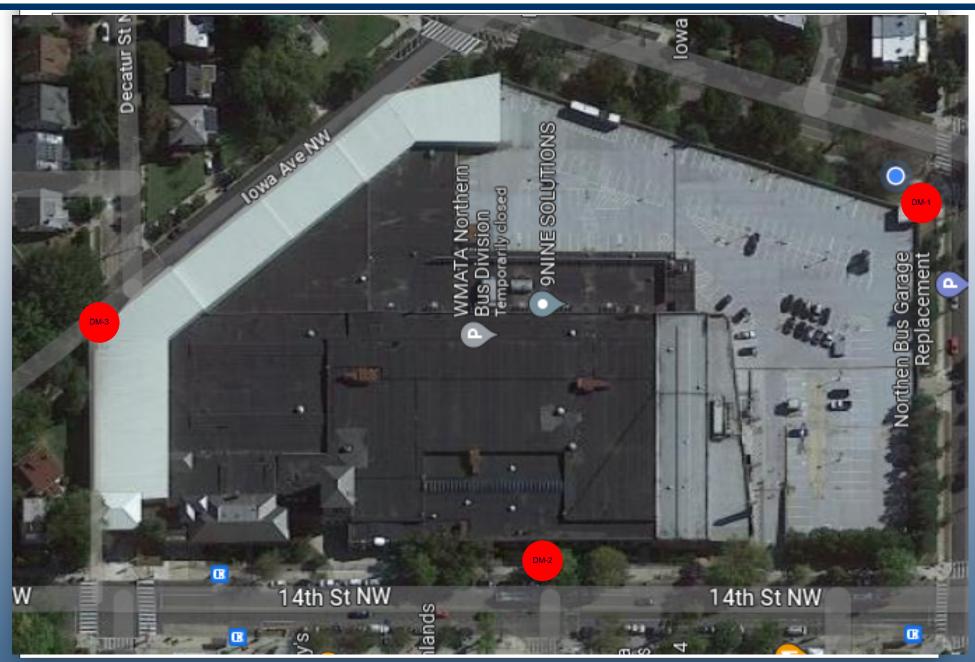
Figure 1: Vibration and Noise Monitor Location Plan

Five noise monitors are positioned around the perimeter of the project site. (See Figure 1) Under DC regulations, the regulatory standard is 80 dBA, measured 25 ft from the property line (20 DCMR 2802.1). Because the noise monitoring devices are placed on the property line (rather than a 25 ft offset), the monitoring threshold for site activities is adjusted to 85 dBA (assuming the noise level will dissipate). Noise levels and vibration levels were measured automatically with Micromate and Geophone Instrument.

Five vibration monitors are positioned around the perimeter of the project site. (See Figure 1) Vibration thresholds are based the WMATA Design Criteria. Monitors VM-1 and VM-2 are set at a lower vibration threshold due to their proximity to the historic façade, which is more sensitive to any movement. Noise levels and vibration levels were measured automatically with Micromate and Geophone Instrument.

Three dust monitors are positioned at the project site. (See Figure 2) EPA regulatory thresholds are based on a 24-hour

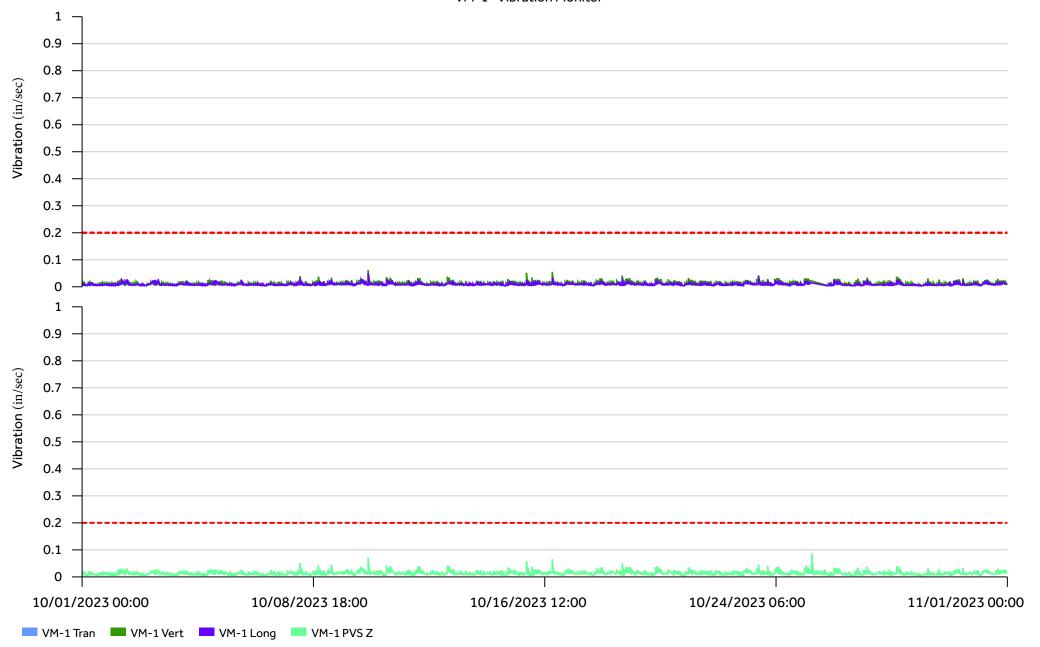
Graph 1: VM-1- Vibration Monitor

No vibration exceedance was reported during the month.

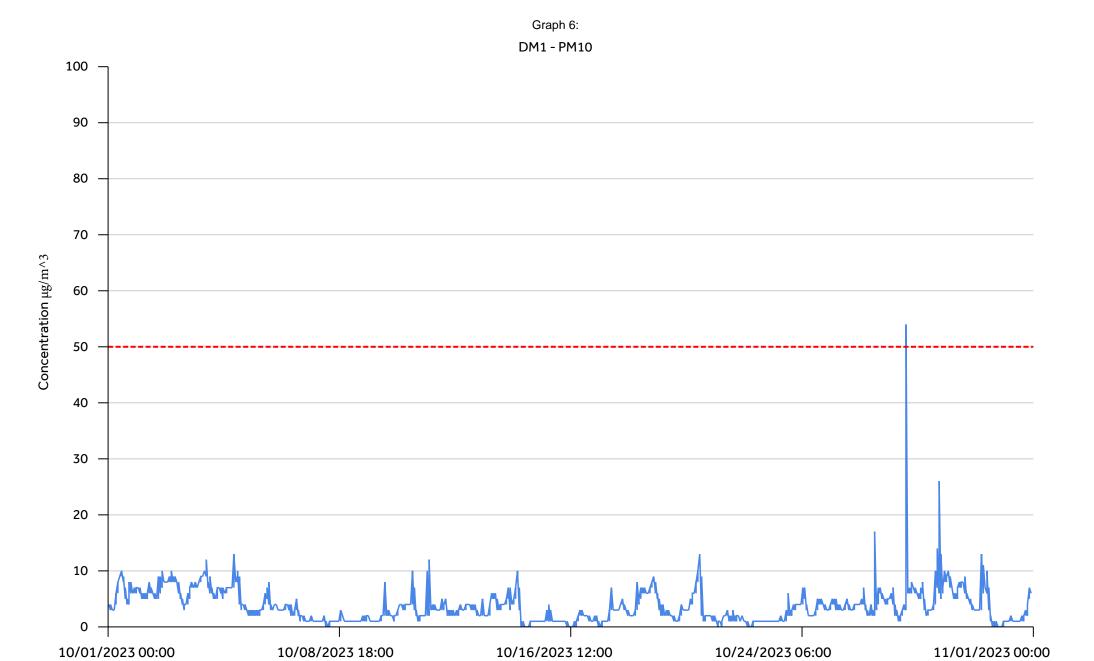
■ DM1_PM10 Z

There was one air quality exceedances in the month of October 2023. DM1 recorded a PM2.5 of 50 μ g/m³ and a PM10 of 54 μ g/m³ on October 27 at 6:32pm due to higher winds in the evening.

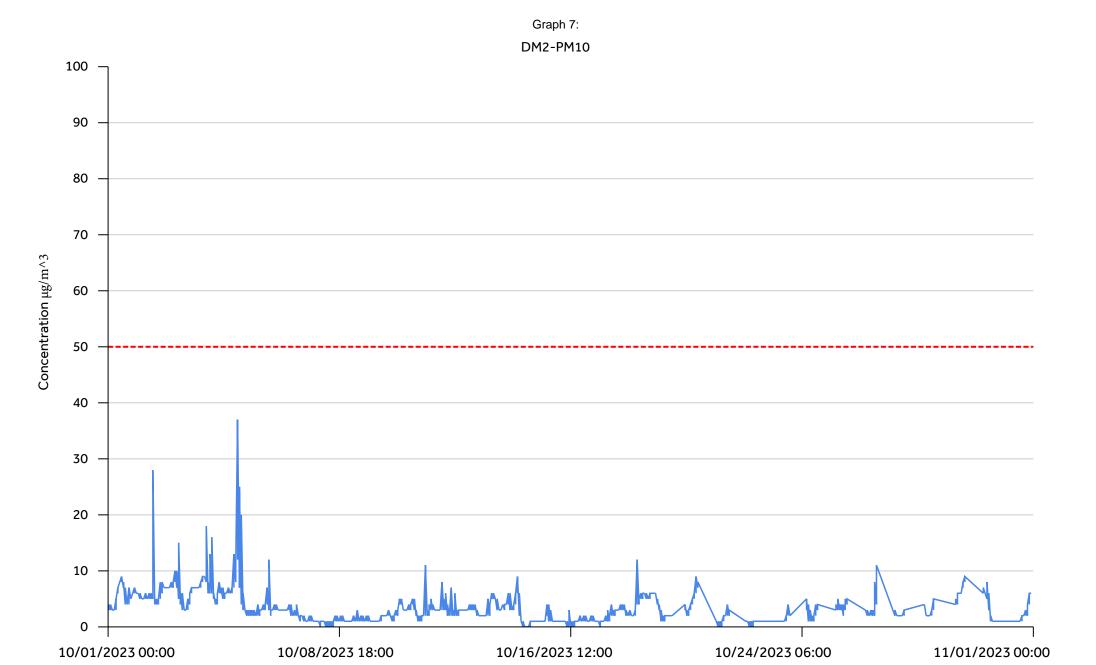
■ DM2_PM10 Z

DM2 began experiencing power interruptions after a battery exchange on October 19. It was discovered that the battery was not holding a charge above 11 volts resulting in interruptions in overnight measurements. The faulty battery was removed and replaced with a fresh battery. Two of the units have been fitted with hardware that allows tracking and alarming upon low voltage. Due to site restrictions, DM1 cannot be plugged into main power so continued battery swaps will be the interim solution until site conditions change.
