# Northern Bus Garage

## Noise, Vibration, and Dust Monitoring Report (September 2023)

Noise, Vibration, and Dust levels were monitored as part of the reconstruction of Northern Bus Garage, 4615 14<sup>th</sup> Street, NW, Washington, DC, for the month of September 2023.

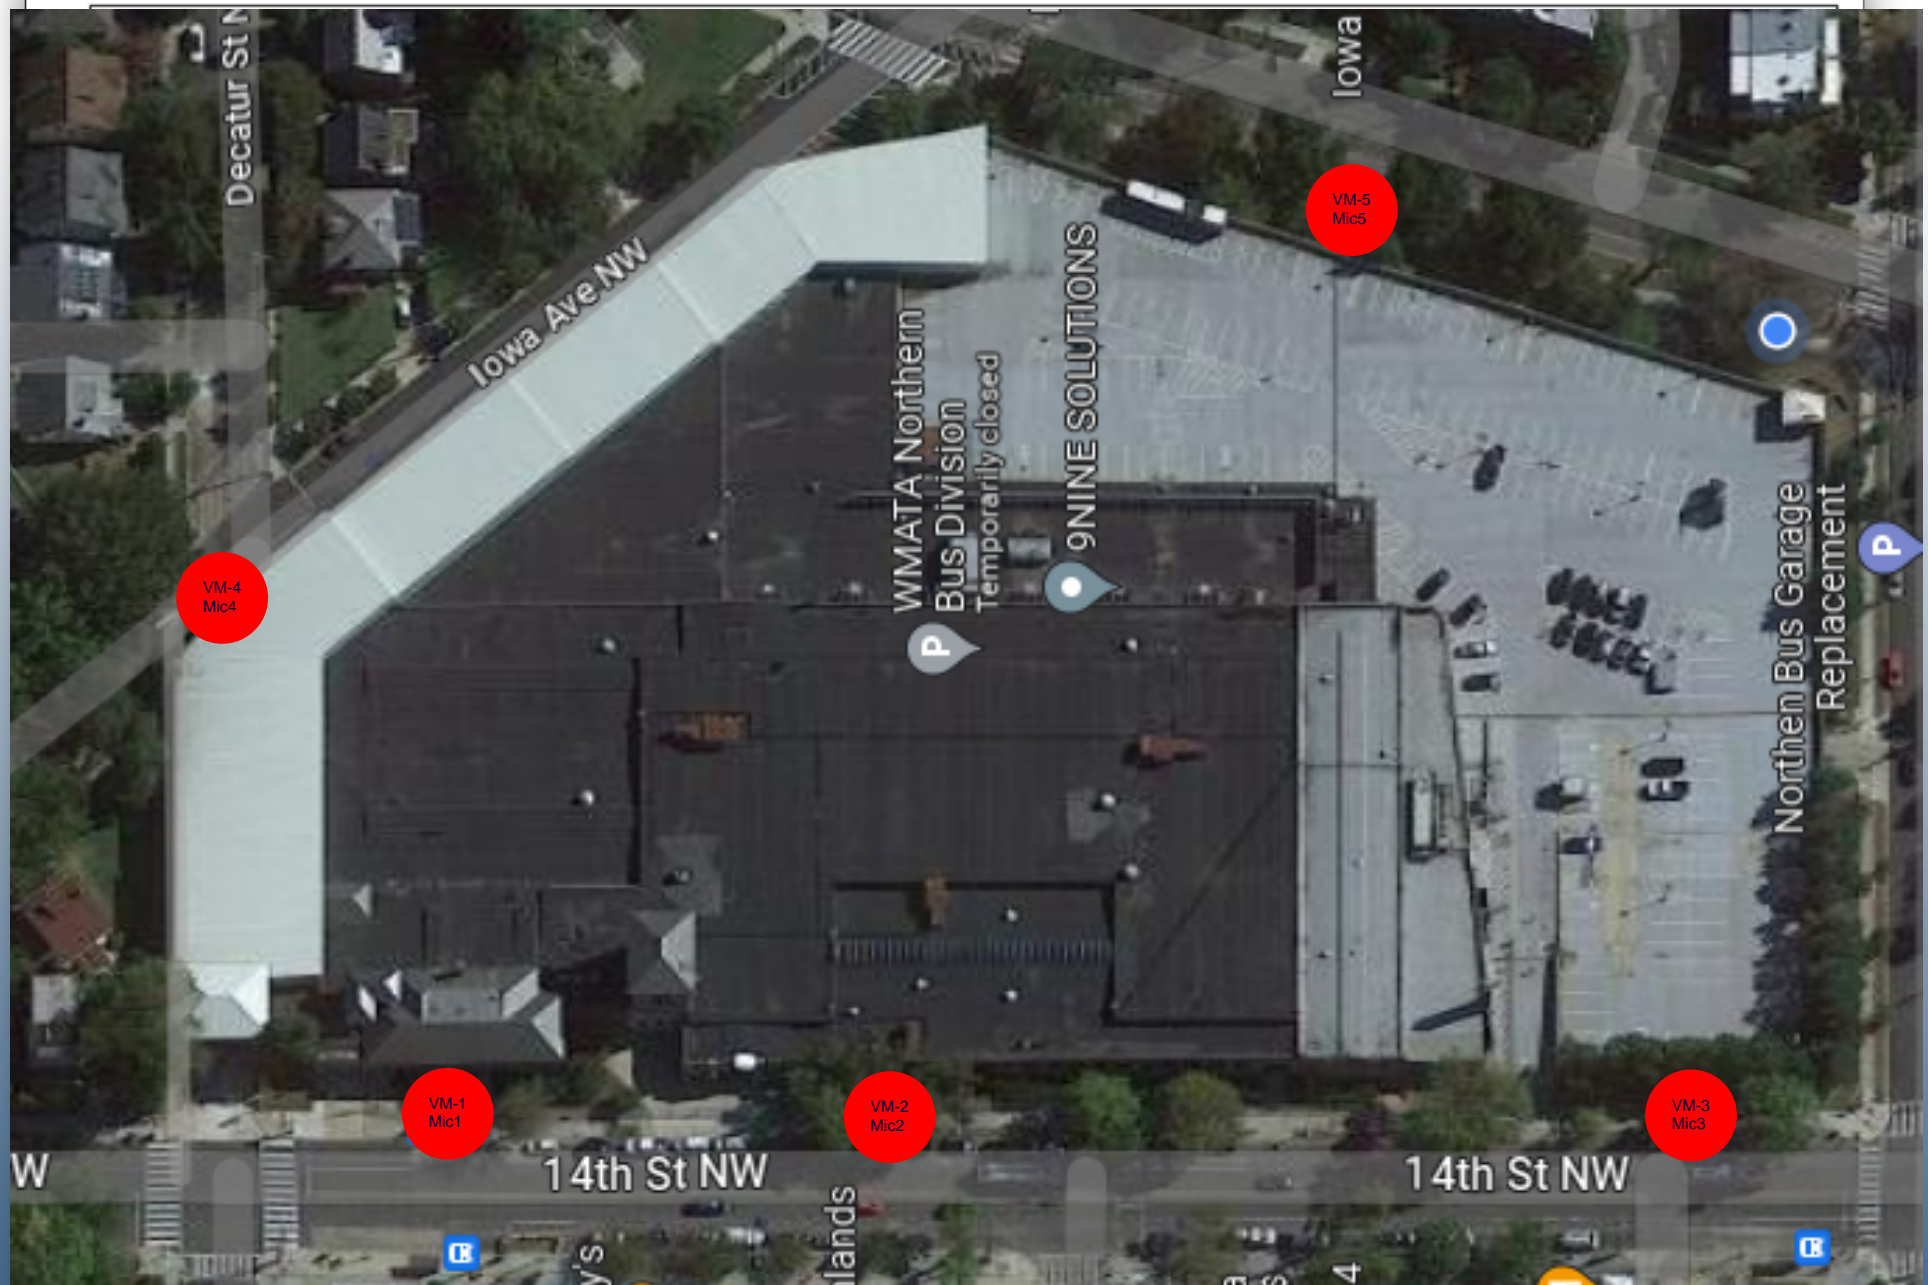
# Figure 1: Vibration and Noise Monitor Location Plan

Five noise monitors are positioned around the perimeter of the project site. (See Figure 1) Under DC regulations, the regulatory standard is 80 dBA, measured 25 ft from the property line (20 DCMR 2802.1). Because the noise monitoring devices are placed on the property line (rather than a 25 ft offset), the monitoring threshold for site activities is adjusted to 85 dBA (assuming the noise level will dissipate). Noise levels and vibration levels were measured automatically with Micromate and Geophone Instrument.

Five vibration monitors are positioned around the perimeter of the project site. (See Figure 1) Vibration thresholds are based the WMATA Design Criteria. Monitors VM-1 and VM-2 are set at a lower vibration threshold due to their proximity to the historic façade, which is more sensitive to any movement. Noise levels and vibration levels were measured automatically with Micromate and Geophone Instrument.

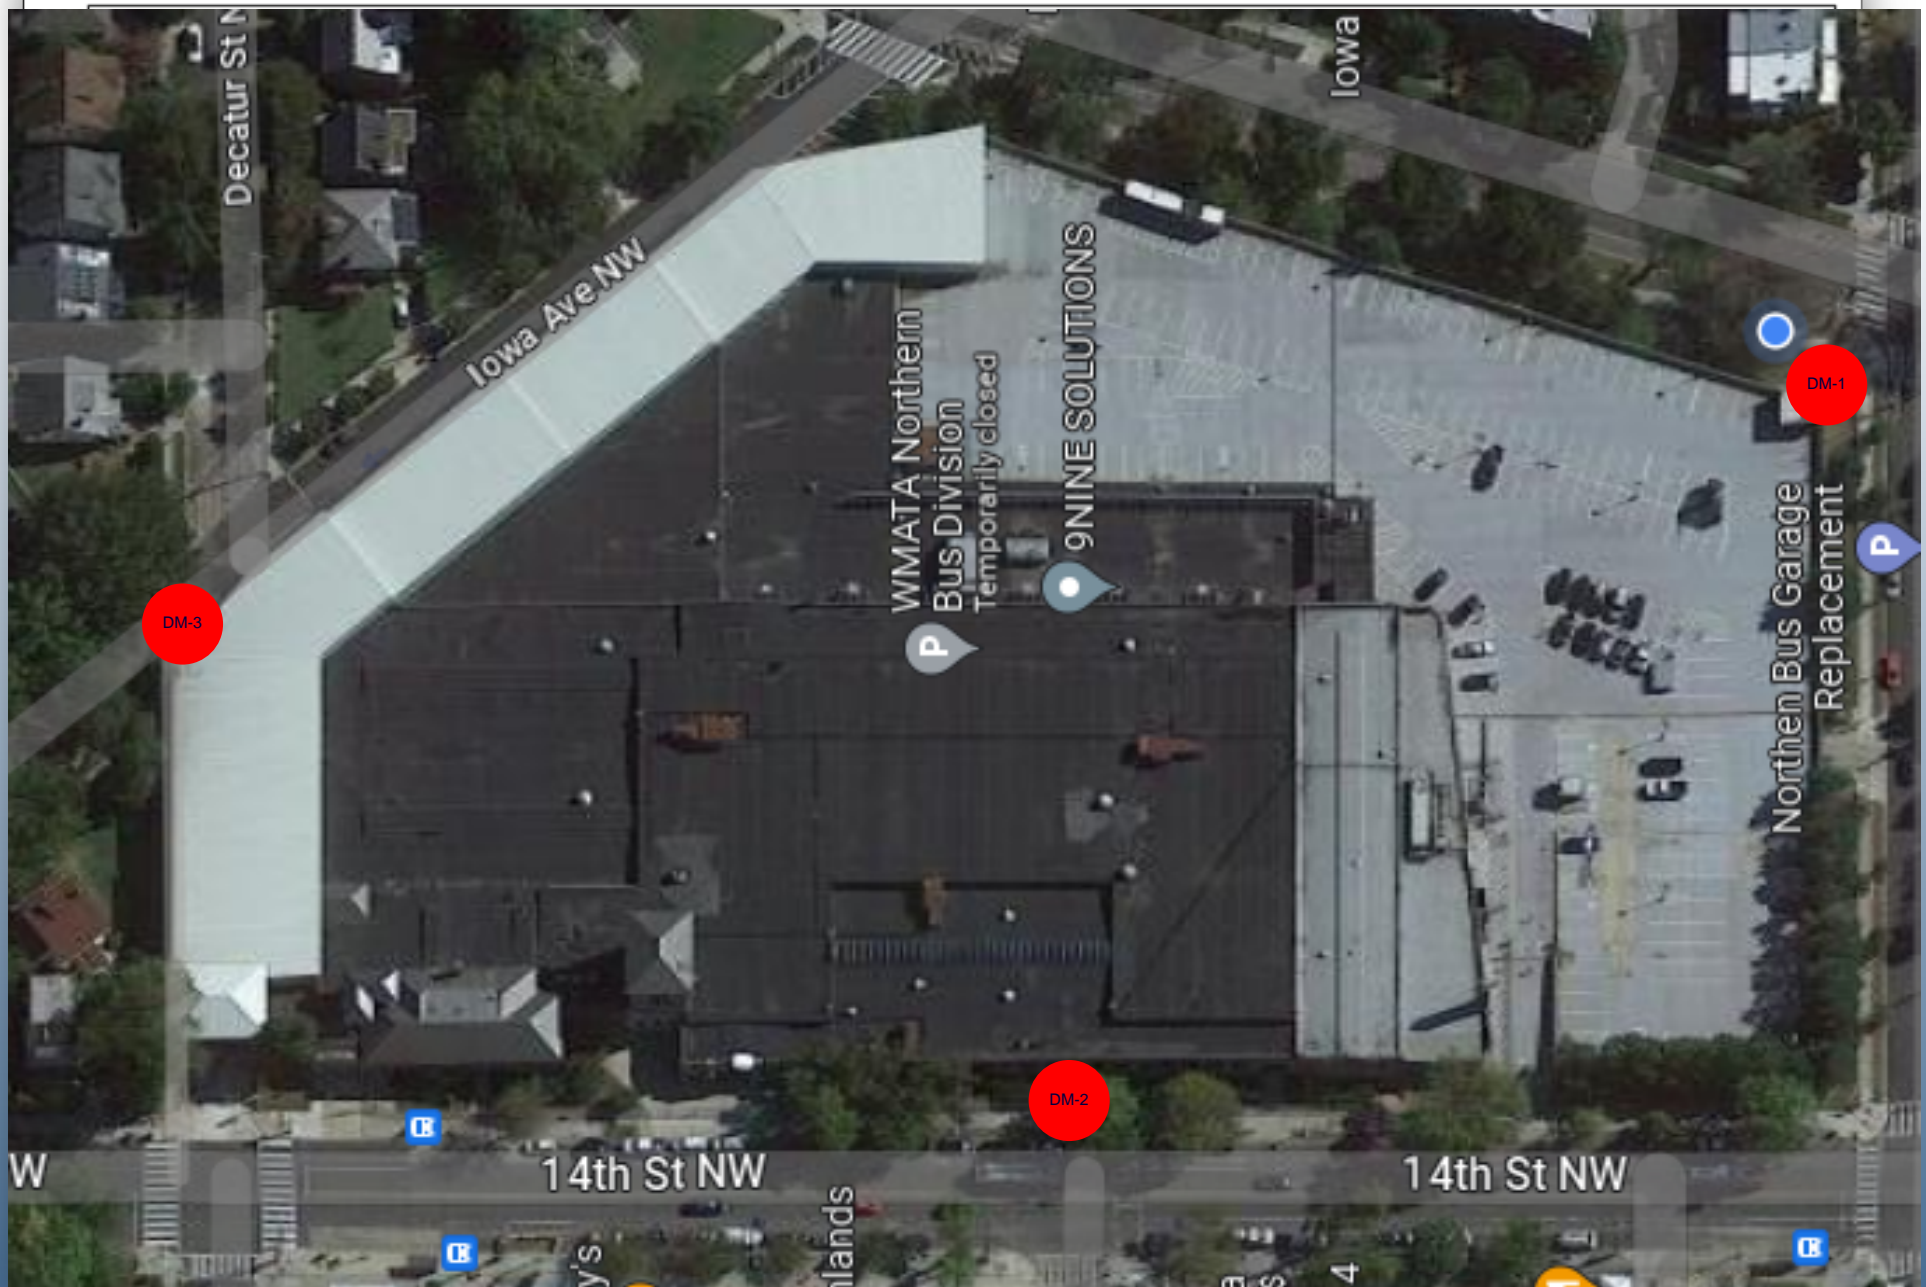
# Figure 2: Dust Monitor Location Plan

Three dust monitors are positioned at the project site. (See Figure 2) EPA regulatory thresholds are based on a 24-hour monitoring period; the project has adopted thresholds to monitor site levels and provide an indication of when EPA standards might be exceeded. (See Table 3) Dust measurements were monitored using Aeroqual Dust Sentry Pro.

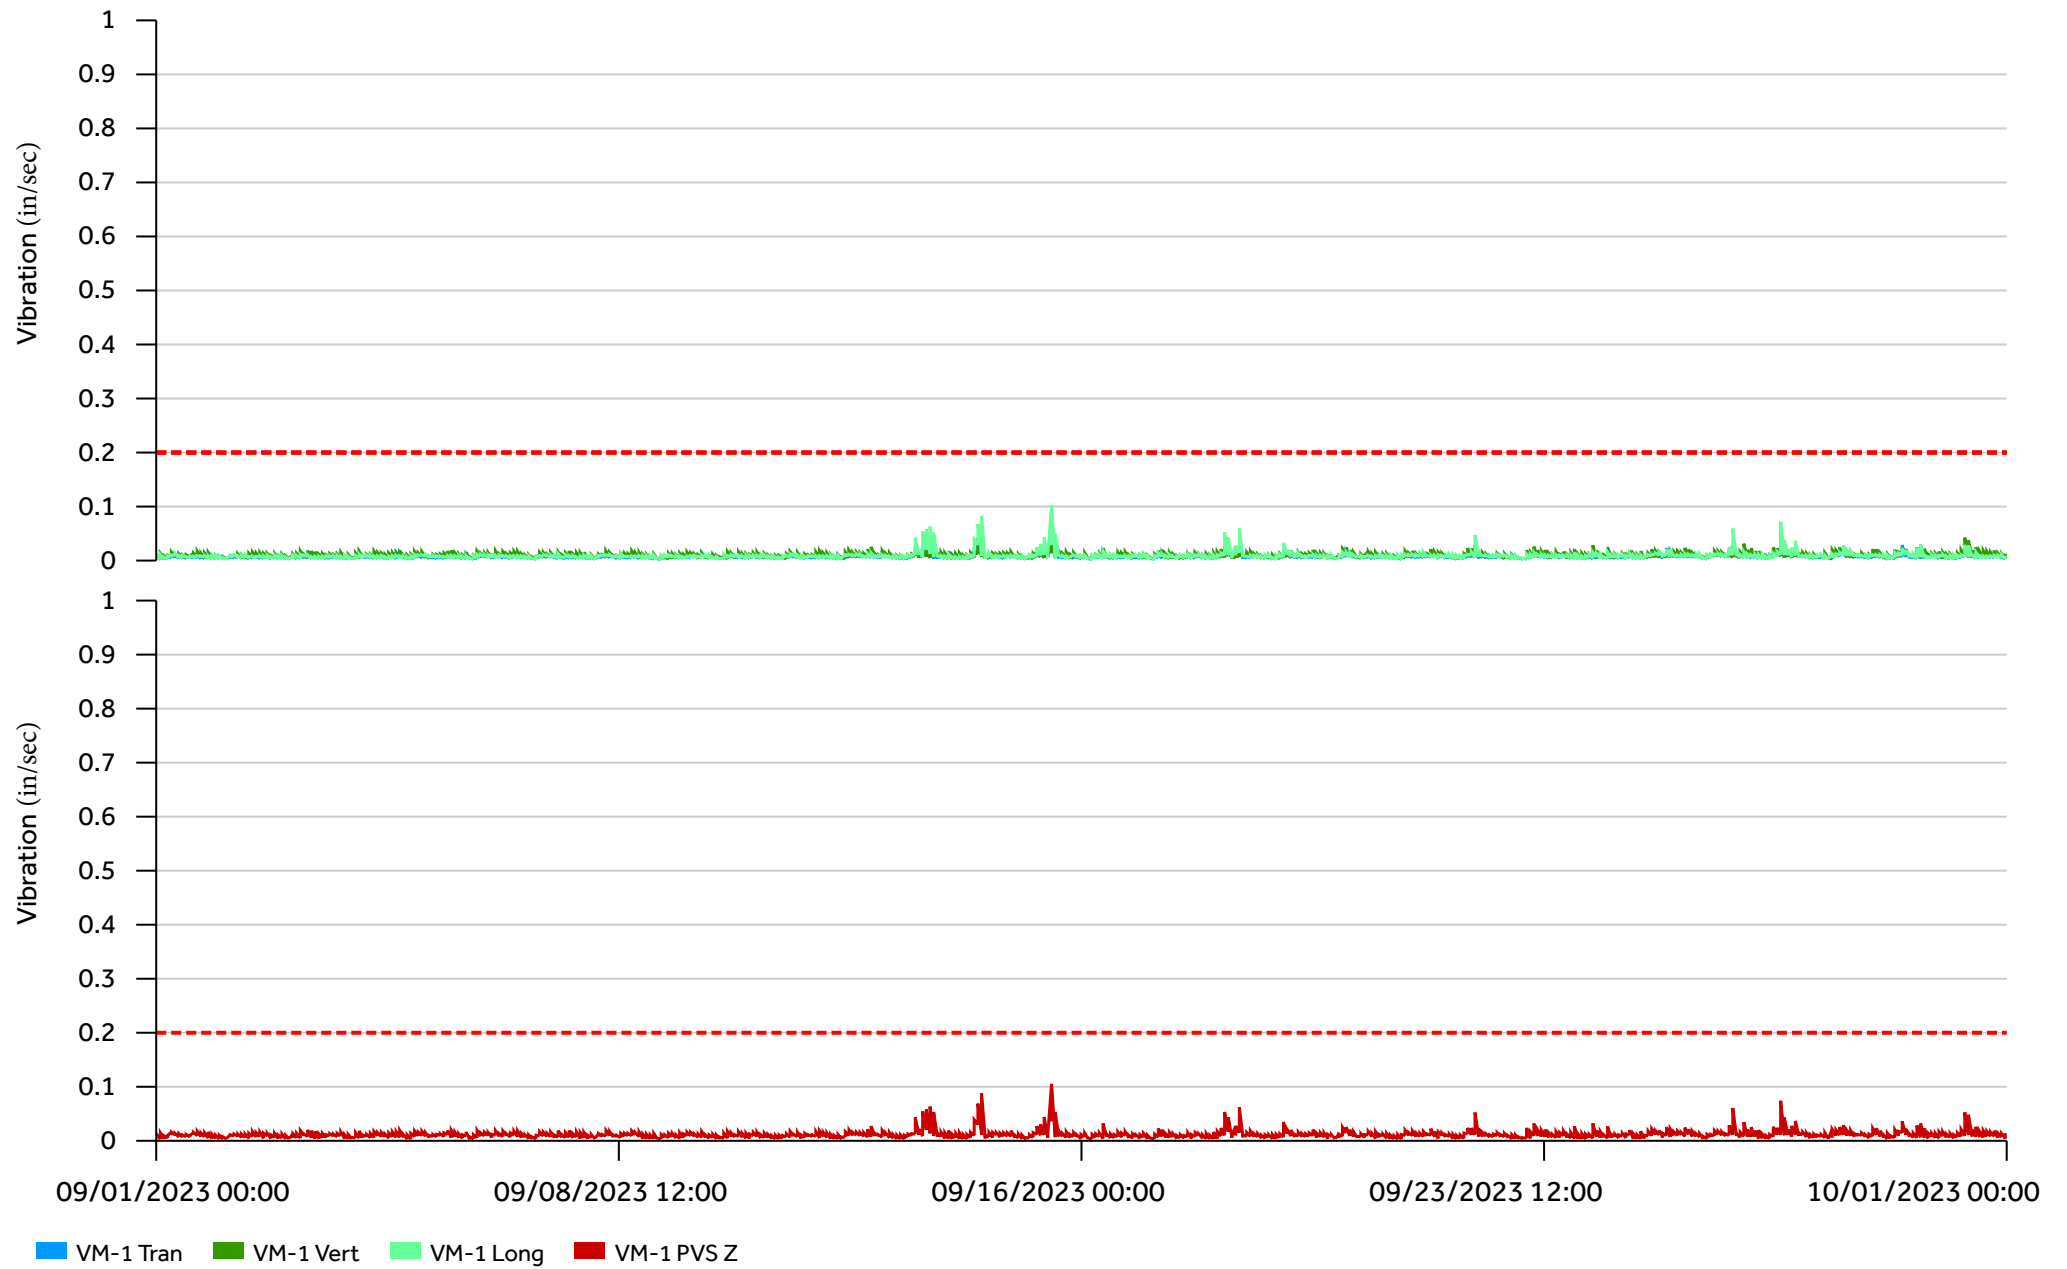
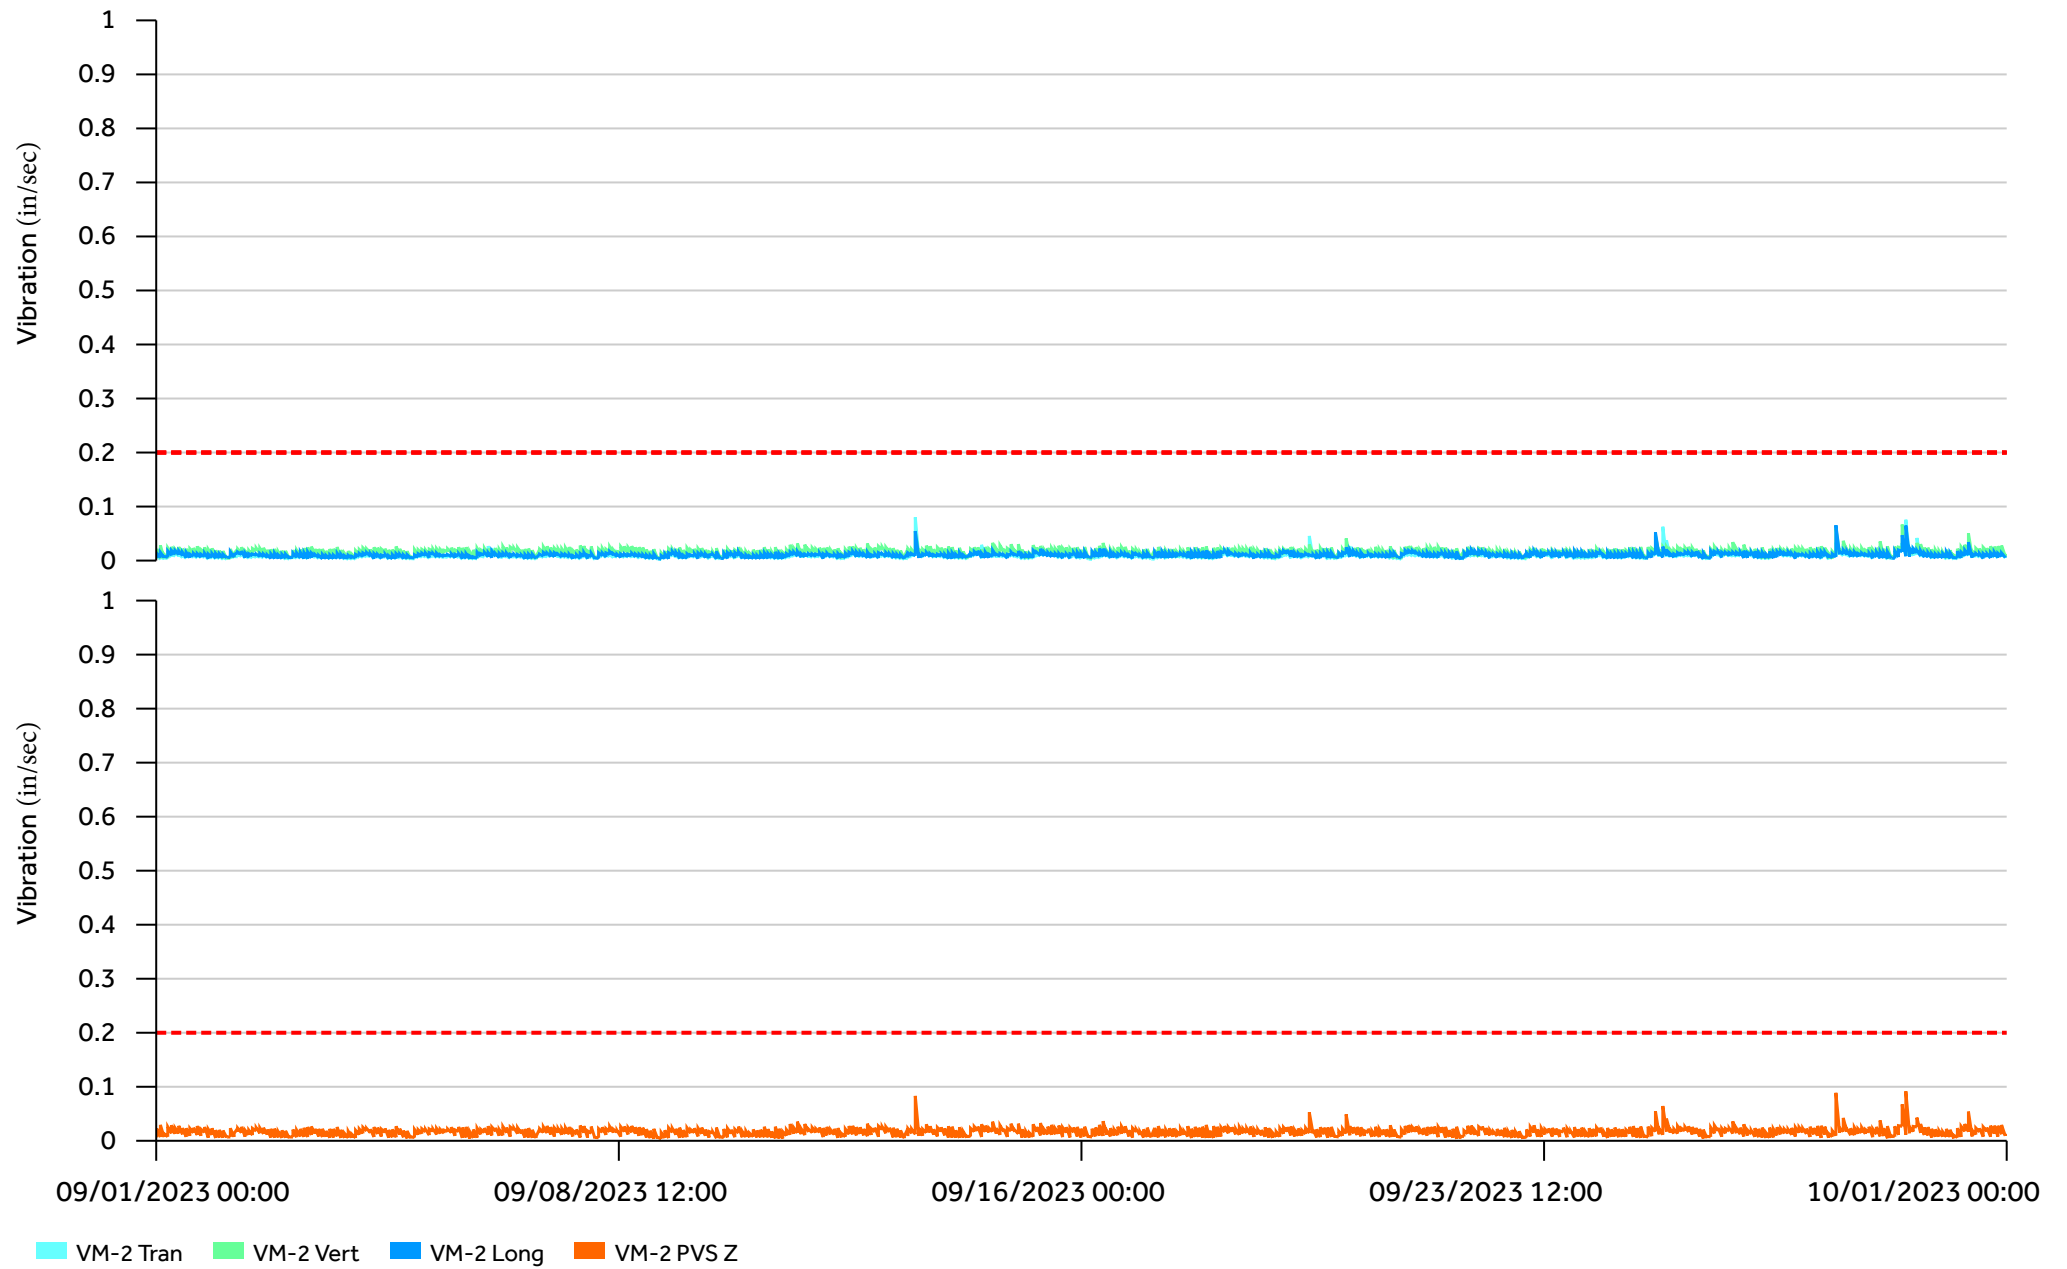
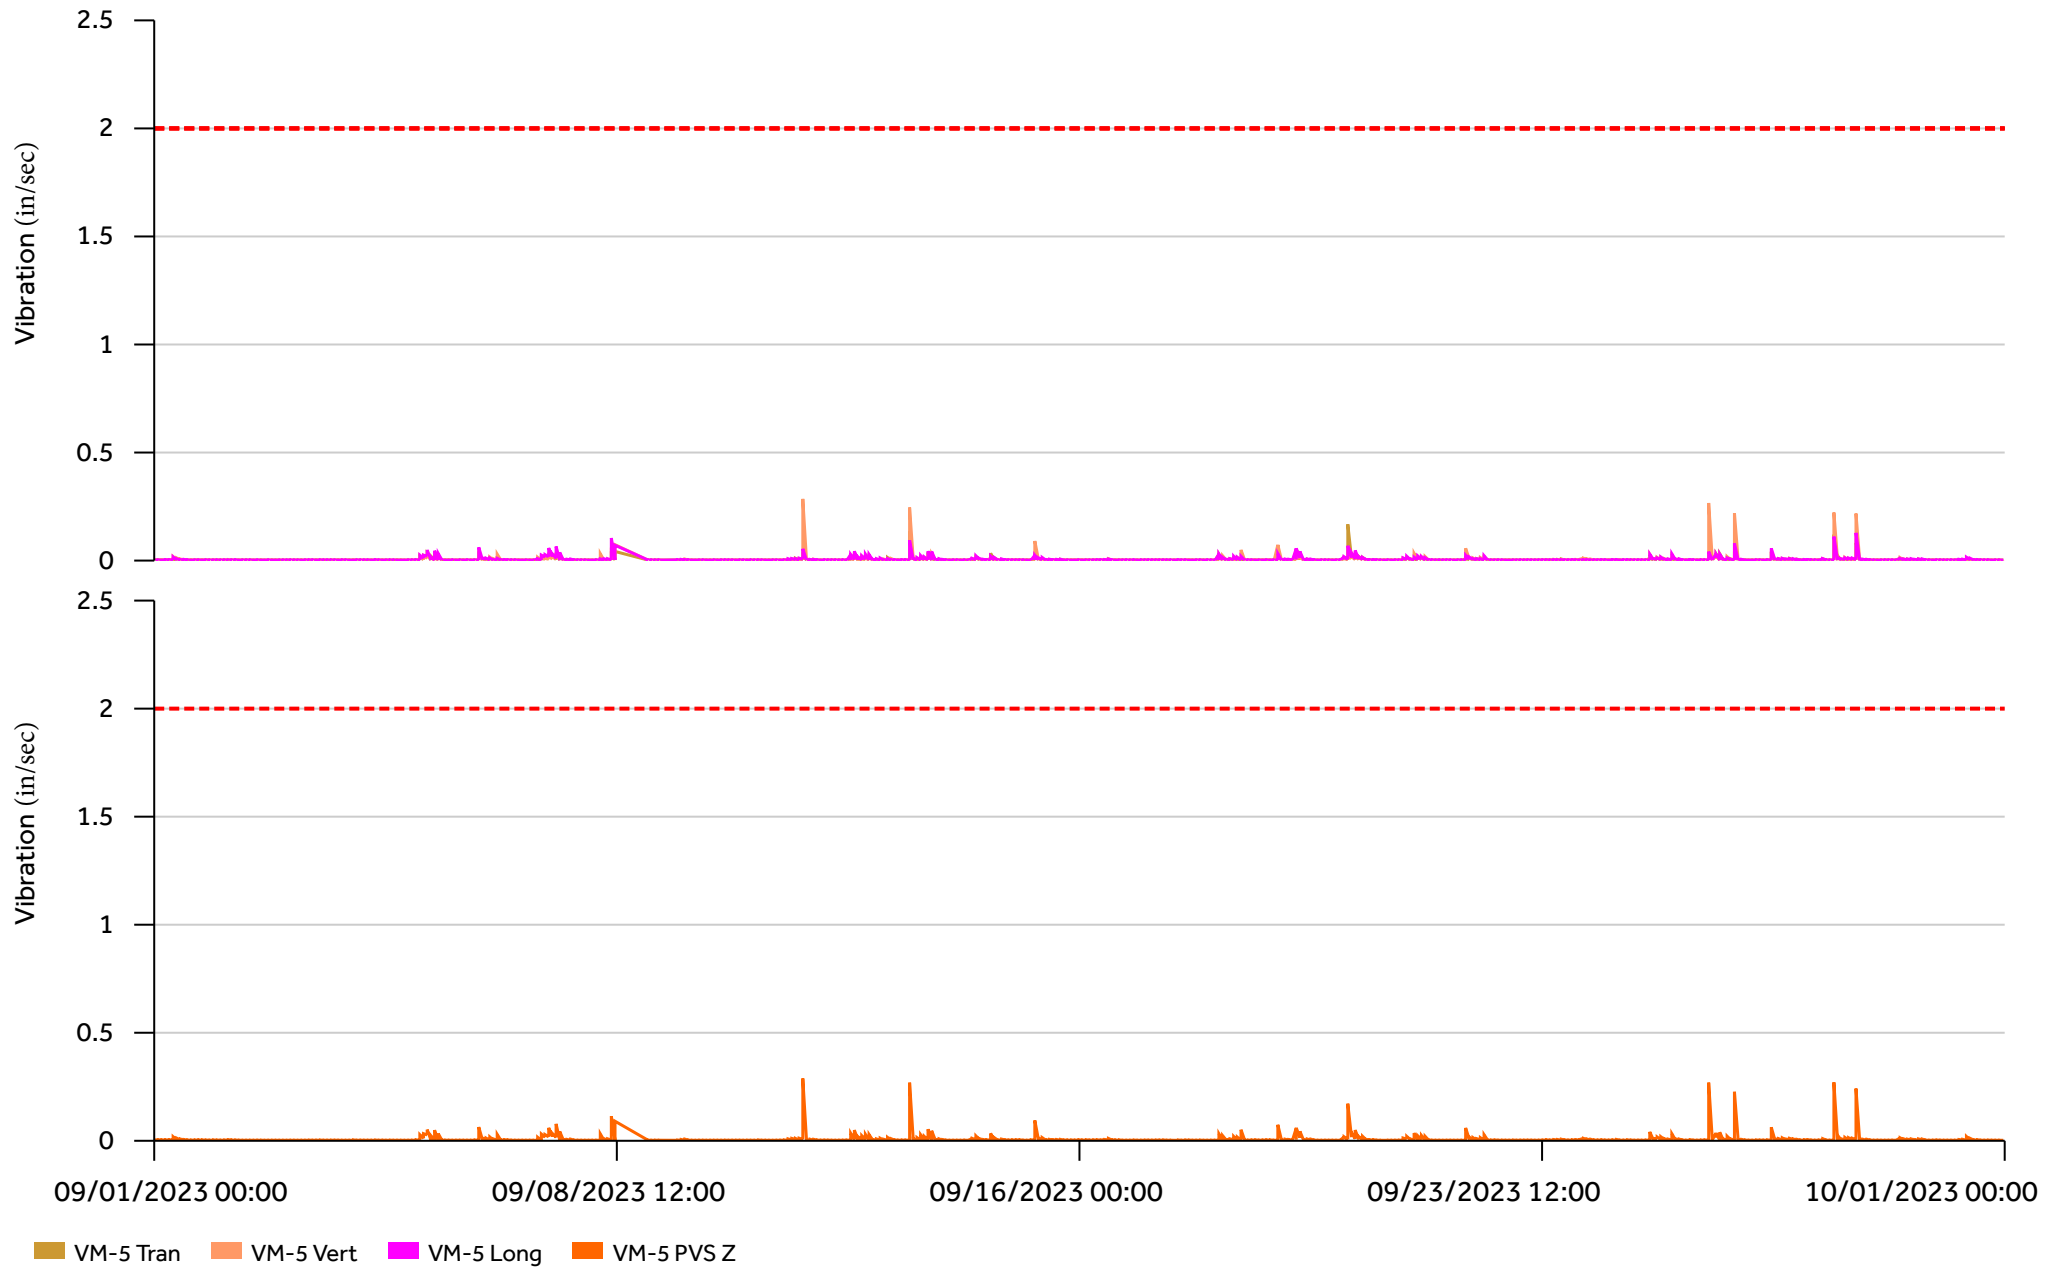
Graphs showing monitoring results are presented in Graphs 1 to 5.

No vibration exceedance was reported during the month.
