Northern Bus Garage Noise, Vibration, and Dust Monitoring Report (September 2023)

Noise, Vibration, and Dust levels were monitored as part of the reconstruction of Northern Bus Garage, 4615 14th Street, NW, Washington, DC, for the month of September 2023.

WMATA Bus Garage Monthly Report

September 2023

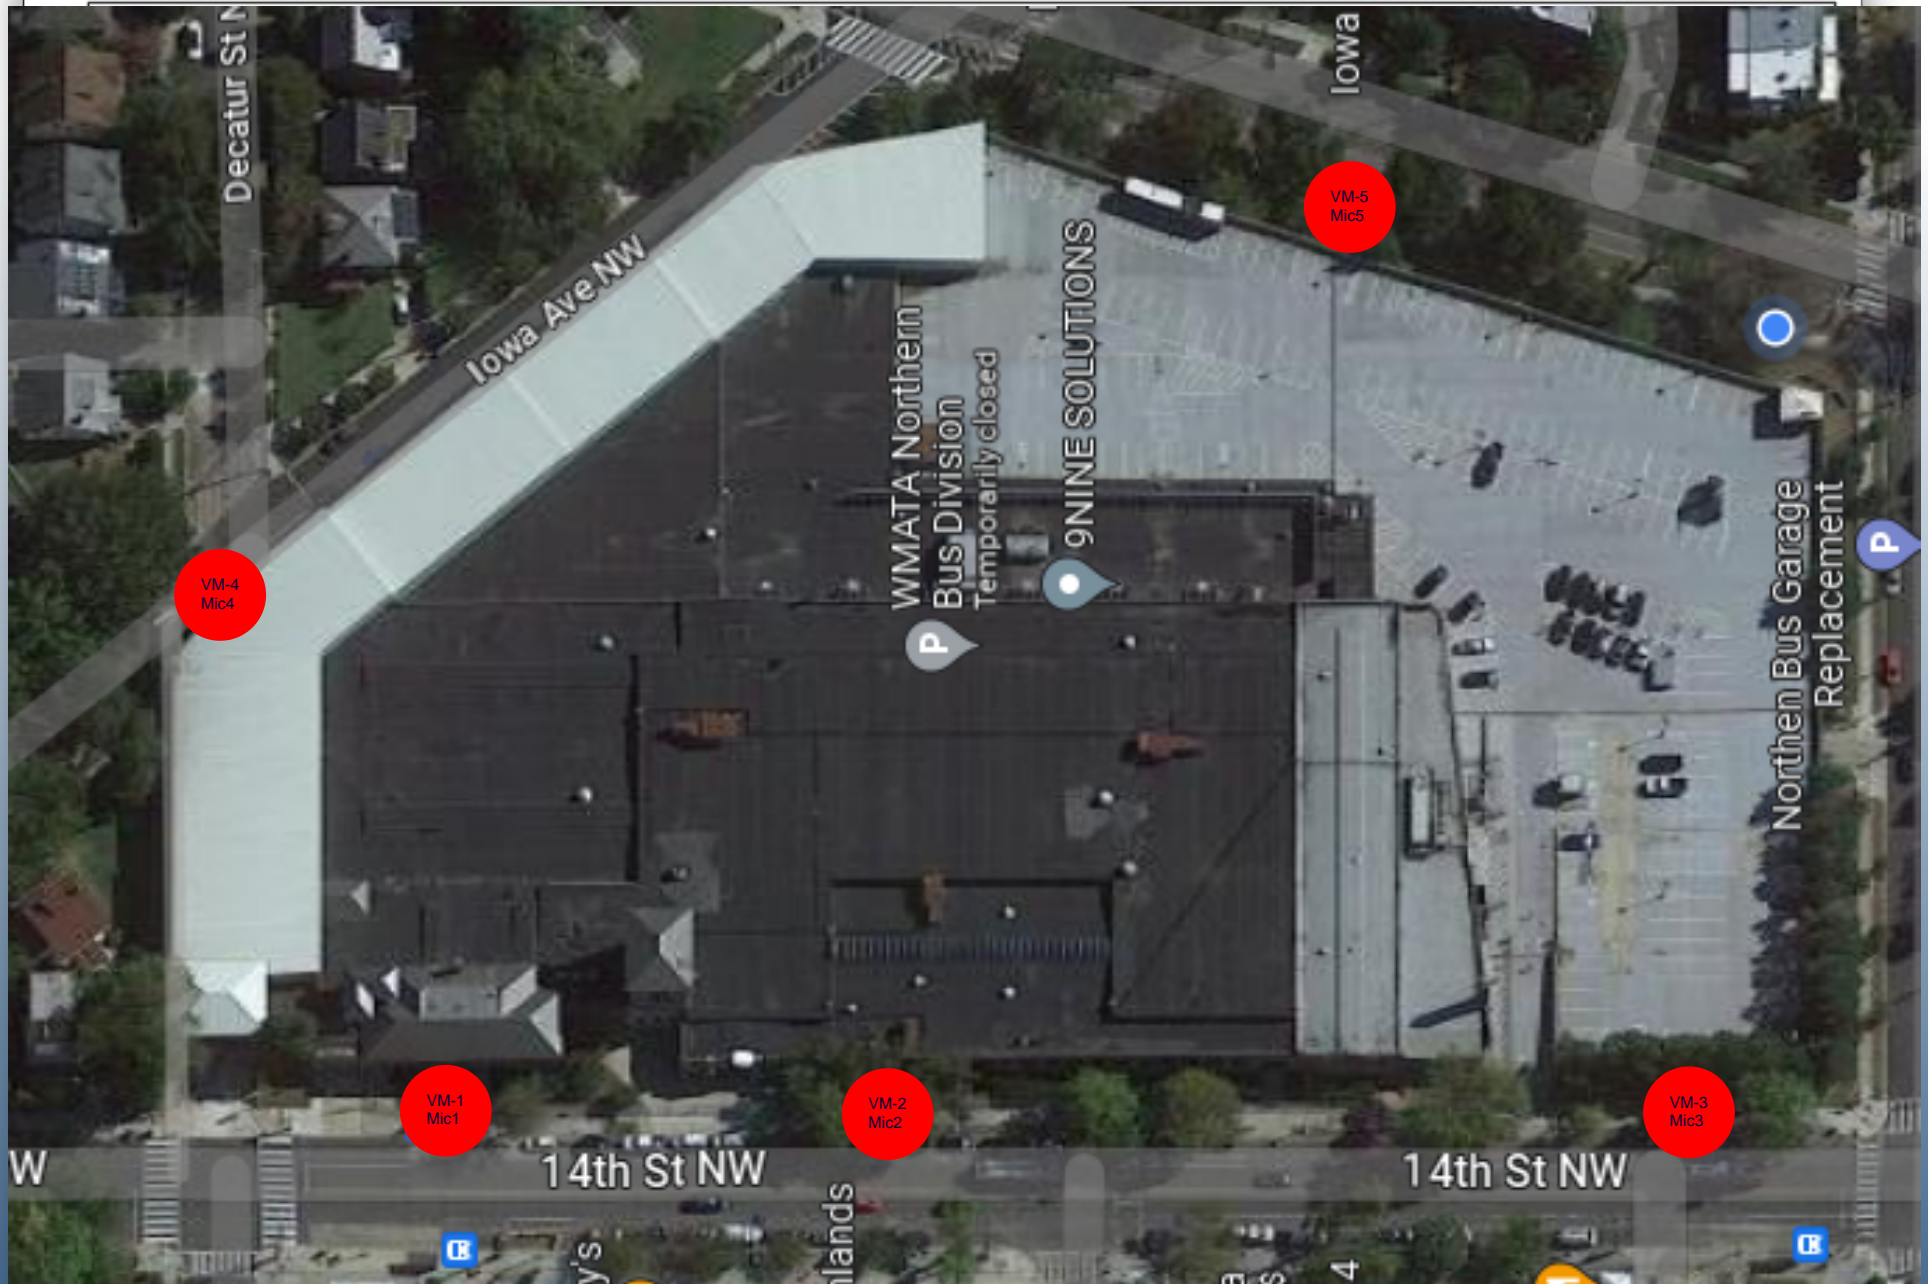
Figure 1: Vibration and Noise Monitor Location Plan

Five noise monitors are positioned around the perimeter of the project site. (See Figure 1) Under DC regulations, the regulatory standard is 80 dBA, measured 25 ft from the property line (20 DCMR 2802.1). Because the noise monitoring devices are placed on the property line (rather than a 25 ft offset), the monitoring threshold for site activities is adjusted to 85 dBA (assuming the noise level will dissipate). Noise levels and vibration levels were measured automatically with Micromate and Geophone Instrument.

Five vibration monitors are positioned around the perimeter of the project site. (See Figure 1) Vibration thresholds are based the WMATA Design Criteria. Monitors VM-1 and VM-2 are set at a lower vibration threshold due to their proximity to the historic façade, which is more sensitive to any movement. Noise levels and vibration levels were measured automatically with Micromate and Geophone Instrument.

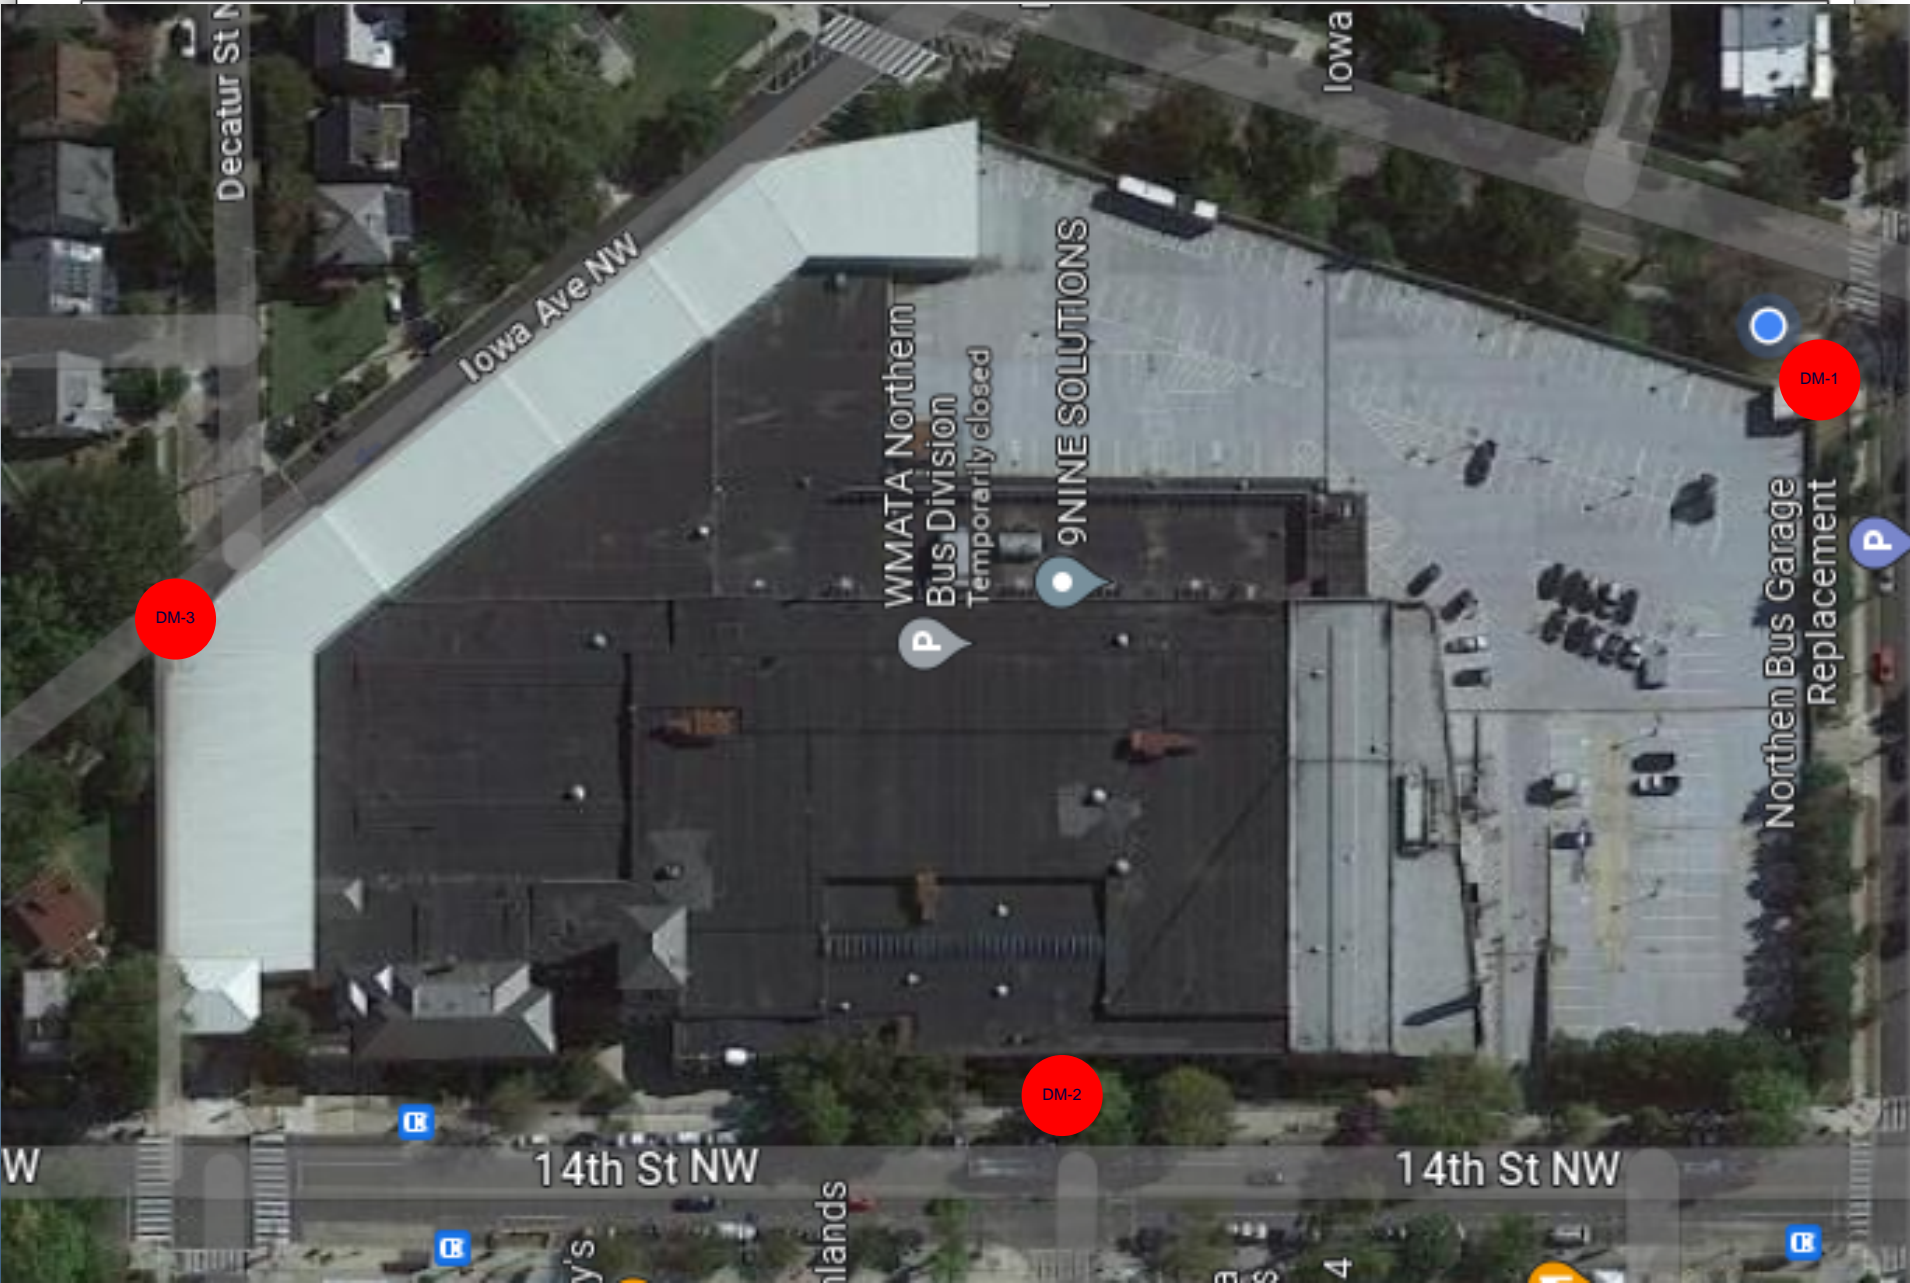
Figure 2: Dust Monitor Location Plan

Three dust monitors are positioned at the project site. (See Figure 2) EPA regulatory thresholds are based on a 24-hour monitoring period; the project has adopted thresholds to monitor site levels and provide an indication of when EPA

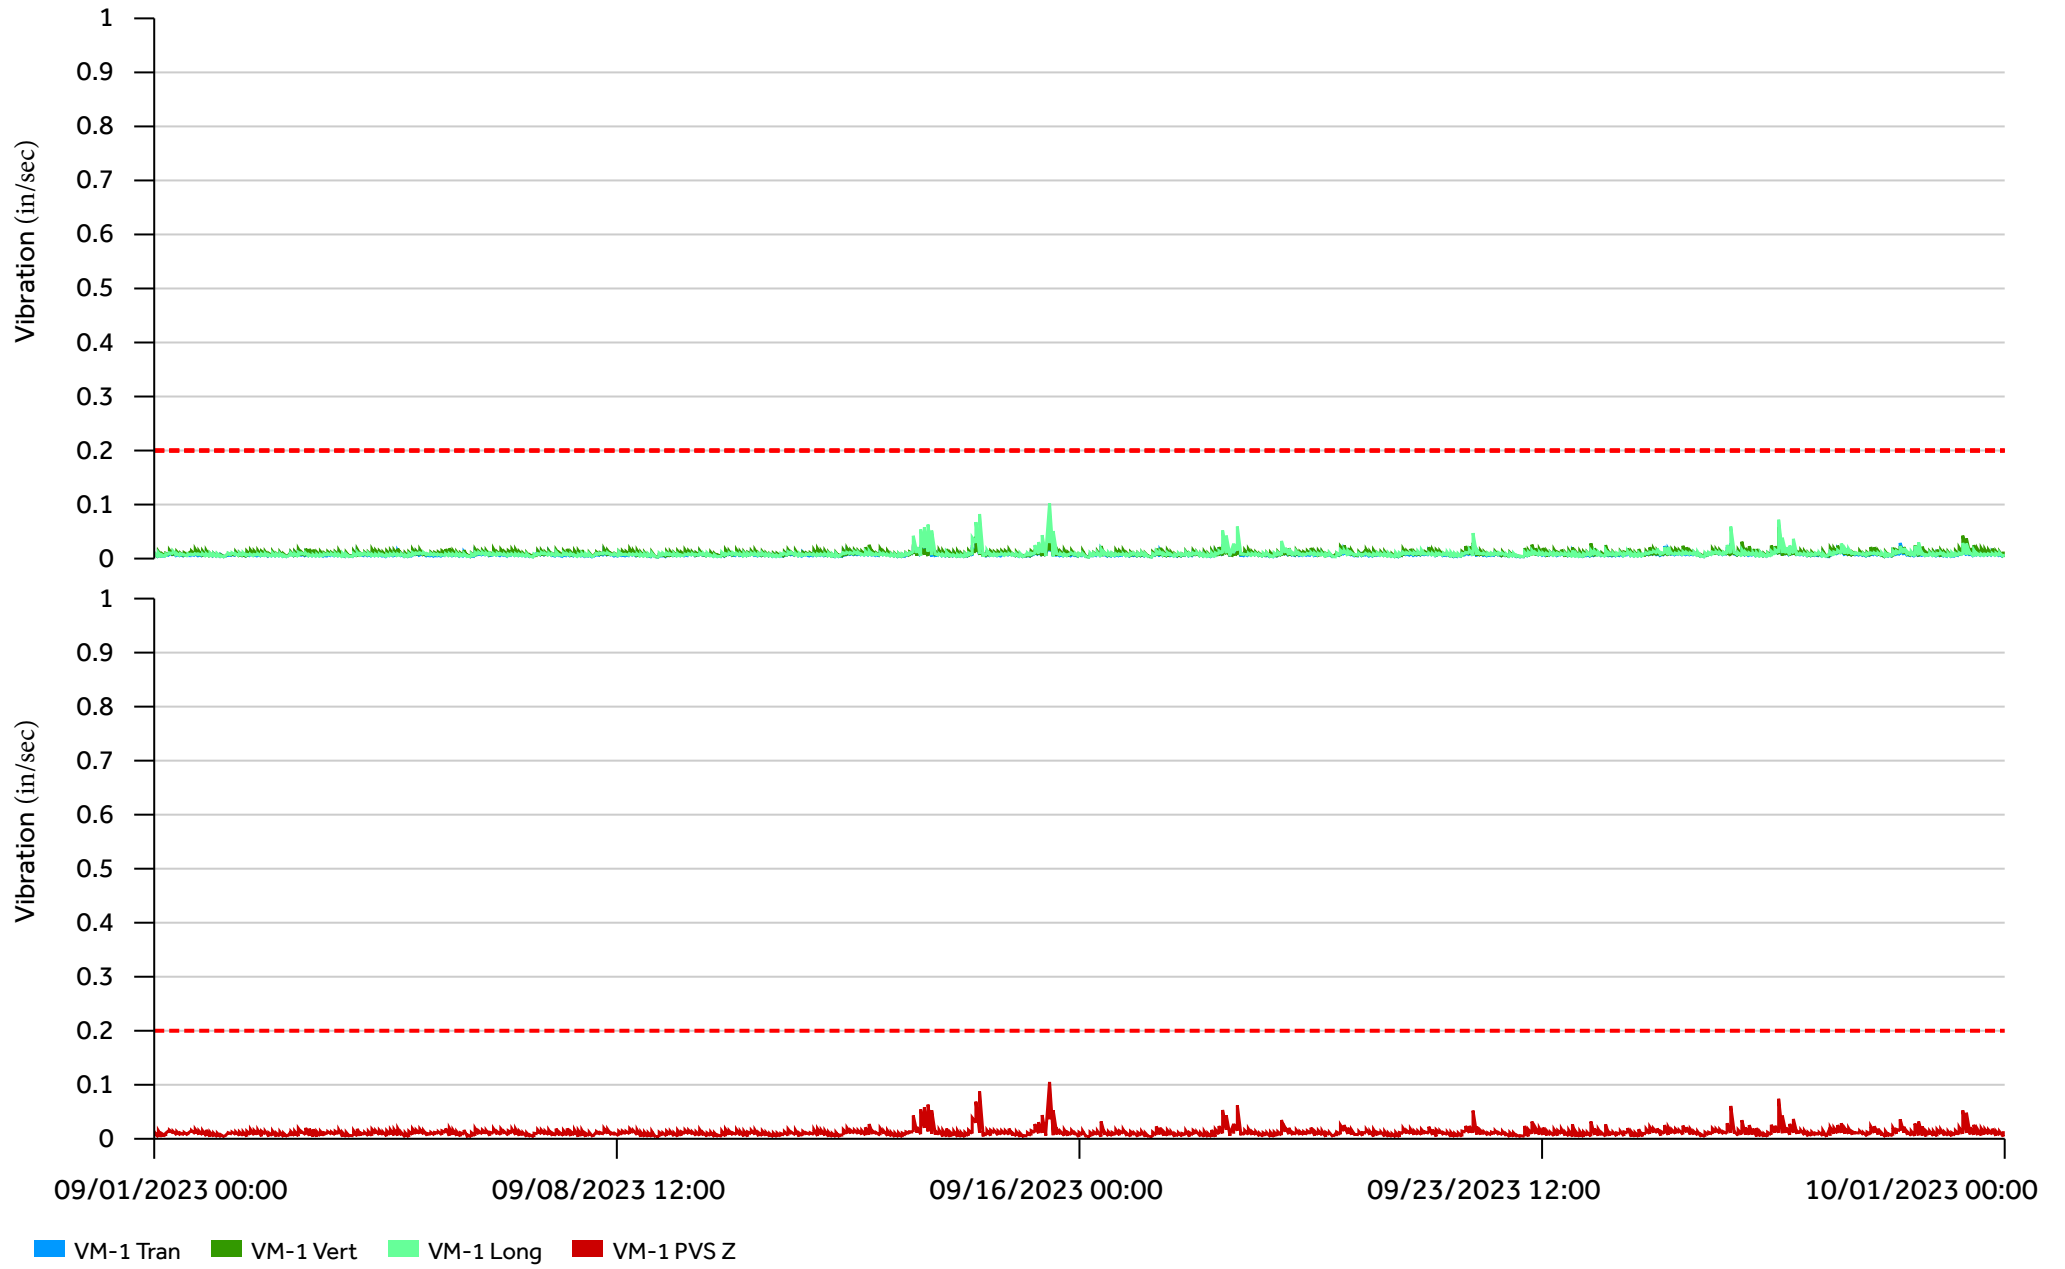
Graph 1:
VM-1- Vibration Monitor

No vibration exceedance was reported during the month.

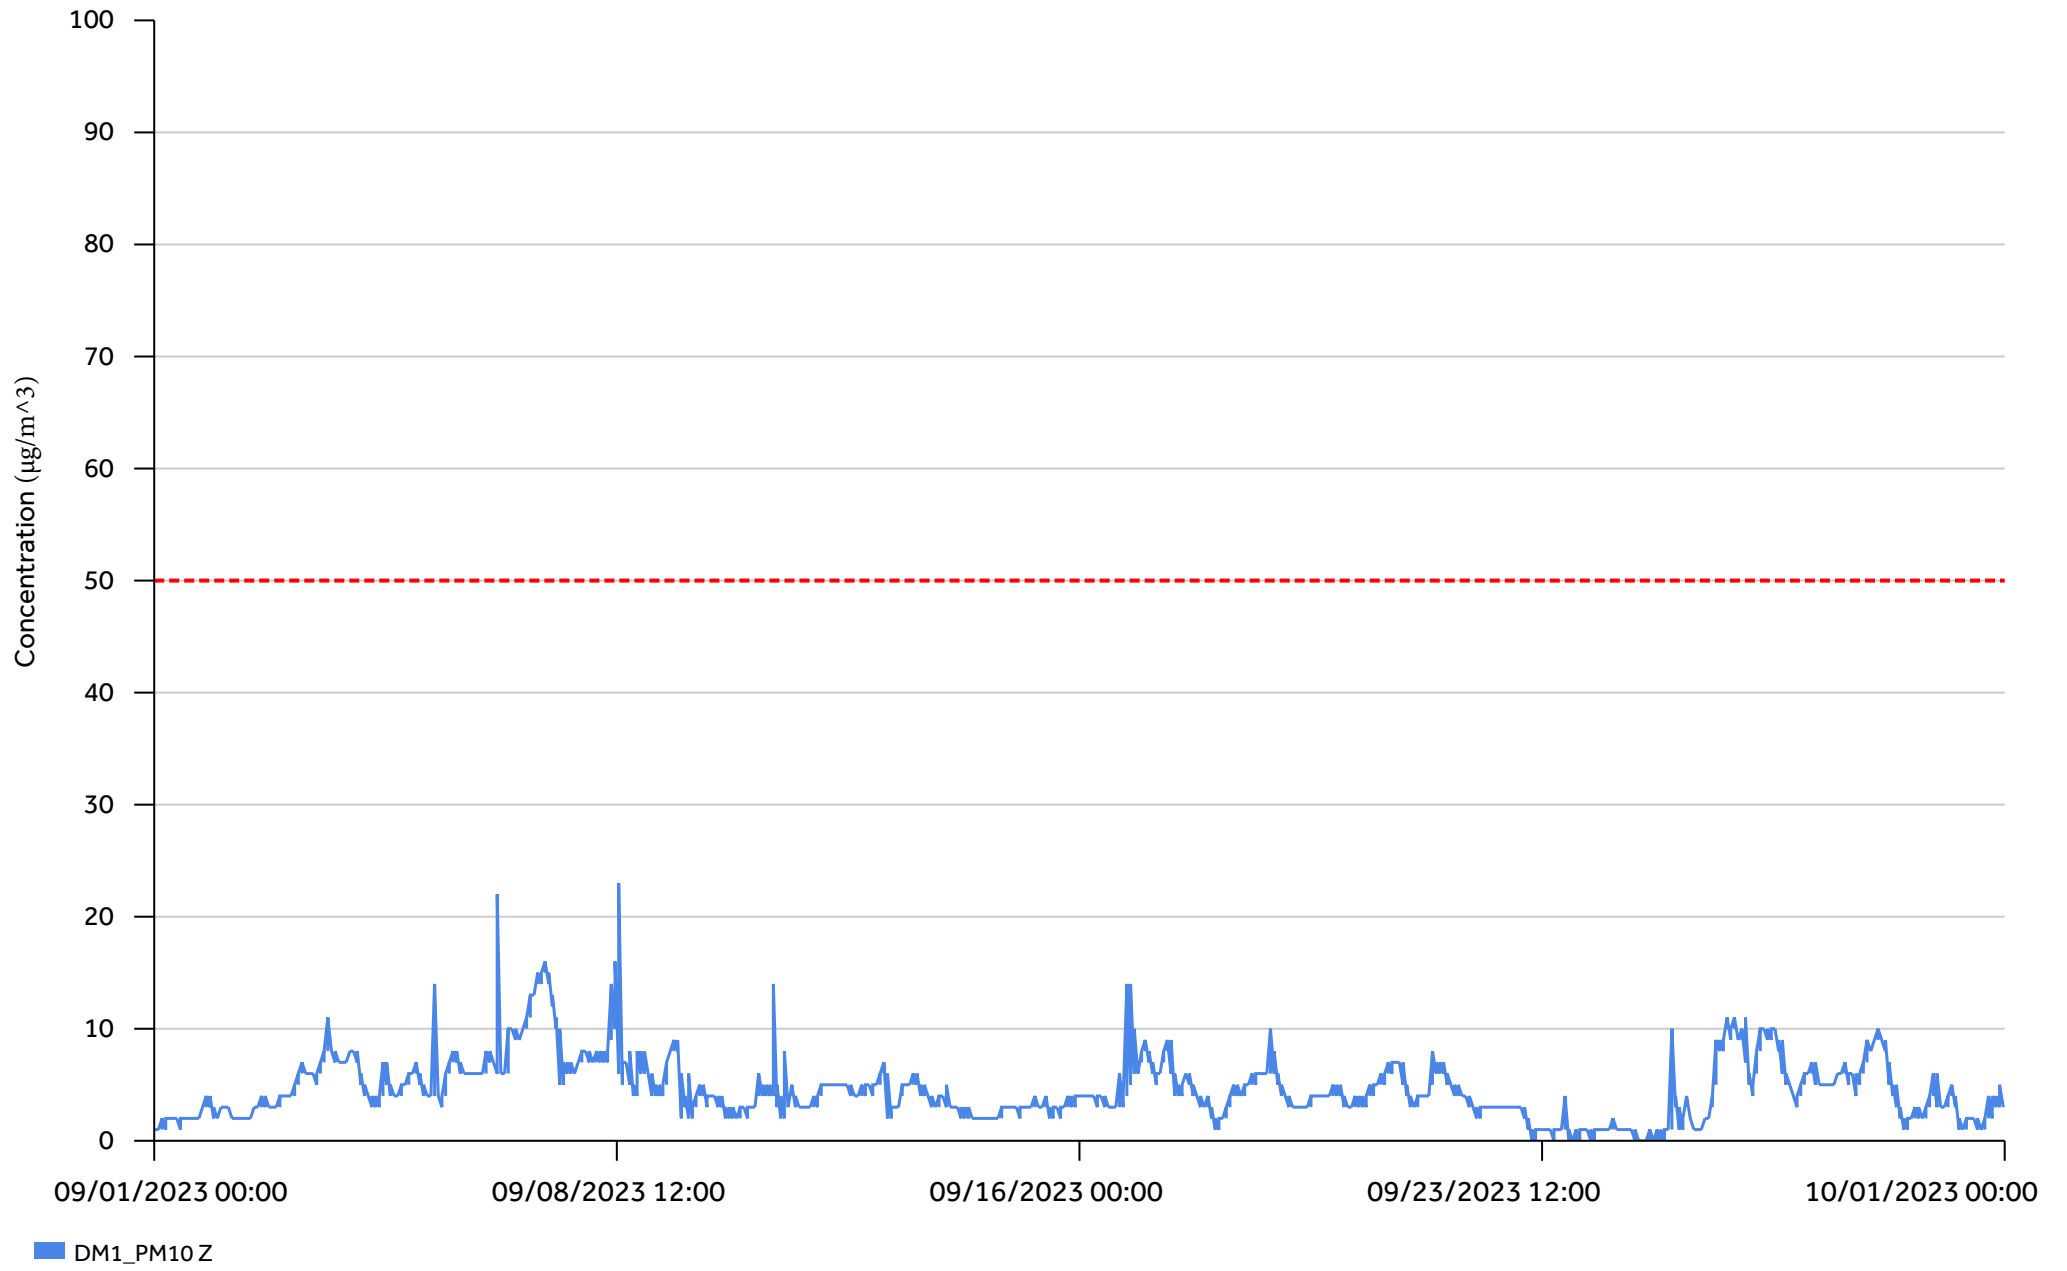
Graph 6:
DM1 - PM10

No dust monitoring exceedance was reported during the month.
