Northern Bus Garage

Noise, Vibration, and Dust Monitoring Report (September 2024)

Noise, Vibration, and Dust levels were monitored as part of the reconstruction of Northern Bus Garage, 4615 14th Street, NW, Washington, DC, for the month of September 2024.

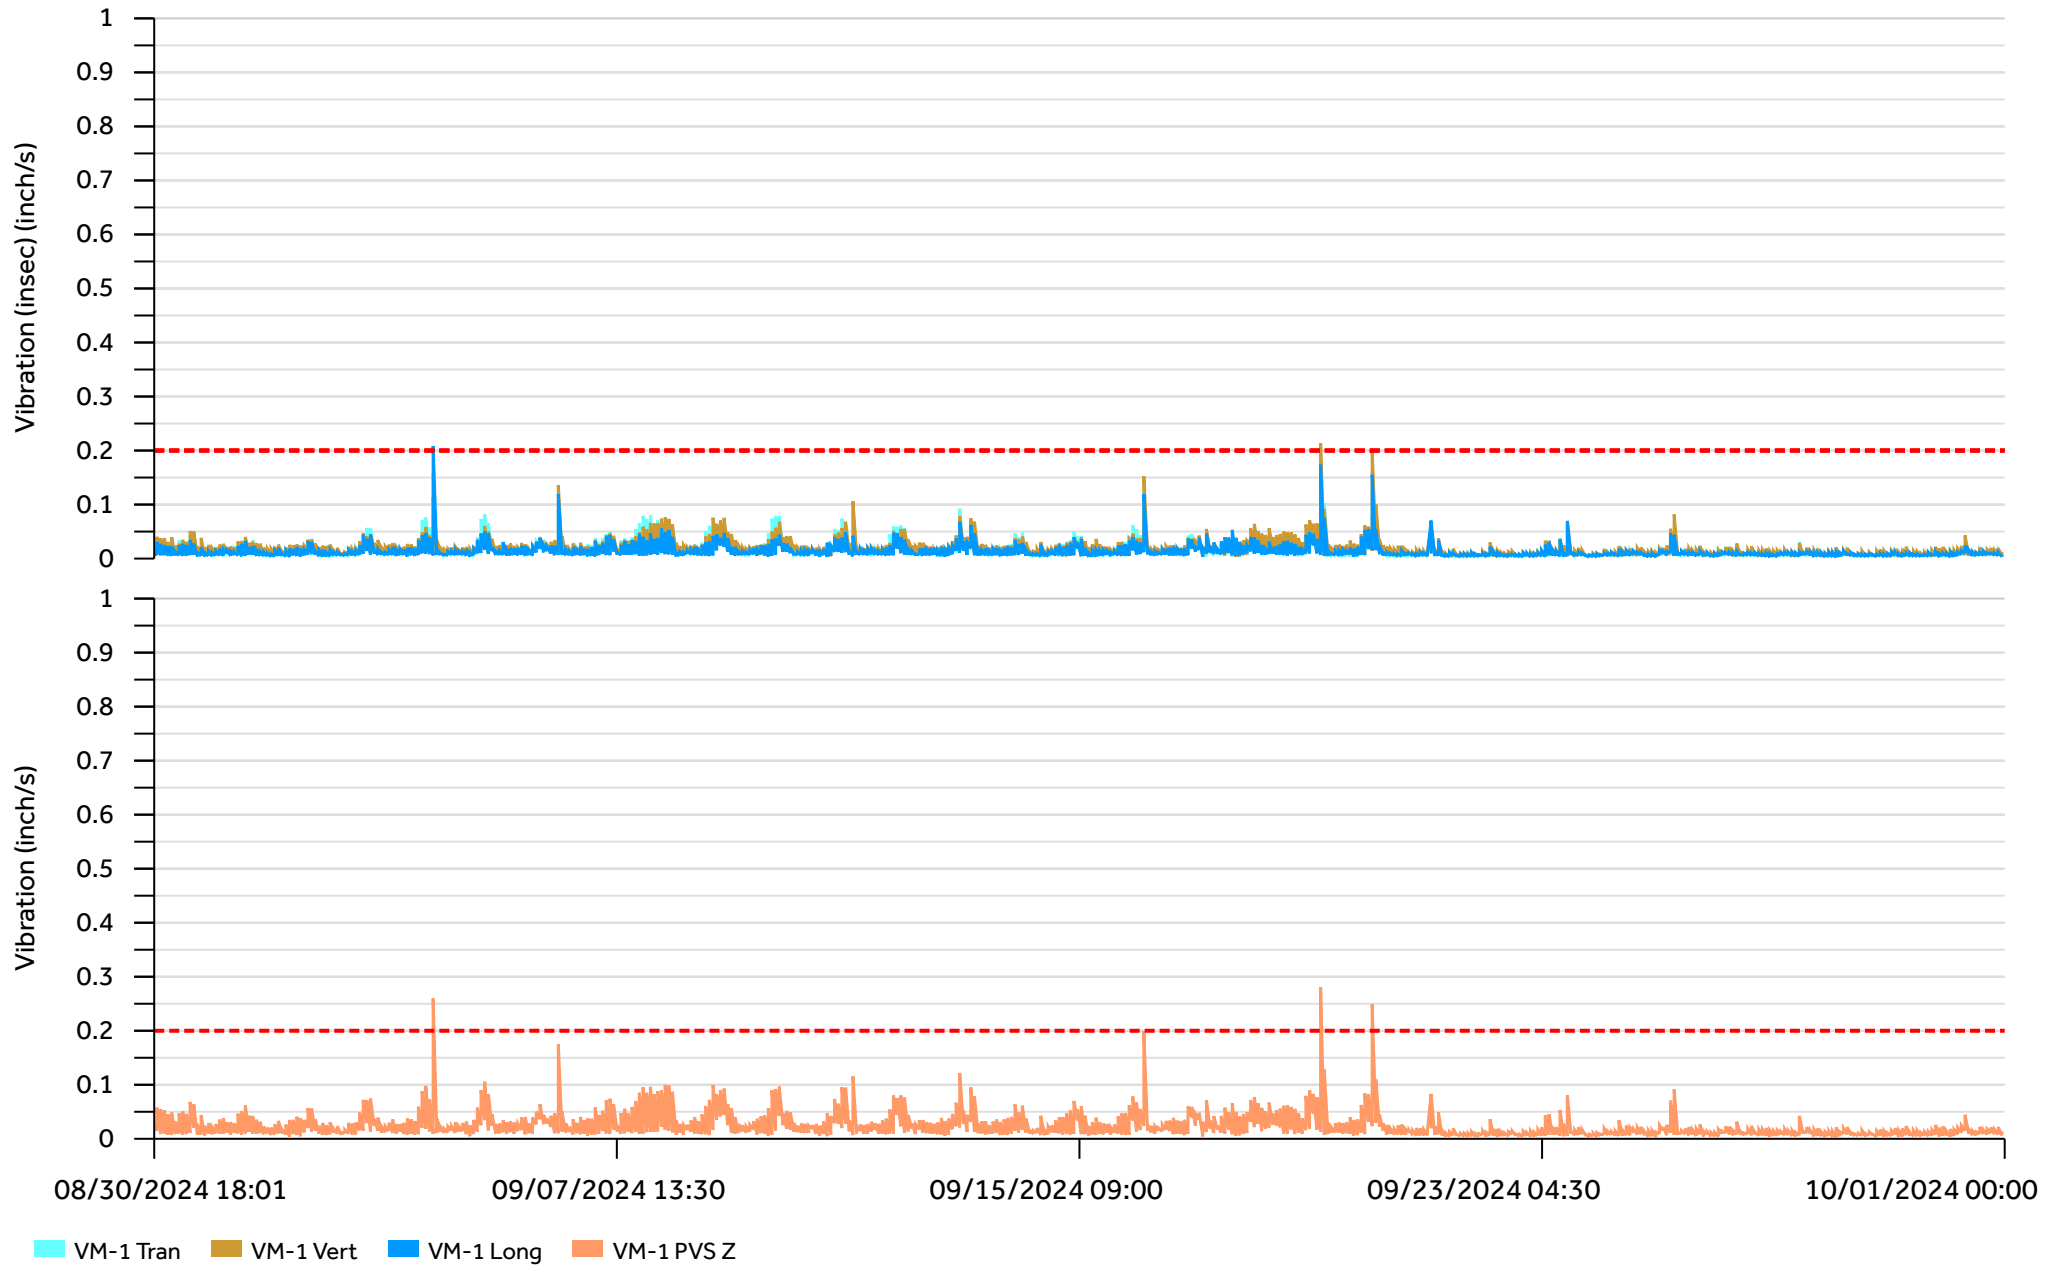
Graph 1
VM-1- Vibration Monitor

There were two (2) vibration exceedances in the month of September.

- VM1 exhibited a vibration exceedance of 0.21 in/sec on September 4 at 11:25, due to waterproofing subcontractor moving materials into the jobsite.
- VM1 exhibited a vibration exceedance of 0.21 in/sec on September 19 at 11:52, caused by rolling/vibrating temporary pavement on 14th Street.

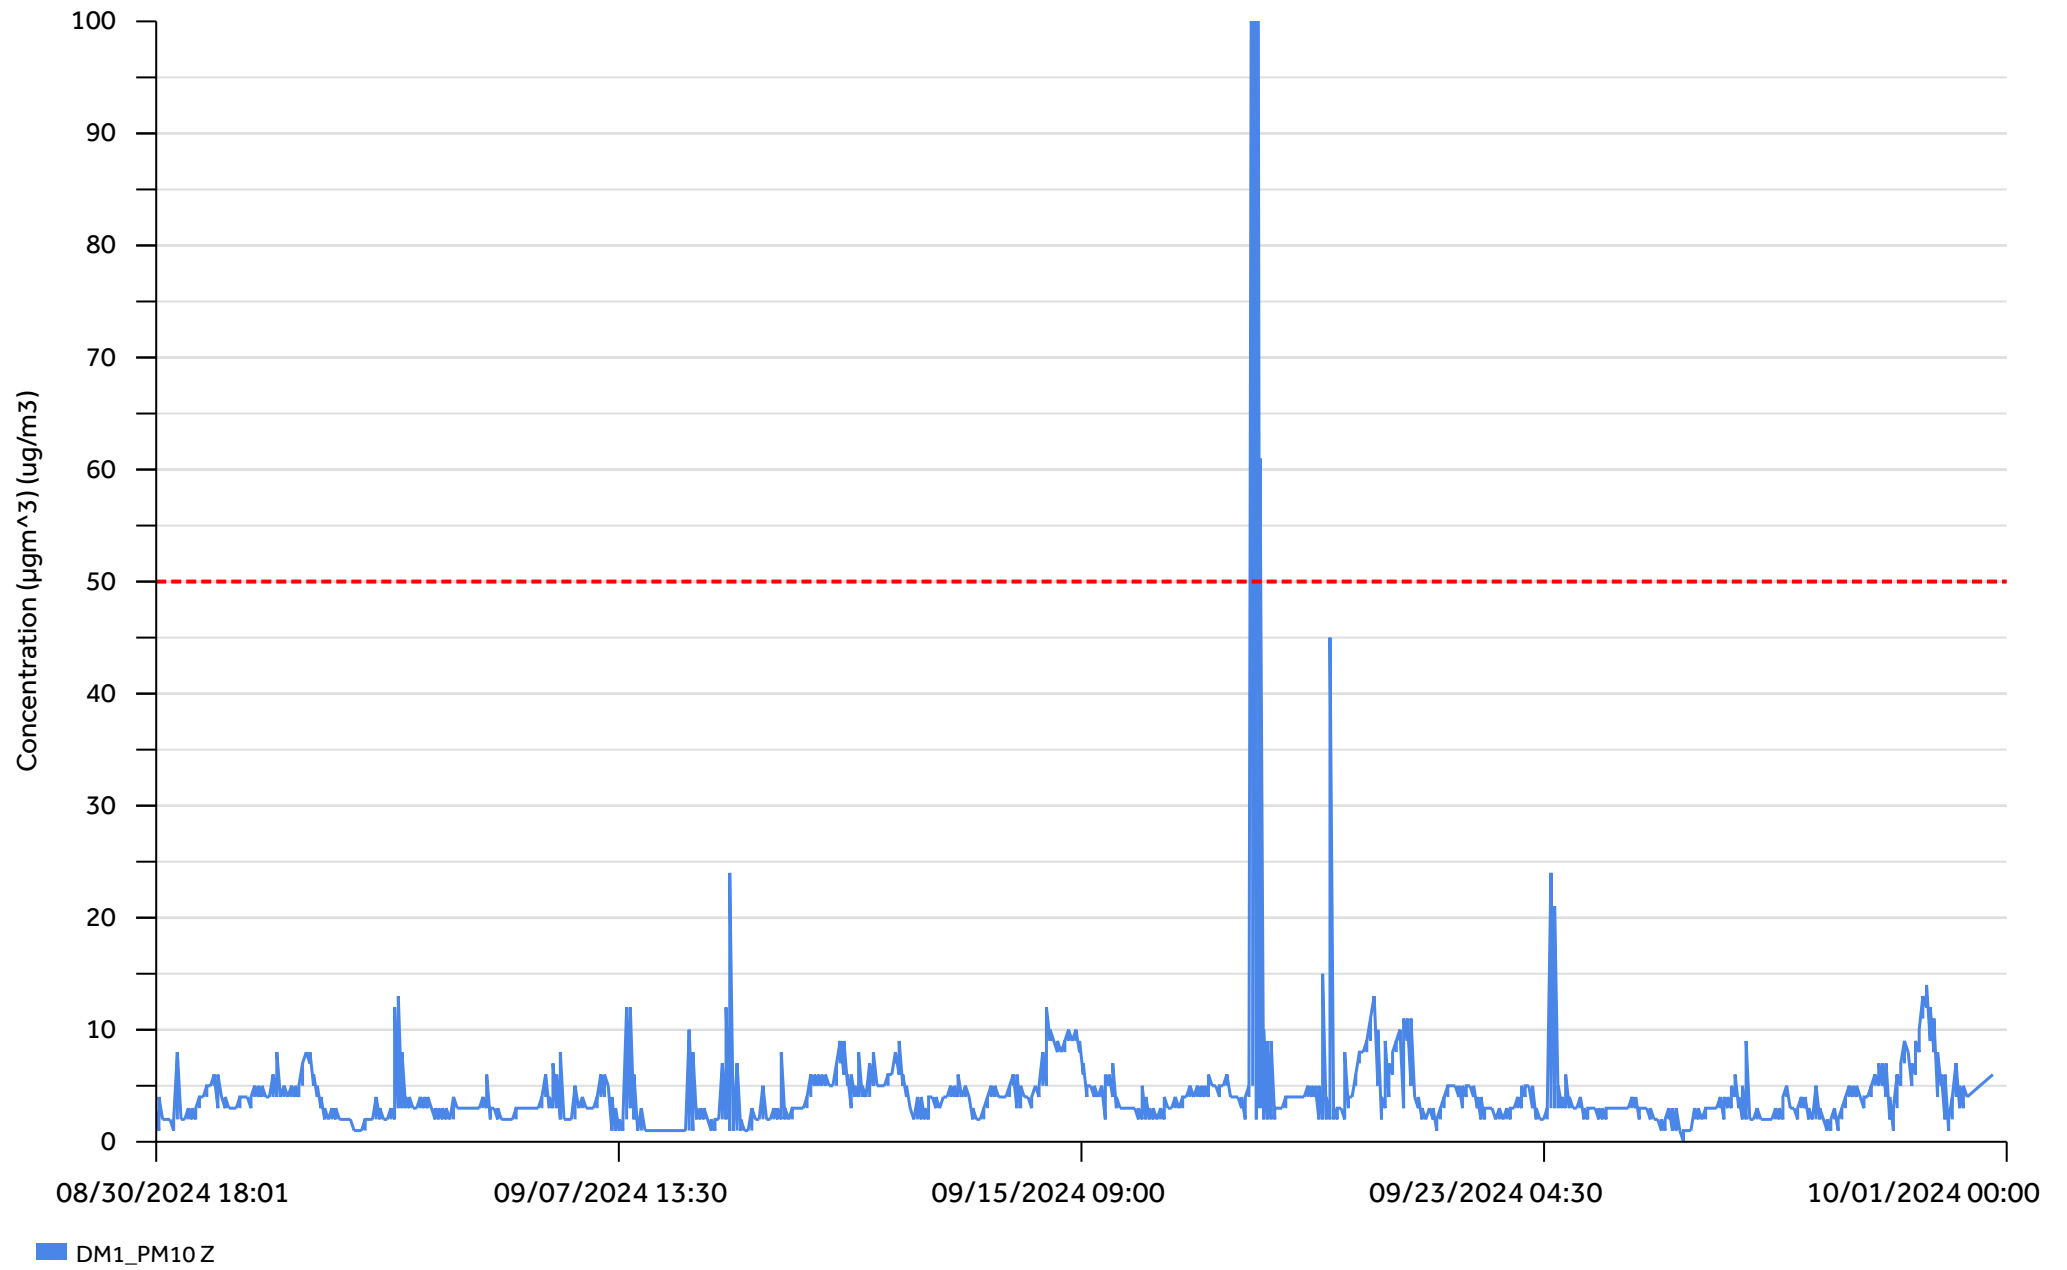
Graph 6

- Subcontractor was using water hose to control dust at that time.
- DM1 – Exceedance of the PM₁₀ limit on 9/18 at 07:16 with a reading of 164 µg/m³.
 - Exceedance due to Demolition subcontractor using hydraulic hammer to chip concrete next to monitoring station.

- DM1 – Exceedance of the PM₁₀ limit on 9/18 at 09:16 with a reading of 217 µg/m³.
 - Exceedance due to Demolition subcontractor using hydraulic hammer to chip concrete next to monitoring station.

- Subcontractor was using water hose to control dust at that time.

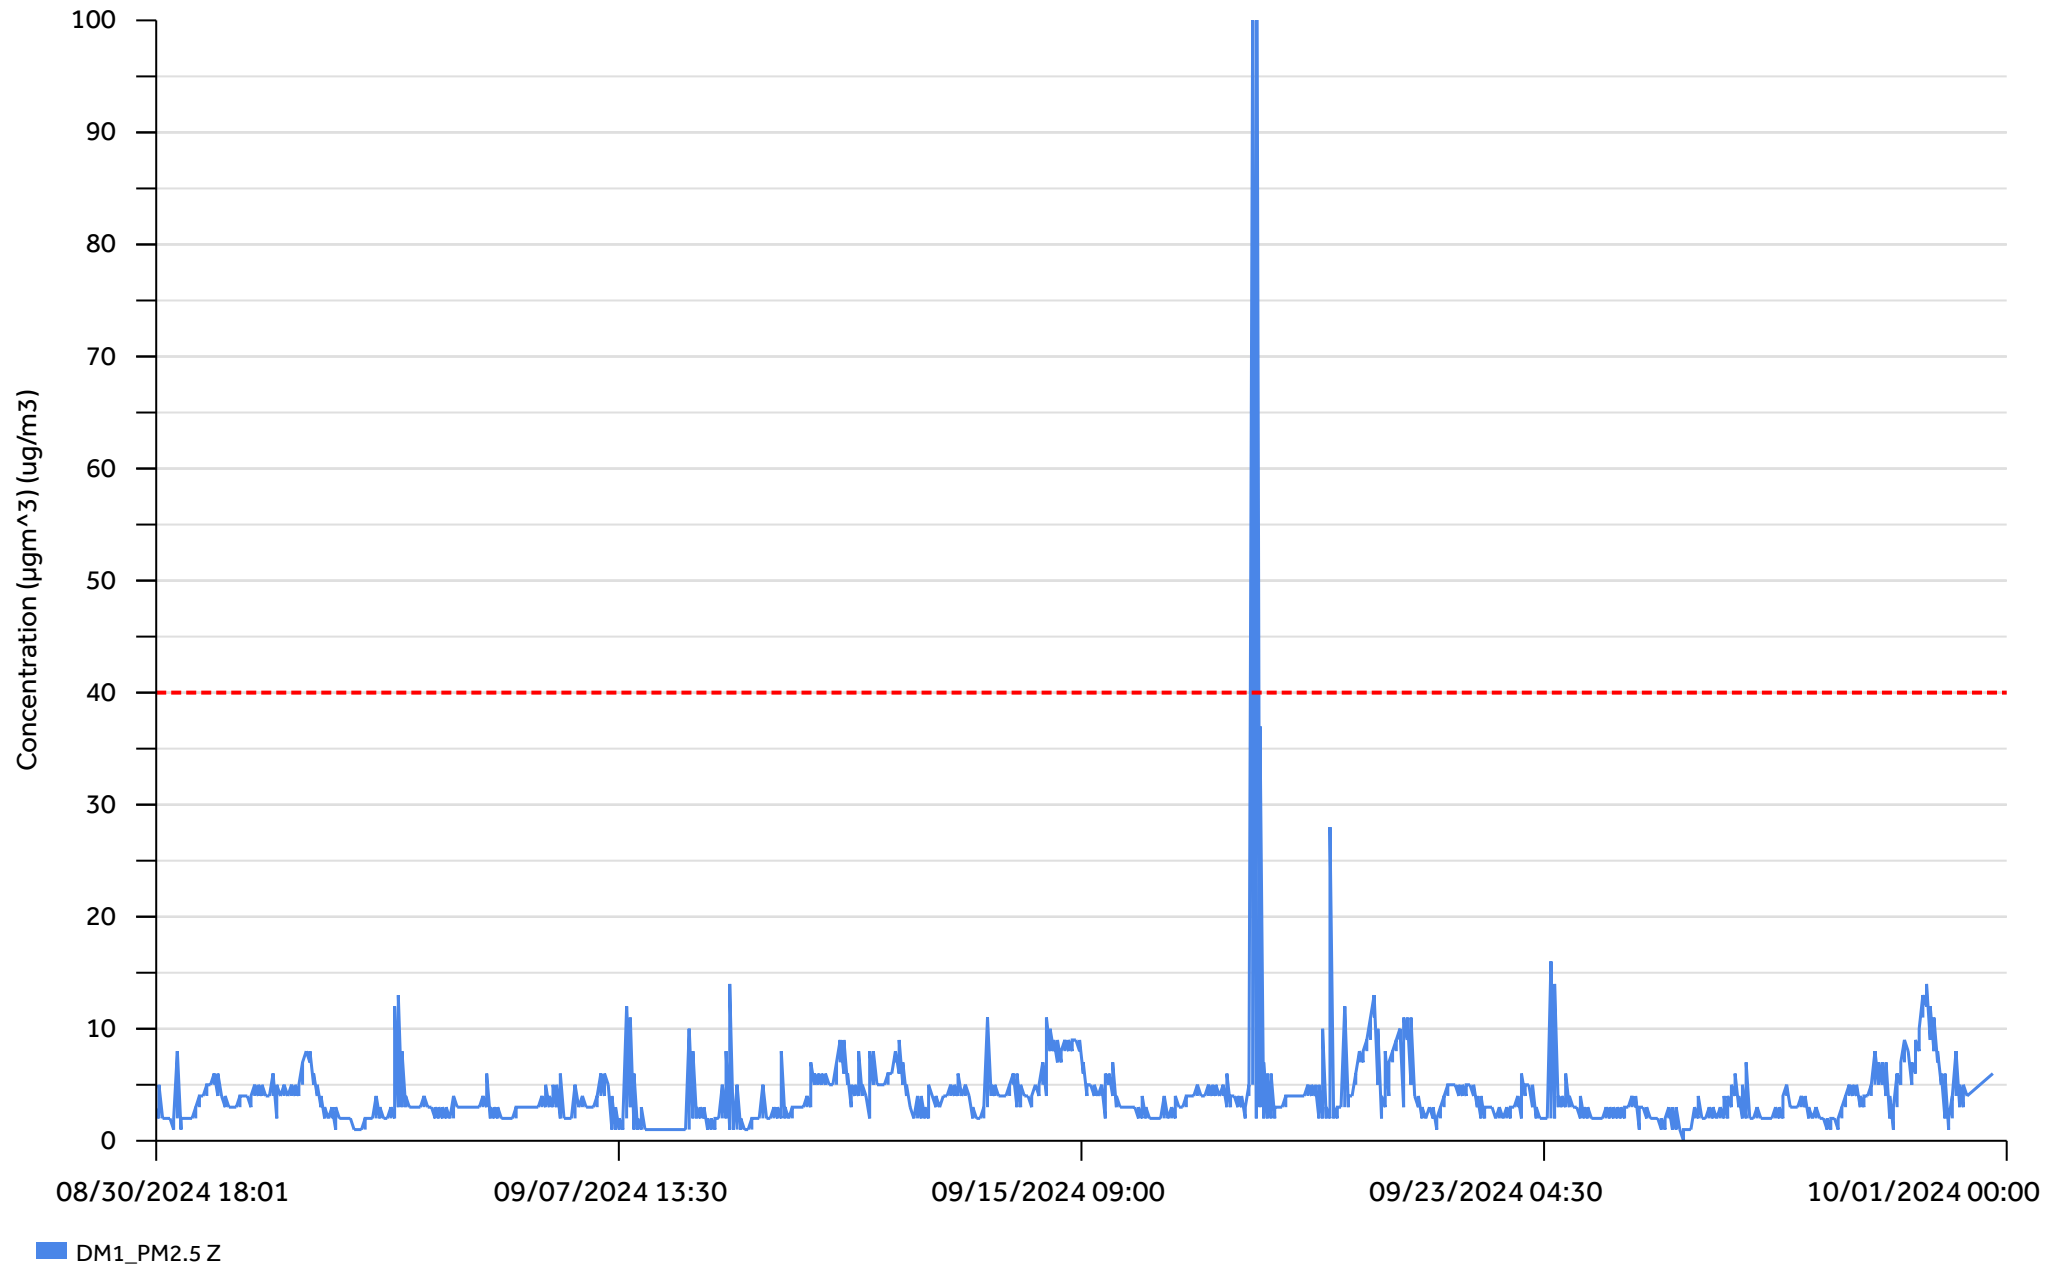
Graph 9
DM1-PM2.5

- DM1 – Exceedance of the PM_{2.5} limit on 9/18 at 07:16 with a reading of 100 µg/m³.
 - Exceedance due to Demolition subcontractor using hydraulic hammer to chip concrete next to monitoring station.

- Subcontractor was using water hose to control dust at that time.
- DM1 – Exceedance of the PM_{2.5} limit on 9/18 at 09:16 with a reading of 128 µg/m³.

- Exceedance due to Demolition subcontractor using hydraulic hammer to chip concrete next to monitoring station.
 - Subcontractor was using water hose to control dust at that time.
