Washington Metropolitan Area Transit Authority Board Action/Information Summary

Briefing on Red Signal Overruns

Update on Red Signal Violations

Investigation and Analysis of WMATA 2014 Red Signal Violation Incidents

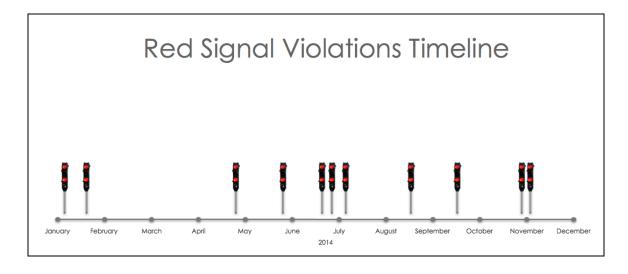
Figure No. 2

WMATA 2014 RED SIGNAL VIOLATION INCIDENTS BY TIME OF YEAR

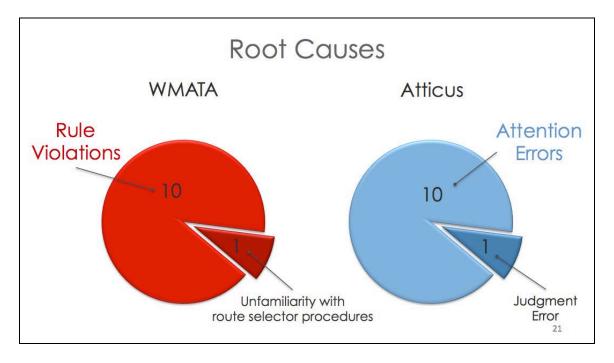
Figure No. 4

COMPARISON OF WMATA' VS. ATTICUS' DETERMINATION OF THE ROOT CAUSES OF WMATA'S 2014 RED SIGNAL VIOLATION INCIDENTS

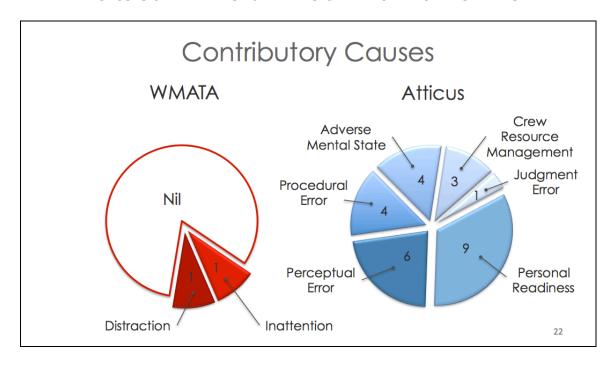
Figure No. 5

COMPARISON OF WMATA' VS. ATTICUS' DETERMINATION OF THE CONTRIBUTORY CAUSES OF WMATA'S 2014 RED SIGNAL VIOLATION INCIDENTS

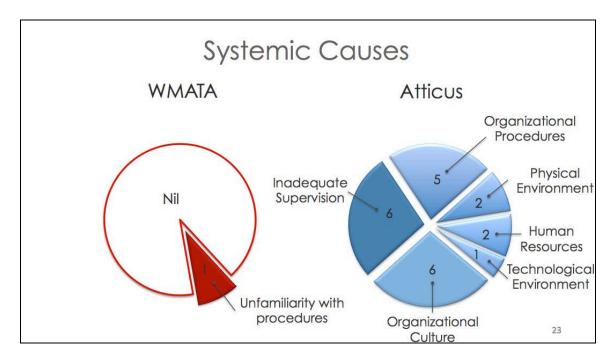
Figure No. 6

COMPARISON OF WMATA' VS. ATTICUS' DETERMINATION OF THE SYSTEMIC CAUSES OF WMATA 2014 RED SIGNAL VIOLATION INCIDENTS
