Washington Metropolitan Area Transit Authority
Board Action/Information Summary

Metrorail Incident Near Farragut North

MetroRail Incident near Farragut North Metro Station

Safety Committee
September 22, 2016

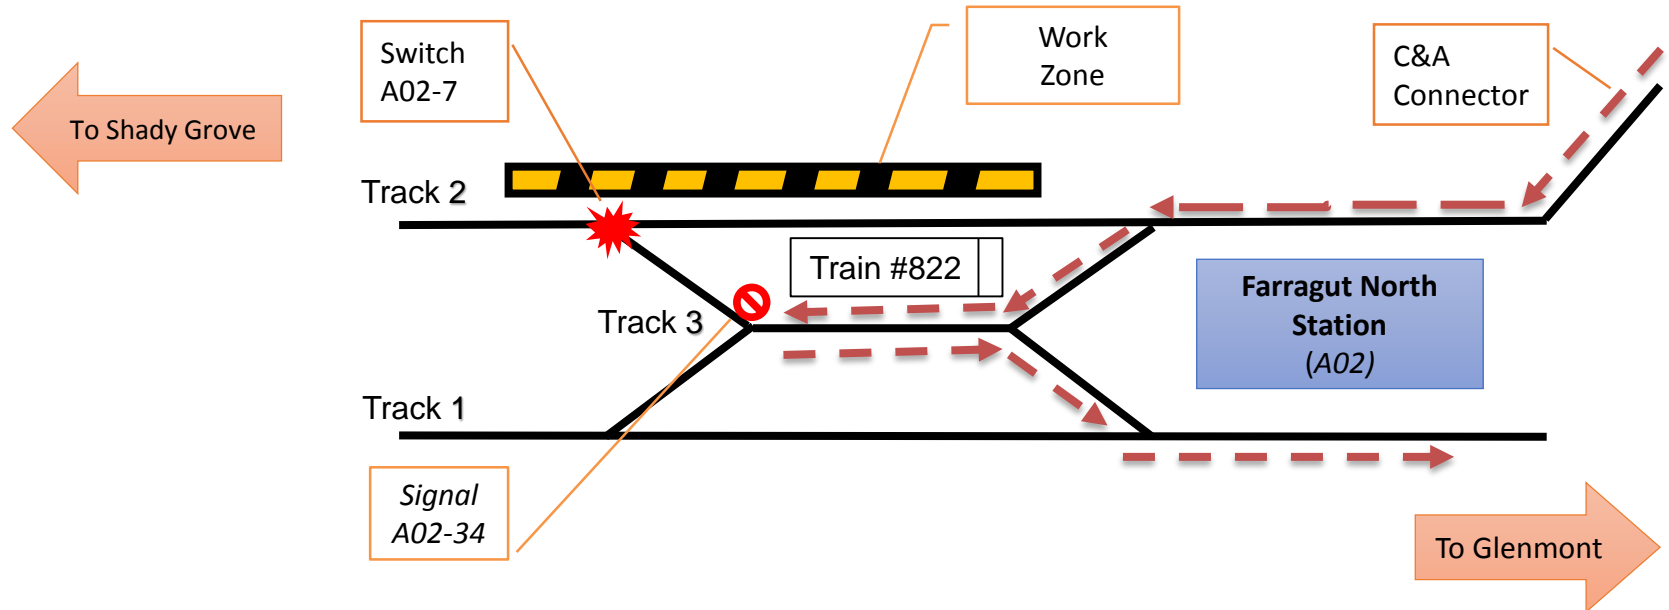
Non-Revenue Train Diagram

- Switch #7 blocked and clamped in reverse position
- ROCC failed to remotely place an auxiliary switch call on Switch #7
- Route into the pocket track is established for non-revenue train #822
- Switch #7 went out of correspondence due to non-revenue train entering pocket track

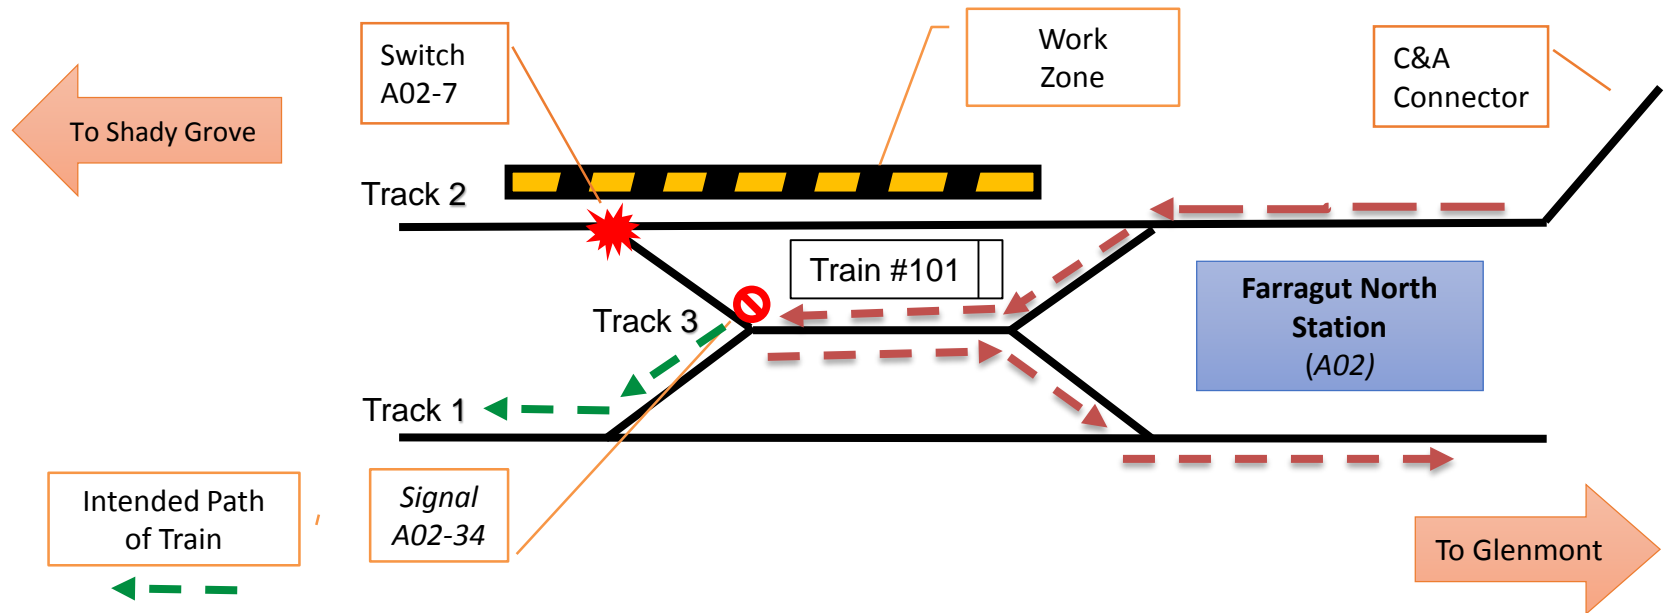
Incident Train Diagram

- Train #101 proceed to Track #3 while Switch #7 was out of correspondence
- ROCC made several attempts to contact Train #101 to no avail
- Field Personnel were instructed to make contact with Train #101 to communicate ROCC instructions
- Radio Communication was affected due to car mounted radio had a defect
