ASSET (BUS SHELTER) IMPROVEMENT EVALUATION STUDY

Final Report

June 2013

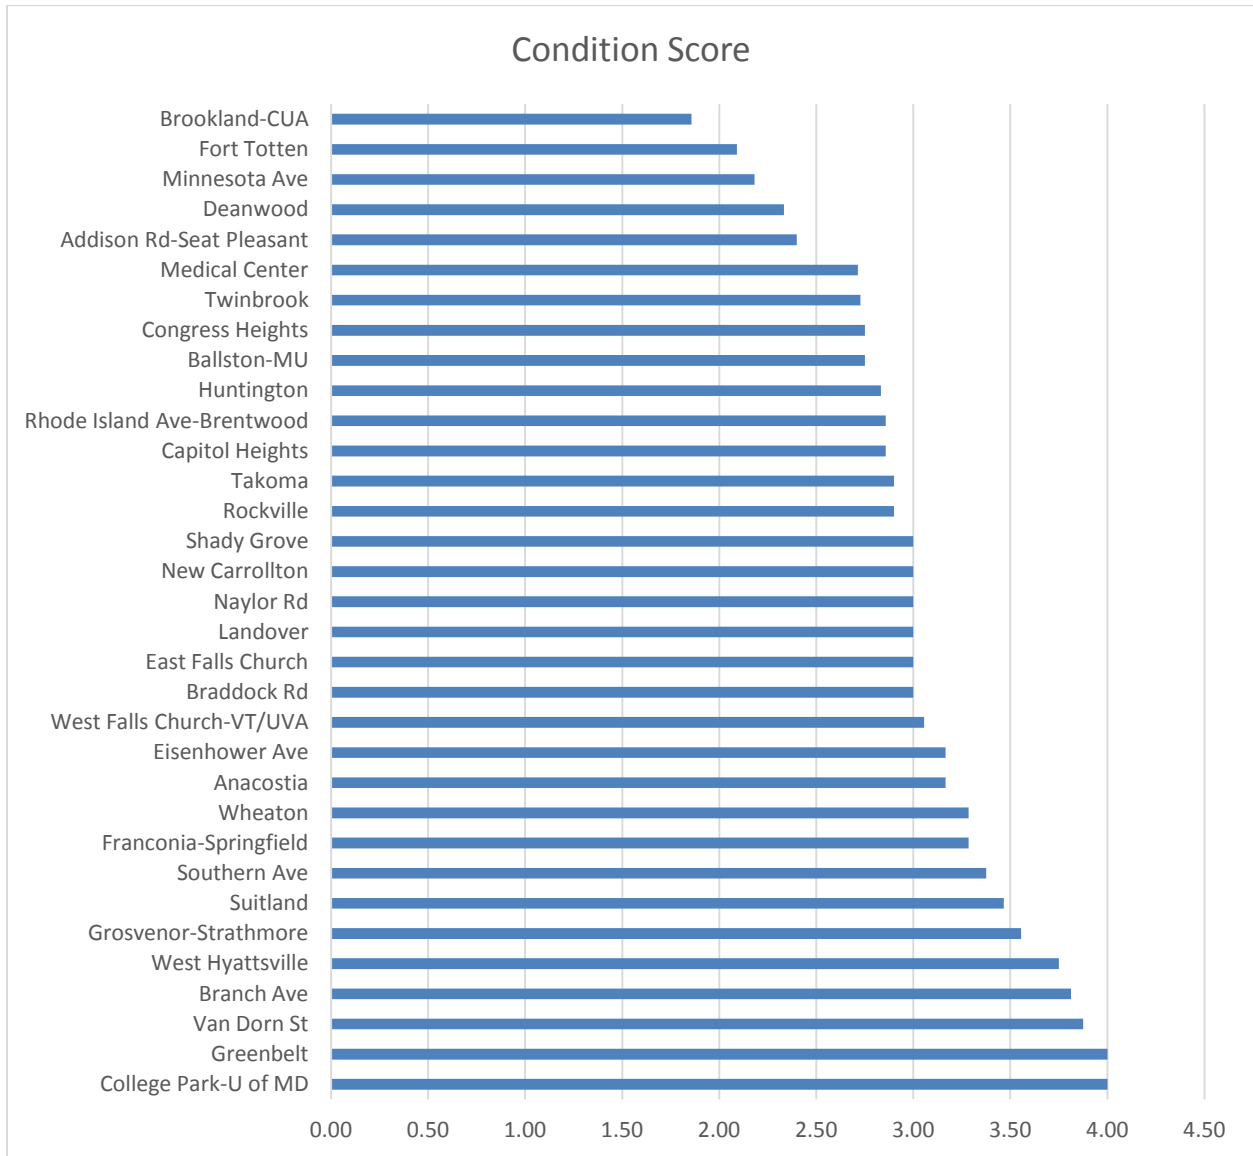
Figure 1 - Overall Station Condition Scores

Once each shelter at a station was evaluated and given a score based on the conditions described in **Table 2**, the shelter scores were averaged by station to give each station a final score from 1 to 5. Station scores ranged from 1.86 at Brookland-CUA to 4.0 at Greenbelt and College Park. **Table 3** lists the overall score for each station. **Figure 1** displays these results graphically.

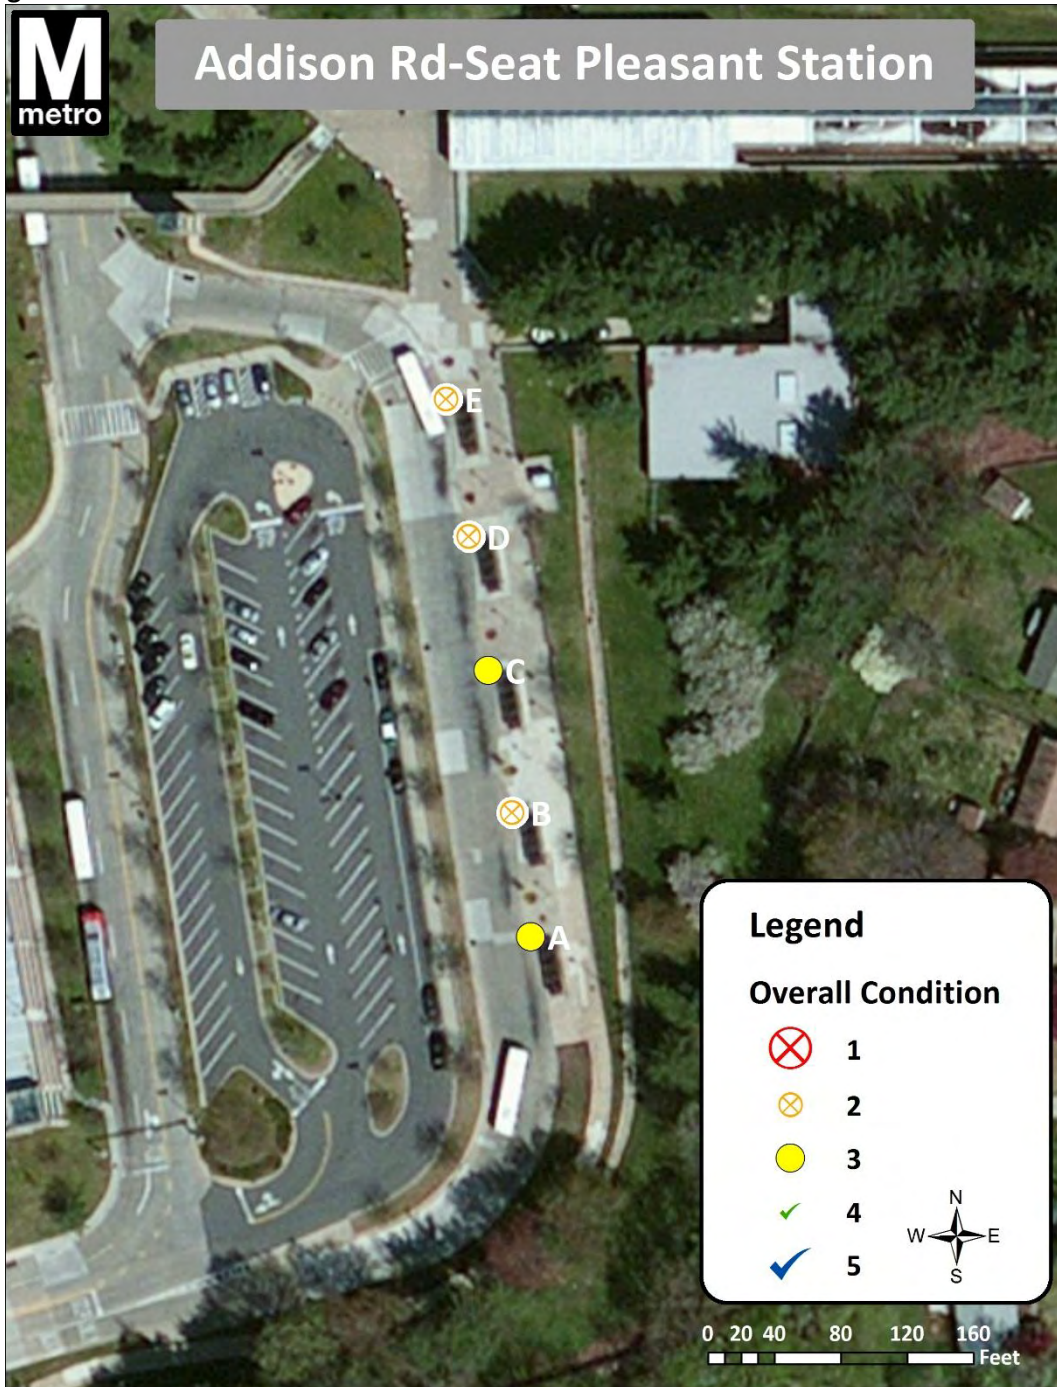
Figure 6: Overall Condition Score of Addison Road-Seat Pleasant Metrorail Station Shelters

Overall, shelter conditions at the station are poor, with a station condition score of 2.4. Table 1 summarizes conditions for each individual shelter. The shelters, as a whole, scored the lowest in frame

and panel condition, with most shelters showing rust and warped or broken panels. Shelters B and D are in the worst condition, with poor pads and significant rust on their frames. Shelter A is the only shelter without significant rust on its frame. Shelter E has damaged panels, including one popping out of the frame. Dome tops at the station are slightly below average, with fading and cracking present. **Figures 2 through 5** illustrate the different shelter conditions at the station, while **Figure 6** summarizes each shelter’s overall condition score.

Overall, the station was ranked 7th for replacement based on shelter condition and demand. Based on shelter condition only, the station ranked 6th for replacement. A federal grant to reconstruct the bus bays and shelters at the station is in place and therefore, this station should be WMATA's top priority for replacement.

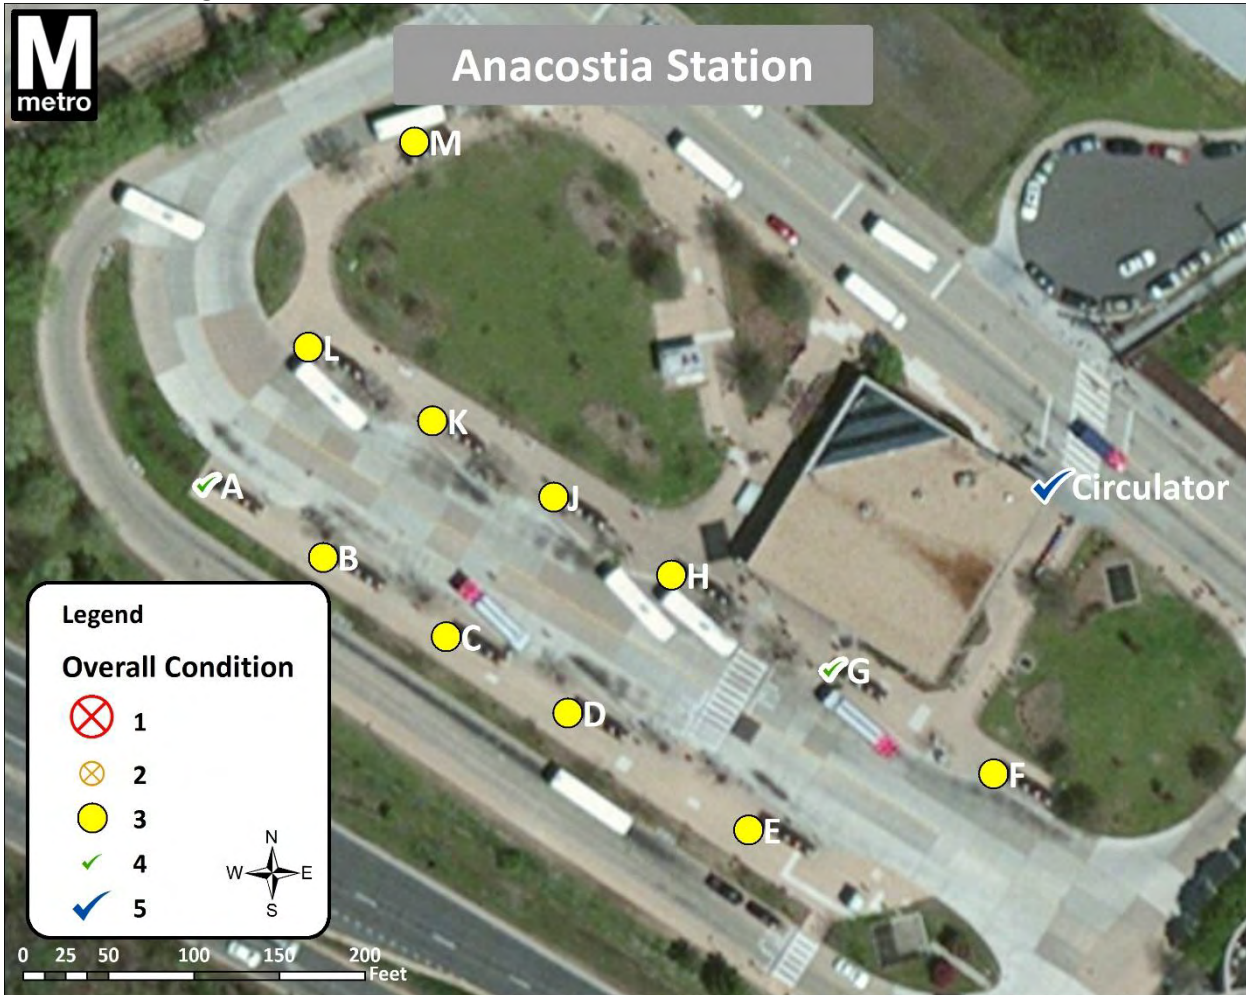
Figure 12: Overall Condition Score of Anacostia Metrorail Station Shelters

Overall, shelter conditions at the station are above average, with a station condition score of 3.2. **Table 2** summarizes conditions for each individual shelter. The shelters as a whole scored the lowest in panels and dome tops. Shelters B, C, D, E, F, H, J, L and M all had damaged panels with smearing, glossing, and

cracking. Shelters C and L also had some cracking damage to their dome tops. Benches and pads at the station were in above average shape, and frames had minimal rust with the exception of shelters B, C, K, and L.

Overall, the station was ranked 12th for replacement based on shelter condition and demand. Based on shelter condition only, the station ranked 22nd for replacement.

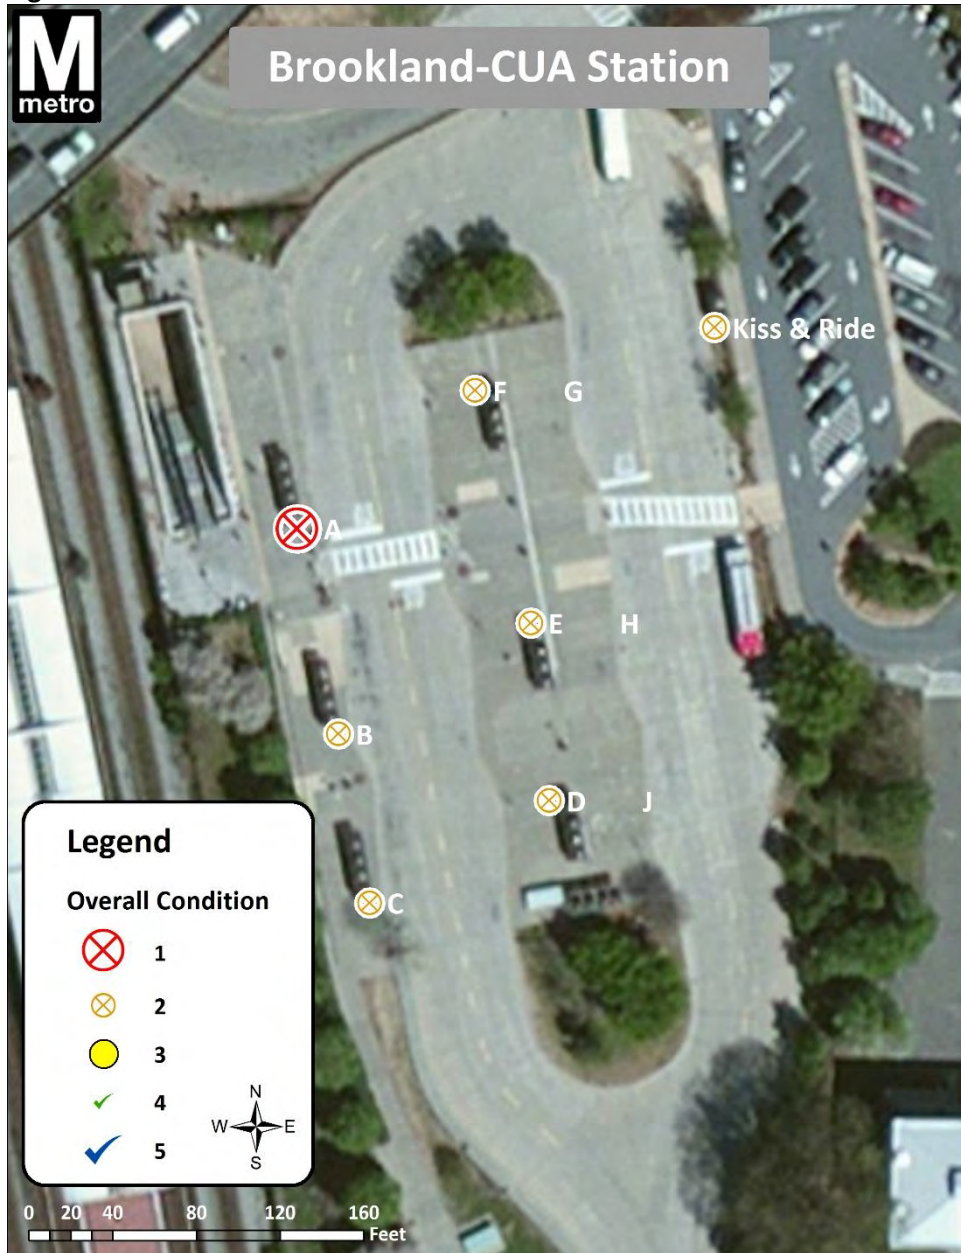
Figure 30: Overall Condition Score of Brookland-CUA Metrorail Station Shelters

Overall, shelter conditions at the Brookland station are poor, with an overall station condition score of 1.9. **Table 5** summarizes conditions for each individual shelter. The shelters, as a whole, scored the lowest in frame and bench condition, though panel and dome top condition were also below average. Shelter A is in particularly bad condition, with an overall condition score of 1. Shelter A had significant rust on its frame, missing panels, a missing dome top and worn/split benches. Shelters B, C, and D/J also had significant rust on their frames, while shelters E/H and F/G also had missing dome tops. Shelter D/J also had a hole in its frame.

Overall, the station was ranked second for replacement based on shelter condition and demand. Based on shelter condition only, the station ranked first for replacement.

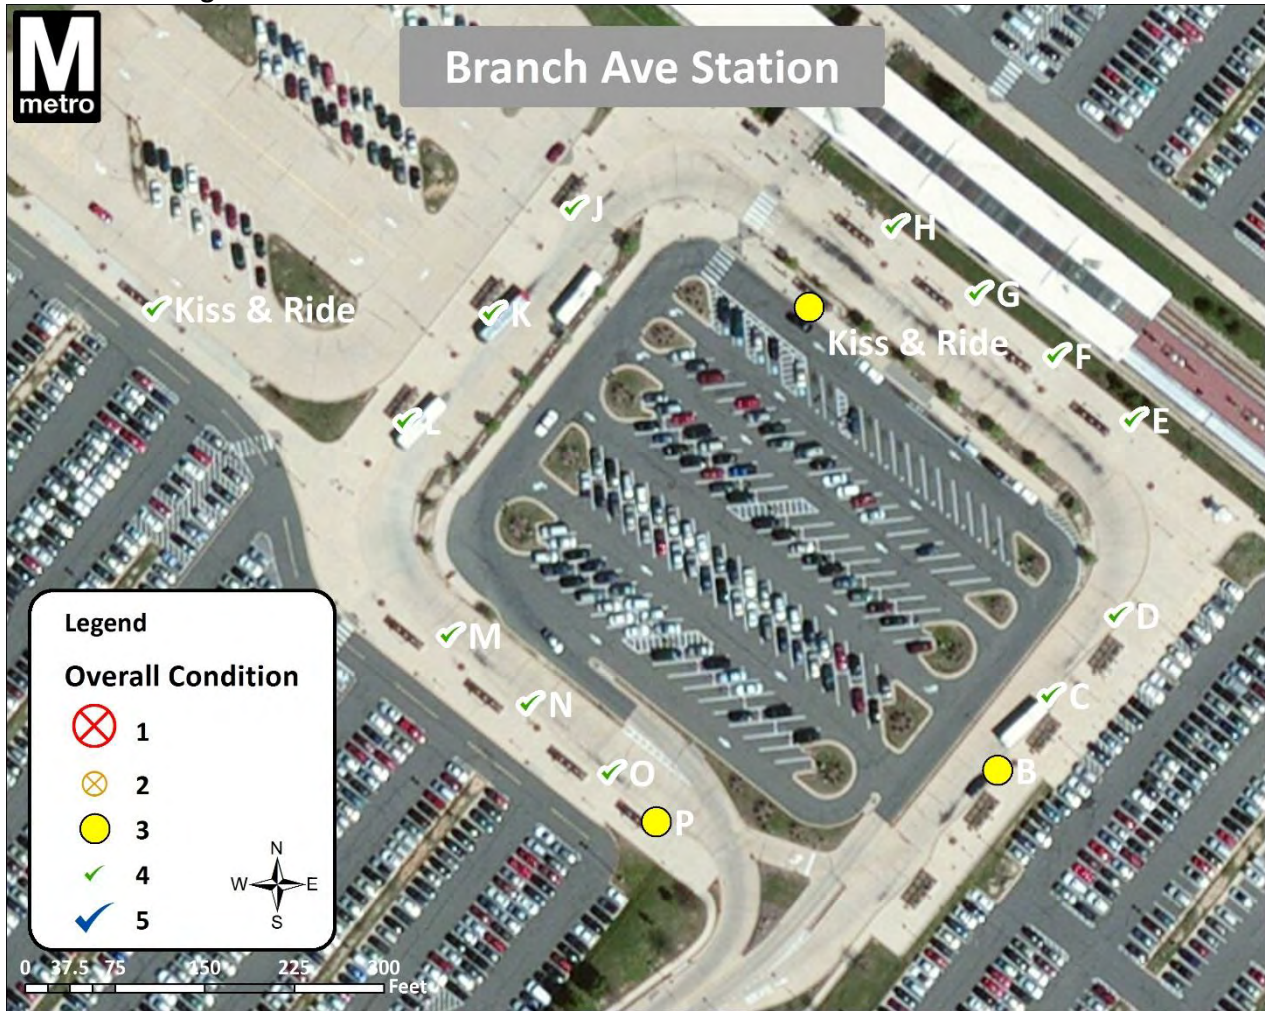
Figure 36: Overall Condition Score of Branch Ave Metrorail Station Shelters

Overall, shelter conditions at the station are above average, with a station condition score of 3.8. **Table 6** summarizes conditions for each individual shelter. The shelters had notably good frame conditions and good dome top conditions, particularly shelters B, E, K, O, and P. There was very little visible rust on any of the shelters, though chipped or peeled frame paint was noticed on shelters E, F, and L. Shelters B and P each had a panel missing, though other panels on shelter B were in good condition. The east Kiss-and-Ride shelter had two panels missing and a worn/weathered bench. Of any element at the station, the shelter benches were in the worst condition overall.

Overall, the station was ranked 32st for replacement based on shelter condition and demand. Based on shelter condition only, the station ranked 30th for replacement.

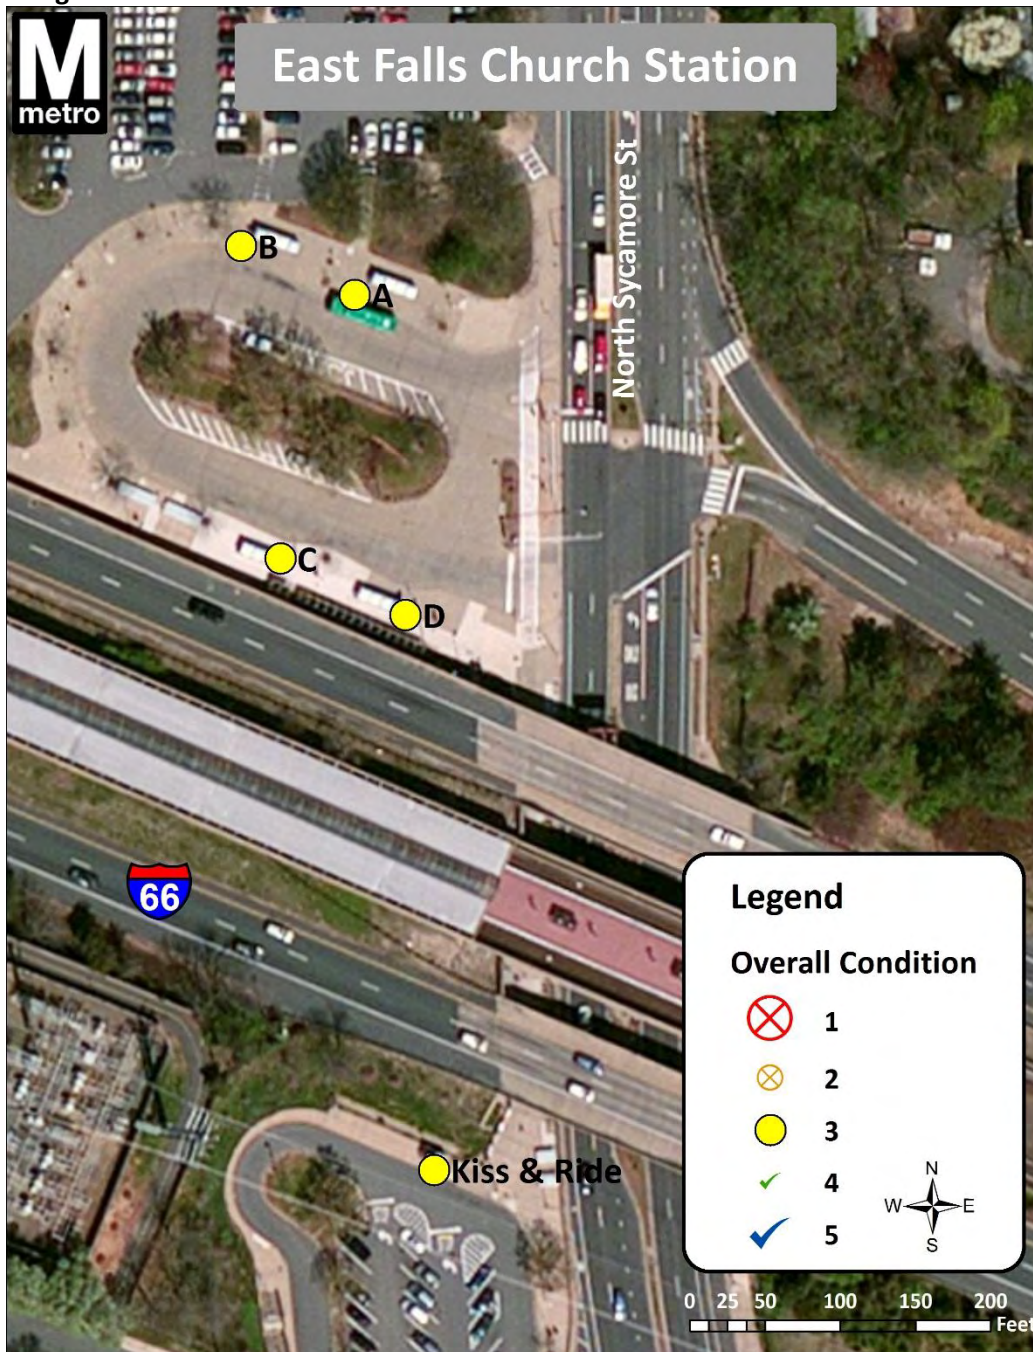
Figure 64: Overall Condition Score of East Falls Church Metrorail Station Shelters

Overall, shelter conditions at the station are average, with a station condition score of 3.0. **Table 11** summarizes conditions for each individual shelter. The shelters as a whole scored the lowest in bench condition. Shelters A and B and the Kiss-and-Ride shelter all had worn benches. Shelter panels at the station were generally in average condition, with some rust stains, fading, and scratching on all of them.

Overall, the station was ranked 22nd for replacement based on shelter condition and demand. Based on shelter condition only, the station ranked 16th for replacement.

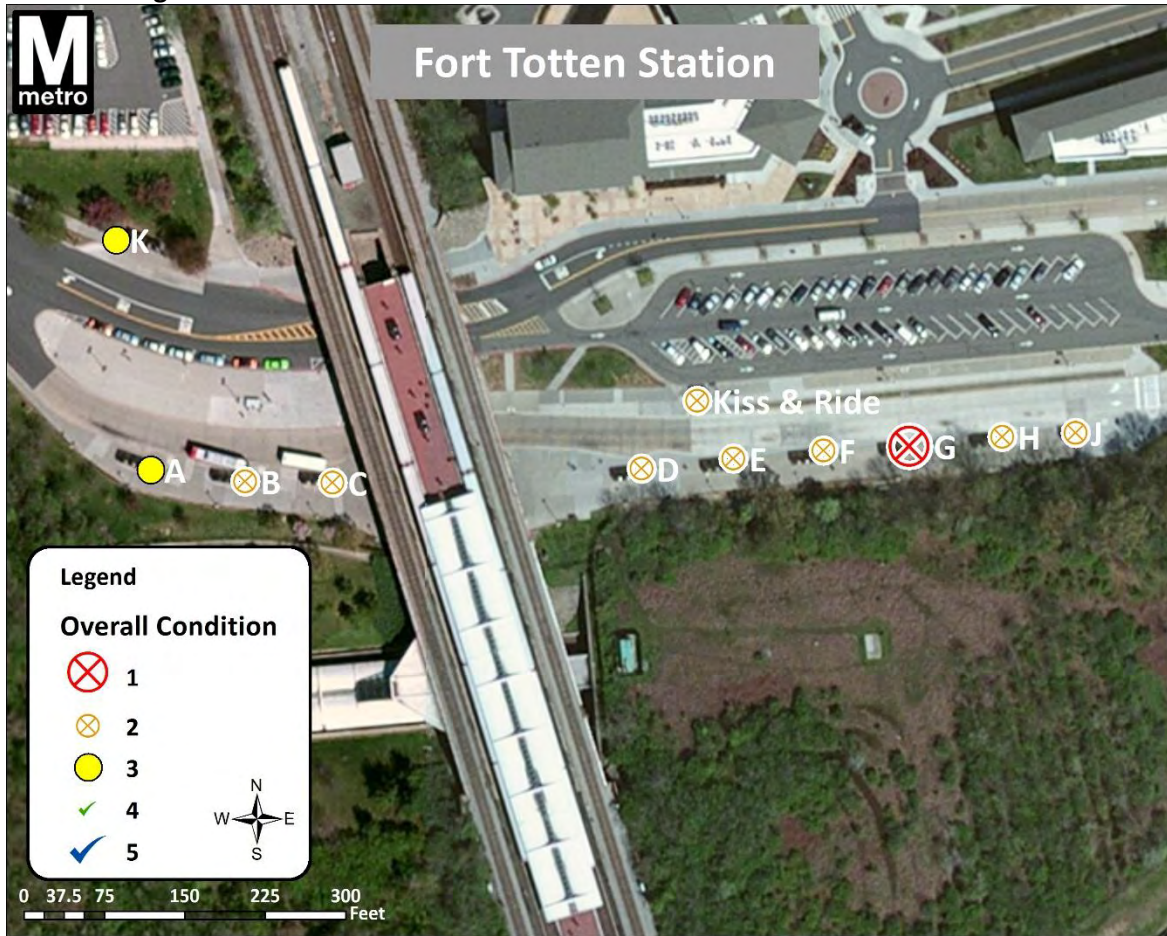
Figure 77: Overall Condition Score of Fort Totten Metrorail Station Shelters

Overall, shelter conditions at the station are poor, with a station condition score of 2.1. **Table 13** summarizes conditions for each individual shelter. The shelters as a whole scored the lowest in panel condition and frame condition, though the overall condition of every shelter element was below average. Shelter G is in particularly bad condition, with an overall score of 1. It has a missing dome top, missing panels and significant rust on its frame. Shelter D and the Kiss-and-Ride shelter are also missing panels, while shelter H has two severely cracked panels. Shelter C is also missing a dome top. Significant frame rust is present on shelters B, C, E, F, and G, while poor pad conditions exist at shelters A, E, G, and J and the Kiss-and-Ride shelter.

Overall, the station was ranked first for replacement based on shelter condition and demand. Based on shelter condition only, the station ranked second for replacement.

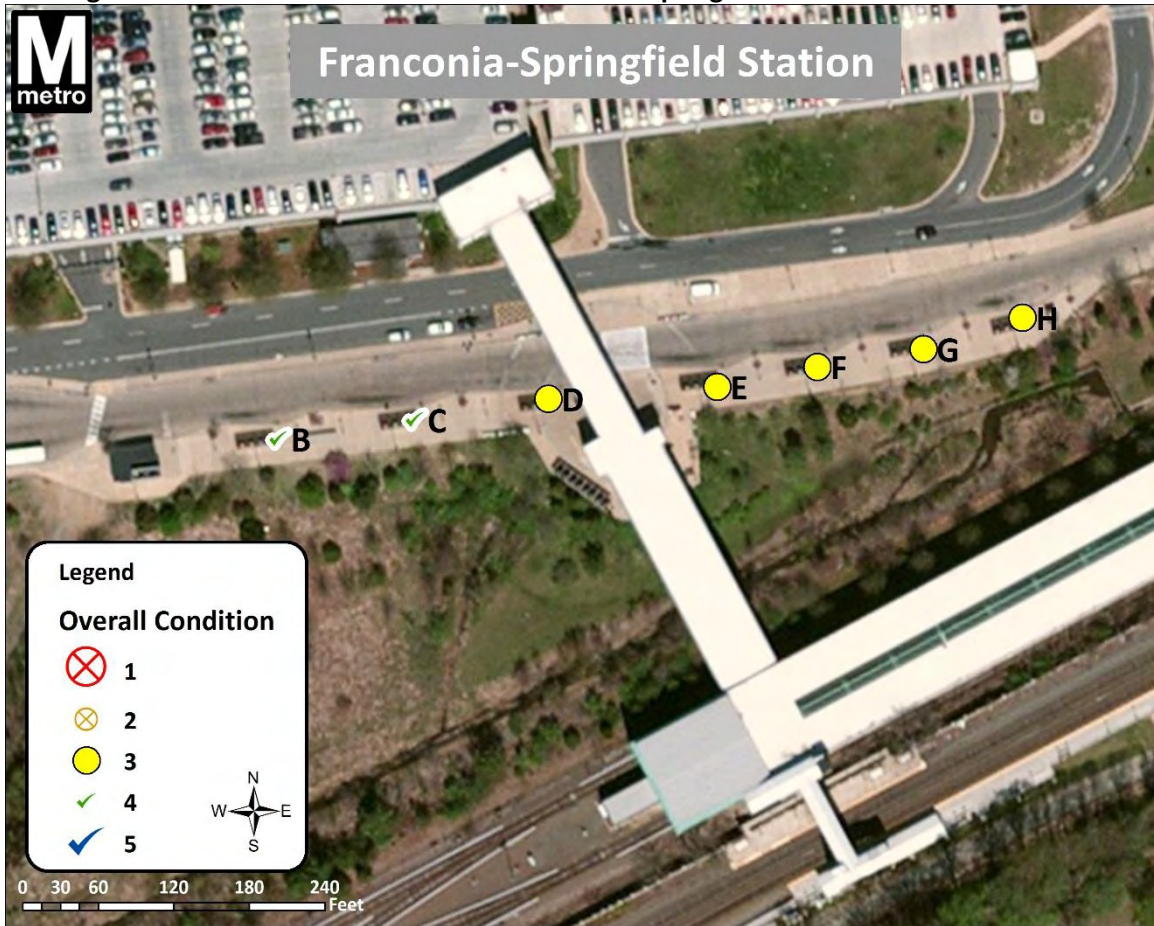
Figure 82: Overall Condition Score of Franconia-Springfield Metrorail Station Shelters

Overall, shelter conditions at the station are above average, with a station condition score of 3.4. **Table 14** summarizes conditions for each individual shelter. The shelters as a whole scored the lowest in panel condition, with damaged panels present on shelters D, E, and F. Shelters E and F also had significant rust on their frames. Overall bench conditions were average, while pad conditions were above average at each shelter except F and G.

Overall, the station was ranked 19th for replacement based on shelter condition and demand. Based on shelter condition only, the station ranked 24th for replacement.

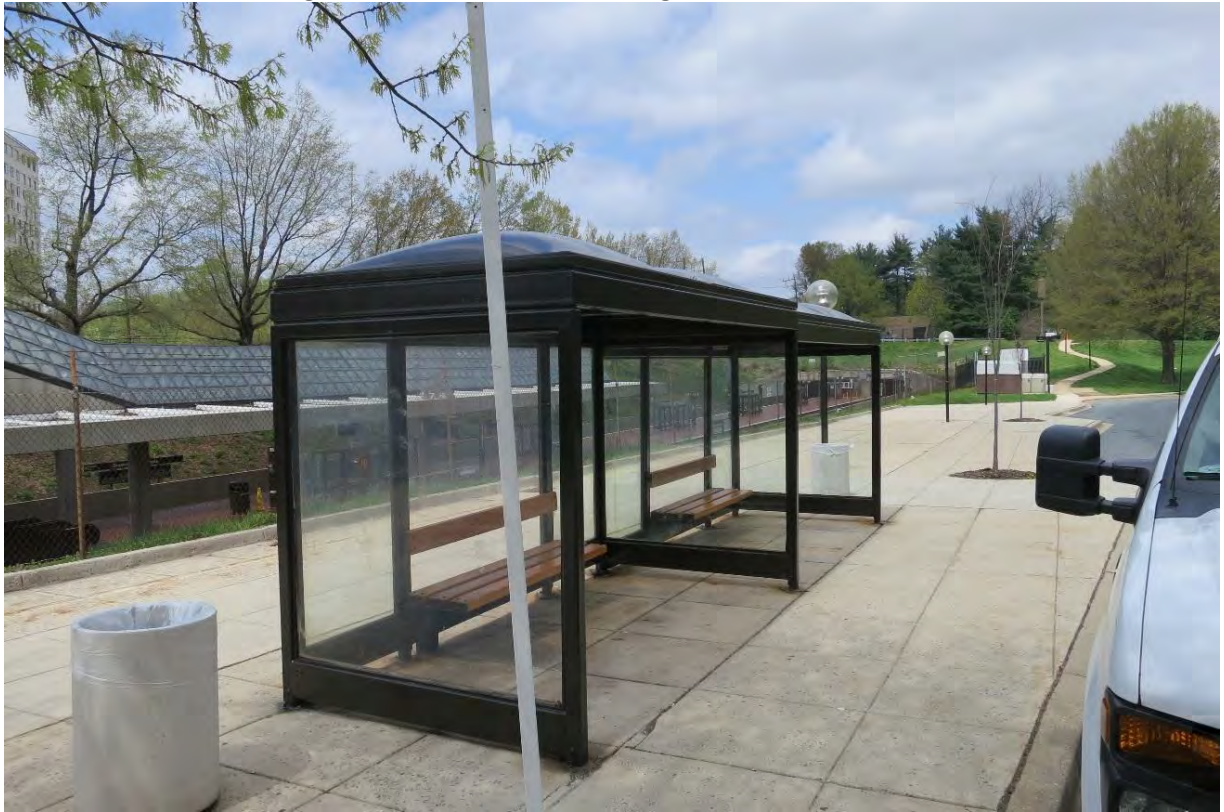
Figure 91: Overall Above Average Condition, Shelter D

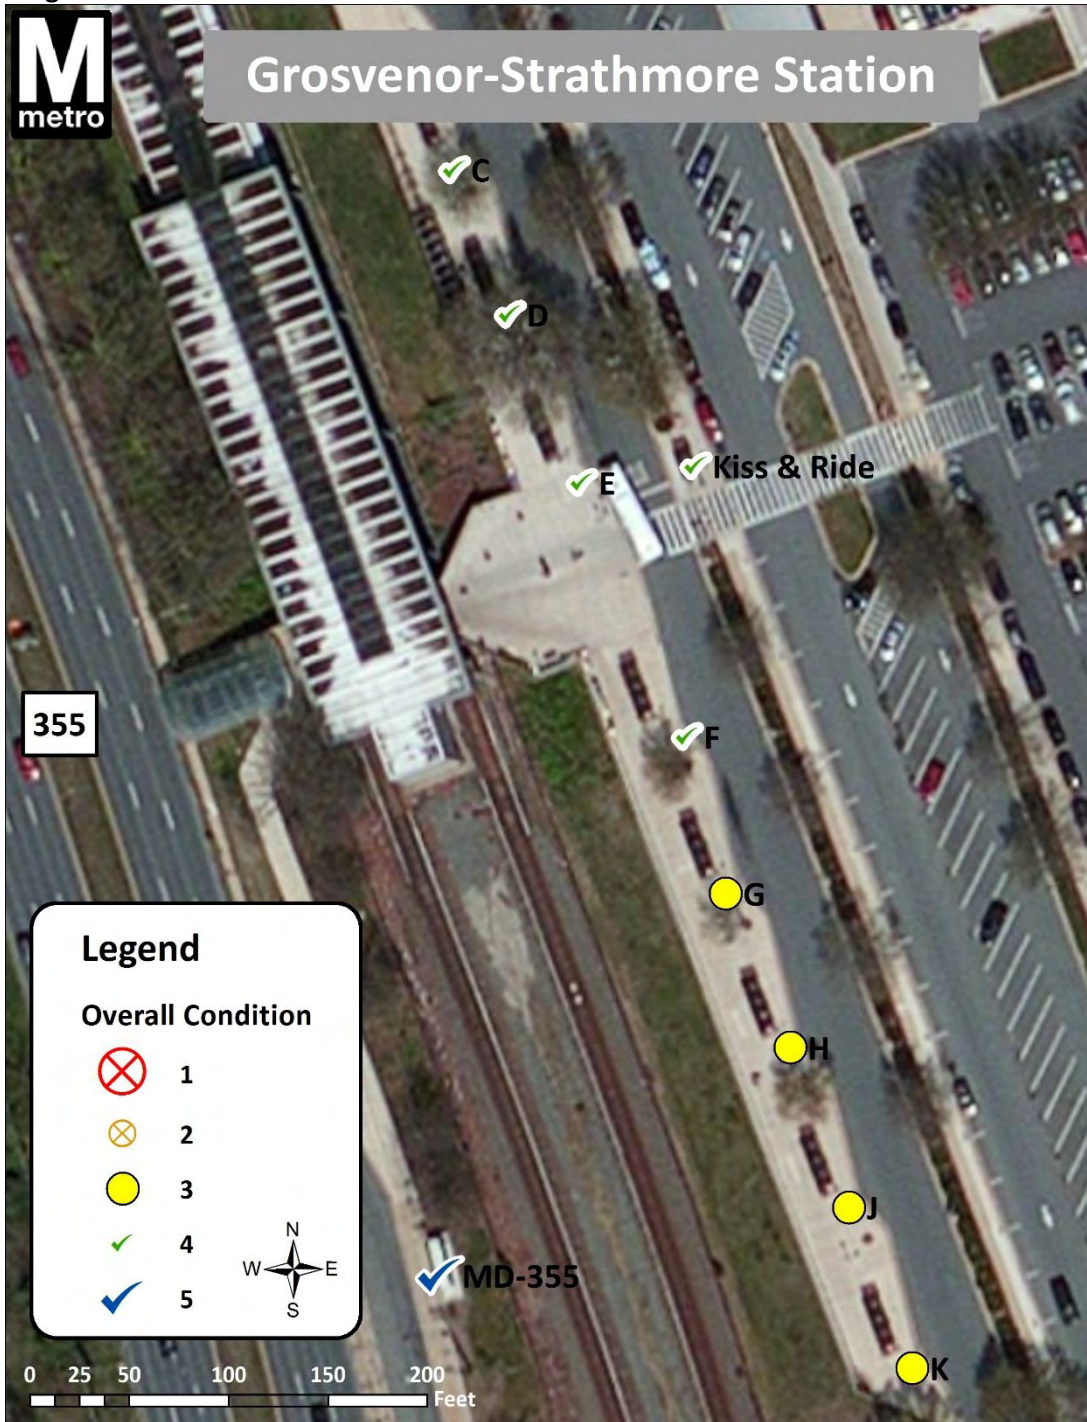
Figure 92: Overall Condition Score of Grosvenor-Strathmore Metrorail Station Shelters

Overall, shelter conditions at the station are above average, with a station condition score of 3.6. **Table 16** summarizes conditions for each individual shelter. The shelters as a whole scored the lowest in pad condition. There are no shelters in particularly bad condition, though shelters G, H, J and K have panels, benches and pads in only fair condition. The J5 bus stop on MD-355 is in excellent condition and is a newer design than the rest of the shelters at the station.

Overall, the station was ranked 33rd (last) for replacement based on shelter condition and demand. Based on shelter condition only, the station ranked 28th for replacement.

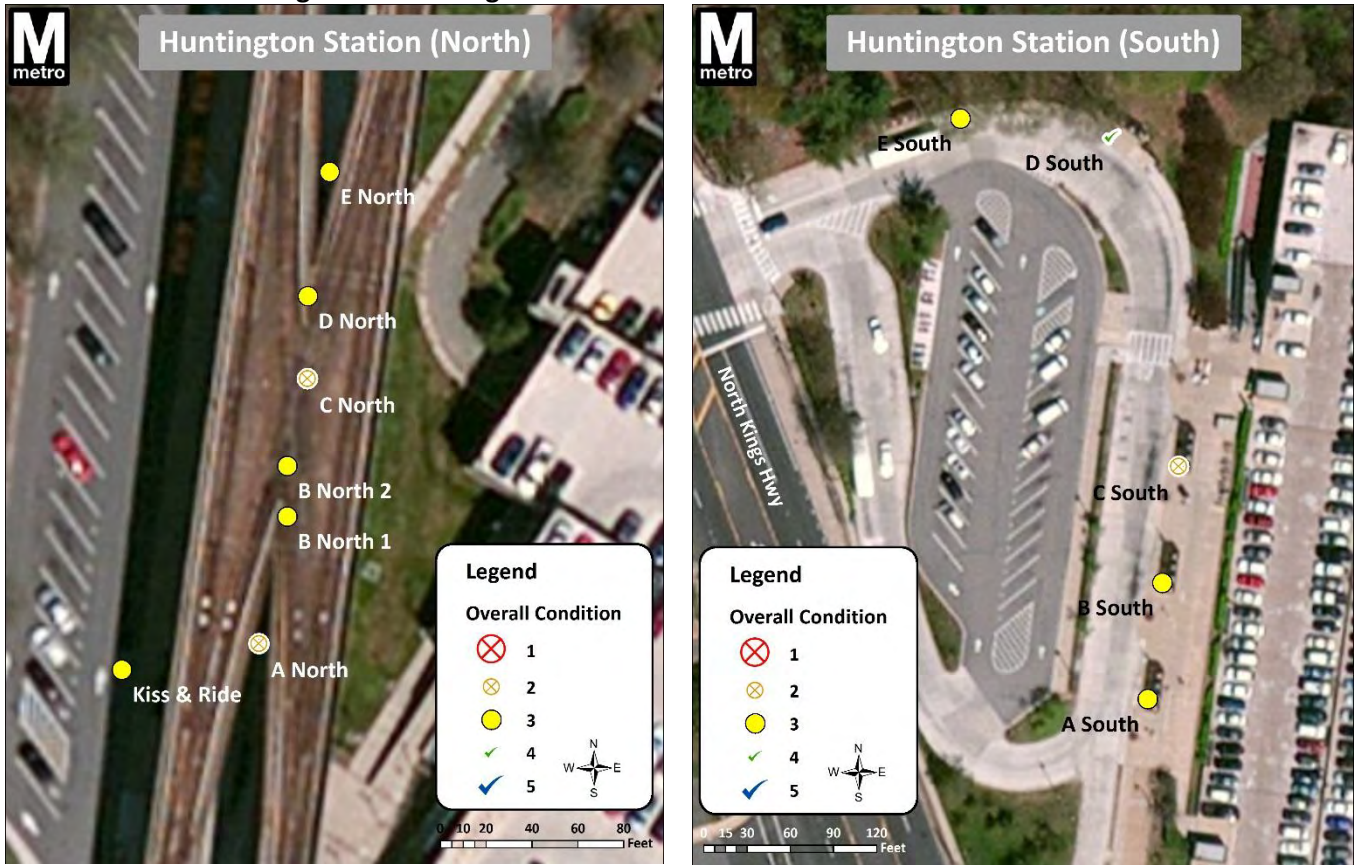
Figure 99: Huntington Metrorail Station Overall Shelter Conditions

Overall, shelter conditions at the station are slightly below average, with a station condition score of 2.8. **Table 17** summarizes conditions for each individual shelter. The shelters as a whole scored the lowest in frame condition and pad condition, with significant frame rust and pad cracking present. Shelters A North and C South were in the worst condition, both receiving an overall condition score of 2. Both of these shelters had significant rust, damaged panels and a cracked pad, with A North missing a panel as well. C North had rusted to the point of having holes in its frame. All of the shelters at the station had fairly significant frame rust while every shelter except the Kiss-and-Ride shelter and shelter D South had some panel fading, smearing, or other damage.

Overall, the station was ranked 7th for replacement based on shelter condition and demand. Based on shelter condition only, the station ranked 10th for replacement.

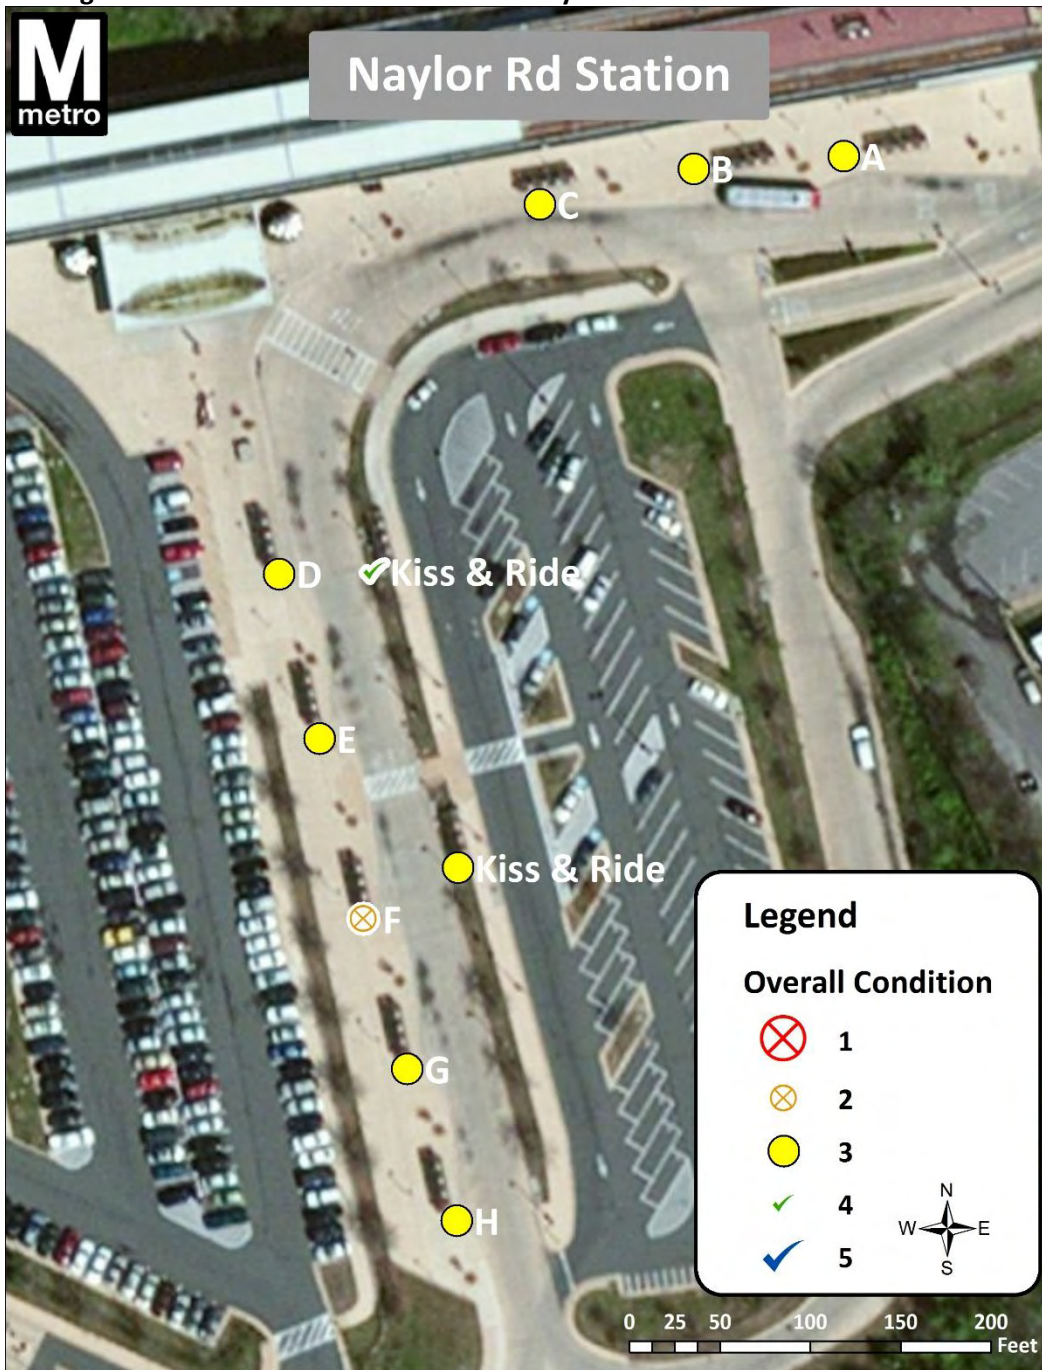
Figure 121: Overall Condition Score of Naylor Road Metrorail Station Shelters

Overall, shelter conditions at the station are average, with a station condition score of 3.0. **Table 21** summarizes conditions for each individual shelter. The shelters as a whole scored the lowest in panel

Overall, the station was ranked 18th for replacement based on shelter condition and demand. Based on shelter condition only, the station ranked 18th for replacement.

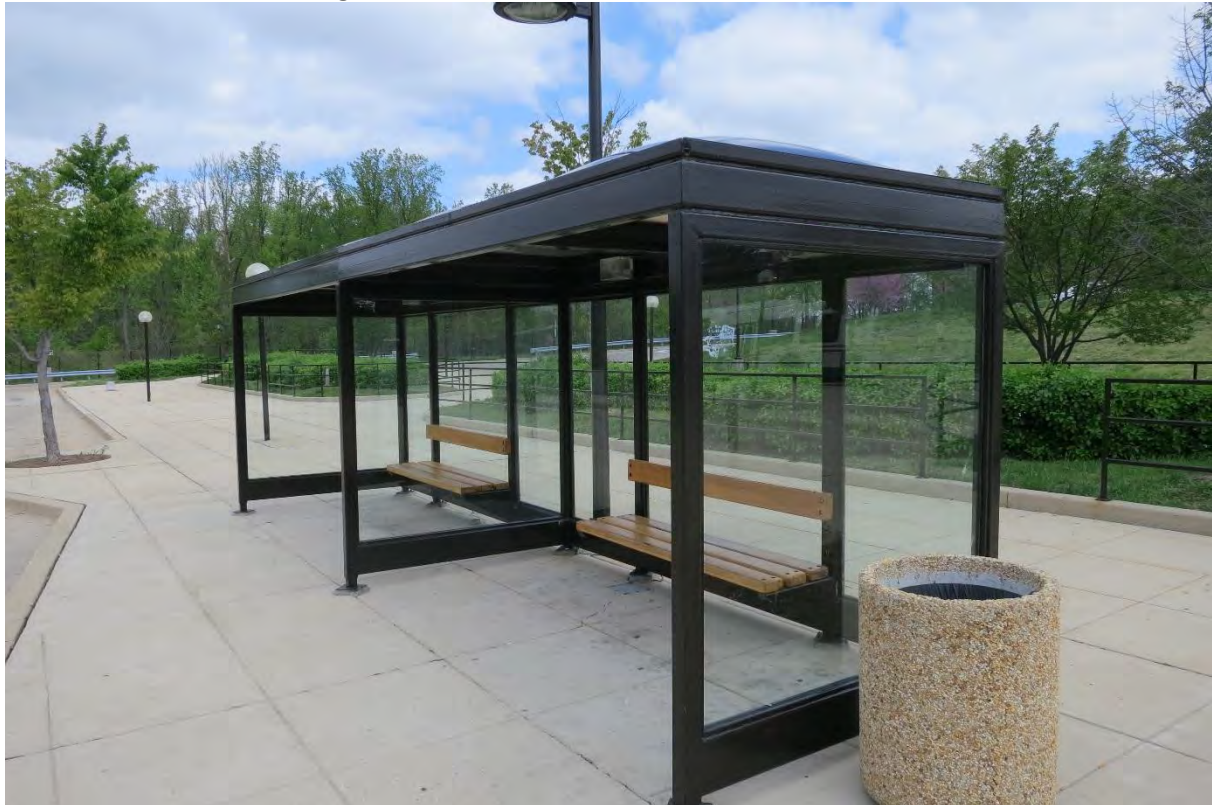
Figure 154: Excellent Frame Condition, Shelter G

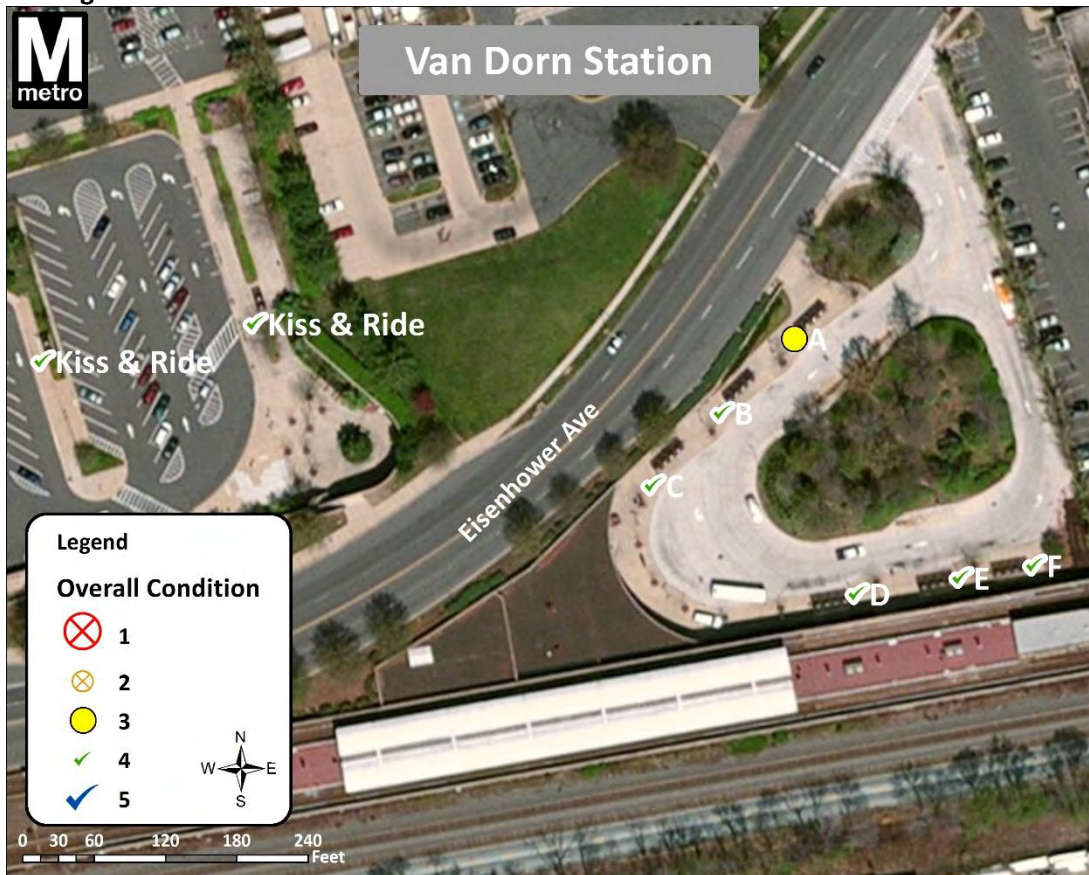
Figure 174: Overall Condition Score of Van Dorn Street Metrorail Station Shelters

Overall, shelter conditions at this station are above average, with a station condition score of 3.9. Table 30 summarizes conditions for each individual shelter. The shelters as a whole scored the lowest in dome top conditions, though they were still above average overall. The dome tops on shelters A, B and C showed some signs of fading and wear. Frame conditions were good overall, with little to no signs of rust on any of the shelters and only some minor paint peeling on shelter B and the south Kiss-and-Ride shelter. Panel conditions were above average, with fading, scratching, and smearing present on shelters A, B (minor) and D only. Bench conditions were good, with minimal signs of wear overall. Pad conditions were also good, with minor cracking present only at shelter A and the north Kiss-and-Ride shelter.

Overall, the station was ranked 28th for replacement based on shelter condition and demand. Based on shelter condition only, the station ranked 31st for replacement.

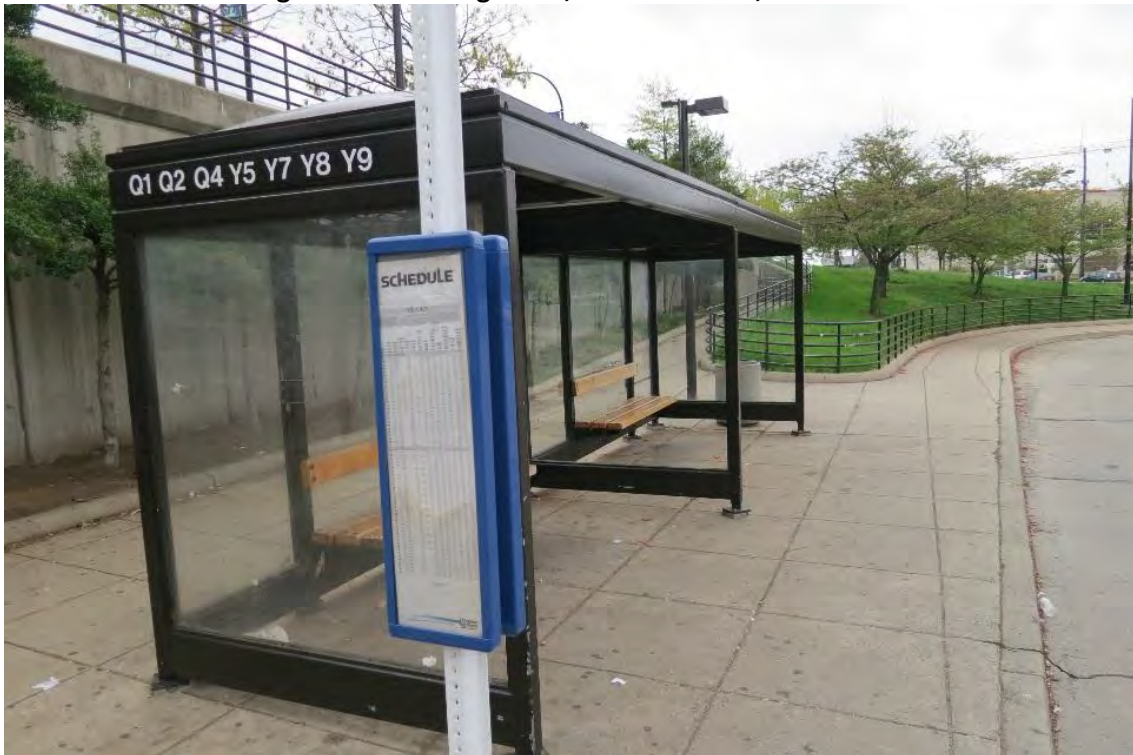
Figure 190: Missing Panel, Worn Benches, Shelter A
