Washington Metropolitan Area Transit Authority
INTERNAL REVIEW 2017

Comprehensive Internal Review: Metrorail Service Delivery

Rail Station Americans with Disabilities Act (ADA) Compliance Assessment **(11)**

Metrorail Train Operator Activities **(12)**

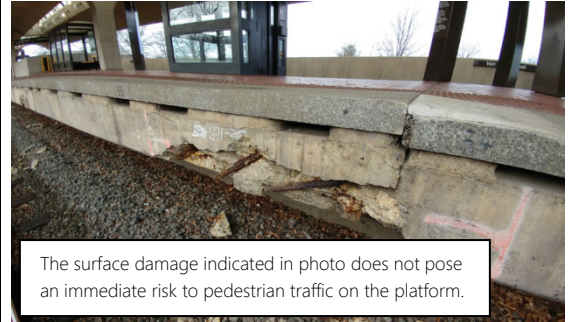
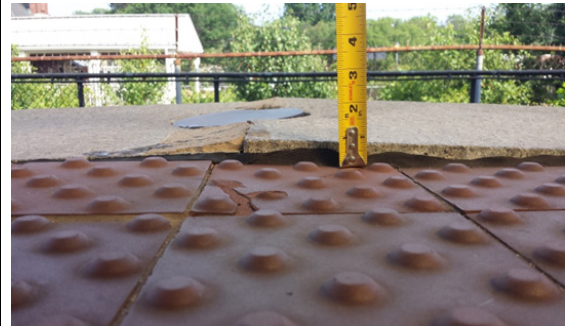
Track 1 platform, chain marker 691+25, the existence of tripping hazards in the platform areas due to the platform substructures being in a state of deterioration.

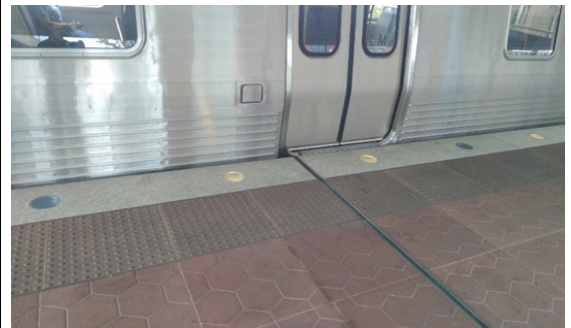
Photograph #3

Out of service platform edge lighting were noted in several stations.

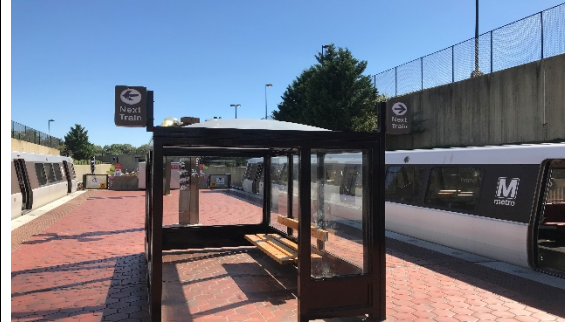
Two trains berthed at the same time in a terminal station. The lack of announcements two (2) minutes and thirty (30) seconds prior to the departure causes confusion among customers on which train to board.

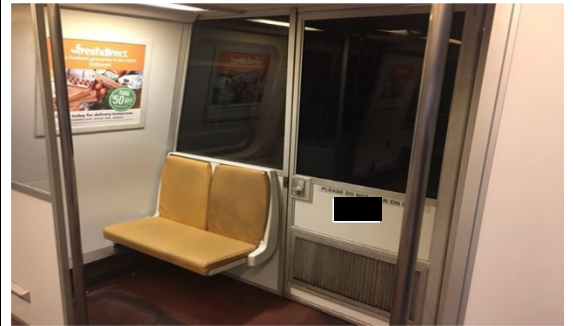
Photograph #2

Wrong configuration the trailing operating cab door, which does not allow passenger access to the emergency call station.

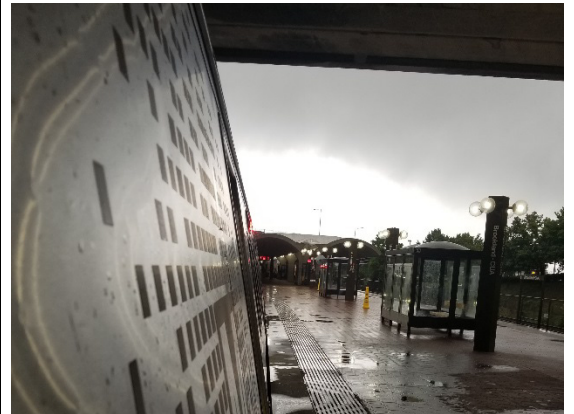
Photograph #3

Operator cannot view the entire length of the train at Brookland station, track 2, and Silver Spring Station, track 2, due to the convex curvature nature of the track.
