Washington Metropolitan Area Transit Authority

# Metrorail Structural Inspections

## QICO Internal Review

June 9, 2017

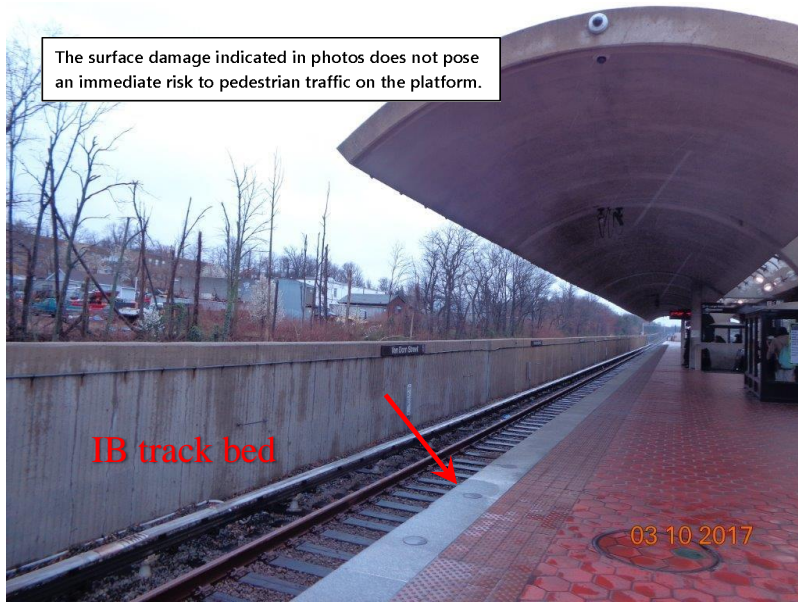
Figure 1: The location as marked is where the worst deterioration (approximately Chain Marker 690+00) is located.

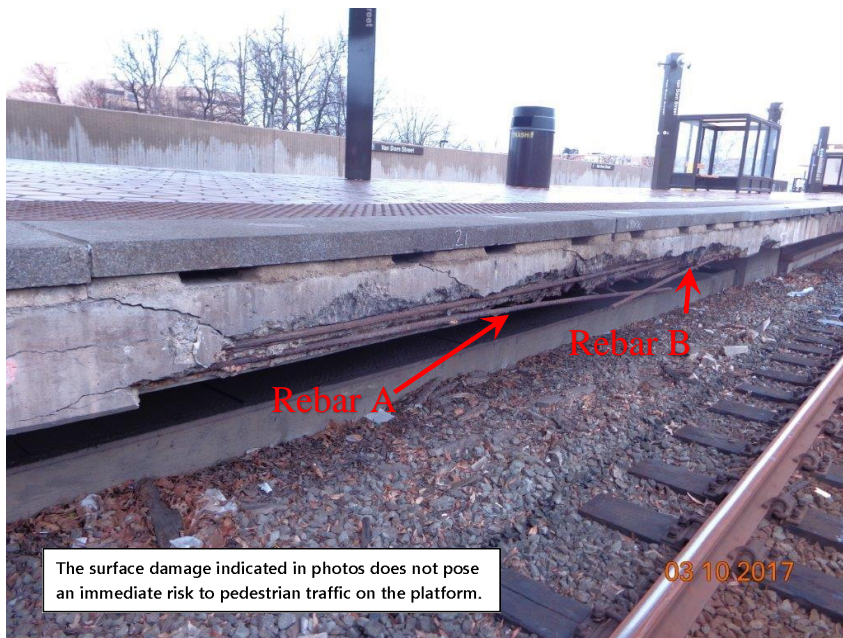
Figure 2: Side view of concrete deterioration and rebar corrosion/separation.

1. Immediate cutoff of rebars A, B and C at Chain Marker 290+00 as stated above.
2. Platform edge concrete repair at Chain Marker 290+00 on the inbound side shall be performed as soon as possible.

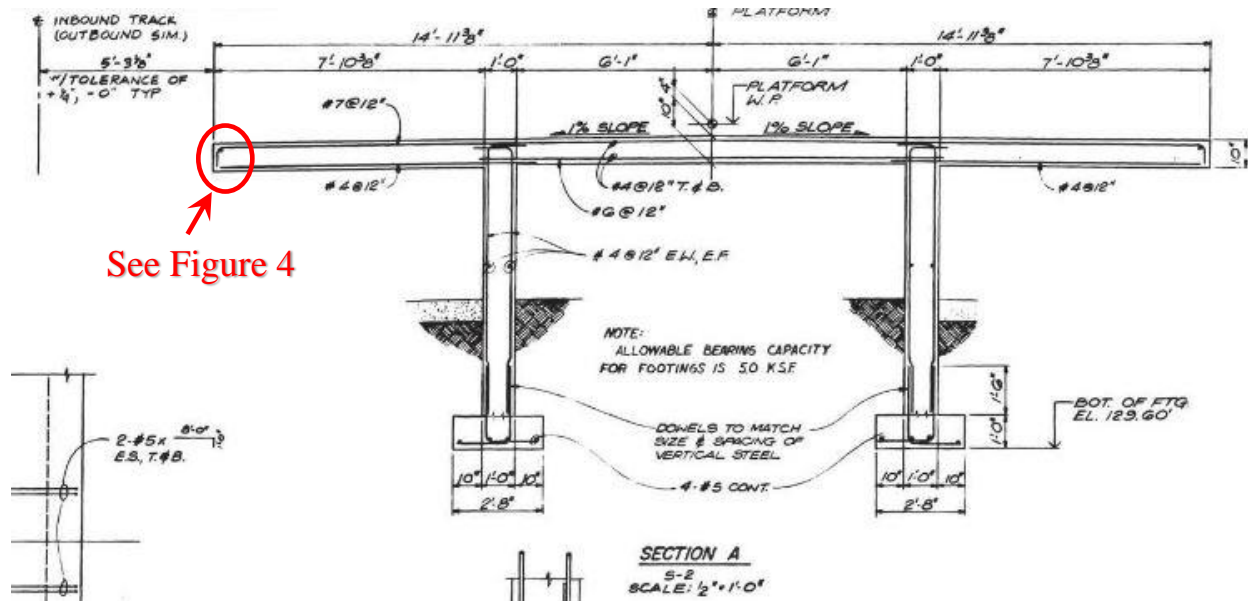
Figure 3: The section shows reinforcing details where Figure 2 existing condition is located.

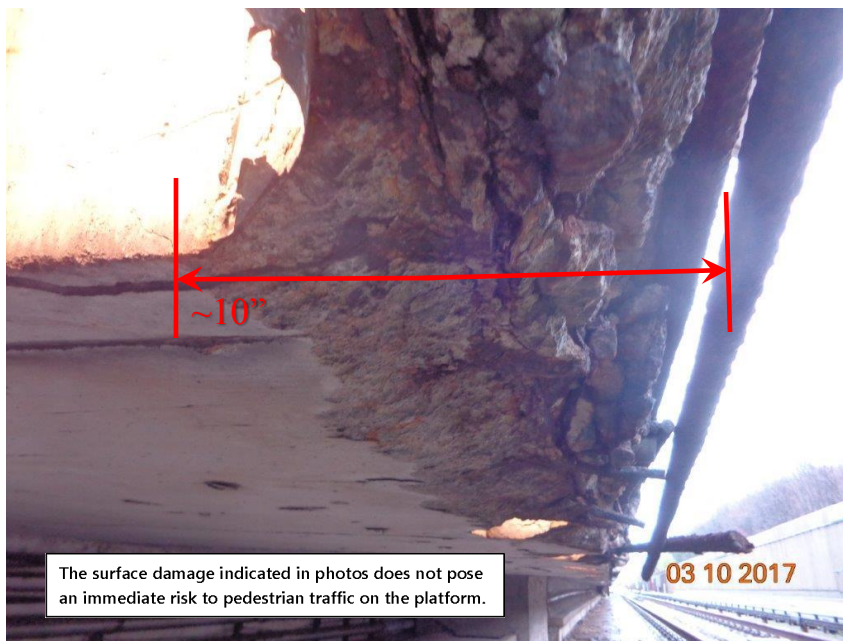
The surface damage indicated in photos does not pose an immediate risk to pedestrian traffic on the platform.

Figure 4: Close-up view from underside of platform edge. Most of spalls are within 5” from the edge of concrete. 10” is the limit for existing deterioration condition.

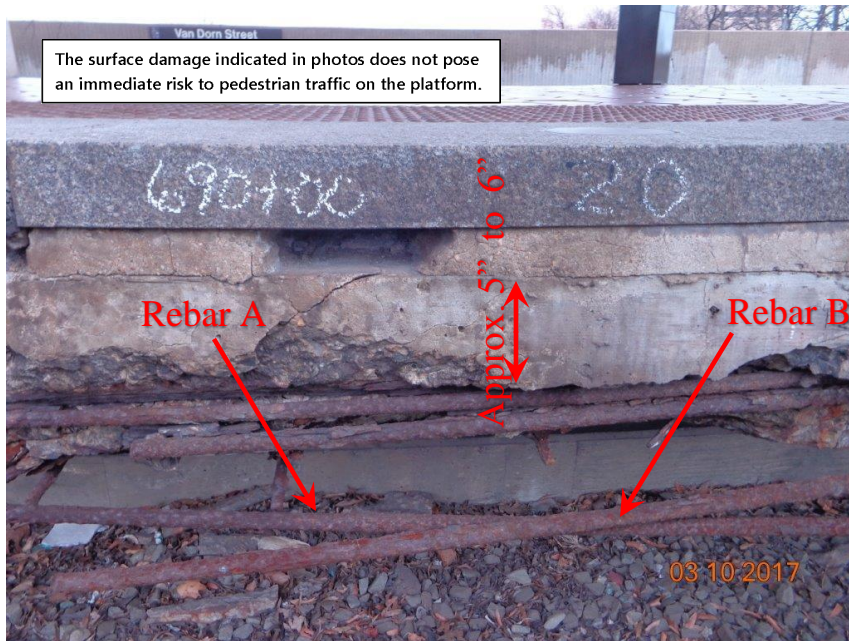
Figure 5: Close-up view of the surface as shown in Figure 2. The rebars as marked intrude into the track bed area and should be truncated for safety.

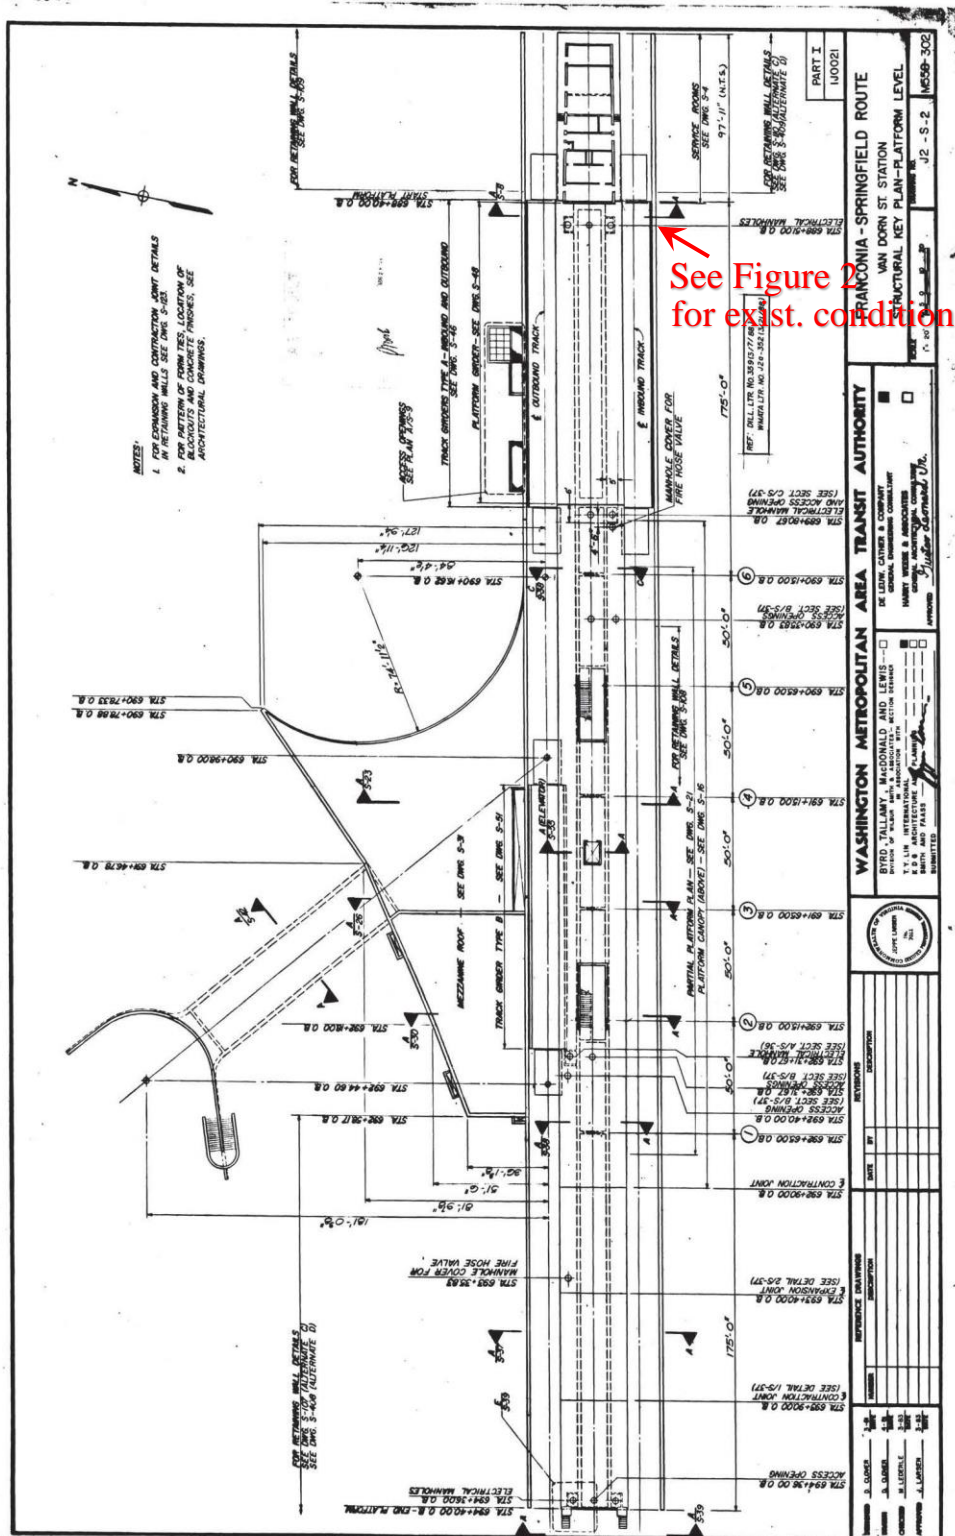
Figure 7: Plan of Van Dorn Street Station shows worst deterioration location. See Figure 8 for section details.

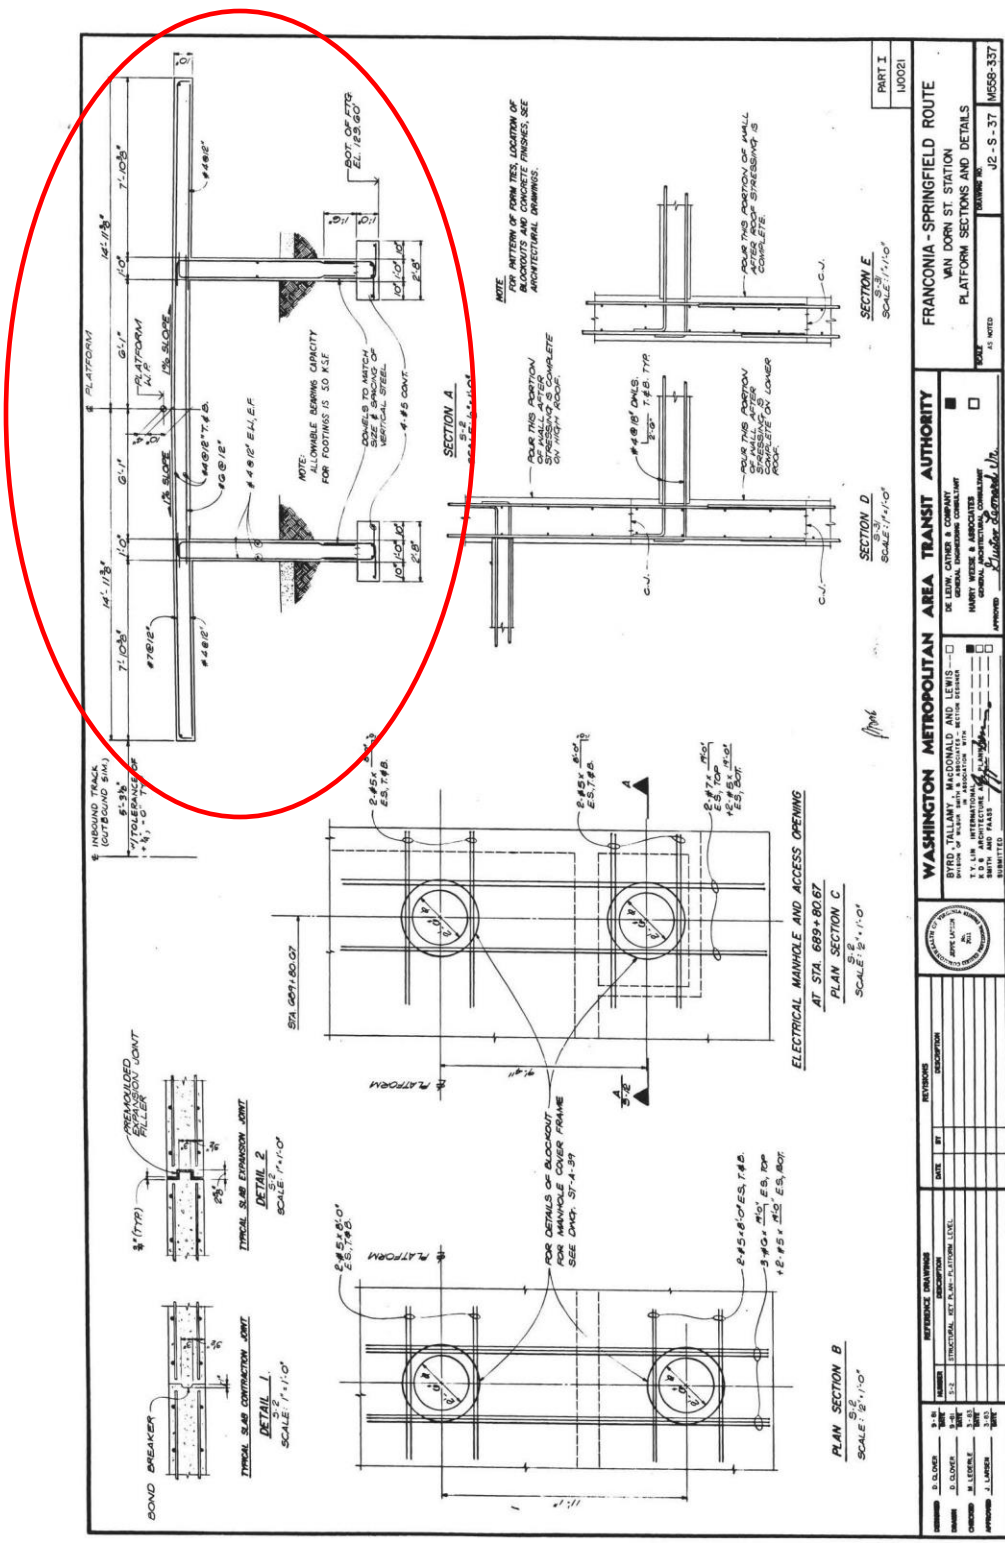
Figure 8: Section A shows reinforcing details which reflects redundant existing longitudinal rebars in Figure 2. Refer to Figure 7 for the location.

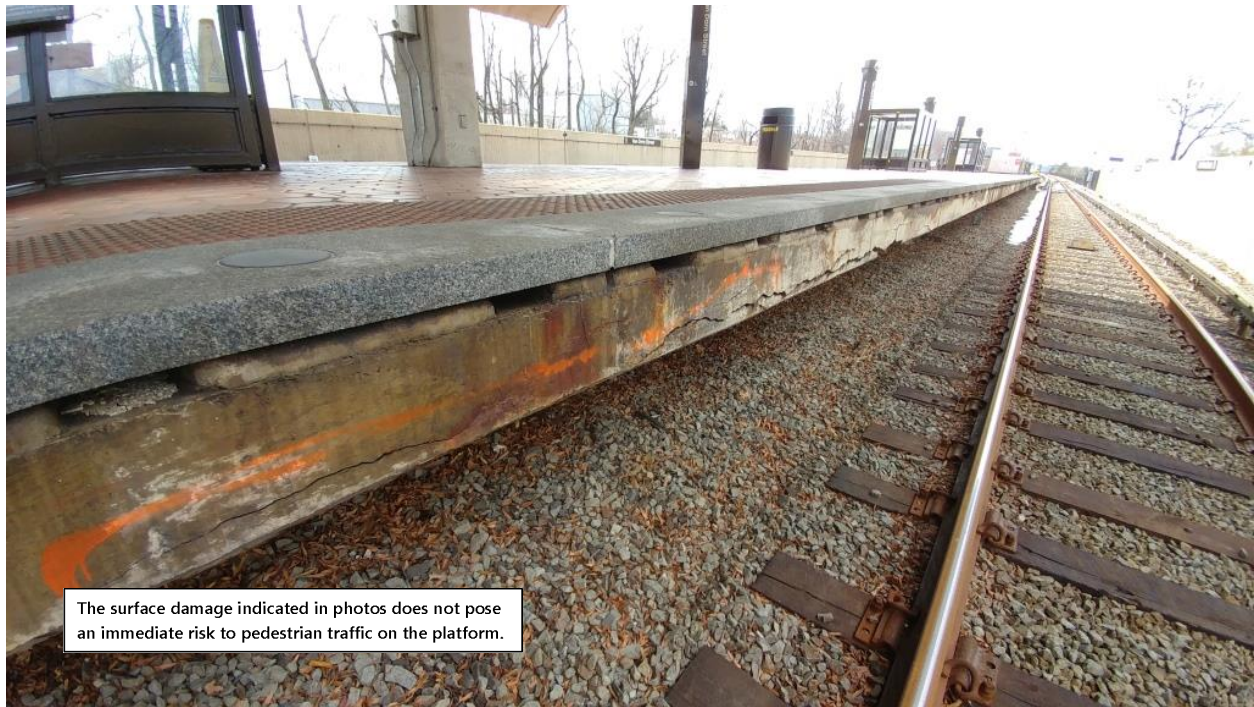
The surface damage indicated in photos does not pose an immediate risk to pedestrian traffic on the platform.

**Figure 1:** General condition of existing platforms (track 2 shown). Existing concrete edge is generally deteriorated.

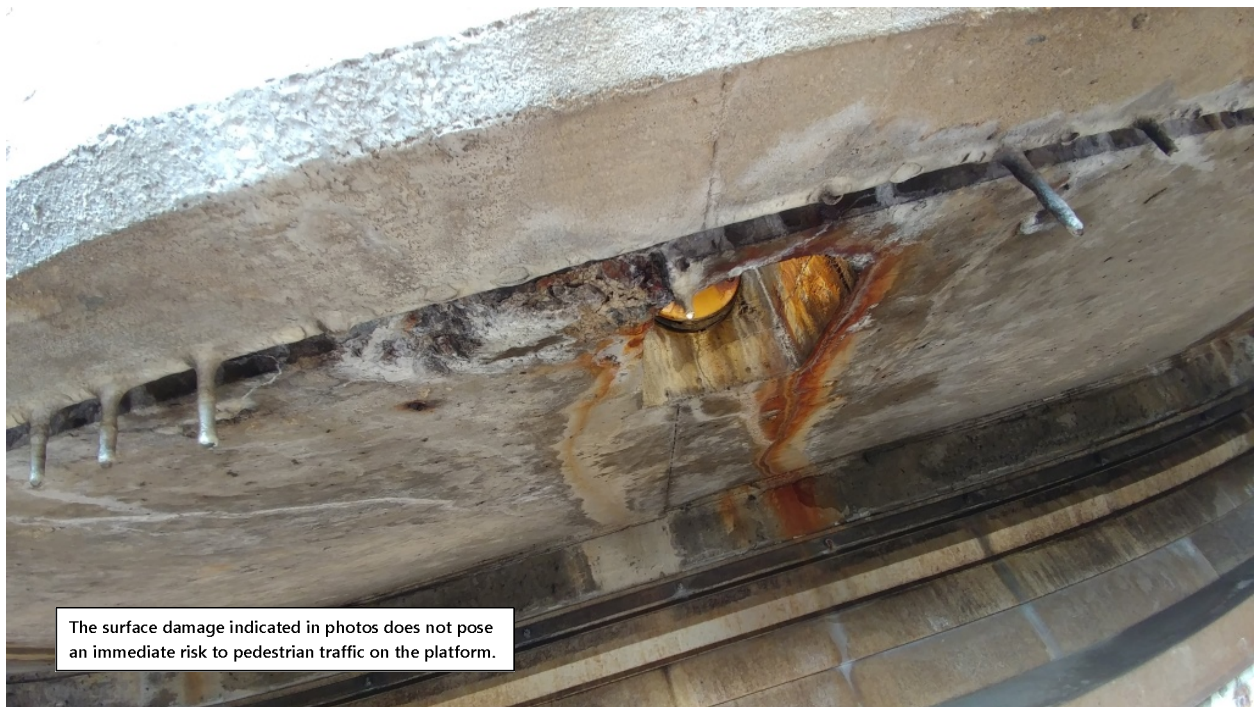
The surface damage indicated in photos does not pose an immediate risk to pedestrian traffic on the platform.

**Figure 2:** Typical deterioration at bottom of the slab with cracks and efflorescence near the lights

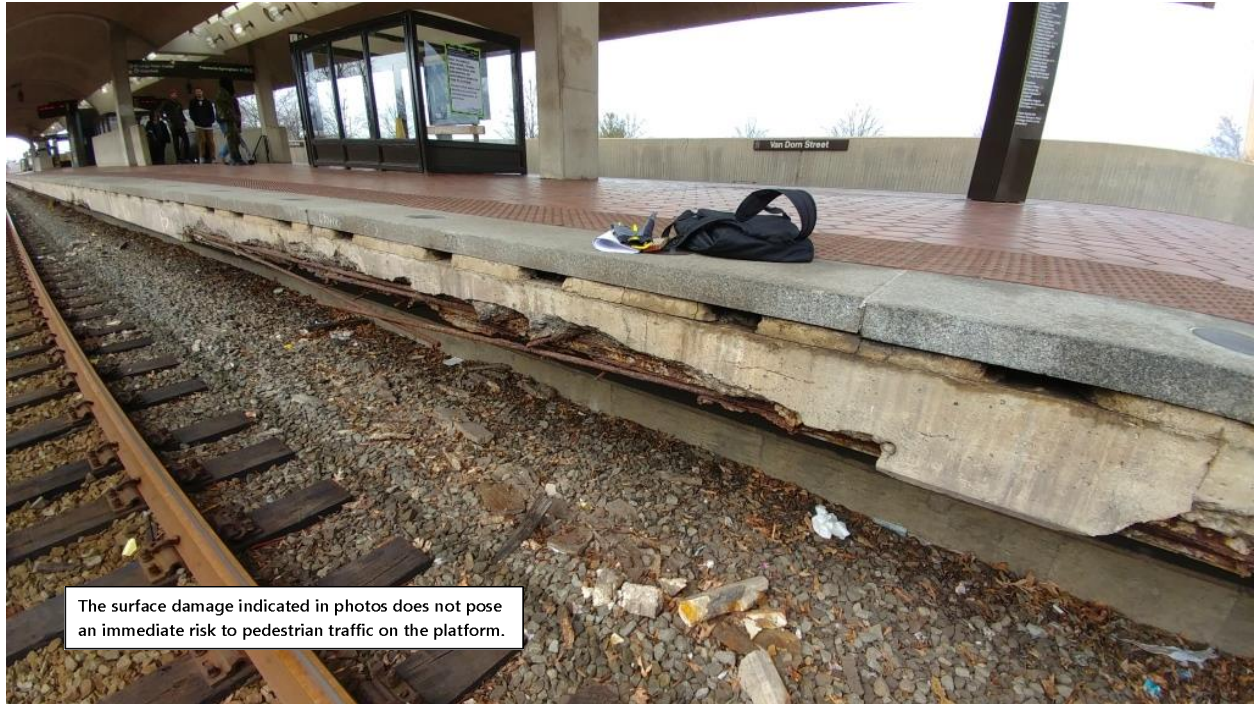
The surface damage indicated in photos does not pose an immediate risk to pedestrian traffic on the platform.

**Figure 3:** Large spall with exposed reinforcing steel at the edge of Track 1 platform, Chain Marker 690+00

1. Cut the exposed longitudinal reinforcing steel and install a temporary support system under the platform edge at Track 1 near Chain Marker 690+00.
2. Repair the edge and bottom of the platform concrete. The existing rebar shall be exposed and cleaned prior to forming the concrete repair. New reinforcing steel shall be adequately lapped with the existing bars or adequately embedded in the existing concrete. Proper drainage and waterproofing shall be provided between the granite veneer and the new concrete at repair areas.

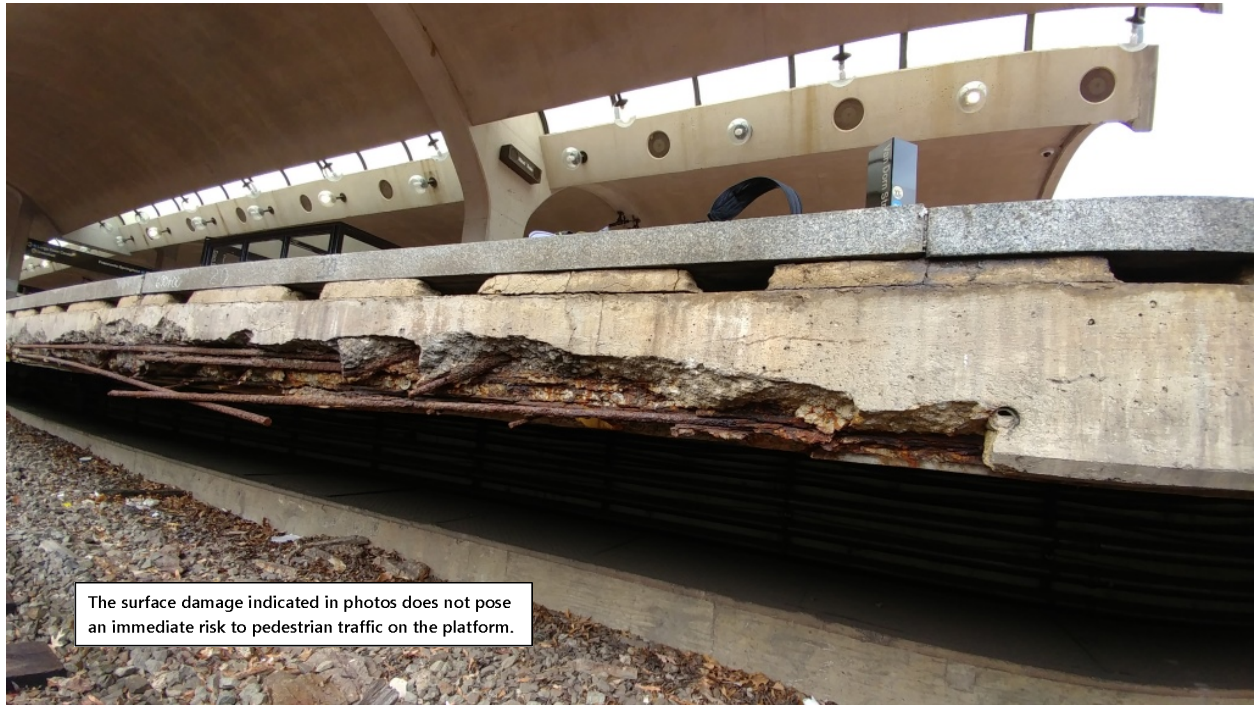
The surface damage indicated in photos does not pose an immediate risk to pedestrian traffic on the platform.

**Figure 4:** Large spall with exposed reinforcing steel at the edge of Track 1 platform, Chain Marker 690+00

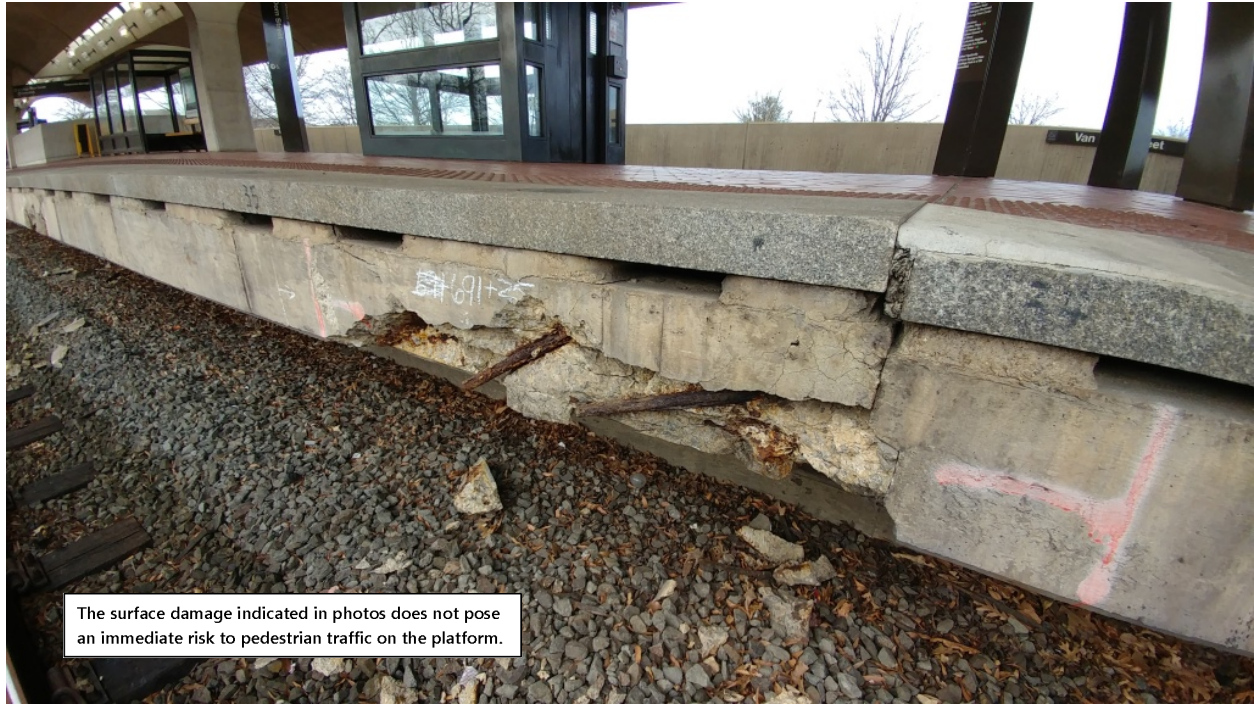
The surface damage indicated in photos does not pose an immediate risk to pedestrian traffic on the platform.

**Figure 5:** Large spall with exposed reinforcing steel at the edge of Track 1 platform, Chain Marker 691+25

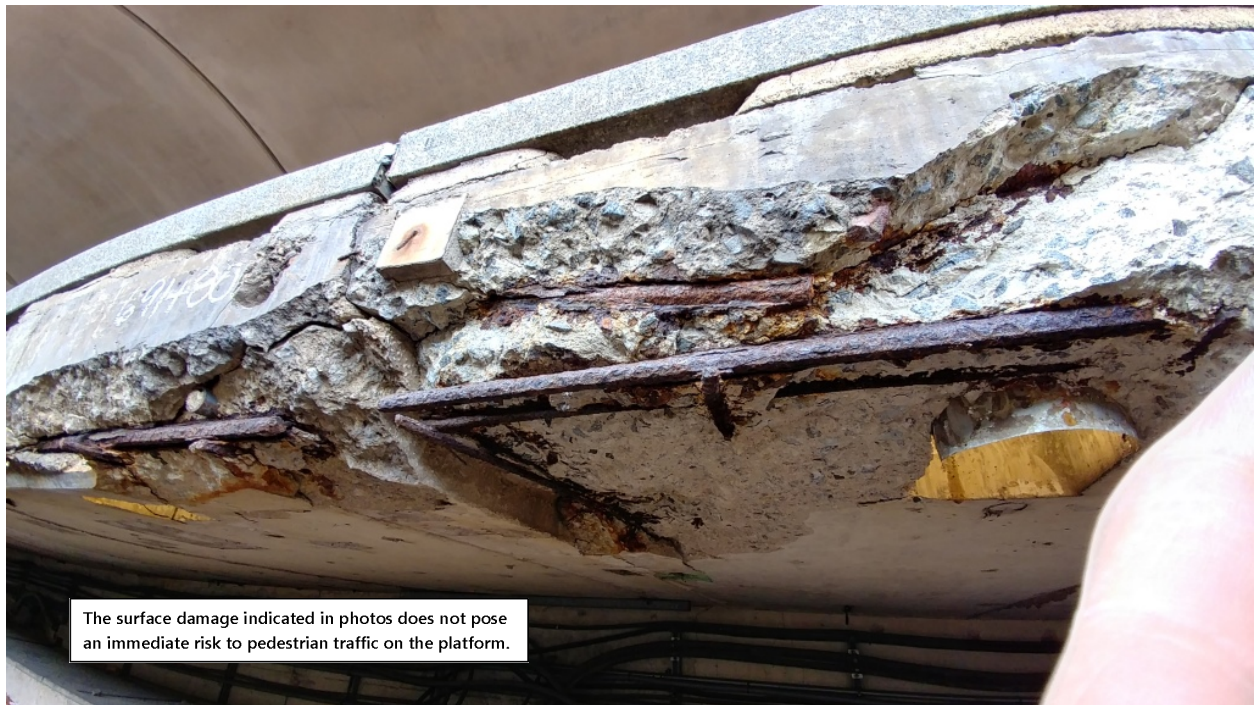
The surface damage indicated in photos does not pose an immediate risk to pedestrian traffic on the platform.

**Figure 6:** Large spall with exposed reinforcing steel at the edge of Track 1 platform, Chain Marker 691+90

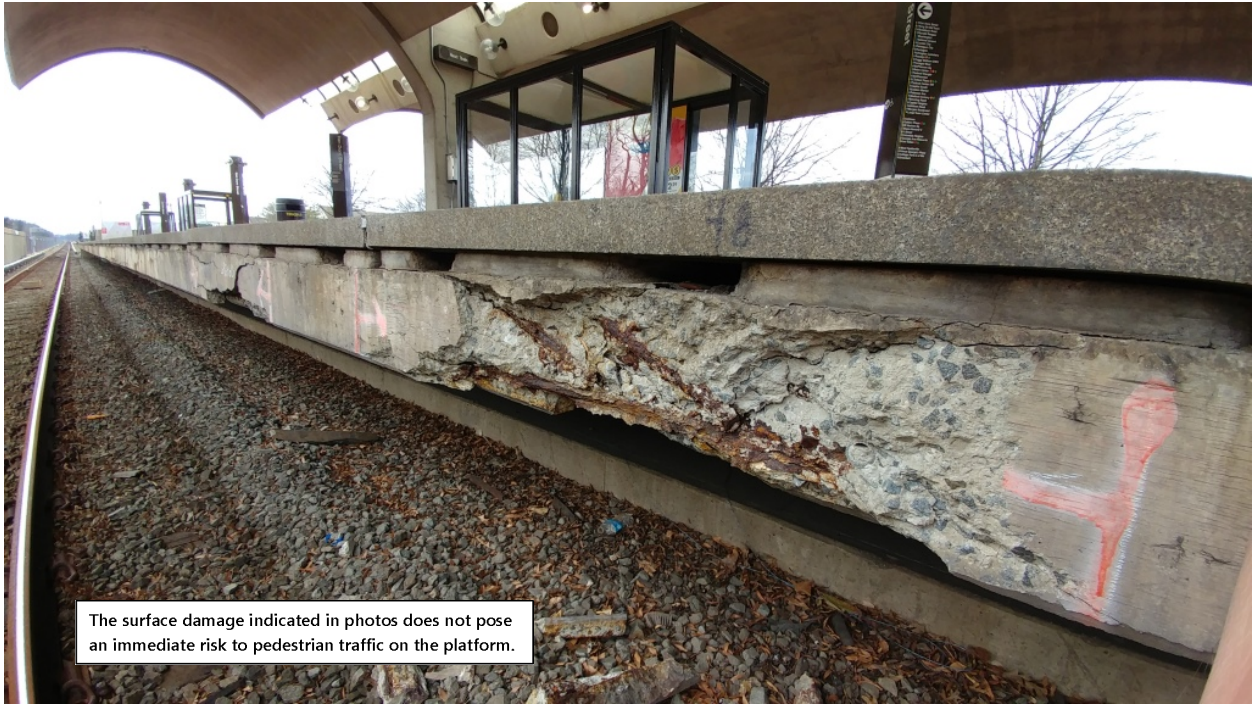
**Figure7:** Large spall with exposed reinforcing steel at the edge of Track 1 platform, Chain Marker 692+50

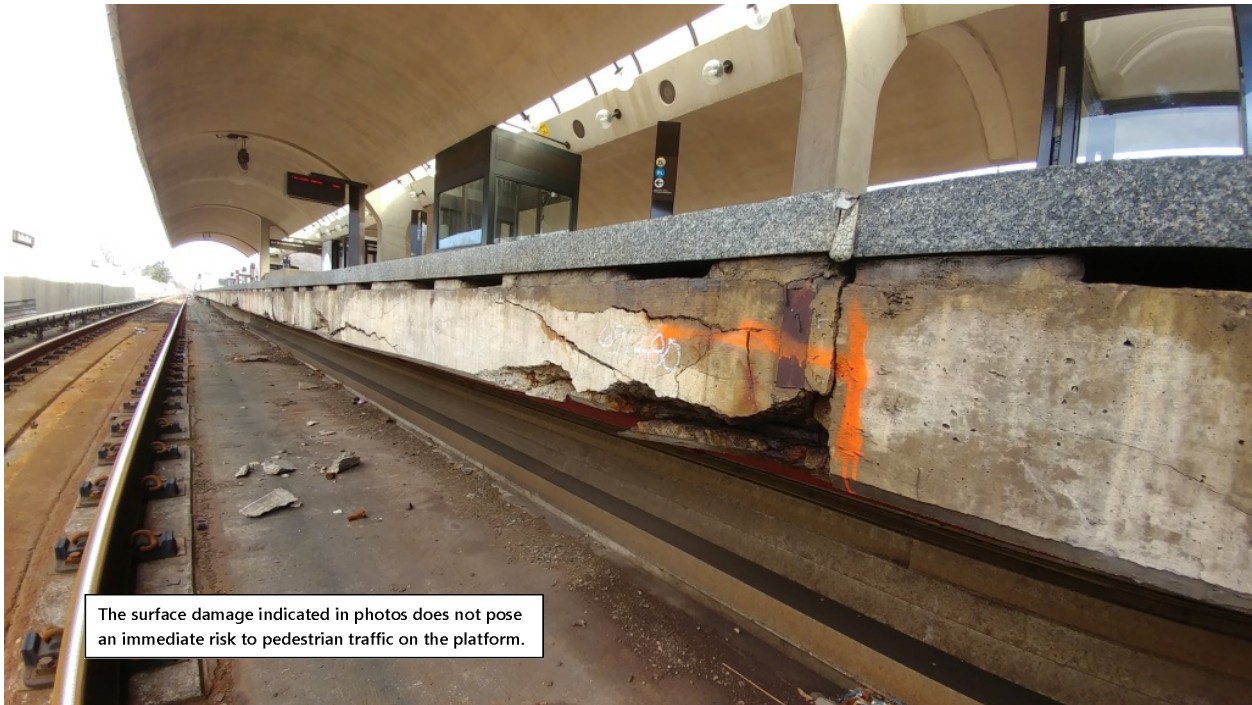
**Figure 8:** Large spall with exposed reinforcing steel at the edge of Track 2 platform, Chain Marker 691+80

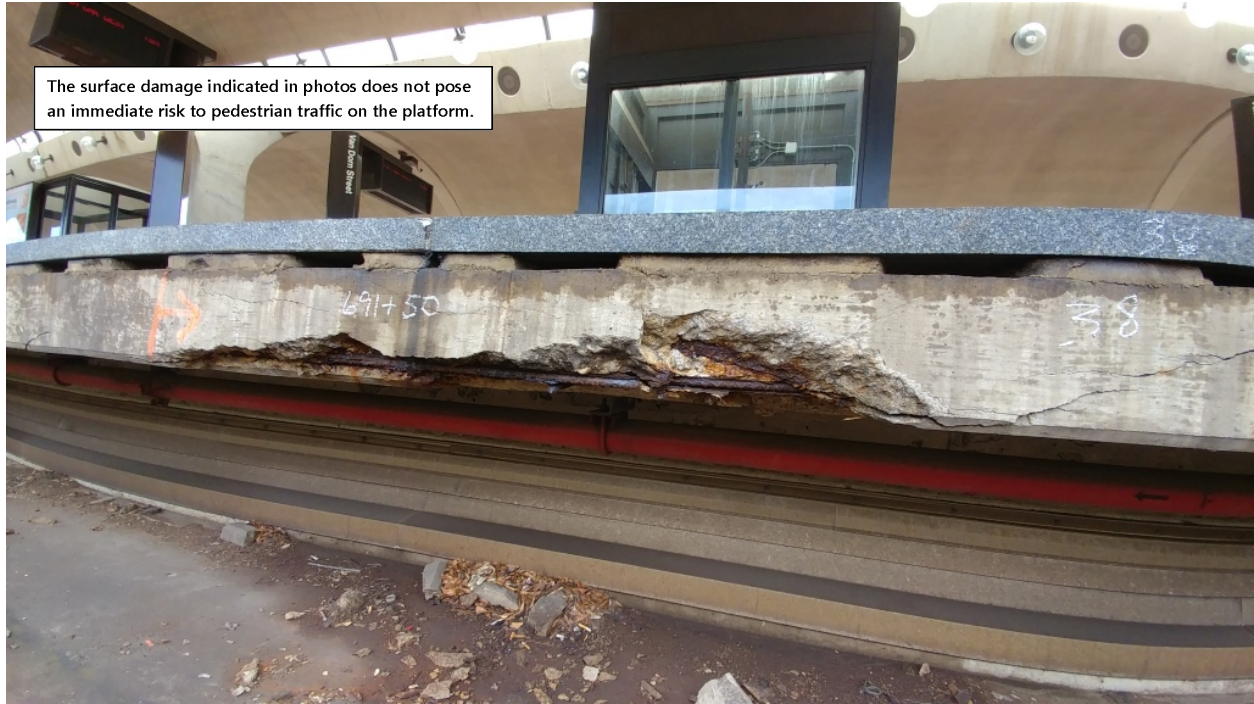
**Figure 9:** Large spall with exposed reinforcing steel at the edge of Track 2 platform, Chain Marker 691+50

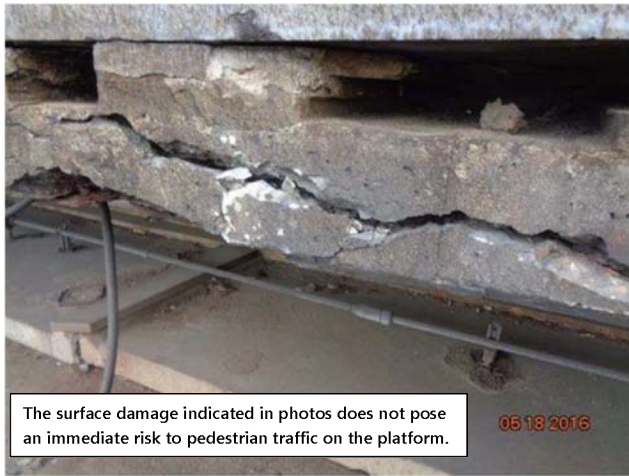
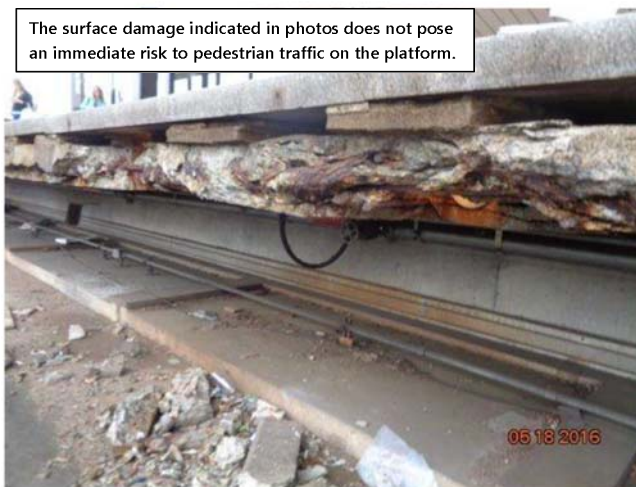
**King Street. TYP defects encountered on both tracks within the platform**

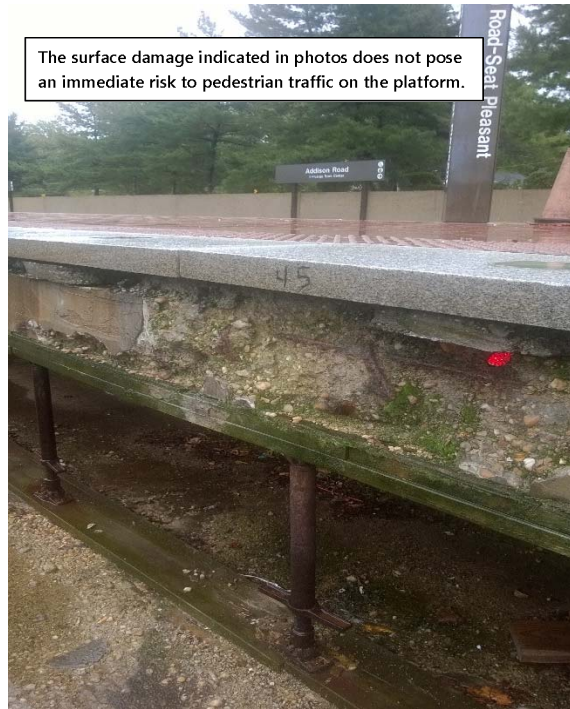
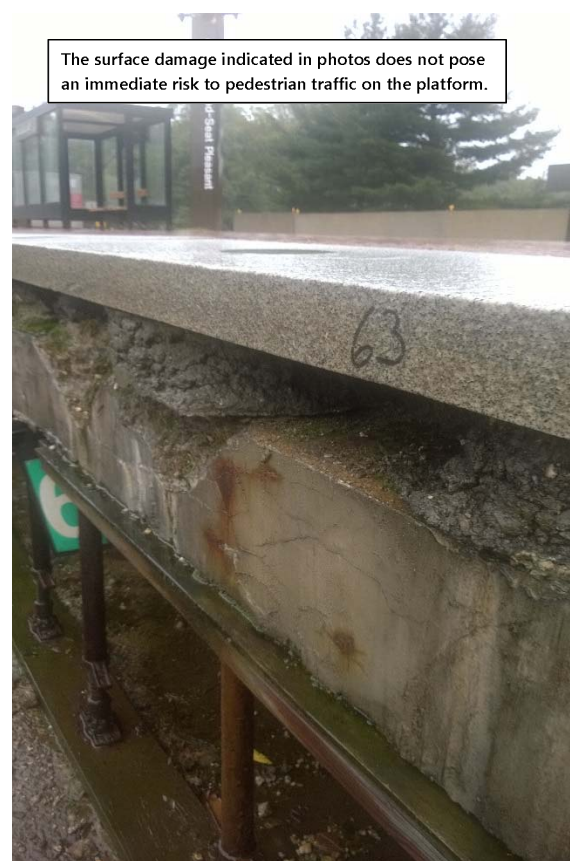
**Addison Rd platform. Track 2 TYP defects. TRK 1 we have corrected 25% of the platform.**

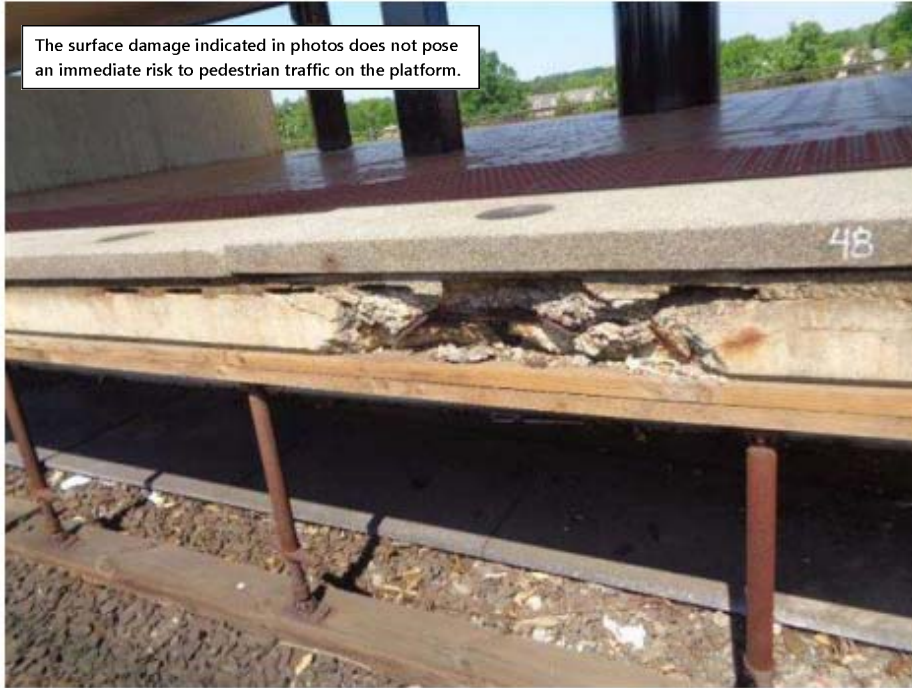
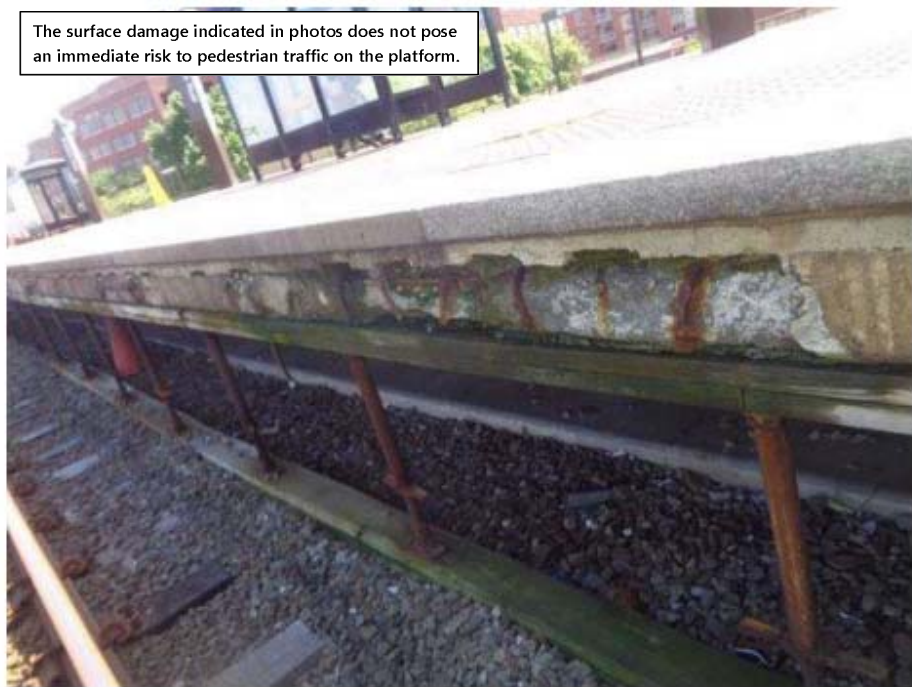
**Braddock Rd. Station TYP platform defects both tracks**

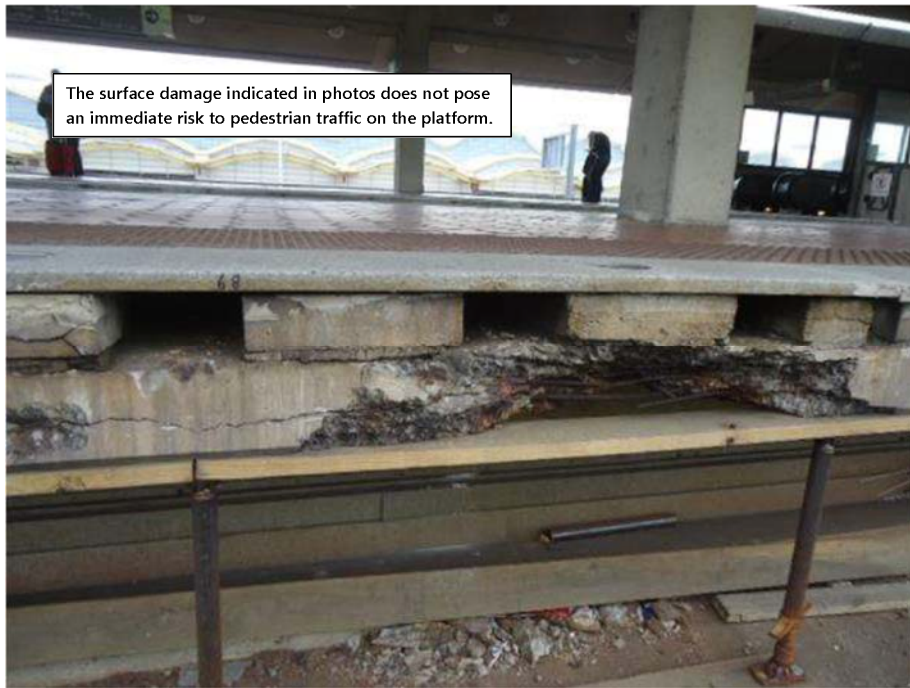
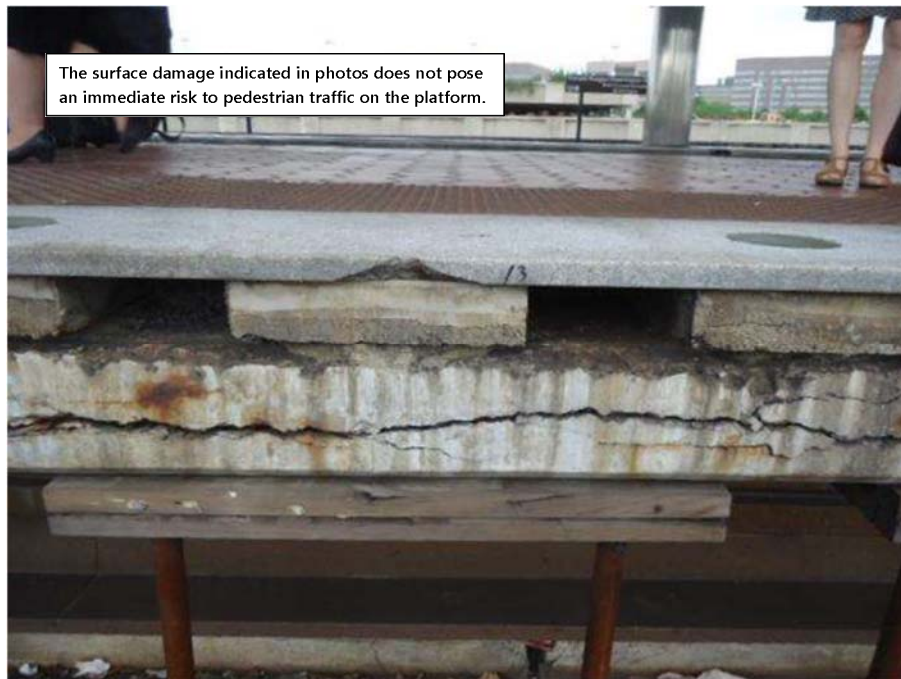
**National Airport. TYP platform defects TRK 1-2-3.**

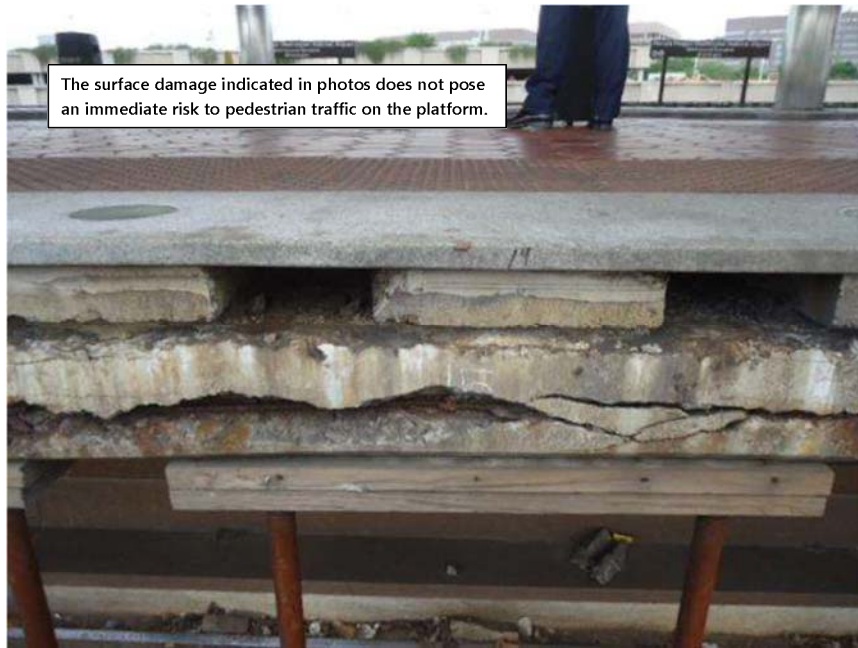
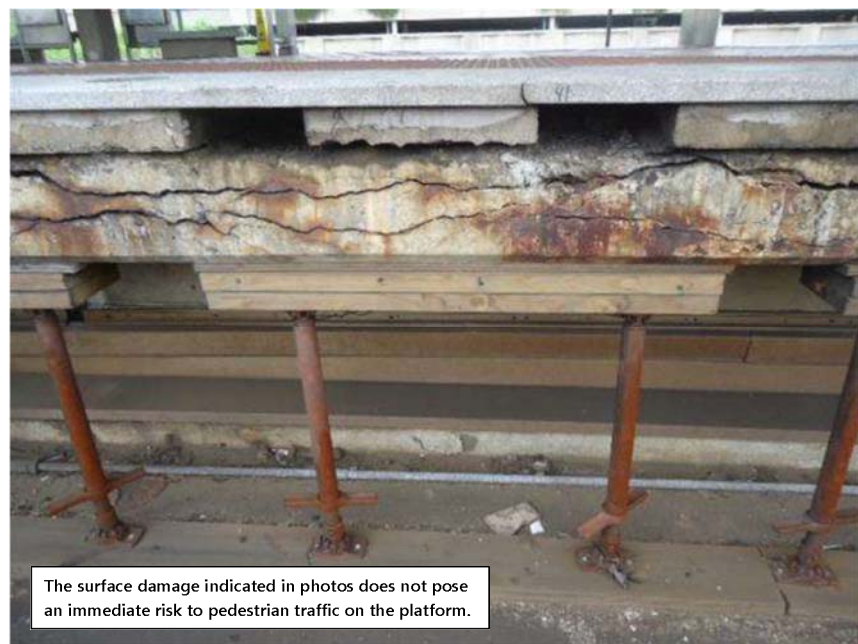
**National Airport. TYP platform defects TRK 1-2-3.**

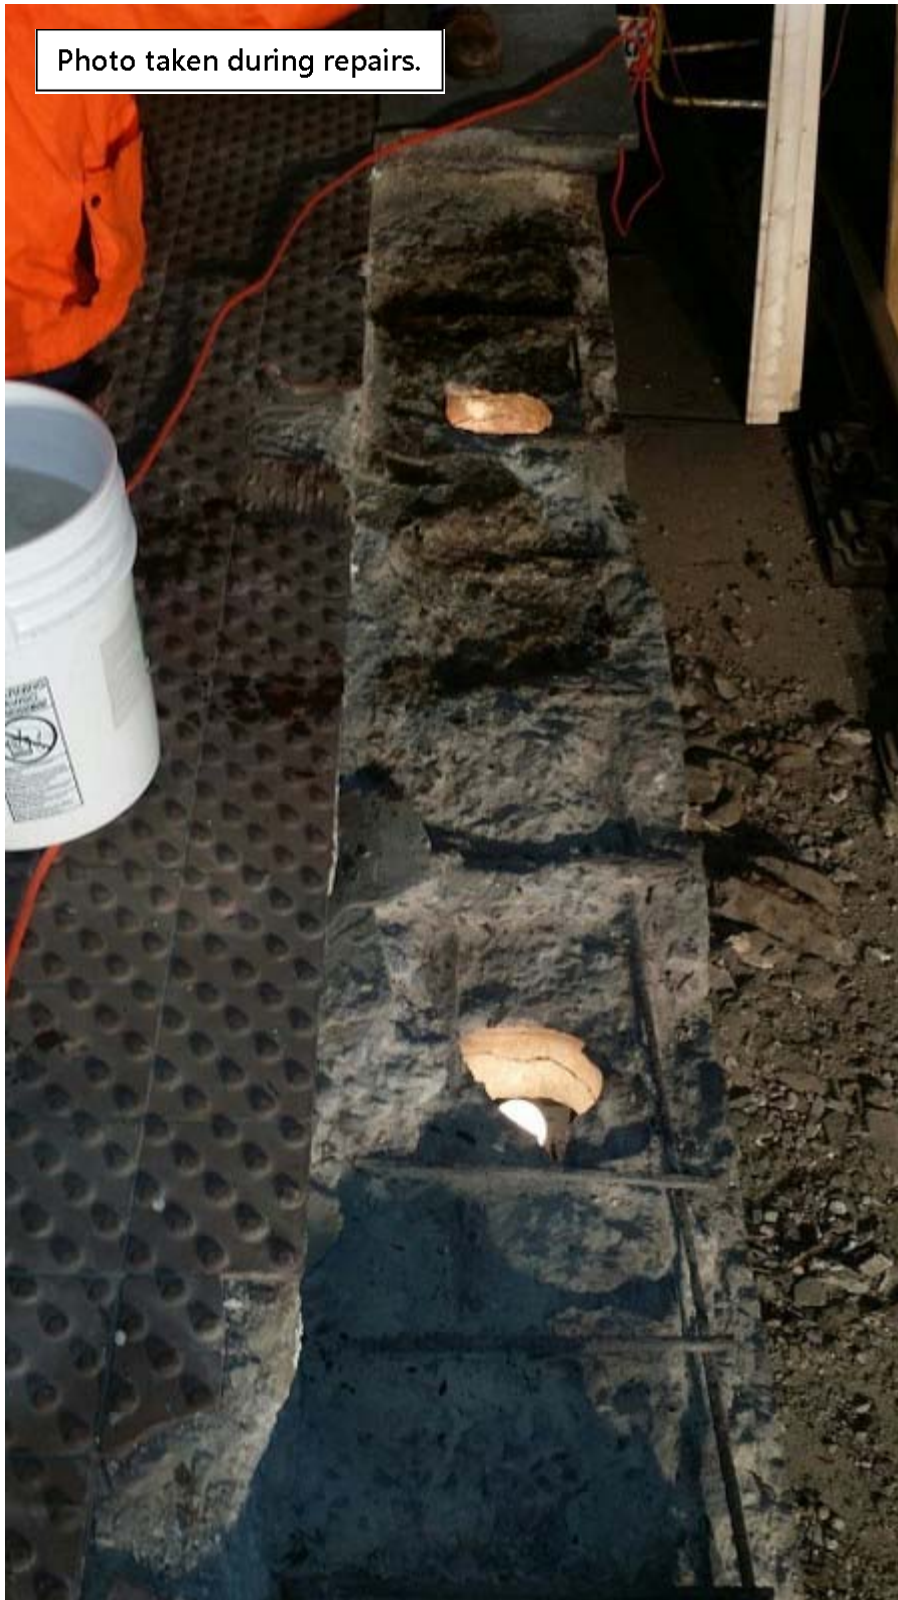
National Airport. TYP platform defects TRK 1-2-3.

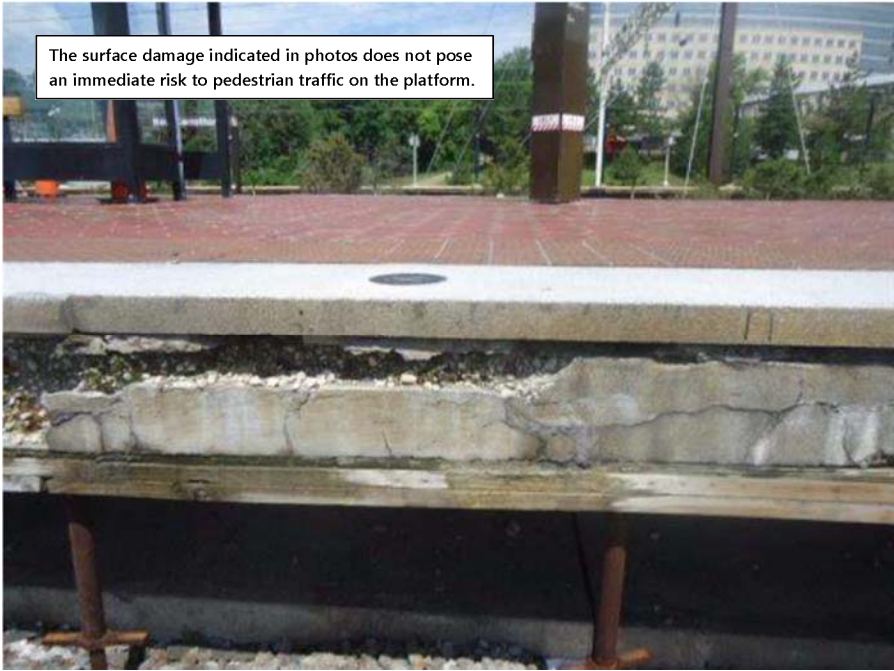
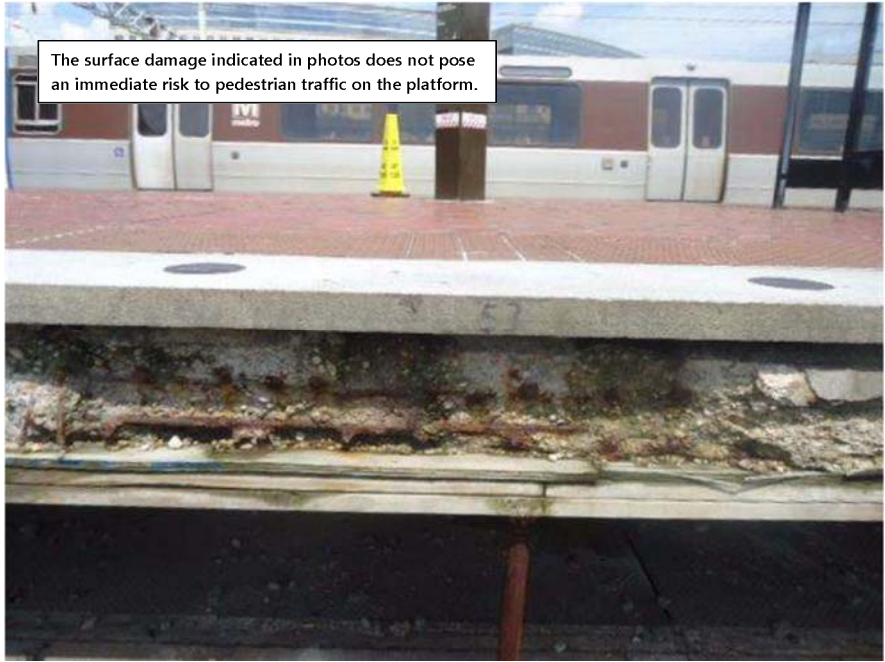
**NC platform. TRK 1-2 TYP defects**
