Washington Metropolitan Area Transit Authority

# Metrorail Structural Inspections

## QICO Internal Review

June 9, 2017

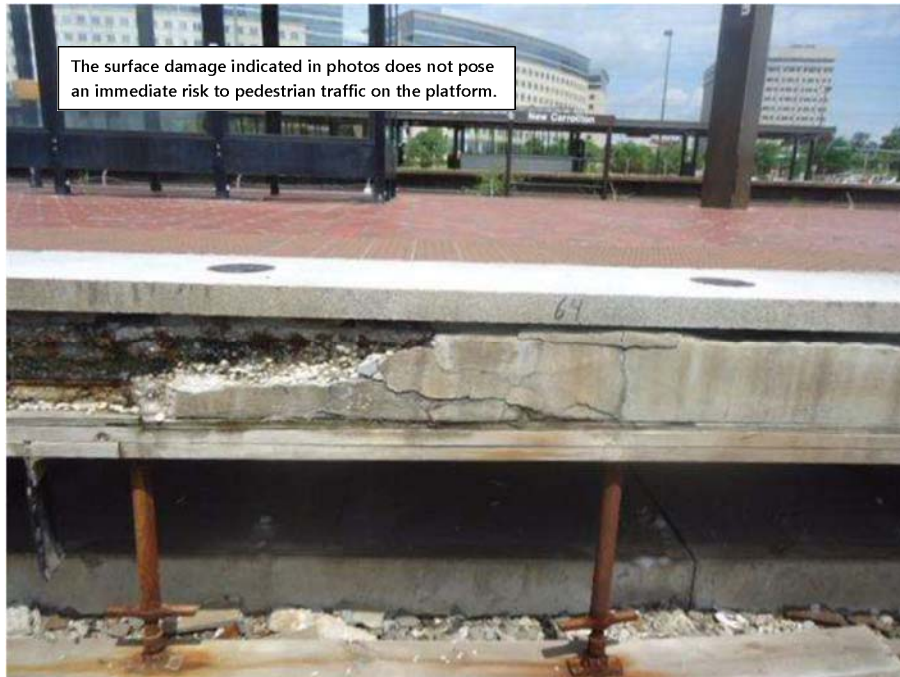
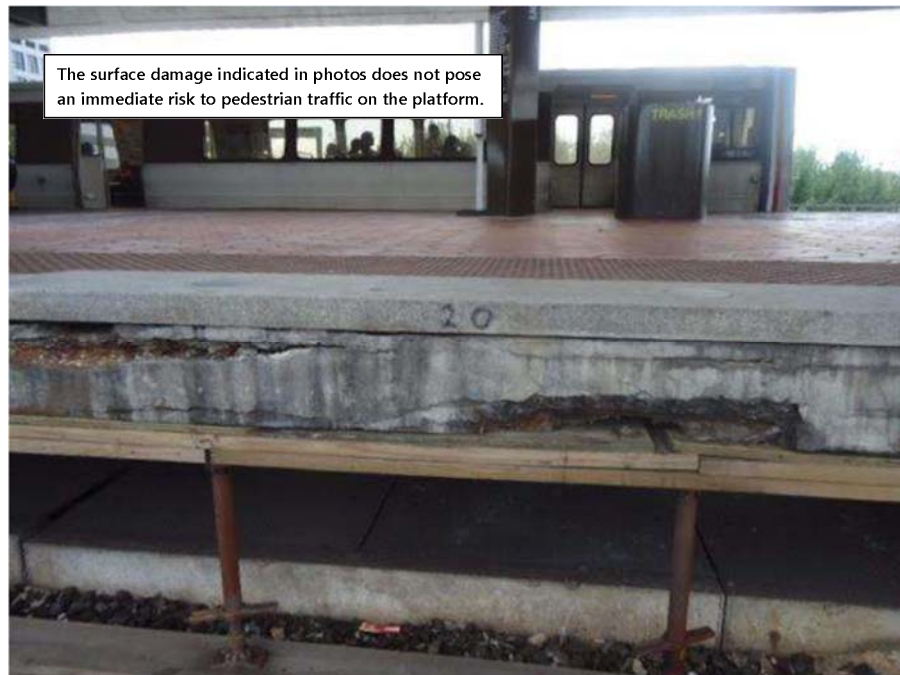
### NC platform. TRK 1-2 TYP defects

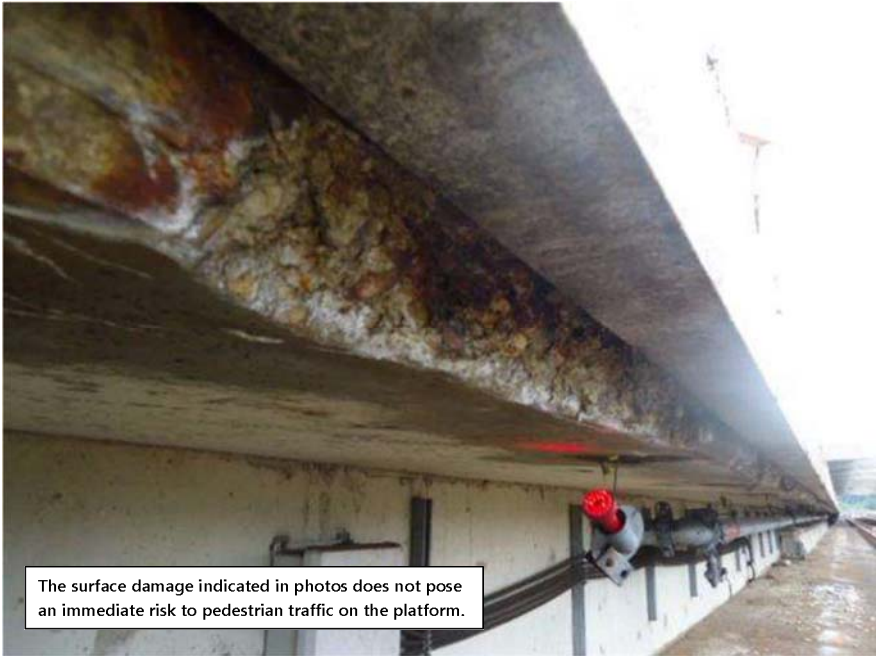
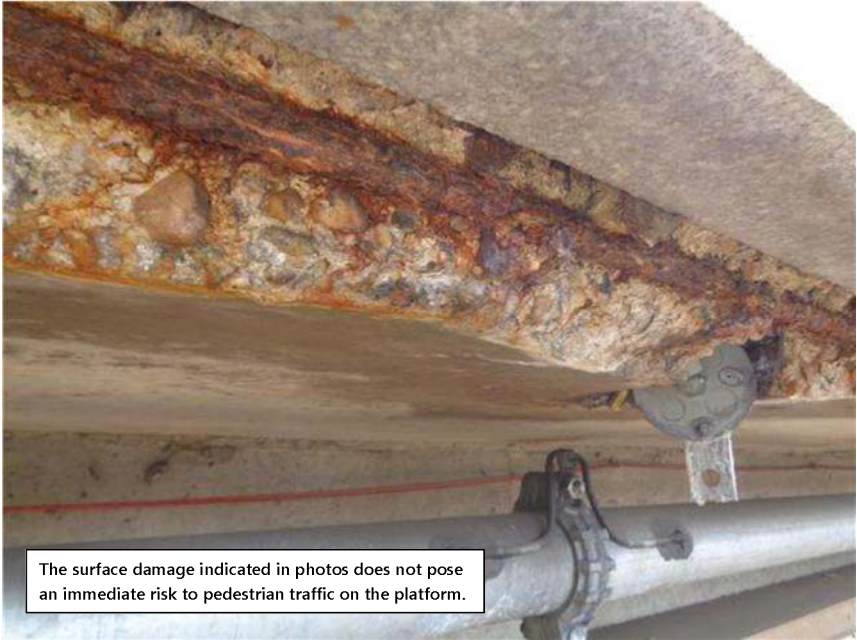
West Hyattsville platform. TYP defects TRK 1-2

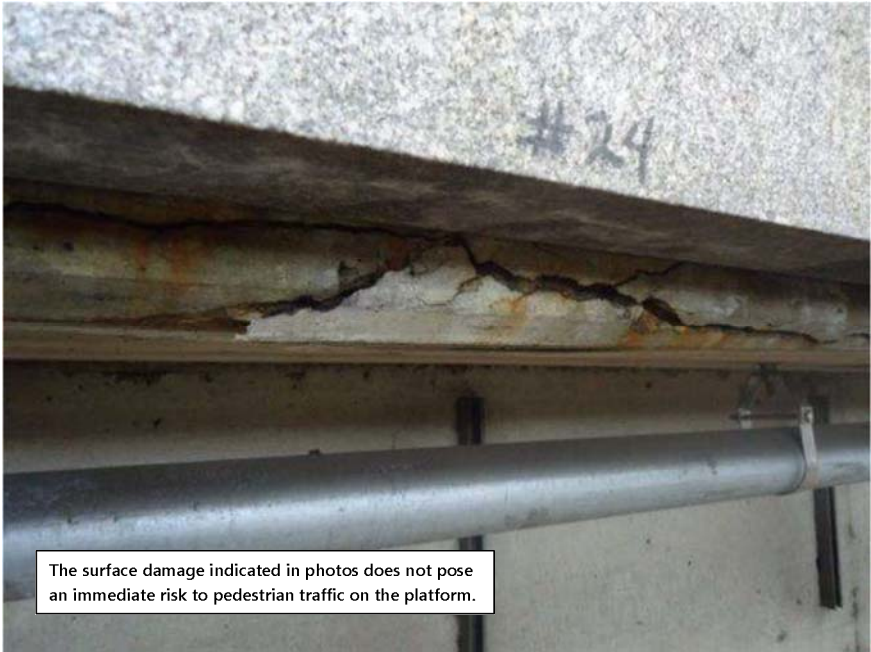
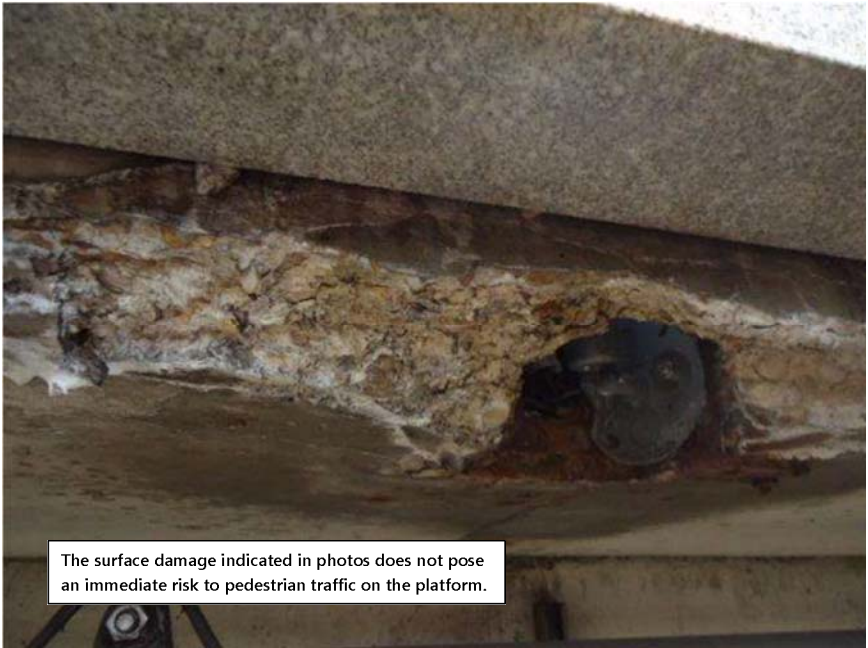
**West Hyattsville platform. TYP defects TRK 1-2**

The surface damage indicated in photos does not pose an immediate risk to pedestrian traffic on the platform.

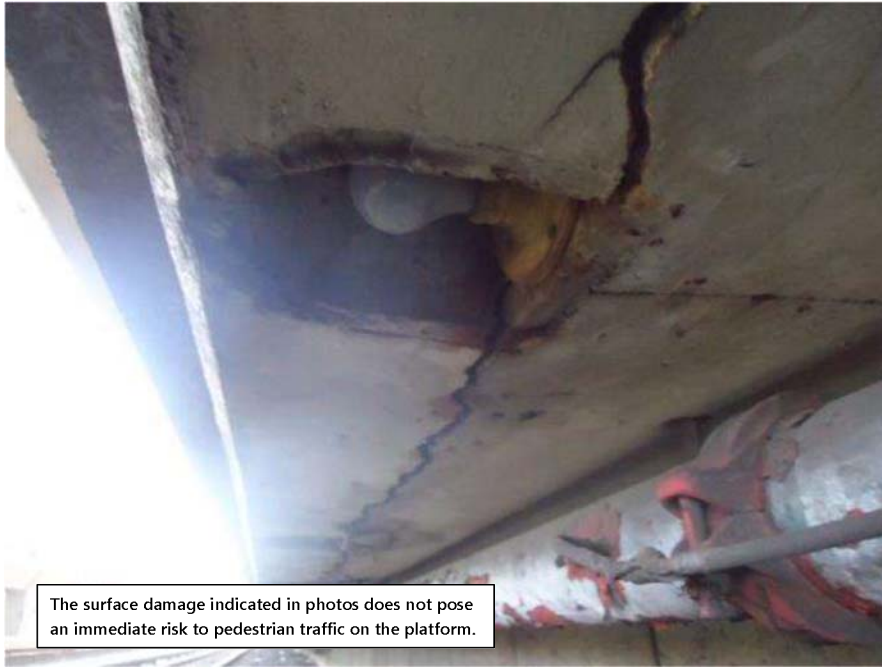
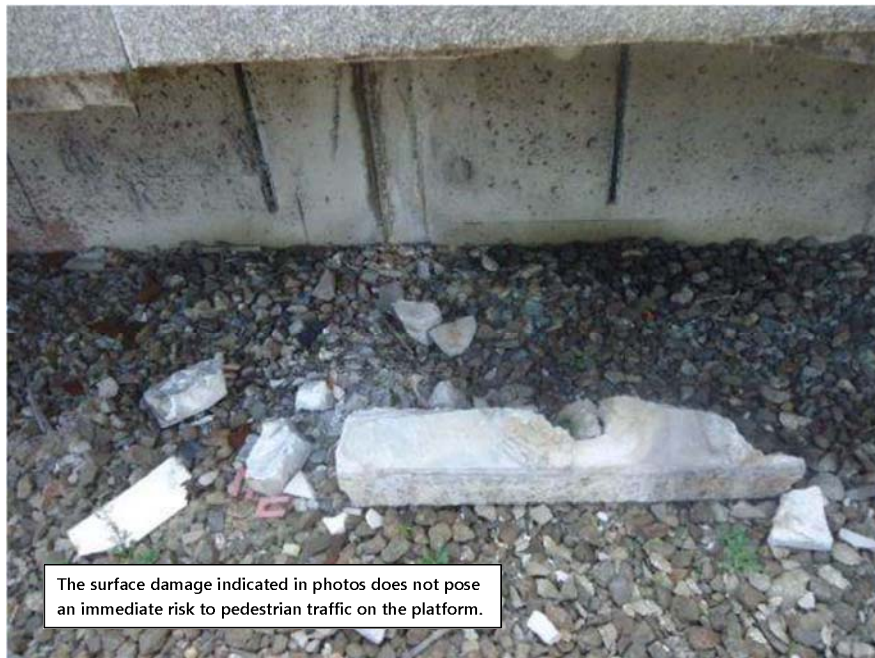
**Cheverly platform. TYP defects TRK 1-2**

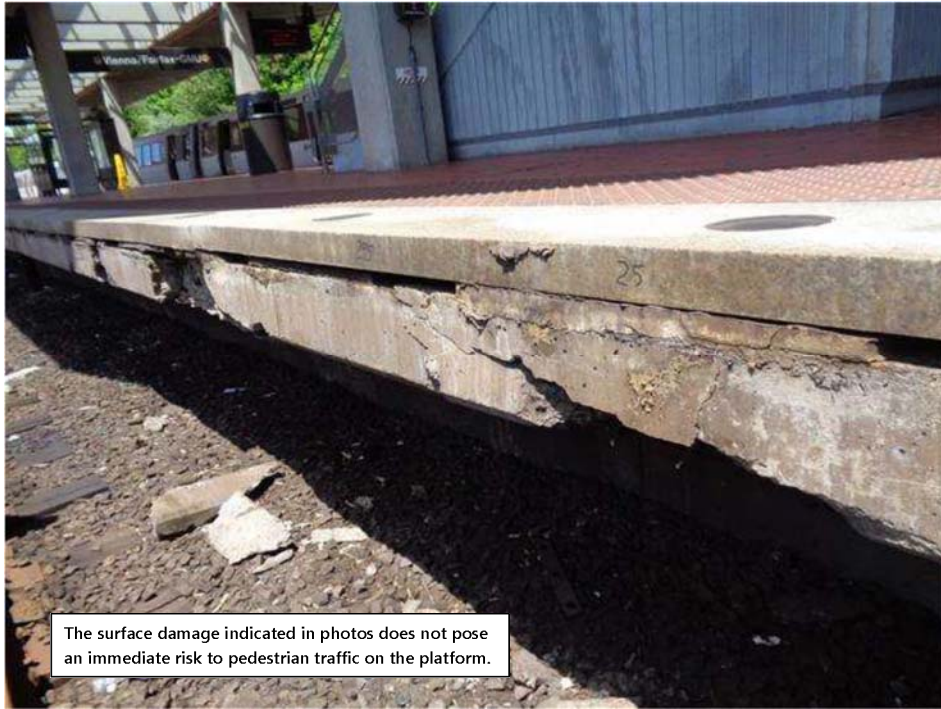
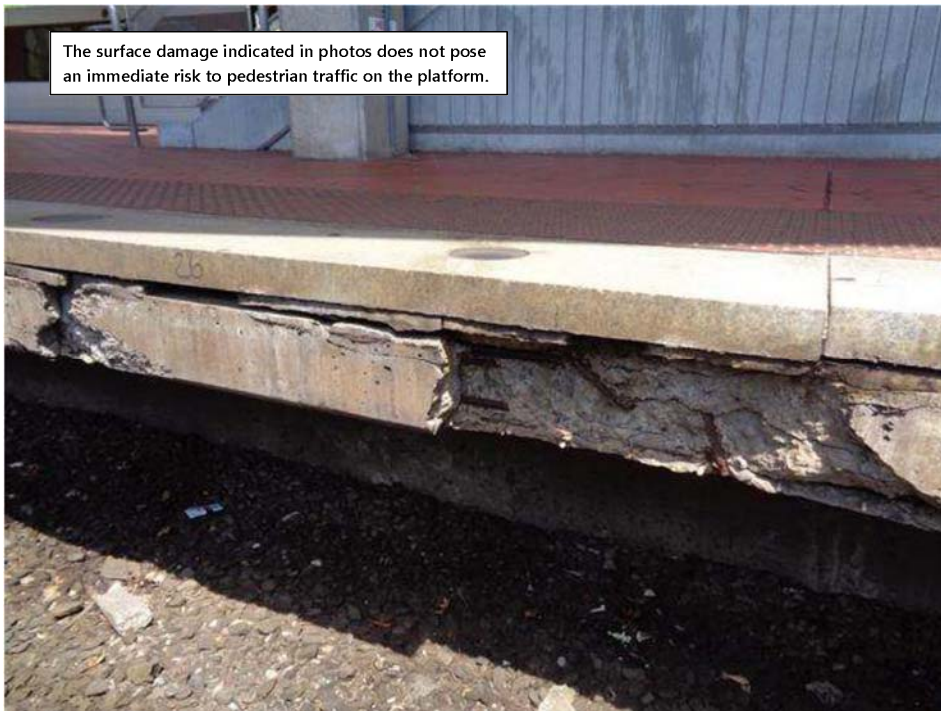
**Vienna platform. TYP defects TRK 1-2**

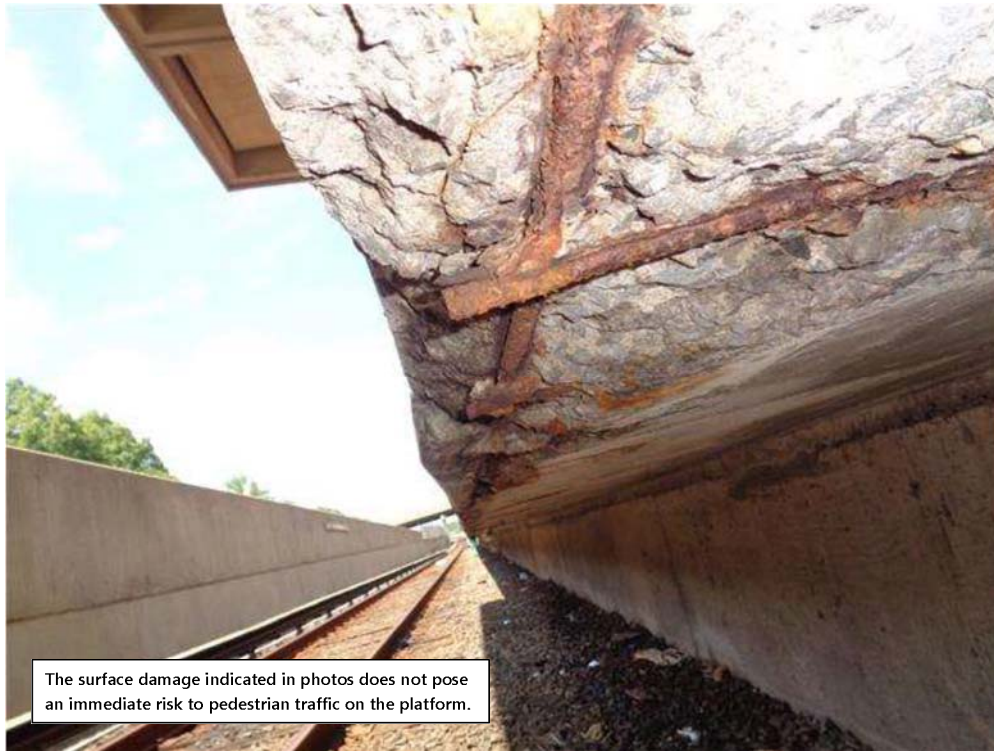
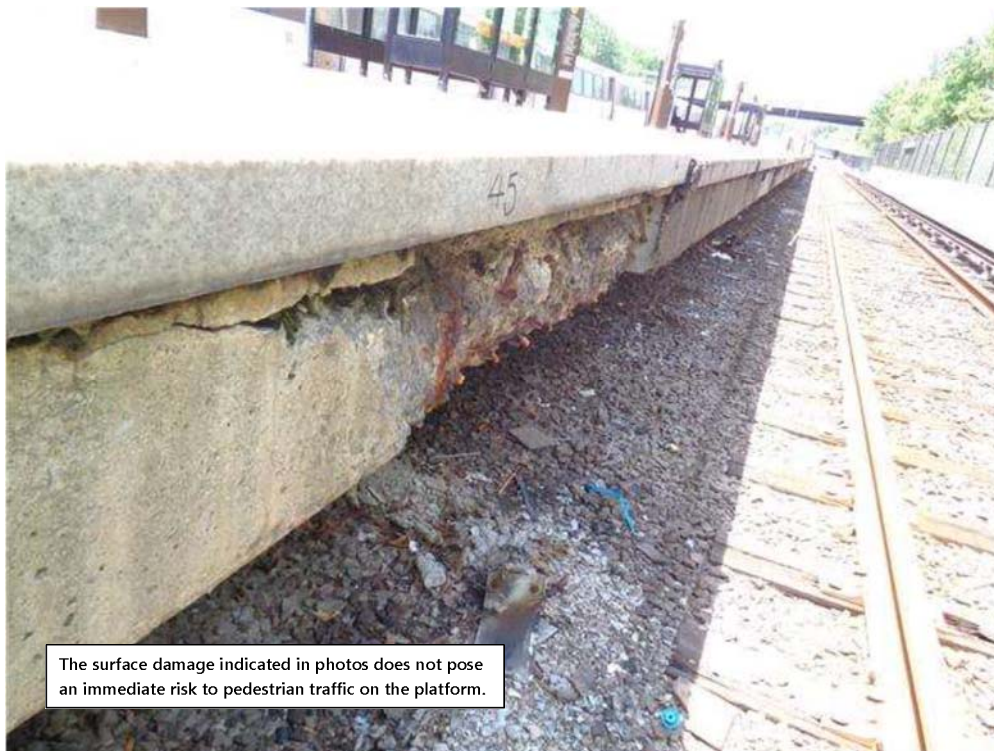
**Vienna platform. TYP defects TRK 1-2**

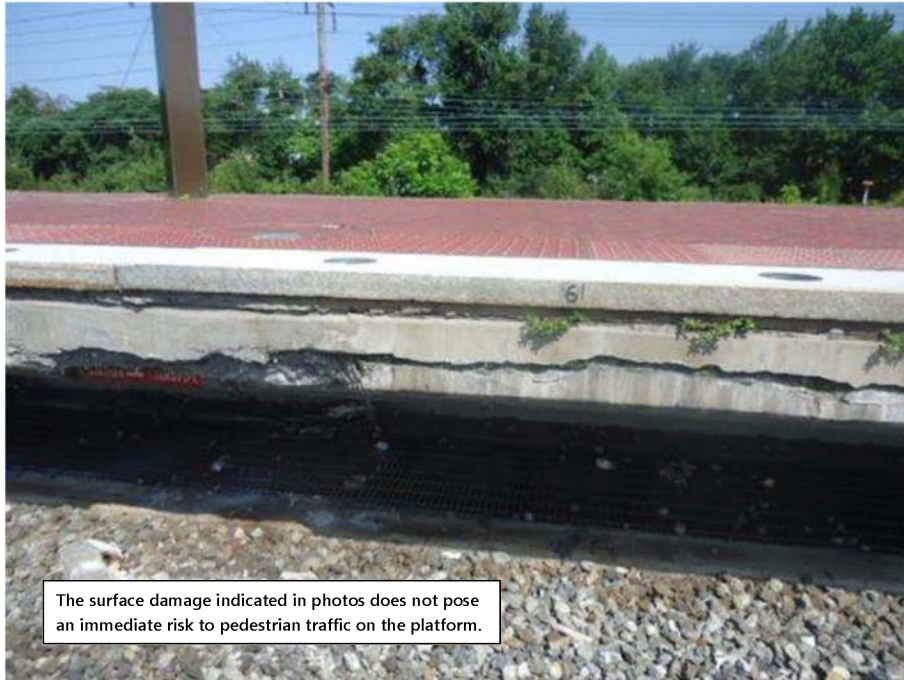
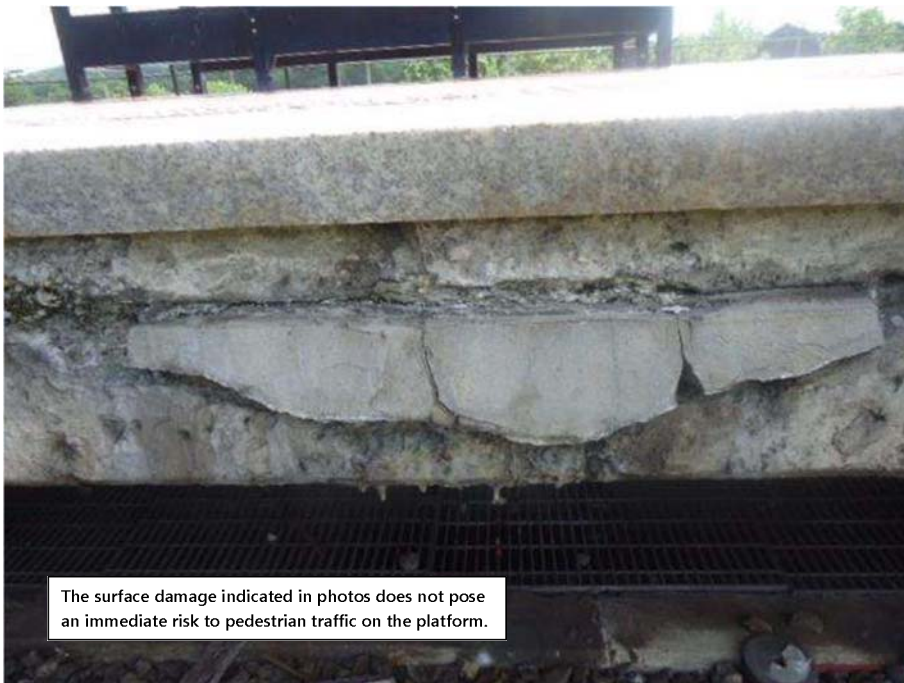
**Landover platform. TYP defects TRK 1-2**

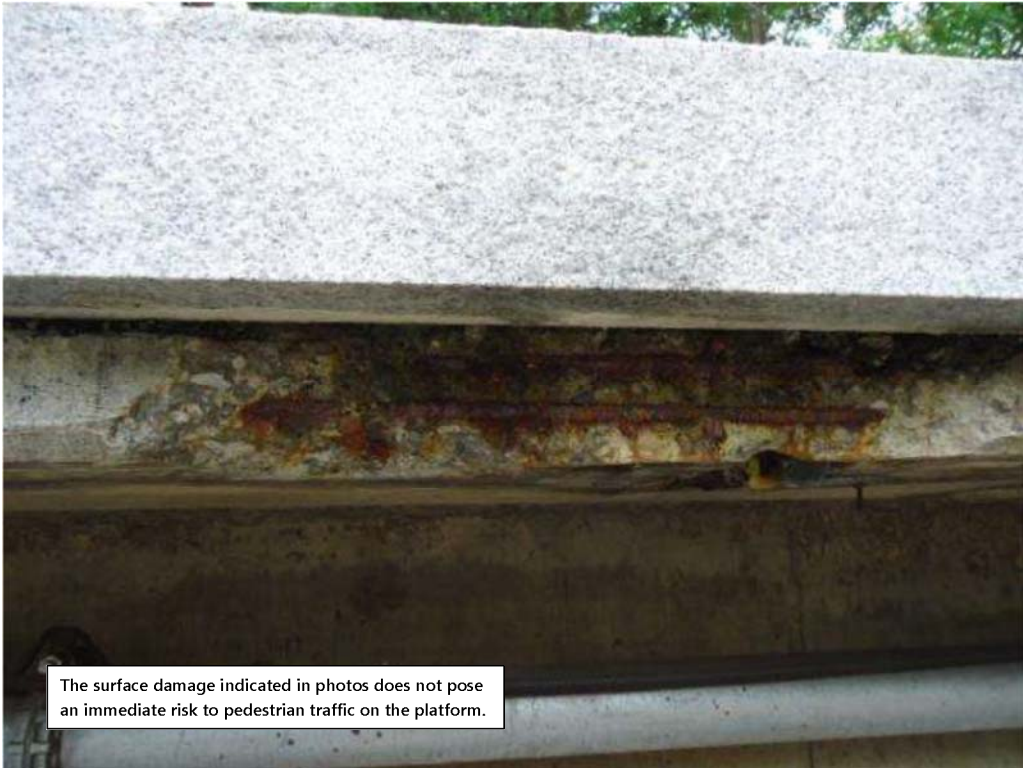
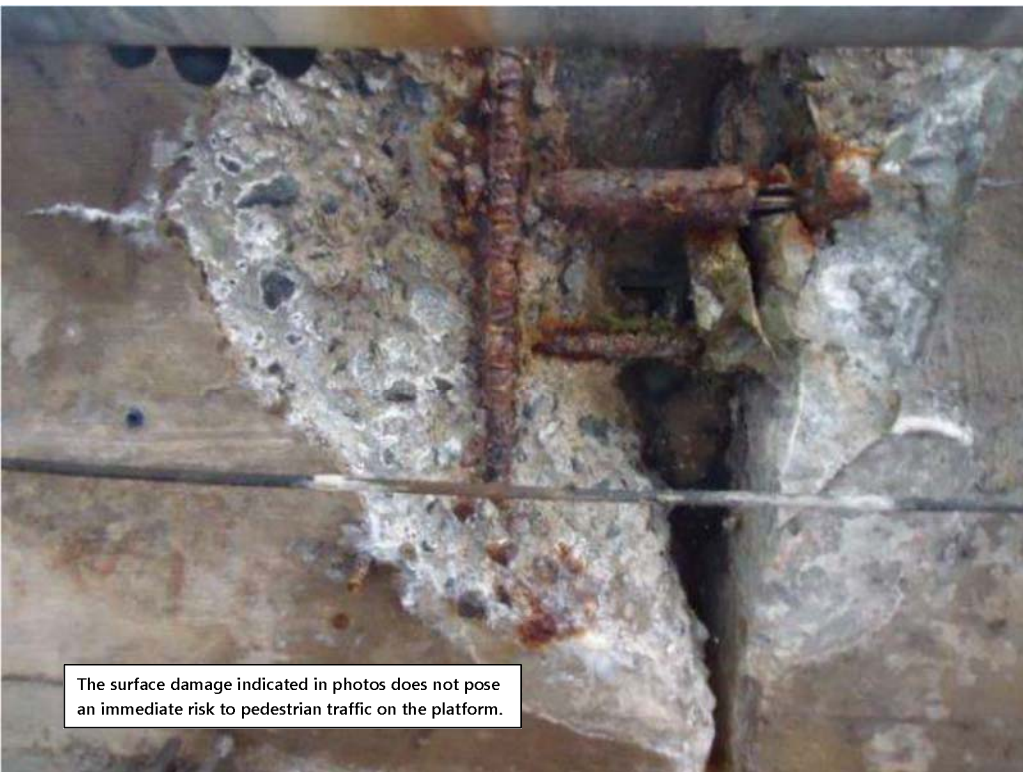
**Arlington Cemetery platform. TYP defects TRK 1-2**

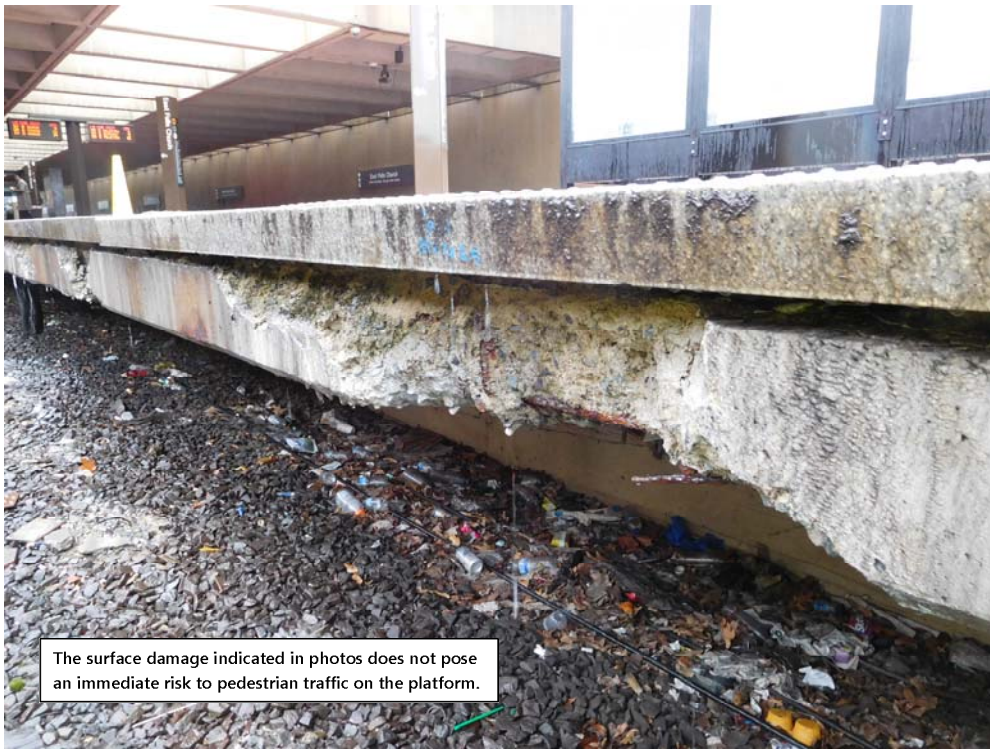
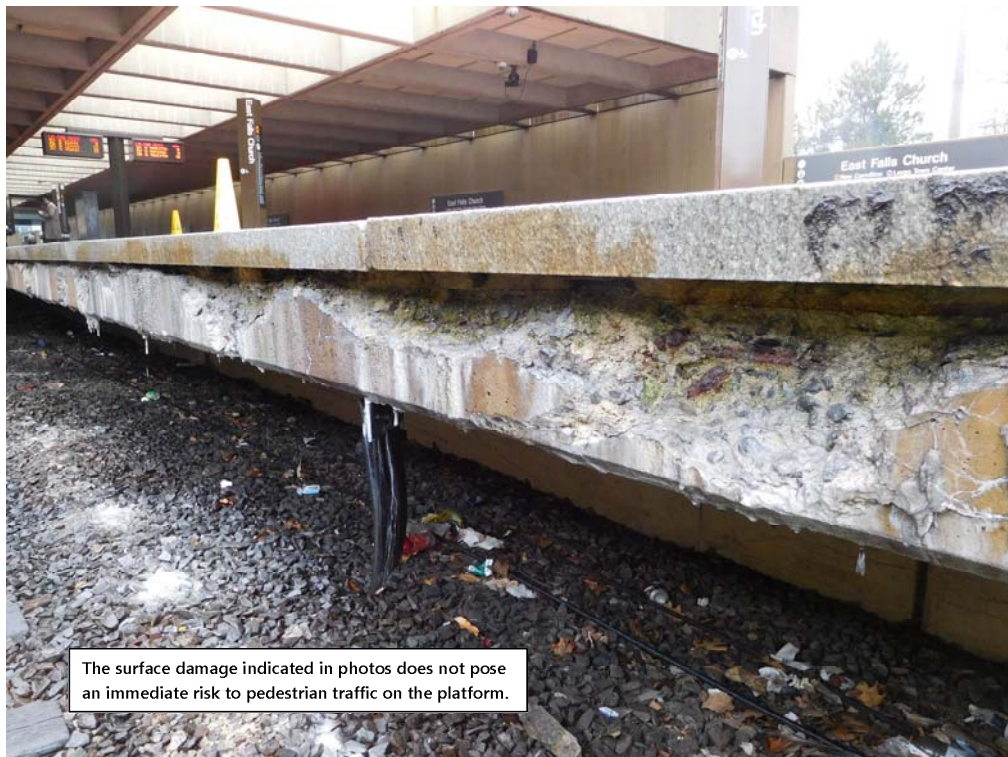
**East Falls Church platform. TYP defects TRK 2**

**STRC rehabbed TRK 1 during surge 11**

The surface damage indicated in photos does not pose an immediate risk to pedestrian traffic on the platform.

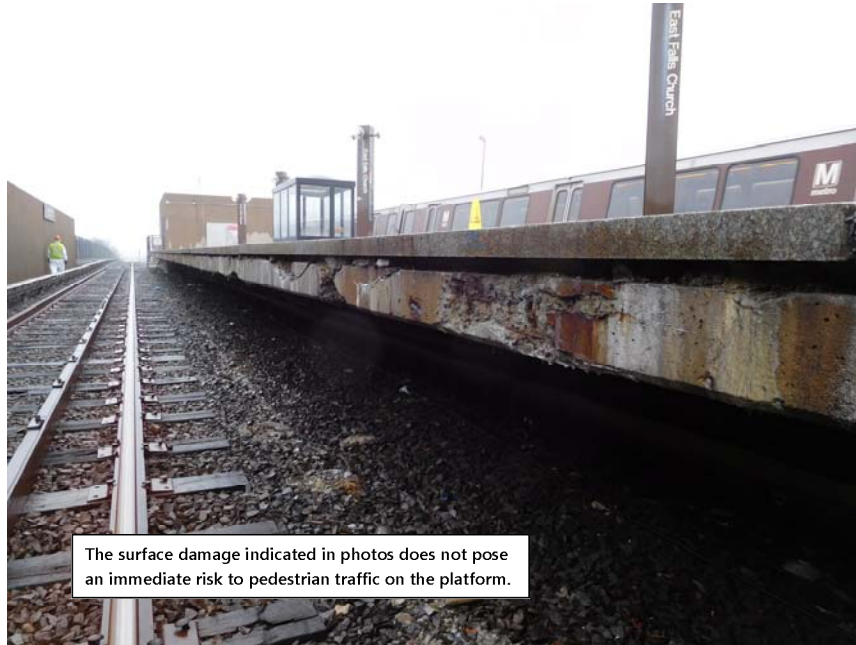
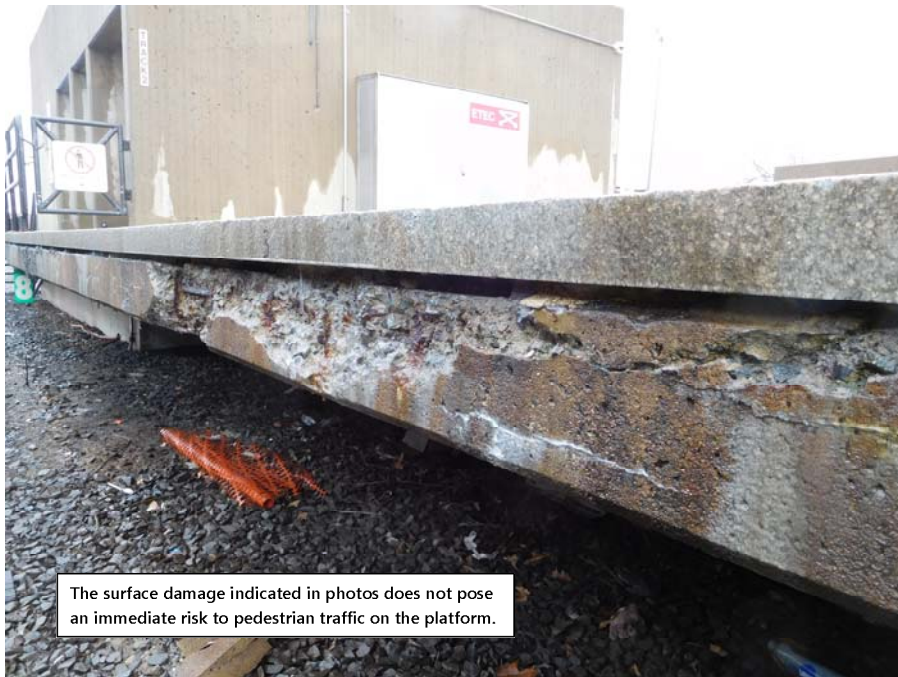
**East Falls Church platform. TYP defects TRK 2**

**STRC rehabbed TRK 1 during surge 11**

The surface damage indicated in photos does not pose an immediate risk to pedestrian traffic on the platform.

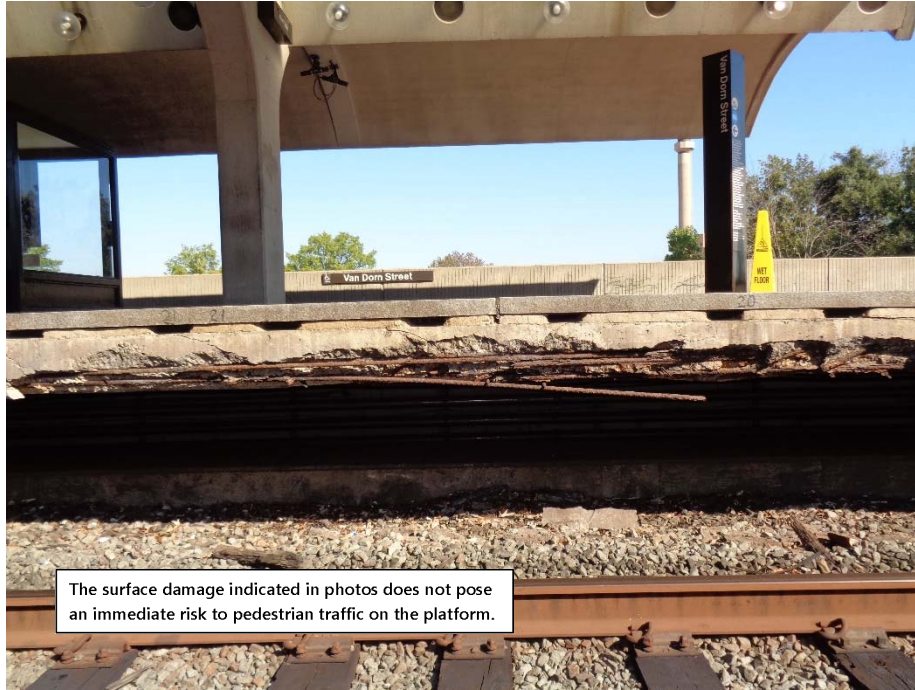
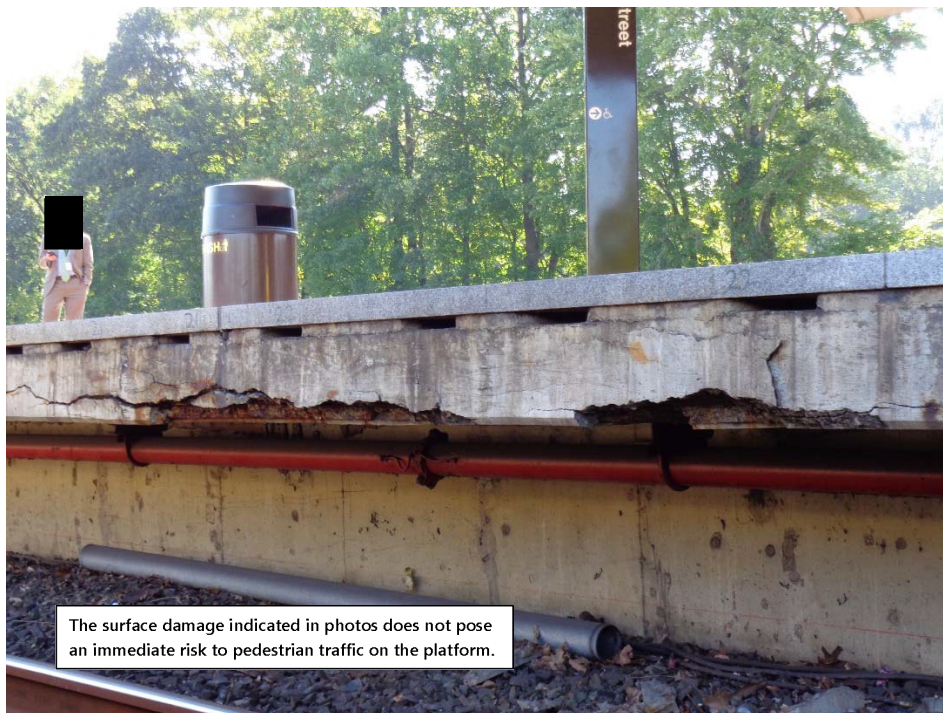
**Van Dorn Station platform. TYP defects TRK 1-2**

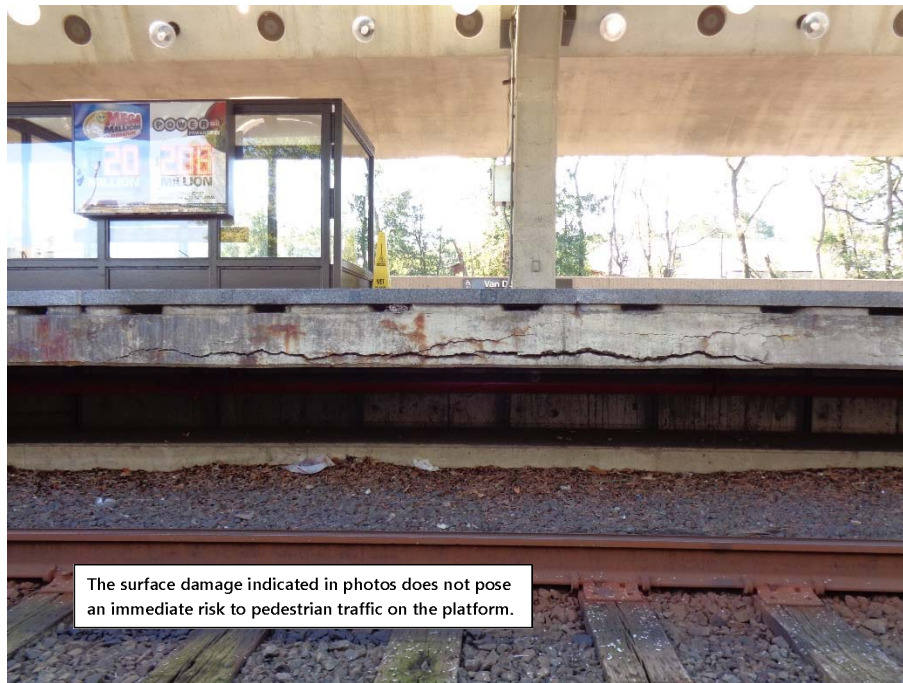
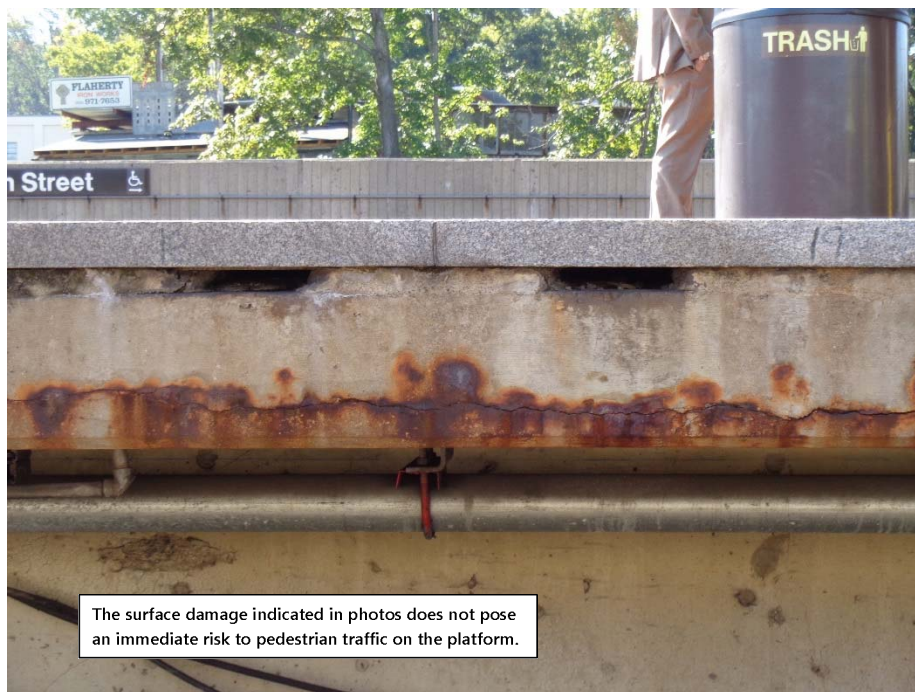
**Van Dorn Station platform. TYP defects TRK 1-2**

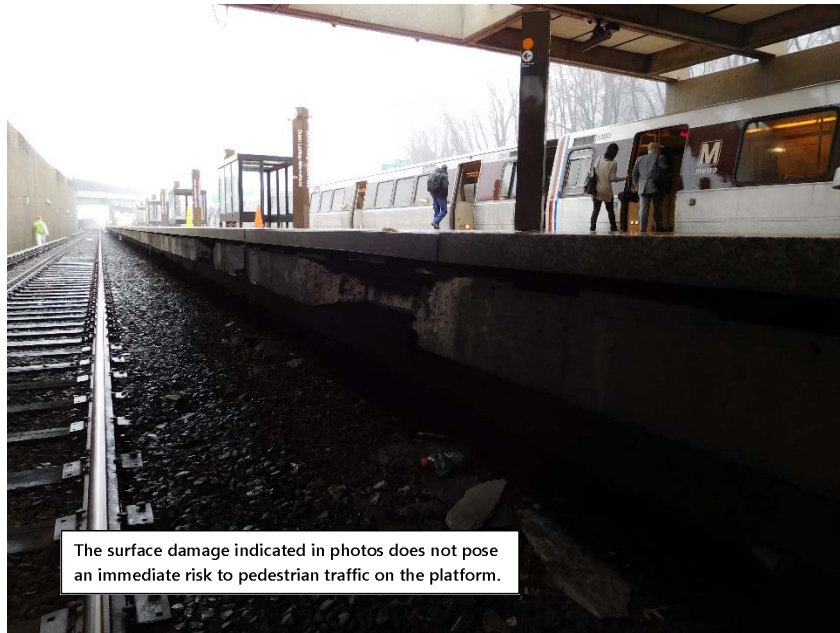
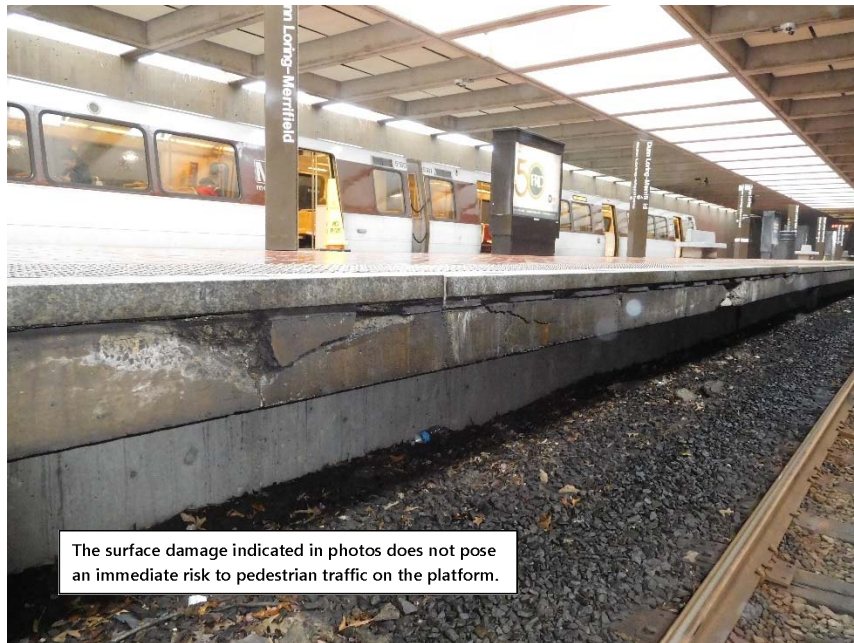
**Dunn Loring Station platform. TYP defects TRK 1-2**

**STRC corrected TRK 2 during surge 9**

The surface damage indicated in photos does not pose an immediate risk to pedestrian traffic on the platform.

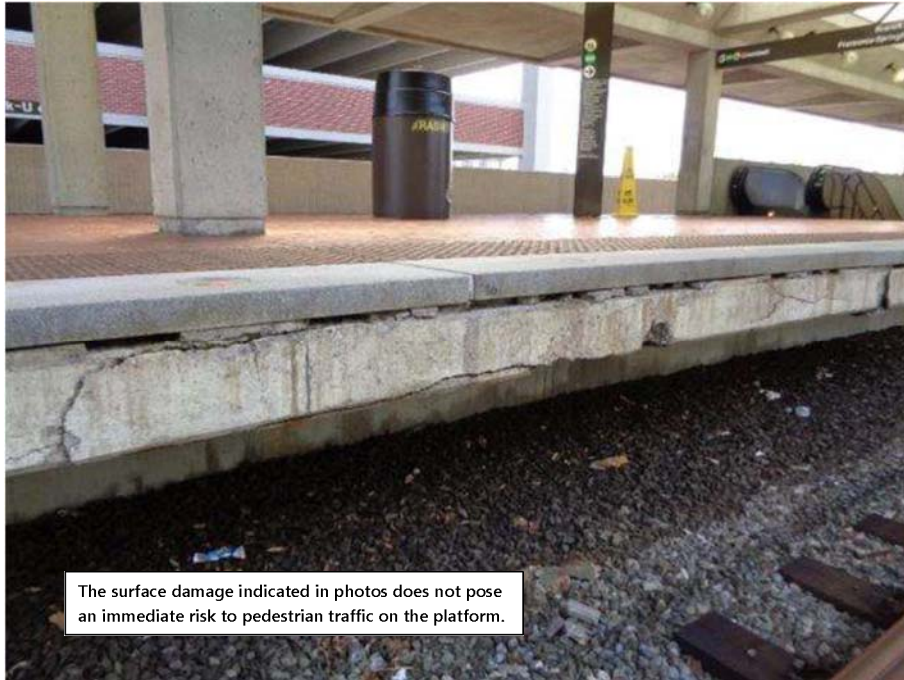
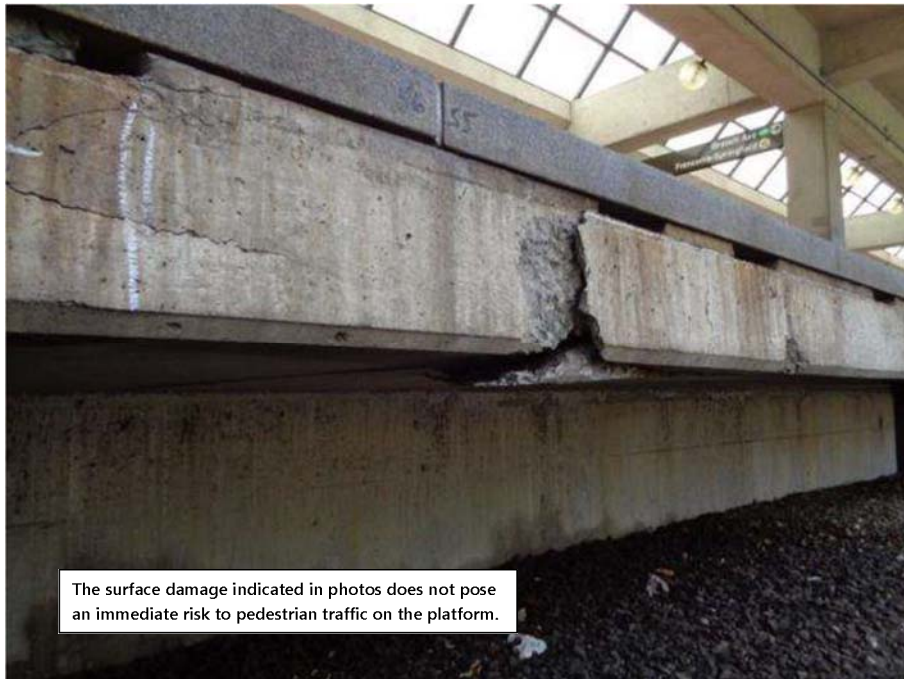
College Park platform TRK 2

The surface damage indicated in photos does not pose an immediate risk to pedestrian traffic on the platform.

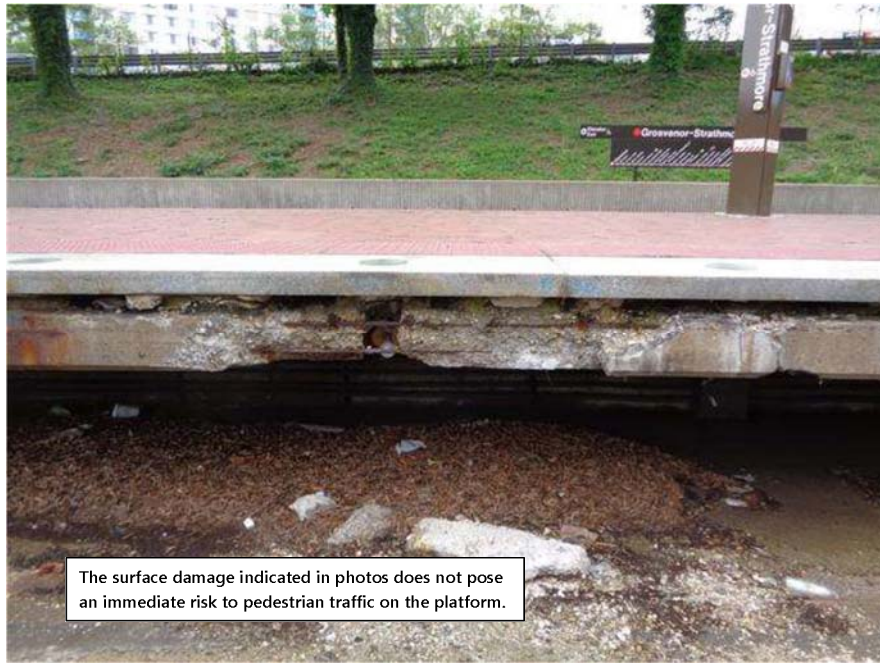
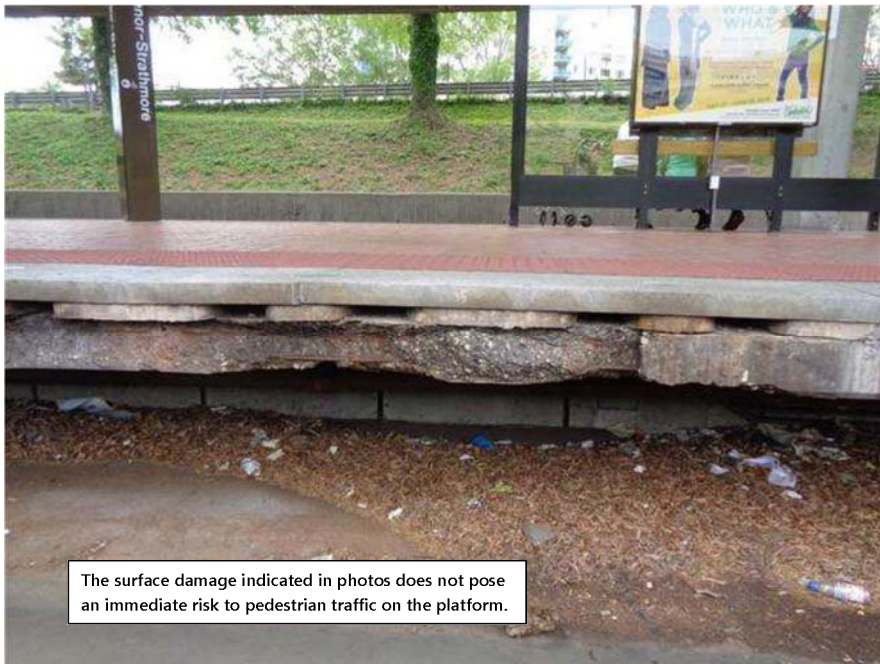
Grosvenor Station platform. TYP defects TRK 1-2

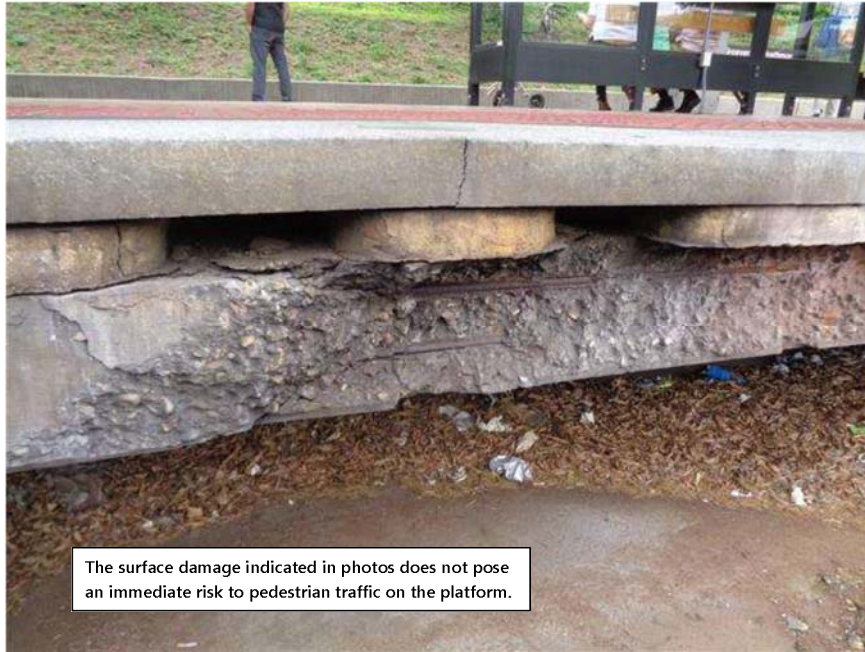
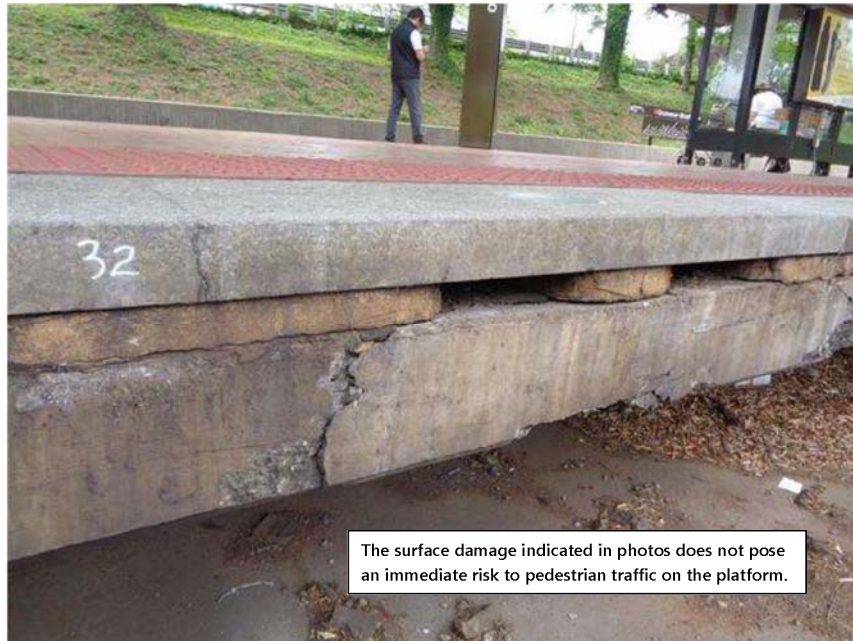
Grosvenor Station platform. TYP defects TRK 1-2

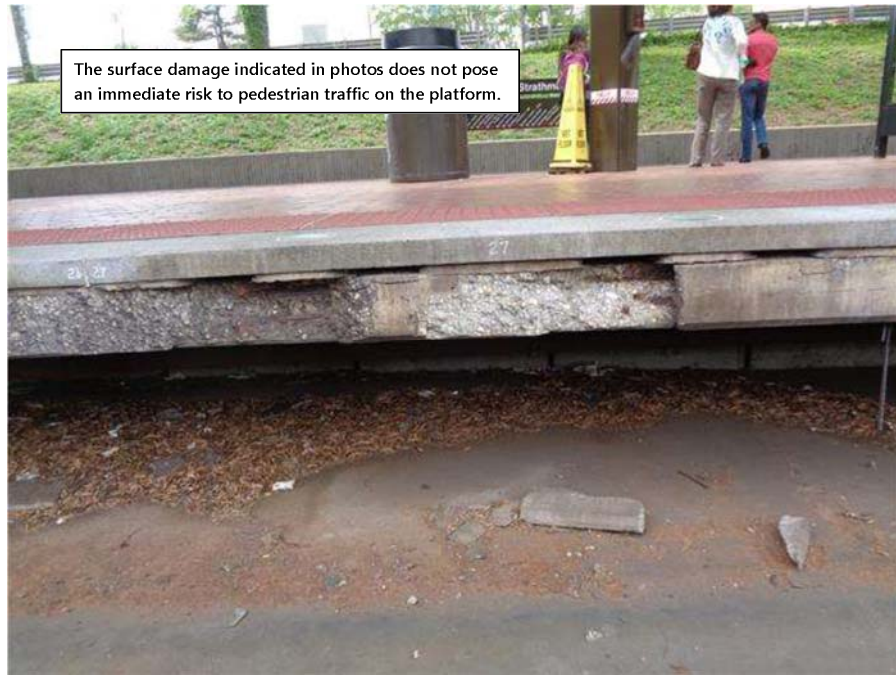
**Grosvenor Station platform. TYP defects TRK 1-2**

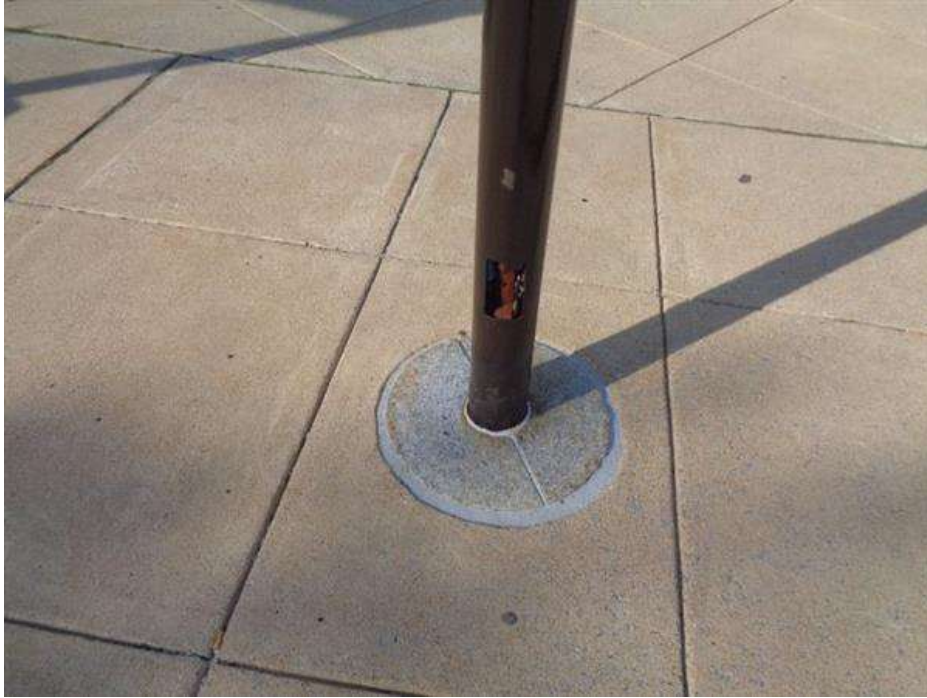
Photo 37

Cover plate for light post is missing.

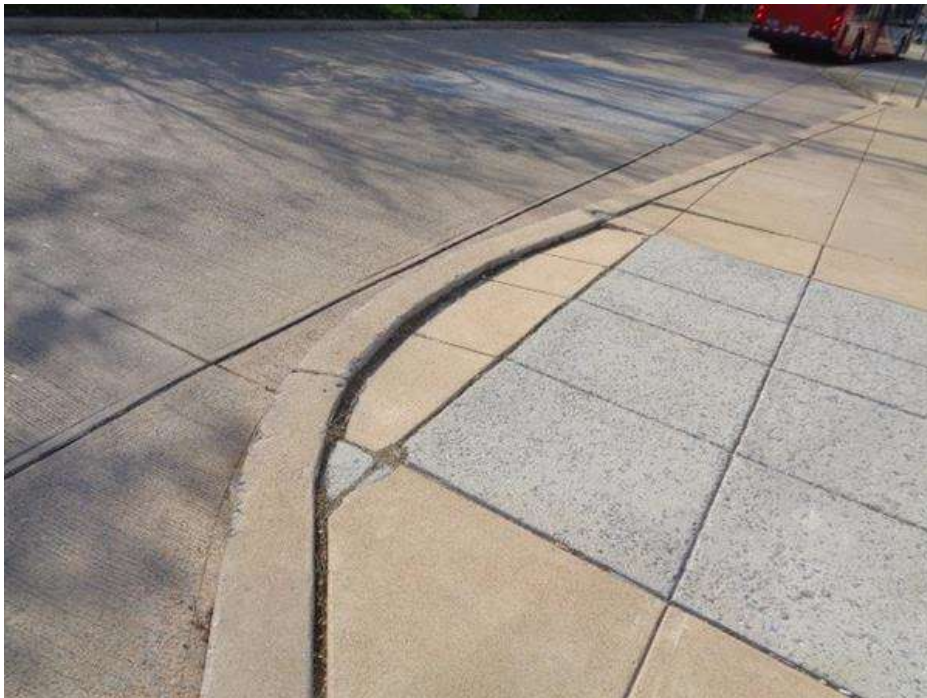
Photo 38

North side walk between bus loops M8, M9 has sank 2.5".

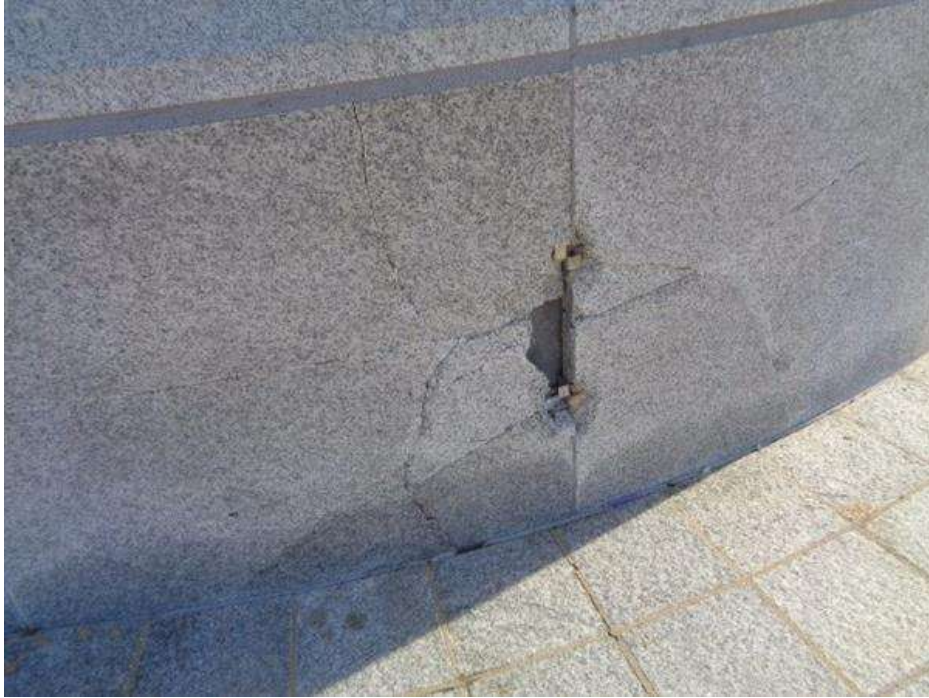
Photo 39

Collision damage to the parapet wall on the north side entrance.
