Washington Metropolitan Area Transit Authority

# Metrorail Structural Inspections

## QICO Internal Review

June 9, 2017

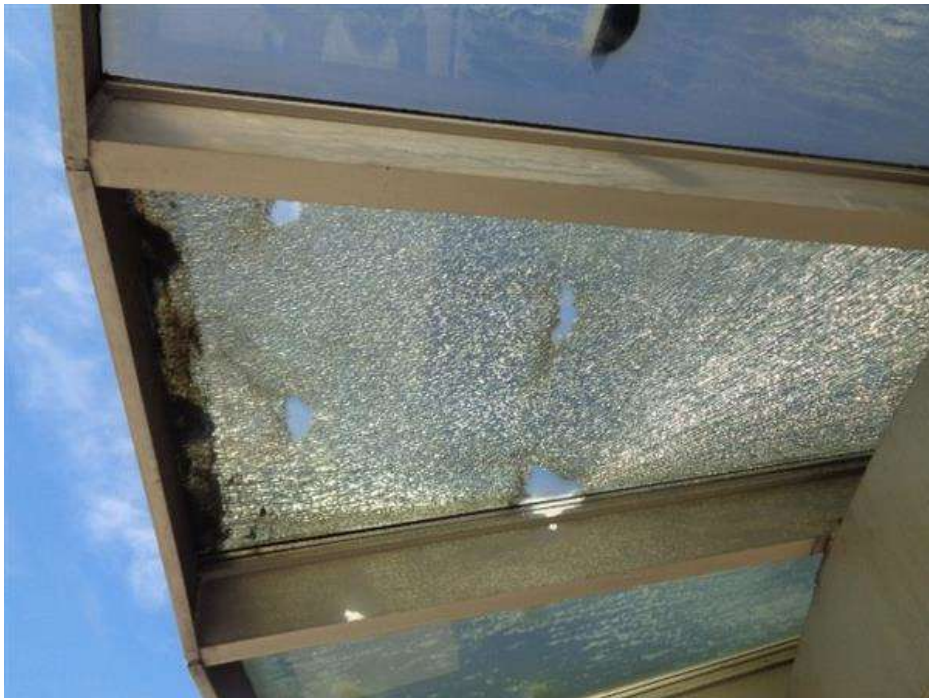
Photo 40

Cracked glass panel on the canopy on the north side.
