Northern Bus Garage Reconstruction Project

Summer Community Meeting

August 14, 2023

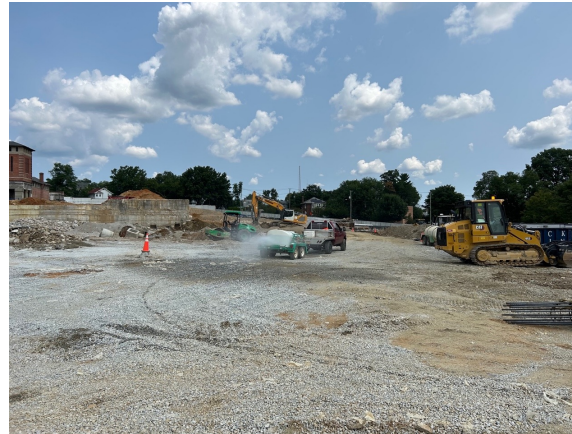
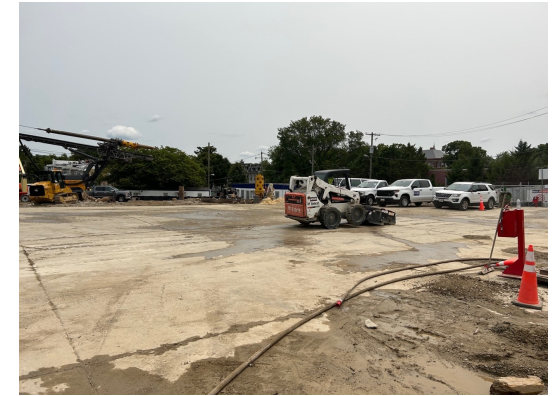
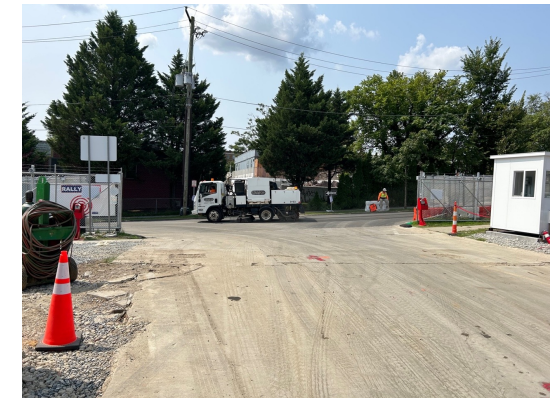
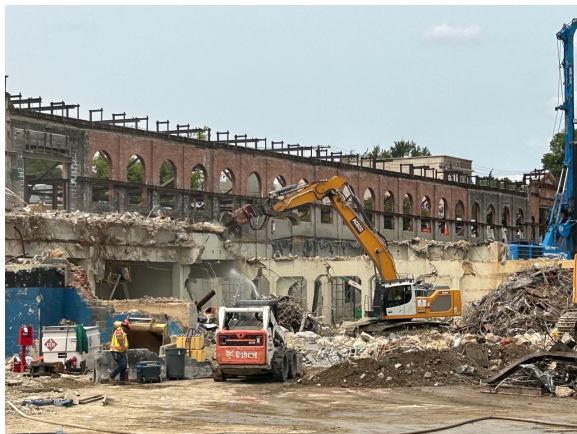
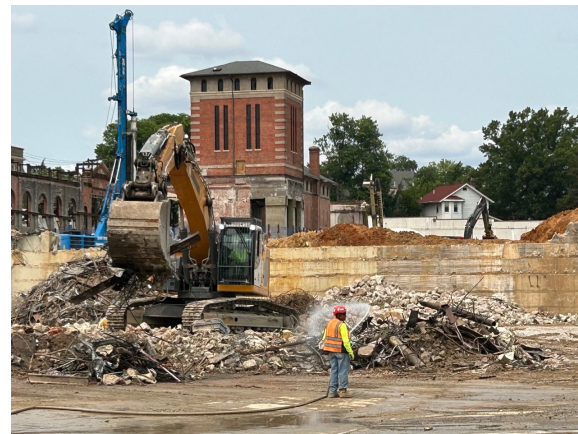
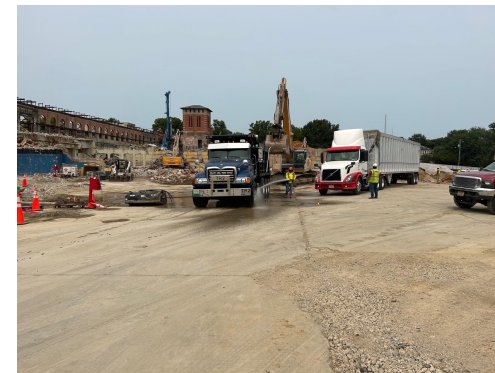
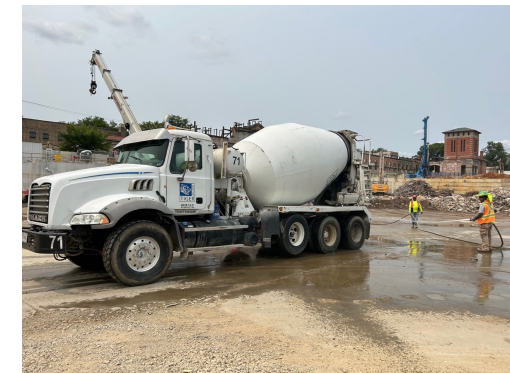
Housekeeping Best Practices

- All Erosion and Sedimentation Control (ESC) measures regularly maintained and inspected after each storm event
- Street sweeping to manage tracking from the site and within the site
- Wash construction vehicle wheels before exiting when muddy
- DOEE-compliant dust management being used for demolition activities
- All food waste is captured in dedicated trash receptacles
- Required daily work area clean up

- Pest control subcontractor retained with regular monitoring of project
- Bait stations are maintained at 50 feet on center around perimeter of project inside the fence line (51 total)

- Street sweeping
- Water application on haul roads
- Wheel washing
- Stone covering

- Dust suppression with hose spray

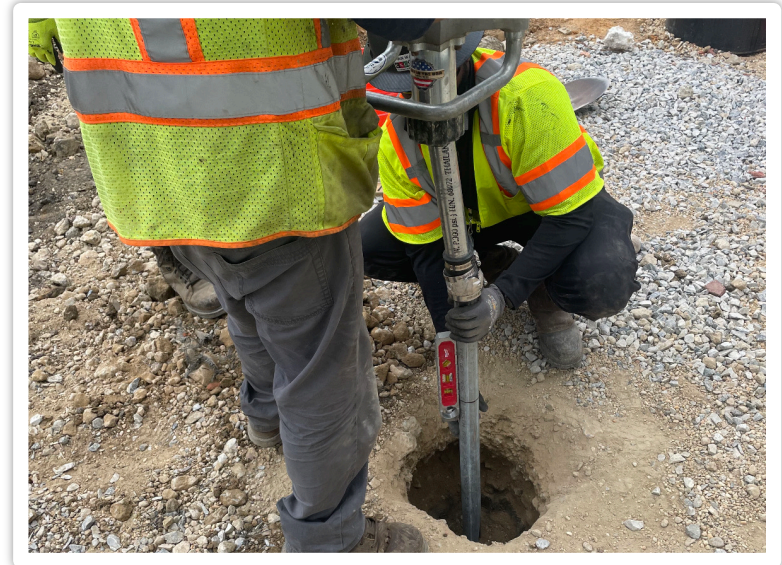
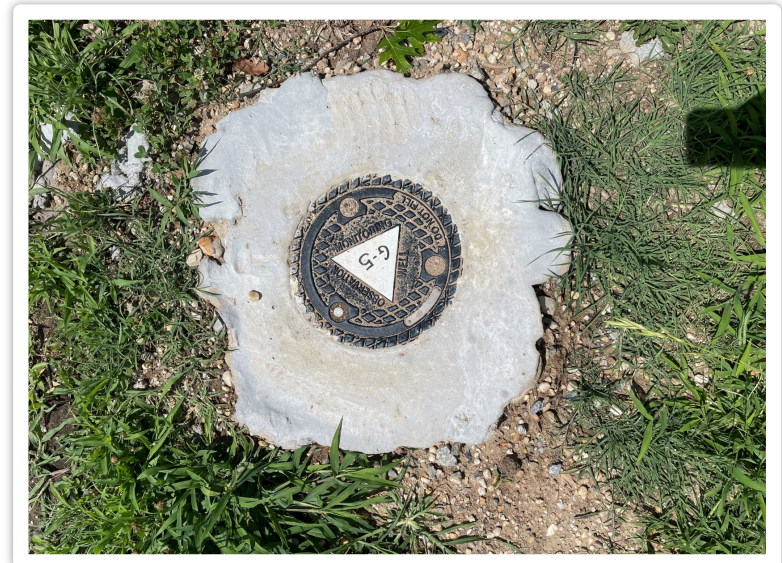
- Completed asbestos abatement
- Managing all excavated soils per DOEE and District regulations

- Completed installation of in-ground monitoring instruments
 - Inclinometers
 - Observation wells
 - Utility monitoring points (UMP's)
 - Ground monitoring points (GMP's)

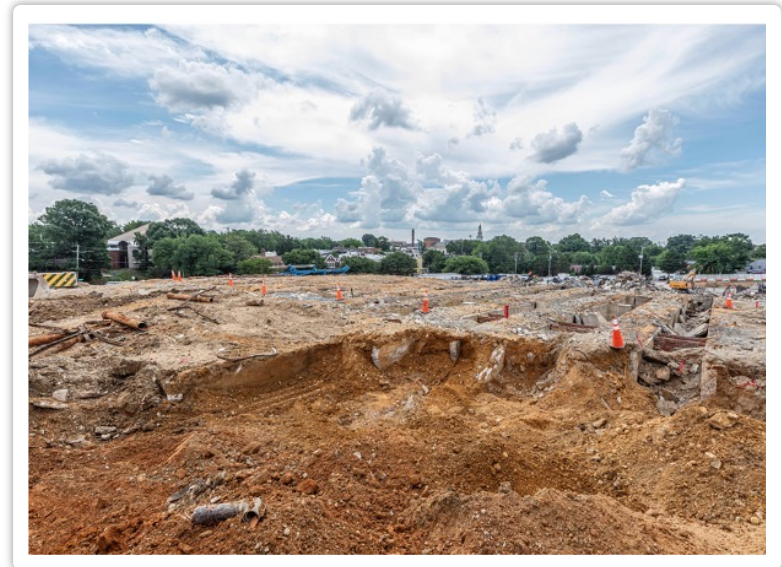
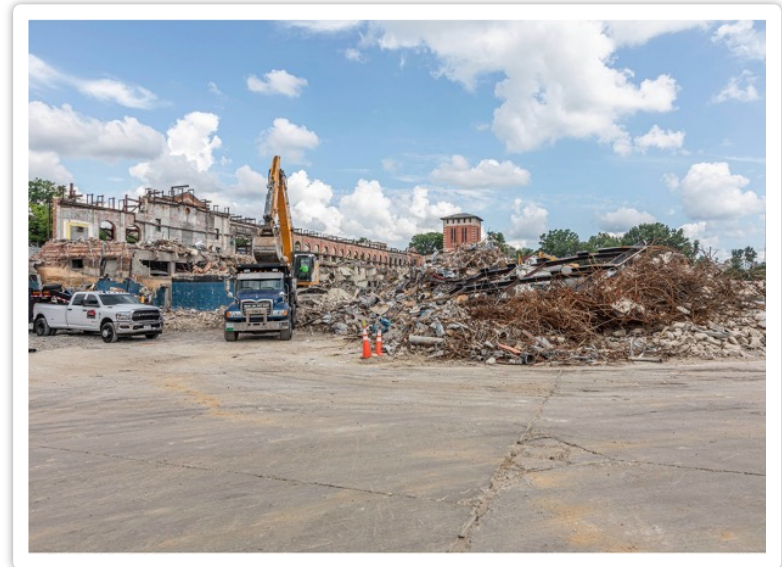
- Completed bulk demolition of historic car barn
- Removed remnants of historic trolley pits discovered under the floor slabs
- Completed hand separation at historic façade
- Continue to process demolition debris for recycling
- Over 95% of demolition waste is being diverted from landfills

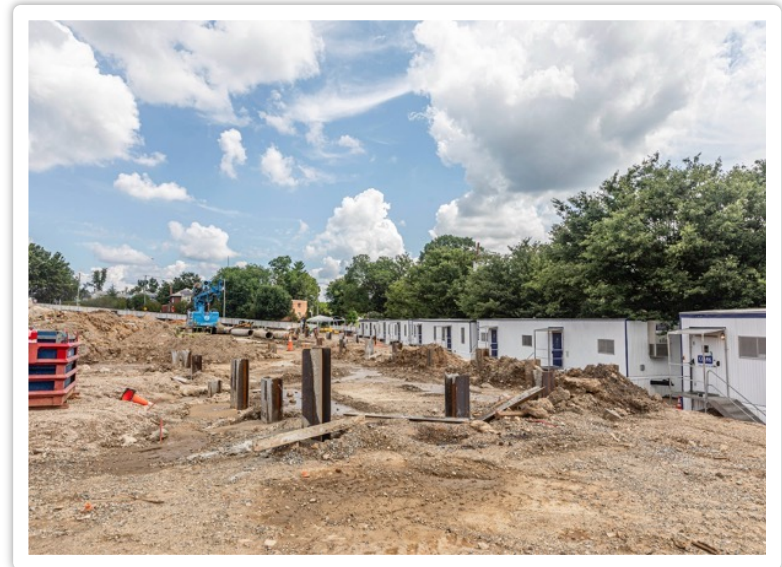
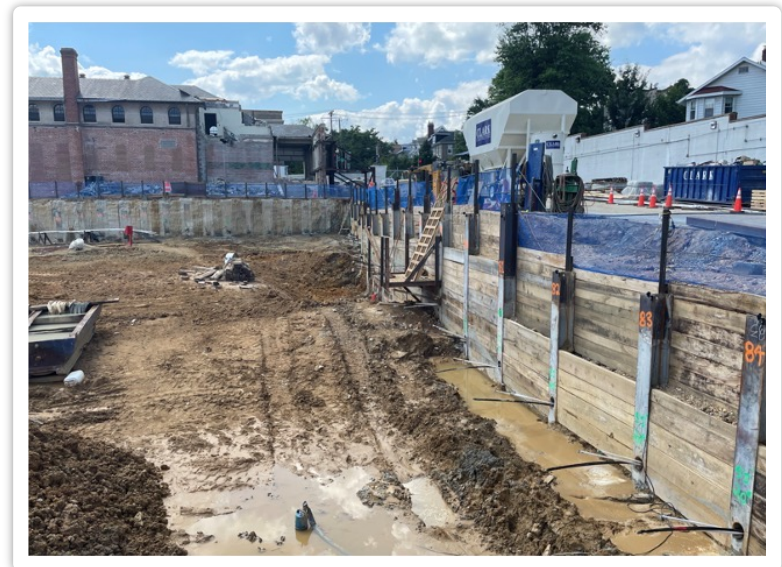
- Completed drilling SOE pile installation east of the historic administration building
- Starting installation of lagging and tiebacks
- Completed drilling SOE piles for new storm water cisterns and tanks
- Mass excavation for new building basement underway

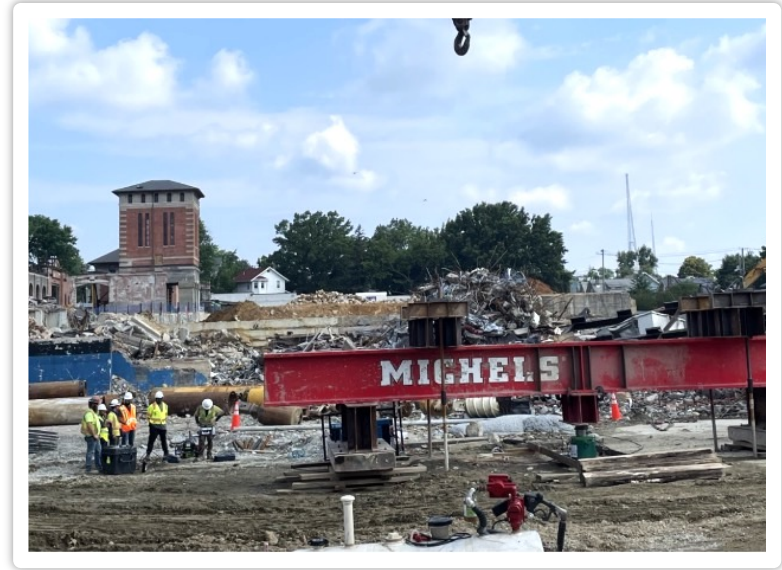
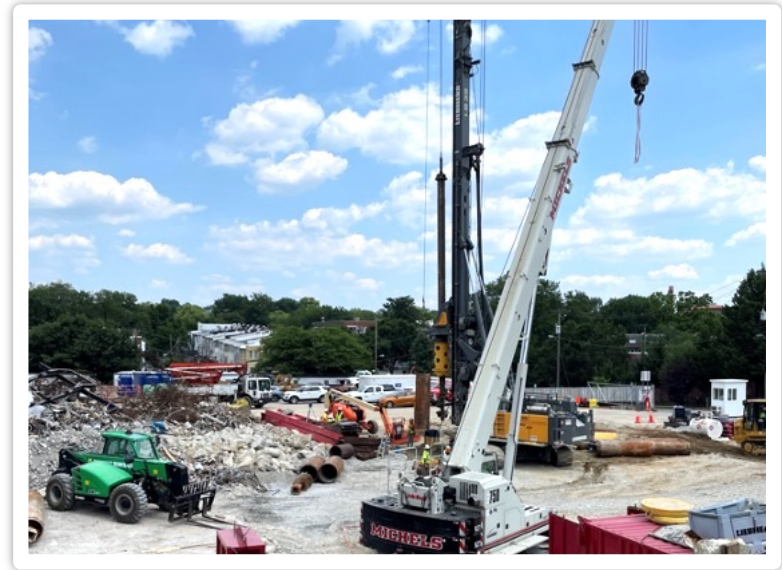
- Mobilized drilled shaft operations
- Completed pile load test
- Started production drill shaft installation

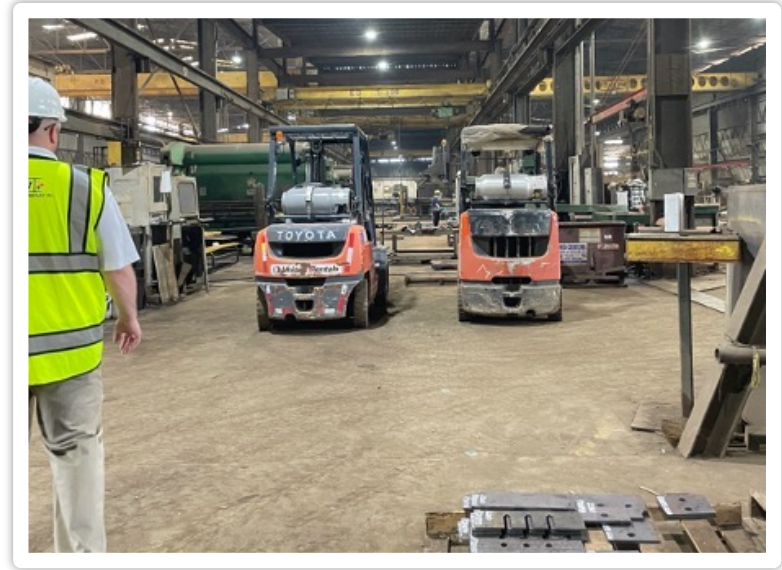
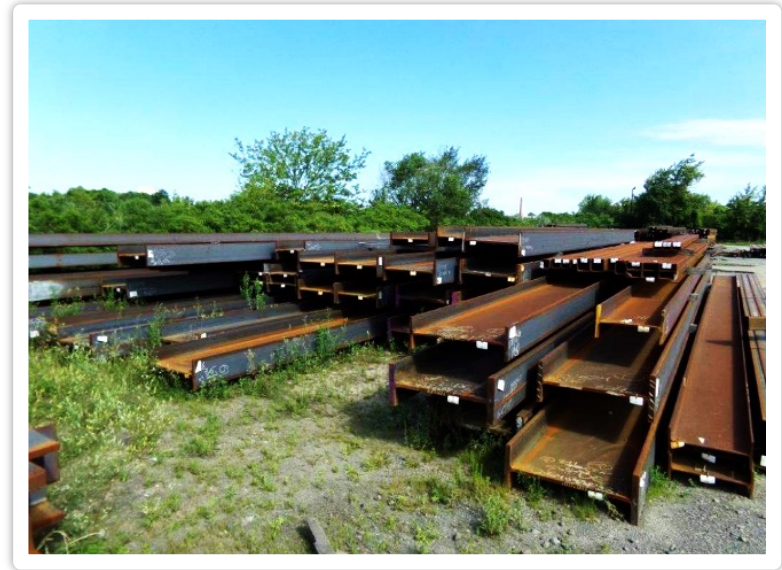
- Completed QC audit at steel fabricators shop
- Started structural steel fabrication

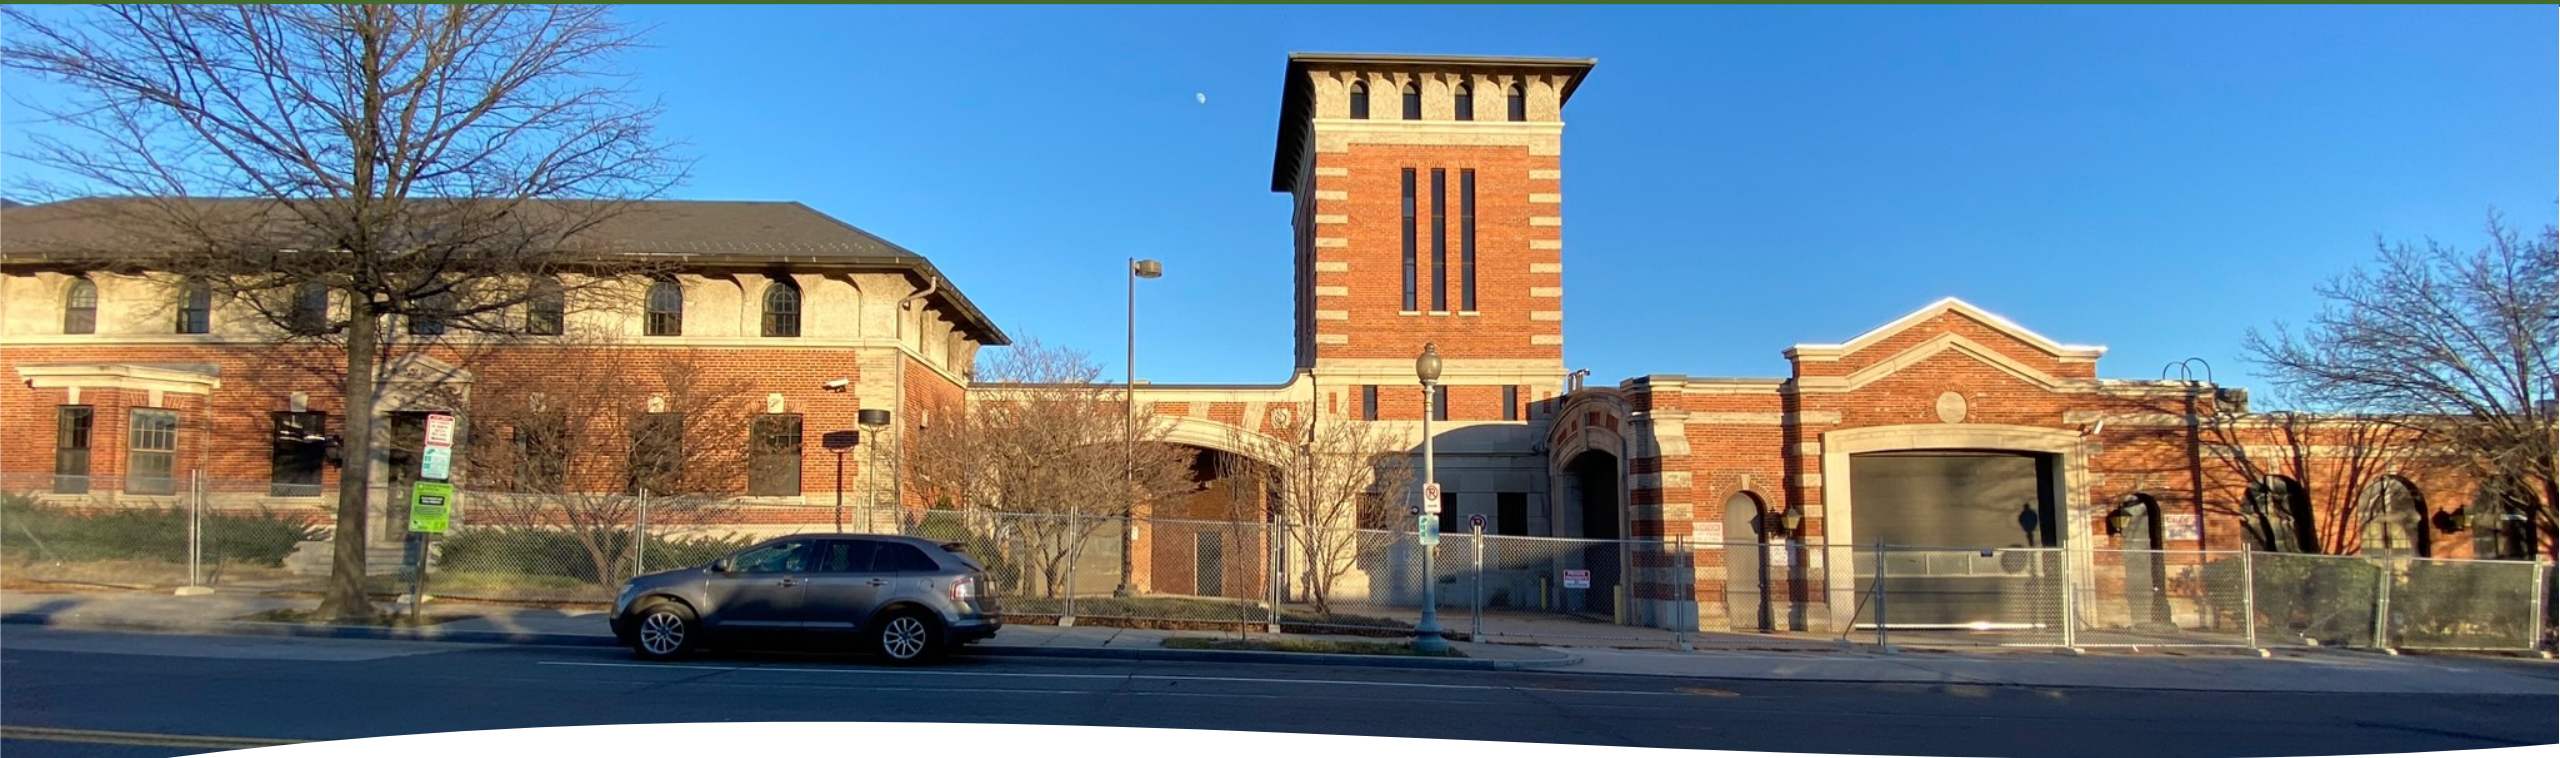
- 40% design reviews completed
- WMATA BEB design criteria finalized
- Initial fire hazard analysis completed and under review
- New service routing being coordinated with PEPCO
 - Will be run underground from the Fort Slocum Substation

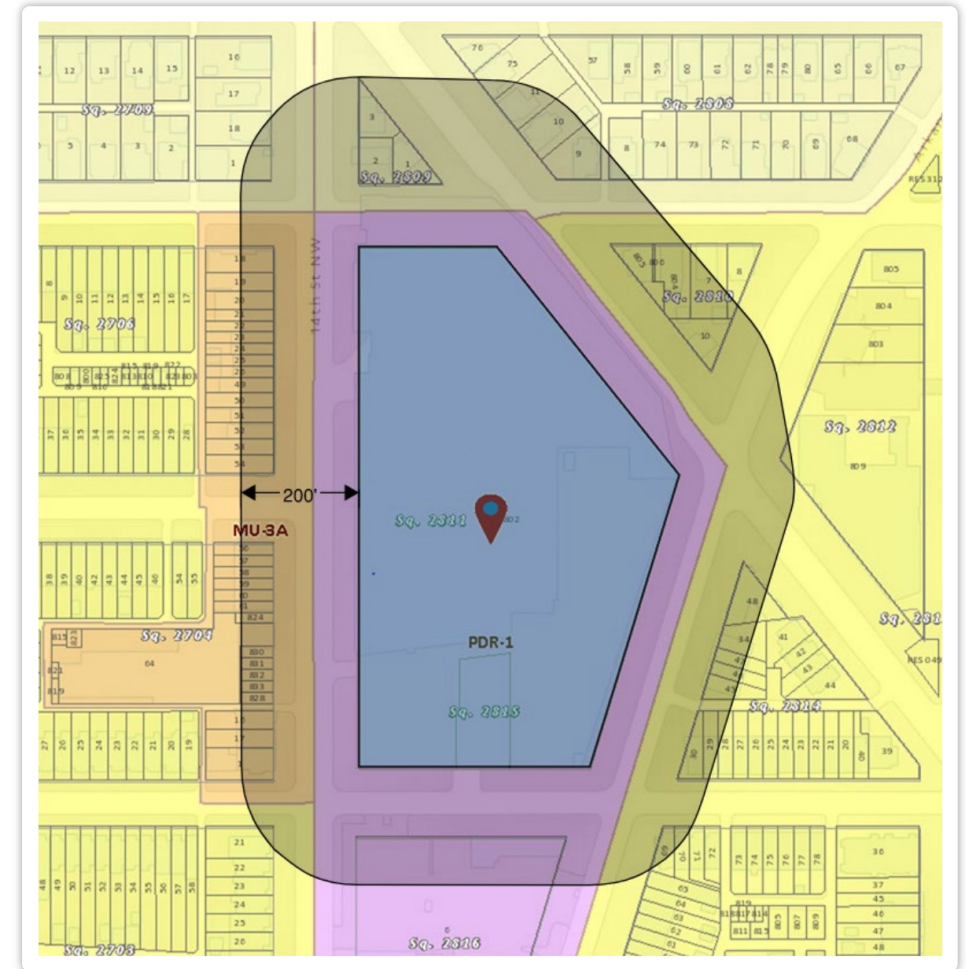
Preconstruction Survey Update

- Map shows an overlay with the properties that fall within 200 ft of the proposed new bus garage
- For more detailed information on the preconstruction survey, please visit https://wmata.com/initiatives/plans/northern-bus-garage/upload/Northern_June15_FINAL_Slides.pdf (slides 29 – 33)

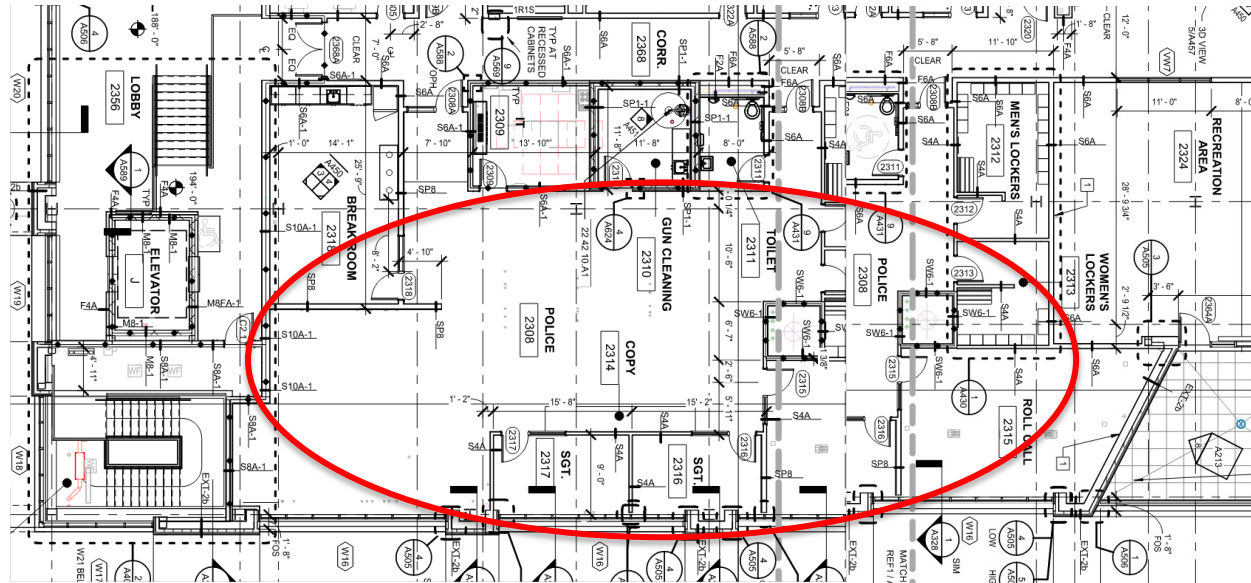
MTPD Substation Space at NBG

- 3,890 square feet
- 13 officer workstations
- 2 offices for sergeants
- Officer break room
- Firearm maintenance room
- Roll Call / Conference room
- Separate locker rooms for men and women
- Unisex restroom
- IT room

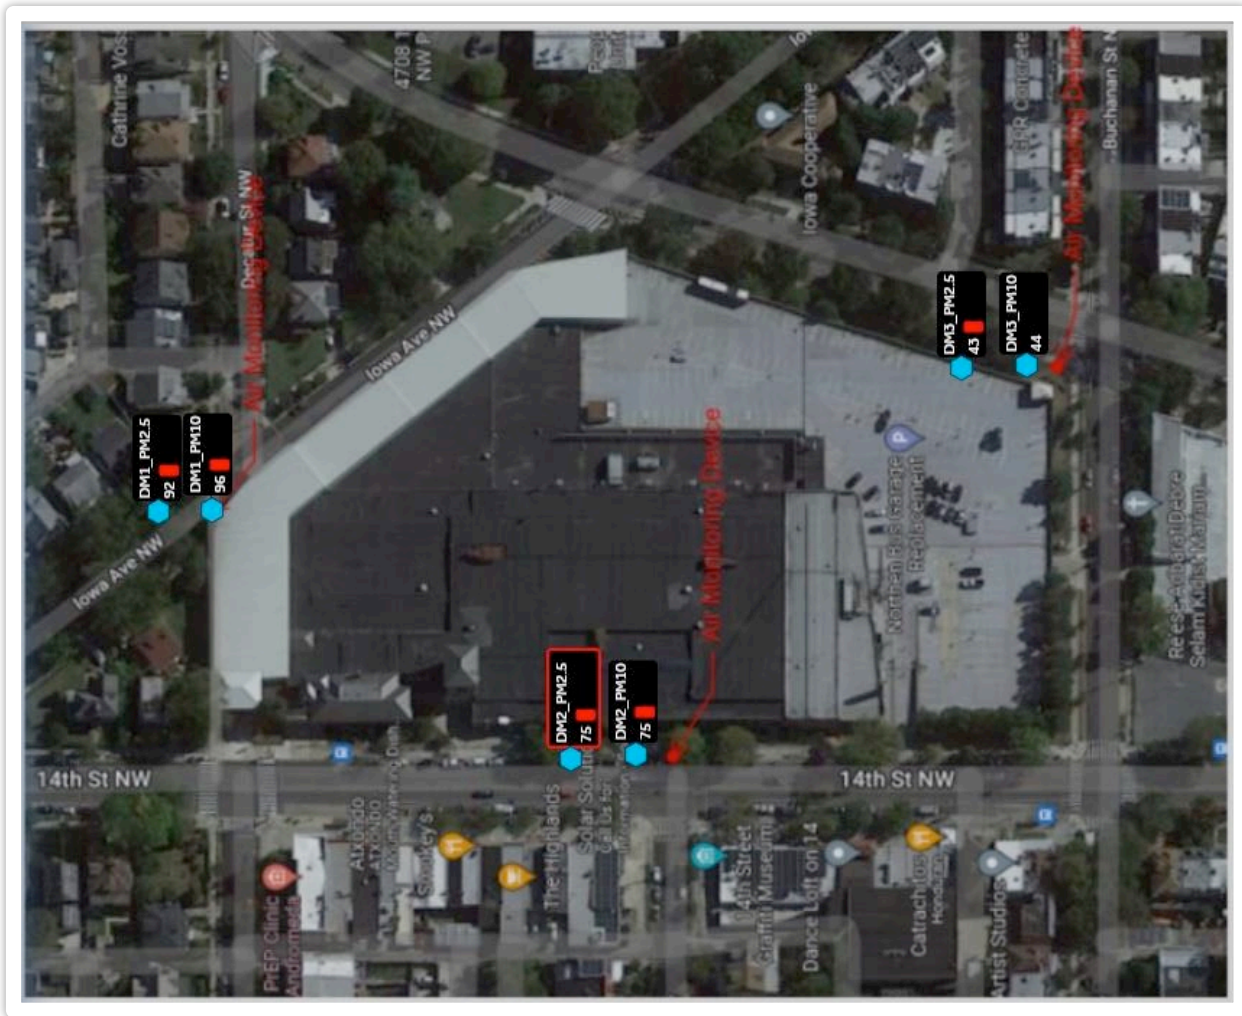
Dust Monitors

- June 2023 report has been posted.
- July 2023 report is in preparation.
- Dust Monitoring
 - 3 monitors
 - Exceedances June 7-9 and Jun 29, which correlate to wildfires and regional events.
- Noise Monitoring
 - 5 monitors
 - Multiple exceedances reported.
 - Issues:
 - Unable to distinguish site-related noise from ambient noise.
 - Multiple exceedances reported in the evenings and on weekends
- Will consult with DOEE about how to address this.
- Vibration Monitoring
 - 5 monitors
 - VM2 reported an exceedance that was caused by a faulty sensor.
