WMATA Northern Bus Garage

Concept Review Submission
D.C. Historic Preservation Review Board
Filing Date: November 13, 2020
Meeting Date: December 17, 2020

Building Description & Historic Significance

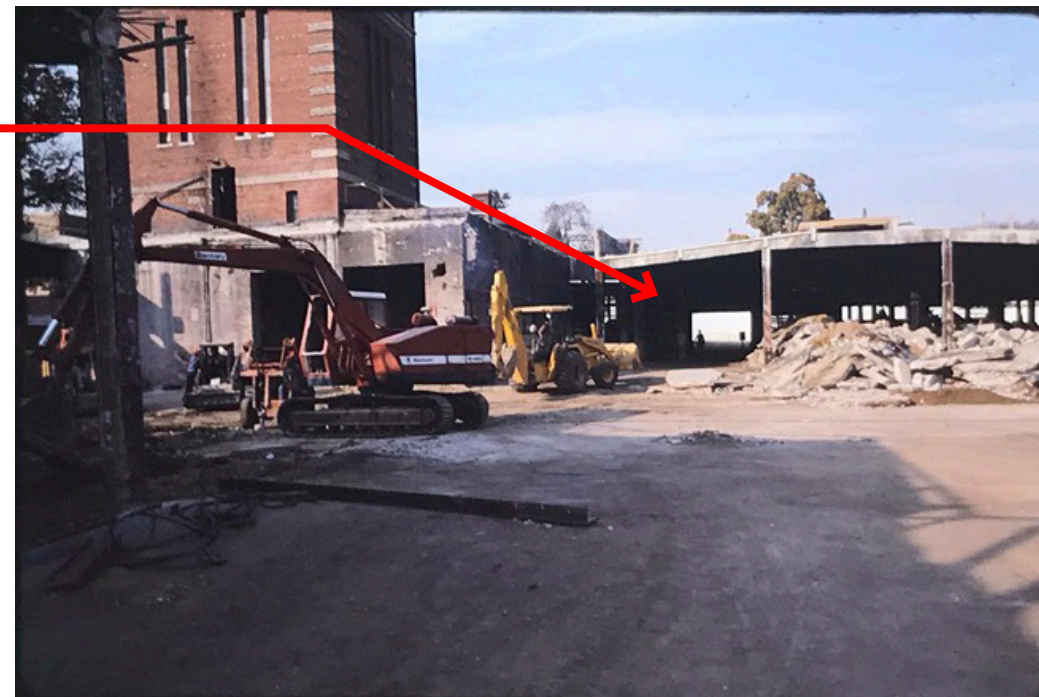
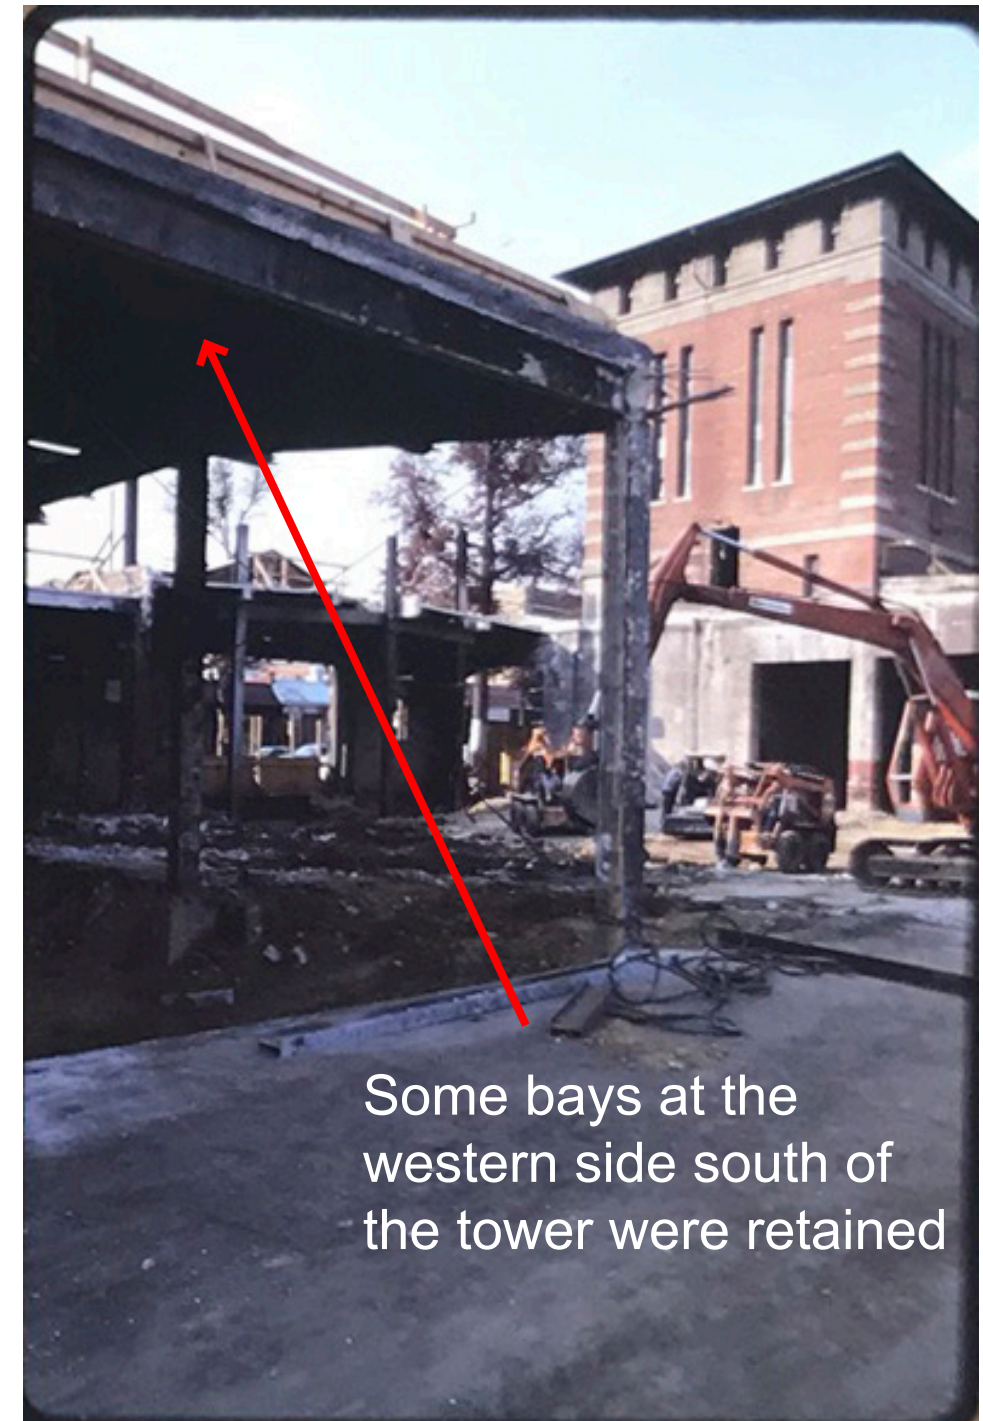
Alterations – 1987-1992 Renovation and Addition

Majority of the roof and interior columns demolished; one perimeter bay of roof retained

Some bays at the northern end of the property were retained

Some bays at the western side south of the tower were retained

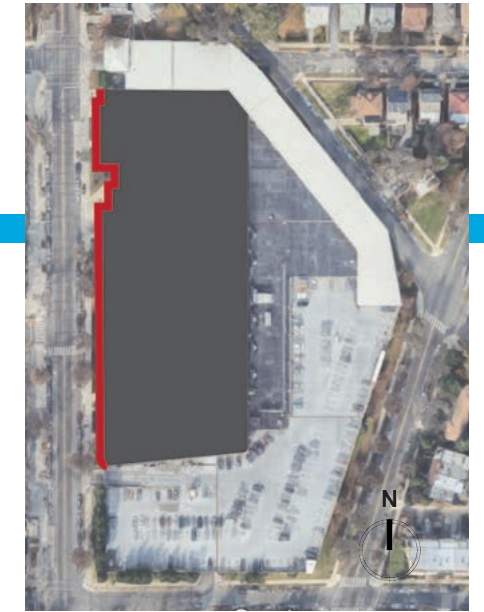
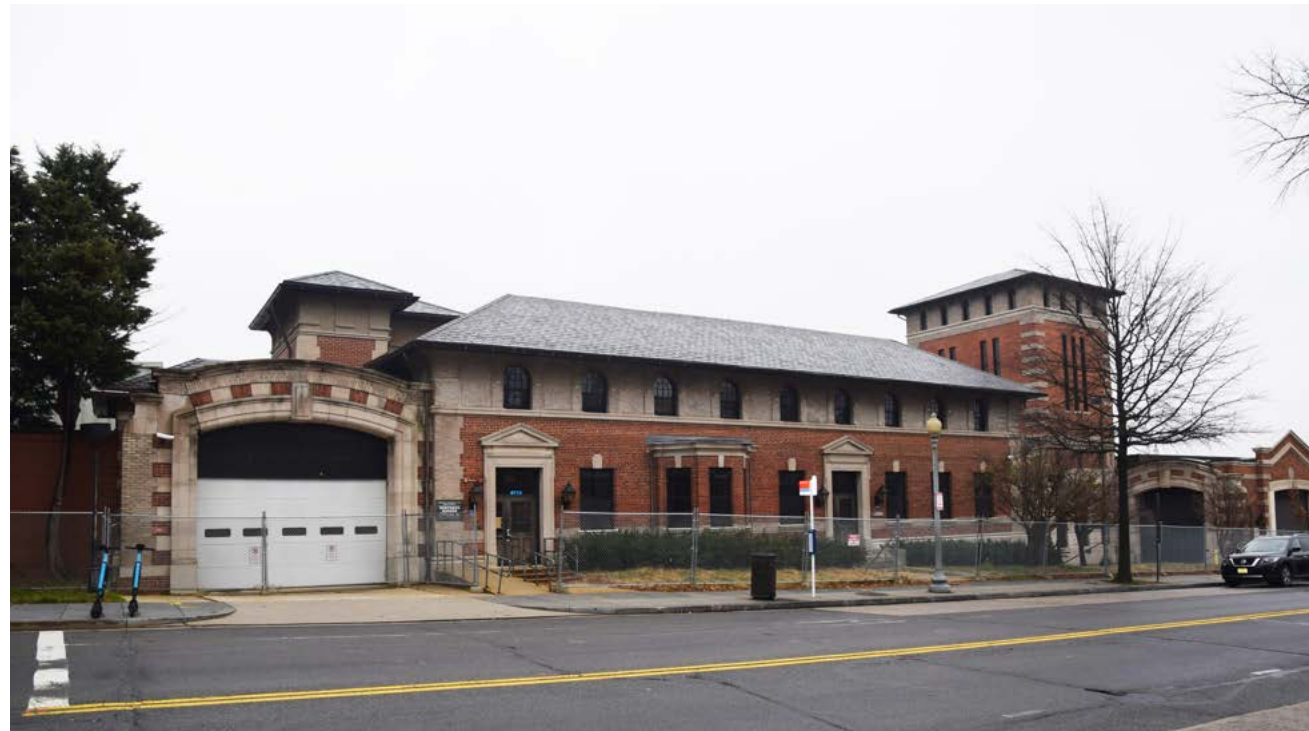
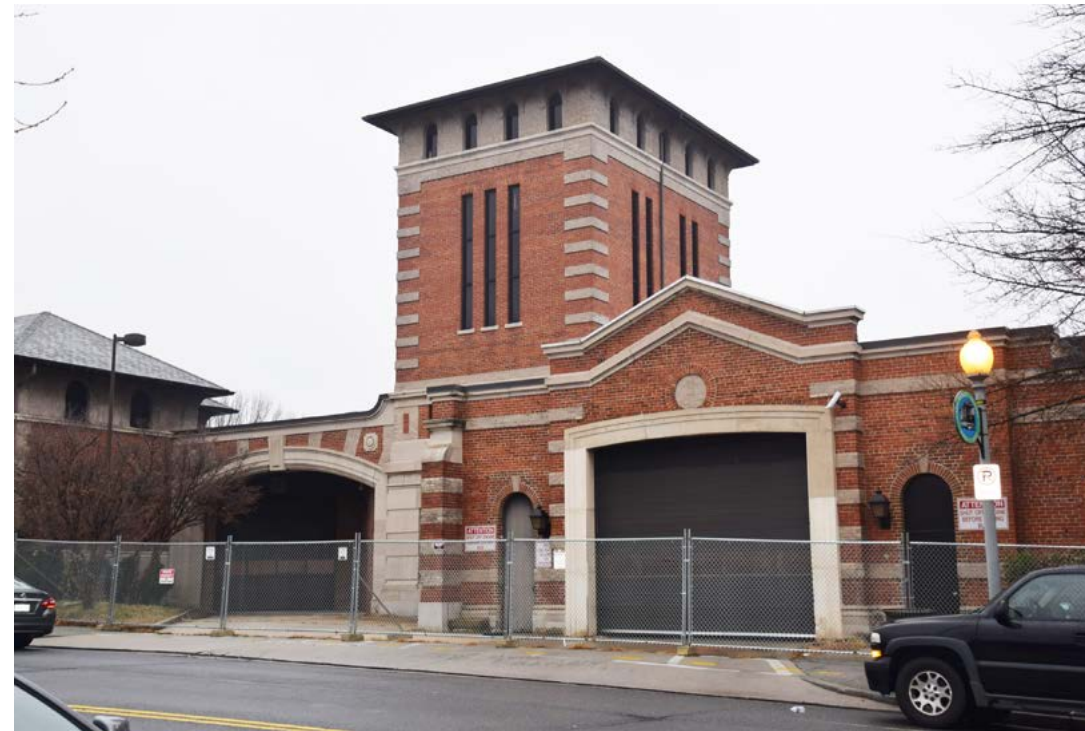
Existing Conditions – West Elevation

[Left] Administrative offices at north side; [Right] Tower with original entry at left and added entry at right

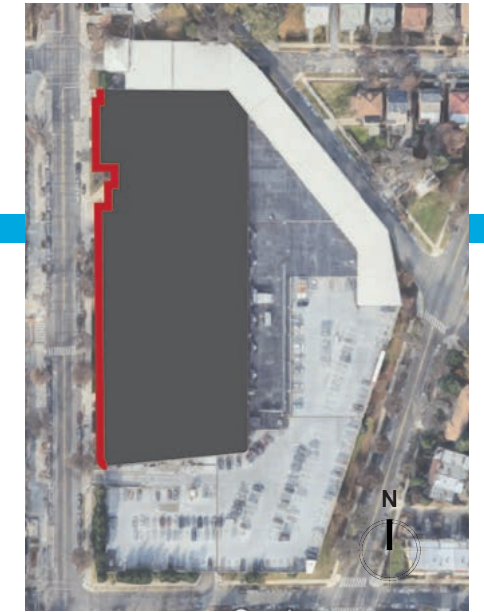
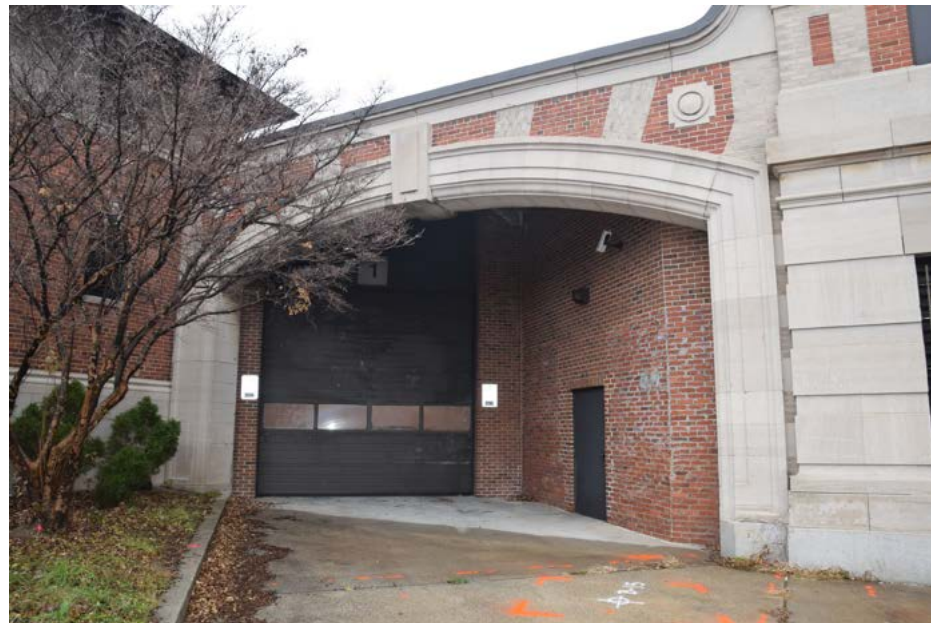
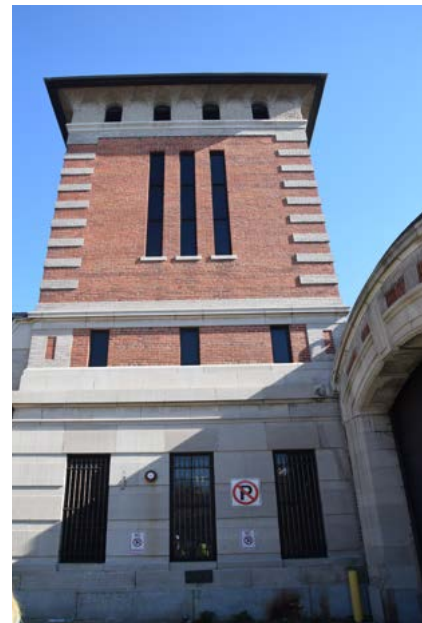
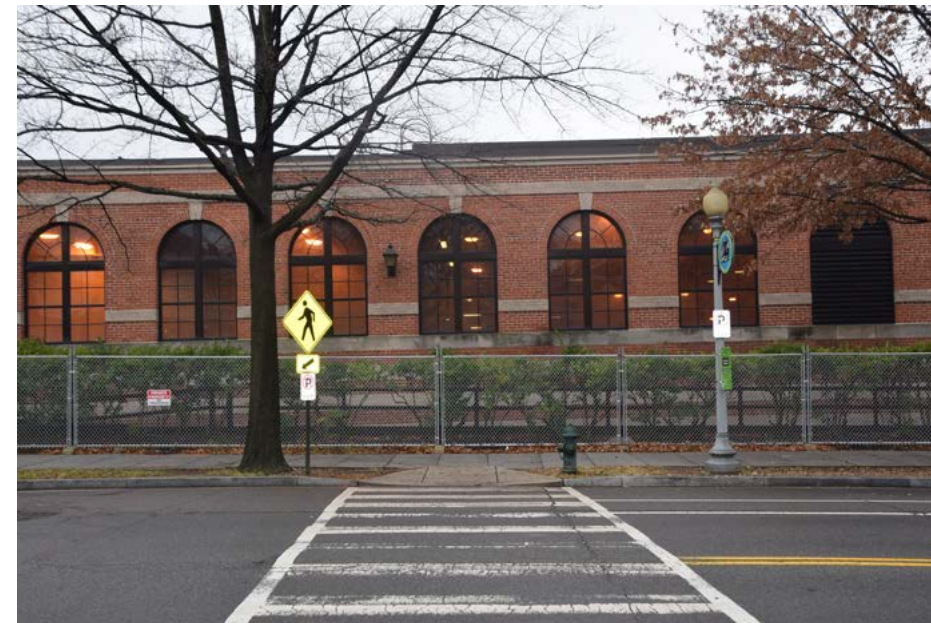
Northern Bus Garage Existing Conditions – West Elevation

[Left] Bus entry to the left of the tower has been altered with non-historic brick walls; [Center] west elevation of the tower; [Right] window bays at the southern end of the building

Southern end of west elevation; bus entry on left was added in 1987

Southern end of west elevation; arched windows have been converted to door and window at center of pedimented bay has been infilled with brick

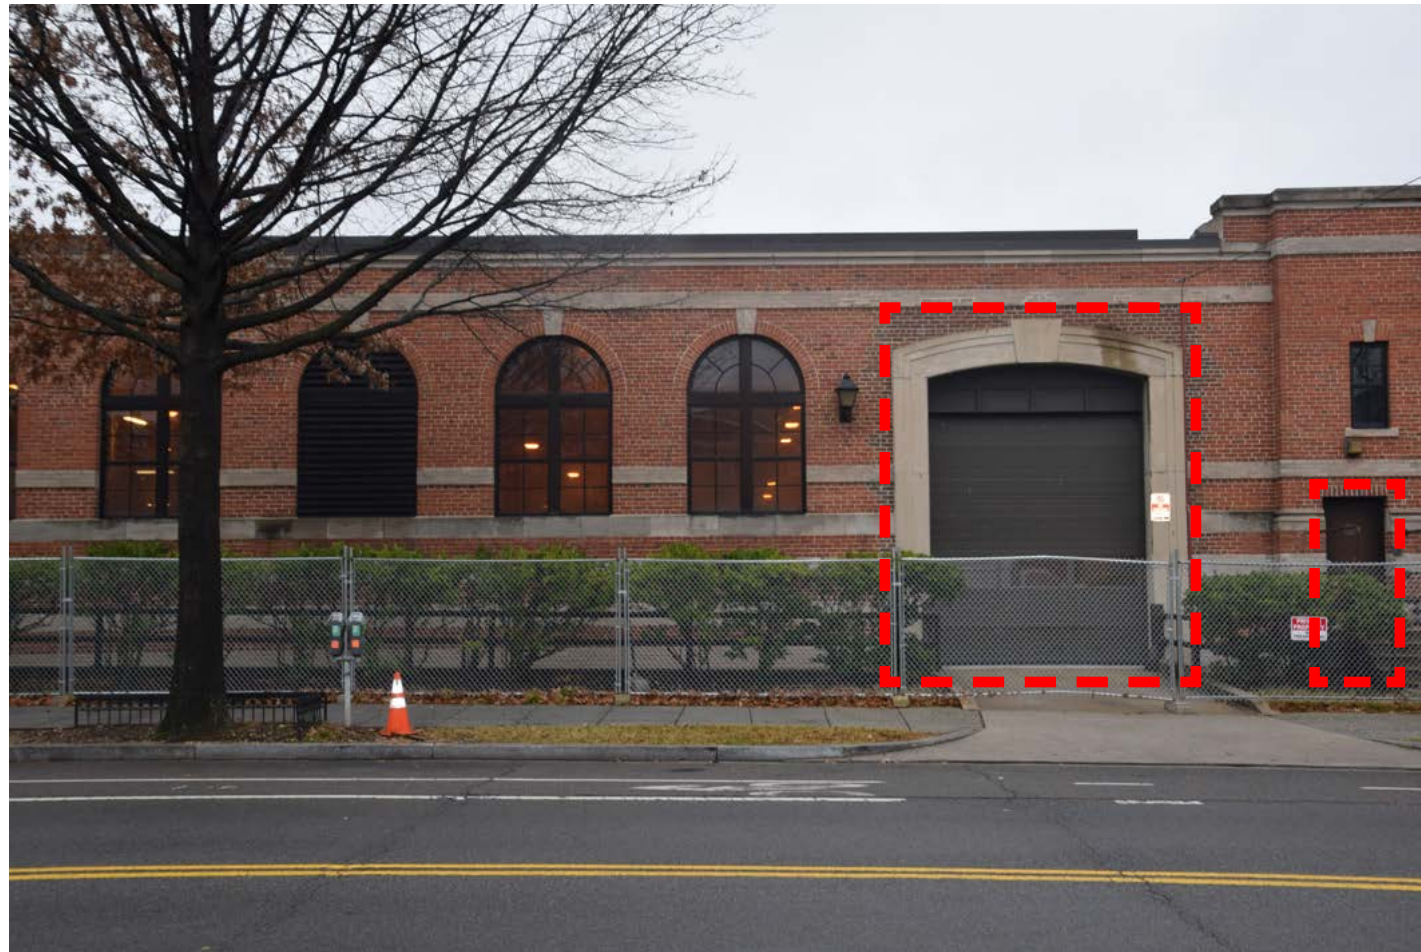
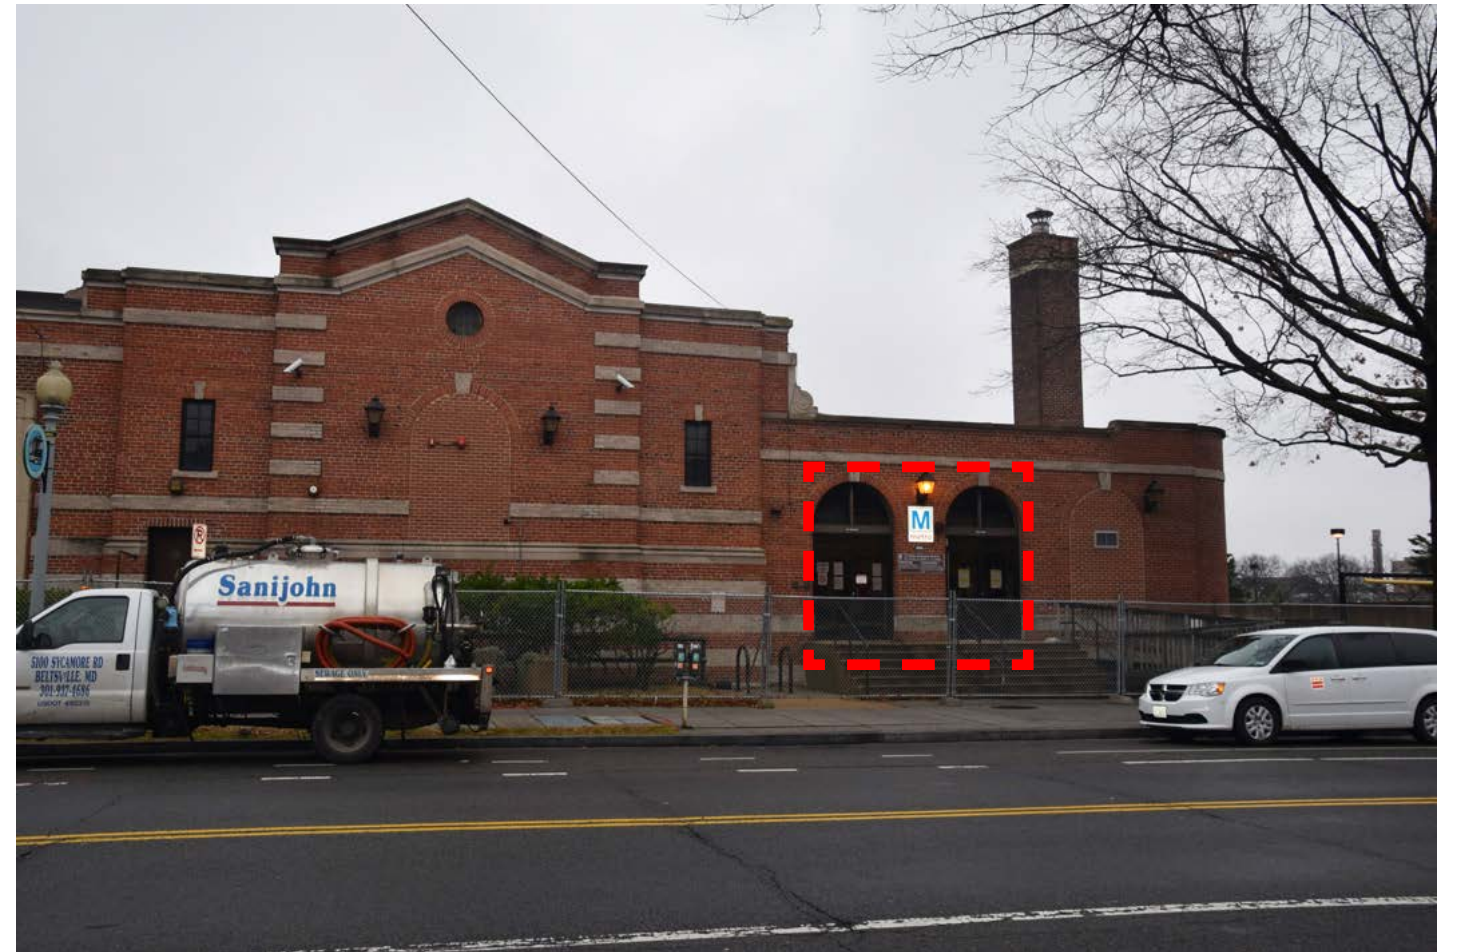
1987-1992 Exterior Alterations to West Elevation

New Openings =

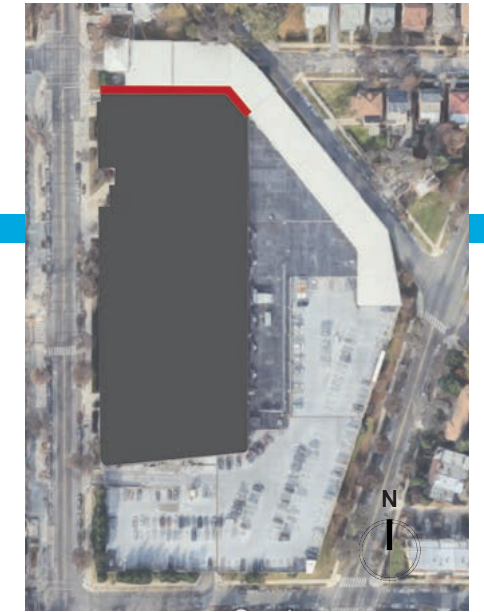
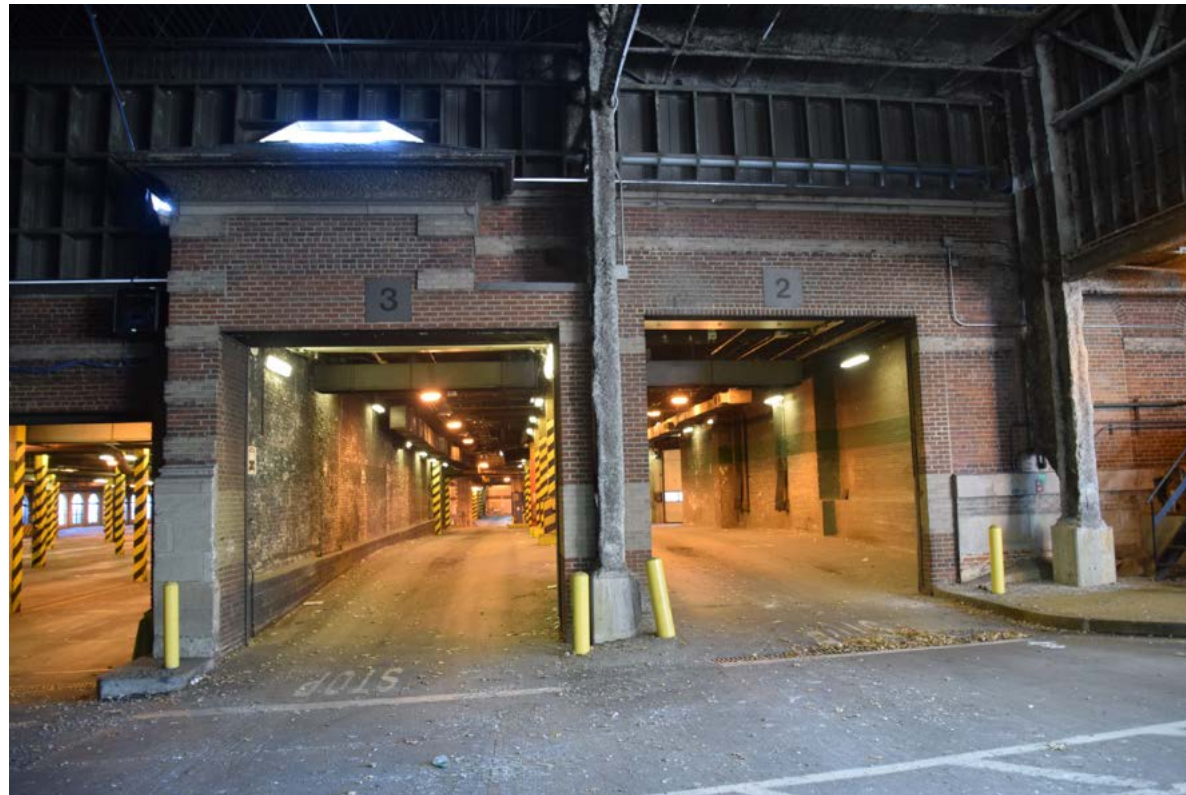
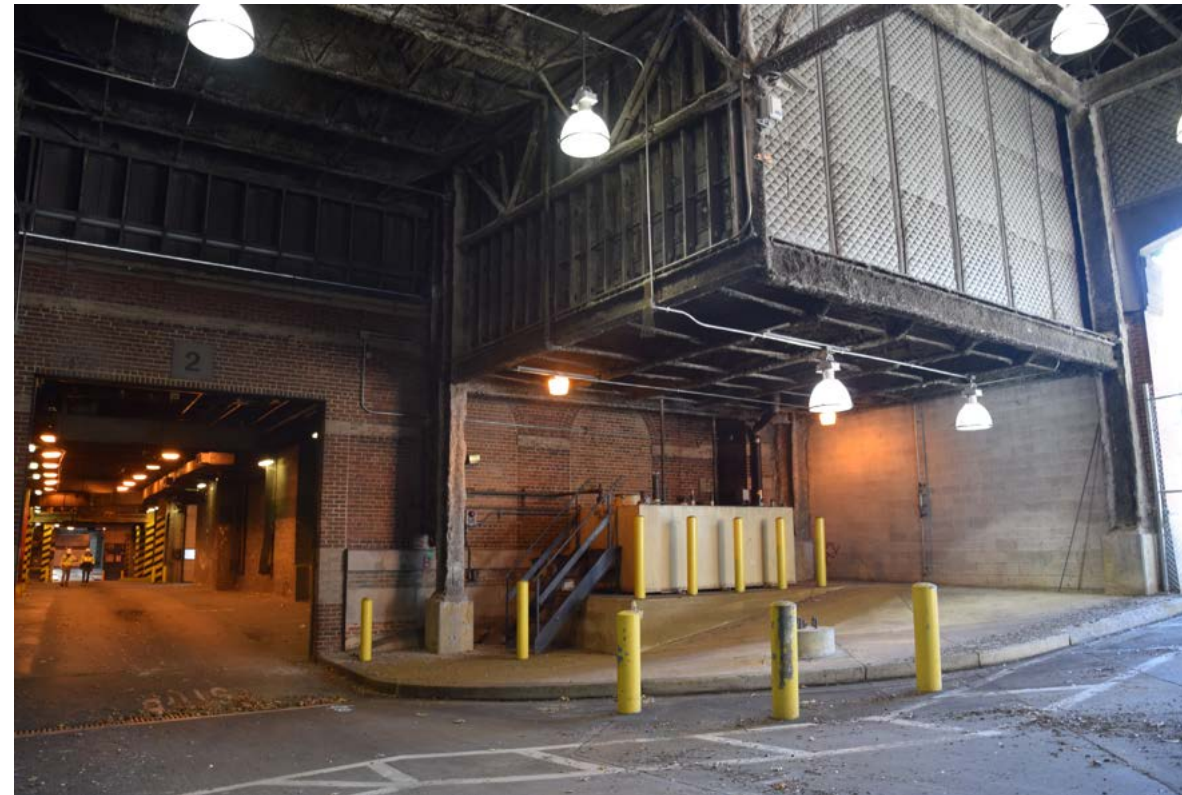
Northern Bus Garage Existing Conditions – Original North Elevation

[Left] Original north elevation is currently enclosed and original windows have been infilled with brick; [Right] new bus openings have been added

Hipped roof pavilion at north elevation

Bus openings have been added and the area enclosed with truncated roof

Angled wall on north elevation features bus opening

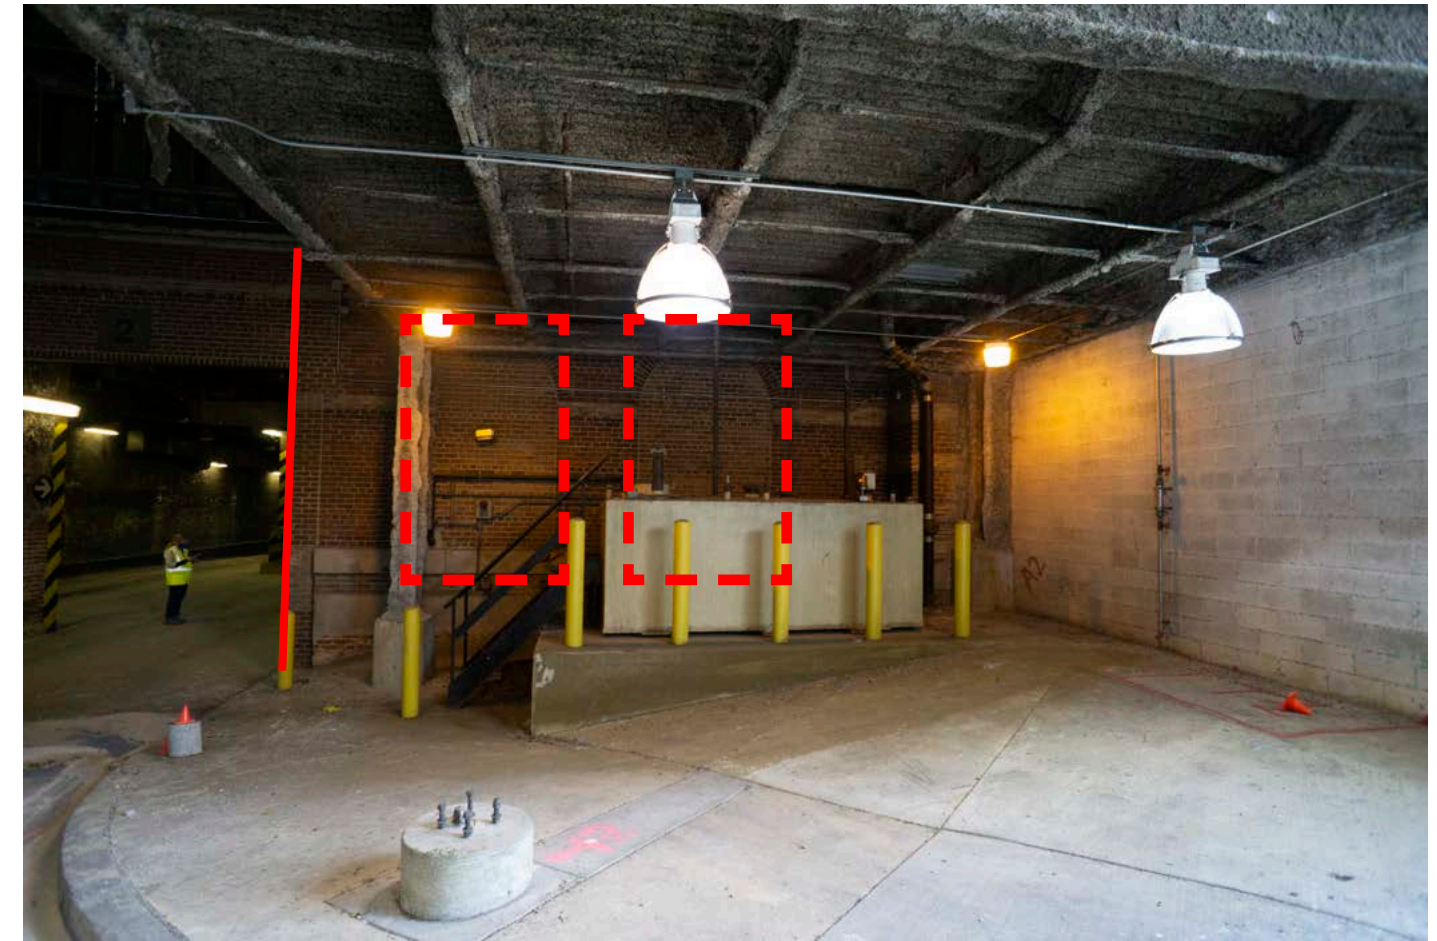
1987-1992 Exterior Alterations to Original North Elevation

Area of North Wall to be Restored =

Infilled Windows to be Restored =

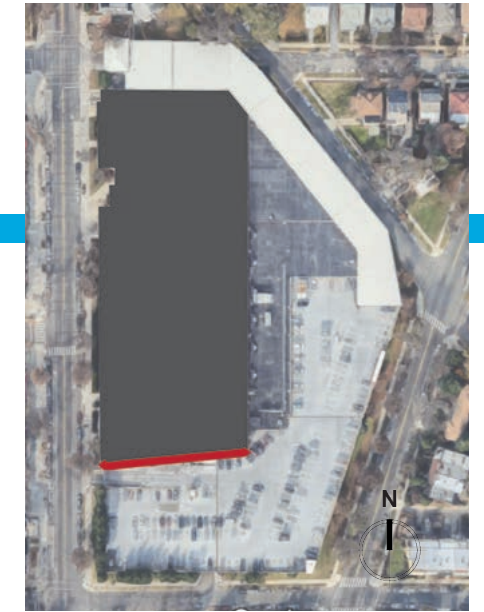
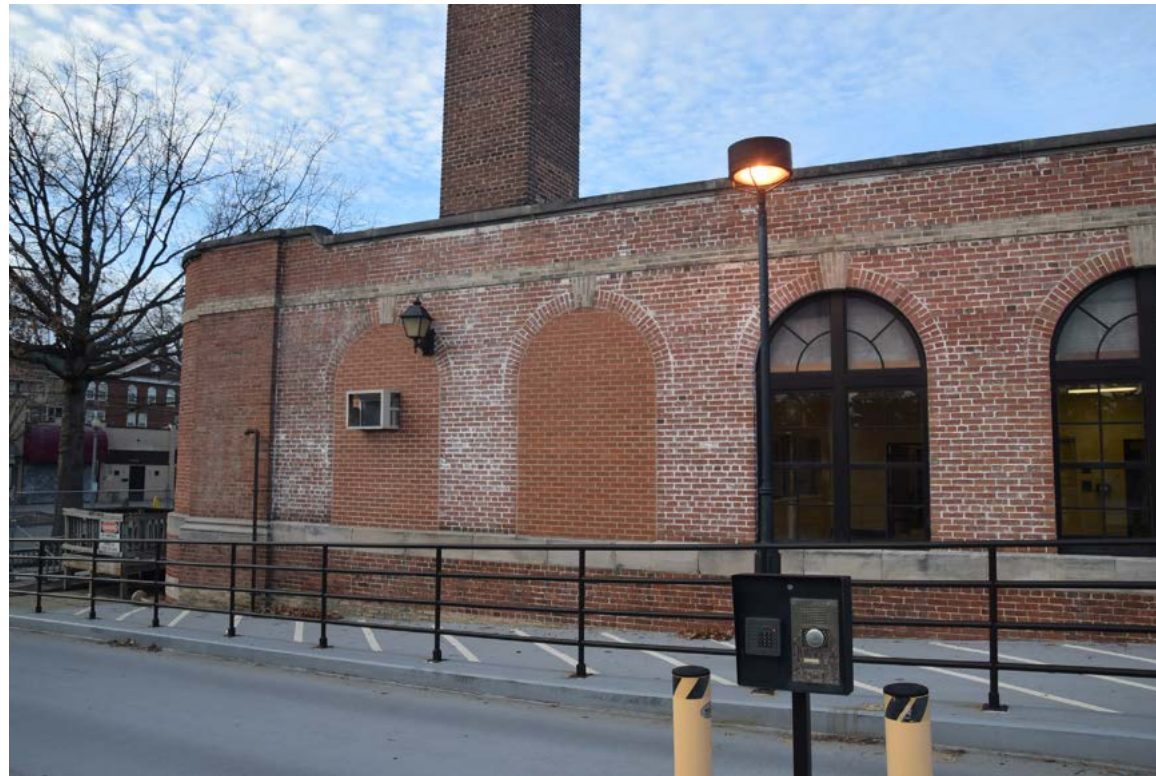
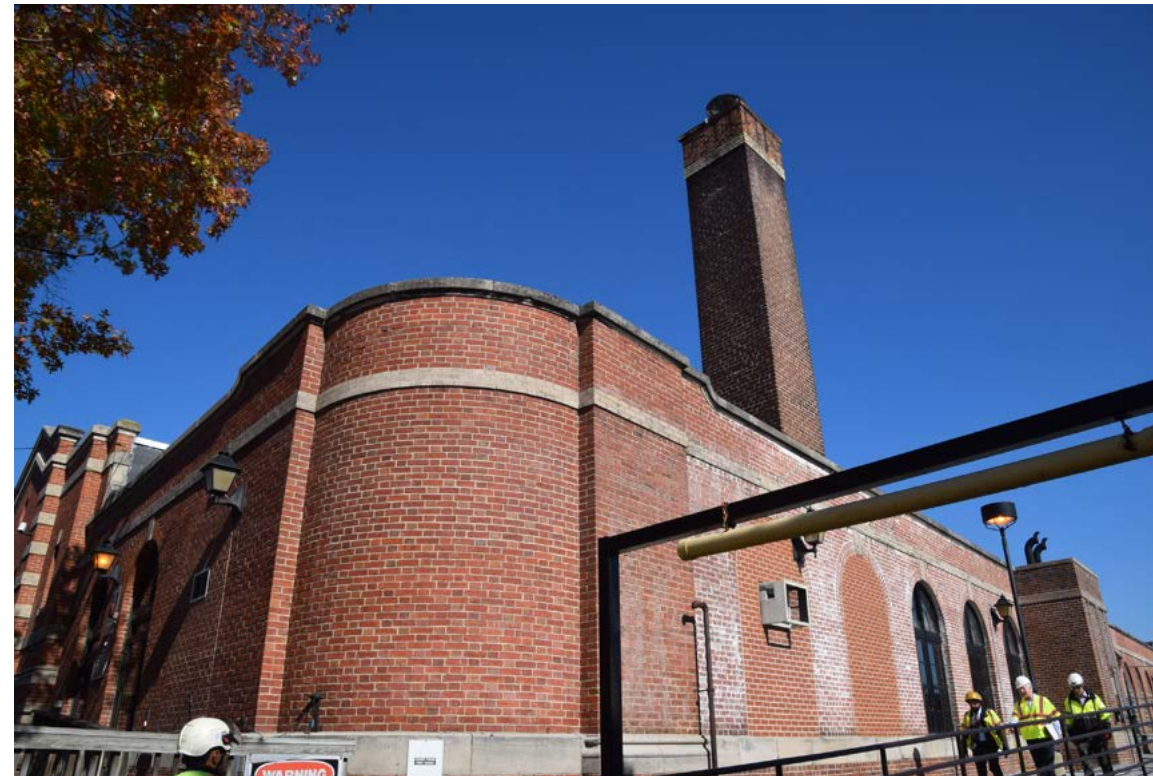
Existing Conditions – South & East Elevations

[Left] Bricked-in windows below chimney; [Right] southwest corner of the building is rounded

Bump-out wall on left, added 1987-1992

Window opening has been converted to a door

East Elevation Window openings have been infilled with brick

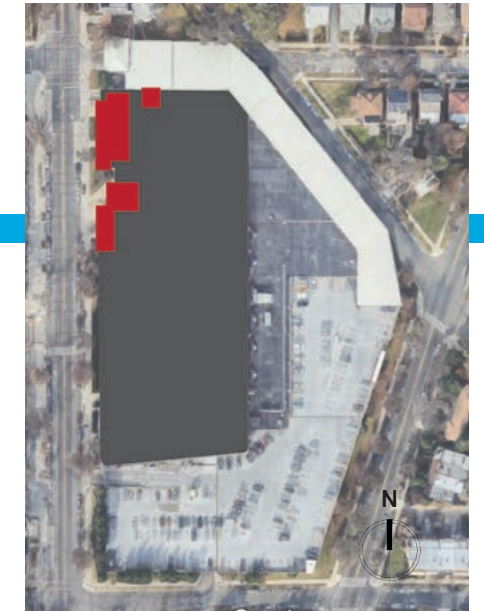
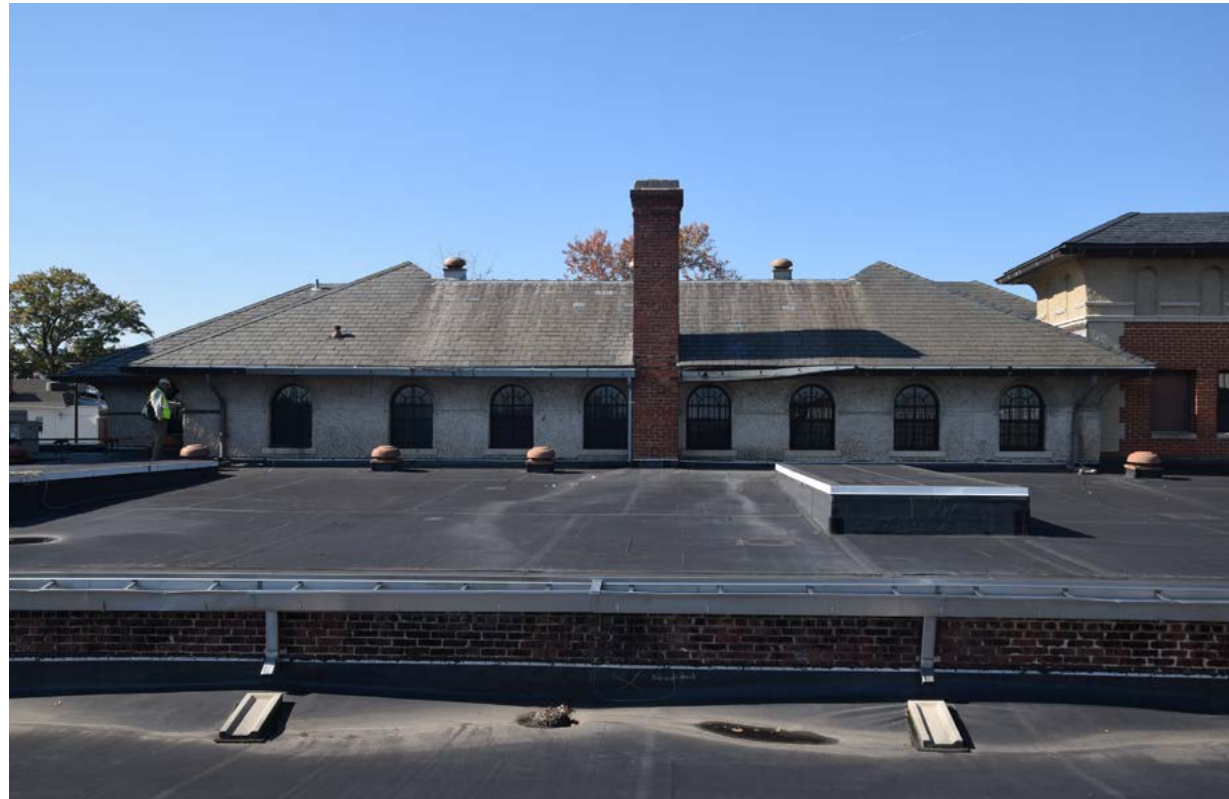
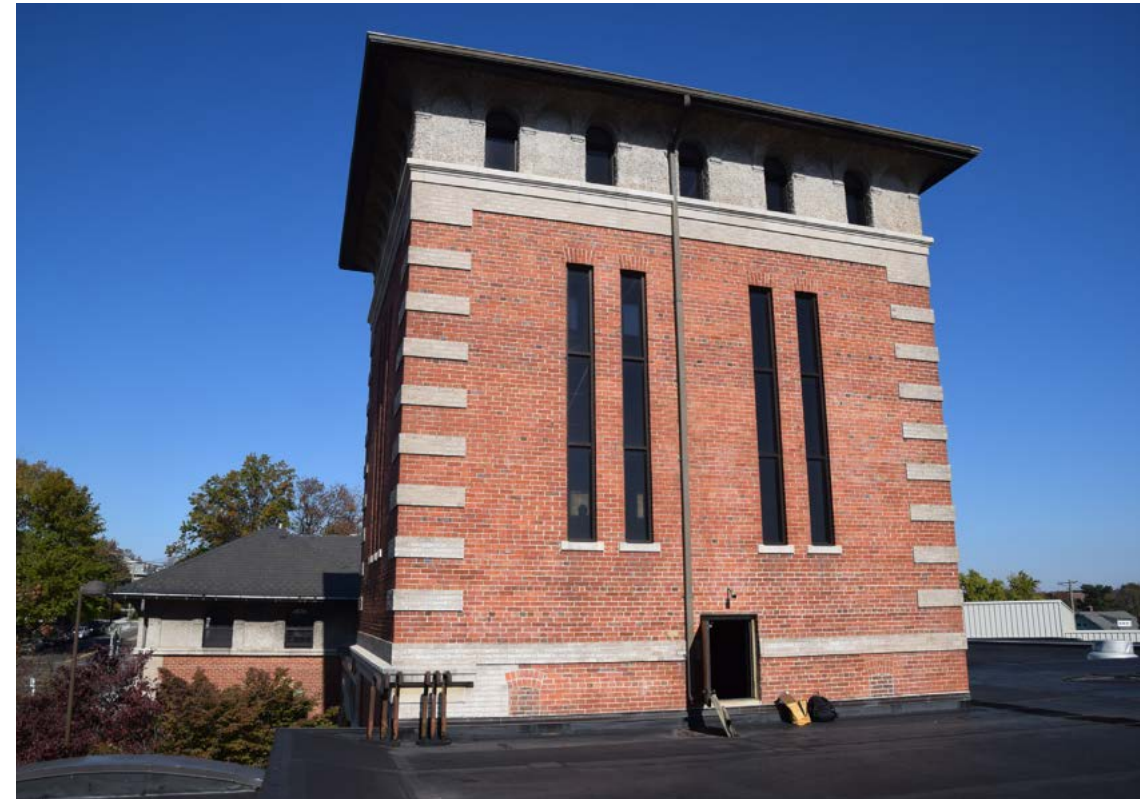
Existing Conditions – Roof and Tower

[Left] East elevation of the administrative offices with stair tower addition on right; [Right] south elevation of the tower and admin building beyond on the left

Admin offices chimney

View looking northwest towards the admin offices and hipped roof pavilion on right

Non-historic stair and elevator tower, added 1987-1992

Triangular parapet facing 14th Street

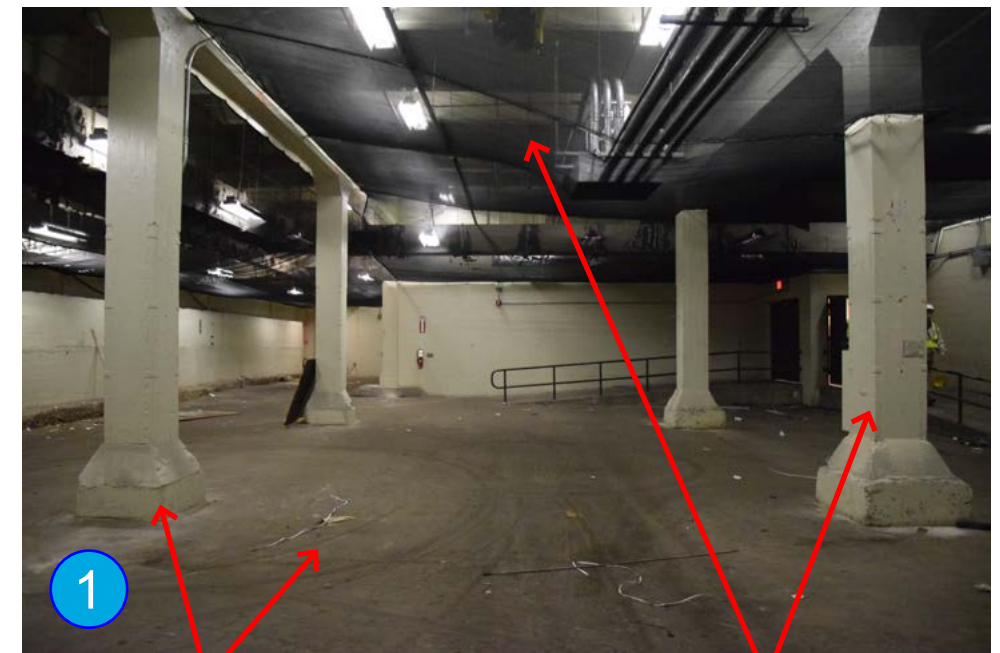
Northern Bus Garage Historic Fabric – Lower Level

Columns and portions of the lower level ceiling slab are historic. The lower level was excavated during the 1987-1992 renovation and the columns and foundation walls are supported by new concrete footings.

Non-historic floor and column footings

Historic columns and ceiling

1989 As-Built Drawing

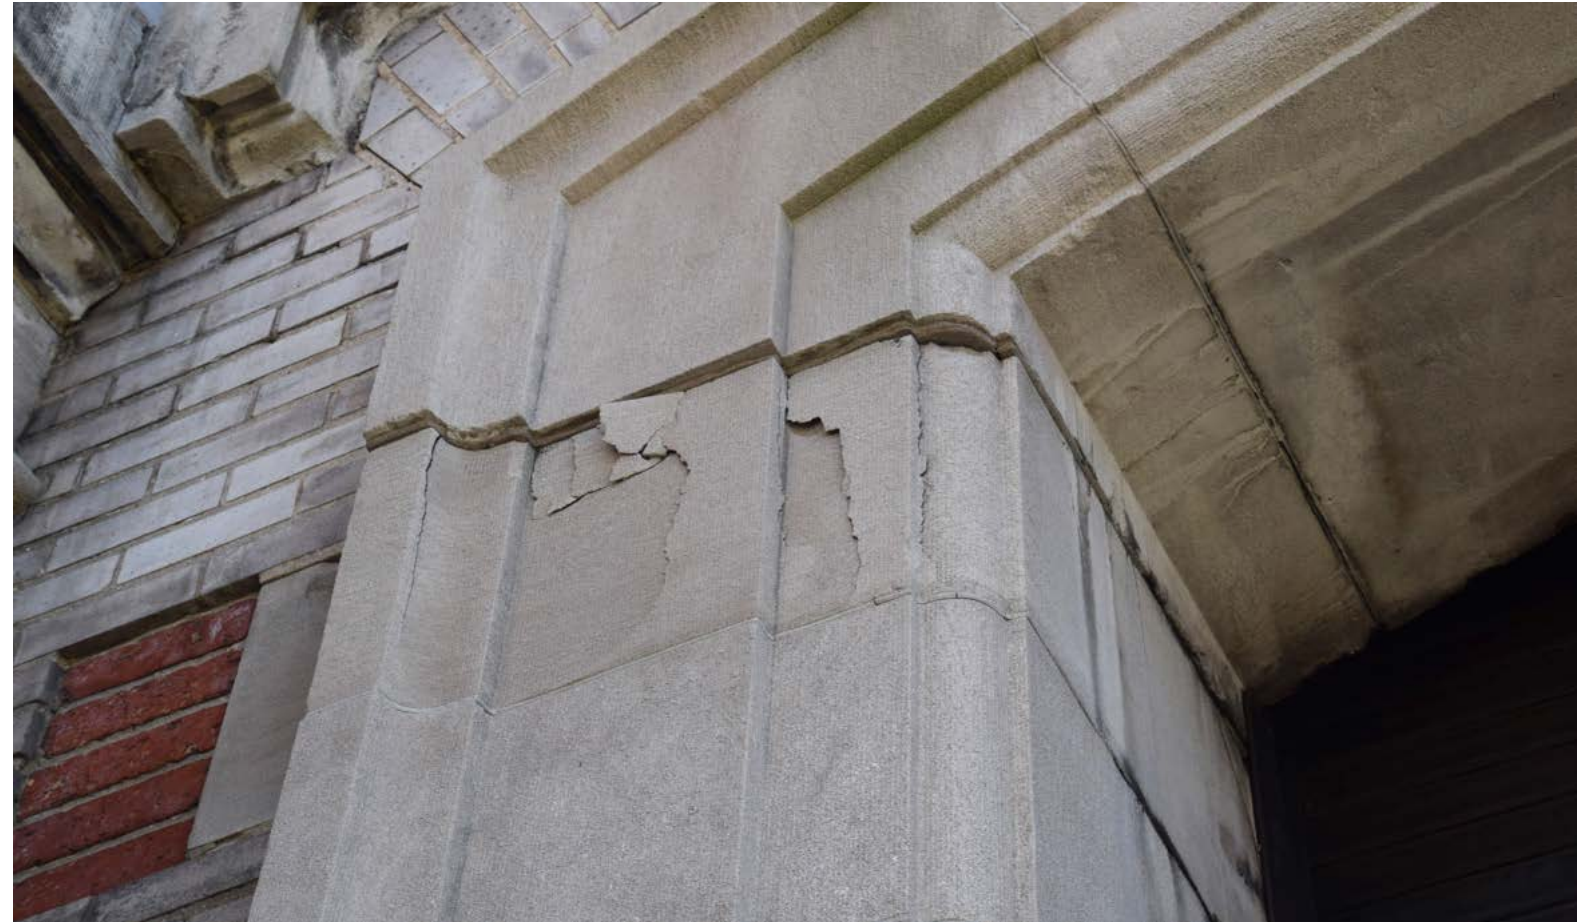
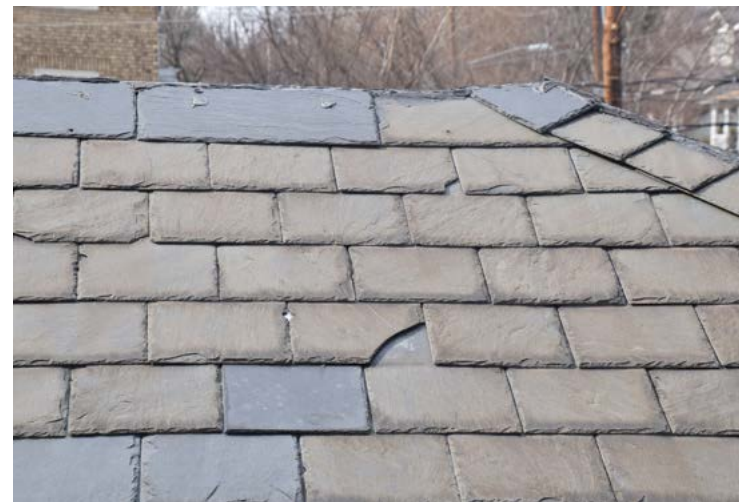
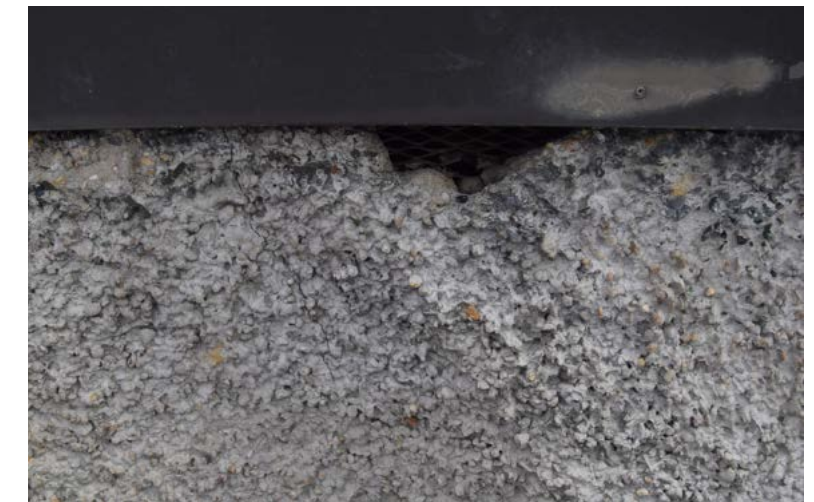
[Top] Cracked and spalling masonry surrounding an original street car barn opening; [Left] Slate roof of the administrative offices exhibits broken slates and inappropriate previous repairs; [Right] Stucco under the eaves of the administrative offices exhibits cracking and spalling

- Repointing masonry, especially vertical joints at the cornice and string courses.
- Repairing masonry spalls and cracks
- Replacing previous inappropriate or failing patches and repairs
- Masonry cleaning, using the gentlest means necessary
- Repairing cracking and missing stucco
- Replacing slate roof at the administrative offices and tower
