ON-STREET BUS TERMINAL STUDY

Washington Metropolitan Area Transit Authority

March 2013

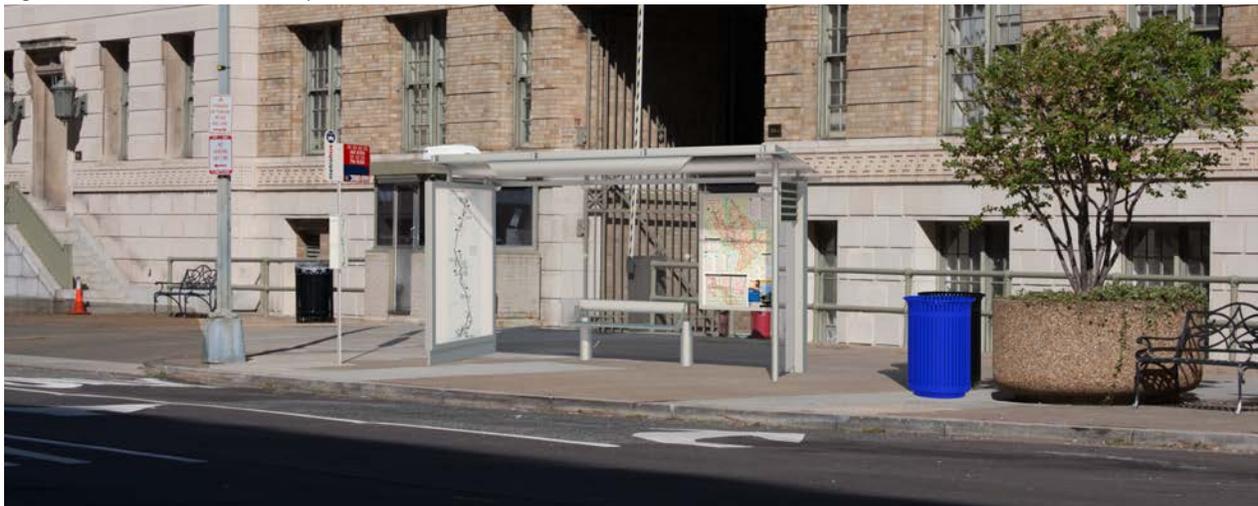
Figure ES-1: C Street SW - Proposed Shelter

In addition, the installation of a new bus shelter and additional amenities required for a basic stop is recommend at stop 1000692 (located on the 14th Street SW end of C Street SW).

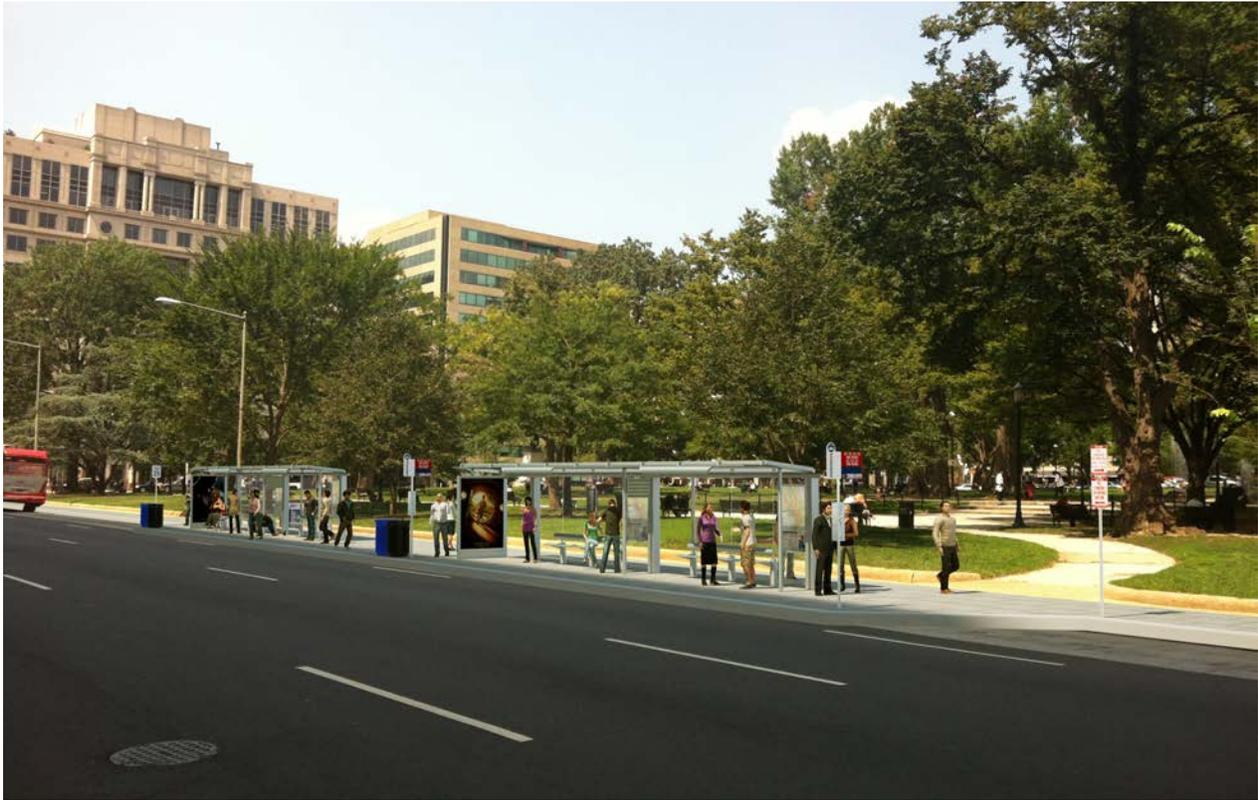
Figure ES-2: Franklin Square - Curb Extension and Shelters on I Street NW

At Franklin Square, the most extensive recommended modifications would occur along I Street NW. A mid-block curb extension on I Street NW would accommodate transit center class passenger amenities. The existing five stops along I Street NW would be consolidated into three stops (stop number 1003653, 1003661, and 1003662).

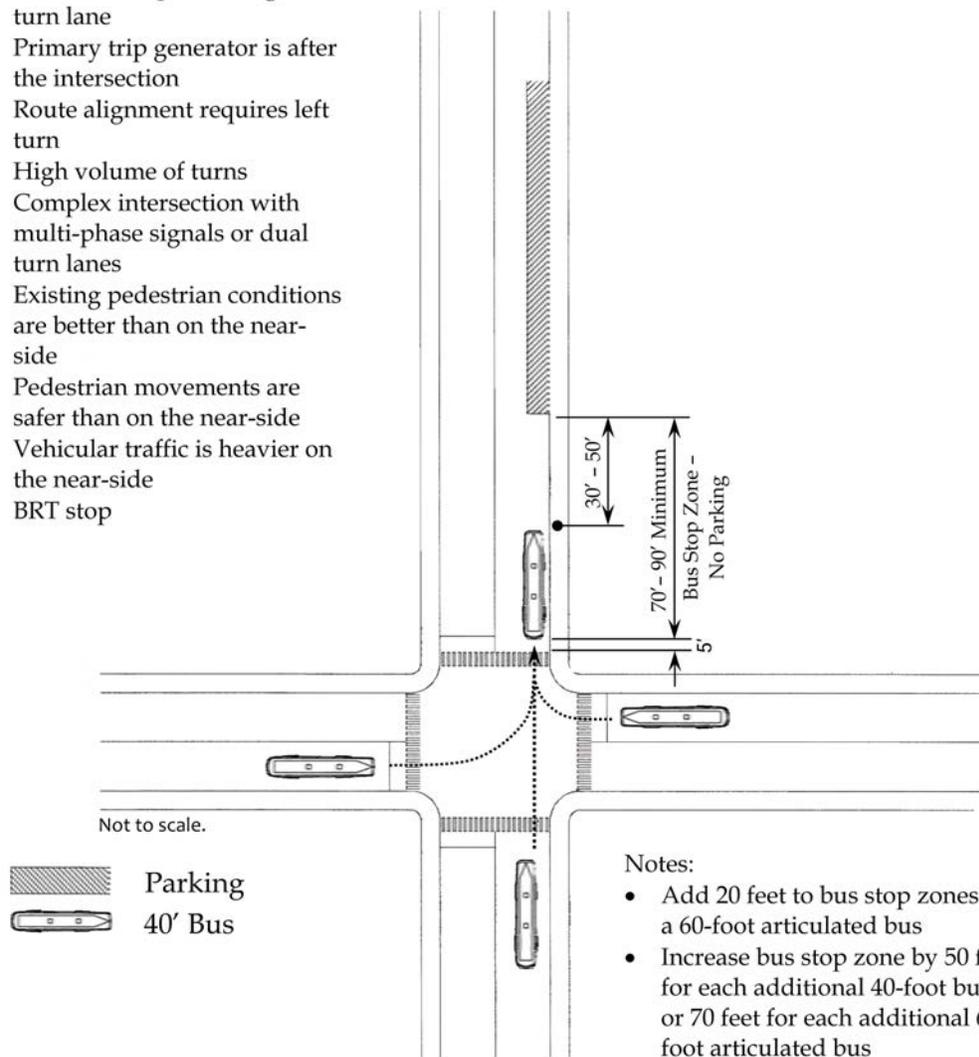
- Near-side stop is in a right turn lane
- Primary trip generator is after the intersection
- Route alignment requires left turn
- High volume of turns
- Complex intersection with multi-phase signals or dual turn lanes
- Existing pedestrian conditions are better than on the near-side
- Pedestrian movements are safer than on the near-side
- Vehicular traffic is heavier on the near-side
- BRT stop

Source: WMATA Guidelines for the Design and Placement of Transit Stops (2009)

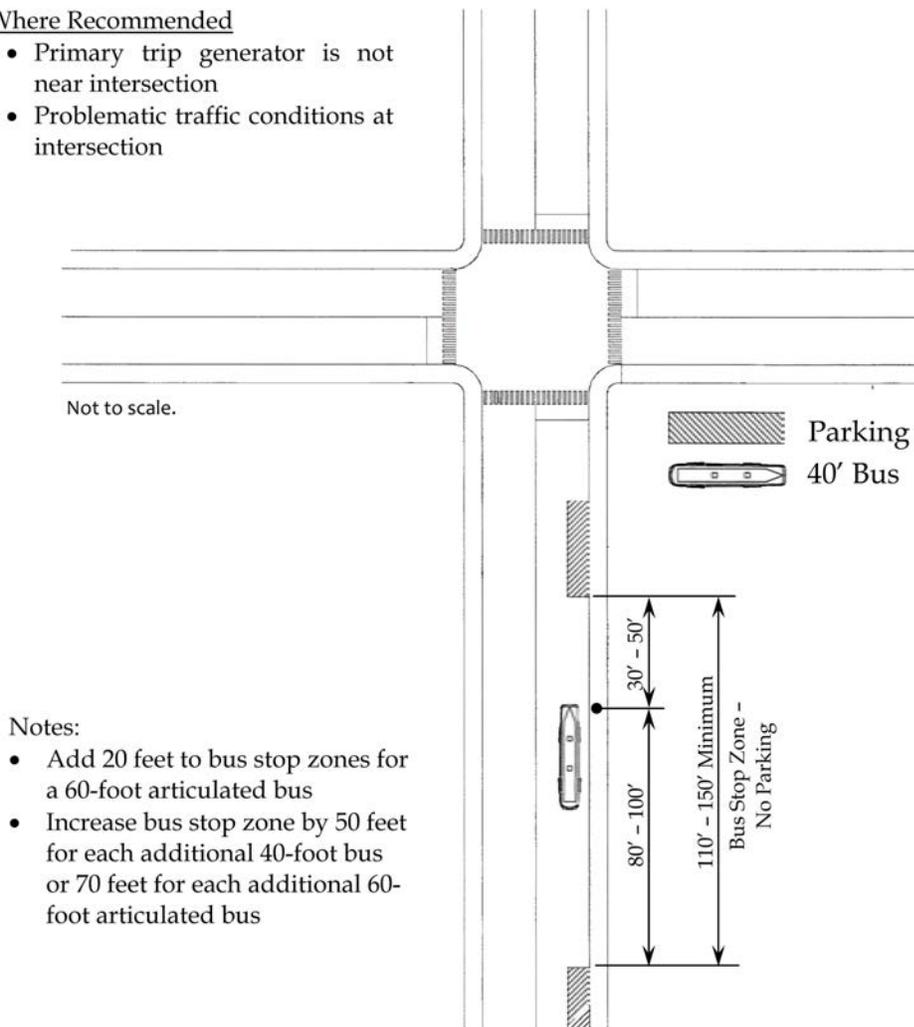
- Primary trip generator is not near intersection
- Problematic traffic conditions at intersection

- Add 20 feet to bus stop zones for a 60-foot articulated bus
- Increase bus stop zone by 50 feet for each additional 40-foot bus or 70 feet for each additional 60-foot articulated bus

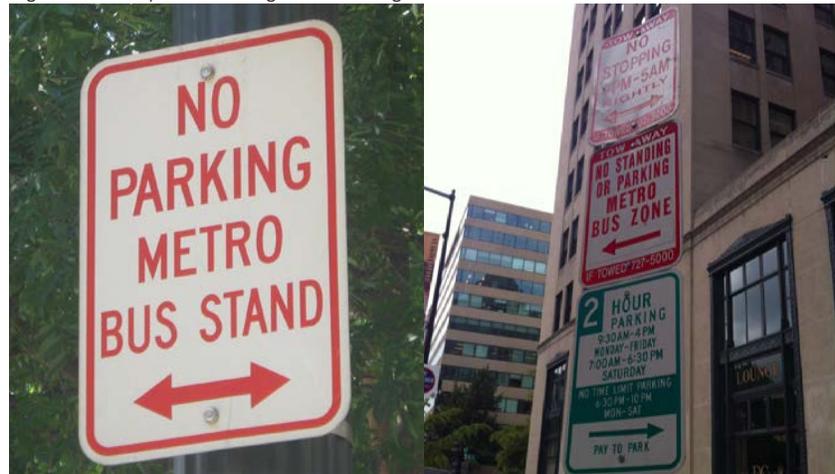
Figure 5: Sample Street Signs Indicating Metrobus Zone

In addition to the clear space requirements established by the bus stop placement, the bus zone should be clearly demarcated by street signs, which should also limit parking and loading/unloading activities of non-bus vehicles.

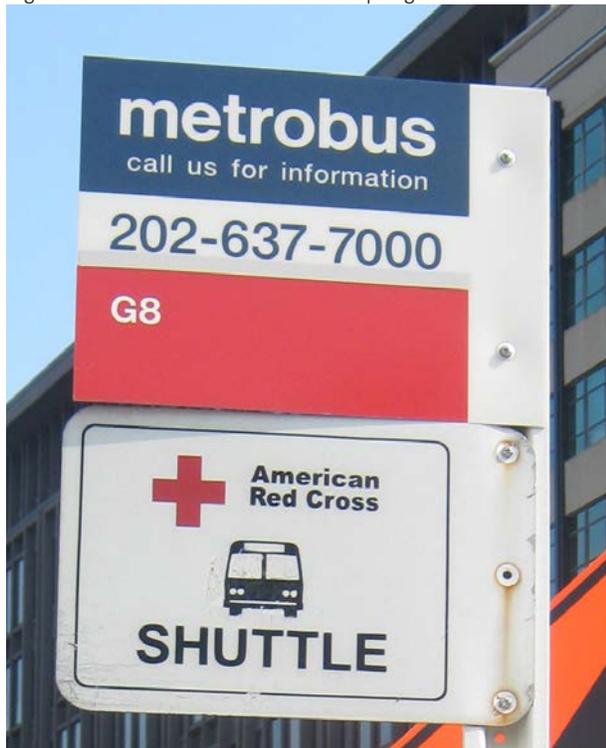
Figure 6: Old WMATA Metrobus Stop Sign

be installed at a distance of at least two feet from the edge of the curb to prevent the buses from hitting the sign and/or the sign post. Currently, WMATA is working on replacing all the existing bus stop signs (Figure 6) with a new version of the sign (Figure 7).

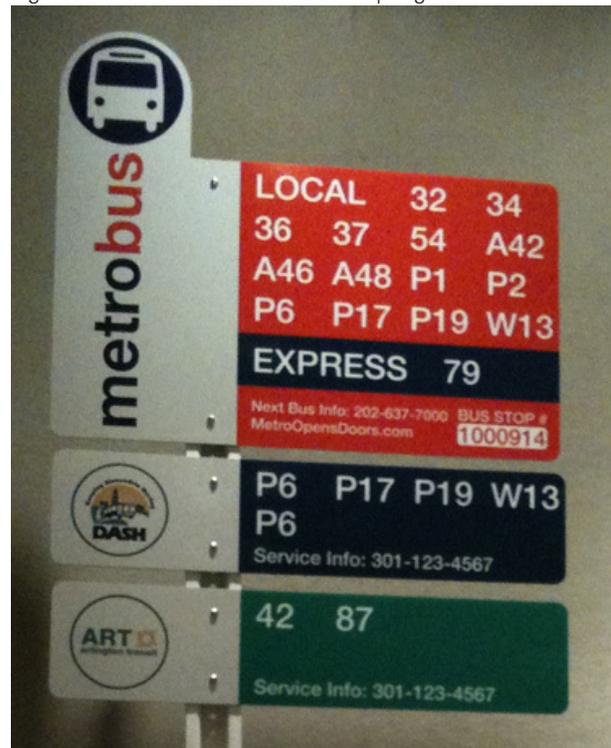
Figure 7: New WMATA Metrobus Stop Sign

All bus stop signs should conform to ADA requirements for height, width and visibility, and should include at minimum, information on stop operator name, contact phone number, and route numbers or names. For more details on bus stop sign requirements, please see the *WMATA Design Guidelines*.

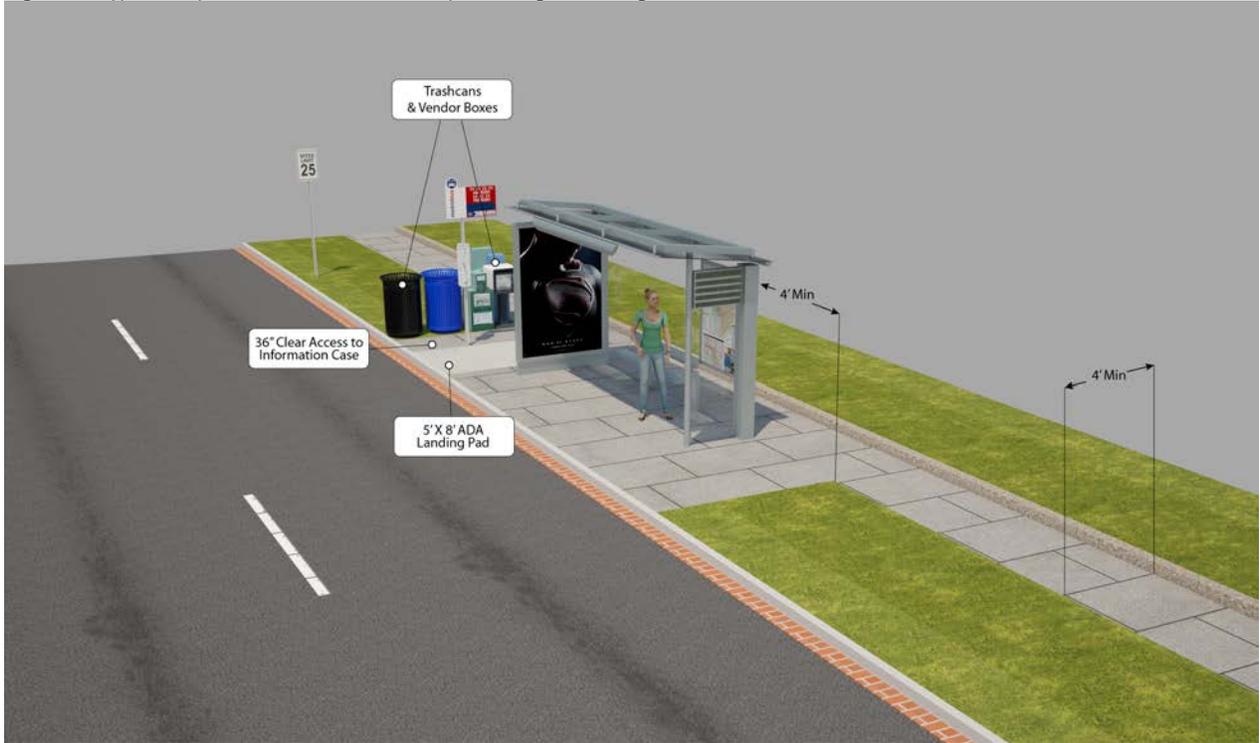
Figure 9: Typical Layout of On-Street Bus Stop Passenger Waiting Area

Typically, the passenger waiting area should be connected to streets, sidewalks, and the rest of the public space by a clear pathway that is at least four feet wide. The waiting area should also provide an ADA-compliant passenger landing area (clear of obstructions) that is at least eight feet by five feet (8'x5') (Figure 9).

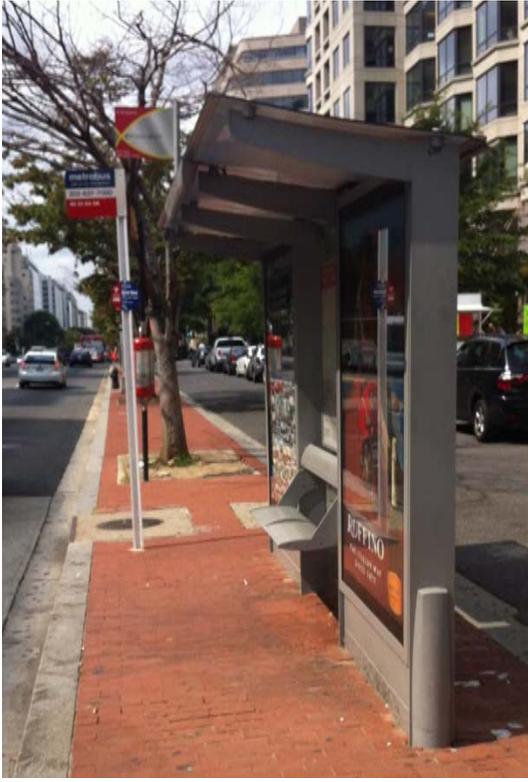
Figure 11: Narrow Three-Panel Shelter

- The narrow three-panel shelter, which is approximately 14 feet long, three feet wide, and eight feet tall (Figure 11).
- The standard three-panel shelter, which is approximately 14 feet long, four and a half feet wide, and eight feet tall (Figure 12).

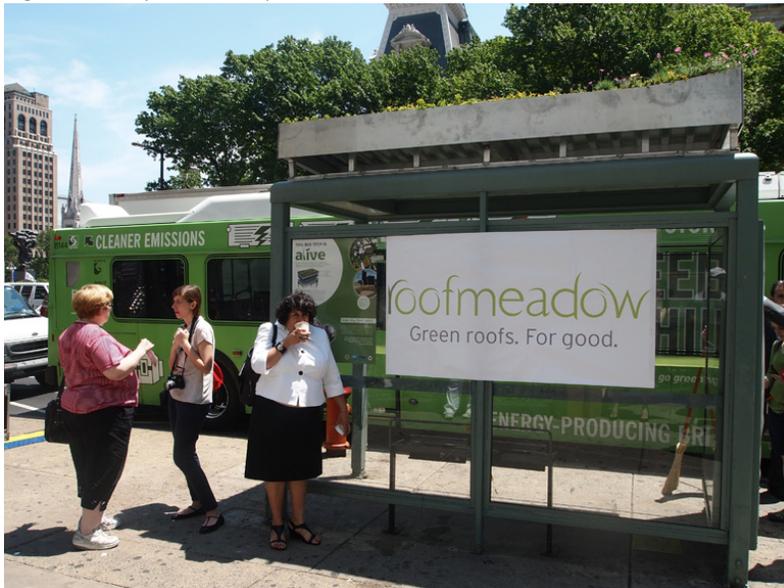
Figure 15: City of Philadelphia and SEPTA Shelter Green Roof Demonstration

Photovoltaic cells on the roof may or may not capture and store enough power to operate all the electrical components of the bus shelter, but can at least reduce the electrical power consumption of each shelter.

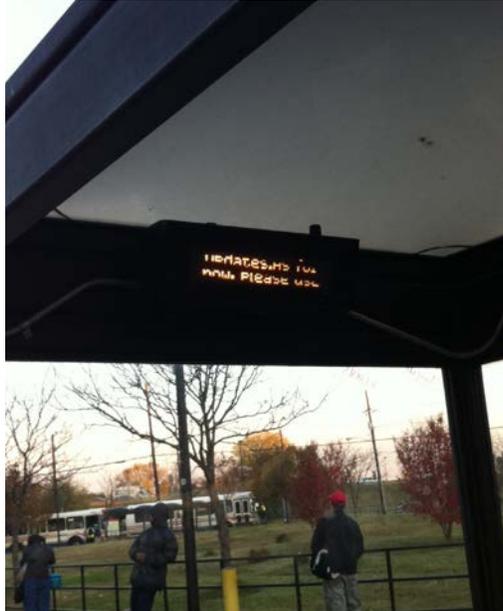
Figure 19: DMS at Anacostia Station

According to the *WMATA Design Guidelines*, all stops that can be classified as enhanced service or transit center require Next Bus information delivered through LED dynamic message signs (DMSs) (Figure 19) and/or Next Bus push button audio boxes (Figure 20). This study recommends that all shelters should accommodate the facilities, or at least supporting infrastructure, to allow the provision of the DMSs and the Next Bus audio boxes.

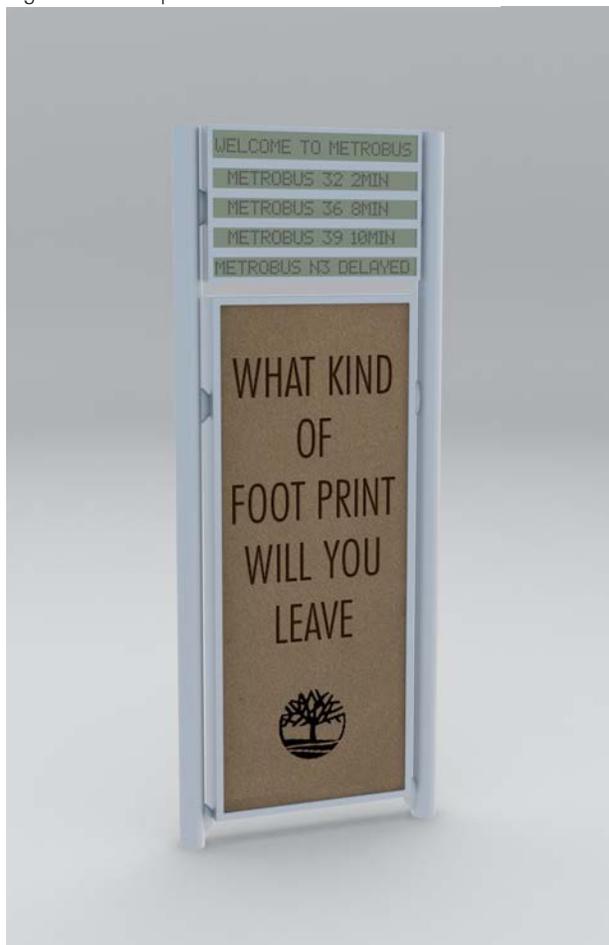
Figure 21: Sample 1 - DMS on Panel Structure

In some cases, physical or regulation constraints may not allow for a shelter to be installed at a bus stop, yet high ridership values could demand the provision of real-time passenger information. Real-time passenger information can be provided using DMS on structures that require less of the passenger area footprint than a bus shelter. For instance, an electrified panel structure could be used that provides real-time passenger information (using DMS) at the top and has room for system maps or advertisement at the bottom (Figure 21 and Figure 22). The panel structure would be illuminated, which would also help provide additional lighting (if needed) for the passenger waiting areas at night. Allowing the bottom half (or $\frac{3}{4}$) of the panel available for advertisement provides the flexibility for revenue generation that could cover the cost of the manufacturing and installation of the structure.

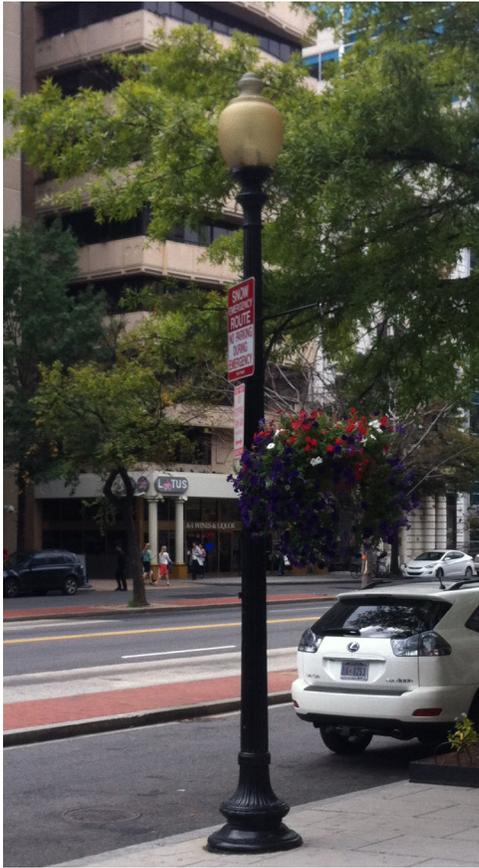
Figure 23: Typical DC Street Light Design

According to the *WMATA Design Guidelines*, transit stops should be located within 30 feet of an overhead (street or ambient) light source (Figure 23).

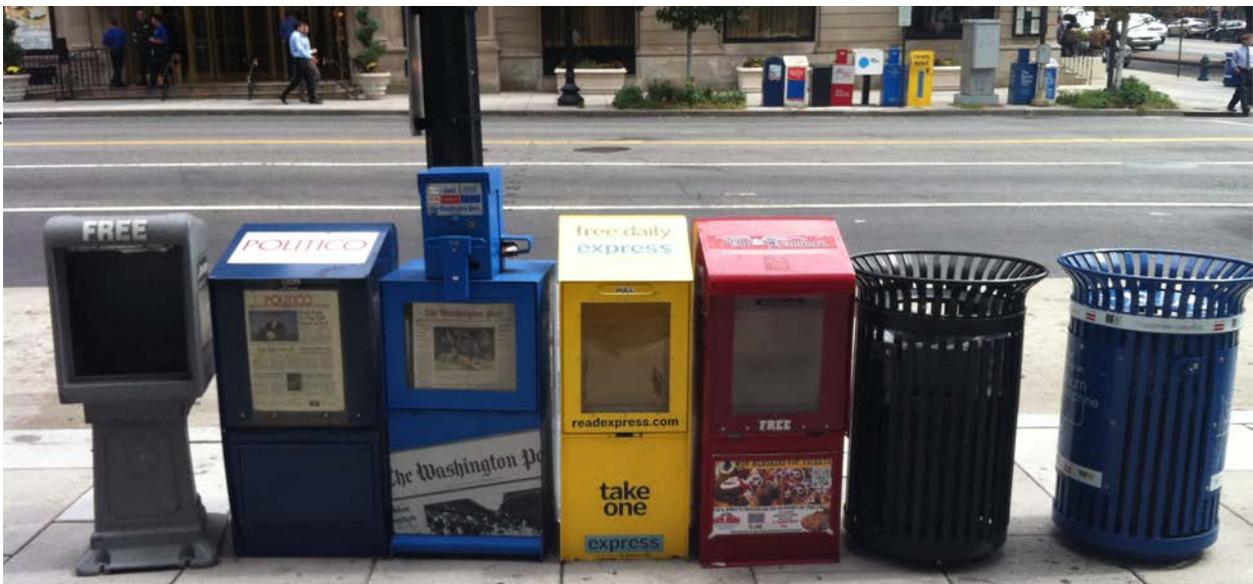
Figure 24: Typical Downtown Washington DC Vendor Boxes and Trash Receptacles

The *WMATA Design Guidelines* indicate that both trash receptacles and vendor boxes must be organized and located to prevent obstruction of pedestrian circulation or the movement of bus passengers (including ADA accessibility). The trash receptacles installed at or near the bus stop should resemble the surrounding street furniture owned and maintained along the corridor or neighborhood (Figure 24). Vendor boxes are typically provided along the curbside space.

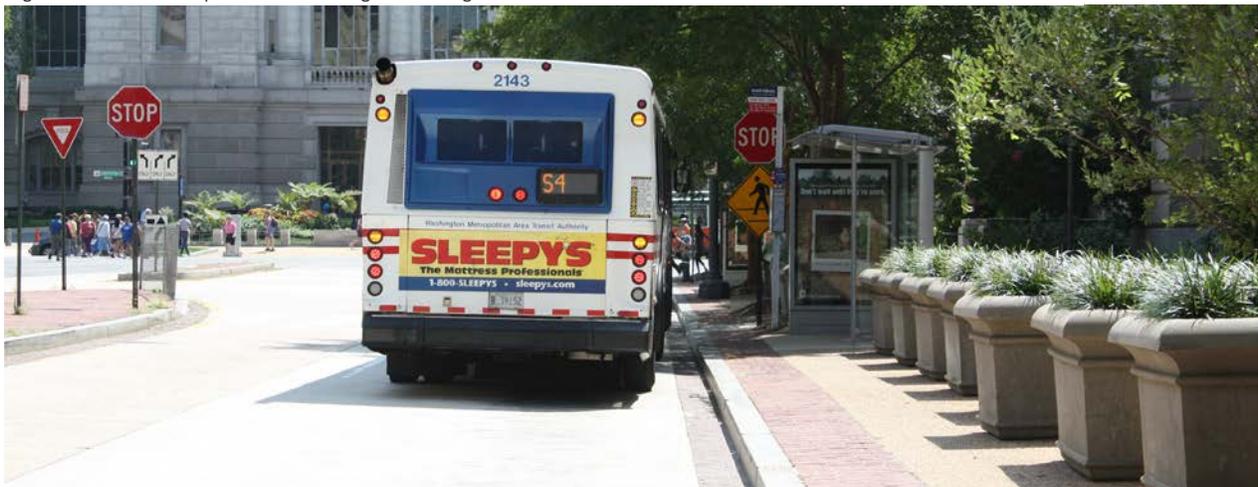
Figure 28: Limited Space for Passenger Waiting Area at 10th Street NW

The largest concern at the stops along 10th Street NW is related to the accessibility to and from the bus passenger waiting area. The presence of unevenly located planters and limited circulation space around the existing bus stops are obstacles in providing an ADA-compliant transit facility at this location (Figure 28).

Particularly on the west sidewalk, the spacing between the planters and the curb does not provide enough space to accommodate an 8’x5’ ADA-compliant landing area (Figure 28). If bus stops that provide ADA-compliant amenities would be recommended in the future, the relocation and/or reorganization of the planters should be considered.

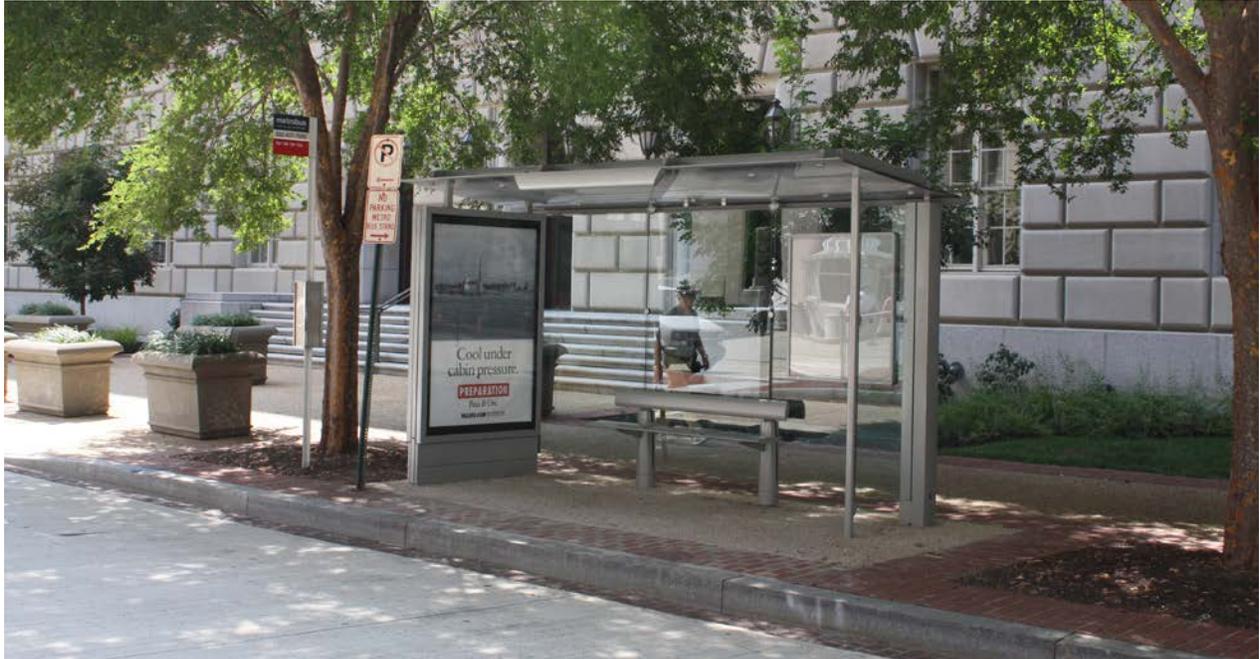
Figure 29: Standard Shelter at Stop 1003691

The current placements of the bus shelters do not provide accessible pathways, with the exception of the shelter at stop 1003287. Stop 1003691 (Figure 29) does not provide an 8’x5’ clear space in the passenger waiting area nor does it provide a bus information case that is ADA-compliant access. In the future, all placements of shelters should provide ADA-compliant infrastructure.

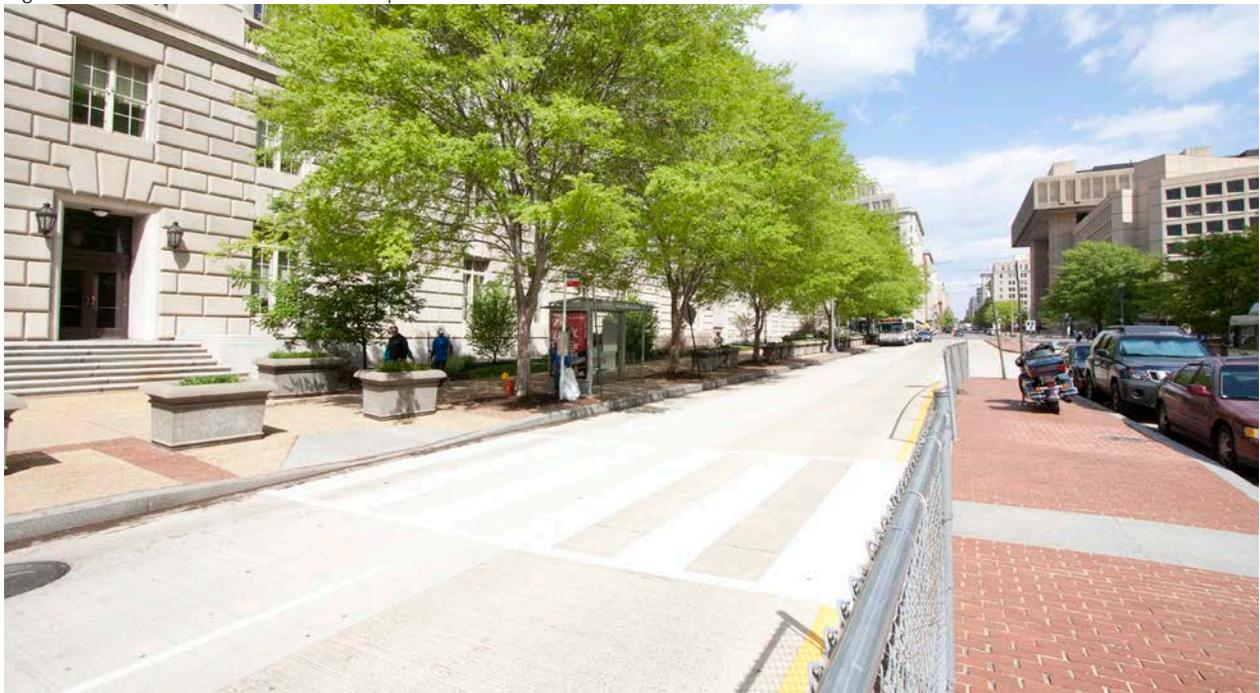
Figure 30: Pedestrian Crosswalk at Stop 1003691

Conflicts between pedestrian and bus circulation is a safety concern at 10th Street NW. If the location grows into a major bus layover and turnaround point, a high volume of bus circulation may increase the number of conflicts with pedestrians, especially at mid-block crossings such as the one shown in Figure 30.

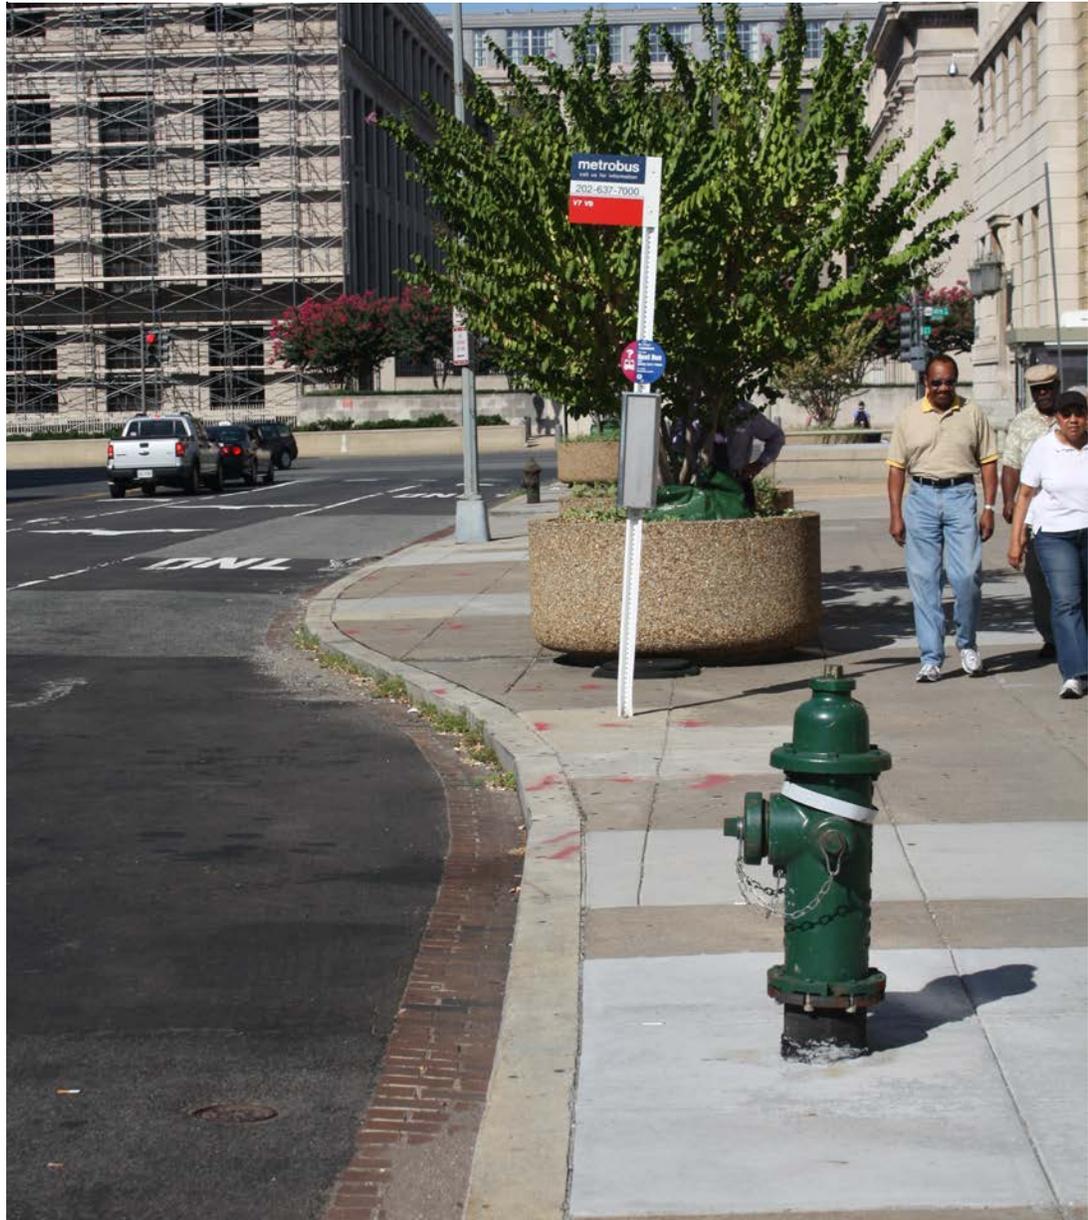
Figure 34: C Street SW Stop 1000692

Both stops at C Street SW were classified as basic stops. Although they were both classified as basic stops, stop 1000692 requires a shelter due to the higher number of daily boardings.

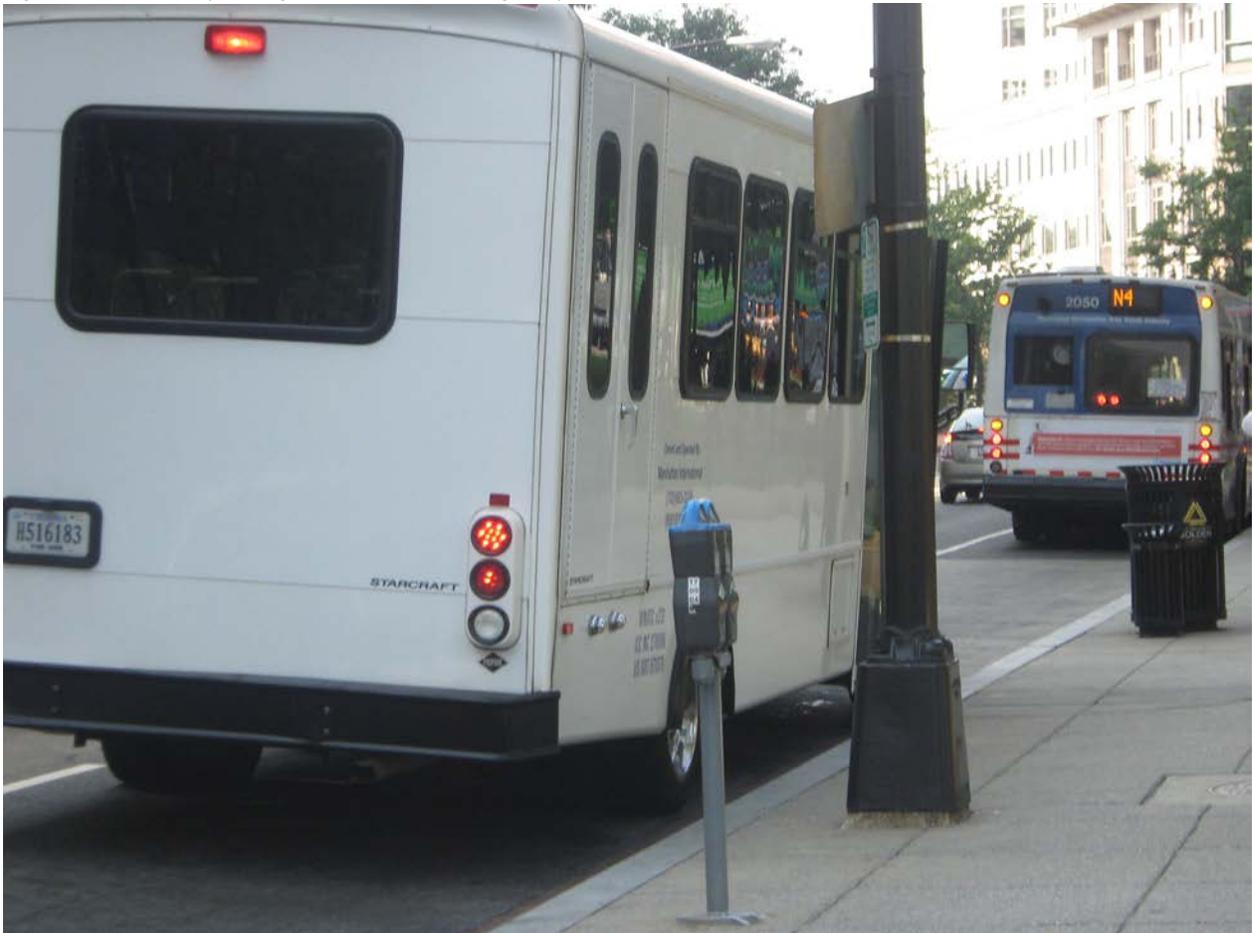
Figure 41: Shuttle Operating in Bus Zone at Farragut Square

With the exception of the stop 1001212, all the stops at Farragut Square have enough space to accommodate the required bus zone, but the presence of confusing street signs do not clearly indicate the extent of the bus zone at each stop. The lack of definition of the bus zone leads to the presence of other users (e.g., shuttles operating in the bus zone of stop 1001193) in the bus zone (Figure 41), which obstruct the efficient and safe operation of the buses.

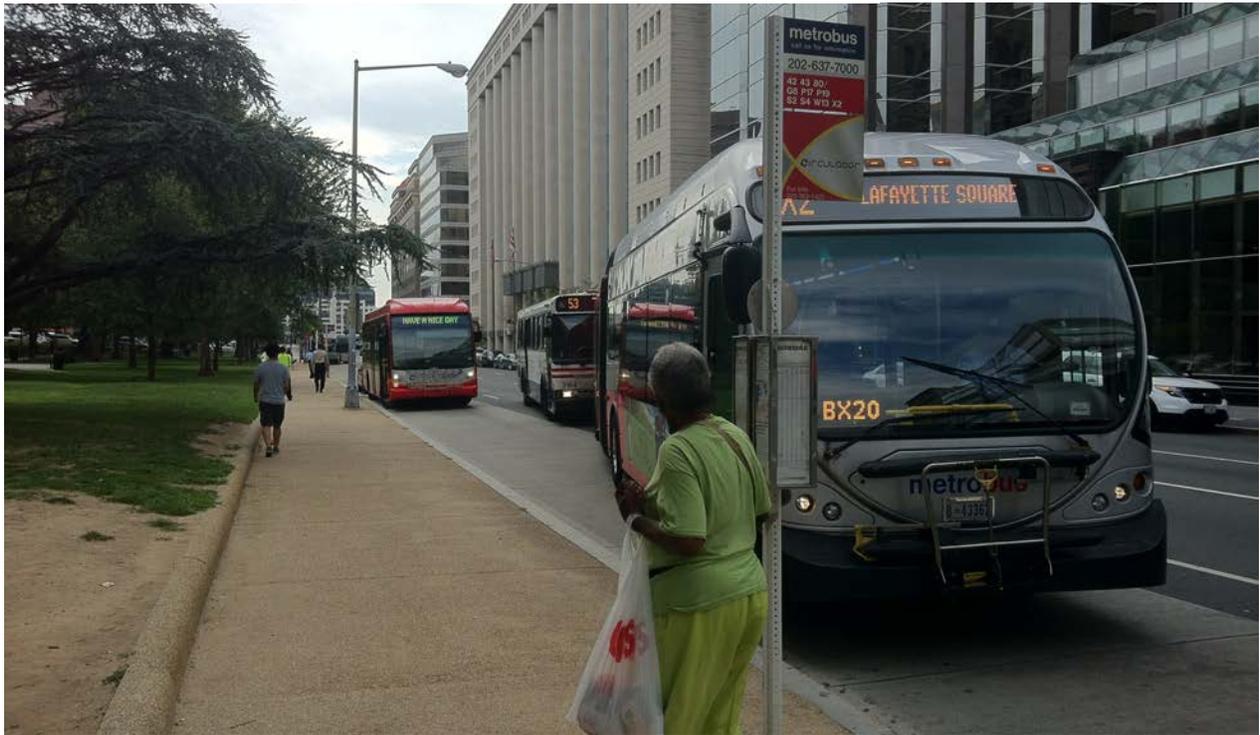
Figure 52: Congested Bus Operation at the Corner of I and 14th Streets NW

One of the major concerns at Franklin Square is the lack of passenger amenities along I Street NW even though a high volume of bus service and operation take place. The lack of passenger amenities distributed evenly along the entire block of I Street NW (on Franklin Square) leads to the congested and unsafe operation of both passengers and buses at the corner of I and 14th Streets NW (Figure 52).

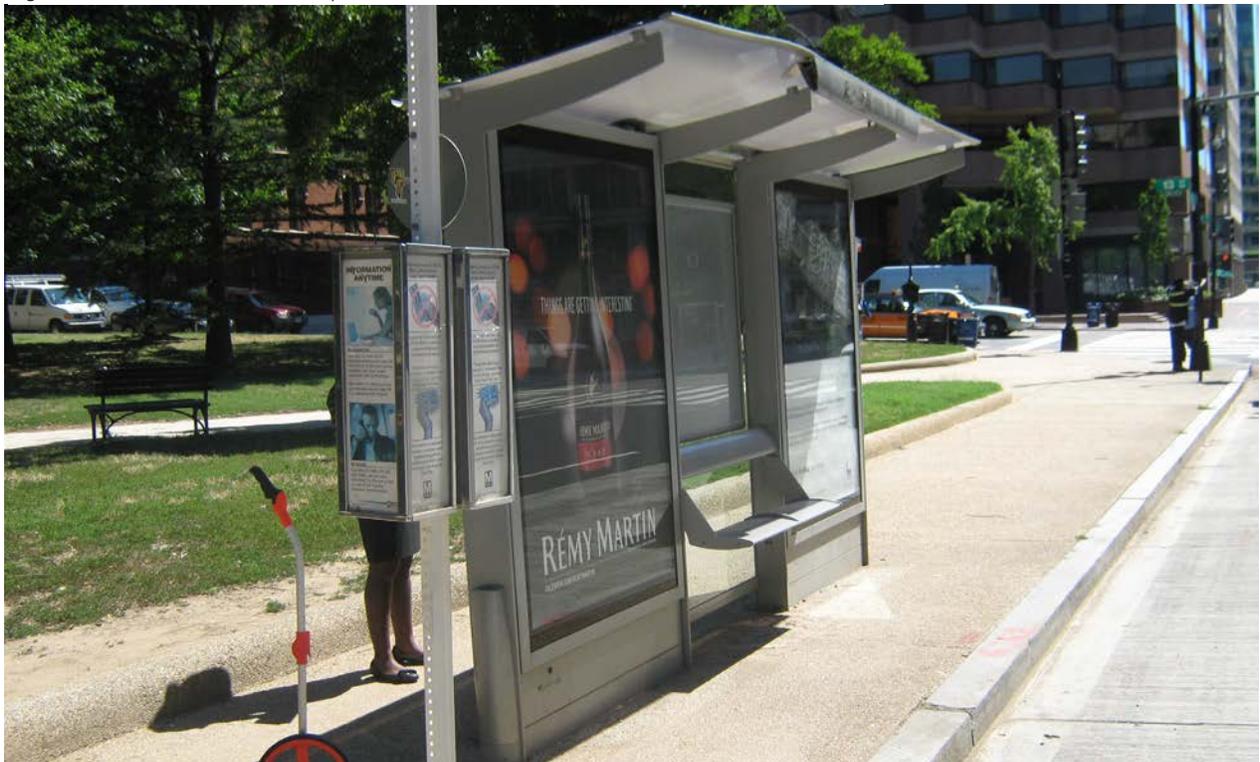
Figure 53: Narrow Shelter at Stop 1001187 on I Street NW

The majority of the stop locations along Franklin Square accommodate sidewalk space to provide ADA-compliant amenities (if needed) in the future. One accessibility concern lies with the possible provision of multiple shelters along I Street NW. The placement of standard three-panel shelter(s) may obstruct the mobility along the I Street NW sidewalk, as the existing narrow bus shelter provides evidence that a full-size shelter on the existing sidewalk would not allow for ADA-compliant clear pathways (Figure 53).

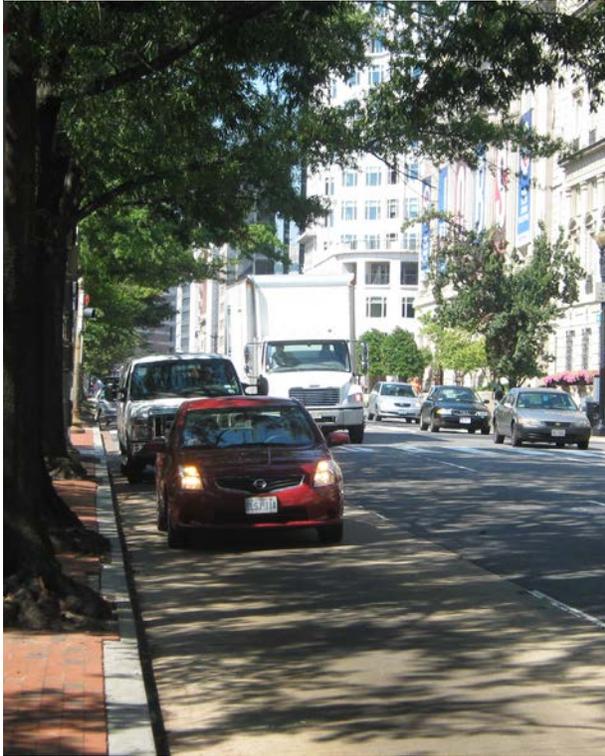
Figure 57: Non-bus Vehicles Use of Bus Zone

The bus zone of stop 1003702 is often overcrowded with buses that are laying over (mostly X2) and buses that are trying to operate at stop 1001141. The congested operation at the bus zone leads to buses boarding and alighting passengers from the adjacent through lane, creating an unsafe environment for passengers. In addition, the cluttered street signs can

cause confusion in determining the extent of the bus zone, which leads to the operation of other non-bus vehicles, which further congest the bus zone (Figure 57).

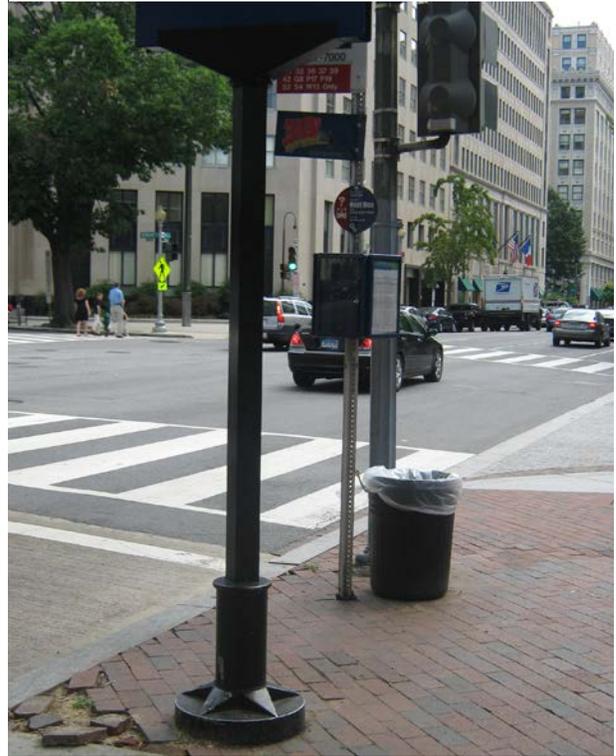
Figure 58: Uneven Pacers at Stop 1001141

One particular safety concern around the passenger area is the brick paved sidewalk. As seen on Figure 58, the brick pavement is in poor conditions along some areas of the sidewalk adjacent to the bus stops. The uneven sidewalk surface creates a hazardous environment for both pedestrian and passenger activities.

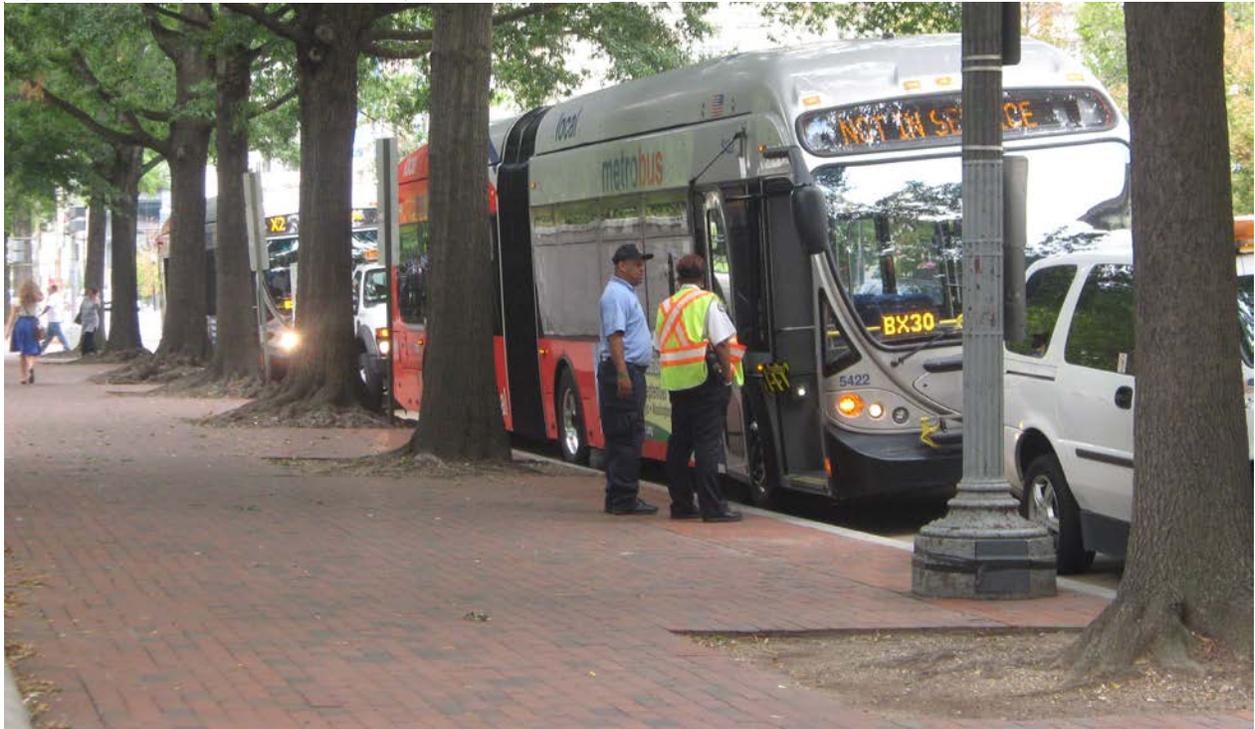
Figure 59: Existing Sidewalk and Passenger Landing Area

The existing sidewalk space provides enough room to accommodate the minimum four feet wide passageway and the 8'x5' landing areas at both stops (Figure 59).

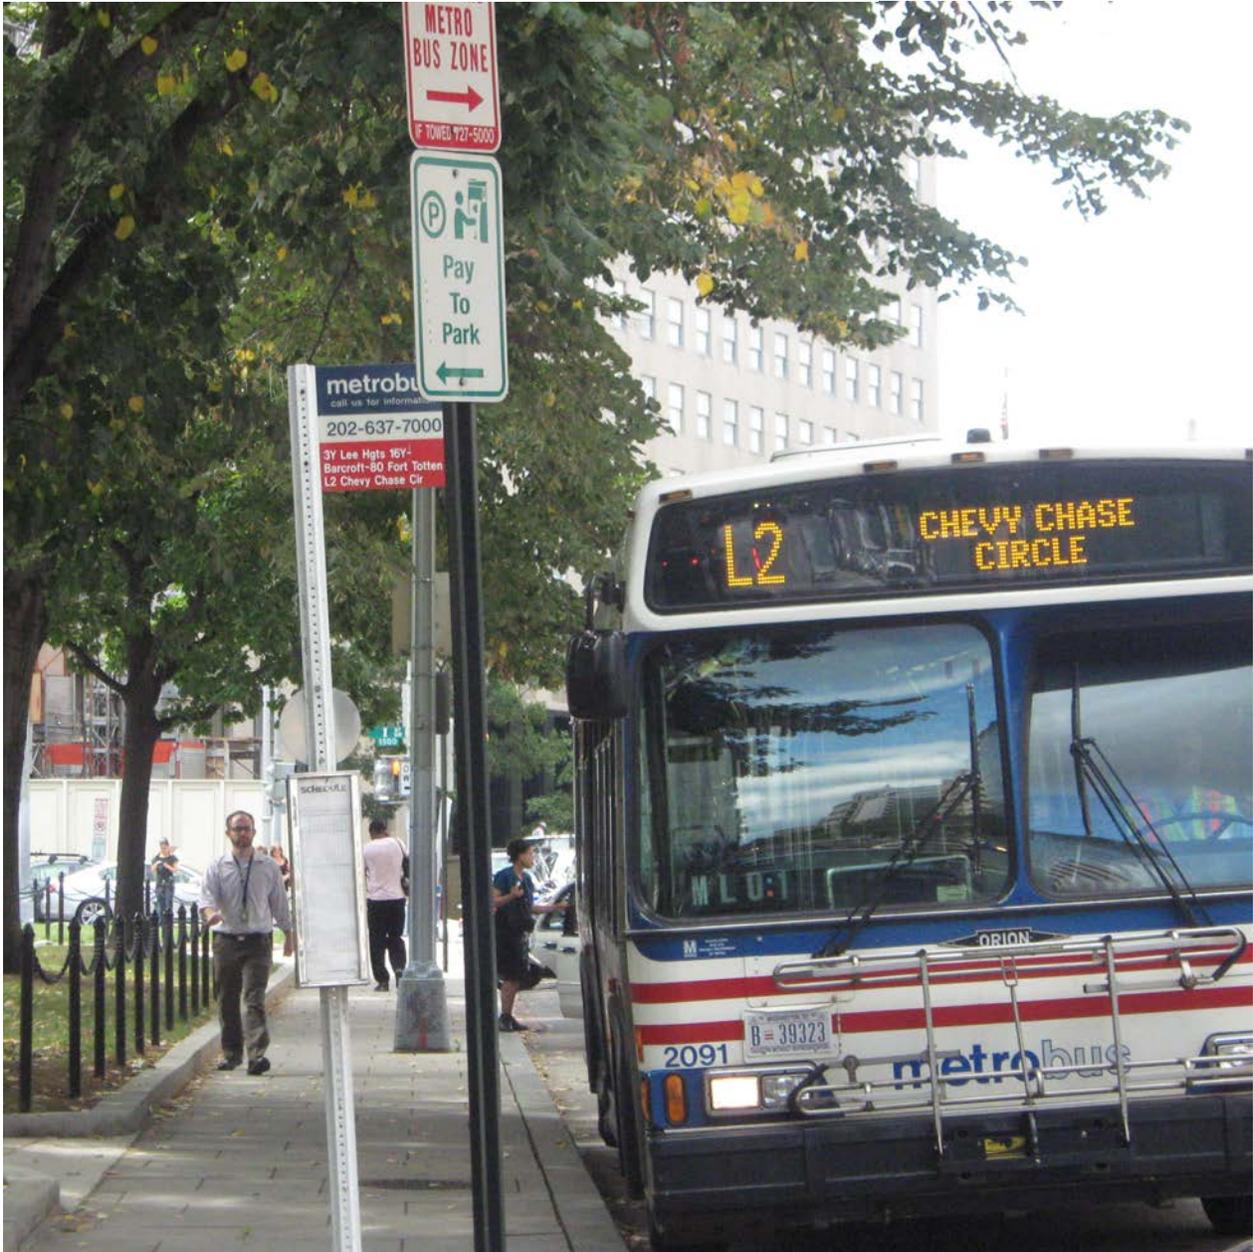
Figure 66: Sidewalk Along 15th Street NW [east]

The sidewalk along I Street NW provides ample sidewalk and space to allow for ADA-compliant amenities at stop 1001185. In contrast, the sidewalk along 15th Street NW [east] is quite narrow (less than seven feet) (Figure 66), which may require creative solutions to accommodate additional amenities for stop 1001199.

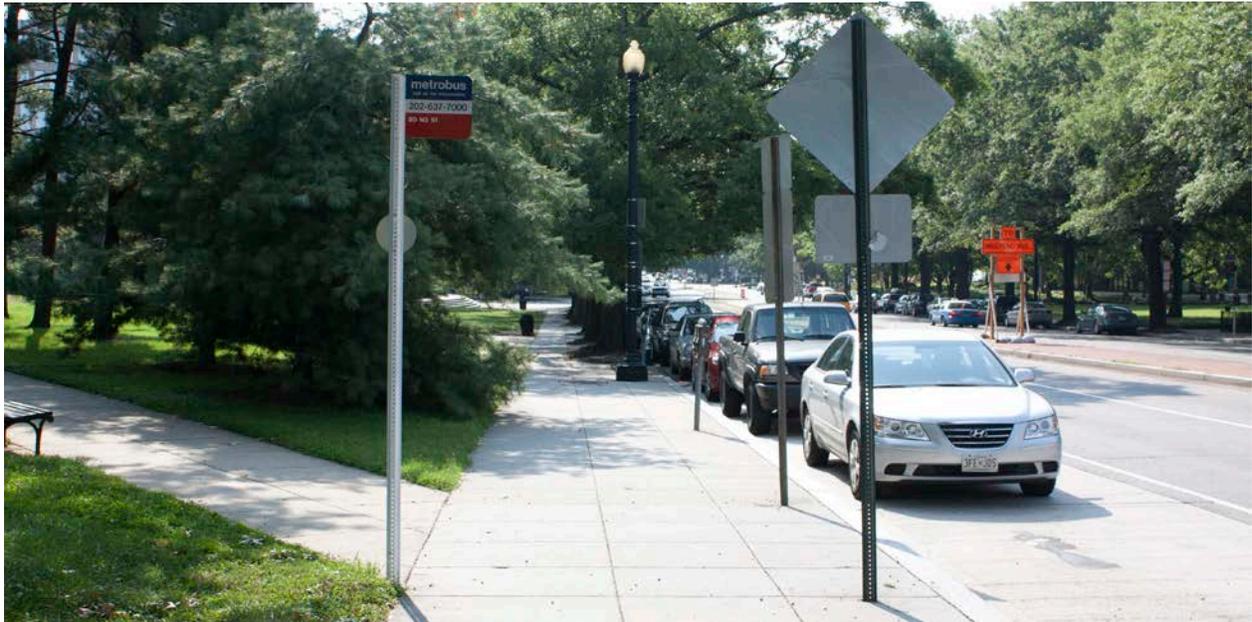
Figure 70: Parking Zone Overlapping with Bus Zone along Virginia Avenue NW

Under existing conditions, the bus zones for stops 1000983 and 1001021 overlap with metered parking zones that, as marked, are only available during non-peak hours (Figure 70). The street signs indicate that the bus zones are utilized as parking zones from 9:30 AM to 4:00 PM (typical weekday), but the 80 route operates all day and requires access to the stops at all times. Buses were observed stopping in the adjacent through lane when parked vehicles were obstructing the curb; a potentially unsafe practice that the bus operators are forced into by the presence of the cars.
