ON-STREET BUS TERMINAL STUDY

Washington Metropolitan Area Transit Authority

March 2013

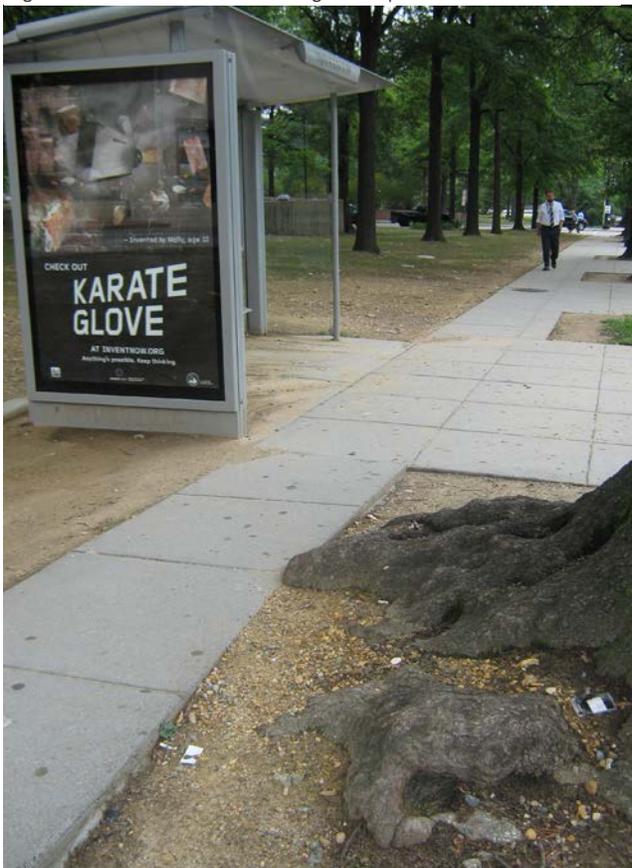
Figure 71: Sidewalk Connecting to Stop 1003537

At Potomac Park, field observation identified an accessibility issue along the sidewalk connecting to stop 1003537. On the eastbound approach to the existing shelter, the sidewalk is less than four feet wide and uneven due to the large tree roots growing beneath (Figure 71).

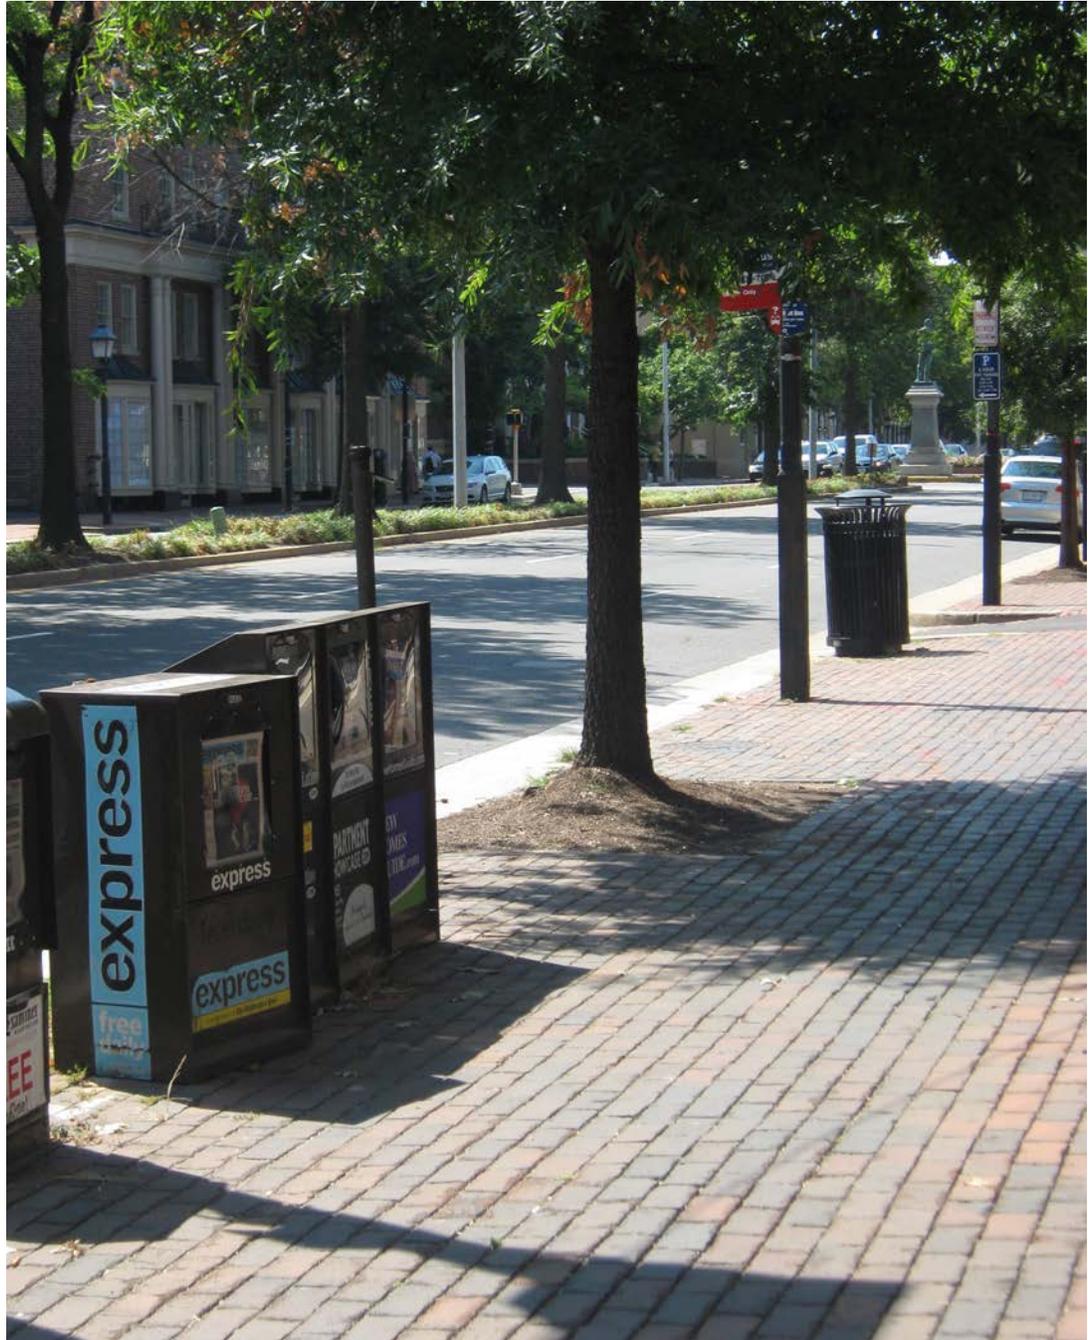
Figure 75: Sidewalk Brick Pavers at Stop 400026

In general the curbside spaces along the bus stop areas are very crowded. Currently, there is plenty of sidewalk space to provide the four feet minimum passageway around the stop, but the future provision of ADA-compliant shelters and other amenities within the limited curbside space may be difficult. In addition, the brick paved sidewalks may cause accessibility difficulties especially for vulnerable users (Figure 75).

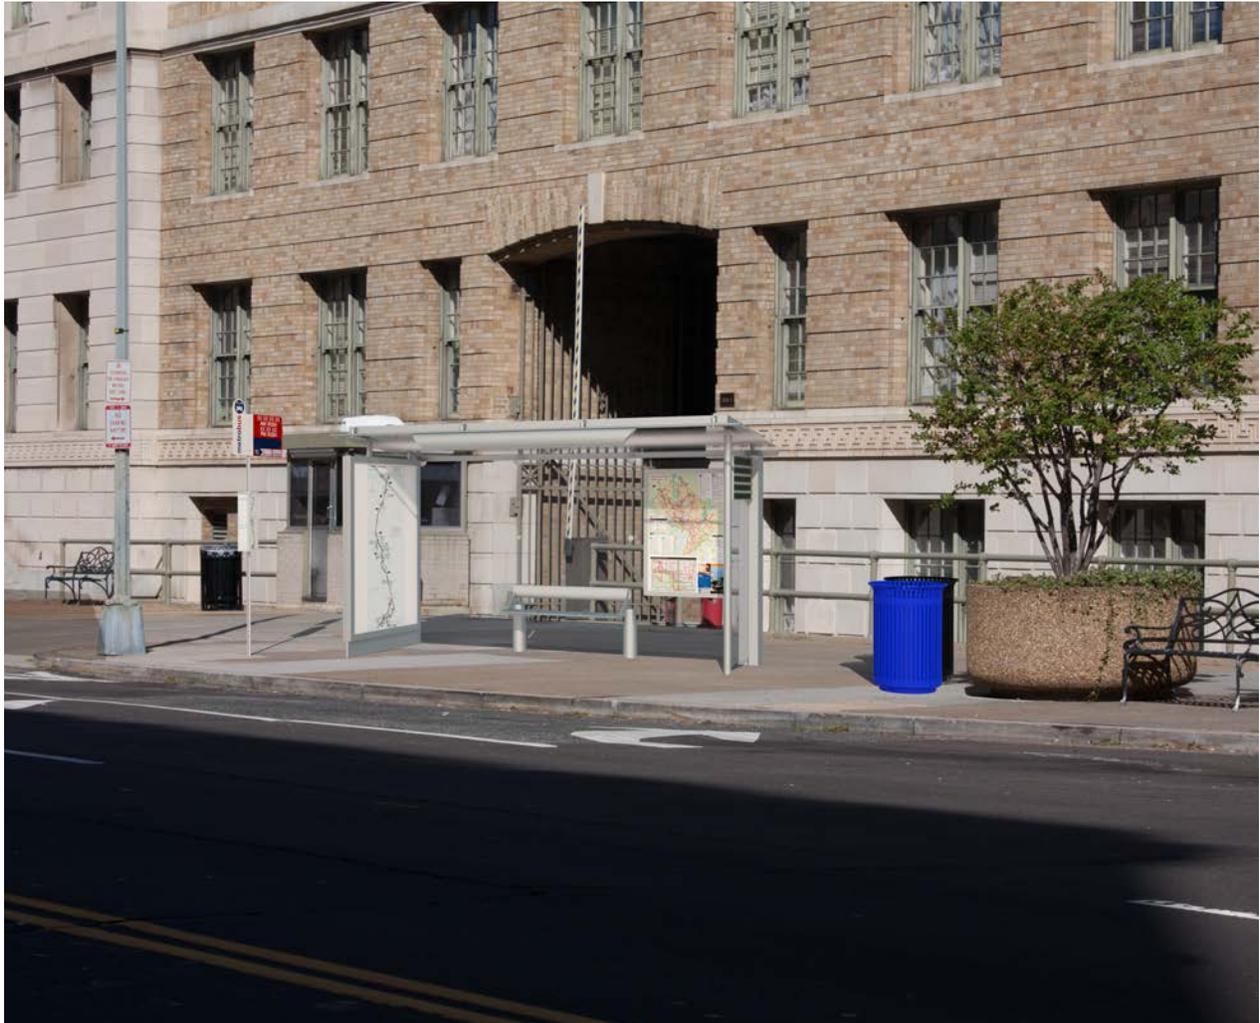
Figure 78: Proposed Shelter Configuration at Stop 1000692 on C Street SW

In addition, the installation of a new bus shelter and additional amenities required for a basic stop is recommend at stop 1000692 (located on the 14th Street SW end of C Street SW).

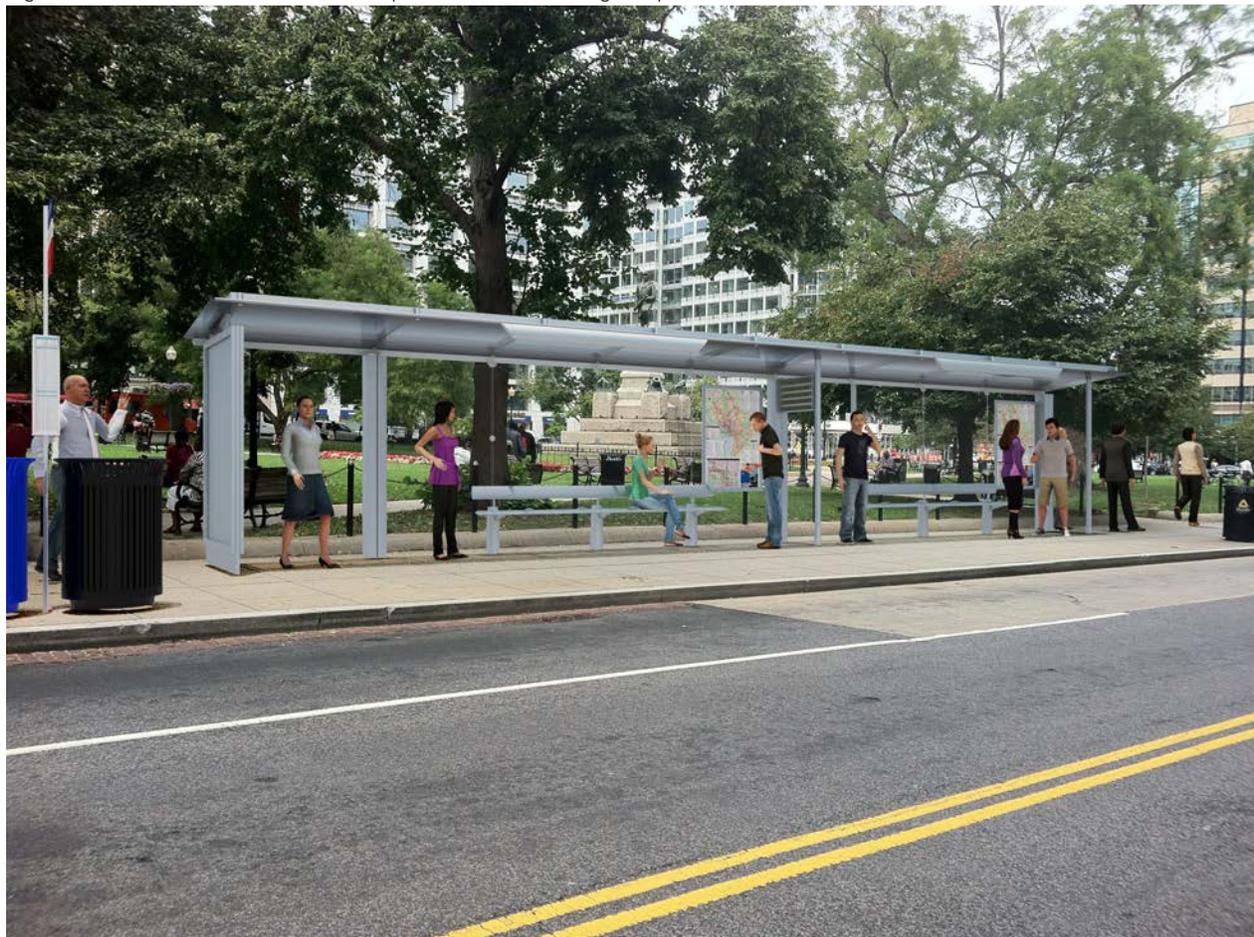
Figure 80: Custom-Sized Shelter at Stop 1001193 on Farragut Square

In addition, the study recommends the installation of two standard three-panel shelters (or a custom size shelter with similar capacity) at stop 1001193 (located on 17th Street NW [west] at I Street NW) and add a standard three-panel shelter at stop 1001183 (on I Street NW) just east of the existing shelter location.

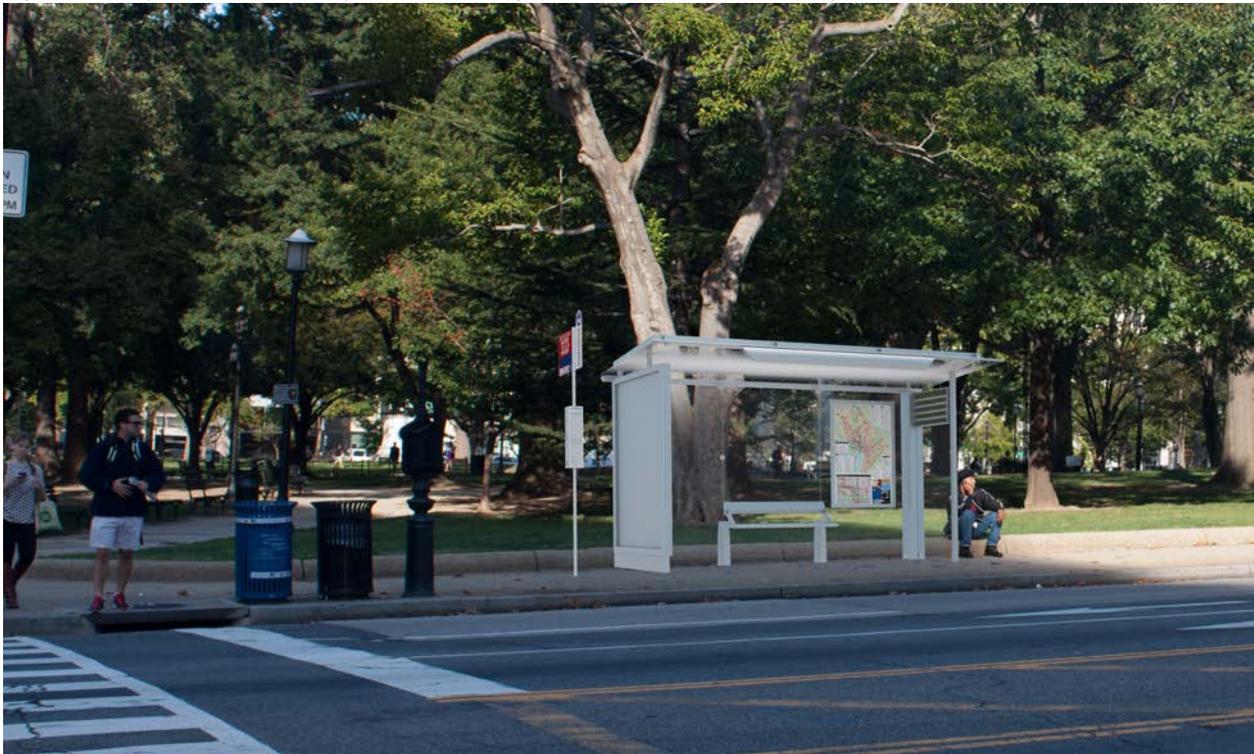
Figure 83: Proposed Shelter at Stop 1001190 Along 13th Street NW on Franklin Square

Similarly, boardings at stop 1001190 would warrant for the installation of a new standard three-panel shelter. Under the existing sidewalk conditions (approximately 11 feet of width) it is possible to install a standard three-panel shelter while allowing the adequate four feet of clear pathway along the rest of the sidewalk. The study recommends the installation of a shelter at stop 1001190 (Figure 83).

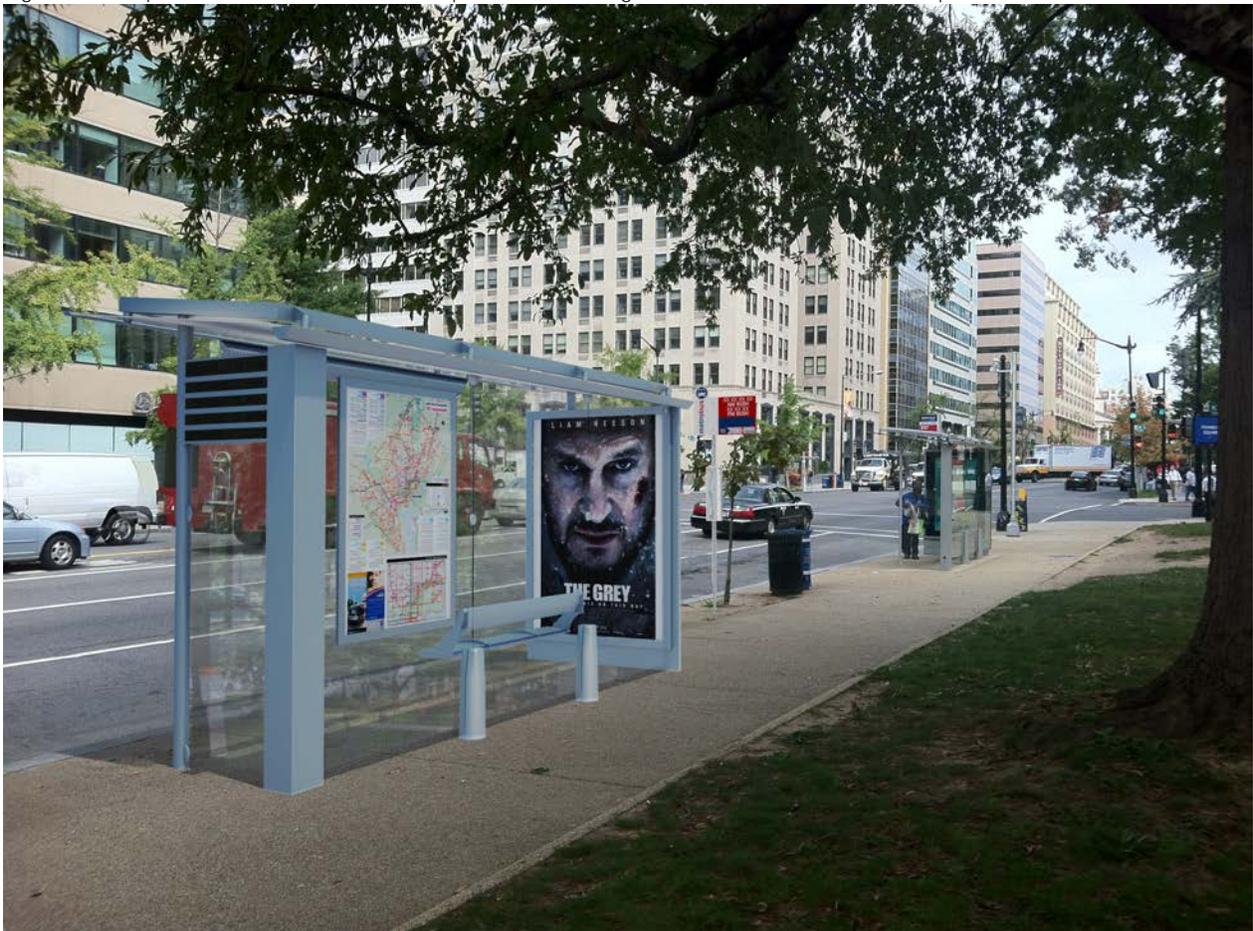
Figure 84: Proposed Additional Shelter at Stop 1001209 Along 14th Street NW on Franklin Square

In addition, a standard three-panel shelter is recommended at stop 1001190 (on 13th Street NW at I Street NW) and an additional standard three-panel shelter at stop 1001209 (on 14th Street NW at K Street NW) just south of the location of the existing shelter.

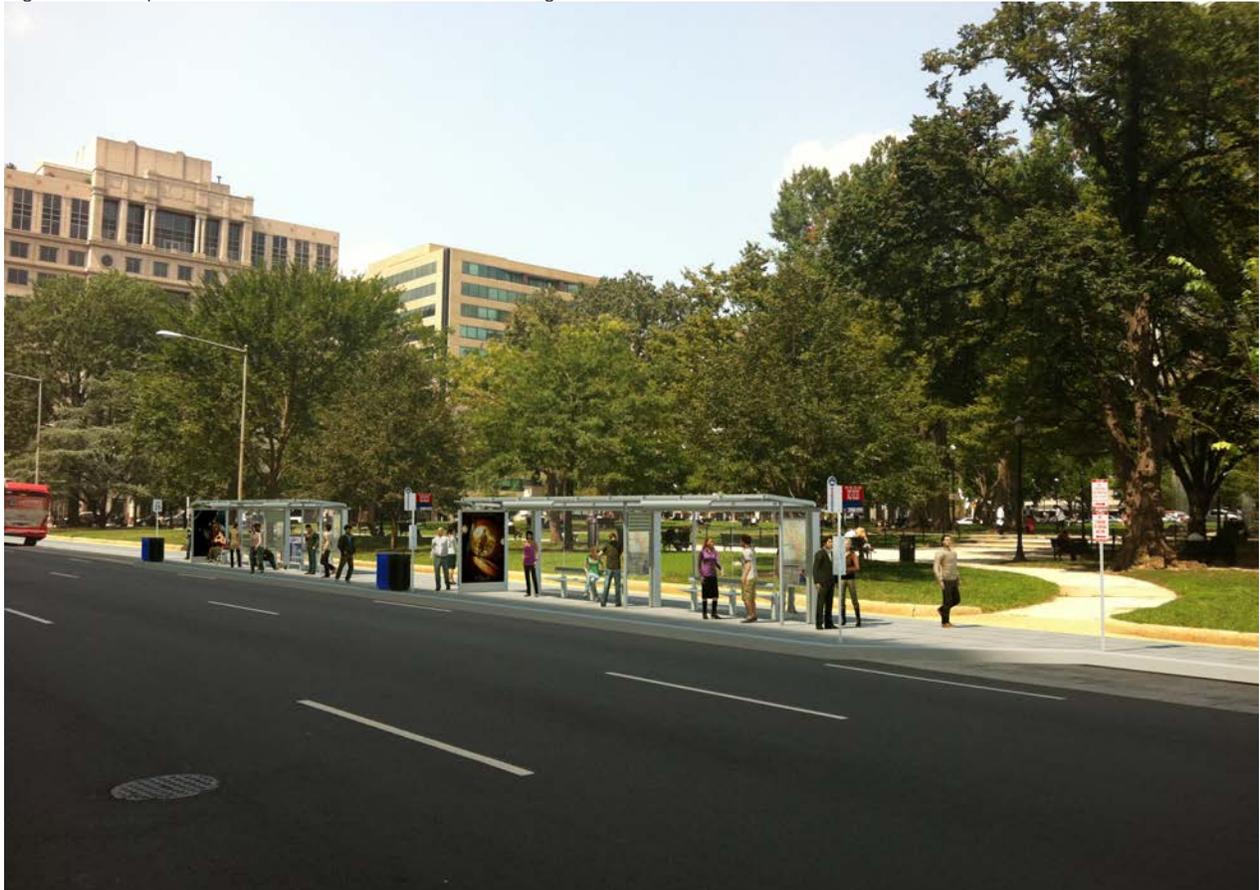
Figure 85: Proposed Curb Extension and Shelter Configuration on I Street NW

At Franklin Square, the most extensive recommended modifications would occur along I Street NW. A mid-block curb extension on I Street NW would accommodate transit center class passenger amenities. The existing five stops along I Street NW would be consolidated into three stops (stop number 1003653, 1003661, and 1003662).

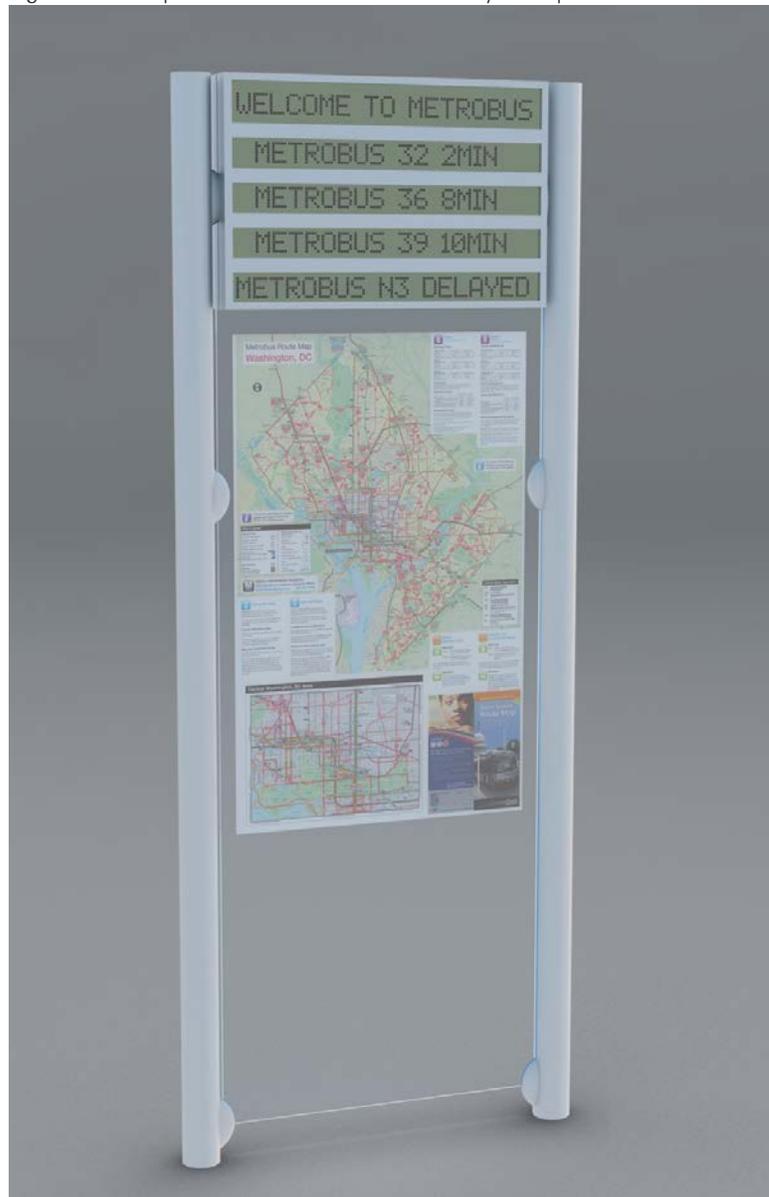
Figure 88: Sample DMS Panel Structure for Lafayette Square

A possible way to provide real-time bus information without having a shelter is to install a facility similar to the illuminated panel with DMS system presented earlier in Section 2 (Figure 88).

The passenger waiting area at Lafayette Square is not well lit due to the limited number of available street lights. The installation of the illuminated panel with the DMS system may provide additional lighting for the passenger waiting areas.

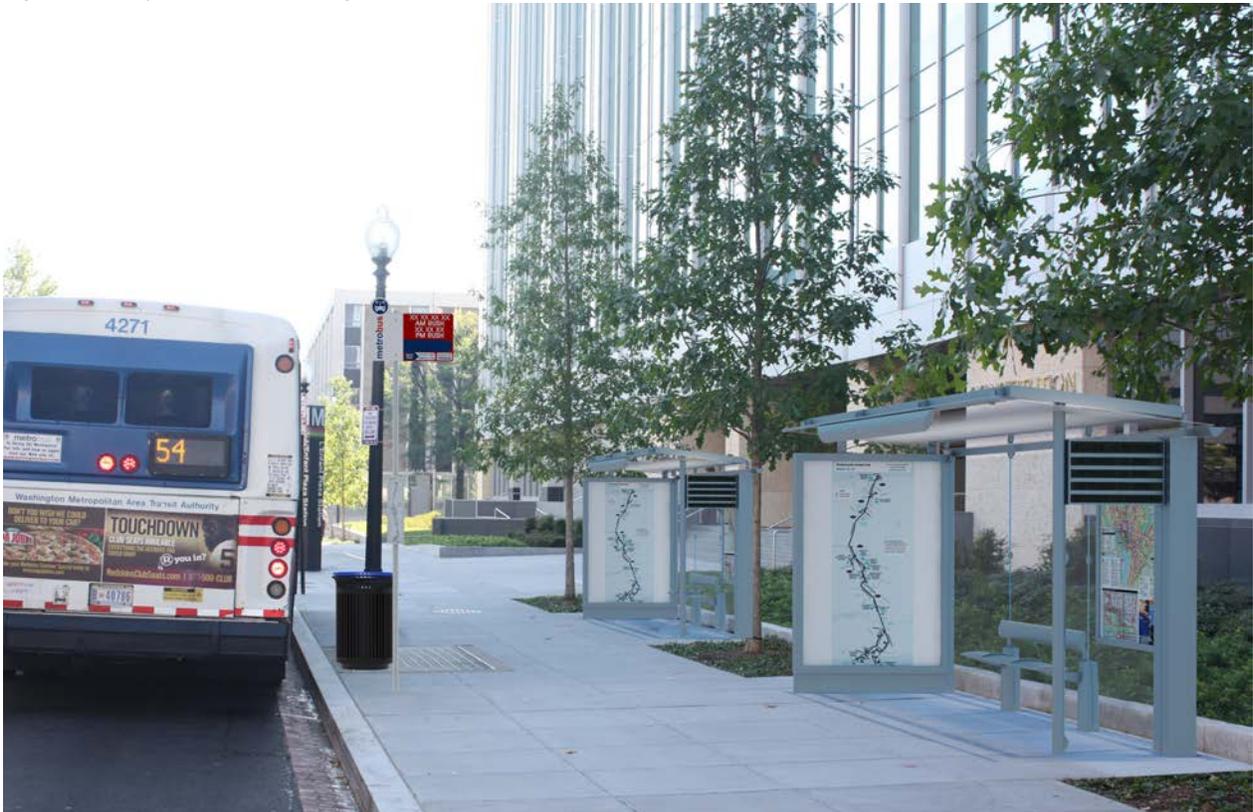
Figure 91: Proposed Shelter Configuration at L'Enfant Plaza

The study recommends the installation of two standard three-panel shelters at stop 1003665 (located on the south side of D Street SW).

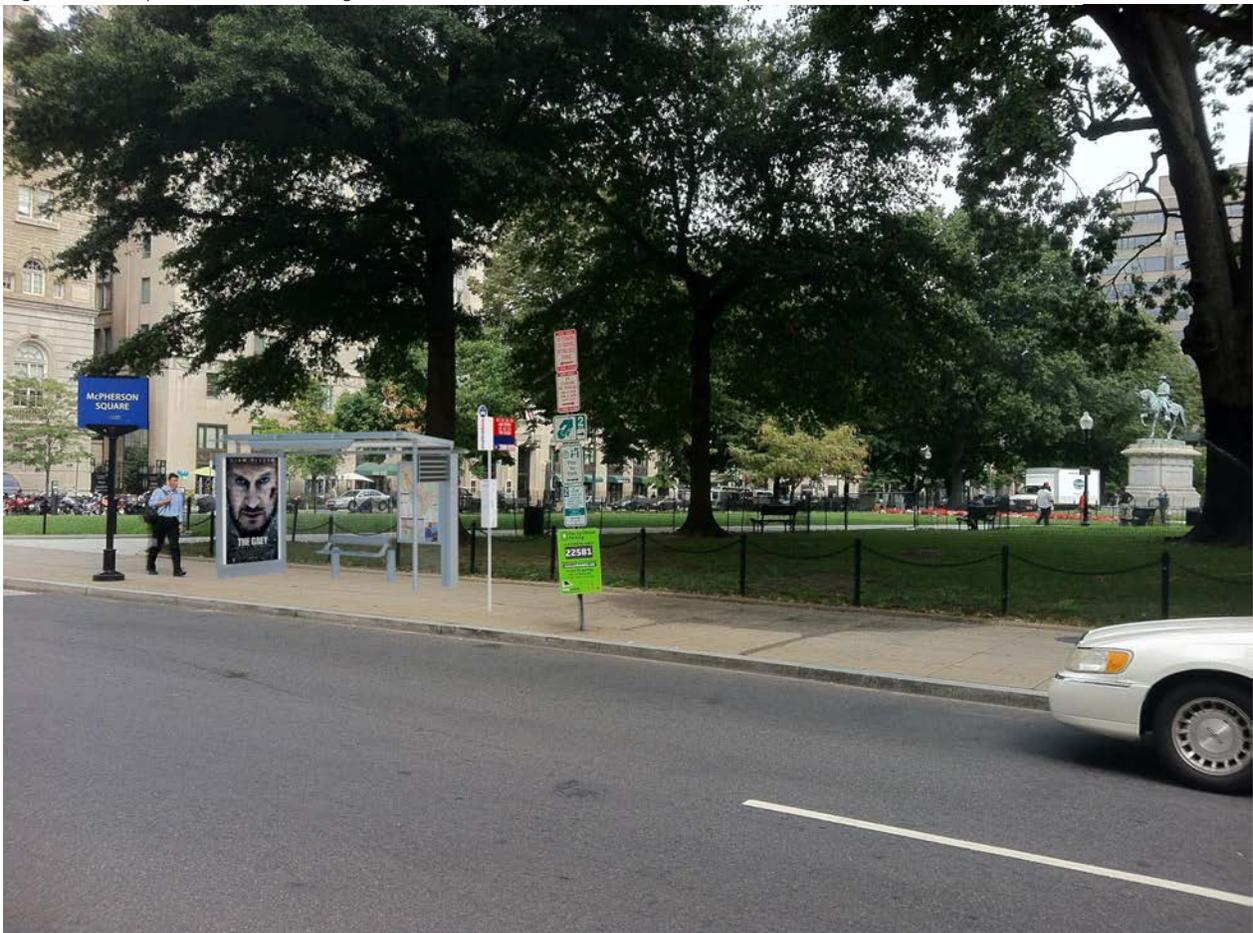
Figure 93: Proposed Shelter Configuration at I Street NW on McPherson Square

The proposed shelter at stop 1001185 would be located approximately 30 feet east of the existing shelter. The new shelter would be a standard three-panel shelter (Figure 93).

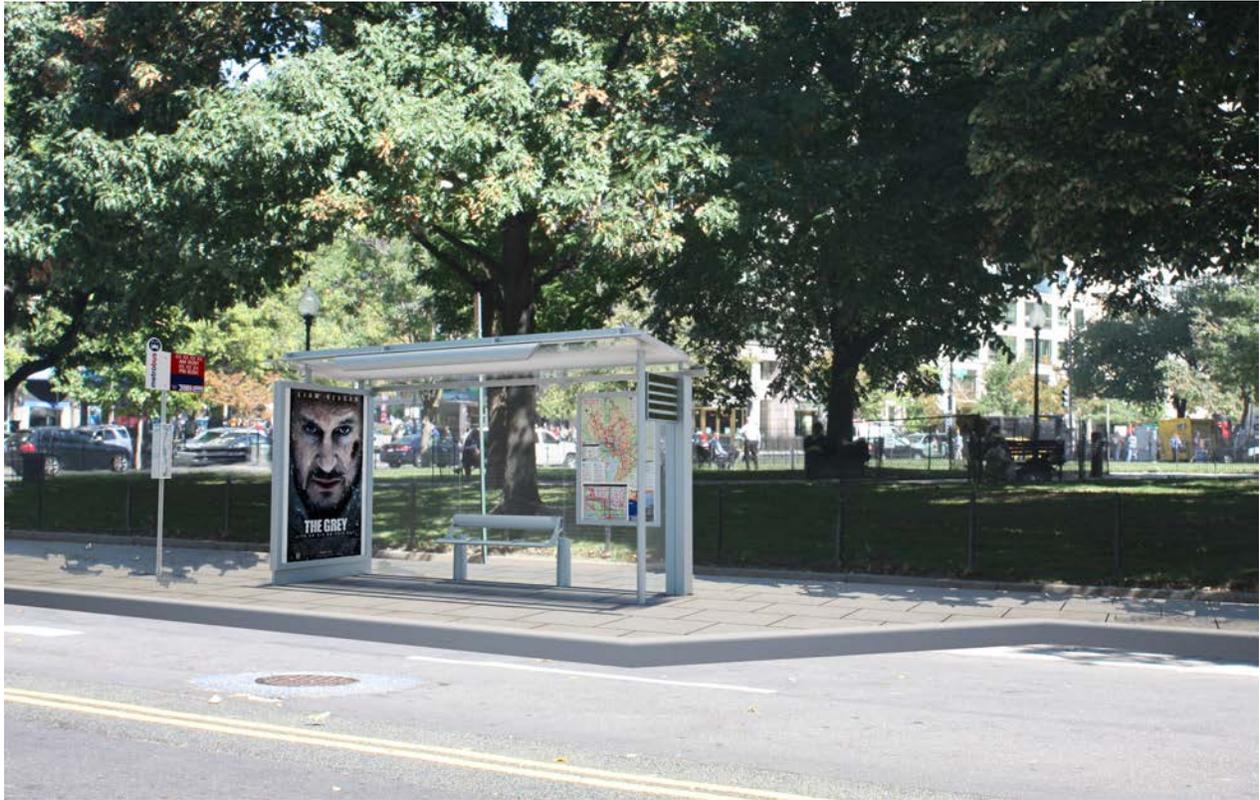
Figure 94: Proposed Shelter and Curb Extension Configuration at 15th Street NW [west] on McPherson Square

The study recommends the extension of the existing bus zone (approximately 20 feet north) of stop 1001199 (located on 15th Street NW [west] at I Street NW). The extended bus zone would also have a new curb extension that would provide enough space to accommodate a new standard three-panel shelter and the required four feet clear pathway along the sidewalk.

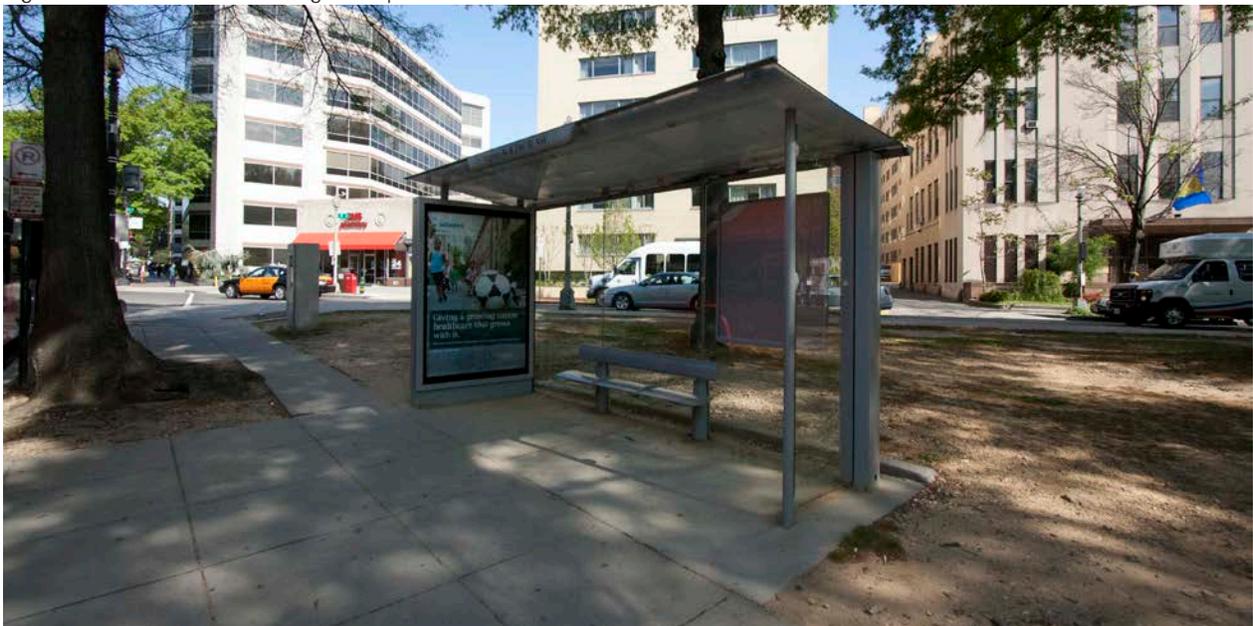
Figure 96: Sidewalk Connecting to Stop 1003537 at Potomac Park

In addition, the western sidewalk approach to stop 1003537 (located on Virginia Avenue NW at E Street NW) does not provide the four feet minimum clear pathway due to an obstruction caused by a large tree root growing in the adjacent tree box. The study recommends shifting the existing shelter several feet to the north and/or to the east to allow the expansion of the existing sidewalk to meet the required four feet minimum width.

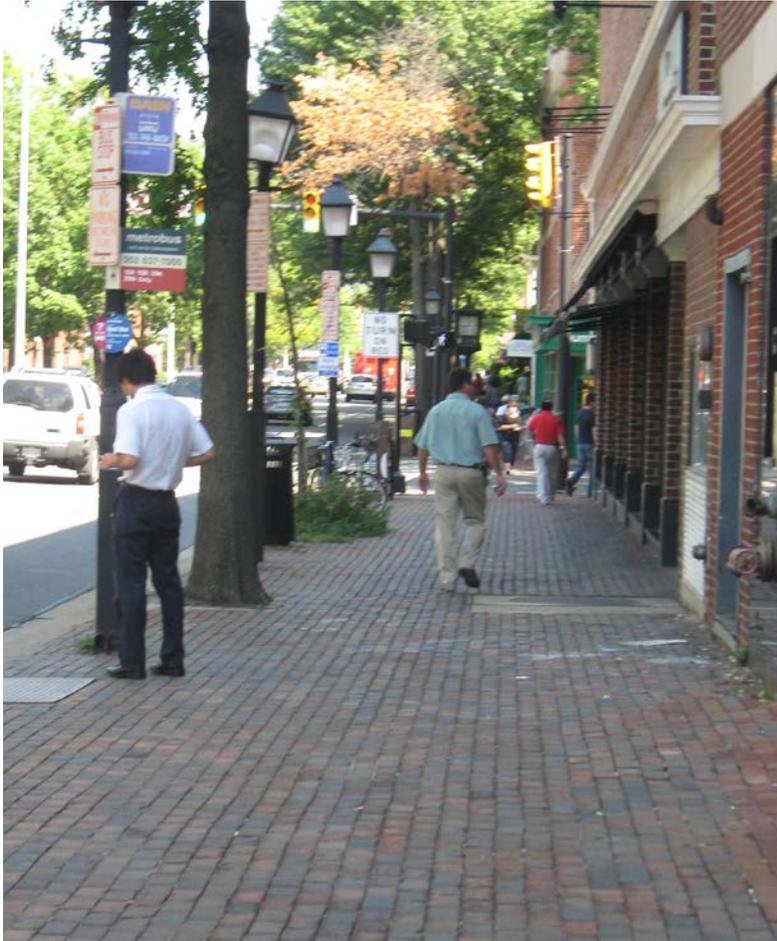
Figure 98: Stop 4000025 on Washington Street at King Street

The bus zone for stop 4000026 is limited to the existing 65 feet as it is physically constrained by King Street to the north and an alley driveway to the south. Due to physical restrictions in expanding the bus zone, stop 4000026 would have to continue operation at this non-standard far-side stop. The study recommends the installation of street signs that would explicitly indicate the bus zone, in addition to the existing no-parking street signs.
